Shoreline Situation Report Newport News, Virginia

Carl H. Hobbs III
Virginia Institute of Marine Science

Special Report In Applied Marine Science and Ocean Engineering Number 55
Chesapeake Research Consortium Report Number 10

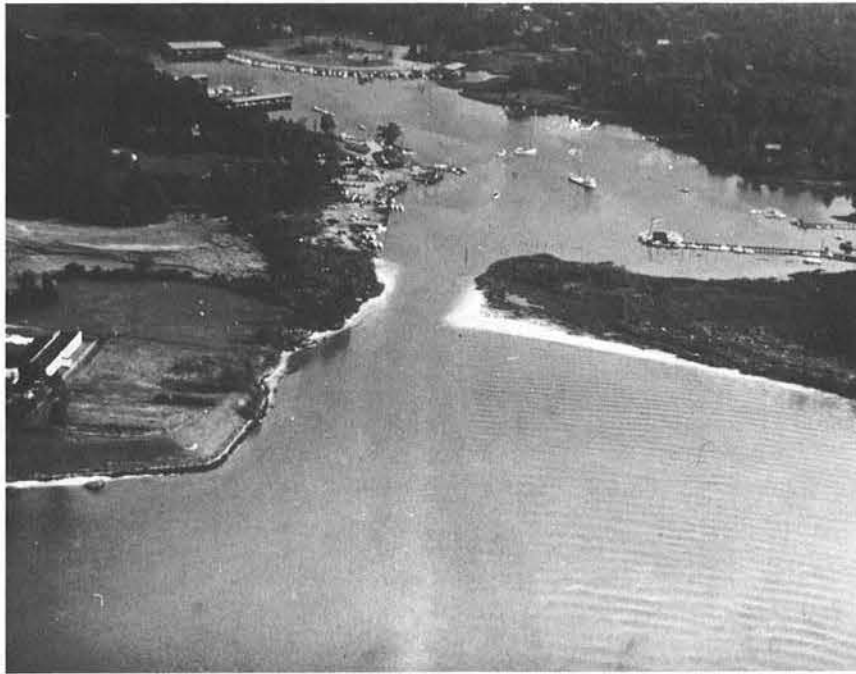
Figure 3

Figure 3: Deep Creek, a major commercial and pleasure boat harbor for the Newport News area.

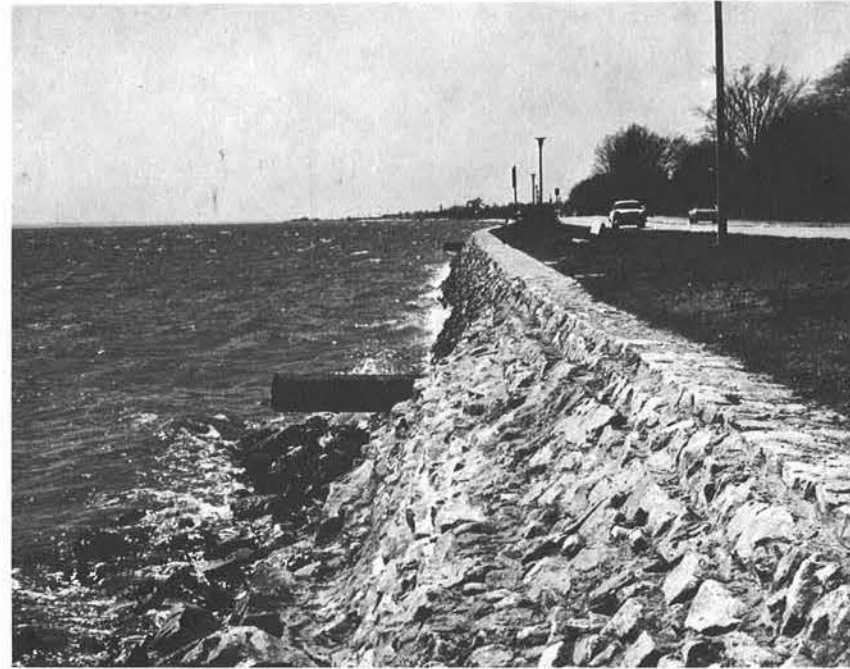
Figure 4

Figure 4: Seawall on Hampton Roads along Chesapeake Avenue near the Newport News - Hampton boundary. The pipes emerging through the wall are storm drains.

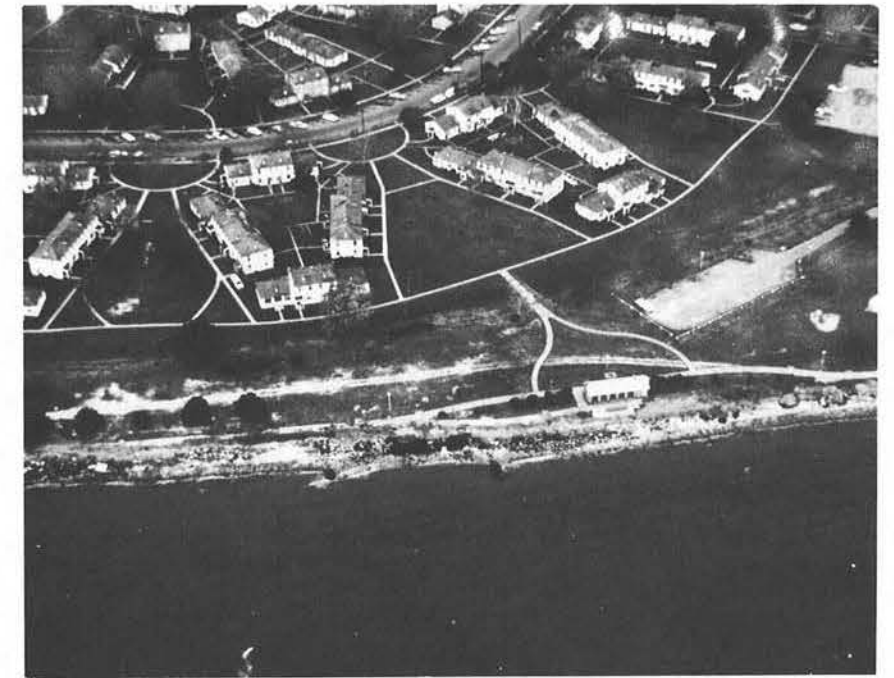
Figure 5

Figure 5: The virtually unprotected shoreline of Anderson Park in the Stuart Gardens area of the city. The groins and dumped rubble riprap contribute little to the defense of the shoreline.

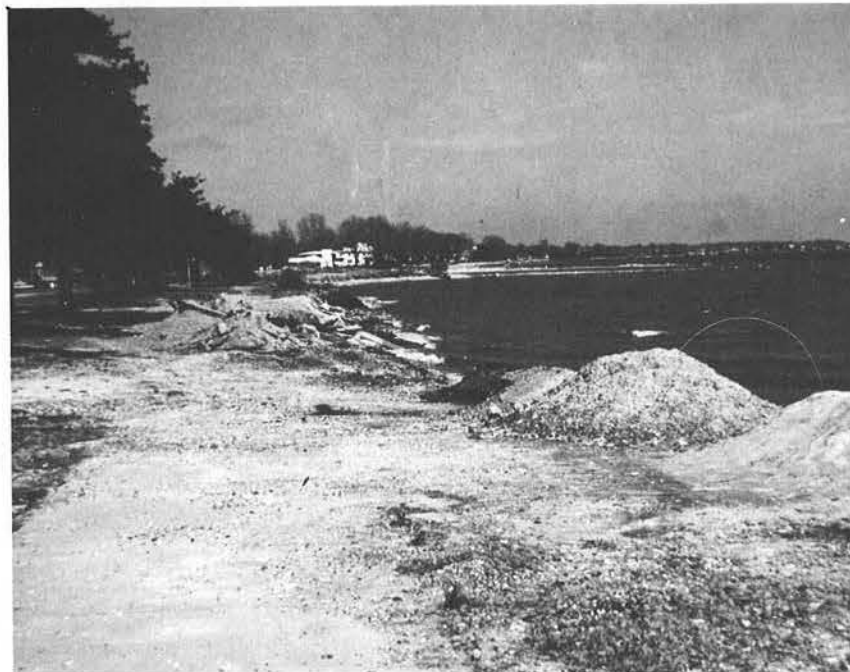
Figure 6

Figure 6: Ground view of the area shown in Figure 5. Shoreline erosion is threatening the paved walkway.

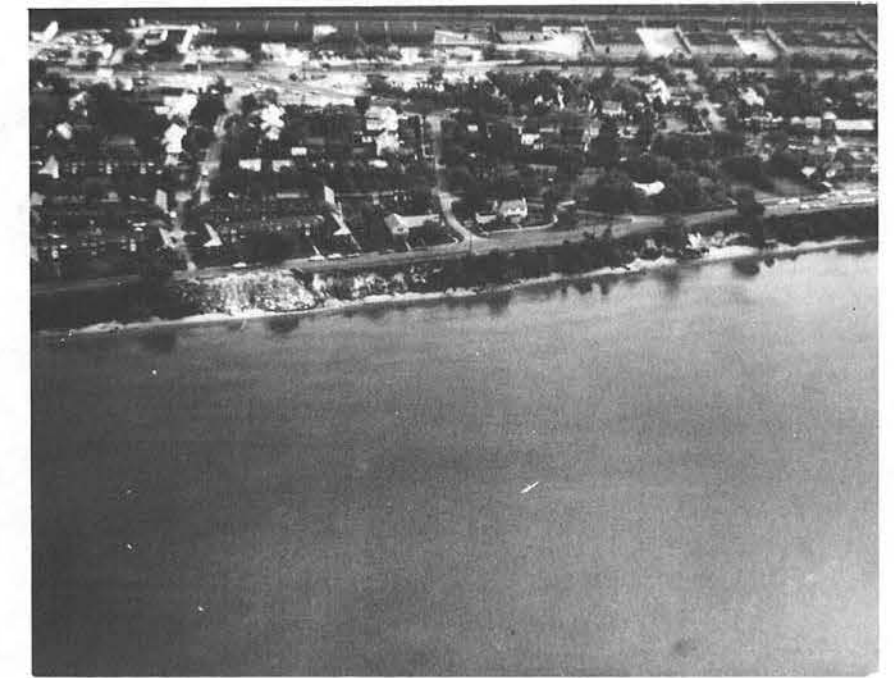
Figure 7

(Figures 7 and 8). At present rubble riprap and dumped fill is slightly hindering the erosional processes. The problem is not now severe and the construction of the new extension to the shipyard may alter the local conditions enough to change the nature of the problem. There is a similar small problem in Huntington Park.

Figure 7: River Road near 70th Street. Erosion is cutting the bluff and threatening the road.

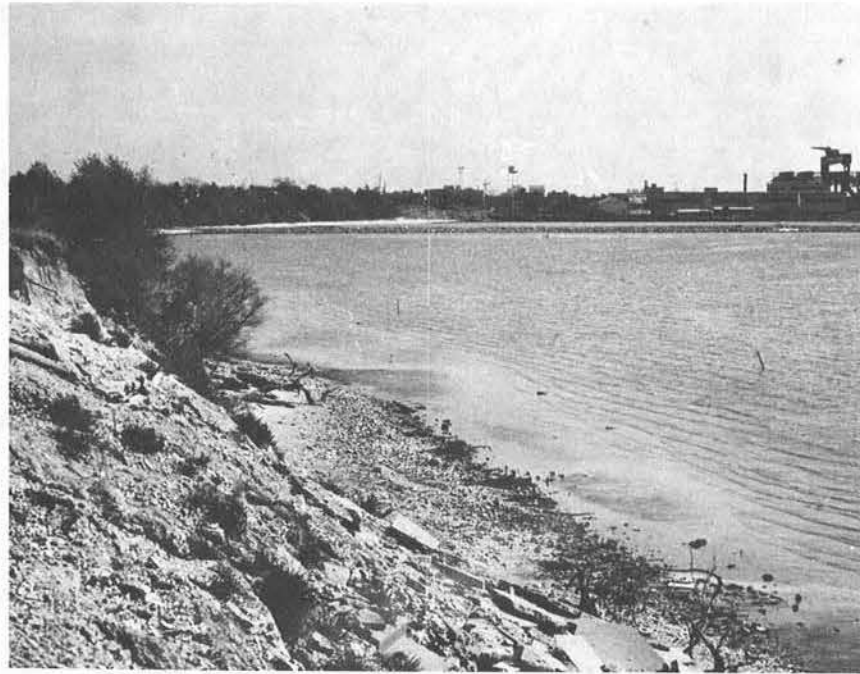
Figure 8

Figure 8: Ground view of Figure 7. North extension of the Newport News Shipbuilding and Drydock Company is in the background.

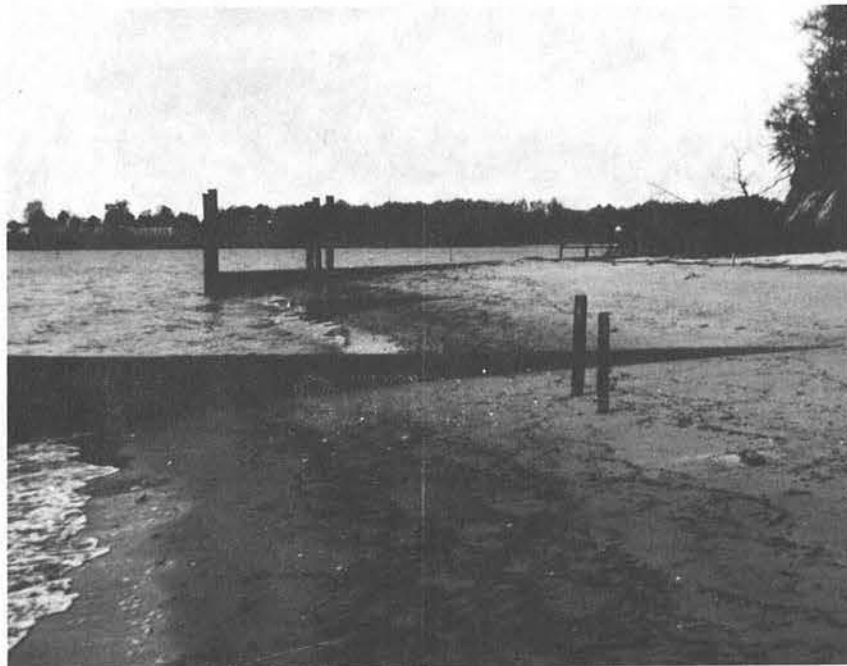
Figure 11

Figure 11: The two long, high, impermeable groins in Figure 9. These two major groins and the lesser intermediate groin have trapped a significant fillet and are protecting the fastland.

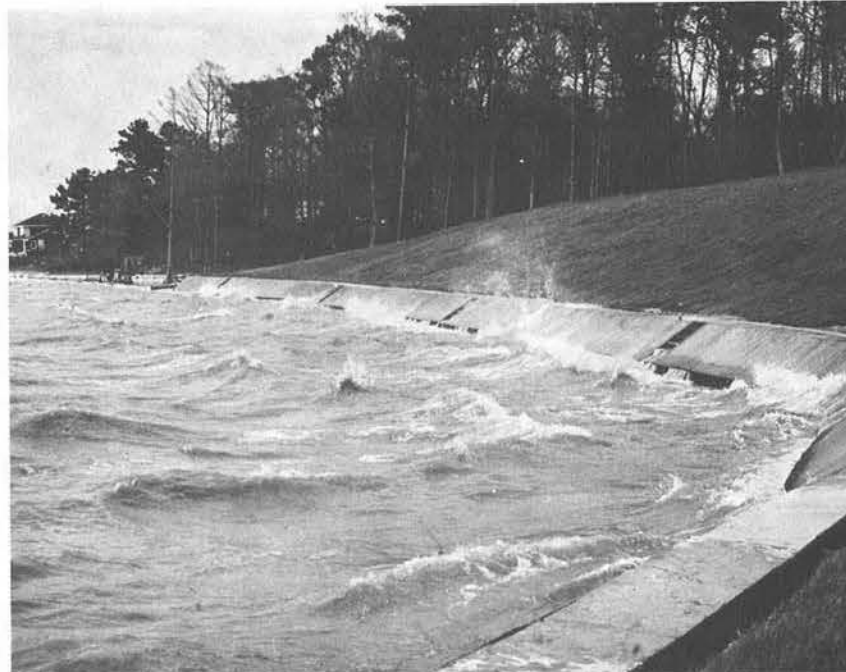
Figure 12

Figure 12: Seawall and graded upland near the foot of Blount Point Road. The seawall is satisfactory except that it can be overtopped by moderate waves. The overtopping allows water to flow behind and to undermine the seawall. The graded upland eases problems of slope maintenance. Note the reflected waves near the wall and the resulting confused sea.
