Charles City County, Virginia Shoreline Inventory Report Methods and Guidelines

Special report in Applied Marine Science and Ocean Engineering No. 436 of the Virginia Institute of Marine Science

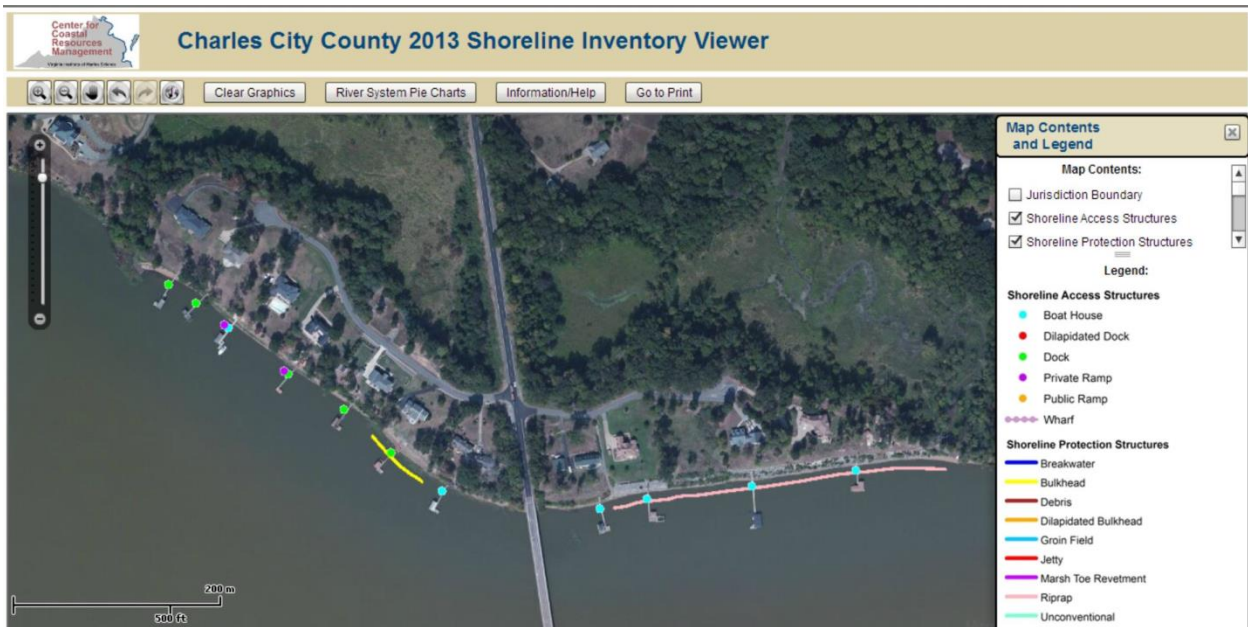
Figure 5. Map Viewer illustrates Shoreline Access and Protection Structures.

In Figure 5 Shoreline Access Structures, and Shoreline Protection structures have been selected along with the boundary. Shoreline Access structures are point features that includes piers and boat ramps. The actual footprint of these structures is not measured; only their location. Shoreline Protection Structures are line features and are mapped and illustrated in the viewer to show where they occur along the shoreline. Figure 6 illustrates riparian land use.

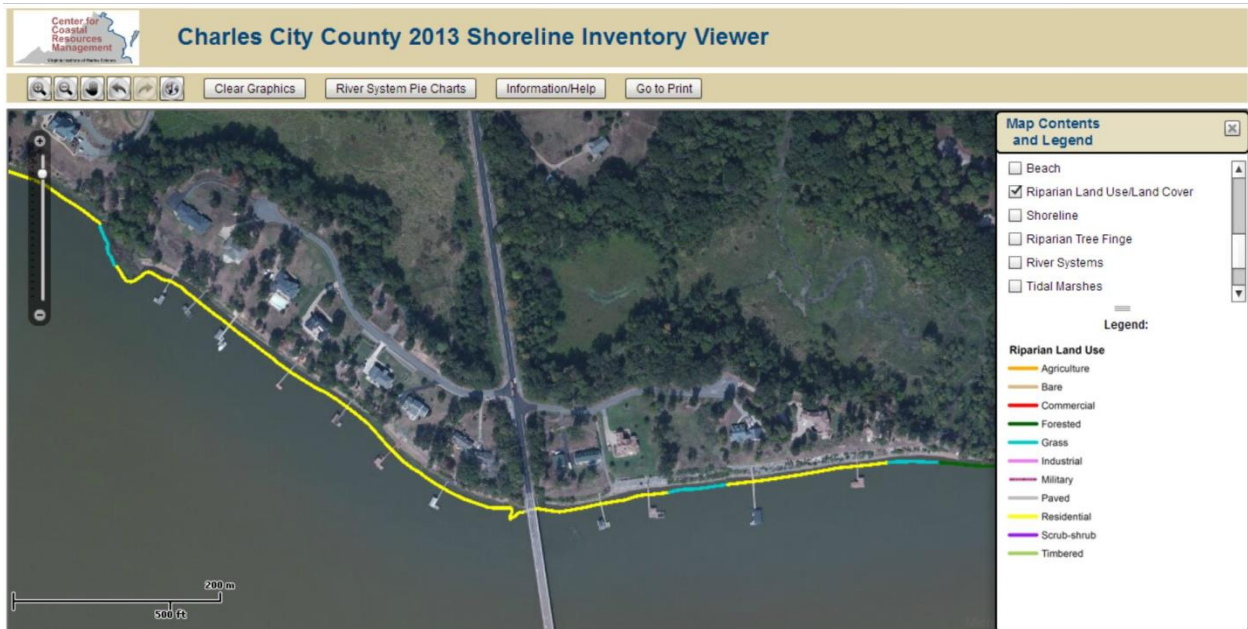
Figure 6. Distribution of land use in the riparian zone is displayed for this region of Charles City County
