## Living Shoreline Design Guidelines for Shore Protection in Virginia's Estuarine Environments

# **Living Shoreline Design Guidelines for Shore Protection in Virginia's Estuarine Environments**

Special Report in Applied Marine Science and Ocean Engineering No. 421

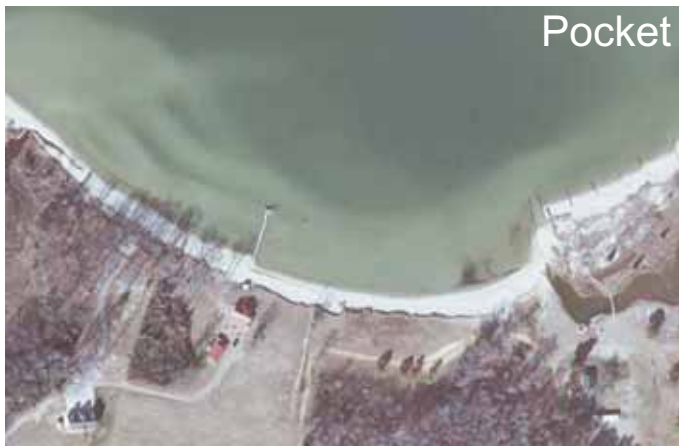
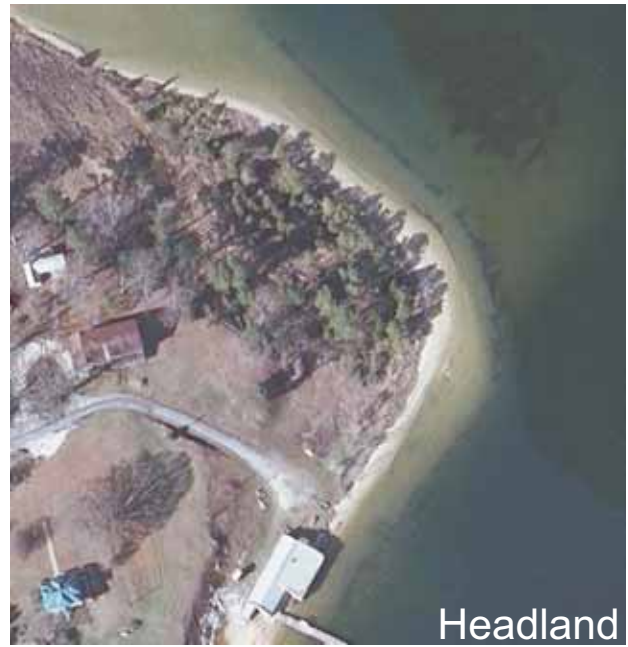
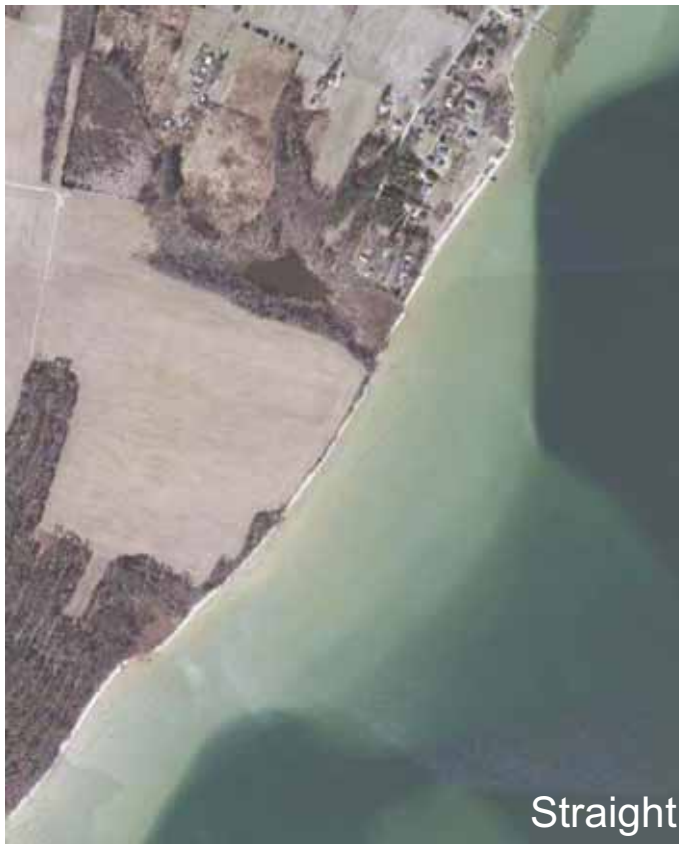
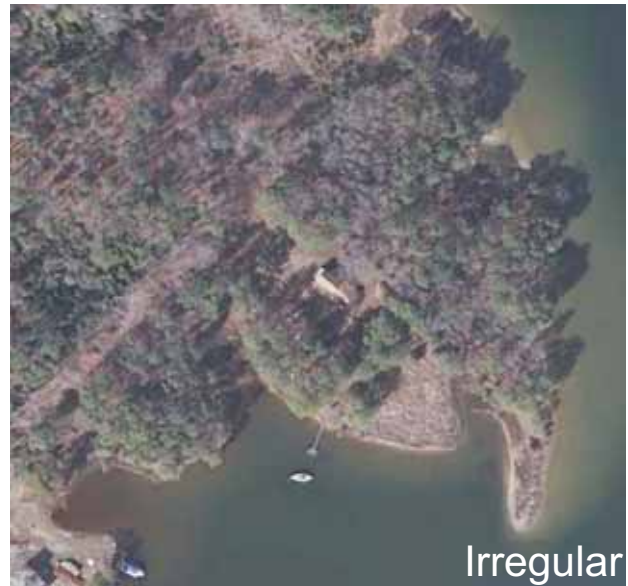
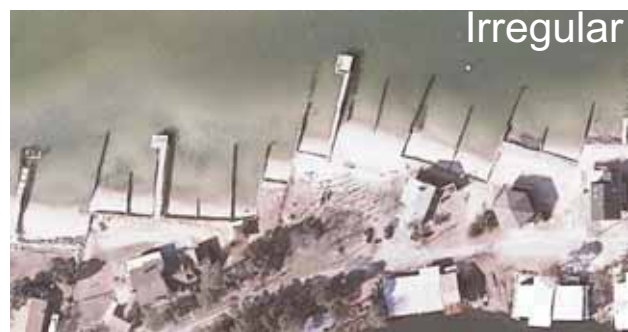
Figure 2-2. Photos illustrating four different types of shore morphology within Chesapeake Bay.

Shore morphology, or structure, can be a difficult parameter to assess because of the variation in types of shoreline throughout Chesapeake Bay. The essence of this parameter is to determine the level of protection from wave action. A pocket or embayed shoreline (Figure 2-2) tends to cause waves to diverge, spread wave energy out, and thus reduce erosion impacts (Figure 2-3). Open, linear shorelines and headlands tend to receive the full impact of the wave climate. The irregular shoreline, sometimes caused by scattered marsh patches or groins, tends to breakup wave crests along its length, reducing impacts.

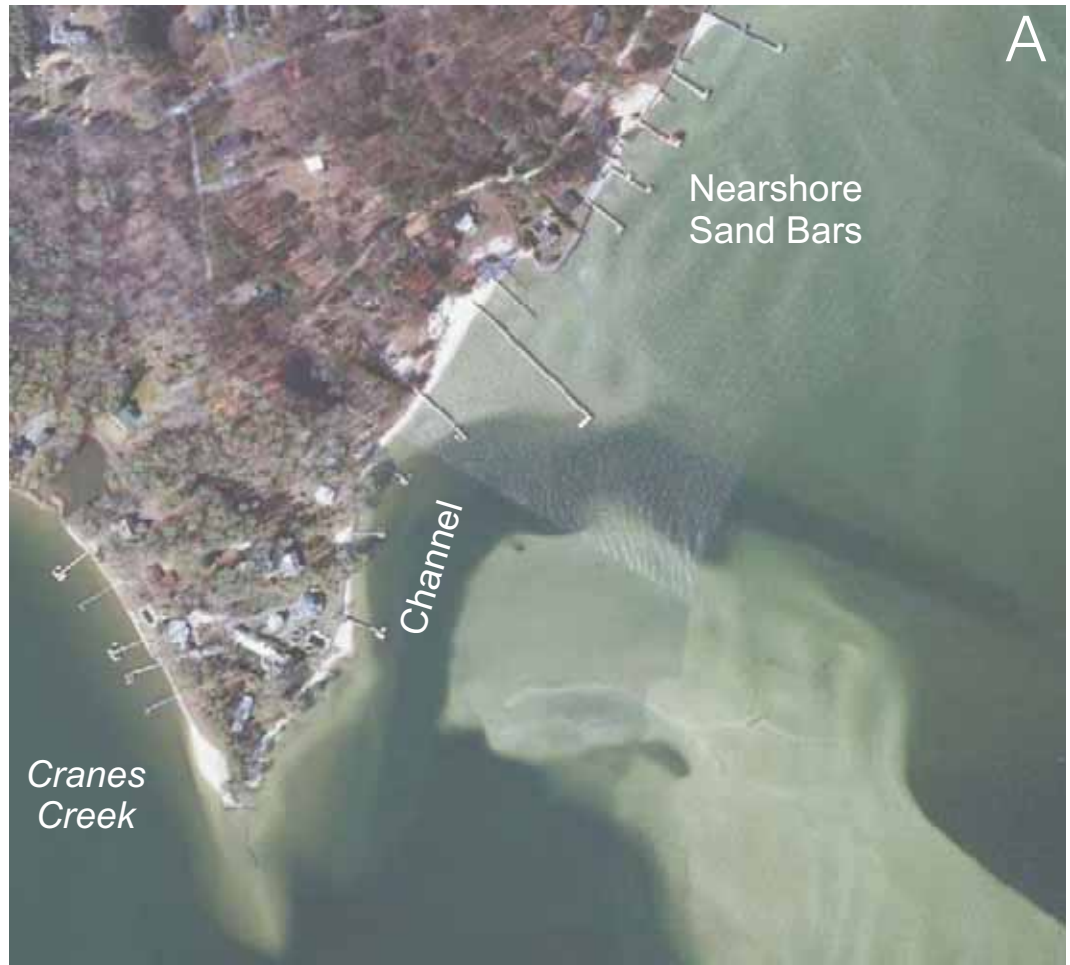
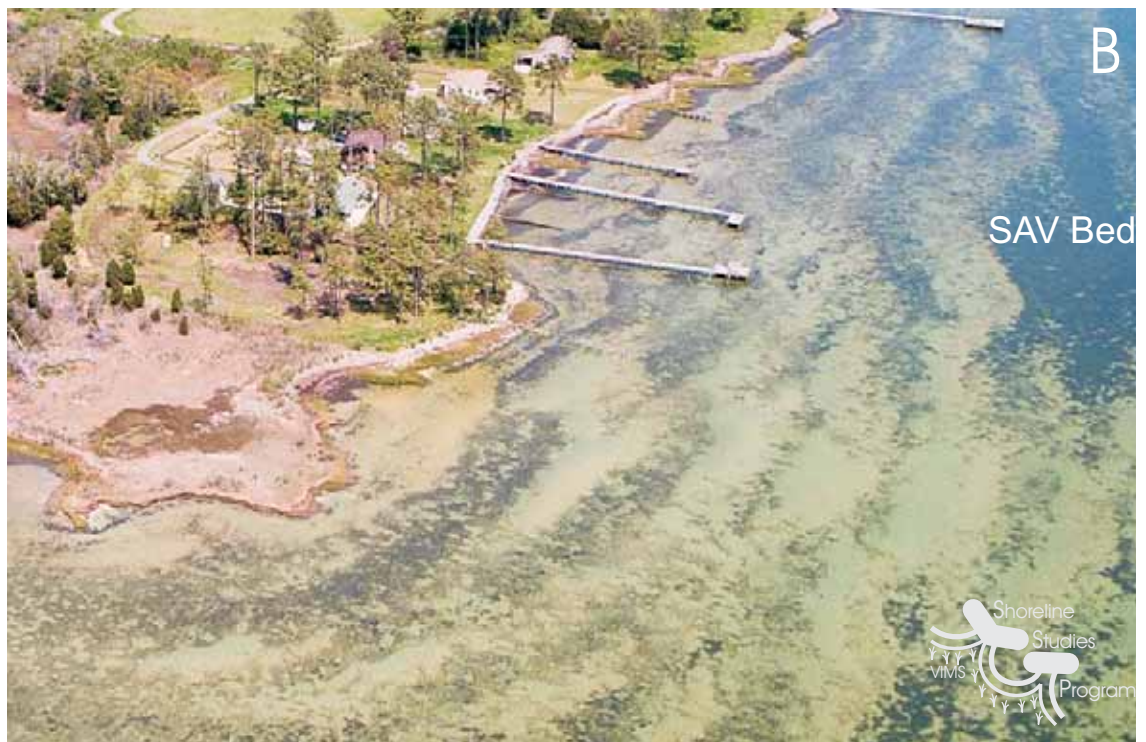
Figure 2-4. Photos showing nearshore bars and submerged aquatic vegetation. A) A VGIN 2009 photo shows the channel into Cranes Creek in Northumberland County, Virginia. Sand bars north of the channel will attenuate waves while the shoreline adjacent to the channel has no bars and will feel the full effect of the waves impacting the shoreline. B) A VIMS aerial photo of Pond Point on the East River in Mathews, Virginia (dated 21 April 2009) showing extensive SAV in the nearshore, as well as sand bars.

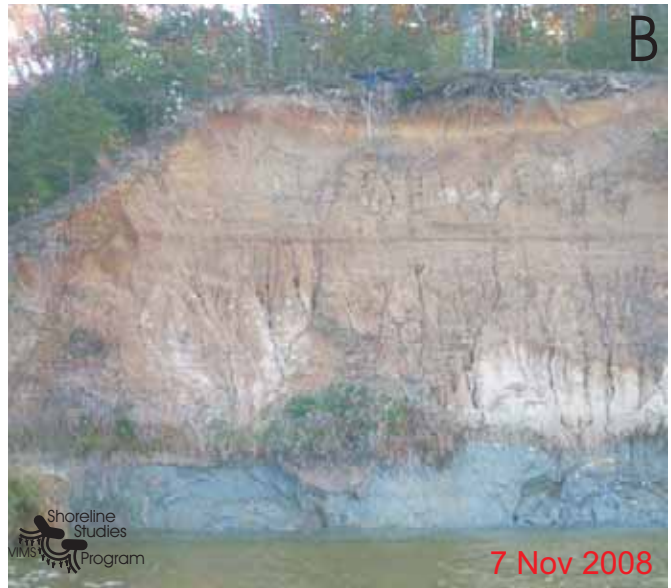
An undercut bank on the East River, Virginia.

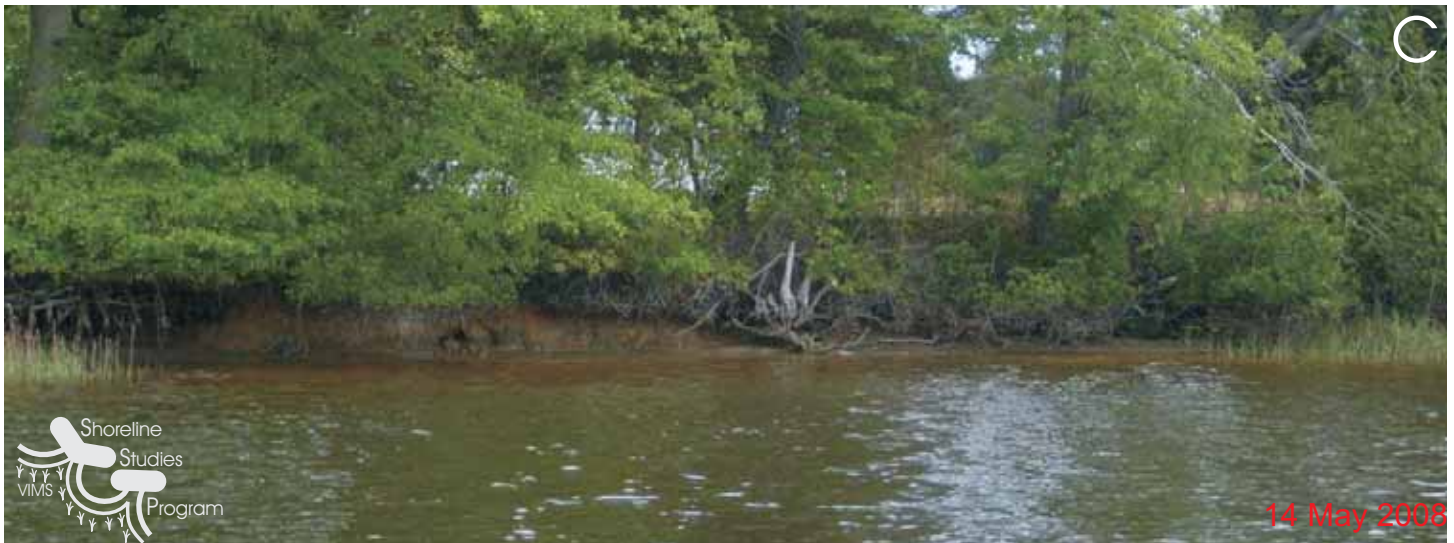
Figure 2-8. Bank condition example photos.

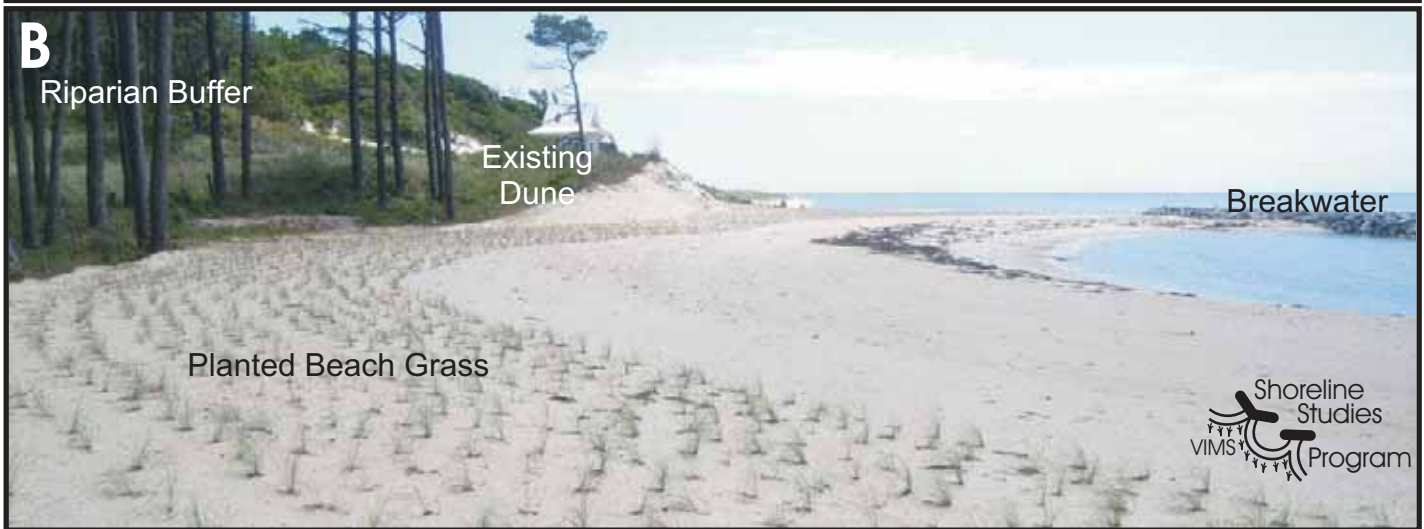
Figure 2-10. Photos depicting aspects of the coastal profile for A) a low-medium energy marsh shoreline and B) a high energy beach shoreline. C) diagram of a connected shore zone shows different landscape elements. C is reprinted courtesy of the VIMS Center for Coastal Resources Management. N = Nitrogen,  $PO_4^{-3}$  = Phosphate.

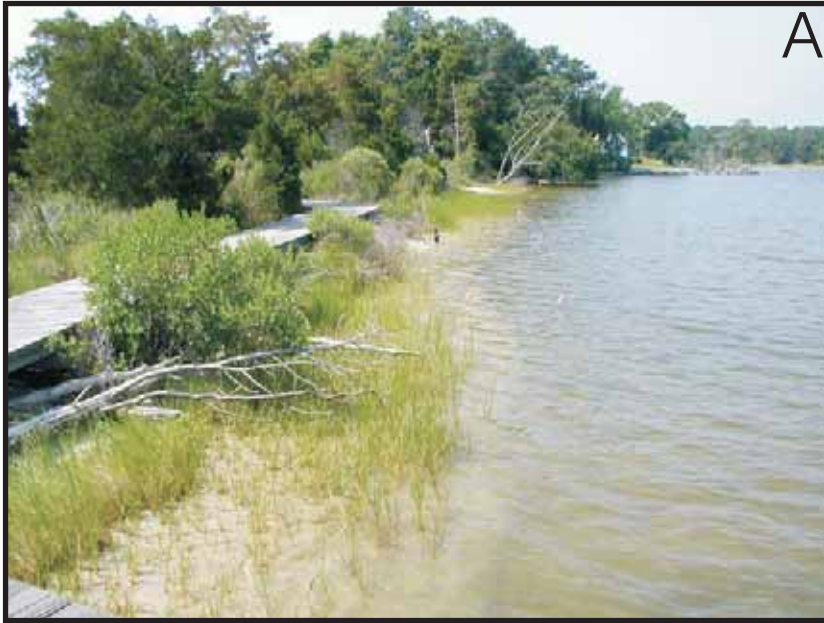
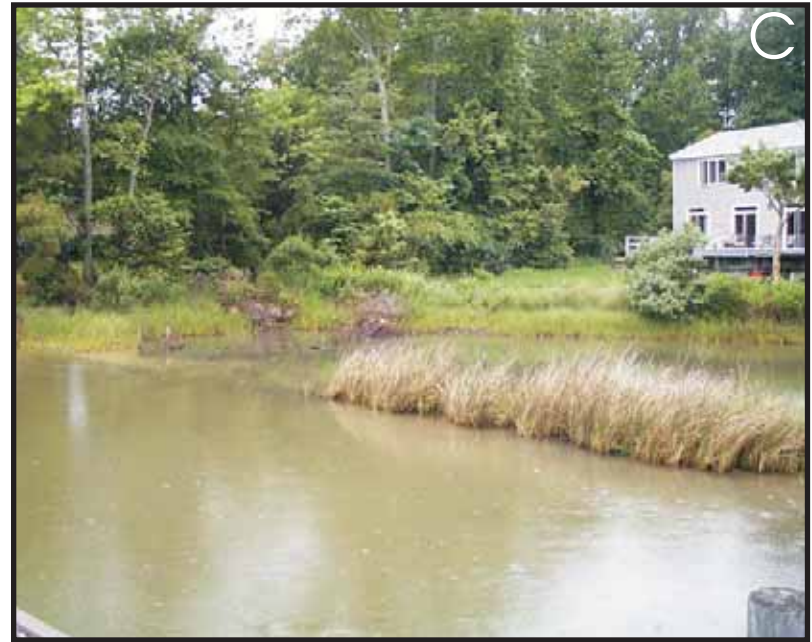
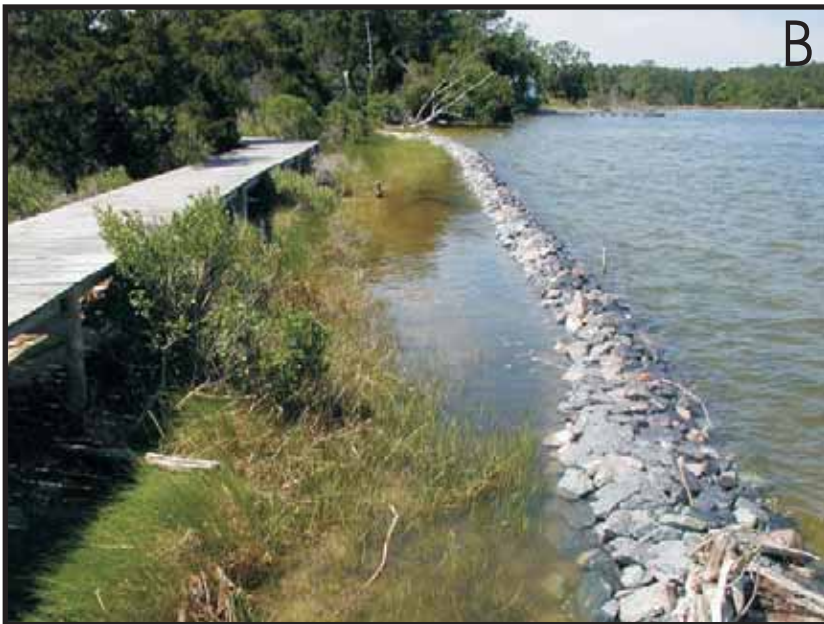
Figure 3-4. Photos showing marsh toe revetments A) before and B) after a project on Cranes Creek in Northumberland County and C) before and D) after a project on Mosquito Creek in Lancaster County, Virginia.

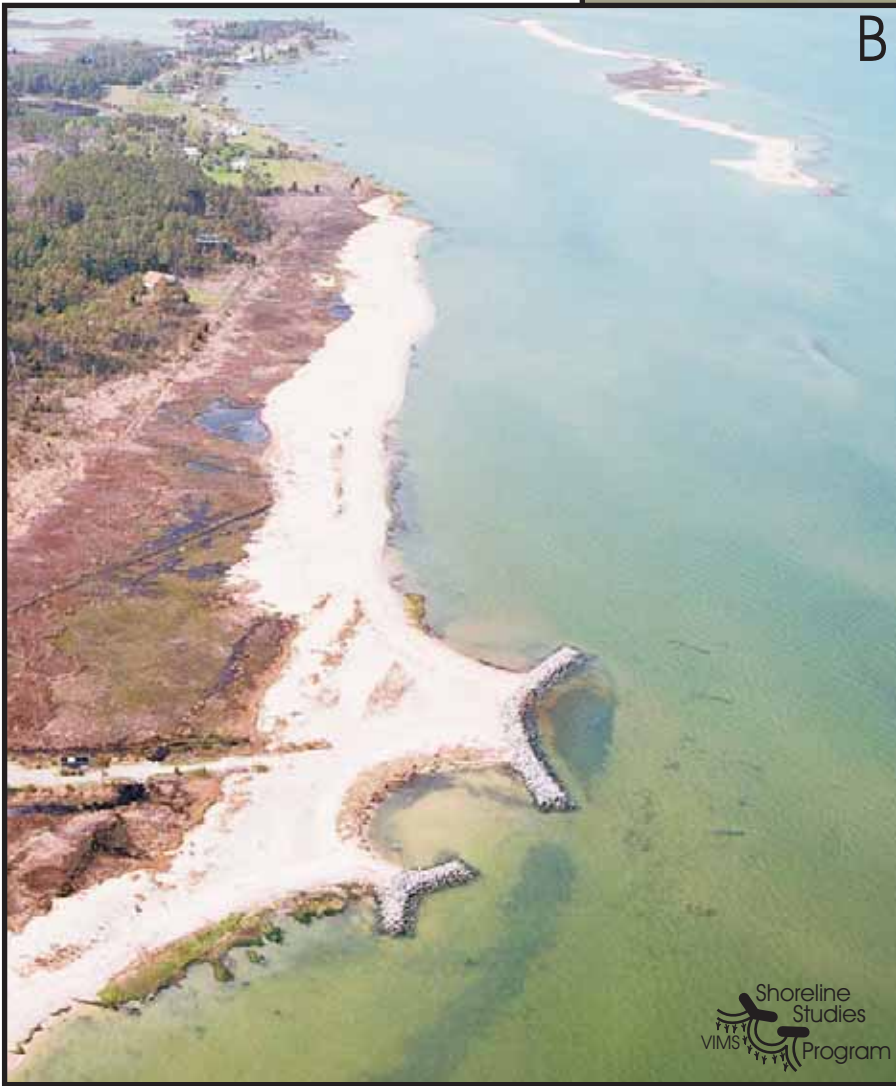
Figure 3-5. Aerial photos of A) Drummond Field breakwaters (June 30, 2005) on the James River, and B) Festival Beach on Chesapeake Bay (April 21, 2010). While the physical characteristics of each site differ, the goals are the same: protect the upland bank/marsh with a wide recreational beach.

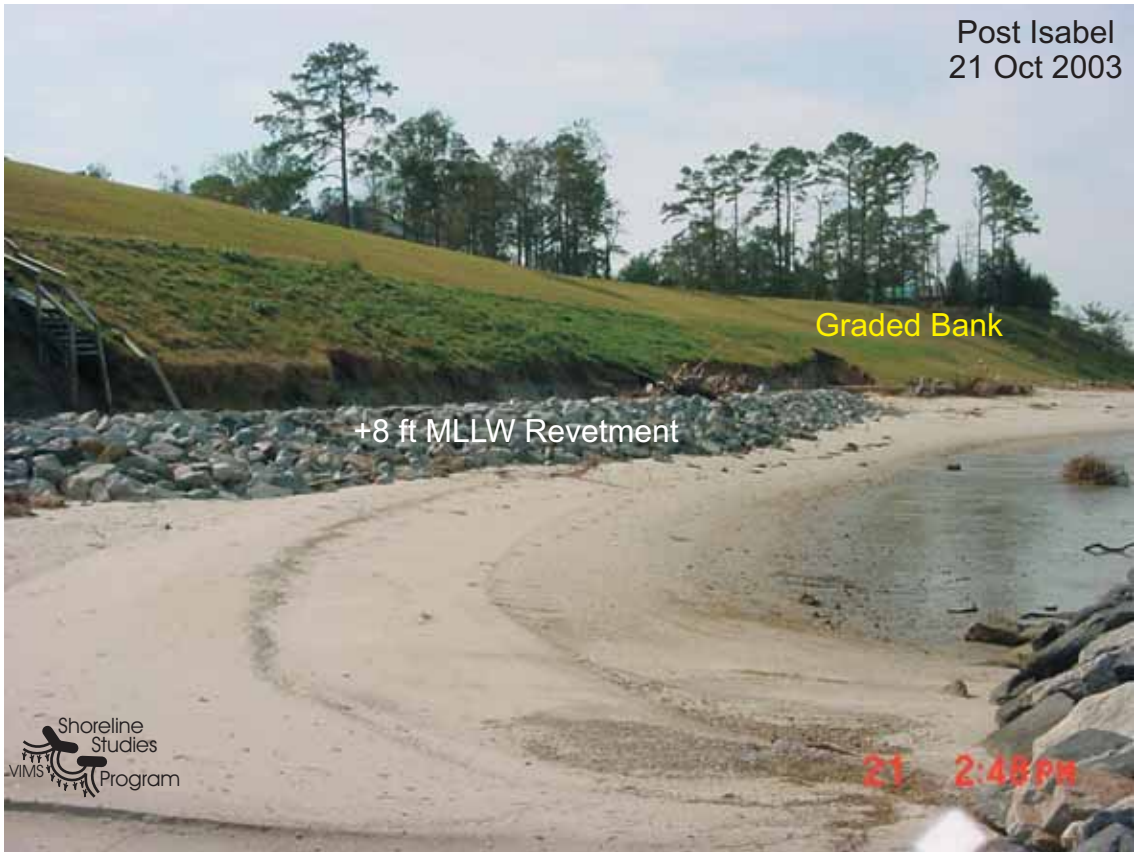
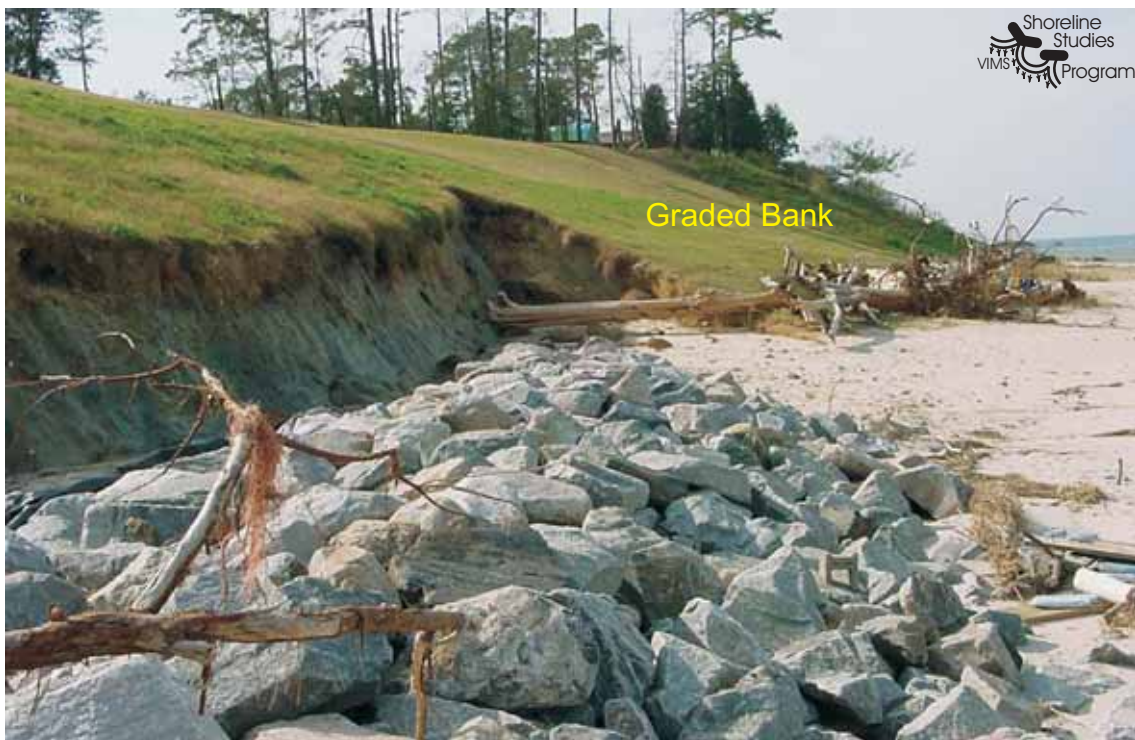
Figure 3-7. Revetment on the James River that was overtopped by storm surge and waves during Hurricane Isabel. Photo dates 21 October 2003.

When the design storm is exceeded, then so is the level of protection. Overtopping a revetment by surge and wave may only create a wave cut scarp across the adjacent bank or bluff (Figure 3-7) such as occurred along the James River during Hurricane Isabel. Has the level of protection been exceeded? The revetment is very much intact and as long as the stability of the bank face and consequently any infrastructure is not threatened, then probably not. If the structure itself fails, particularly early during the storm event, then a more serious problem will result. If the structure fails, the bank fails and the infrastructure are threatened or damaged. No erosion occurred of the graded bank just upriver from the revetment where the beach is wide behind a headland breakwater. The revetment crest elevation is +8 ft MLLW which was three feet less than water and wave heights in that area of the James River.

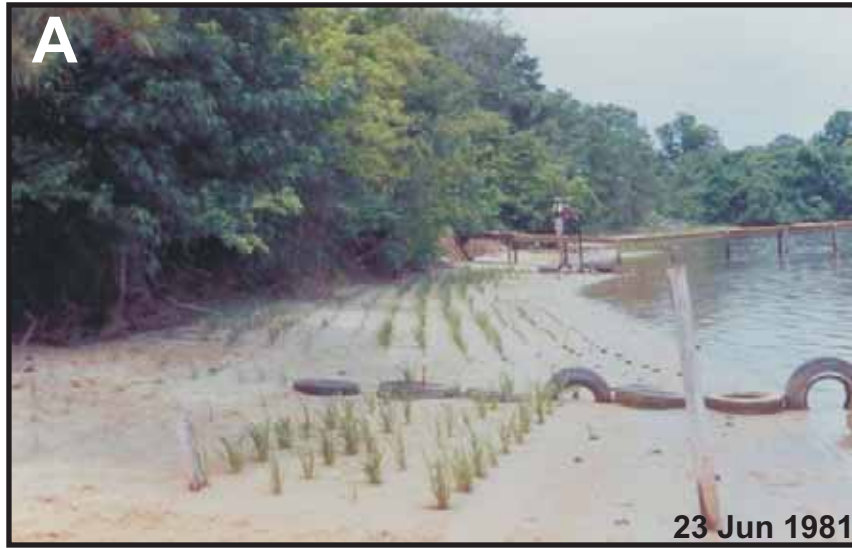
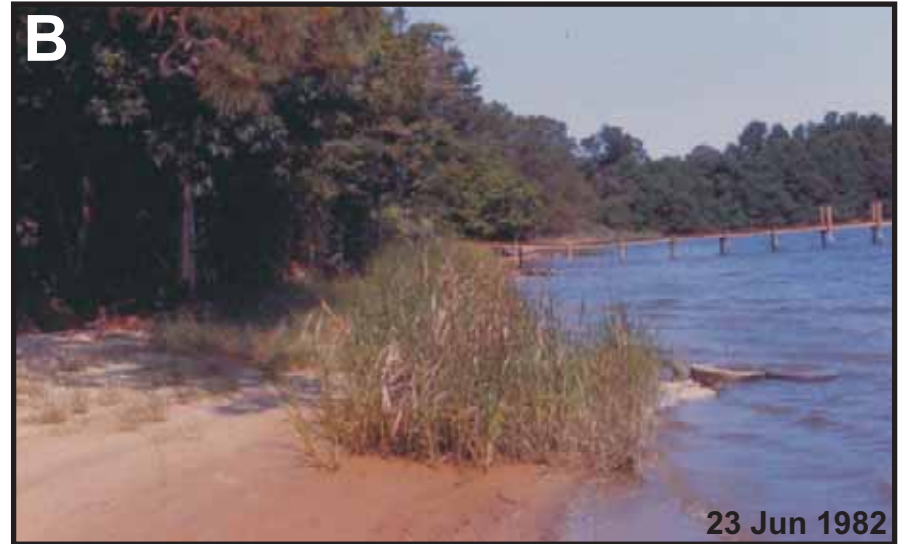
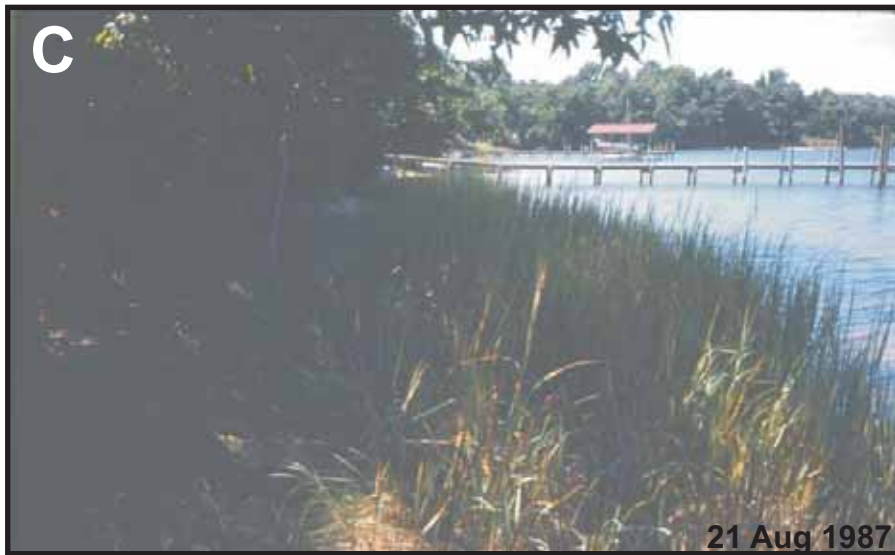
Figure 4-1. Lee marsh management site A) just after installation, B) a year later, C) six years after installation, and D) 25 years after construction.

The Lee is a demonstration site established in 1982 and represented a north-facing, high upland bank with a limited fetch. Mr. Lee was quite helpful in helping plant and monitor the site over the many years since the marsh was planted and re-planted. Alas, limited sunlight kept the marsh from reaching full potential and a small stone revetment was finally installed in 1999 (Figure 4-1).

After 20 years of intermittent maintenance, Mr. Lee finally opted for a small stone revetment. A few shoots of *Spartina alterniflora* remain, but no viable fringe ([Figure 4-1](#)). This site provided the opportunity to monitor a north-facing high bank with a planted marsh fringe. It takes ongoing maintenance and shade control for a viable marsh fringe along north facing shorelines.

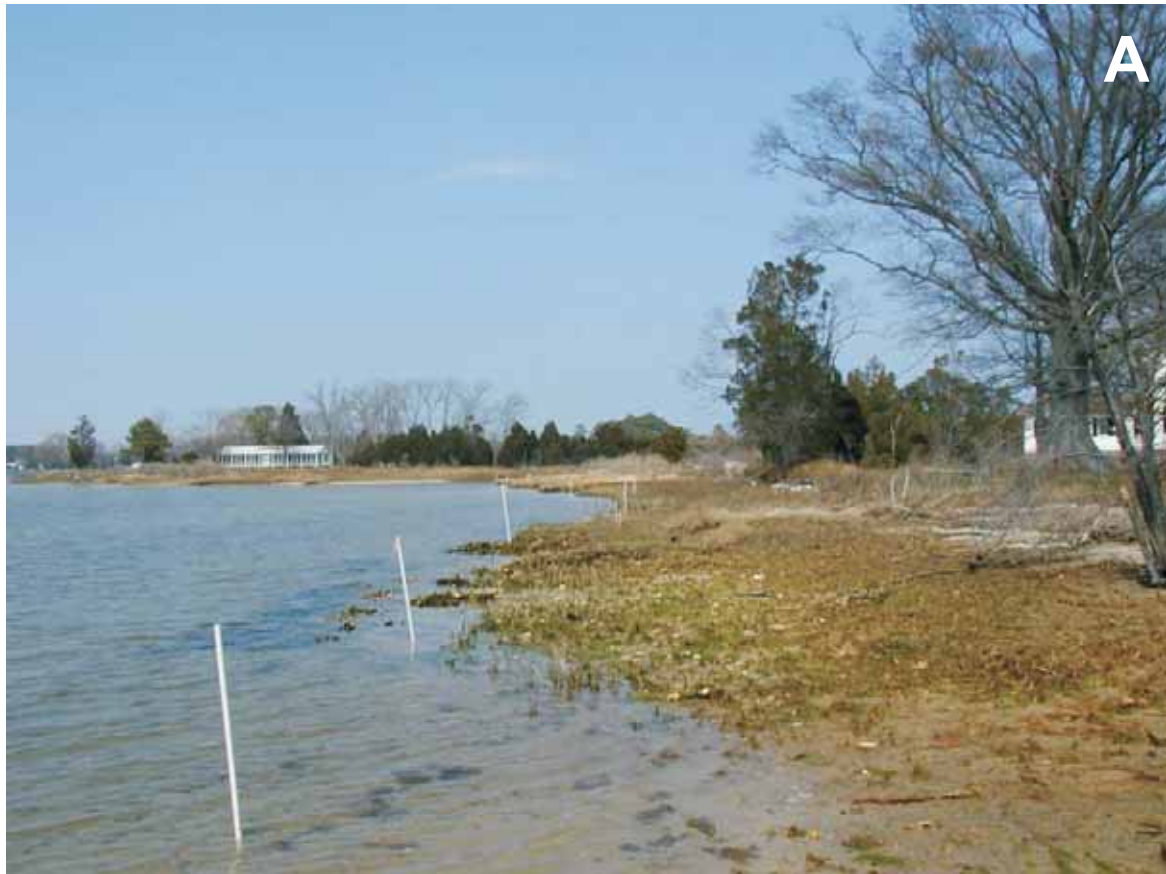
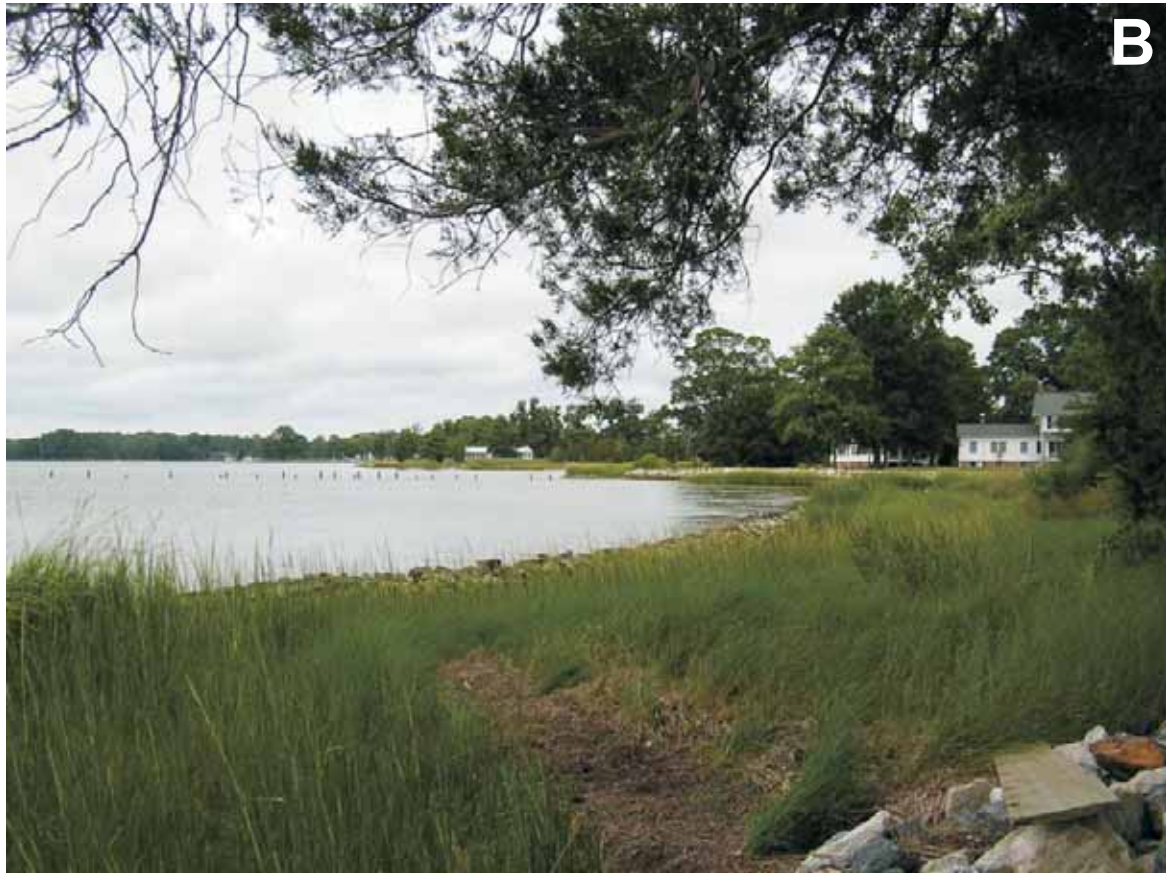
Figure 4-2. Hollerith marsh toe revetment/sill site A) before project with eroding fringing marsh in winter and B) after construction.

This site was surveyed in 2004 and 2005 for a marsh toe revetment study. No evidence of scattered stones, settling or other structural integrity problems due to Hurricane Isabel was found. The low marsh had expanded into previously bare areas and both low marsh and high marsh zones were densely covered with high species diversity for a continuous wide fringing marsh.

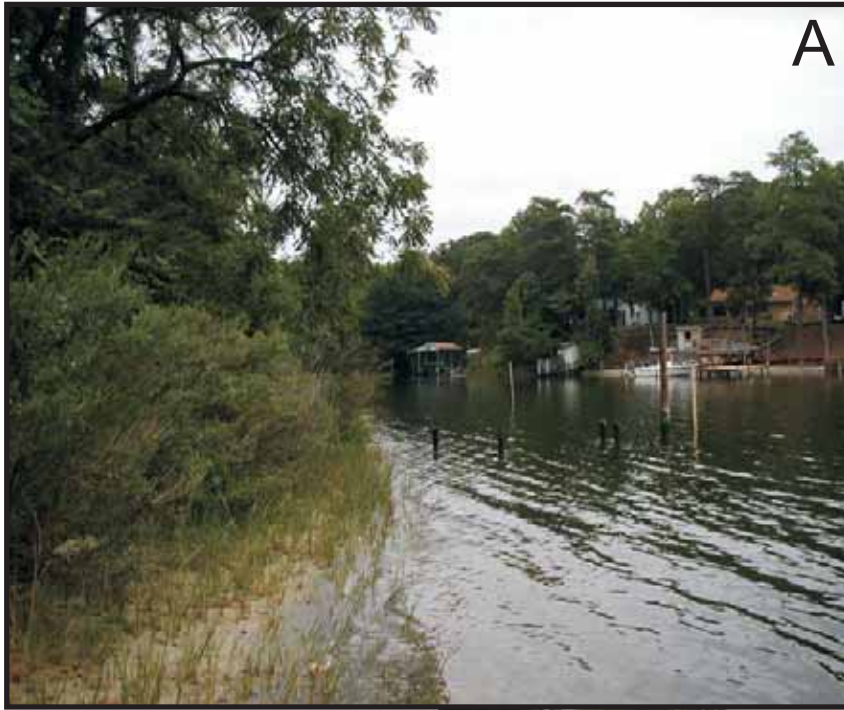
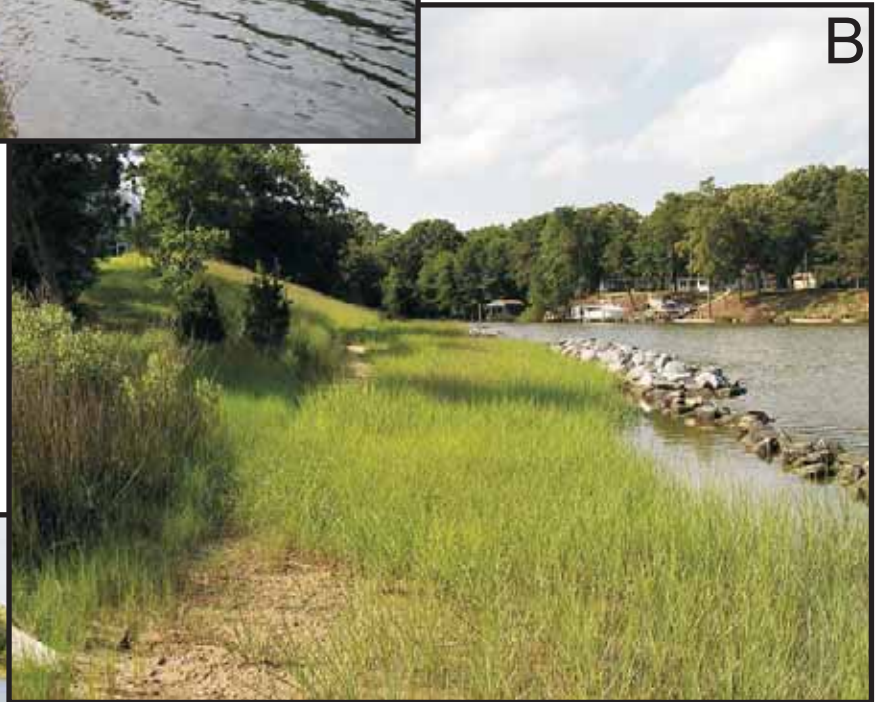
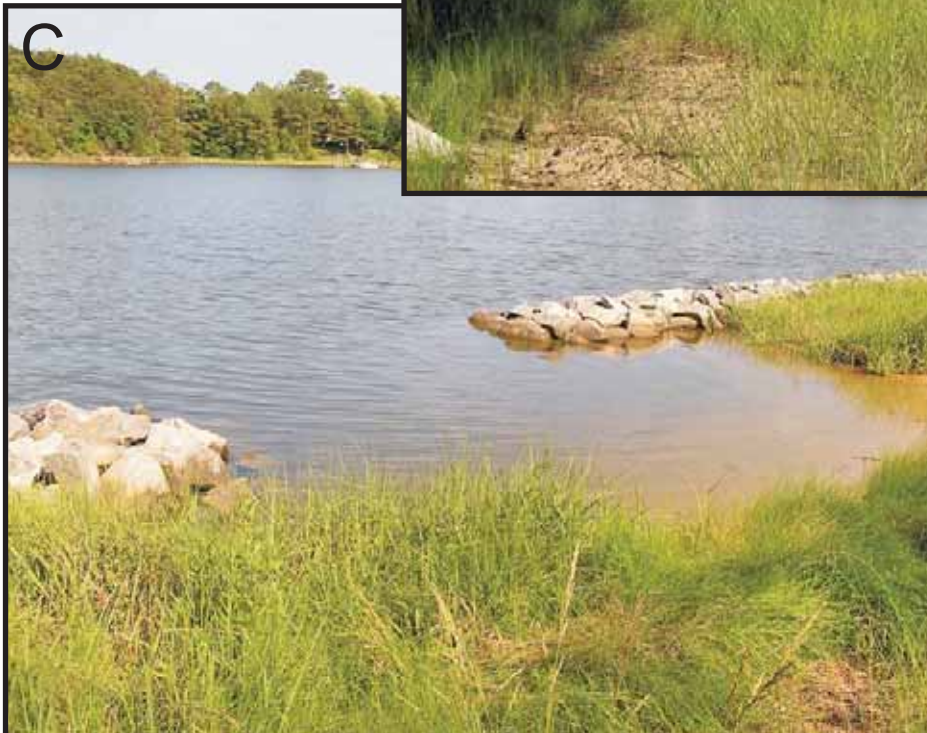
Figure 4-3. Foxx site photos. A) Before construction, the upland bank was undercut and only a small intermittent marsh fringe existed. B) After construction, a wide, marsh fringe and graded bank stabilized the site. C) Gaps in the sill allow waves in, reducing the width of the marsh there.

The Foxx site is located on Sturgeon Creek in Middlesex County and was installed in 2005. Pre-project consultations with the Shoreline Studies Program helped the contractor in his design effort for establishing a Living Shoreline using a sill system. Certain other elements deemed necessary by Mr. Foxx were a graded bank and thinning of the dense small tree and shrubs along the top (Figure 4-3). The base of bank also was undercut which could eventually lead to bank failure.

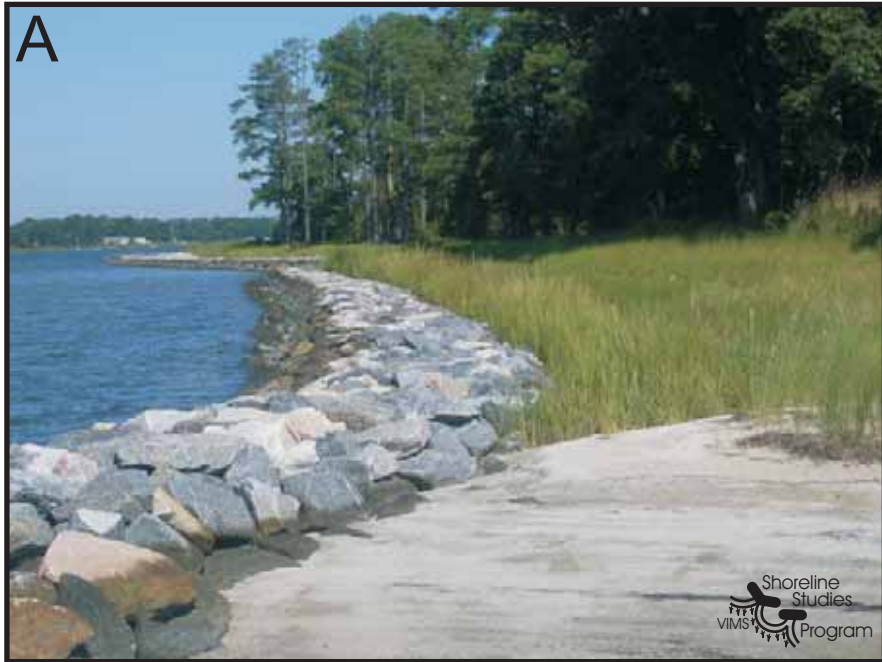
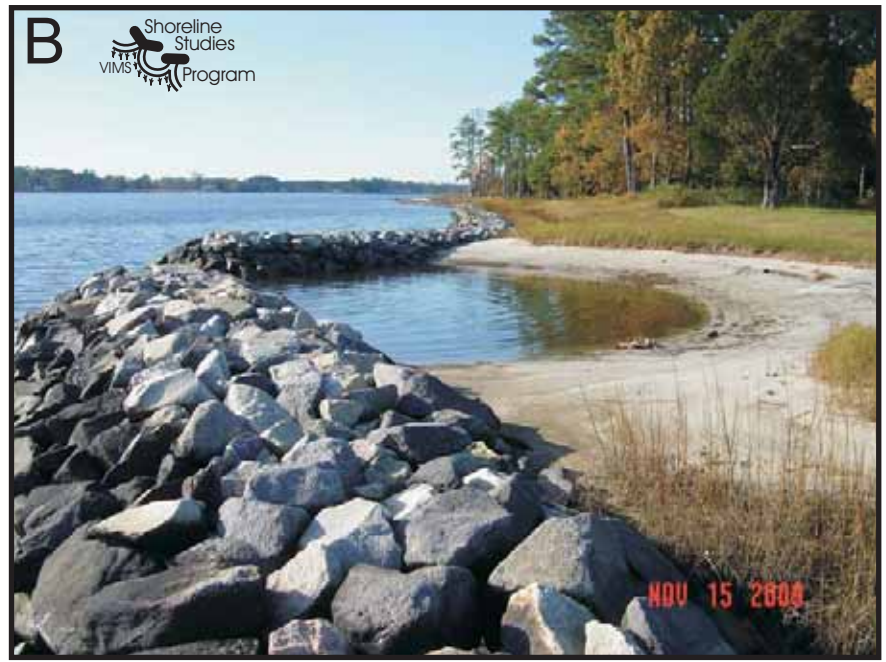
Figure 4-5. Sill system at Poplar Grove on the East River in Mathews County, Virginia six years after completion. A) The sill and marsh fringe provide a wide buffer between the water and the upland. B) The wide gap in the sill provides a pocket beach access area along the shoreline. C) The project zones are clearly visible: stone sill, *S. alterniflora*, *S. patens*, and upland/wooded. D) The old mill sits close to the shoreline. In this area, a revetment was chosen to protect the shoreline.

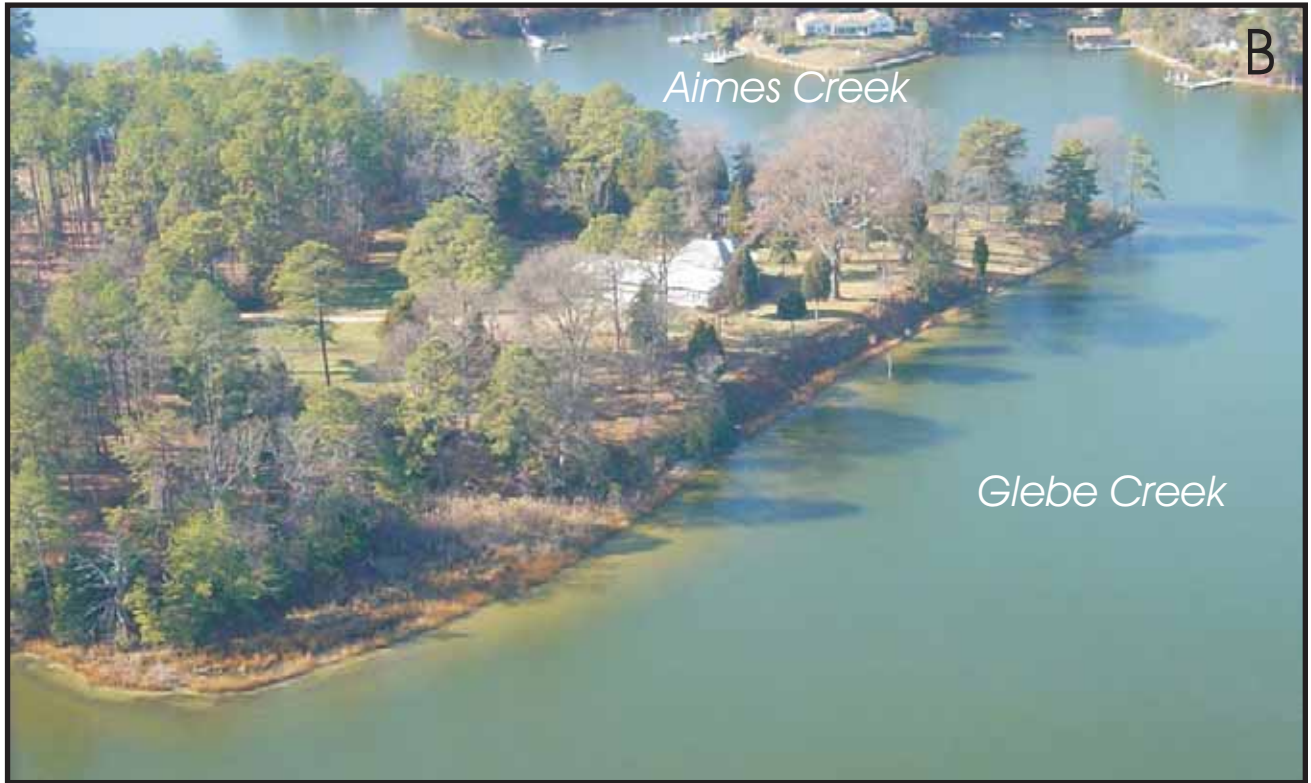
Figure 4-8. Longwood University's Hull Springs Farm on Glebe Creek. A) Before the shoreline project, the bank is eroding in front of the Manor House. B) After the project, the shore zone was widened with sand behind the sills.

Hull Springs Farm was obtained by Longwood University in 2000 to serve as a research venue for various subjects including shoreline processes, habitat, and management. Longwood obtained a grant from NOAA in 2005 to develop a GIS-based shoreline management plan for Lower Machodoc Creek including the approximately two miles of tidal shoreline around Hull Springs Farm. Most of the shoreline at Hull Springs Farm has small fetches and sheltered coasts except for the shoreline in front of the “Manor House” which was actively eroding (Figure 4-8A).

The Hull Springs Farm sill was built in 2008 along about 300 ft of shoreline on Lower Machodoc Creek. This coast is on the distal end of a neck of land between Glebe Creek and Aimes Creek (Figure 4-8). Recent (1994-2007) changes at the site indicate that the shore is eroding between -1 and -2 ft/yr. The site has fetches to the north, northeast, and east of 700, 7,500 and 800 ft, respectively. The north and east fetches are small relative to the northeast, which has more than one mile of fetch out the mouth of Glebe Creek and across Lower Machodoc Creek and is the primary cause of shore erosion during storms. The tide range is 1.8 ft (NOAA). The shoreline occurs as a high upland bank composed of basal clay overlain by some very sandy strata. The base of the bank is generally erosive along the project site while the bank face is erosive to transitional to stable (Figure 4-9A).

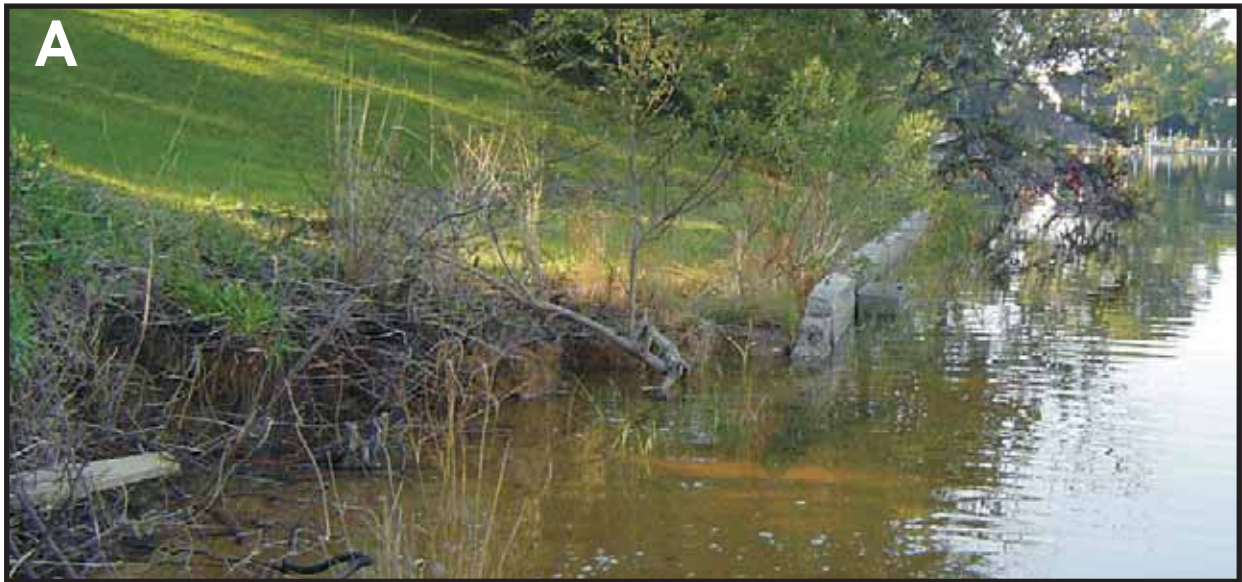
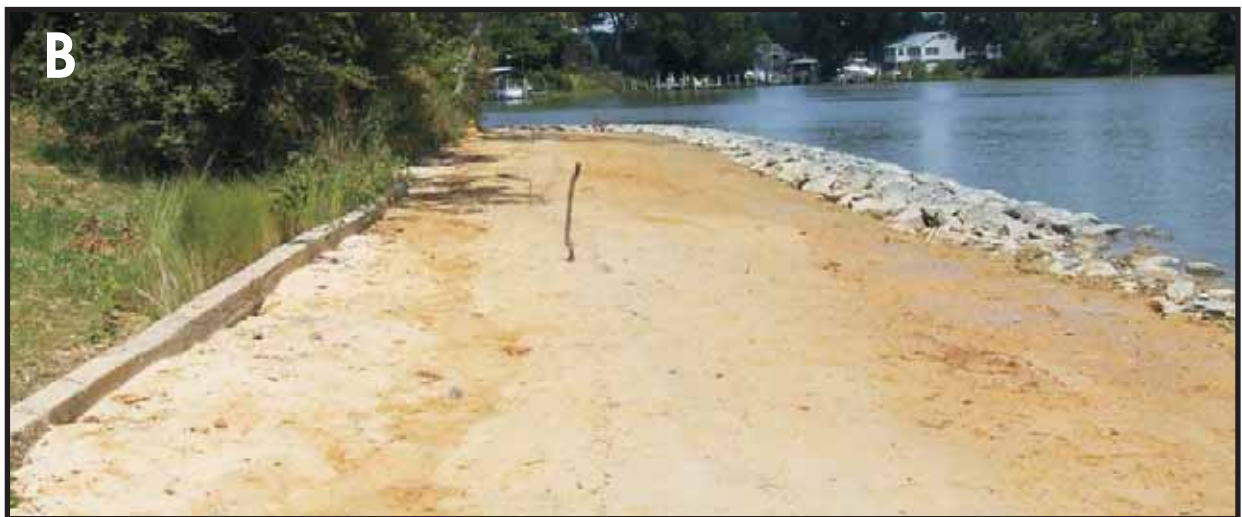
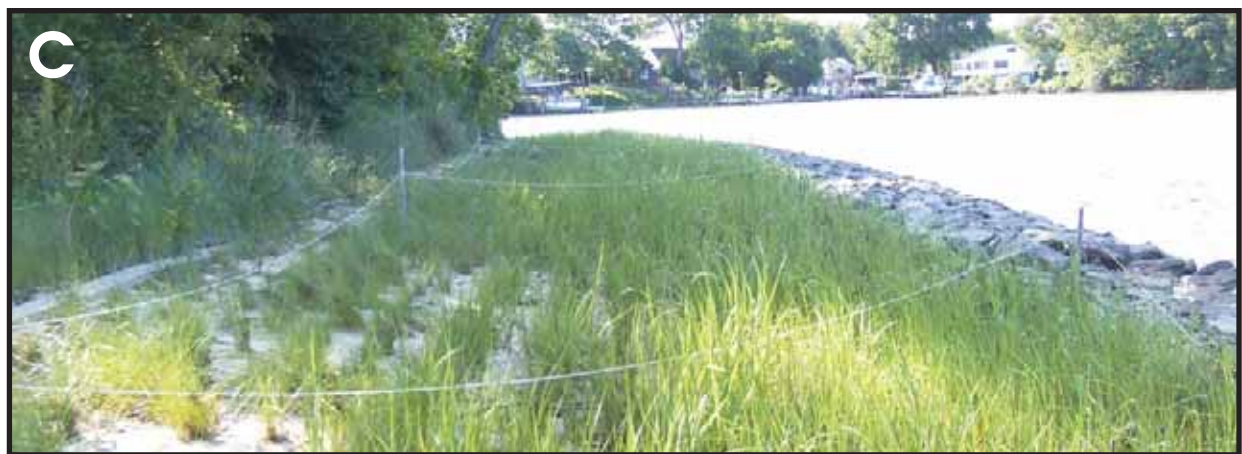
Figure 4-9. Hull Springs Farm shoreline A) before construction, B) after construction of the sill and placement of sand, and C) after planting.
