## Living Shoreline Design Guidelines for Shore Protection in Virginia's Estuarine Environments

# **Living Shoreline Design Guidelines for Shore Protection in Virginia's Estuarine Environments**

Special Report in Applied Marine Science and Ocean Engineering No. 421

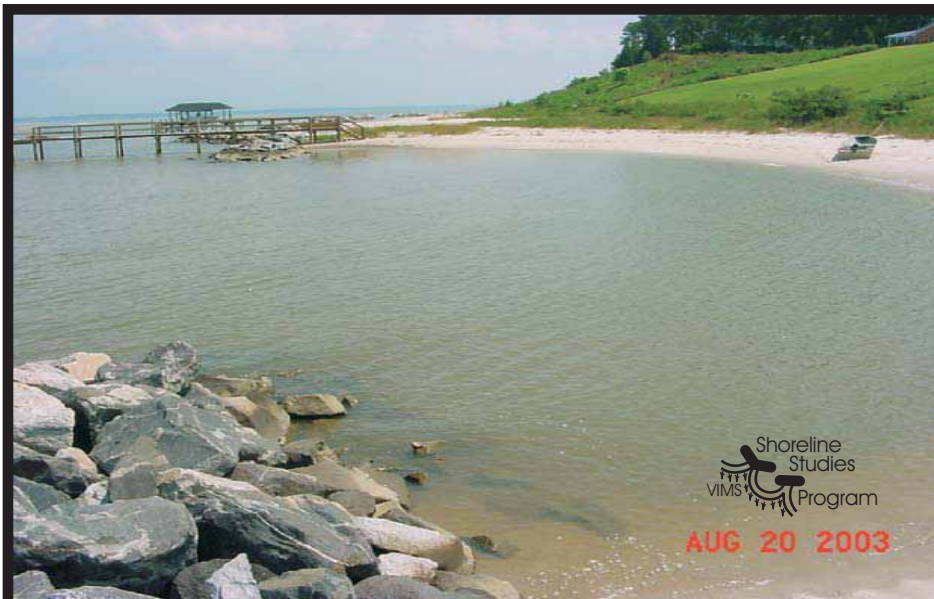
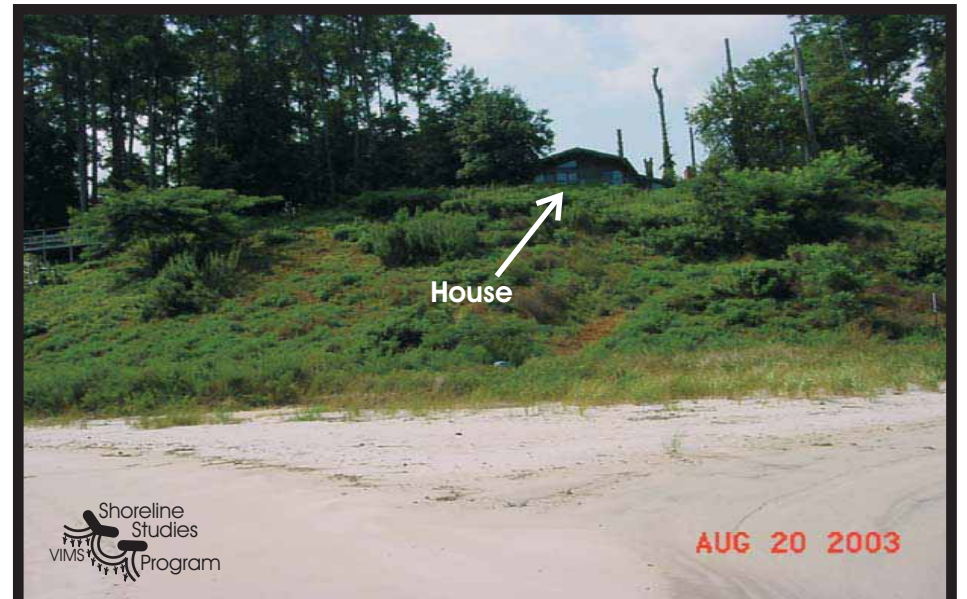
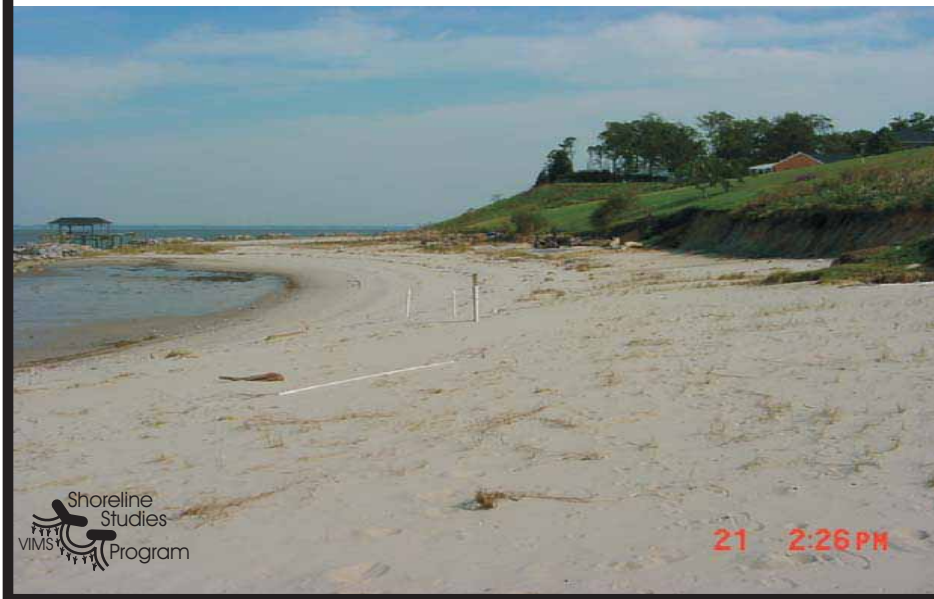
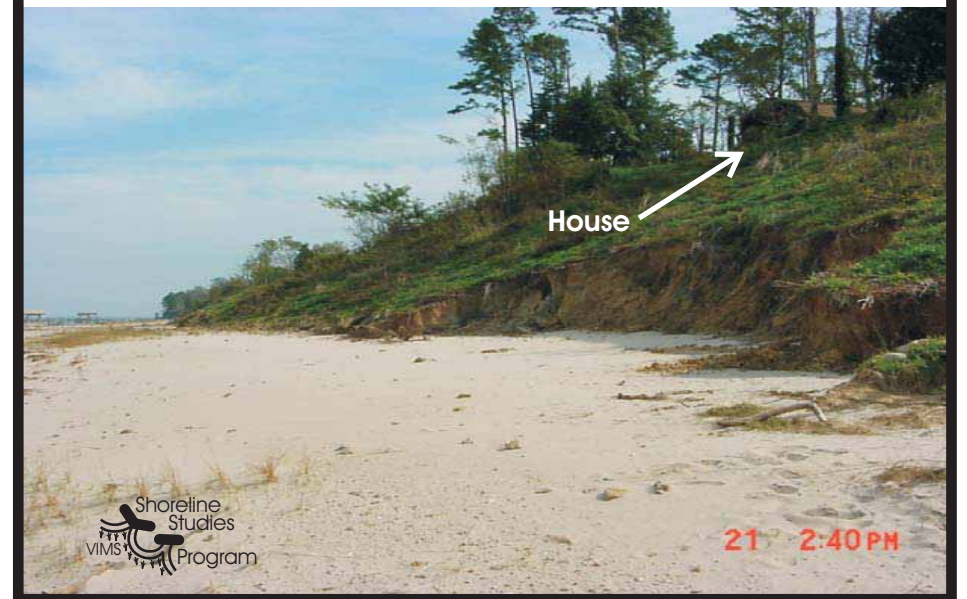
Figure 4-13. Van Dyke ground photos before and after Hurricane Isabel (from Hardaway *et al.*, 2005).

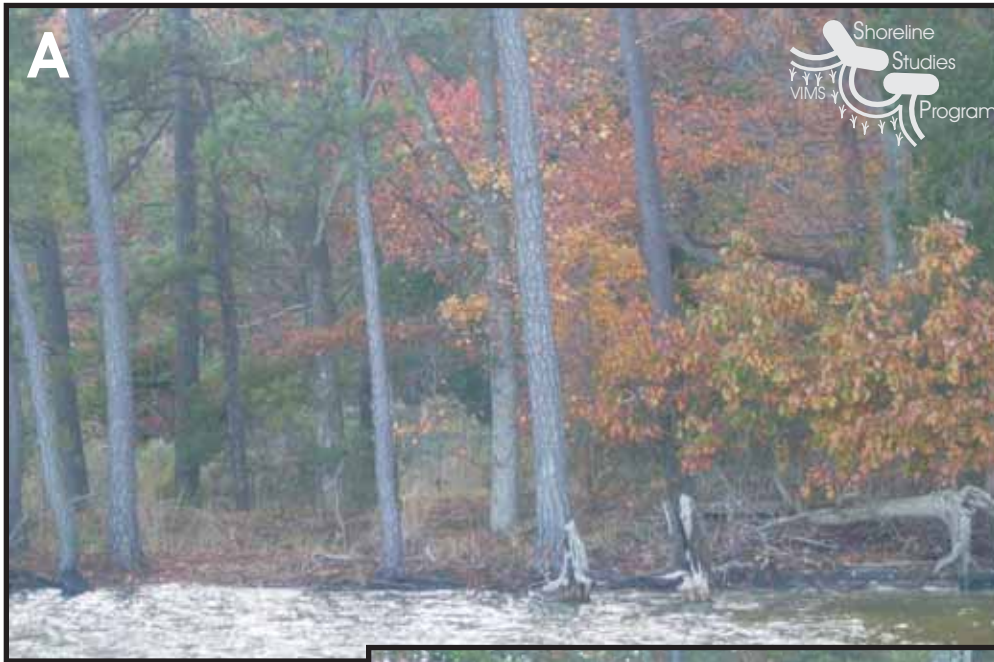
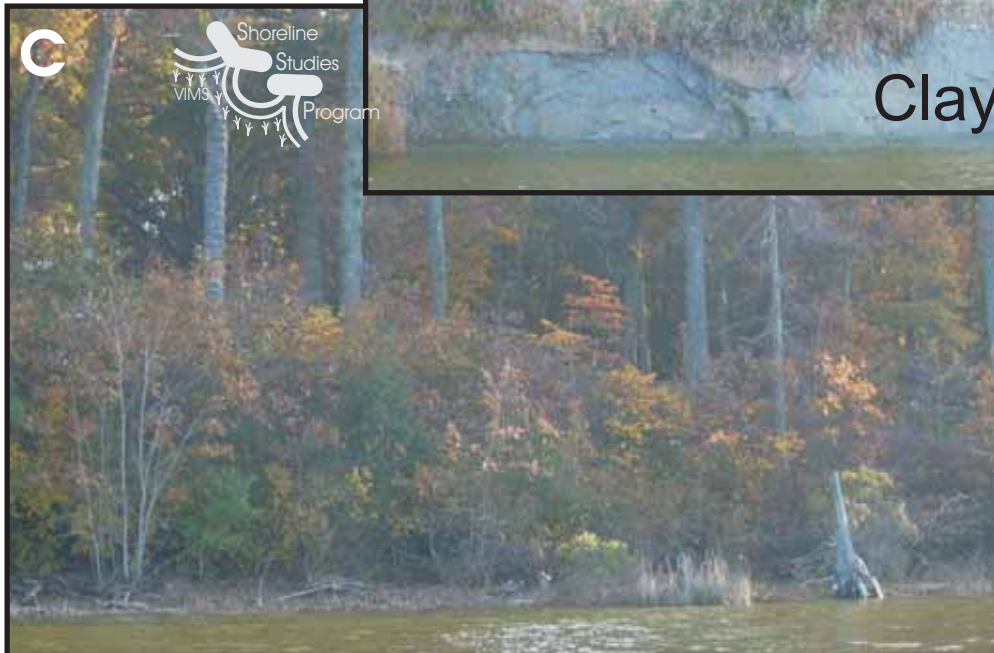
Figure 5-2. Site 349, as identified in the Mathews County Shoreline Management Plan, on the Piankatank River. A) The eastern end of the site is low, wooded and eroding. B) the high banks along the site are vertically-exposed and eroding. C) The western end of the site also is low, wooded and eroding.

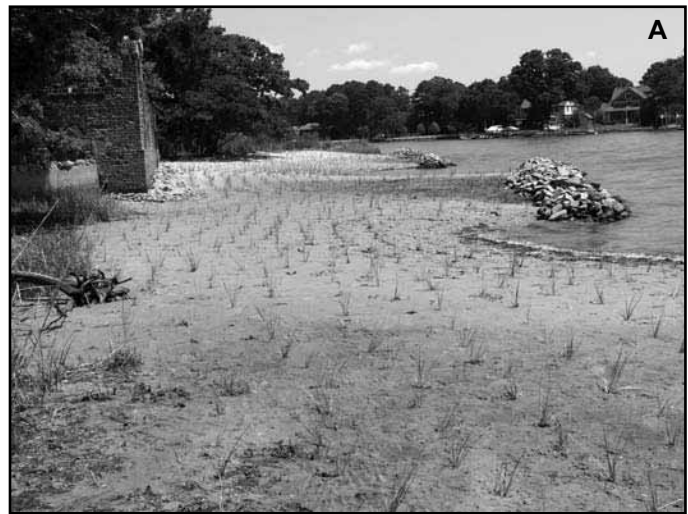
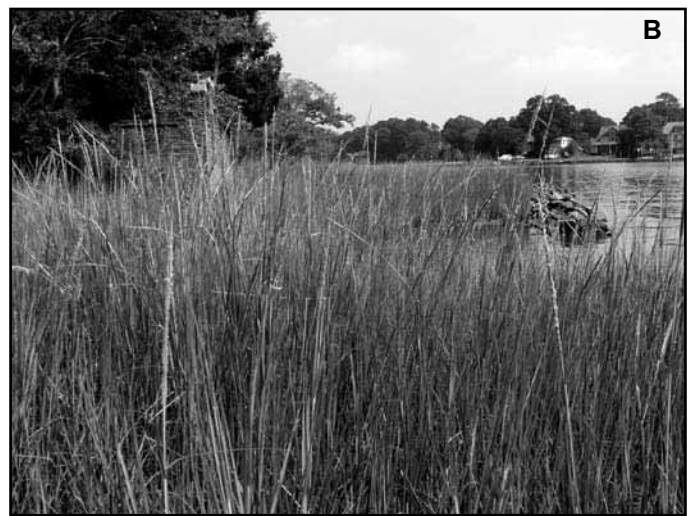
**Figure 1.** Living shoreline using a segmented sill design at the Hermitage site in Virginia (a) immediately after planting (May 2006) and (b) the following summer (August 2007).
