## York County Shoreline Management Plan

# *York County Shoreline Management Plan*

*Prepared for  
York County, Virginia and  
Virginia Coastal Zone Management Program*

Virginia Institute of Marine Science  
College of William & Mary  
Gloucester Point, Virginia

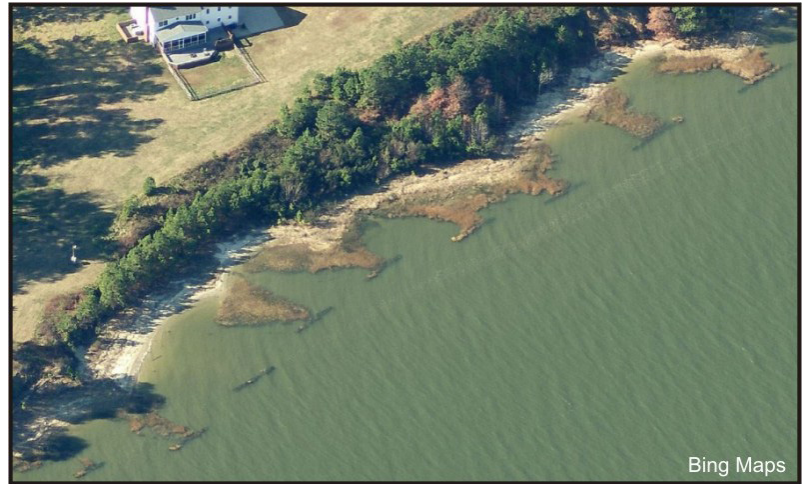
**Figure 2-3.** Eroding banks, marsh fringe, and shore protection structures along the York River between Queens Creek and Skimino Creek. Several of the structures have been effective maintaining a marsh behind it thereby reducing direct wave impact to the upland bank and slowing erosion.

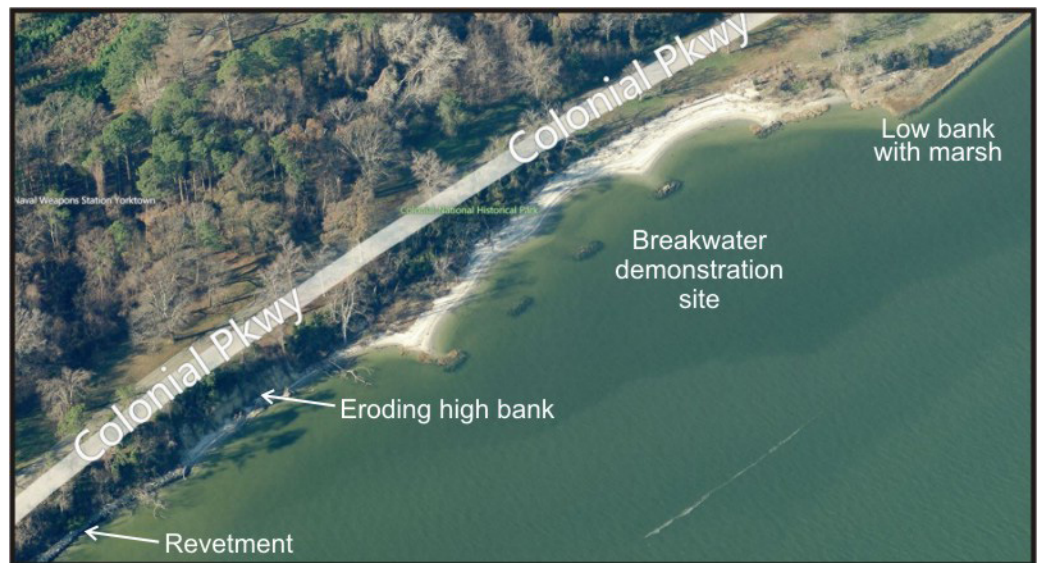
**Figure 2-4.** Upland bank with revetment, an eroding high bank along the National Park Service's Colonial Parkway.

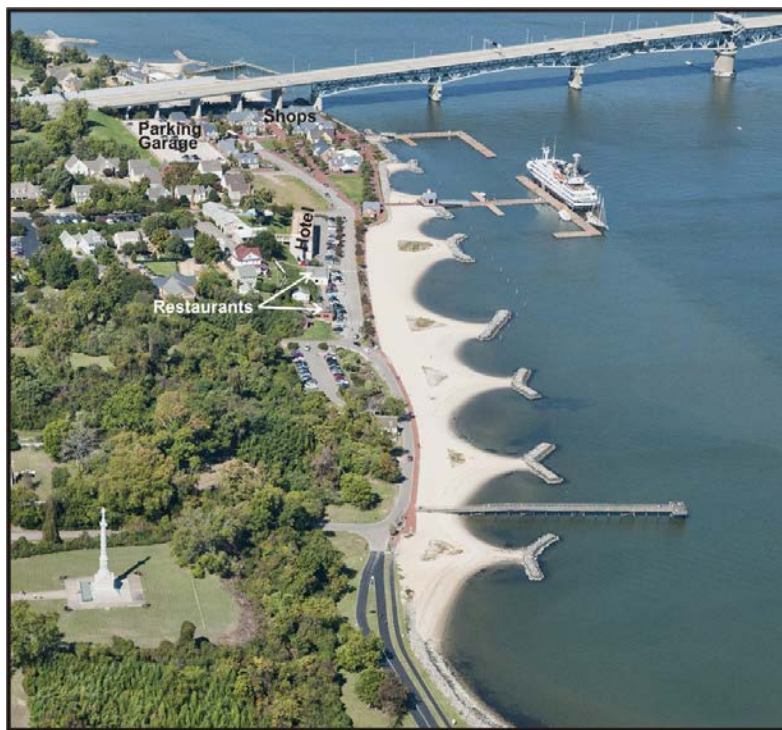
**Figure 2-5.** Yorktown breakwaters and beach nourishment project. Photo date 17 Oct 2010.

a revised commercial landscape. The post WWII era saw the slow decline of the waterfront at Yorktown as the Ferry was replaced by the Coleman Bridge, and the beach eroded away. In the mid-1990s, waterfront revitalization began as breakwaters and beach nourishment were placed to restore the beach. This followed a master plan (Sasaki *et al.*, 1993) that resulted in over 4,000 feet of shoreline protected with breakwaters and beach fill that provided enhanced recreational access (Figure 2-5). Shops and restaurants along with a two-story parking garage were built along the shore. Other commercial interests, restaurants, and a hotel benefited from the Plan. More detailed information on Yorktown can be found in Hardaway *et al.*, 2005; Milligan *et al.*, 1996; and Milligan *et al.*, 2005).

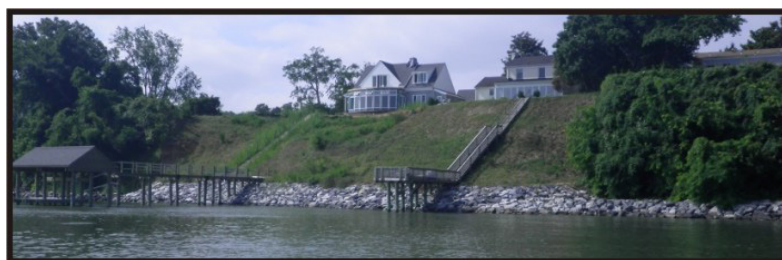
**Figure 2-6.** The shoreline between Yorktown and Wormley Creek generally has high banks that are hardened with stone revetments. Photo date 24 Jul 2013.

From Yorktown to Wormley Creek the shoreline is high banks and mostly hardened by stone revetments (Figure 2-6). This shore reach also includes the U.S. Coast Guard Base which is protected by both a stone revetment and a high bulkhead. Farther alongshore toward Wormley Creek, the Suffolk Scarp, an ancient high stand of sea level that occupied a position along the Virginia and North Carolina coastal plains and intersects the York River just downriver of the Coast Guard Station. It separates the older Chuckatuck Formation (Qc) and Shirley Formation (Qsh) from the younger units of the Tabb Formation (Figure 2-2). This scarp is significant because the topography drops from 50 feet down to about 10 feet above sea level.

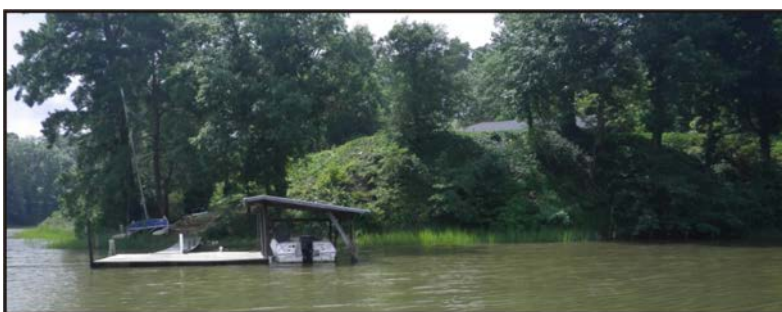
**Figure 2-7.** Steep, vegetated banks with narrow fringe marsh in Wormley Creek. Photo date 23 Jul 2013.

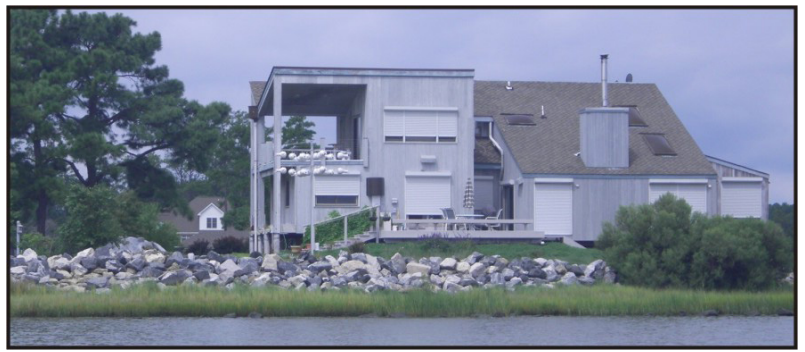
**Figure 2-8.** Low upland bank in a residential area that has a rock revetment for shore protection behind a fringe marsh

Wormley Creek is mostly residential with many shorelines hardened even though erosion rates are very low (Figure 2-8).

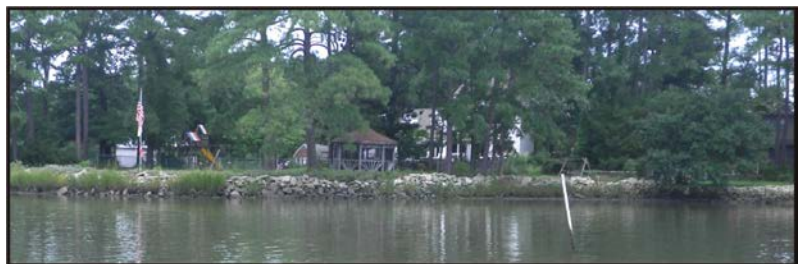
**Figure 2-9.** Low upland bank in a low-energy residential area that has a rock revetment for shore protection. Photo date 25 Jul 2013.

Back Creek, Chisman Creek, and the Poquoson River shorelines are highly developed, residential areas. Since it is eastward of the Suffolk Scarp, the elevations are relatively low (<5-10 feet) leaving properties susceptible to storm surge. Erosion rates also are low with the majority of shorelines having erosion rates of less than 1 foot per year in the areas with very little fetch. Toward the mouths of the creeks/ rivers, increased fetch exposure increases the risk of shoreline erosion. Main Bay shorelines are eroding at a rate of up to -5 feet/year. Even though erosion rates are smaller in the creeks, erosion control structures are widely dispersed along shoreline properties (Figure 2-9).

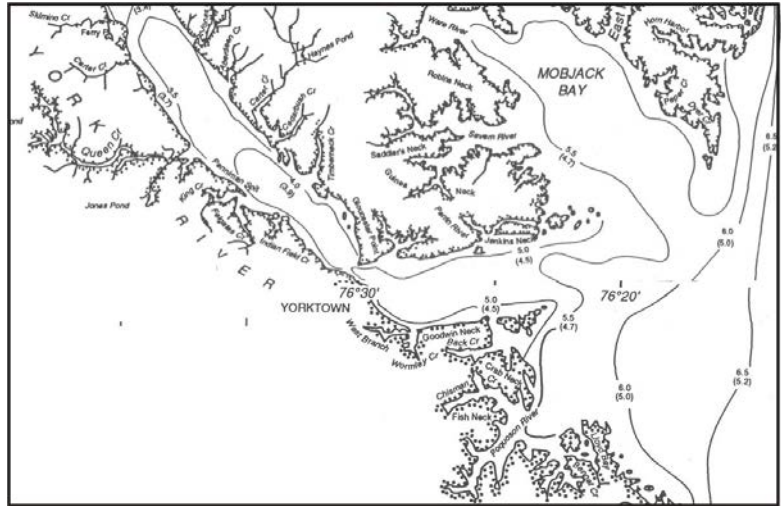
**Figure 2-10.** Predicted wave heights that would result from a 35 mph wind during a possible 2-yr event. (From Basco and Shin, 1993). Wave heights and period (in parentheses) are shown.

Basco and Shin (1993) described the wave climate along the York County coast for use in planning and designing structures. Their analysis utilized moderate winds of 35 miles per hour to generate waves with characteristics that could be expected to impact the coast about once every two years. The storm surge for this event is about 2.5 feet above mean high water or about 4.8 feet above mean low water. From their findings, wave heights and wave periods tend to decrease up the York River (Figure 2-10). Downriver of Yorktown, wave heights and periods could be 5 feet and 4.5 seconds. This decreases to a 3 foot wave that is 3.4 seconds. Along the Chesapeake Bay shoreline, waves are between 5.5 and 6 feet.

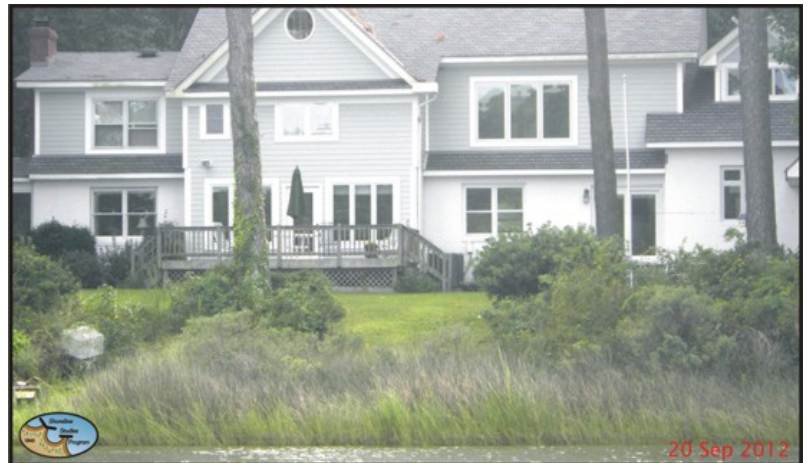
*Figure 3-2. Maintaining and enhancing the riparian and marsh buffers can maintain a stable coastal slope*

Enhancement of both riparian and existing marsh buffers together can be an effective practice to stabilize the coastal slope (Figure 3-2) from the intertidal area to the upland by allowing plants to occupy suitable elevations in dynamic fashion to respond to seasonal fluctuations, shifts in precipitation or gradual storm recovery. At the upland end of the slope, forest buffer restoration and the planting of ornamental grasses, native shrubs and small trees is recommended. Enhancement of the marsh could include marsh plantings, the use of sand fill necessary to plant marsh vegetation, and/or the need for fiber logs to stabilize the bank toe and newly established marsh vegetation.

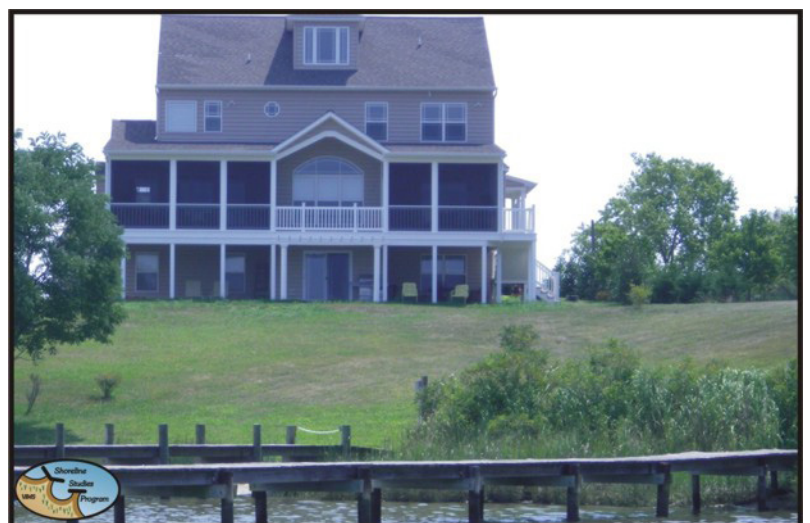
*Figure 3-3. Bank grading in Westmoreland County reduces steepness and will improve growing conditions for vegetation stabilization.*

In cases where the bank is unstable, medium or high in elevation, and very steep, bank grading may be necessary to reduce the steepness of bank slopes for wave run-up and to improve growing conditions for vegetation stabilization (Figure 3-3). The ability to grade a bank may be limited by upland structures, existing defense structures, adjacent property conditions, and/or dense vegetation providing desirable ecosystem services.

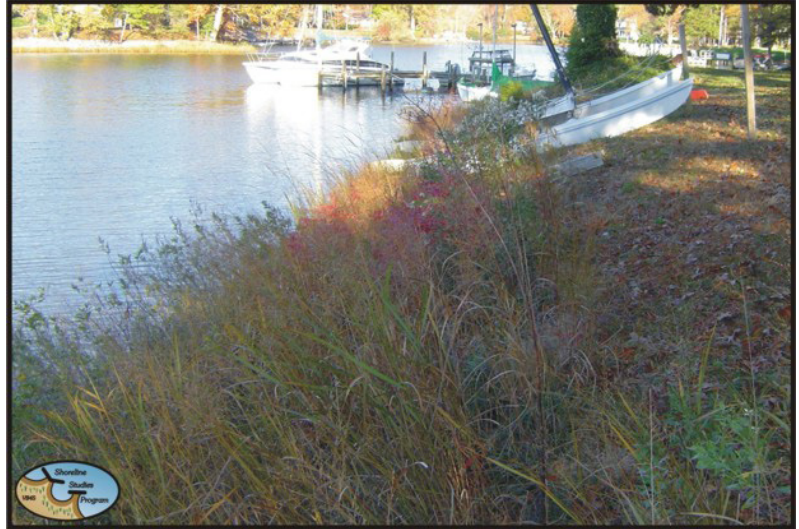
**Figure 3-4.** This low-energy site had minor bank grading, sand added, and *Spartina alterniflora* planted. This photo shows the site after 24 years.

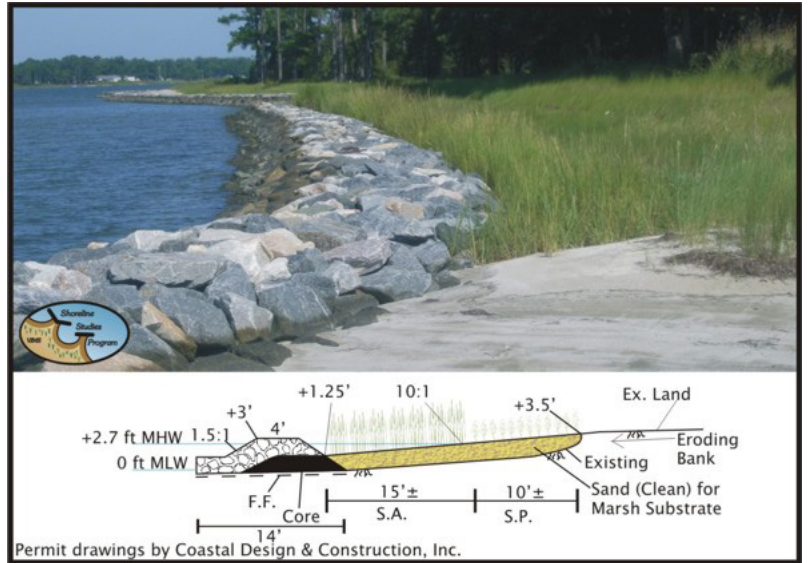
Figure 3-5. Sand fill with stone sills and marsh plantings at Poplar Grove, Mathews County, Virginia after six years and the cross-section used for construction (From Hardaway et al., 2010).

Hardaway and Byrne (1999) indicate that in low wave energy environments, a sill should be placed at or near MLW with sand fill extending from about mean tide level on a 10:1 to the base of an eroding bank. The height of the rock sill should be at least equal to mean high water to provide adequate backshore protection. Armor stone should be VA Class I. A recent installation of a sill in a low energy environment in Westmoreland County was on Glebe Creek at Hull Springs Farm (Figure 3-6). The Hull Springs Farm sill was built in 2008 along about 300 feet of shoreline. The sand fill begins at +3 feet on the bank and old bulkhead and extends on a 10:1 slope to about mid-tide (+0.8 ft mean low water) at the back of the sill. This provides planting widths of about 10 feet for *Spartina alterniflora* and 12 feet for *Spartina*

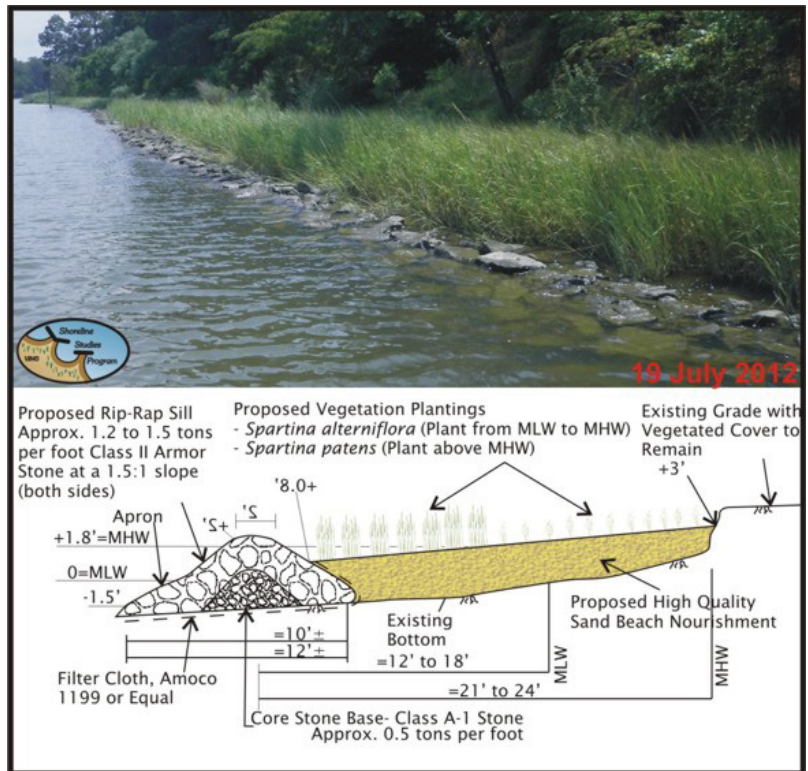
Figure 3-6. Longwood University’s Hull Springs Farm four years after construction and the cross-section used for construction (from Hardaway et al., 2010).

*patens* (Hardaway *et al.*, 2010a). The sill system was built in August 2008 and went through the Veteran's Day Northeaster (2009) with no impacts to the unprotected base of bank. Marsh fringes were heavily covered with snow and ice during the winter of 2009 but reemerged intact.

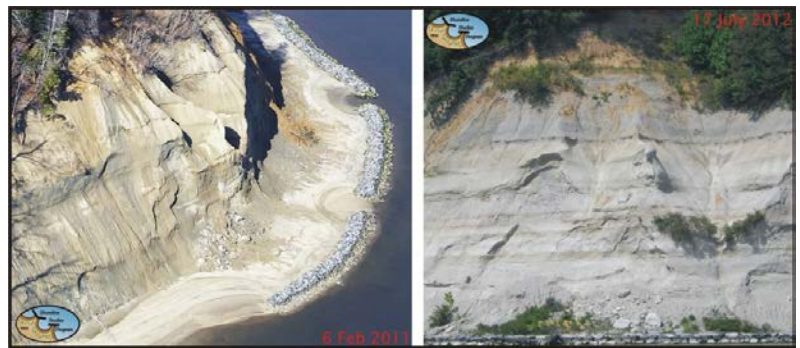
**Figure 3-7.** High sills built along Westmoreland State Park's high energy, high bank shoreline. The material that slumps from the bank will be caught behind the sills and stabilize the base of the bank by protecting it from wave attack. A more recent photo shows that the slump material is starting to become vegetated.

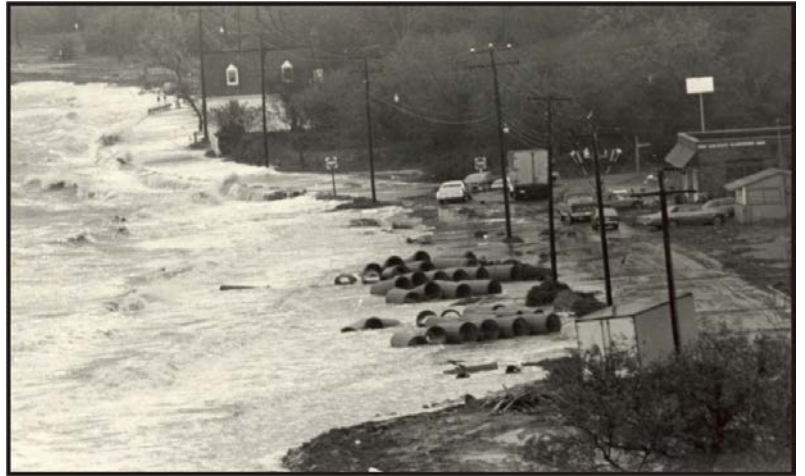
**Figure 3-8.** Photo taken at Yorktown during a spring storm. The low coast was easily overwashed.

Several breakwater examples occur in York County. Historically, the beach at Yorktown was the result of erosion of nearby sandy upland banks which was transported along-shore. Over the years, the beaches along the waterfront began to narrow as the natural sediment supply was depleted by hardening of the updrift shorelines and the continued overwash during storms (Figure 3-8). Since 1978, various projects have taken place along Yorktown's shoreline in order to abate erosion, provide a recreational beach, and minimize damage to the upland during storms. Between 1994 and 2004, seven breakwaters with beach fill were installed along the shoreline (Figure 3-9). These structures have created a stable beach planform along the main recreational beach that was designed to withstand a 50-yr storm event. The shops and piers began construction in 2004, and required modification to the breakwaters along that section of shore. The additional breakwaters upriver of the Coleman Bridge were constructed in early 2005 as a structure downriver of the pier at the end of Comte de Grasse Street. An additional breakwater with pipes to stabilize the flow of Yorktown Creek was constructed in June 2006.

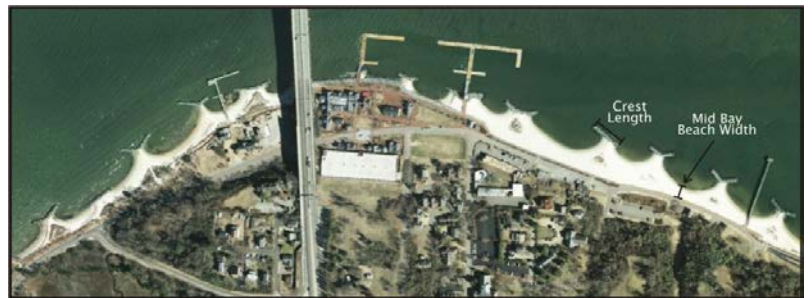
**Figure 3-9.** The breakwaters at Yorktown provide a wide recreational beach as well as storm erosion protection for the business district. These structures were phased in beginning in 1994. 2011 Virginia Base Mapping Program Image.

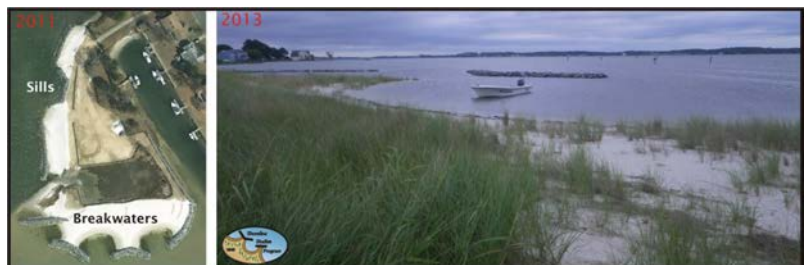
**Figure 3-10.** Headland breakwaters at the confluence of Cabin Creek and the Poquoson River. These structures were built relatively closely-space to provide a recreational beach as well as to protect the upland. Left: A 2011 Virginia Base Mapping Program image shortly after installation. Right: Photo taken in July 2013. Planted beach grasses have thrived at the site.

Another headland breakwater system in York occurs at the confluence of Cabin Creek and the Poquoson River (Figure 3-10). This property is privately owned, and the system represents the use of breakwaters and sill to create a Living Shoreline that includes an enhanced beach/dune system on the open River/Bay exposure that transitions to a sill system along the more fetch-limited creek shoreline. A small inlet also was stabilized in order to protect a pocket tidal marsh on the property. The pre-project shoreline consisted of a broken concrete revetment around the peninsula shaped property. Much of that was incorporated as core material in the stone breakwaters and sill systems.

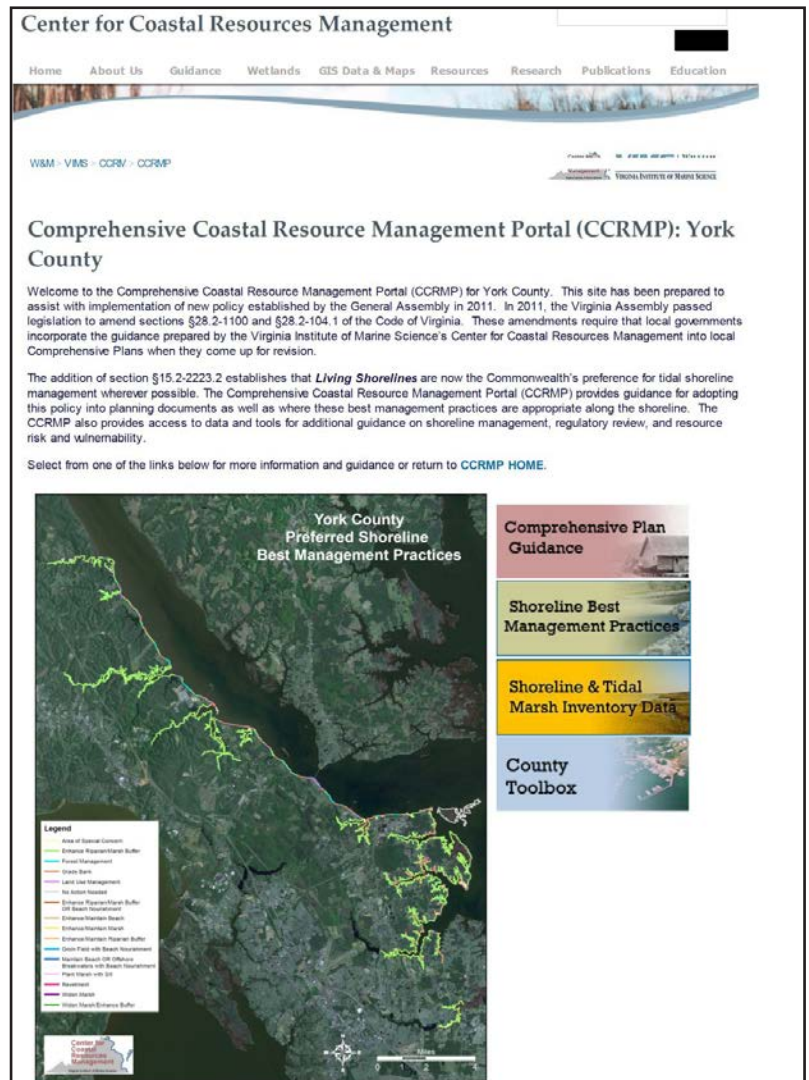
Figure 5-1. Example of the online portal for Comprehensive Coastal Resource Management in York County.

To view the model output, the Center for Coastal Resources Management has developed a Comprehensive Coastal Resource Management portal (Figure 5-1) which includes a pdf file depicting the SMM output, an interactive map viewer that illustrates the SMM output as well as the baseline data for the model (<http://ccrm.vims.edu/ccrmp/york/index.html>).

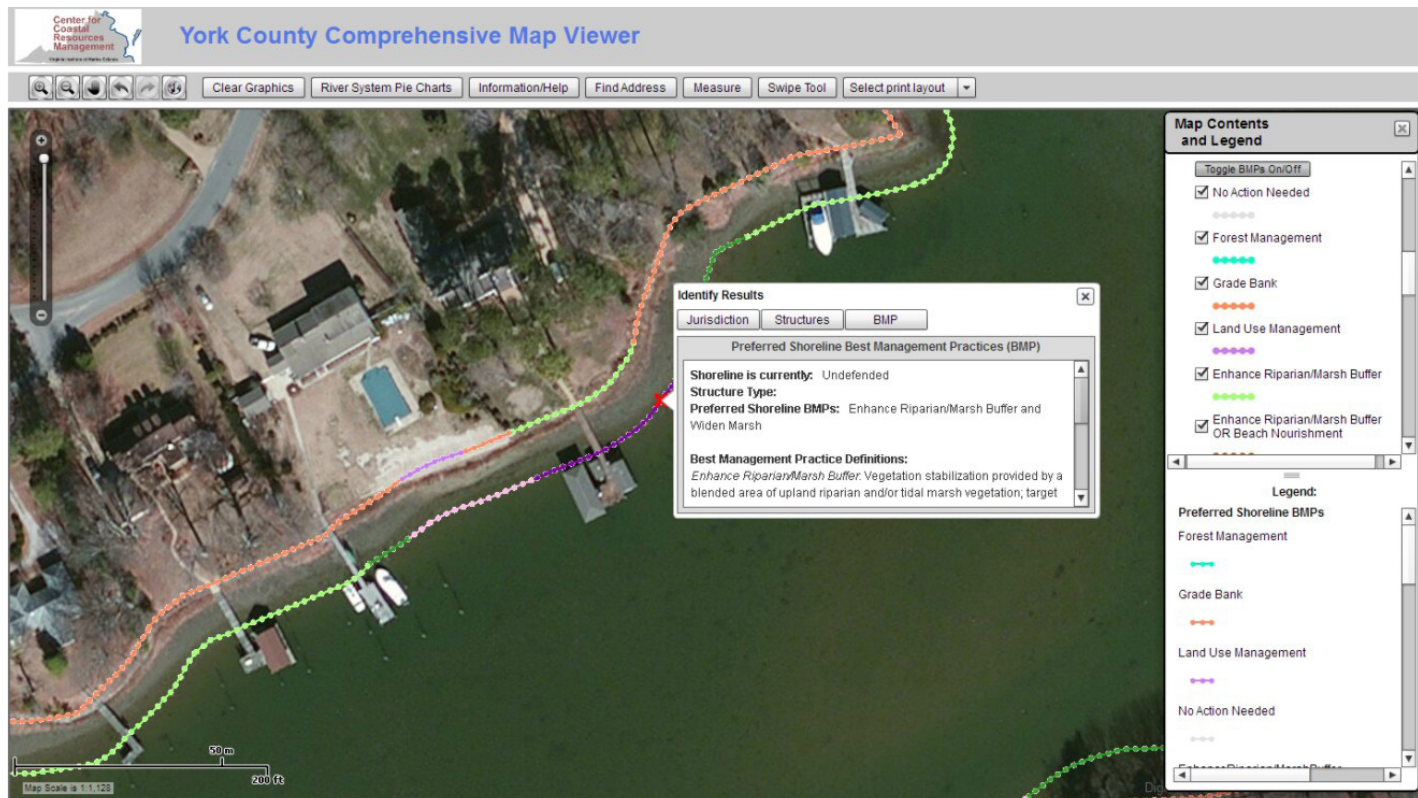
Figure 5-3. The pop-up window contains information about the recommended Shoreline BMP at the site selected. Additional information about the condition of the shoreline also is given.

for printing. When “Shoreline Management Model BMPs” is selected from the list in the right hand panel and toggled “on” the delineation of shoreline BMPs is illustrated in the map viewing window. The clickable interface conveniently allows the user to click anywhere in the map window to receive specific information that pertains to conditions onsite and the recommended shoreline strategy. [Figure 5-3](#) demonstrates a pop-up window displayed onscreen when a shoreline segment is clicked in the map window.

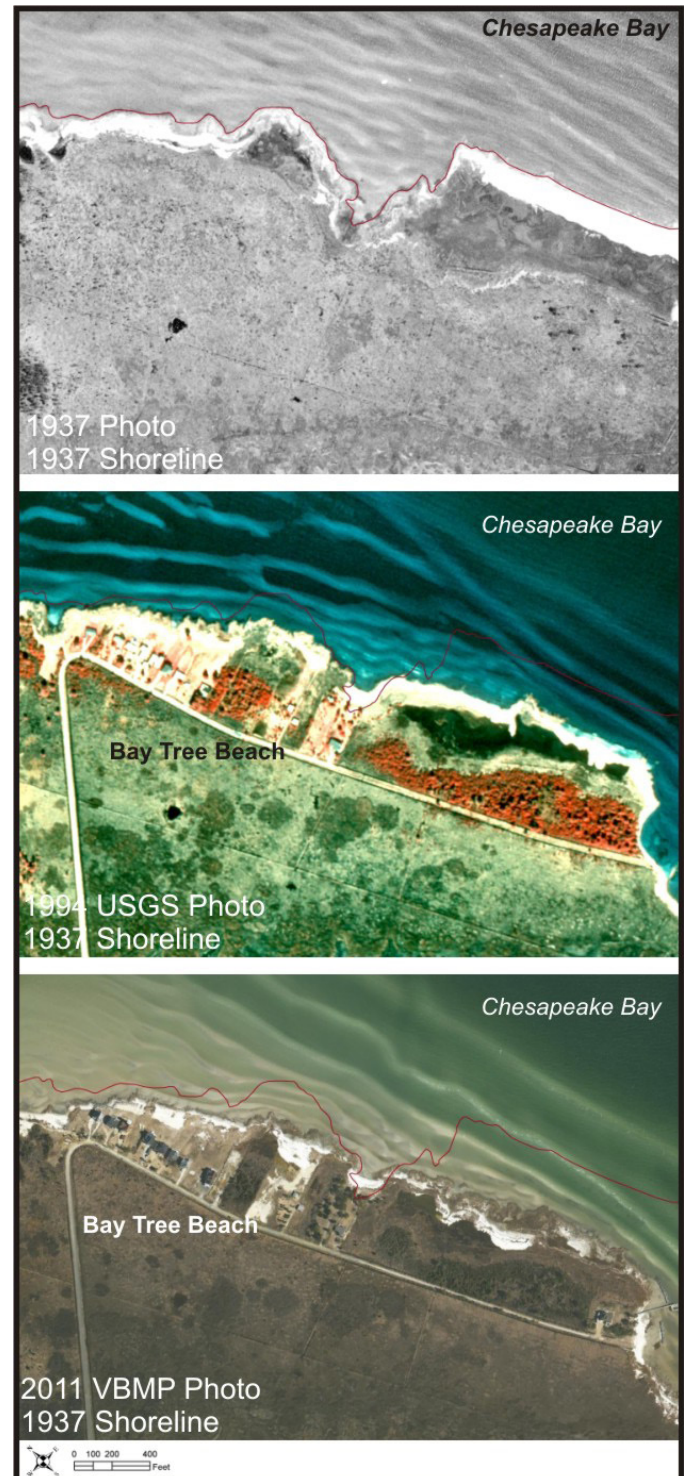
**Figure 5-4.** Bay Tree Beach in 1937 (top), 1994 (middle), and 2011 (bottom). This marsh shoreline along Chesapeake Bay has eroded through time leading some residents to install a revetment for shore protection.

In 1937, the area was uninhabited ([Figure 5-4](#)). At that time, the shoreline was 80 to 300 feet bayward

of its present position. Historic shore erosion has proceeded at a rate of 1 to 4 ft/yr. In 1953, Bay Tree Road existed in its present configuration, crossing the marsh to the shoreline, then bending south. Several lots had been cleared and three houses were built on the north end of the development. More housing was slowly added over time. By 1994, the houses that exist today had been constructed (Figure 5-4). By 2010, a sewer substation was installed at the bend in the road.

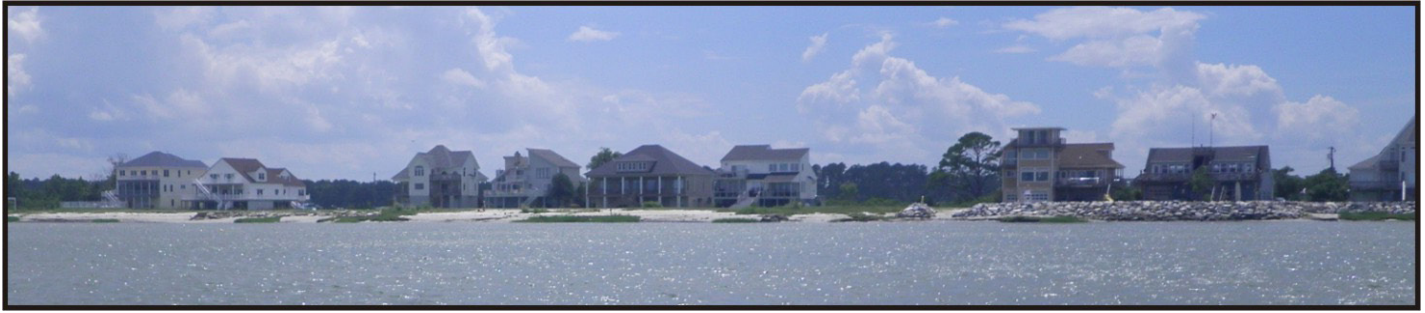
**Figure 5-5.** The Bay Tree Beach shoreline consists of eroding marsh headlands and sand washover. A revetment was constructed along the shoreline.

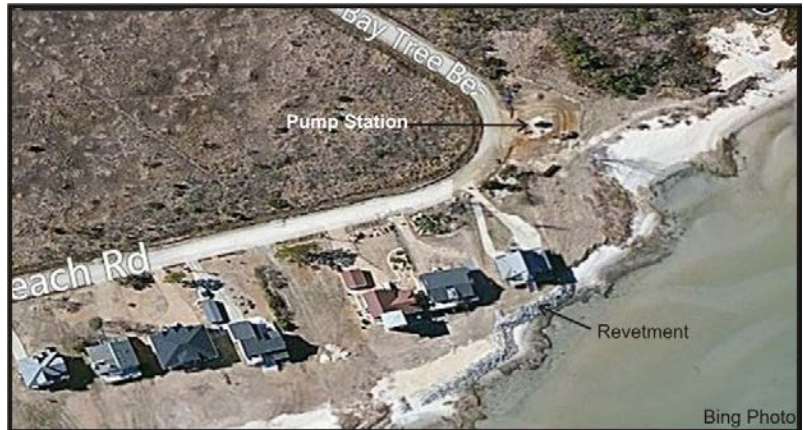
**Figure 5-6.** Erosion is threatening the sewer pump station for Bay Tree Beach.

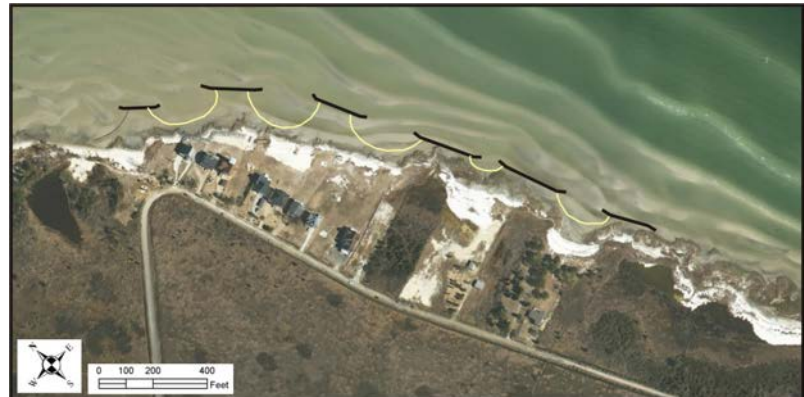
**Figure 5-7.** Site-specific application of the Shoreline Management Model recommendation for Bay Tree Beach. The breakwater system will stabilize the shoreline, provide shore protection, and create a recreational beach. The sills will stabilize the marsh.

The preferred recommendation is a breakwater system (Figure 5-7). Although, expensive, a properly designed and construction headland breakwater system can provide long-term shore protection and create a stable beach/dune system. Even so, on such an exposed and low coast, some maintenance can be expected. The cross-sections for a typical structure and bay beach for this site are shown in Appendix 3, Figure 2B.

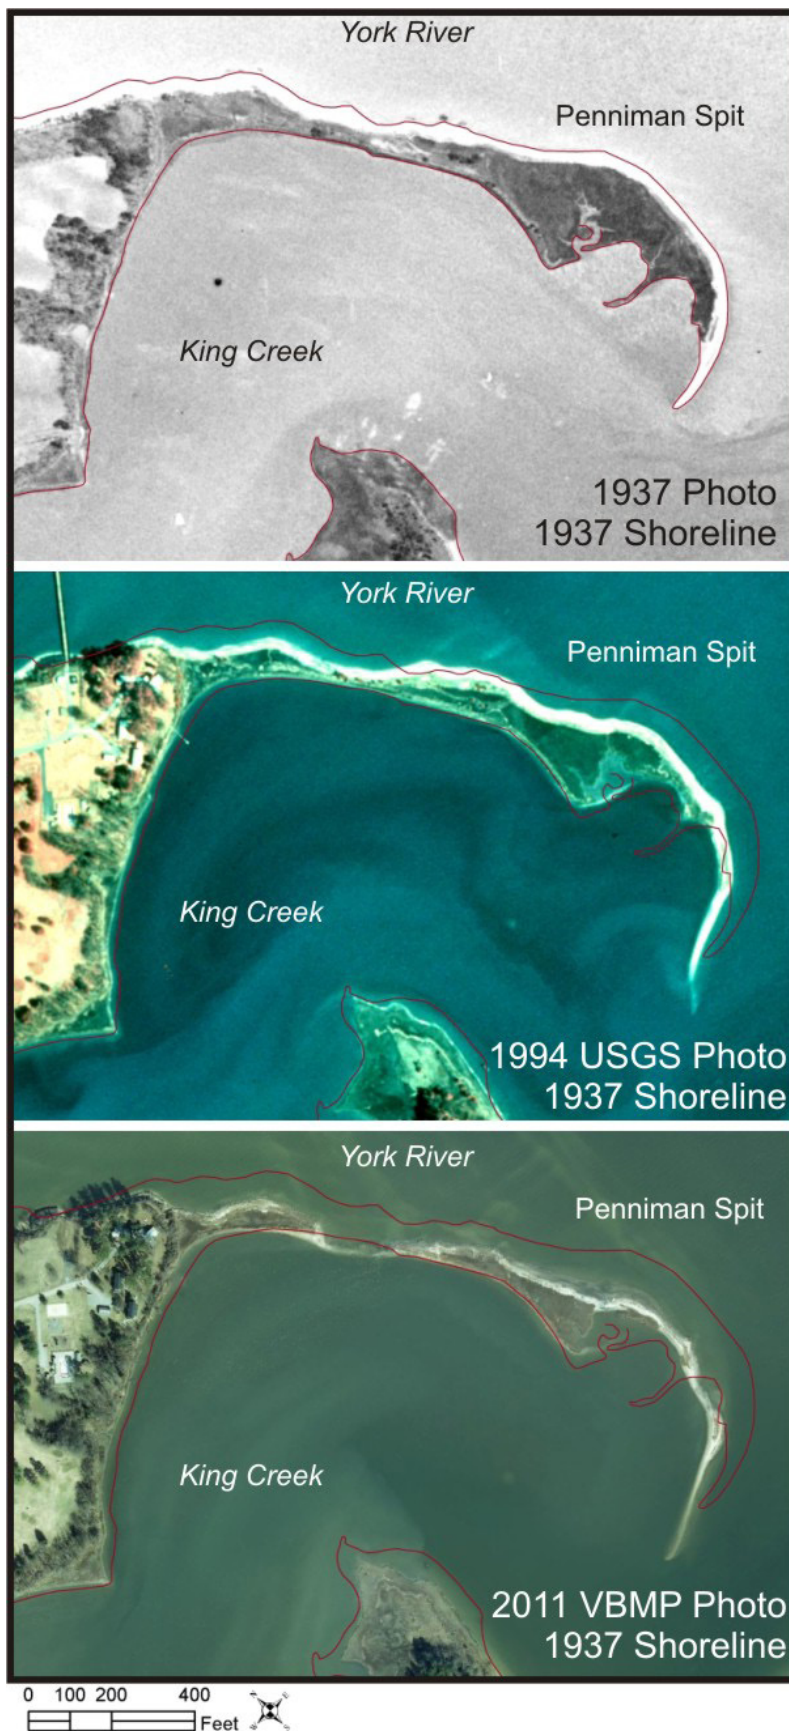
**Figure 5-8.** Penniman Spit in 1937 (top), 1994 (middle), and 2011 (bottom). This marsh spit has eroded through time such that the center section has broken through.

Penniman Spit is located on the York River at the mouth of King Creek and Felgates Creek (Figure 2-1). This spit was once more substantial than its present configuration and size. In 1937, the spit extended across the mouth of King Creek for over 3,000 feet and was over 450 feet at its widest part (Figure 5-8). Between

1937 and 1994, the spit stayed relatively the same length but narrowed by almost 100 feet in some areas. In 2011, the spit had narrowed in some areas by over 200 feet since 1937 and was close to breaching in the center. A 2012 aerial photo shows that the spit has indeed breached and is narrowing near its point of upland attachment (Figure 5-9).

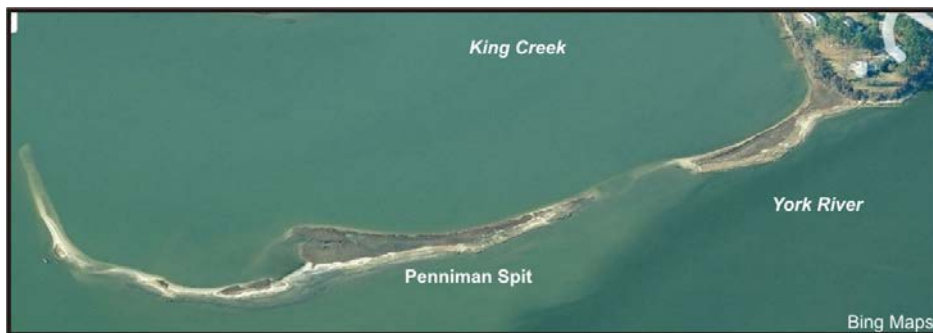
**Figure 5-9.** Penniman Spit in 2012 (Bing Maps) showing the breach through its middle.

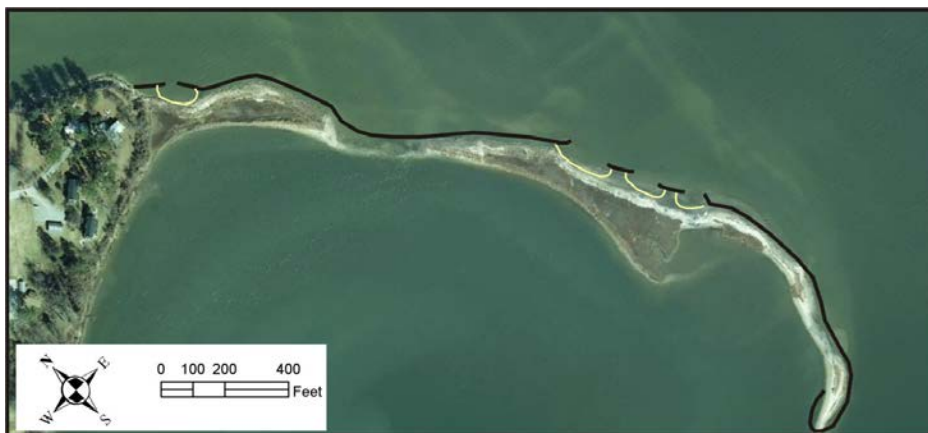
**Figure 5-10.** Site-specific application of the Shoreline Management Model recommendation for Penniman Spit. The sills will rebuild the spit thereby providing protection the shorelines landward of the spit.

In order to continue protecting these shorelines as well as addressing the reduction in sediment transported onto the spit, a semi-continuous sill system is proposed (Figure 5-10). The sill system would rebuild sections of the marsh and protect the remaining sections from continued loss. The typical cross-section for the system is shown in Appendix 3, Figure 1B.

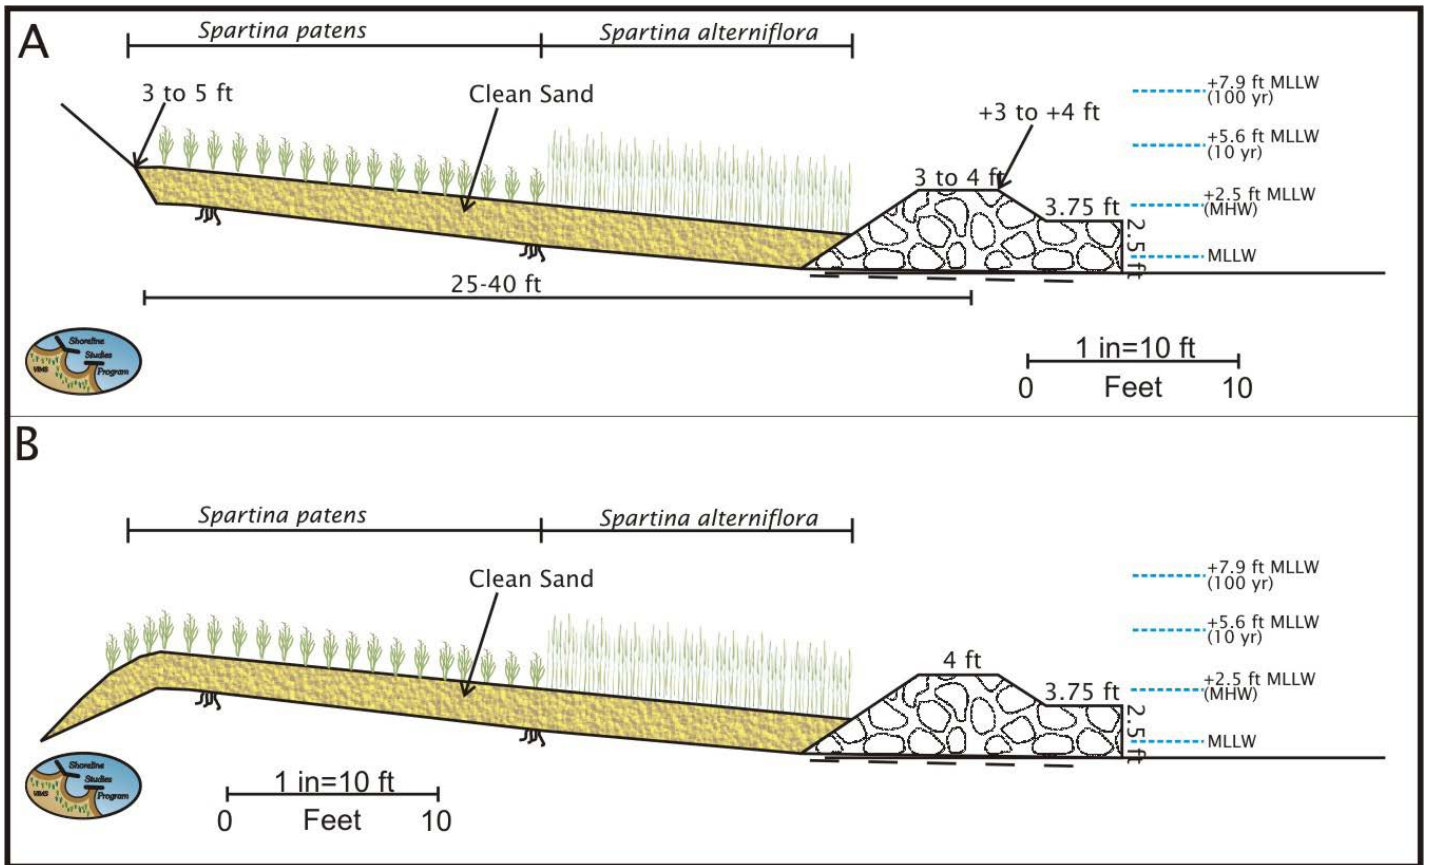
**Appendix 3, Figure 1.** A) Typical cross-section for a high sill that is appropriate for the medium to high energy shorelines of York County. The project utilizes clean sand on an 10:1 (H:V) slope. B) Typical cross-section modified for the area of interest at Penniman Spit.

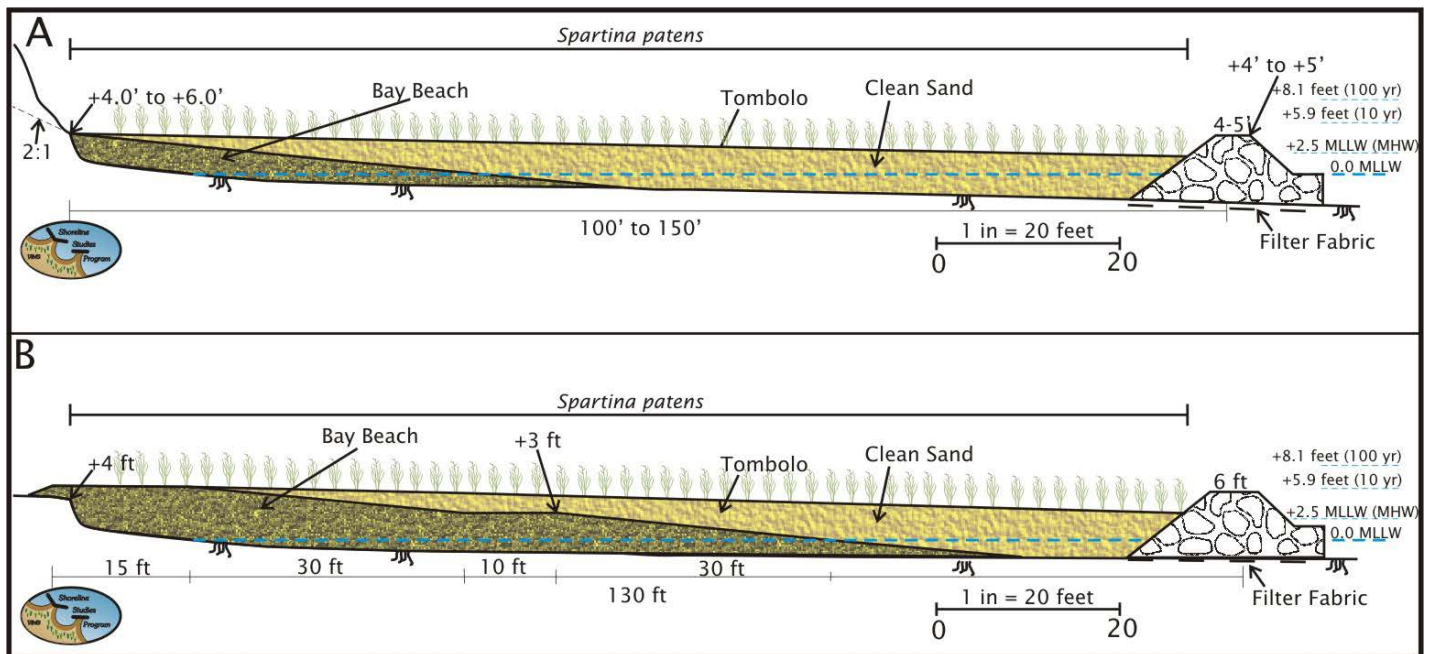
**Appendix 3, Figure 2.** A) Typical cross-section for a breakwater system that is appropriate for the medium to high energy shorelines of York County. Shown is the cross-section for the tombolo and rock structure. In addition, the typical cross-section for the bay beach between the structures is superimposed in a slightly different color. Note: the beach material is the same for the two cross-sections. B) Typical cross-section modified for the area of concern at Bay Tree Beach. Due to Bay Tree Beach's low backshore, a wide dune will have to be built.
