Shoreline Evolution Chesapeake Bay and Piankatank River Shorelines Mathews County, VA

Shoreline Evolution Chesapeake Bay Shoreline Mathews County, Virginia

Shoreline Studies Program ¹
Department of Physical Sciences
and
Wetlands Program ²
Center for Coastal Resources Management

Virginia Institute of Marine Science
College of William & Mary
Gloucester Point, Virginia

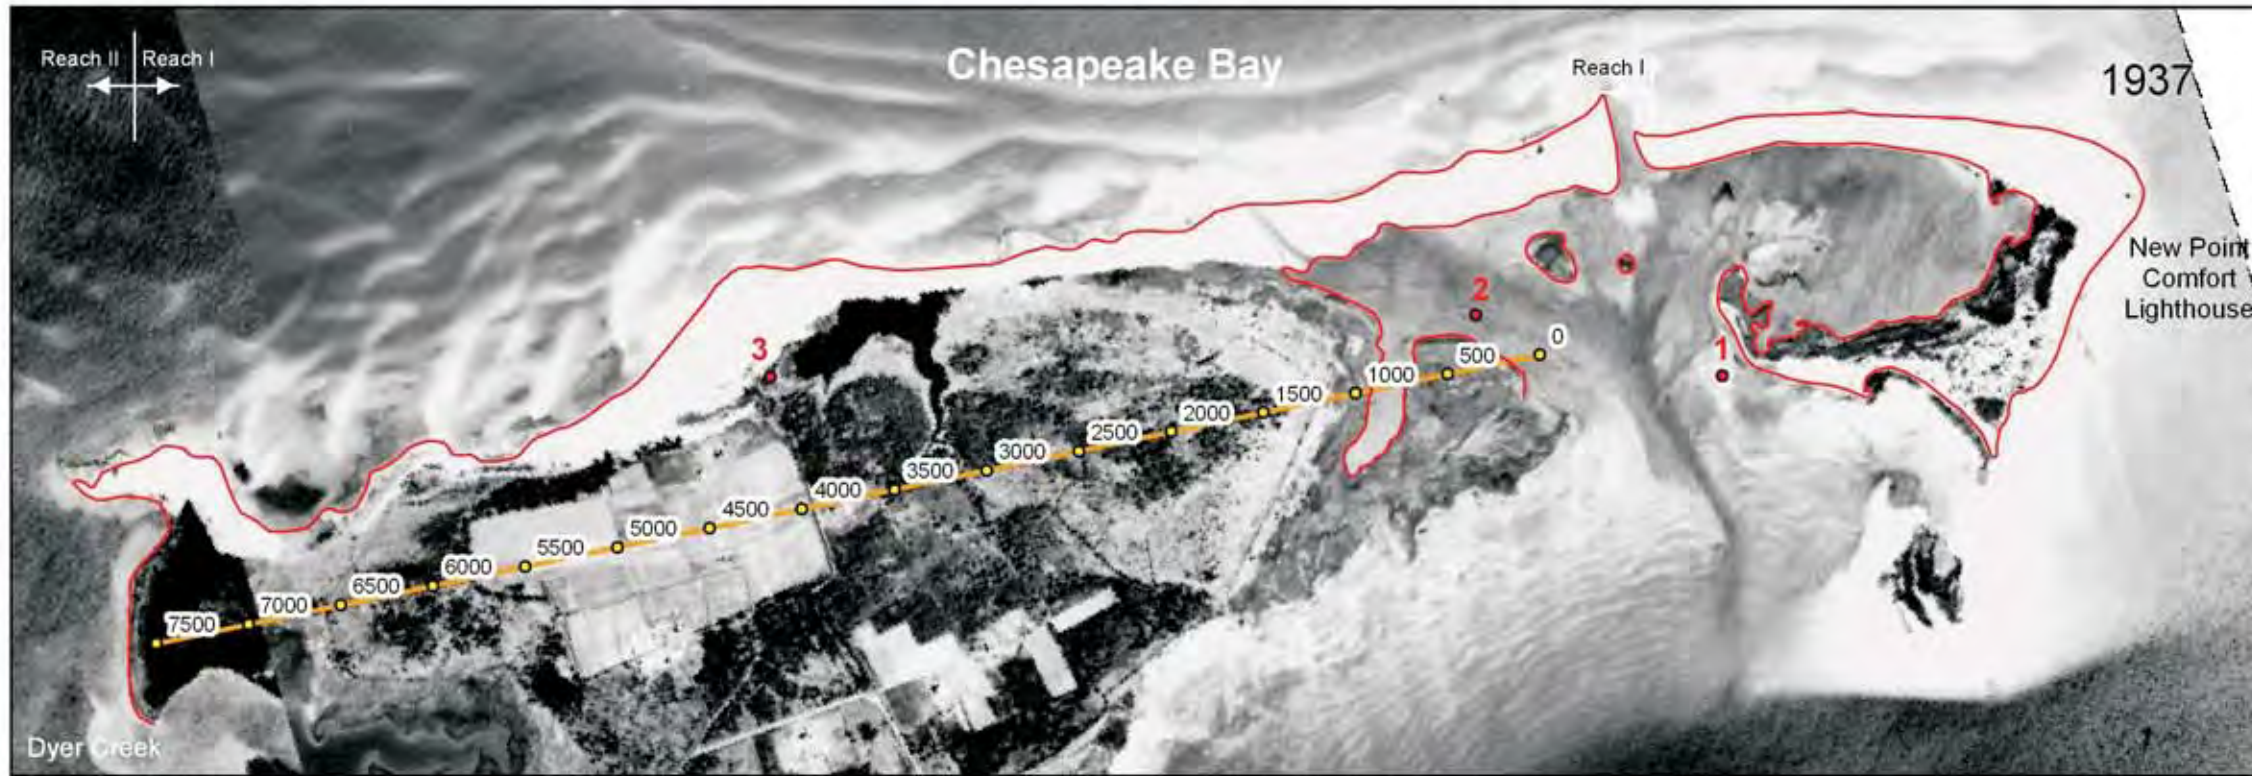
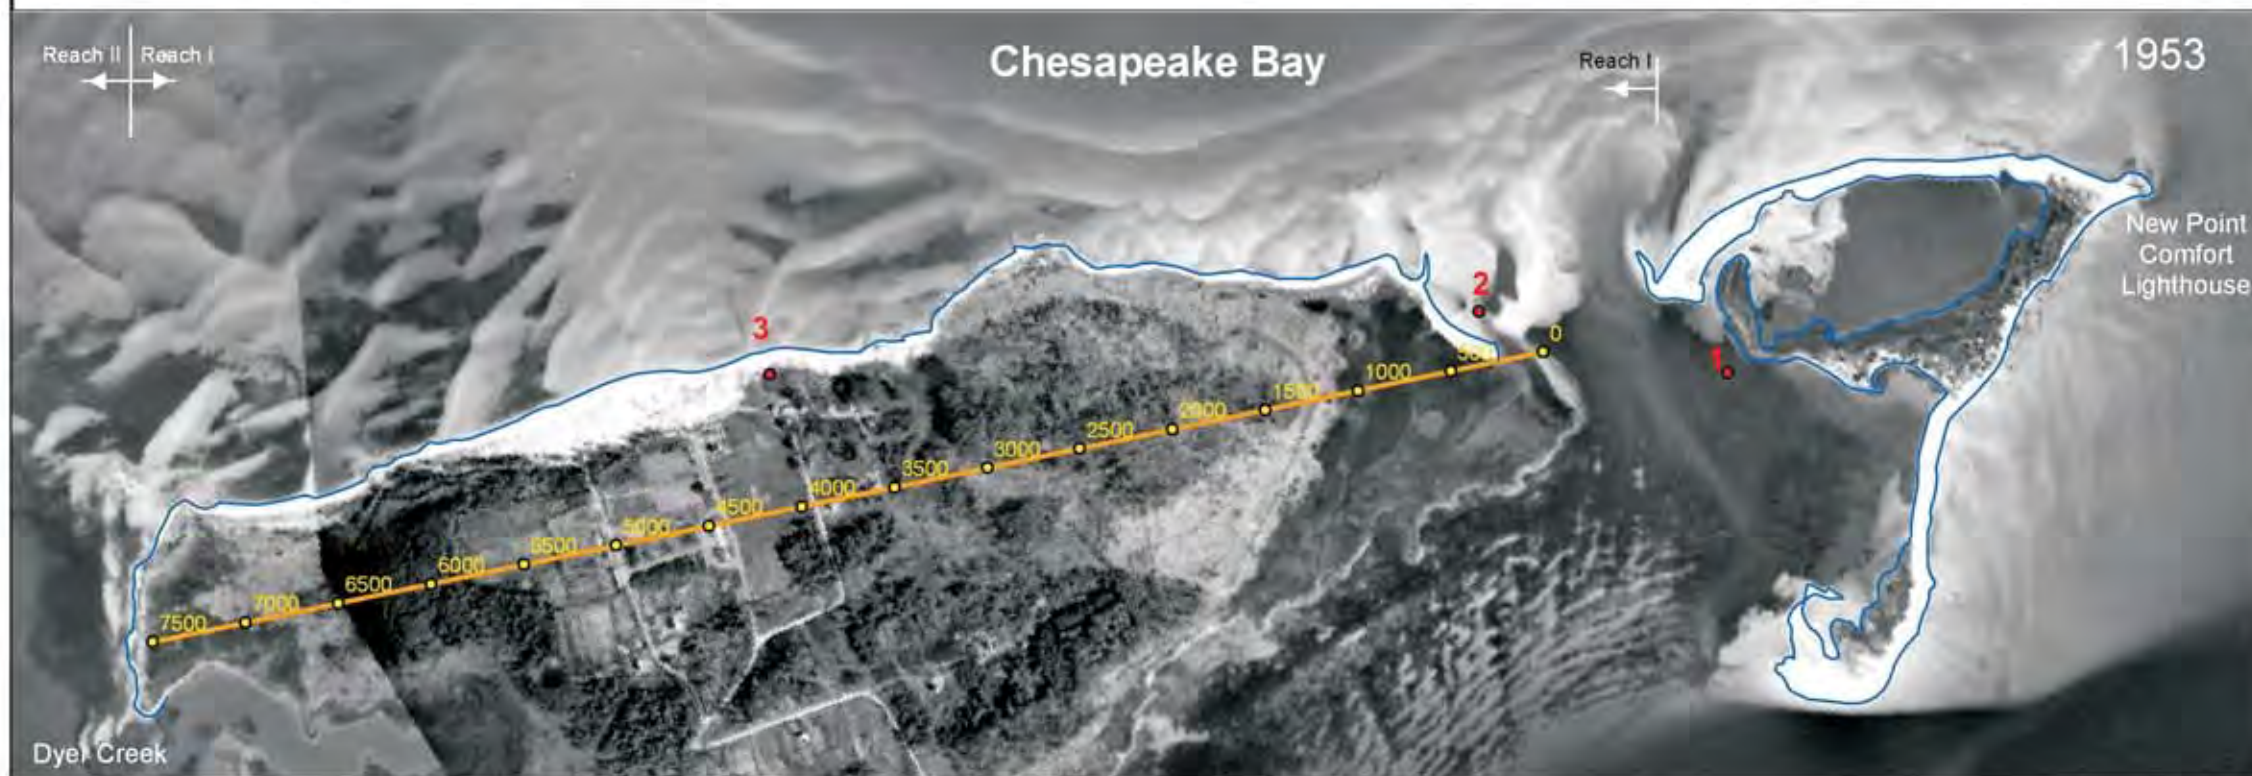
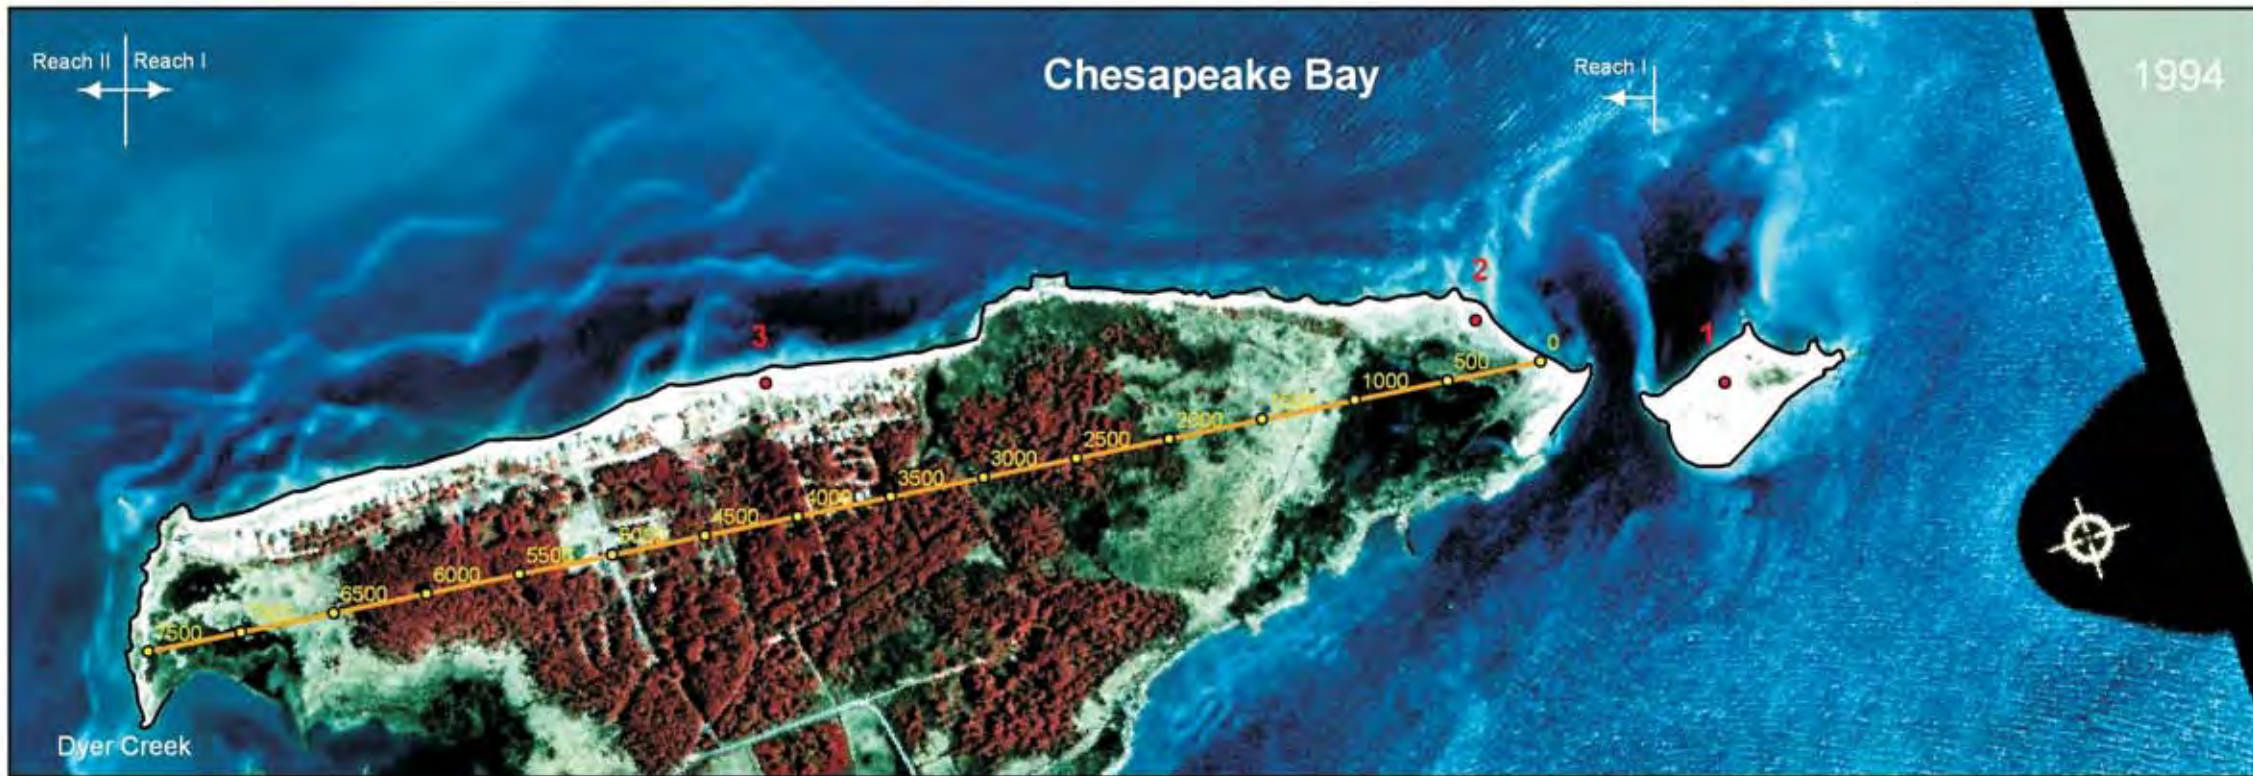
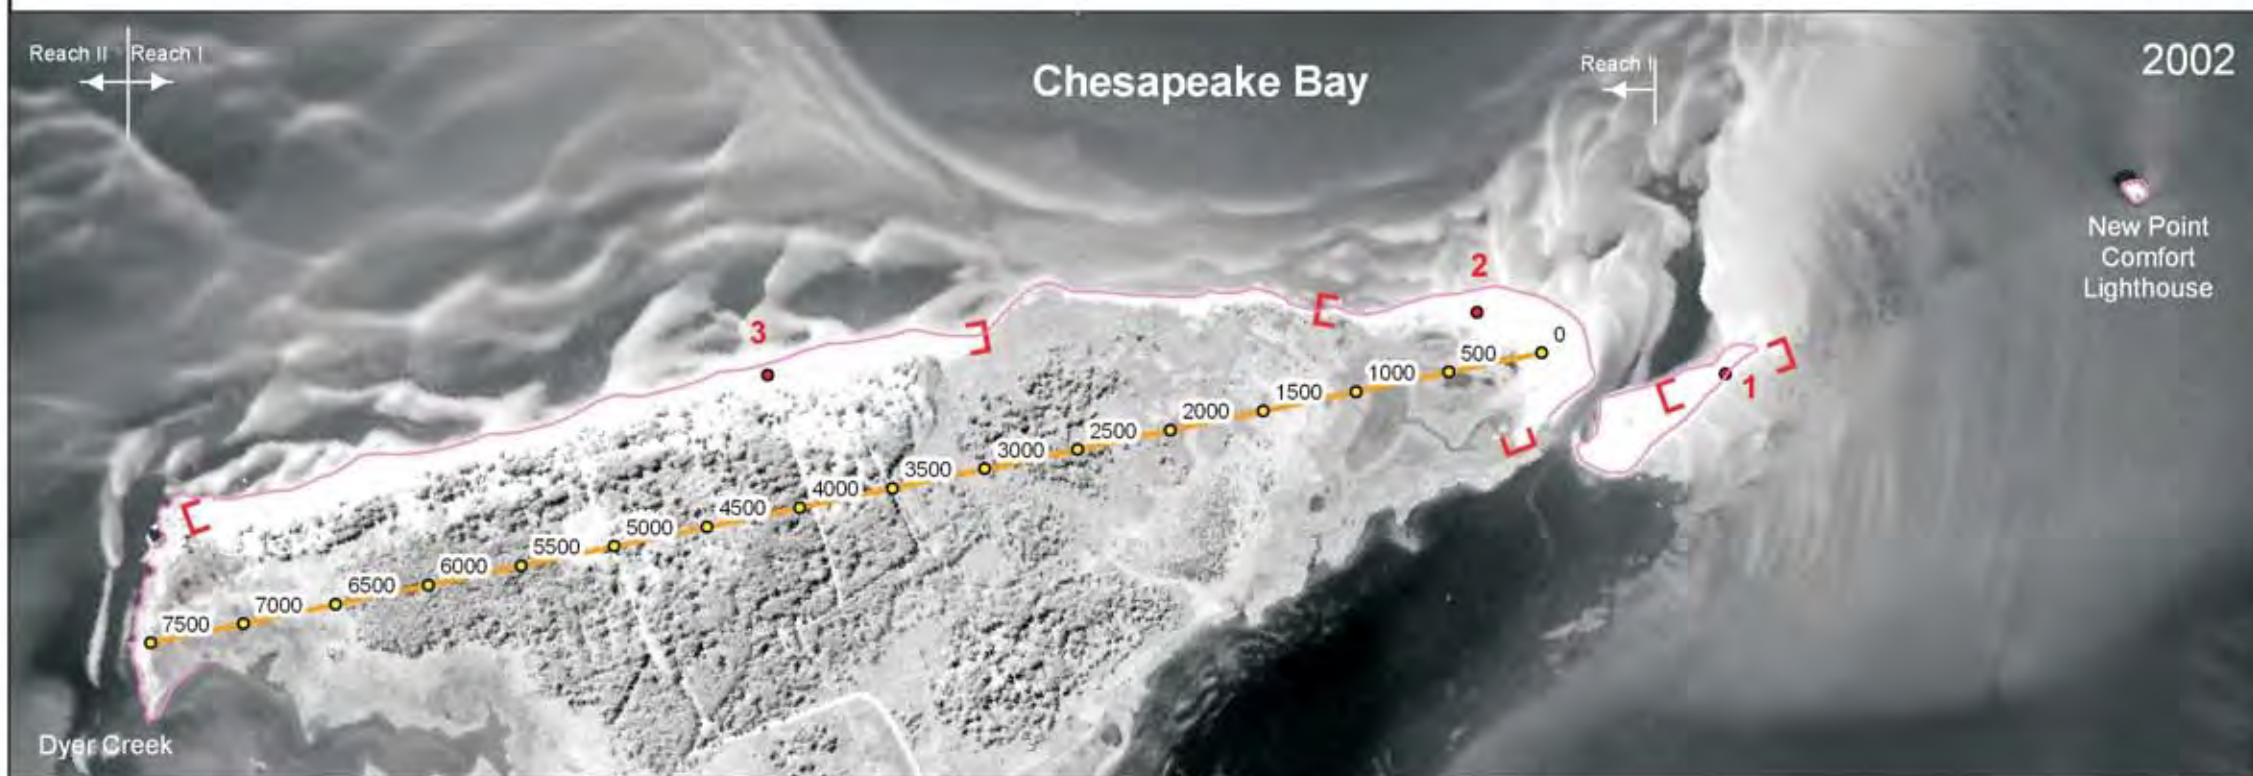
Mathews County
Plate 1
 Morphological Reach I
 New Point Comfort to Dyer Creek

Reach I lies within Plate 1 and extends from New Point to Dyer Creek. Dune sites in Reach I are denoted MA1, MA2 and MA3. As seen in the shoreline change summary of Plate 1, the southern most part of Mathews County has had dramatic shifts in shore position. The dune sites MA1 and MA2 are positioned in areas that were water in 1937. The sand has subsequently shifted into its current position by wave and current forces operating at this confluence of Mobjack Bay and Chesapeake Bay. New Point Comfort Lighthouse, completed in 1805, became an island in the 1850s when Deep Creek breached. The island has since receded leaving the lighthouse completely stranded in Chesapeake Bay. The shore reach at MA3 has been more stable over the years, and the coast has evolved to a semi-equilibrium shore form. Hardening of the point at the north end of Reach I has helped maintain headland control and thereby shore stability on that end of the reach.

The long term shore change rate (1937-2002) of the mainland, where the baseline is drawn, shows an erosional trend from station 0 to about station 4750. The trend is slightly accretional from station 4750 to station 6750, but then is very erosional at the end of the reach where the point seen in 1937 imagery is completely eroded. Overall, the long-term rate of change for this reach is -5.5 ft/yr. Extreme fluctuations in shore change are seen at each end of the reach where wave and current dynamics interact and significantly influence alongshore sand movement.

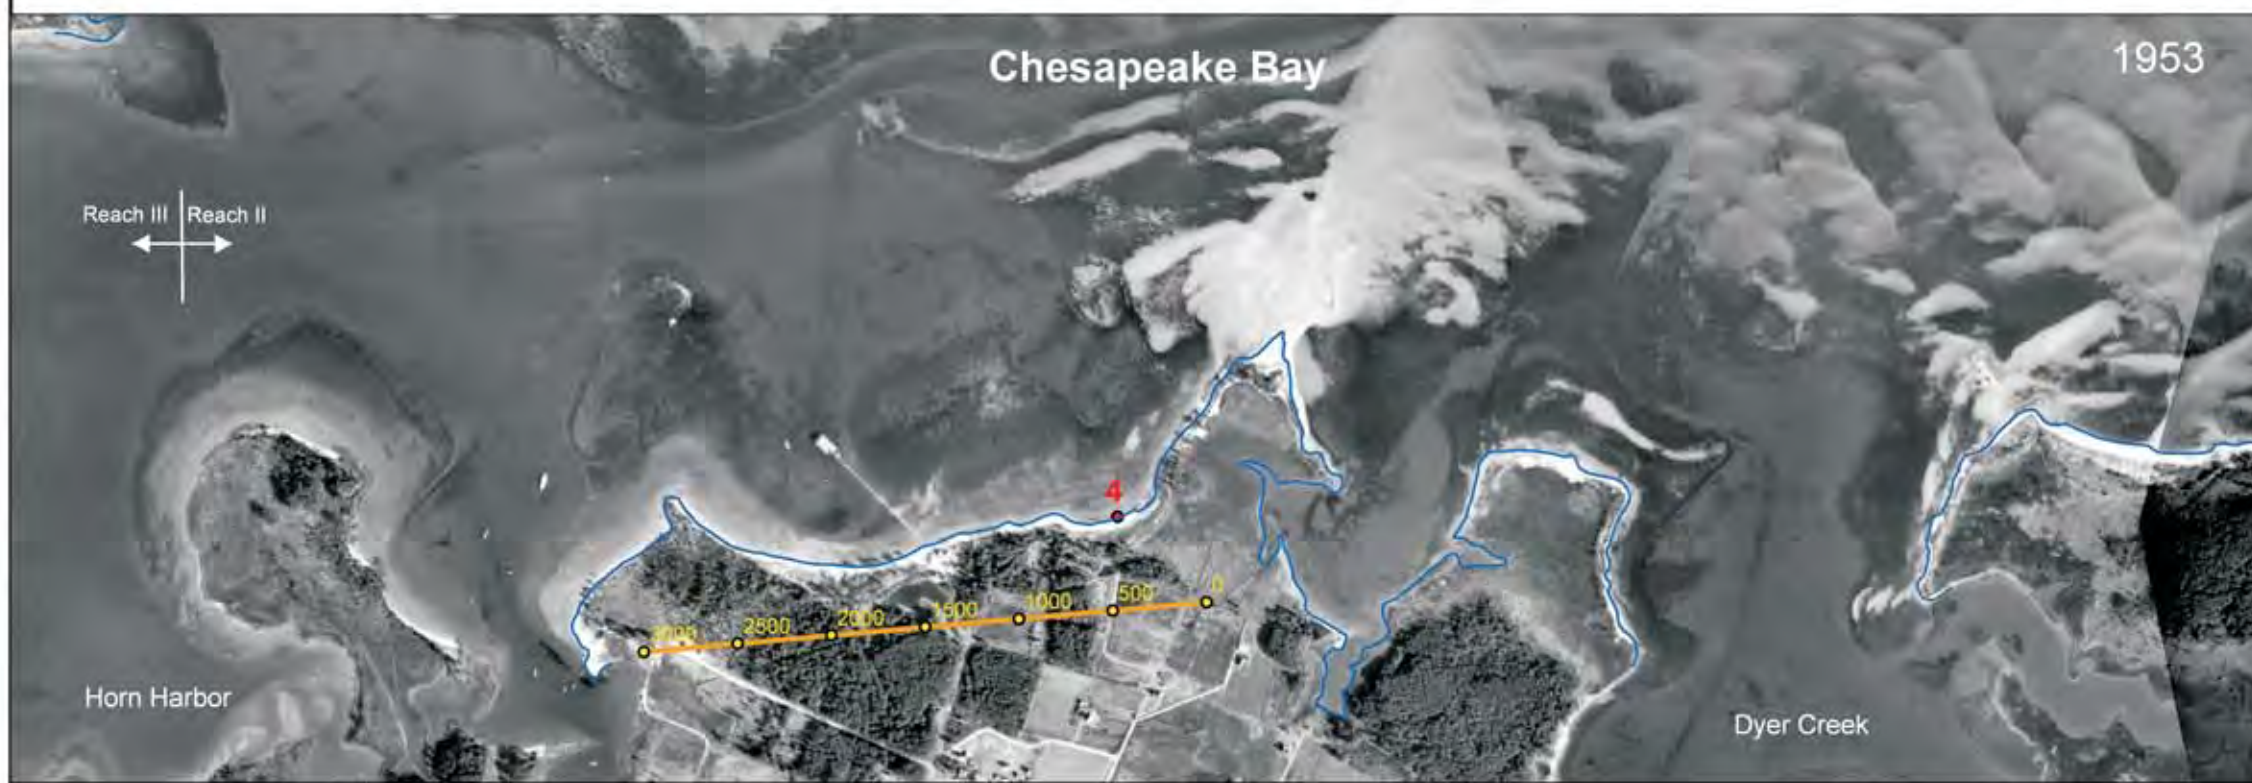
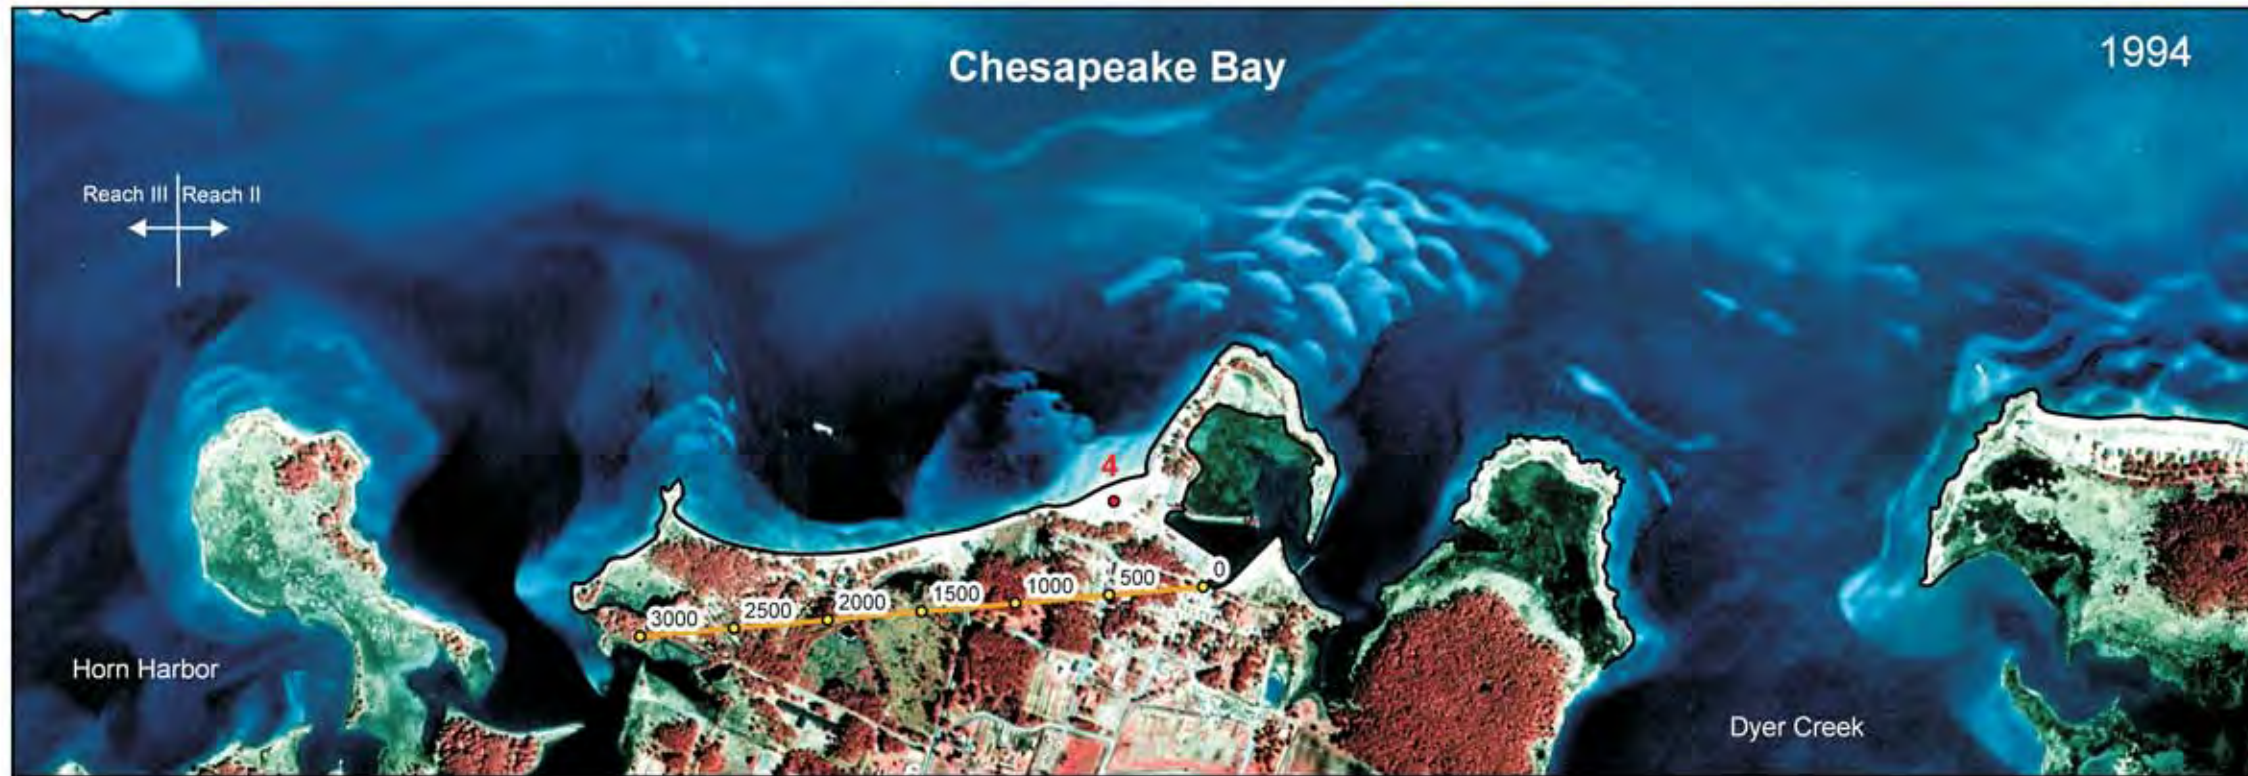
Mathews County
Plate 2
 Morphological Reach II
 Dyer Creek to Horn Harbor

Reach II lies within Plate 2 and extends from Dyer Creek on the south to Horn Harbor on the north. The coast is very convoluted marsh so the baseline method of shore change assessment is limited to a narrow neck of land where dune site MA 4 occurs. An abundance of SAV, tidal flats and nearshore sand bars exist along this reach. A pocket beach existed at about station 500 until about 1953 when the small bay was used intermittently for dredged material disposal from the navigation channel into Horn Harbor. This resulted in the formation of MA4. Overall, this reach is relatively stable with a net change of -0.5 ft/yr between 1937 and 2002.

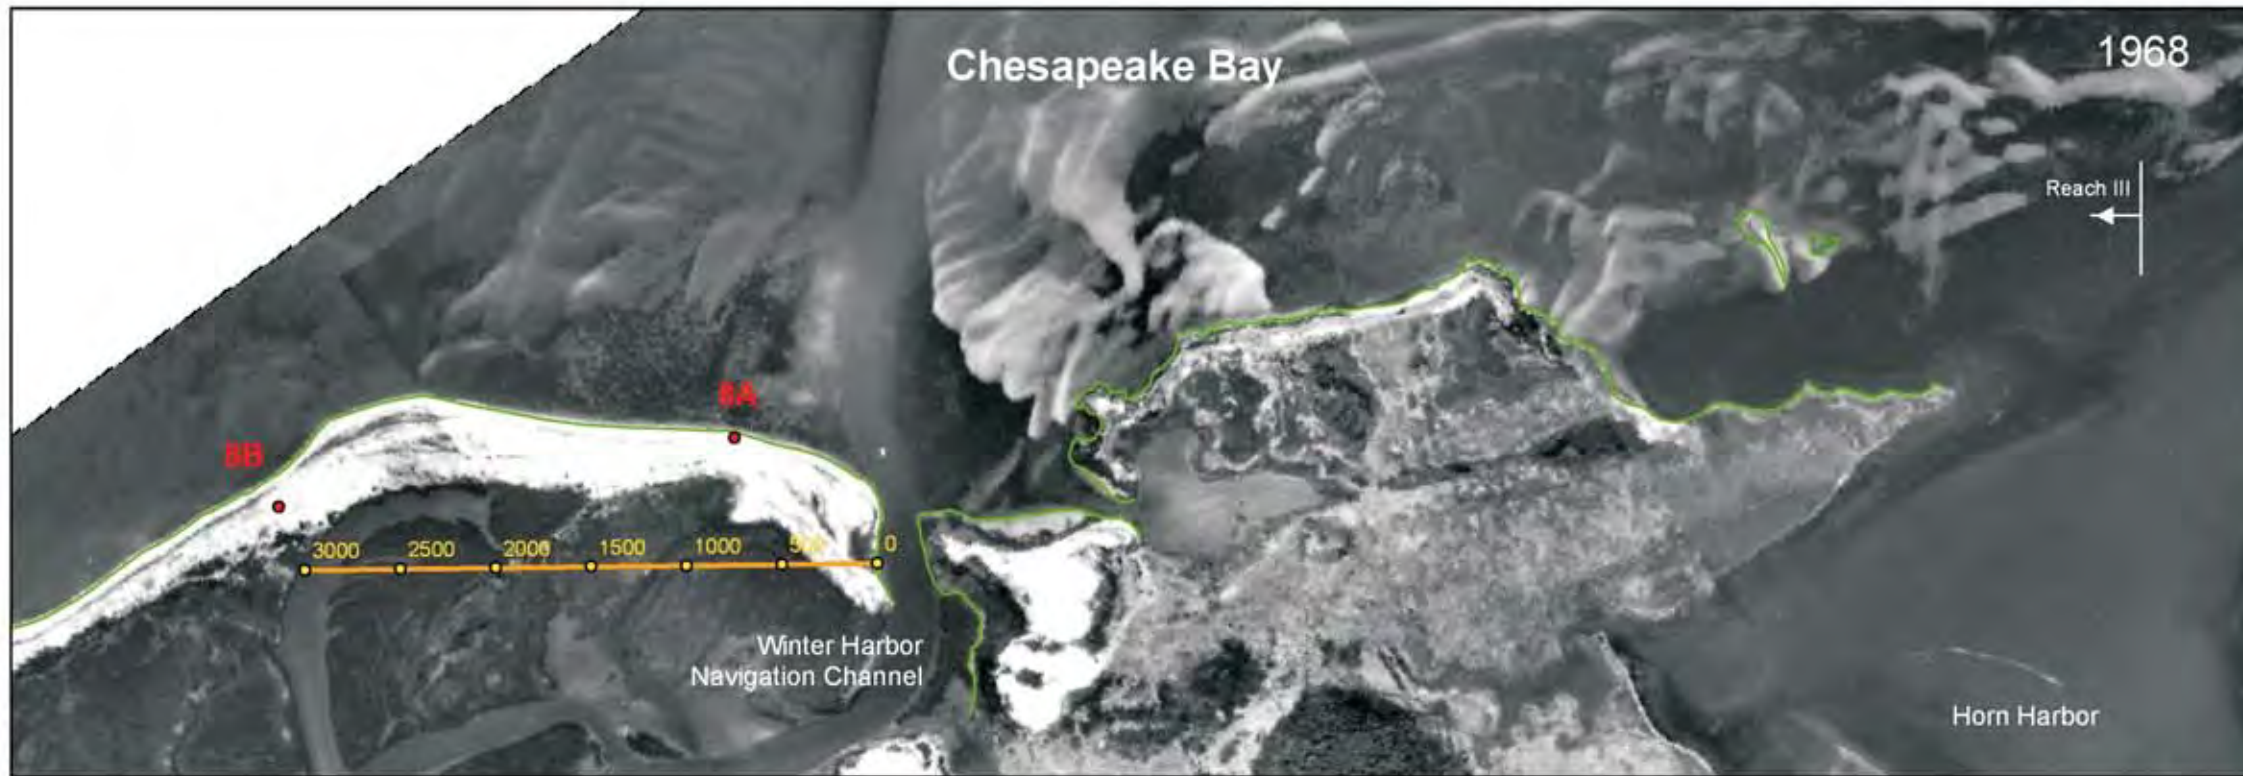
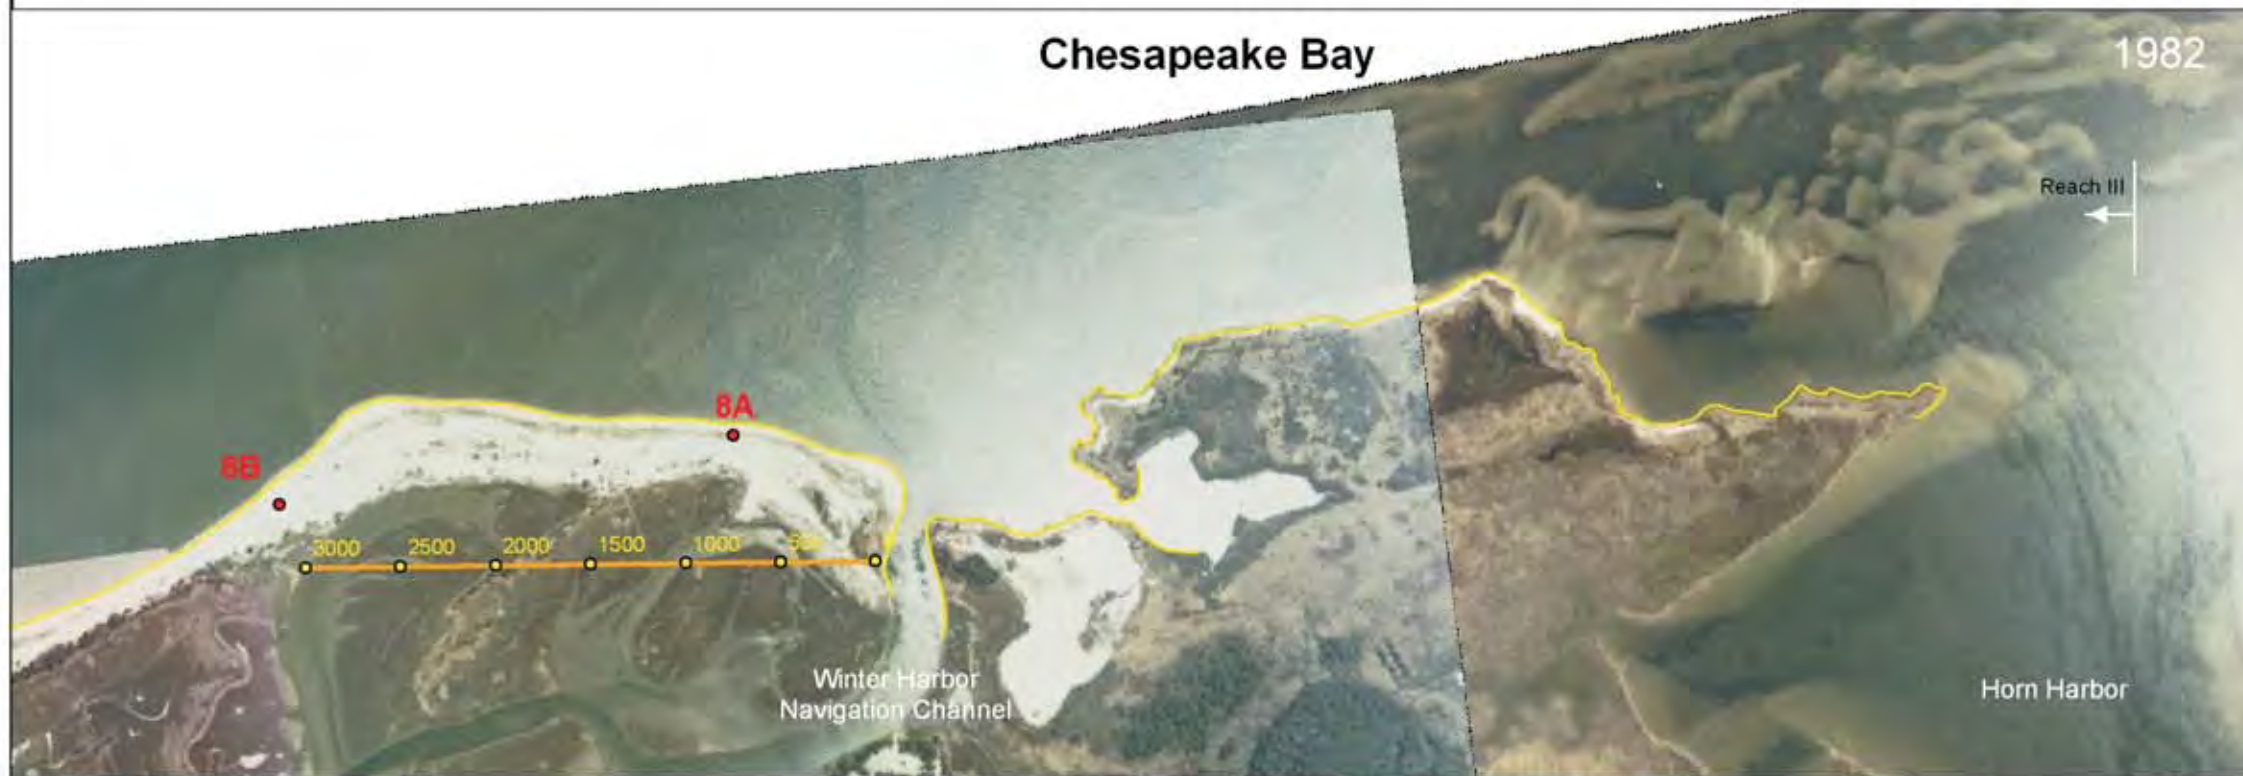
Mathews County
Plate 3
 Morphological Reach III
 Horn Harbor to Winter Harbor

Shoreline configuration along Plate 3 is generally irregular, making shore change assessments using the baseline method difficult. The one short baseline behind MA8A shows a net advance between 1937 and 2002 due, in part, to the area being used for dredge material disposal, but it also appears to be a natural accretionary feature as well. The remainder of the Reach III coast along Plate 4 is dominated by the barrier breach into Winter Harbor. The adjacent shoreline to the south has experienced significant long-term erosion from station 1500 to station 6500. Erosion in this area may have been exacerbated because of the breach. However, a beach fill project performed between 1994 and 2002 increased the shore position significantly and caused the long-term trend to become positive in that area.

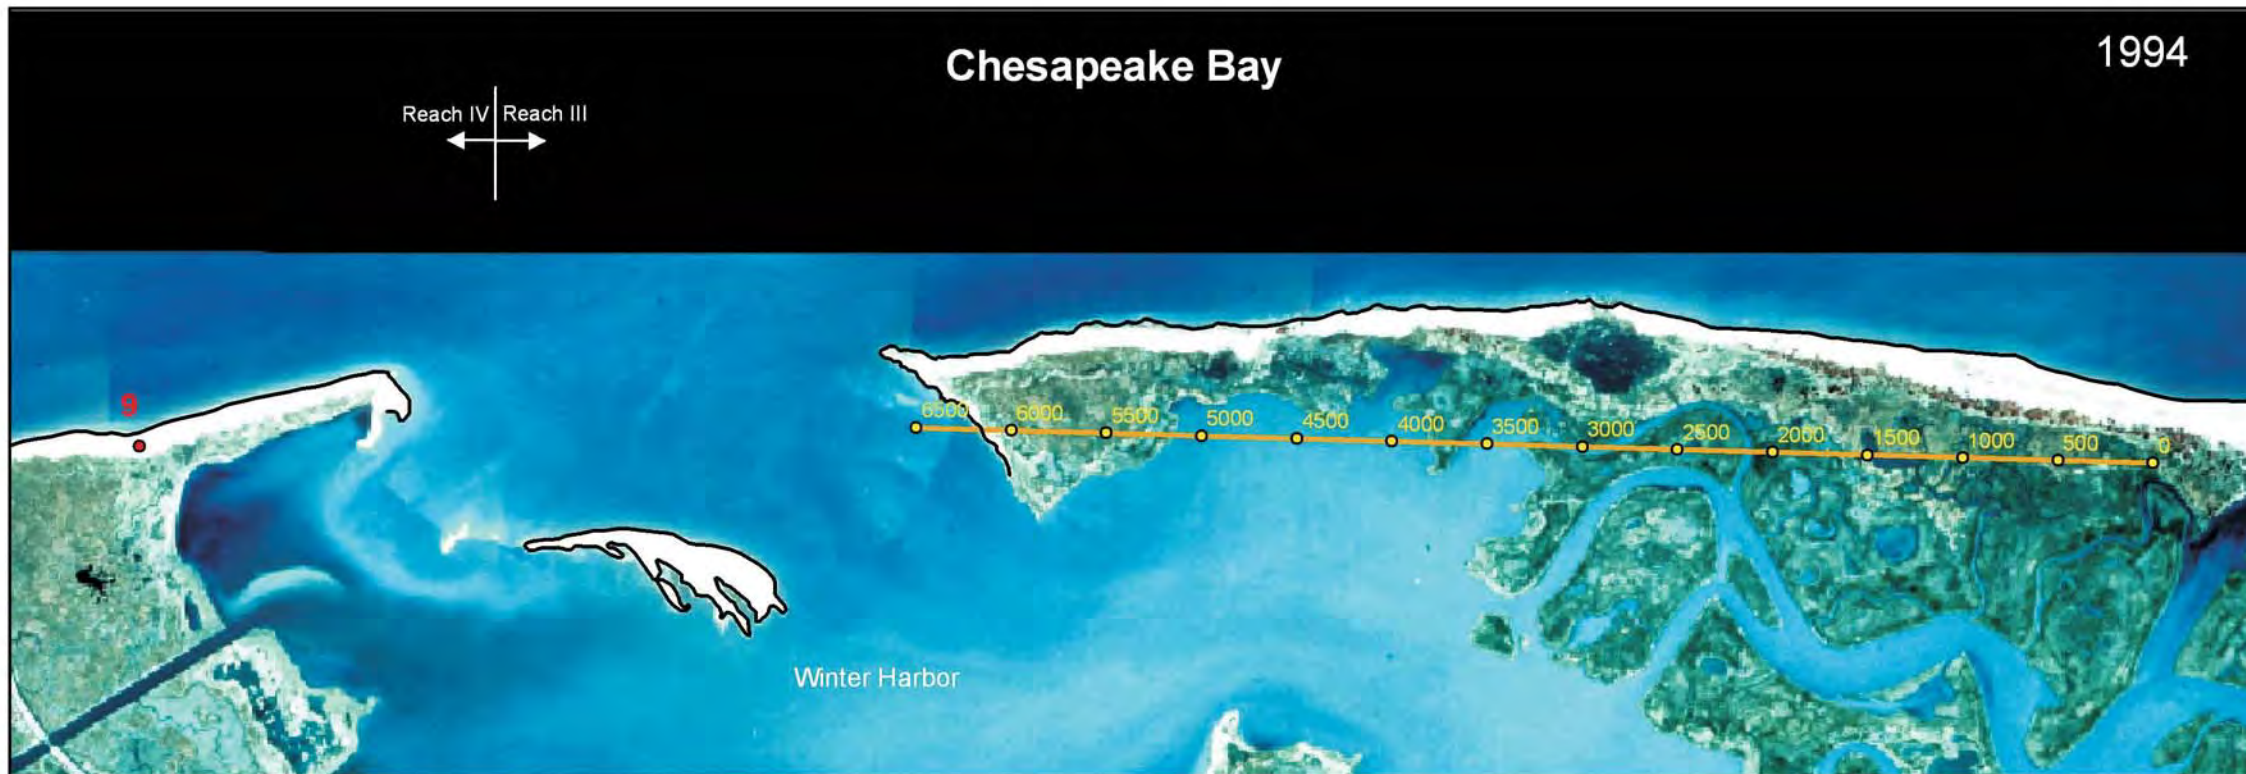
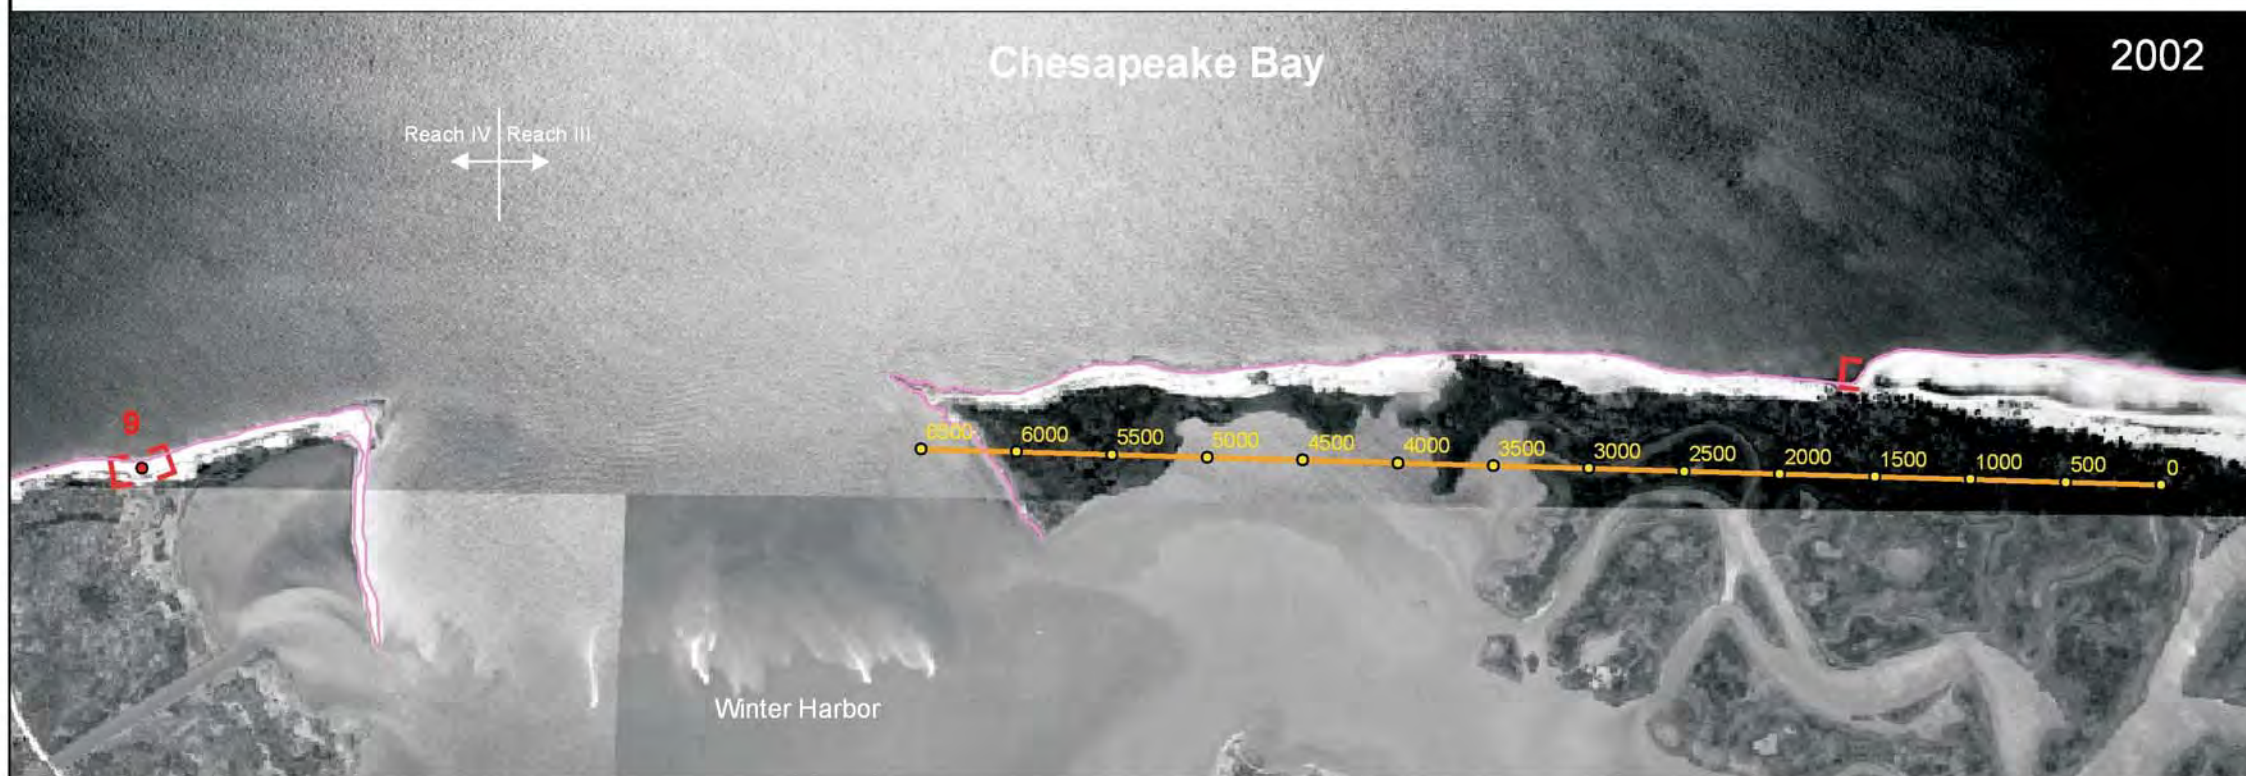
Mathews County
Plate 4
 Morphological Reach III
 Horn Harbor to Winter Harbor

Reach III includes Plates 3 and 4 and extends from Horn Harbor to the opening into Winter Harbor. The breach into Winter Harbor was closed by a sandy barrier up until about 1980 when it was breached (Plate 4). The opening has gotten wider with time and interrupted sand transport along the reach. One dune site, MA8, occurs within Reach III. MA8 has two distinct sub-sections due to the change in direction of shoreline face.

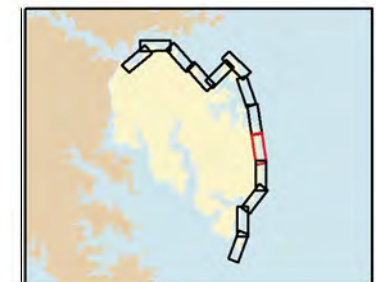
Mathews County Plate 5

Morphological Reach IV
Winter Harbor to Milford Haven

- Identified Dune Sites
- Transect Point
- Baseline
- 1937 Shoreline
- 1953 Shoreline
- 1968 Shoreline
- 1982 Shoreline
- 1994 Shoreline
- 2002 Shoreline

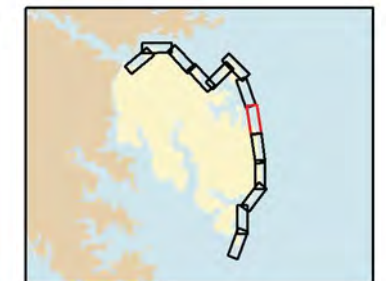
Mathews County Plate 6

Morphological Reach IV
Winter Harbor to Milford Haven

- Transect Point
- Baseline
- 1937 Shoreline
- 1953 Shoreline
- 1968 Shoreline
- 1982 Shoreline
- 1994 Shoreline
- 2002 Shoreline

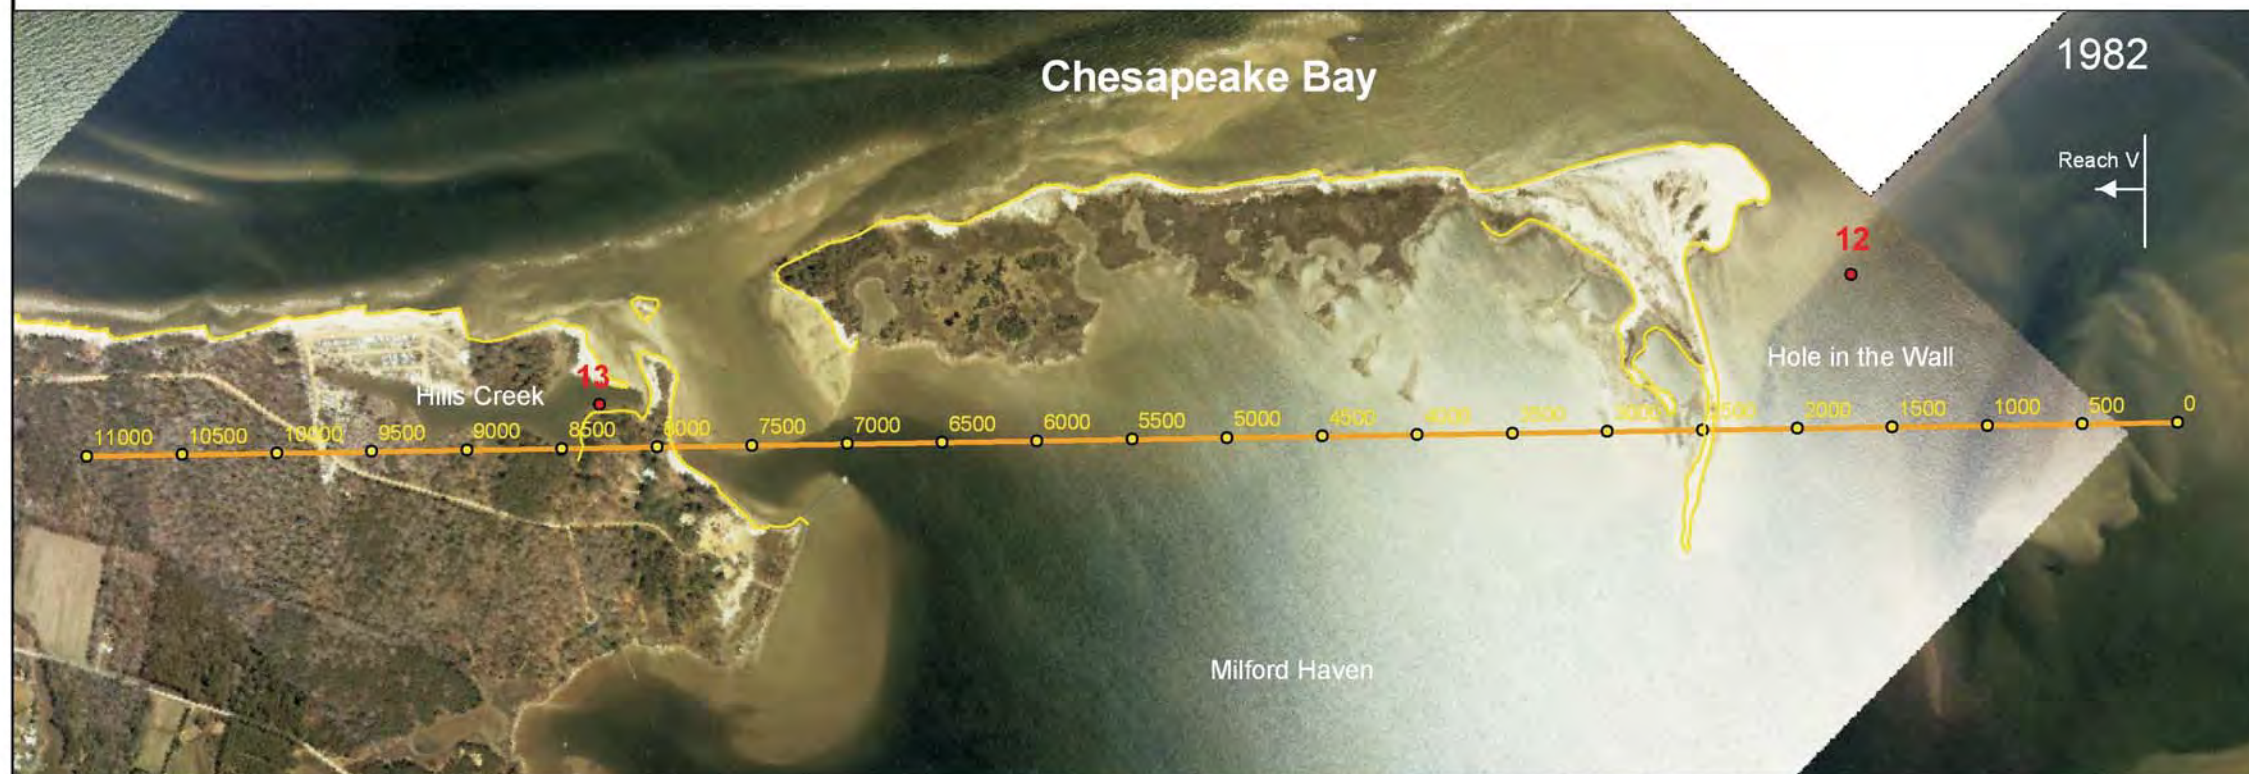
Mathews County Plate 7

- Identified Dune Sites
- Transect Point
- Baseline
- 1968 Shoreline
- 1982 Shoreline

The Hills Creek breach occurred around 1980 and separated the southern spit connection with the Gwynn's Island mainland. The subsequently formed island began to deteriorate in earnest but elongated as well

allowing MA 12 to develop. After the breach, sand poured through and accumulated on the Gwynn's Island mainland where MA 13 developed. Dune site MA12 is probably an ephemeral feature whereas MA13 appears to be a more stable pocket beach configuration. Severe erosion is the long-term trend along the Plate 7 coast.

Dune site MA12 is an ephemeral feature that has been reduced by about ½ since the site visit in 2000 (Figure 8) as shown on the 2002 photo for Plate 7. MA 13 has evolved into a relatively stable pocket beach setting. In fact, the shore accreted between 1994 and 2002. However, the shore just north of the pocket had significant erosion during the same time period. The three dune sites along mainland Gwynn’s Island (MA14, MA15, and MA16) reside in groin fields in relatively stable situations (Figure 8).
