Shoreline Evolution Chesapeake Bay and Piankatank River Shorelines Mathews County, VA

Shoreline Evolution Chesapeake Bay Shoreline Mathews County, Virginia

Shoreline Studies Program ¹
Department of Physical Sciences
and
Wetlands Program ²
Center for Coastal Resources Management

Virginia Institute of Marine Science
College of William & Mary
Gloucester Point, Virginia

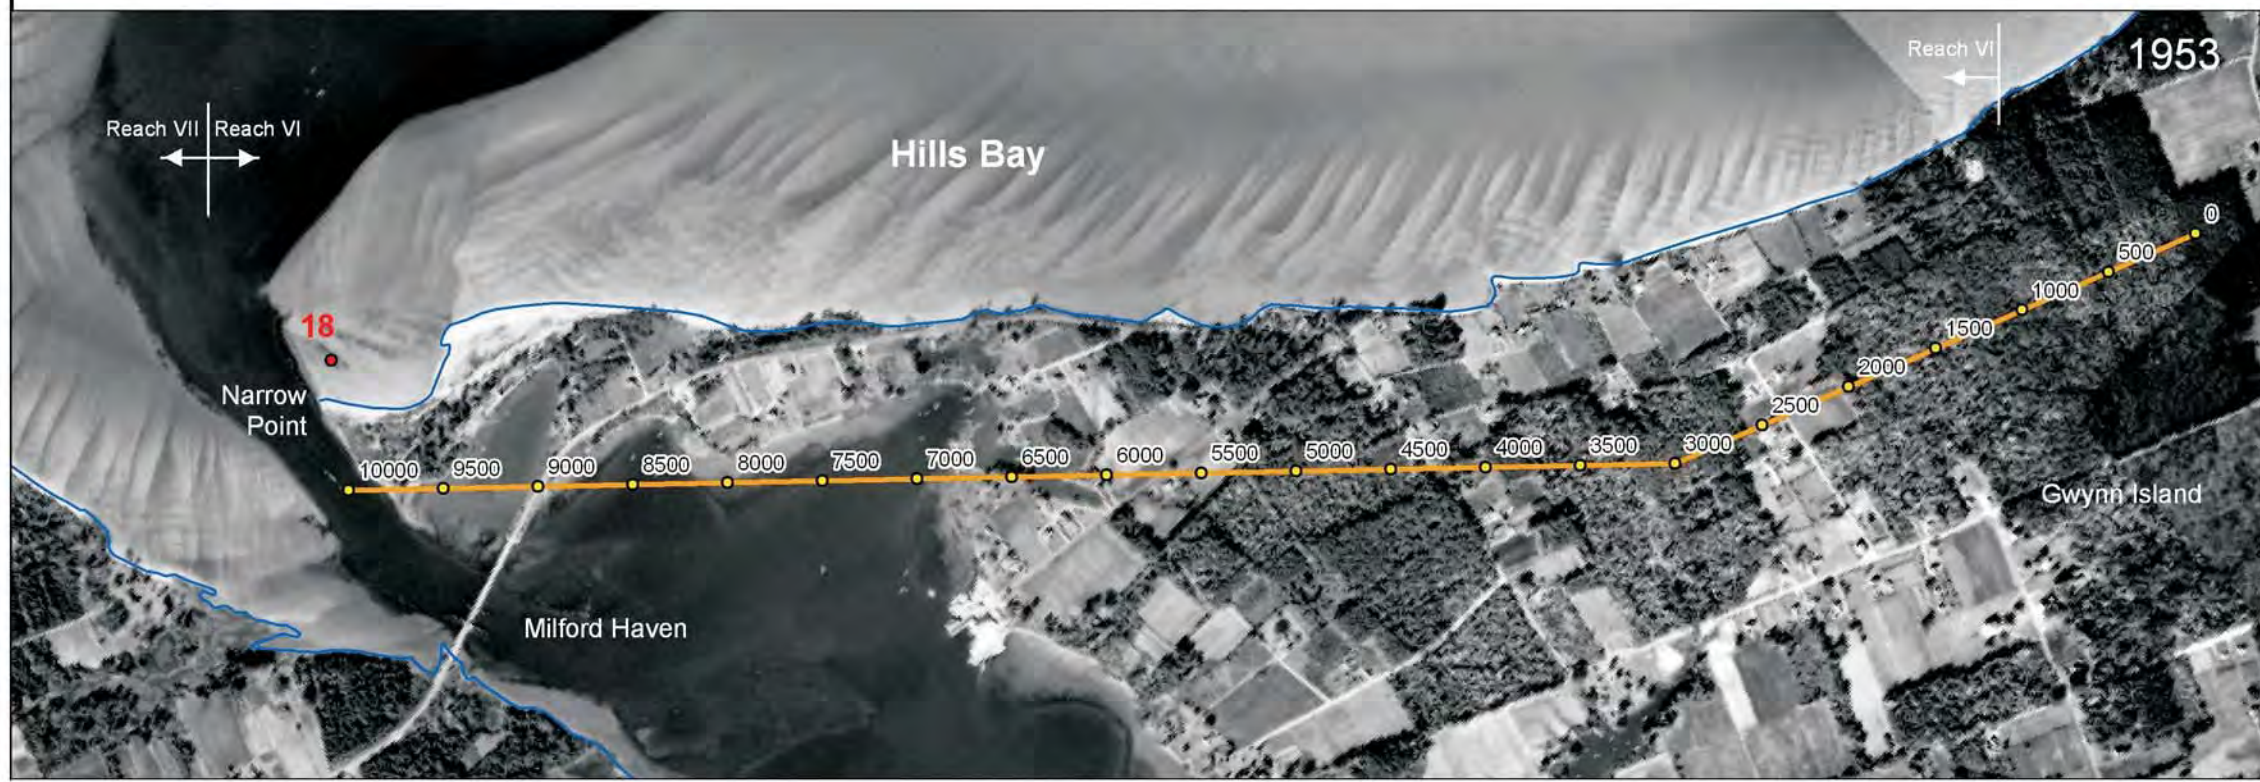
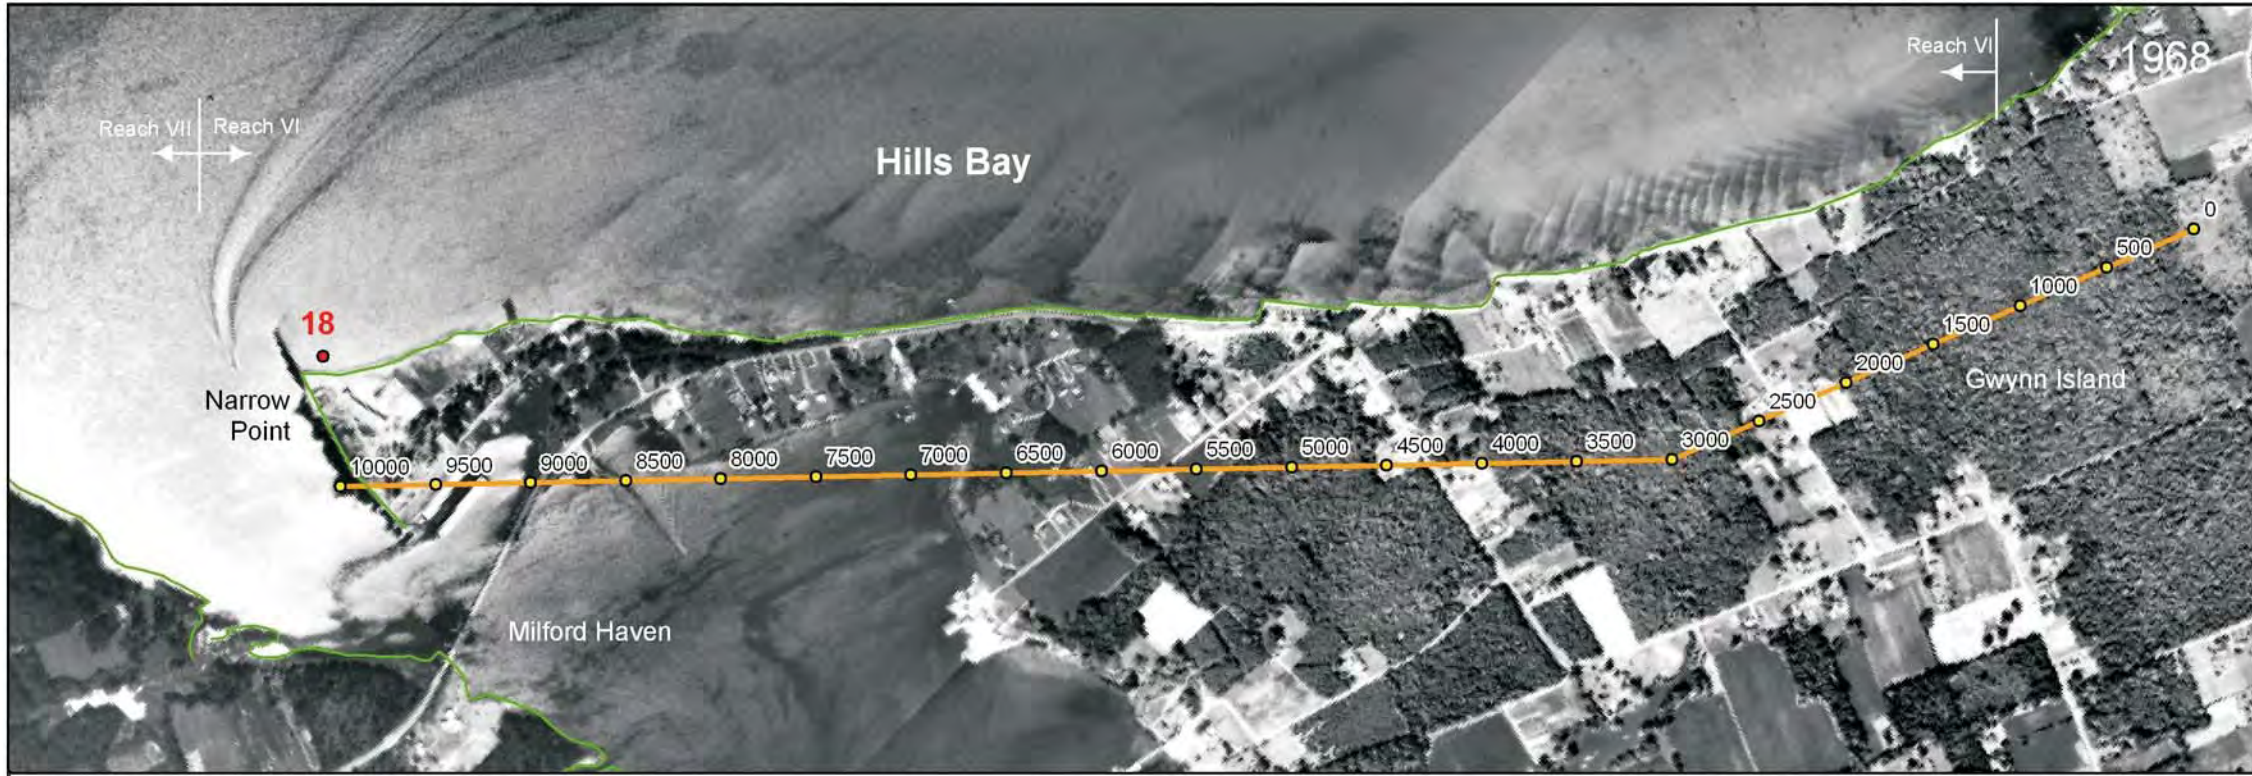
Mathews County
Plate 9
 Morphological Reach VI
 Cherry Point to Milford Haven on Hills Bay

Shore change along most of this reach is slightly erosional to stable except for fluctuations south of station 7000 associated dredge disposal and jetty. Much of the shore has been hardened with bulkheads, groins and riprap from 0 to 8000 as development proceeded long the coast even before 1937. The shallow nearshore and extensive sand bar system have perhaps provided the foundation for the expansion of SAV beds in that region.

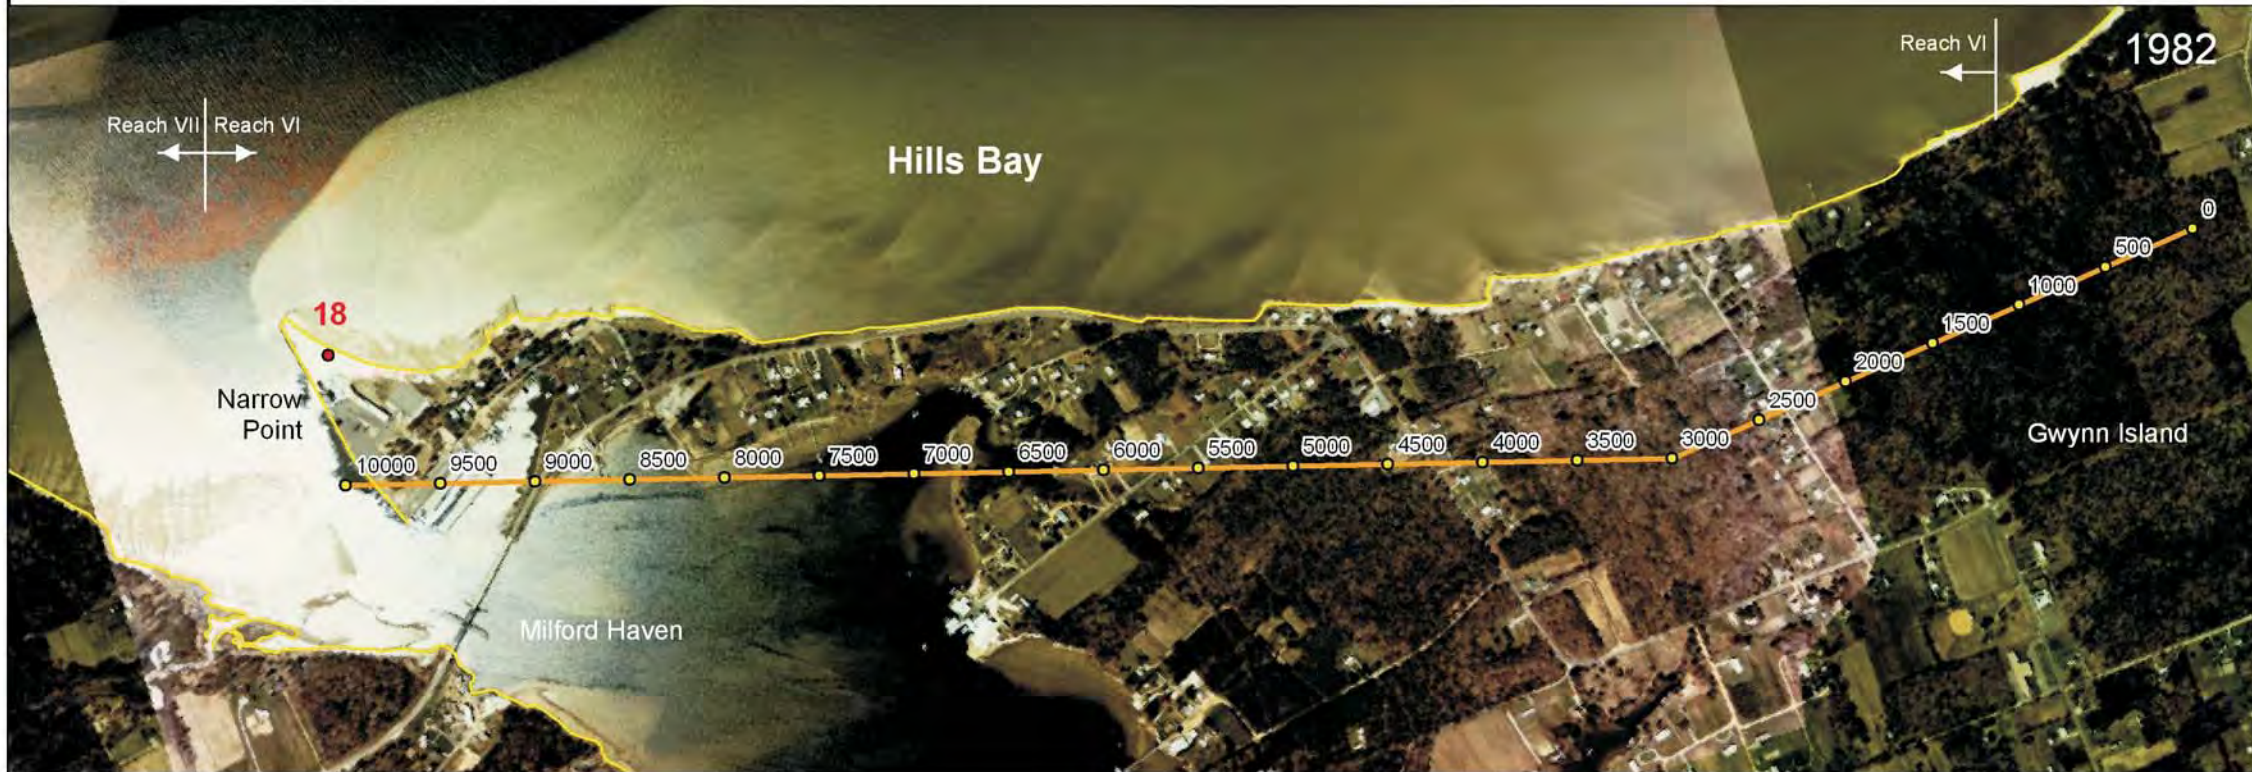
- Identified Dune Sites
- Transect Point
- Baseline
- 1968 Shoreline
- 1982 Shoreline

Reach VI extends from Cherry Point along Hills Bay to Narrow Point and Milford Haven, the northwest coast of Gwynn's Island. It is on Plate 9 and includes dune site MA 18. One interesting feature of this shore reach is the large sand protuberance seen in the 1937 imagery between about station 7,500 and 8,500. This is sandy material dredged from the adjacent navigational channel into Milford Haven. This sand "slug" migrated back toward the channel where much of it was trapped by a subsequently placed jetty. With time, that area accreted and became today's dune site, MA18.

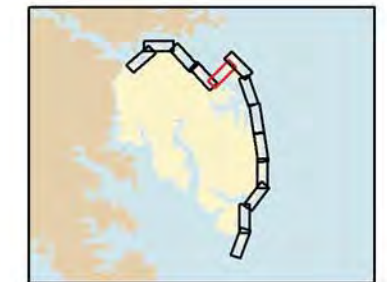
Mathews County Plate 9

- Identified Dune Sites
- Dune Site Limits
- Transect Point
- Baseline
- 1994 Shoreline
- 2002 Shoreline

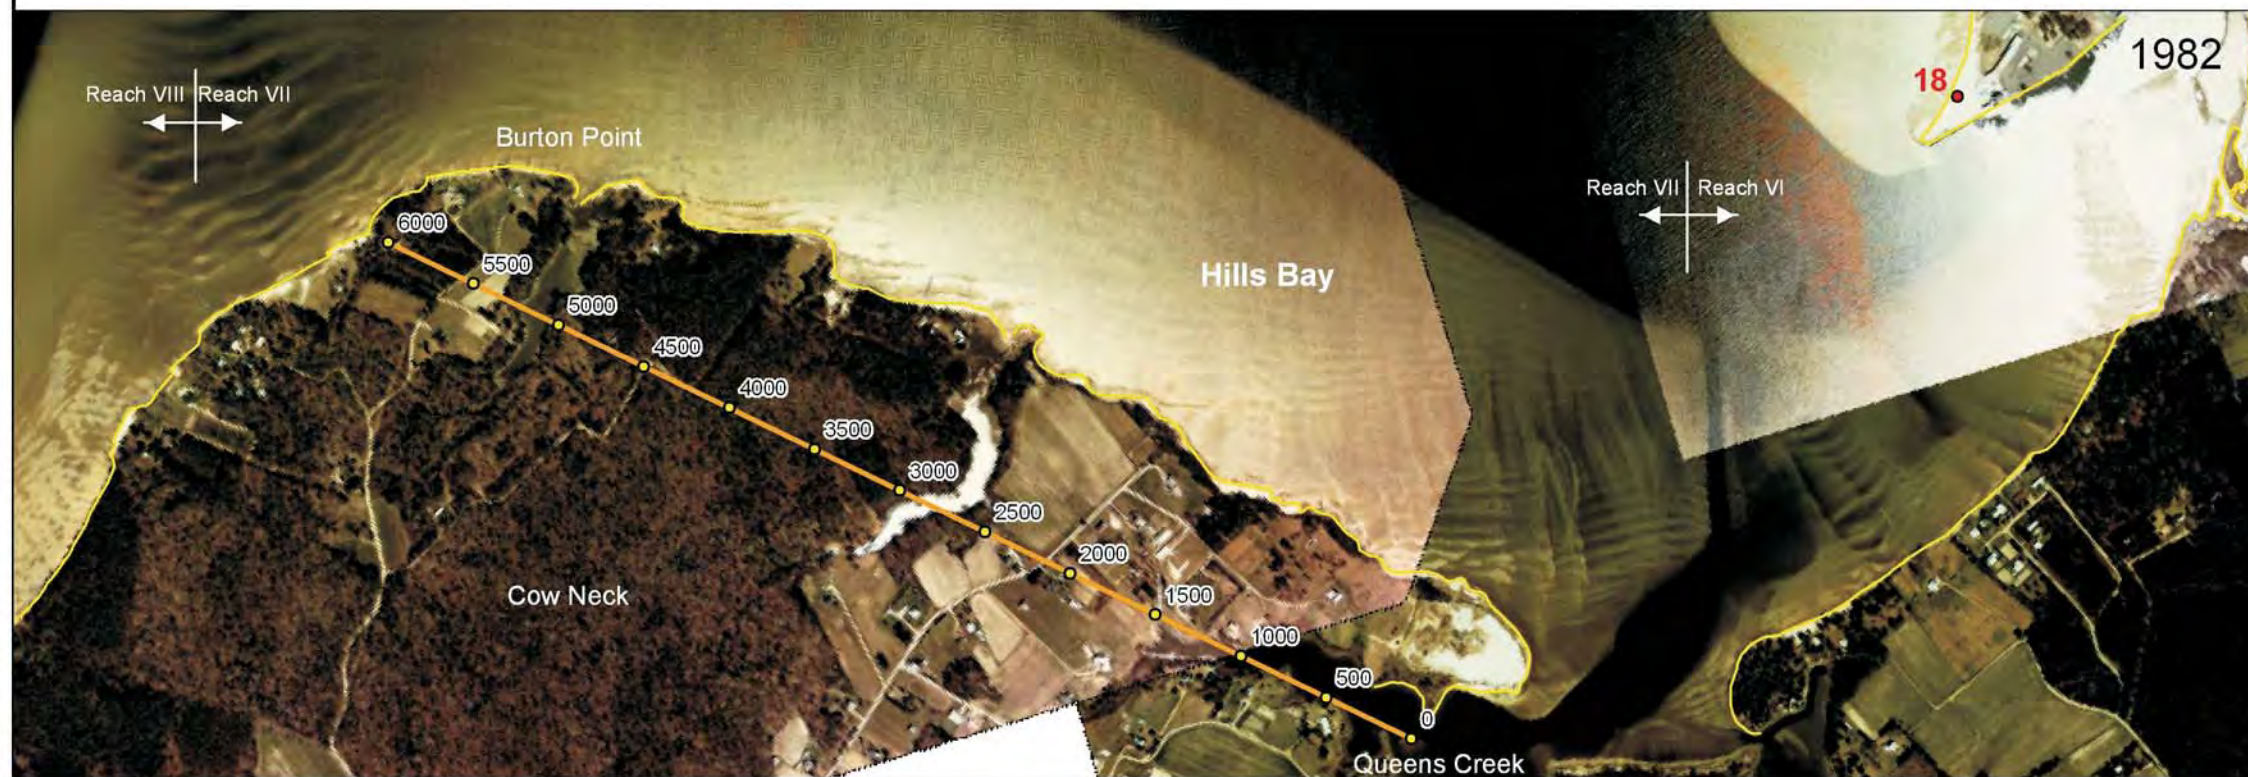
Mathews County Plate 10

Morphological Reach VII
Milford Haven on Hills Bay to Burton Point

- Identified Dune Sites
- Transect Point
- Baseline
- 1968 Shoreline
- 1982 Shoreline

Reach VII is included in Plate 10 and extends from the Milford Haven navigation channel to Queens Creek and then to Burton Point. No dune sites occur along this reach at this time, but historically a thin beach and possibly some small and or isolated dunes did occur. Shore change patterns are irregular much like the coast along the measured baseline, but the net change is an erosional trend.

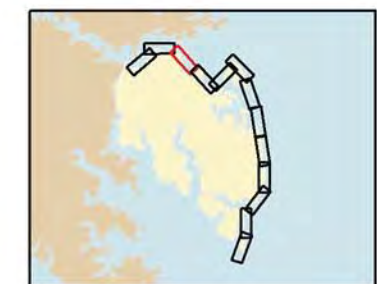
Mathews County Plate 11

Morphological Reach VIII
Burton Point to Iron Point

- Identified Dune Sites
- 1968 Shoreline
- 1982 Shoreline

Reach VIII is included in Plate 11 and extends from Burton Point around Godfrey Bay to Iron Point. The reach includes dune sites MA19, MA20 and MA21. The shoreline occurs as a long curvilinear embayment along Godfrey Bay. The western half of MA 19 is a public beach/landing in Godfrey Bay which has a low accreting dune against a high upland bank. The old dune areas to the east and west have been modified by bank grading and mowing. The coast has been relatively stable over the years with the isolated dune sites being remnants of what appears to have been a more continuous beach in 1937. At that time dunal aerial signatures appear adjacent to Chapel Creek. This creek had jetties installed in 1980 which defined the channel and bounded MA20 and MA21 on either side. Due to the curvilinear nature of the shoreline, change rates were not determined for this reach.

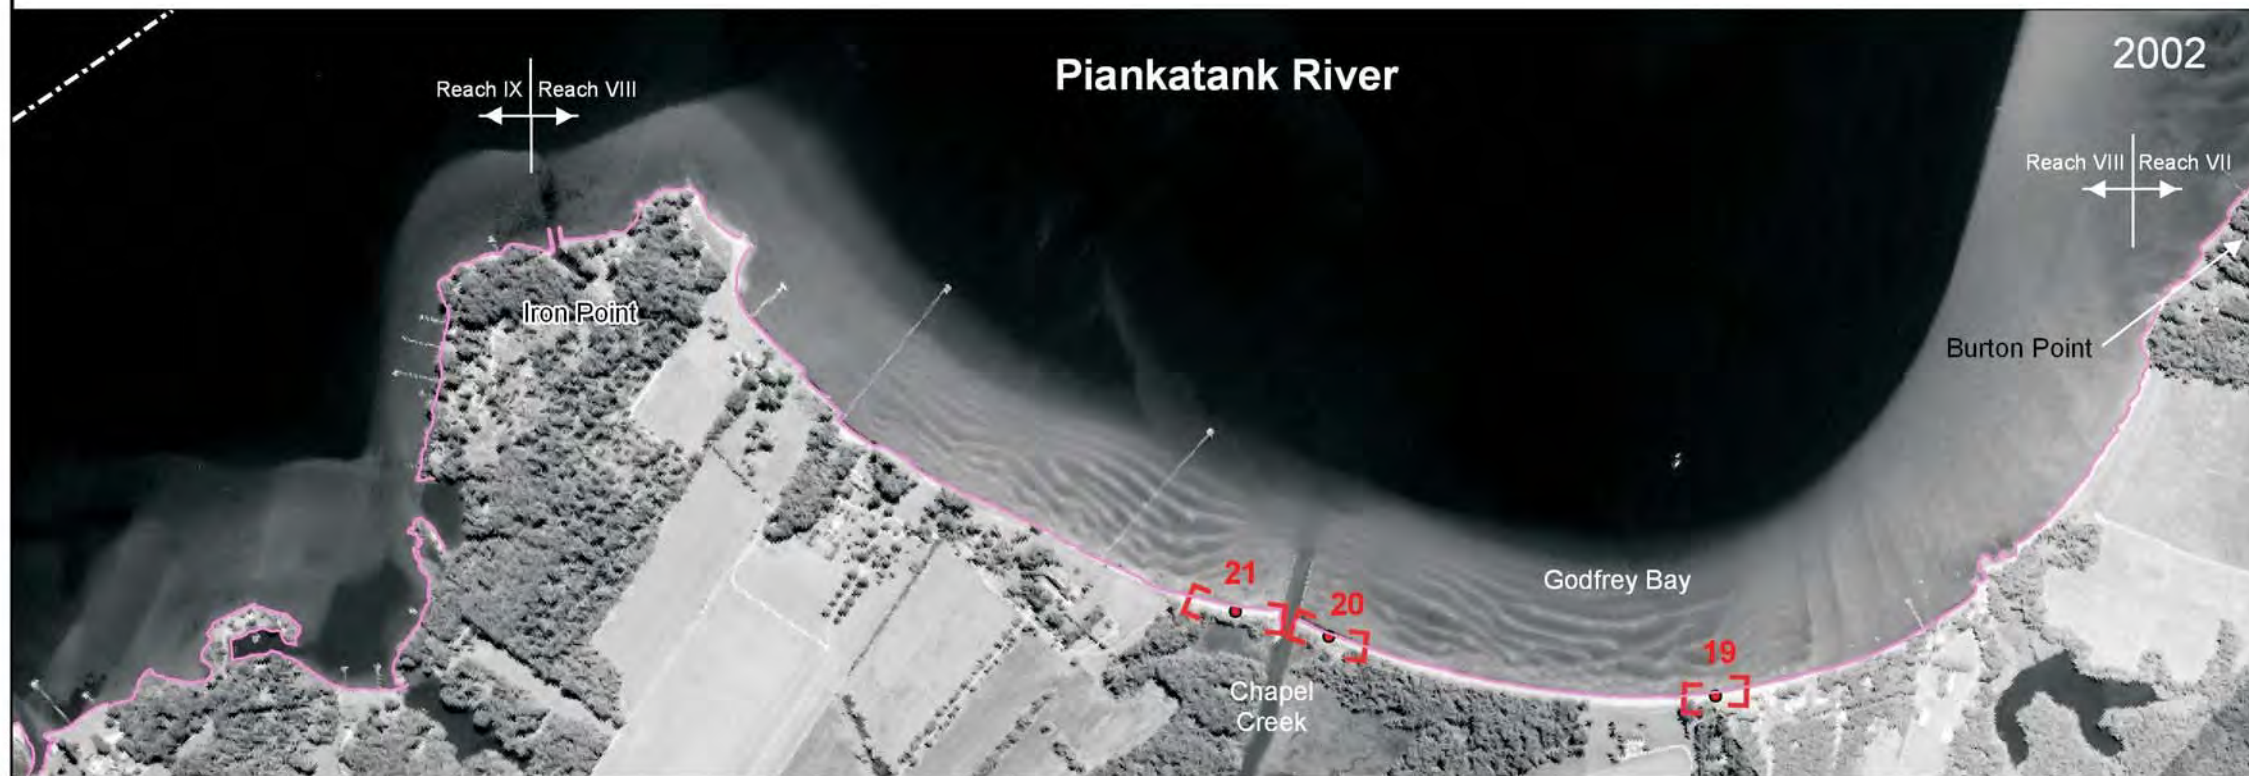
Mathews County Plate 11

Morphological Reach VIII
Burton Point to Iron Point

- Identified Dune Sites
- Dune Site Limits
- 1994 Shoreline
- 2002 Shoreline

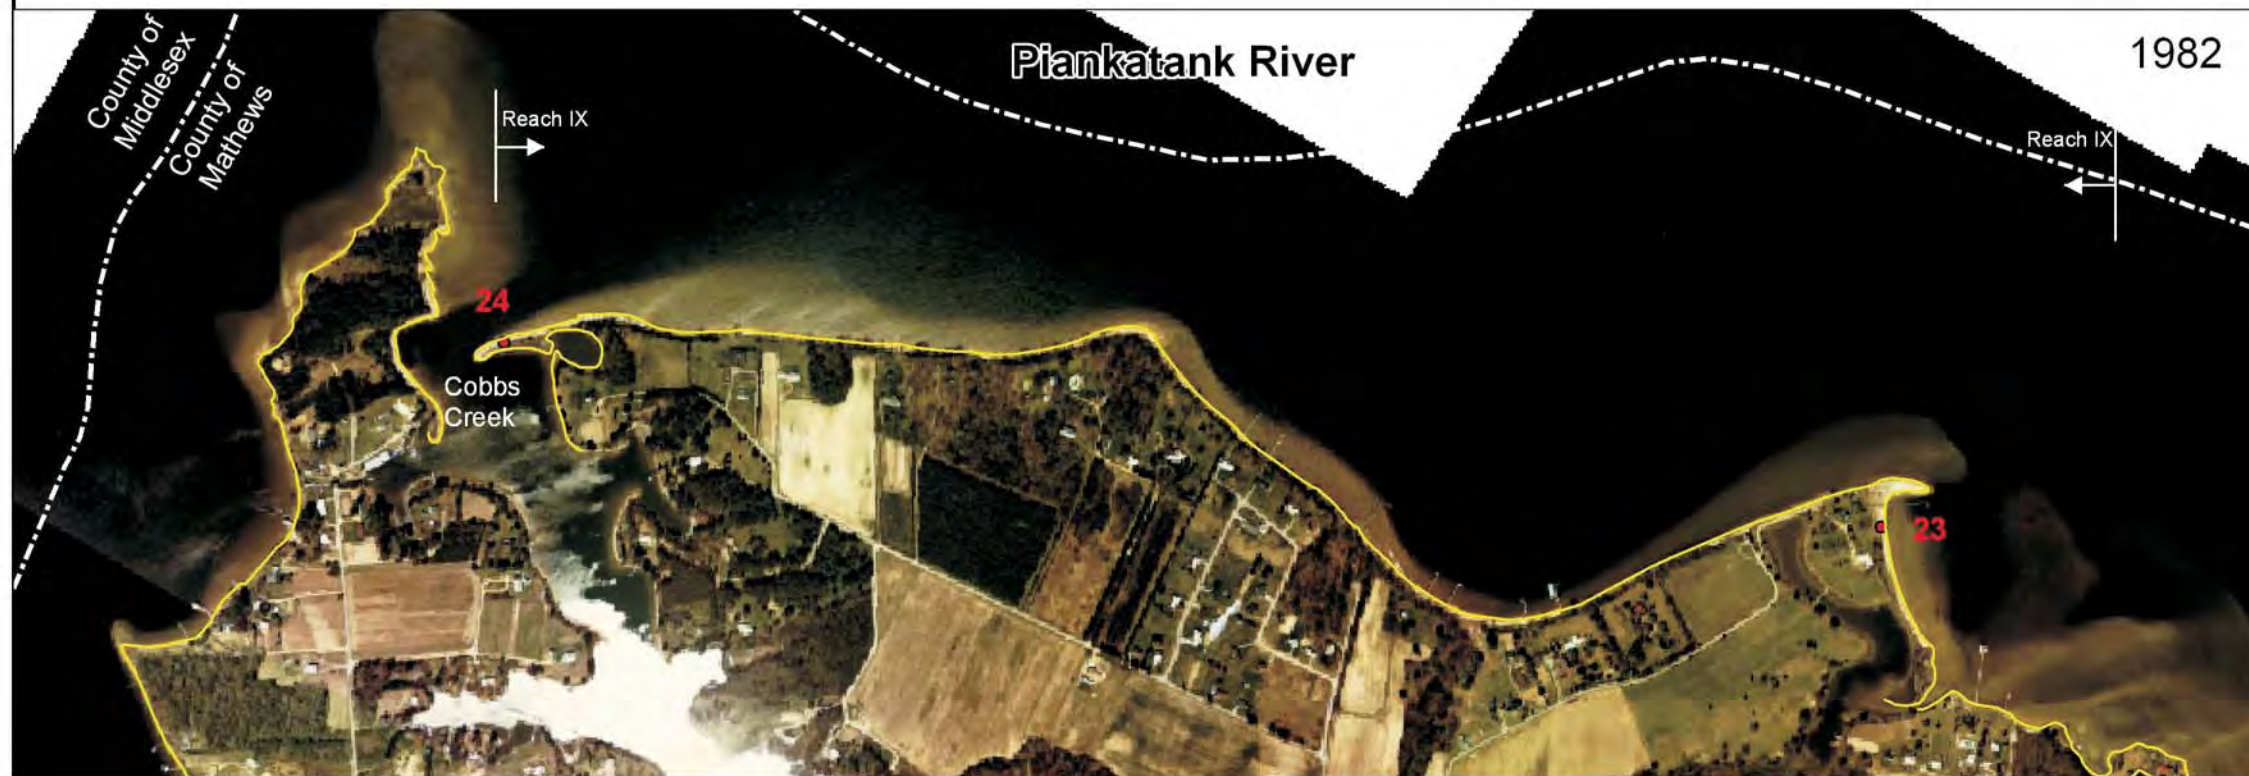
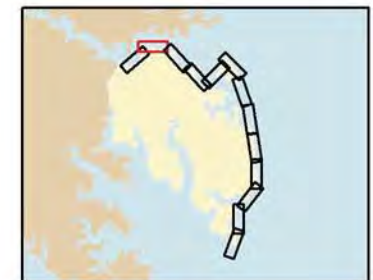
Mathews County Plate 12

Morphological Reach IX
Iron Point to Cobbs Creek

- Identified Dune Sites
- 1968 Shoreline
- 1982 Shoreline

Reach IX extends from Iron Point up the Piankatank River to Cobbs Creek and includes dune sites MA23 and MA24 (Plate 12). These sites are small isolated dunes that appear in the same position over time since 1937. The overall shoreline has changed little over the 65 years of aerial records although rates of change were not calculated to quantify this due to the irregular nature of the shore. The shoreline farther up the Piankatank River in Mathews County shown on Plate 13 had little change and no dune sites.

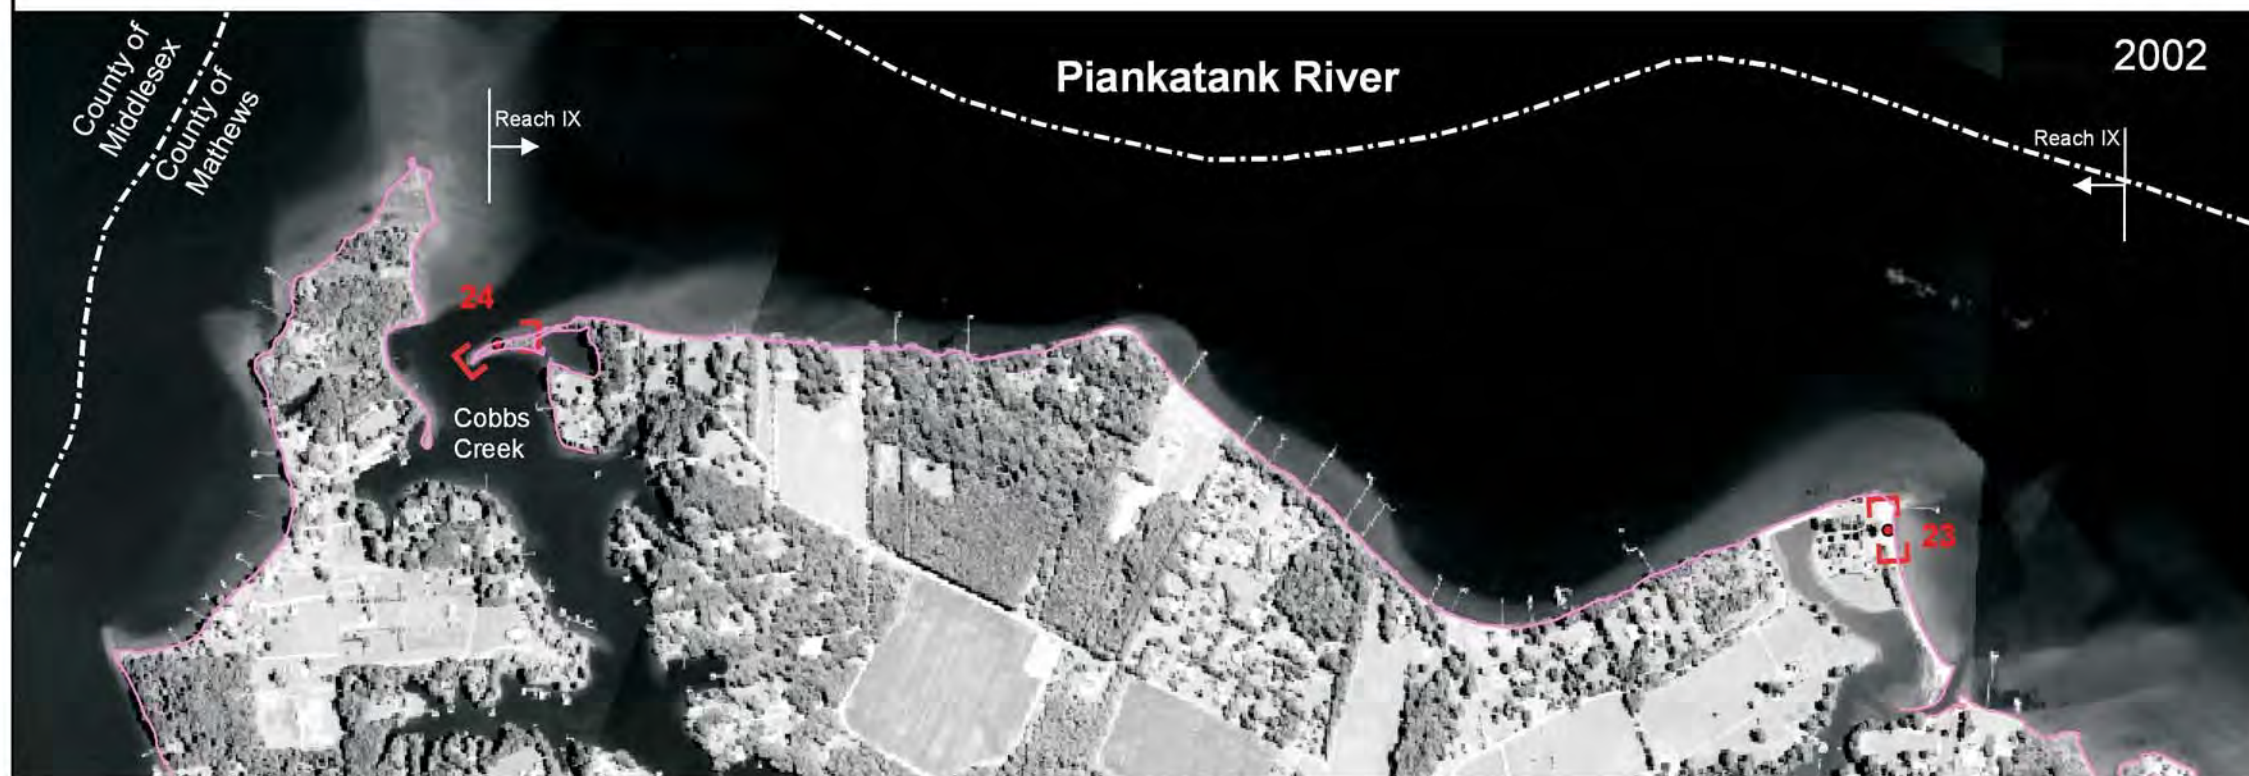
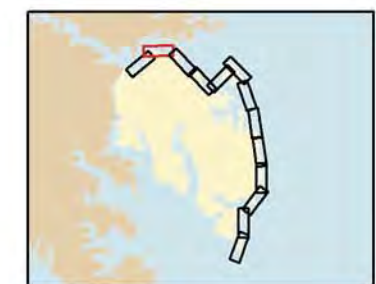
Mathews County Plate 12

Morphological Reach IX
Iron Point to Cobbs Creek

- Identified Dune Sites
- Dune Site Limits
- 1994 Shoreline
- 2002 Shoreline

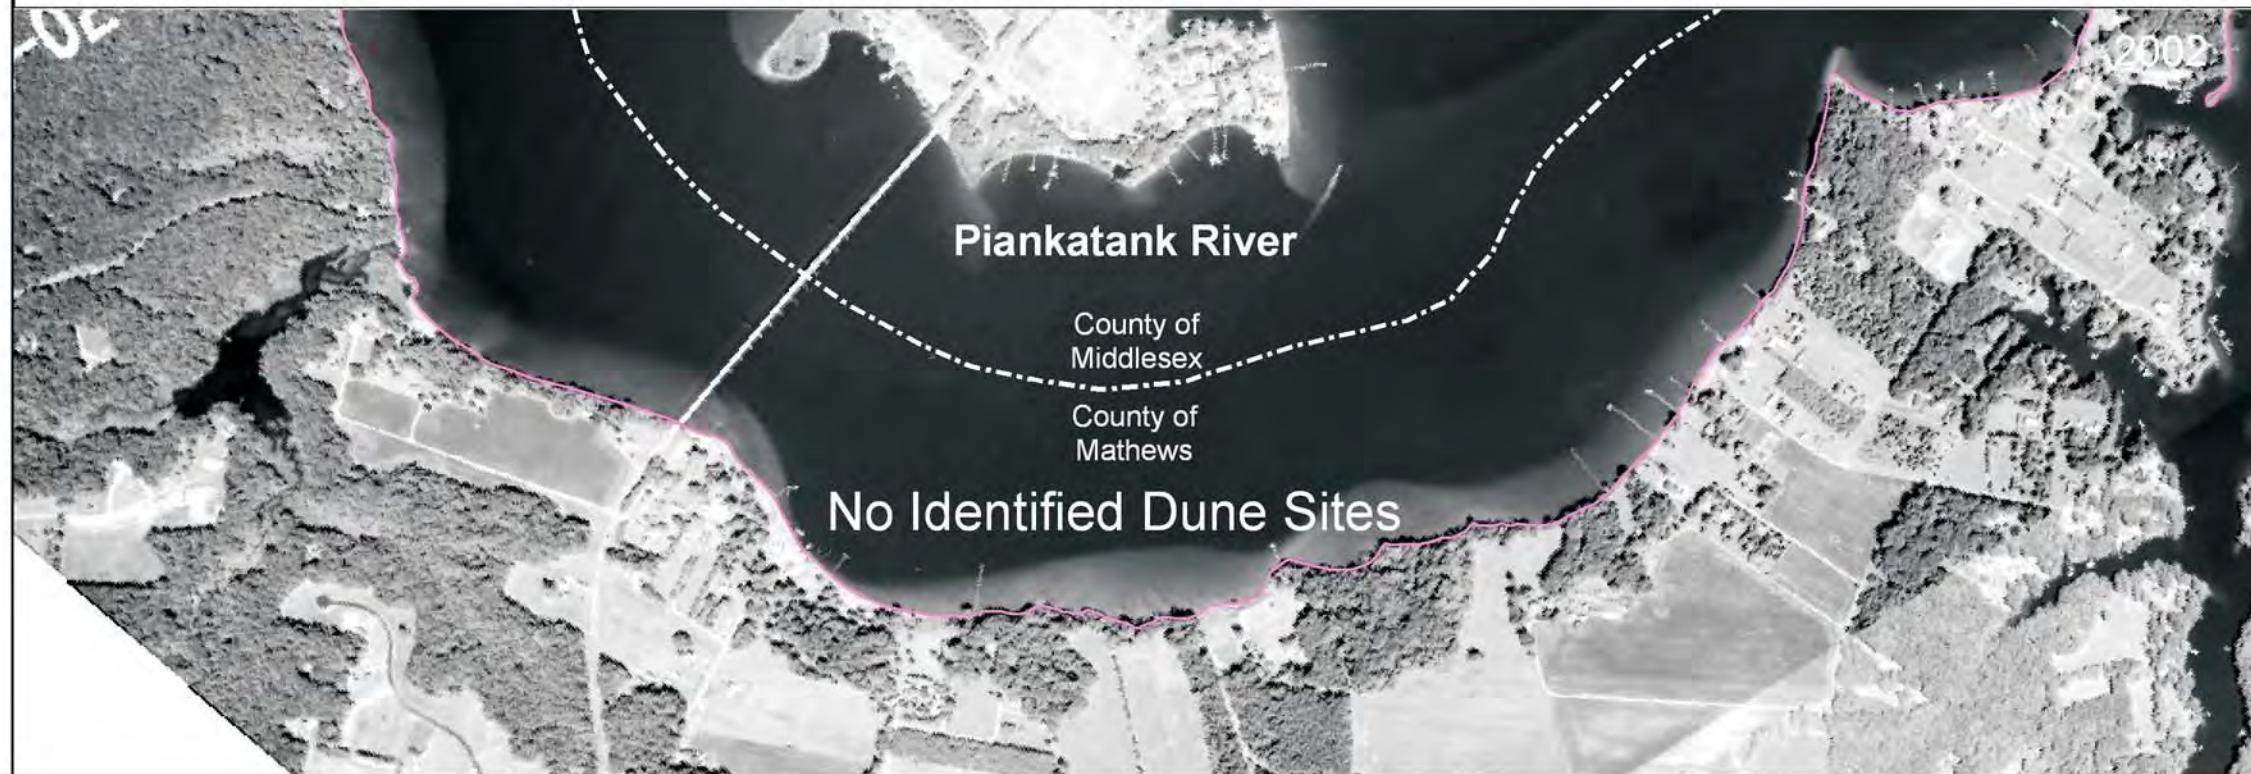
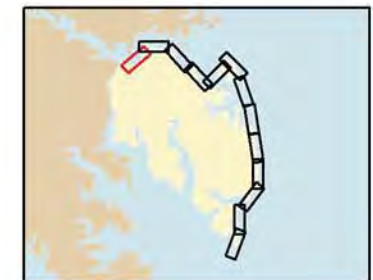
Mathews County
Plate 13

- 1994 Shoreline
- 2002 Shoreline
