City of Suffolk Shoreline Management Plan

*Prepared for
City of Suffolk and
Virginia Coastal Zone Management Program*

April 2014

Shoreline Studies Program

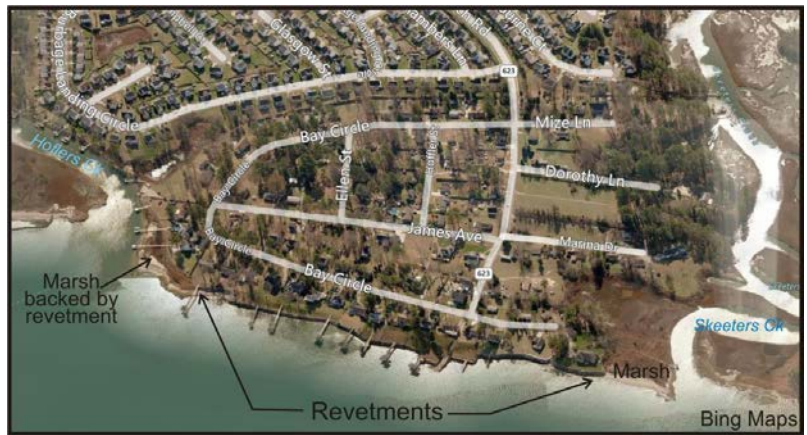
Figure 2-3. Developed shoreline between Hoflers Creek and Skeeters Creek. The shoreline is protected by rock revetments in front of the houses.

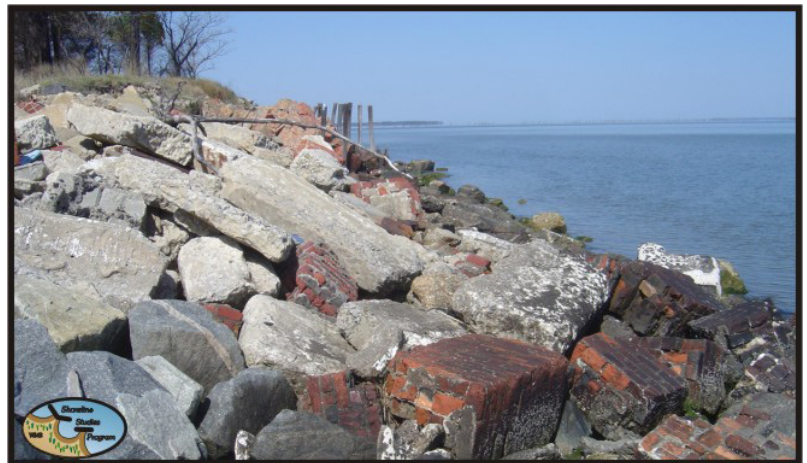
Figure 2-4. Broken concrete revetment along the James River shoreline east of the Nansemond River.

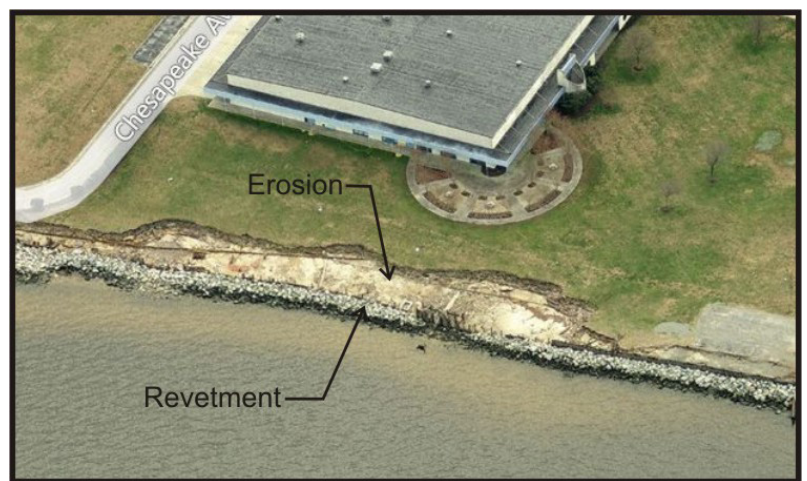
Figure 2-5. Bing map photo showing the rock revetment at Tidewater Community College and the erosion that has taken place landward due to overtopping during storms.

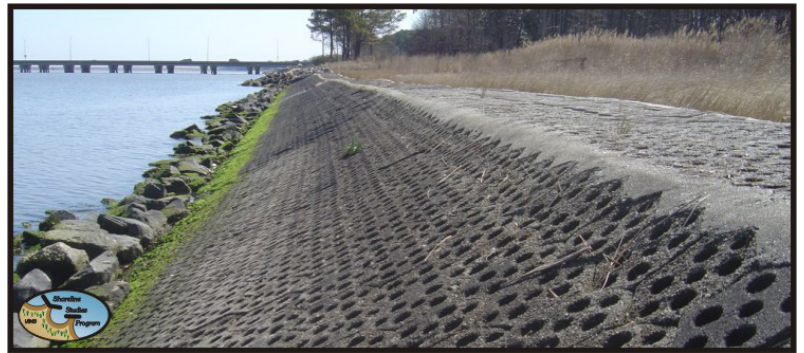
Figure 2-6. Experimental Seabee revetment. Photo date, 22 Mar 2009.

Just west of I-664, an experimental shoreline protection project was installed in 1989 to protect the adjacent pond from erosion and possible breaching. This "Seabee" revetment (Figure 2-6) is built with small, concrete, six-sided blocks placed on a stone substrate. The purpose was to see if these units could be substituted for armor stone on revetments. VIMS monitored the project for several years and found it to be very stable (Hardaway *et al.*, 1994). It appears to still be working today.

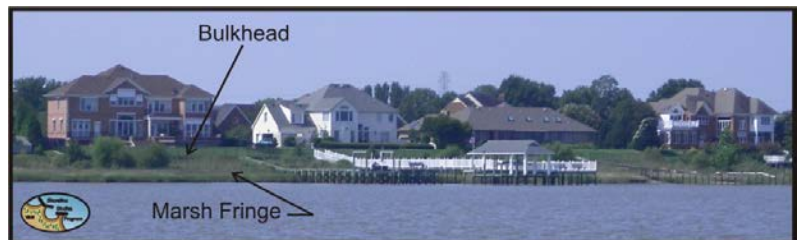
Figure 2-8. Houses along a high bank on the Nansemond River are protected by a marsh fringe and bulkheads constructed at the boundary between the upland and marsh.

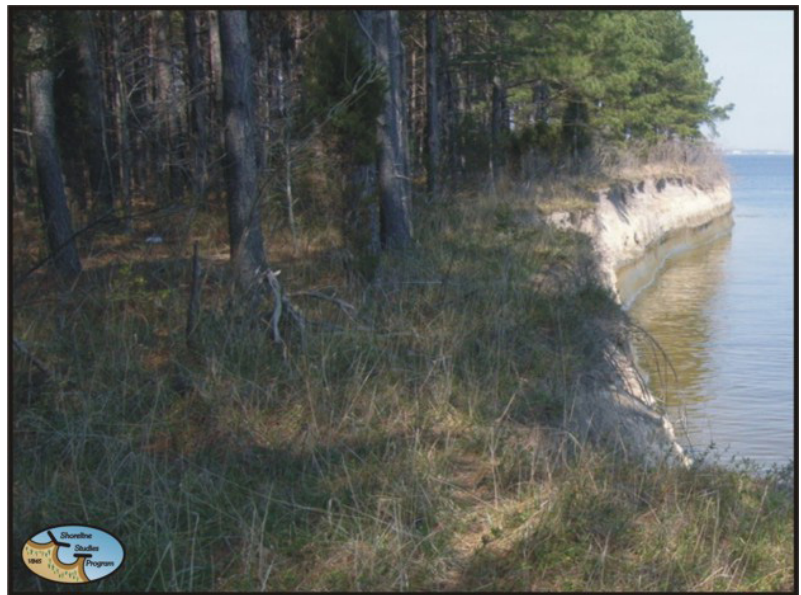
Figure 3-1. One example of forest management in a high energy environment.. The edge of the bank is kept free of tree and shrub growth to reduce bank loss from tree fall.

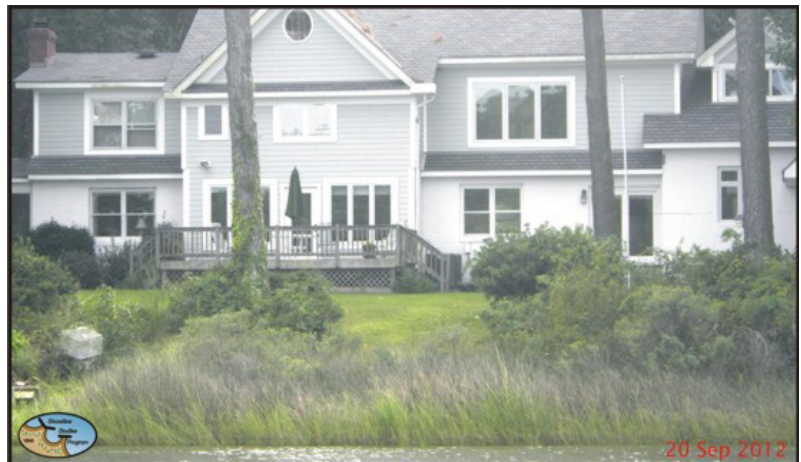
Figure 3-2. Maintaining and enhancing the riparian and marsh buffers can maintain a stable coastal slope.

Enhancement of both riparian and existing marsh buffers together can be an effective practice to stabilize the coastal slope (Figure 3-2) from the intertidal area to the upland by allowing plants to occupy suitable elevations in dynamic fashion to respond to seasonal fluctuations, shifts in precipitation or gradual storm recovery. At the upland end of the slope, forest buffer restoration and the planting of ornamental grasses, native shrubs and small trees is recommended. Enhancement of the marsh could include marsh plantings, the use of sand fill necessary to plant marsh vegetation, and/or the need for fiber logs to stabilize the bank toe and newly established marsh vegetation.

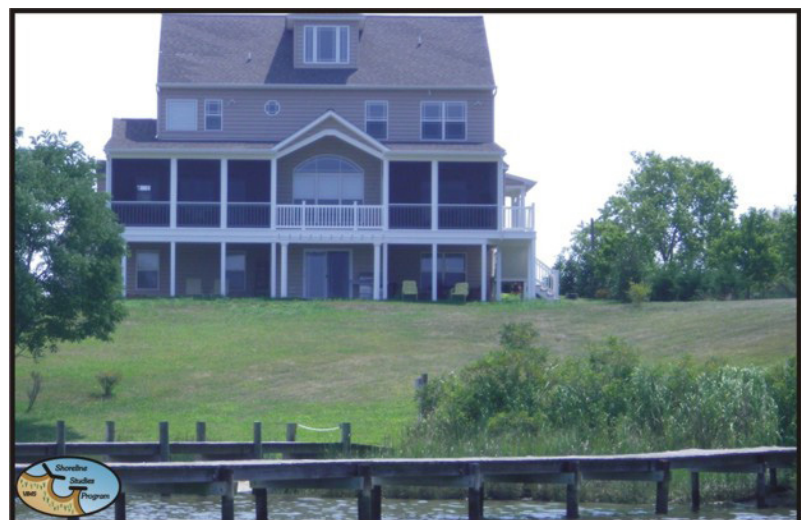
Figure 3-3. Bank grading reduces steepness and will improve growing conditions for vegetation stabilization.

In cases where the bank is unstable, medium or high in elevation, and very steep, bank grading may be necessary to reduce the steepness of bank slopes for wave run-up and to improve growing conditions for vegetation stabilization (Figure 3-3). The

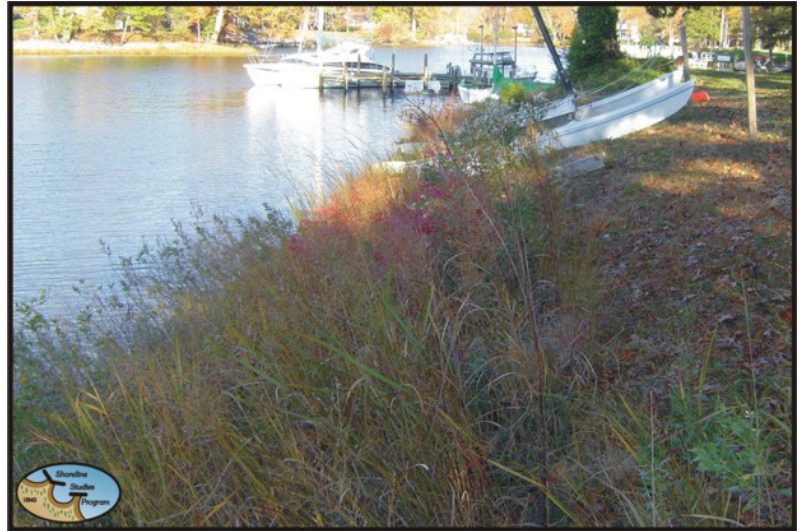
Figure 3-4. This low-energy site had minor bank grading, sand added, and *Spartina alterniflora* planted. This photo shows the site after 24 years.

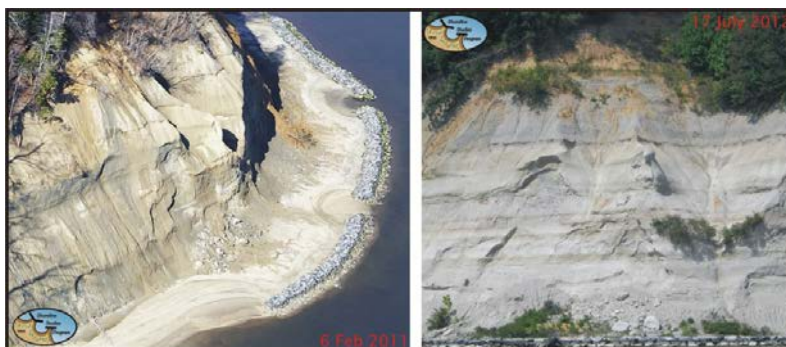
Figure 3-7. High sills built along Westmoreland State Park's high energy, high bank shoreline. The material that slumps from the bank will be caught behind the sills and stabilize the base of the bank by protecting it from wave attack. A more recent photo shows that the slump material is starting to become vegetated.

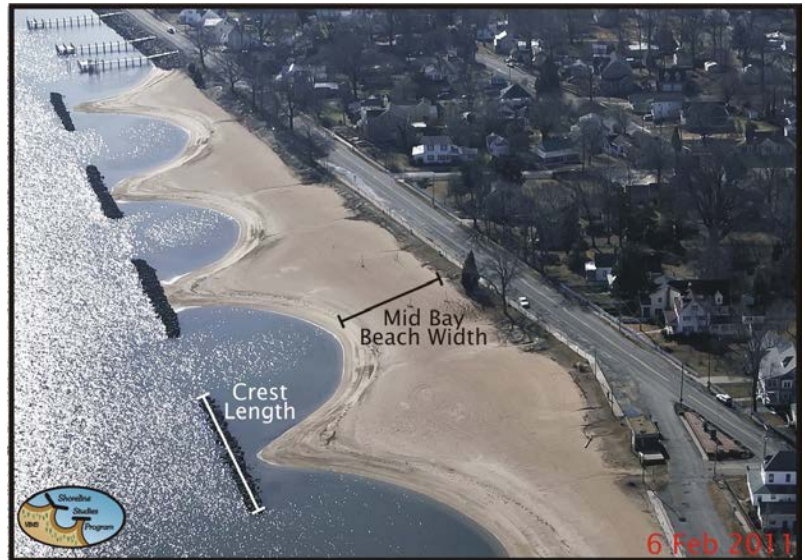
Figure 3-8. The breakwaters at Colonial Beach, Virginia provide a wide recreational beach as well as storm erosion protection for the residential upland. These structures were installed in 1982.

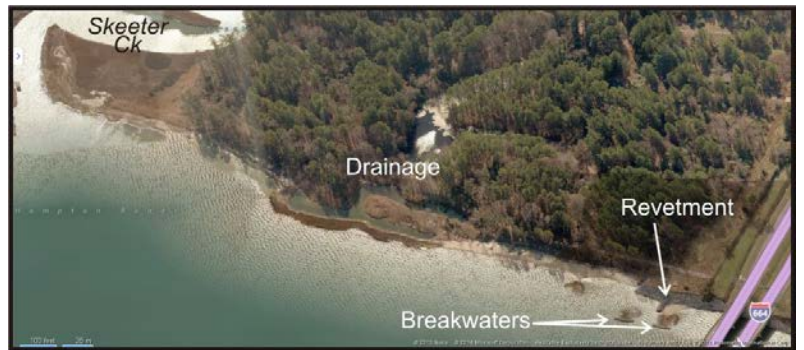
Figure 5-6. Tidewater Community College shoreline east of Interstate 664.

TCC shoreline between Interstate 664 and Skeeter Creek is an area of interest (Figure 5-6). This shoreline is mostly unprotected and consists of a marshy drainage. However, the section of the shoreline immediately adjacent to Interstate 664 has a revetment and two offshore breakwaters. In order to protect the woodlands and marshy drainage from continued erosion, a gapped sill system is proposed for the shoreline between the revetment and Skeeters Creek (Figure 5-7).
