Fairfax County Shoreline Management Plan

***Prepared for
Fairfax County and
Virginia Coastal Zone Management Program***

March 2015

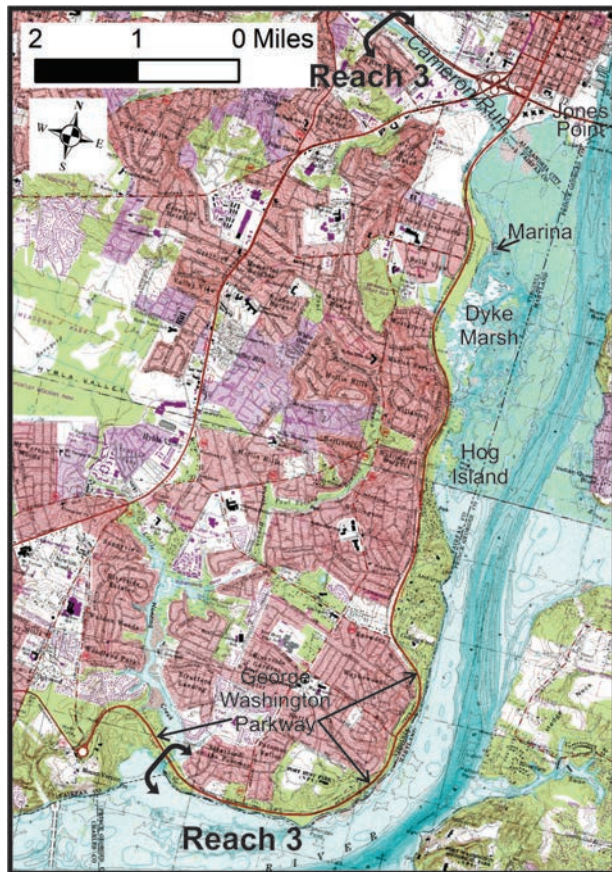
Figure 2-4. Topographic sheet of Reach 3 in Fairfax County.

to Belmont and Occoquan Bays to High Point on Mason Neck, then north along the Potomac River to Hallowing Point (Figure 2-2). Reach 2 extends from Hallowing Point along Gunston Cove and Dogue Creek to Little Hunting Creek (Figure 2-3). Reach 3 extends from Little Hunting Creek along the Potomac to Cameron Run (Figure 2-4).

Reach 3 extends up the Potomac River to the border with Alexandria City. The creek at the border is called both Hunting Creek and Cameron Run on topographic maps (Figure 2-4); however, this report uses Cameron Run. The George Washington Memorial Parkway (GWP) runs along the shoreline for several miles of the reach. The shoreline occurs as a low wooded bank except where the GWP gets close to the river. The GWP coast varies from low to high upland bank that is intermittently landscaped and hardened (Figure 2-17).

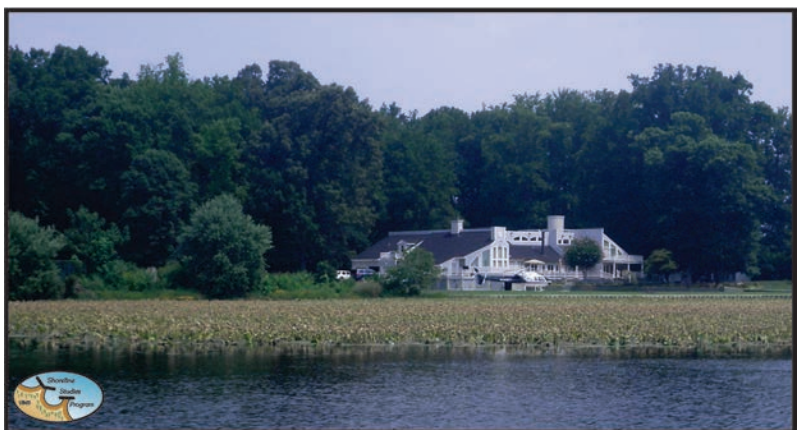
Figure 2-5. Broad, fringing tidal fresh water marshes along Belmont Bay.

Broad and fringing tidal fresh water marshes occur along the entrance of Belmont Bay (Figure 2-5). The coast has limited development with hardened

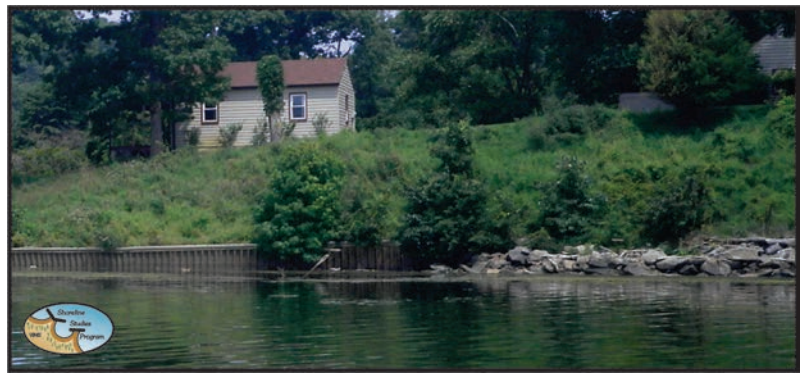
Figure 2-6. Shore protection along eroding banks of Belmont Bay.

shorelines (Figure 2-6) that transition to intermittently eroding upland banks along Belmont Bay to Kanés Creek (Figure 2-7). From Kanés Creek to Sandy Point the shoreline is alternating high eroding banks and low marsh coast with numerous trees along the bank and shore. This shore segment is part of Mason Neck State Park. There are three gabion structures just down river of the Park visitor's center (Figure 2-8) that are acting as breakwaters along the shoreline.

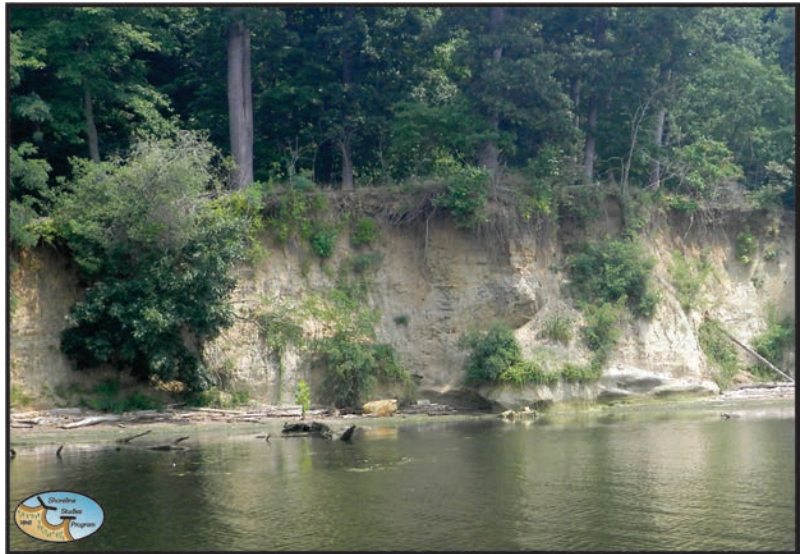
Figure 2-7. Eroding banks along Belmont Bay.

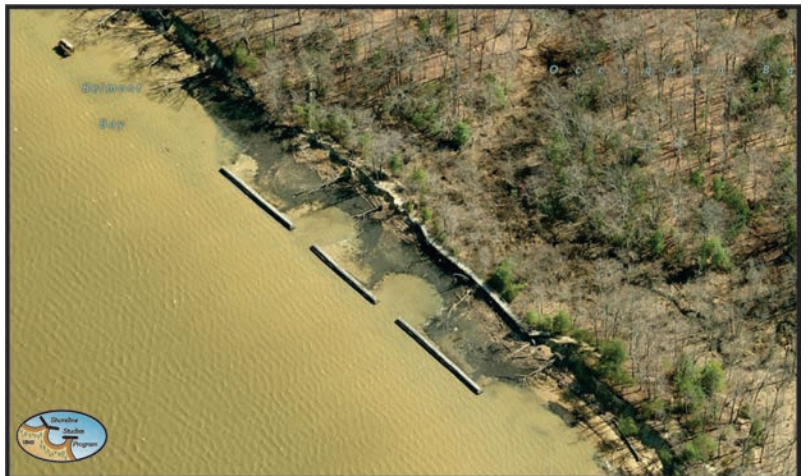
Figure 2-8. Gabion structures that are acting as breakwaters along Mason Neck State Park. From Bing Maps.

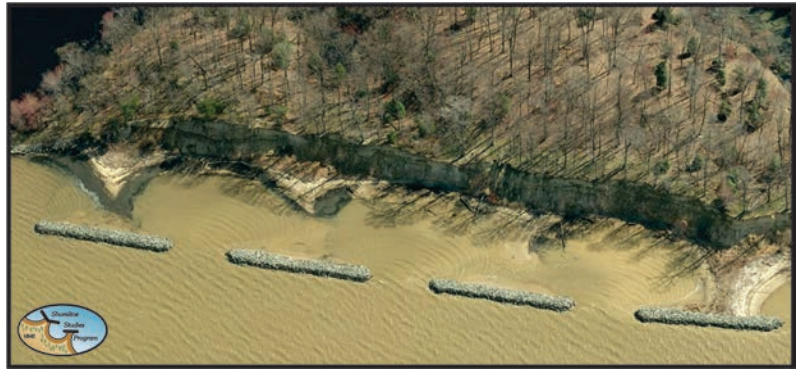
Figure 2-9. One attached and three detached breakwaters along Mason Neck north of High Point. As the sandy bank erodes, the breakwaters likely will become attached. From Bing Maps.

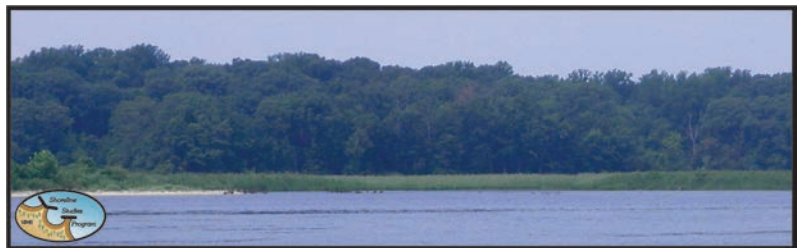
Figure 2-10. Broad, shallow marsh along the Potomac River between High Point and Hallowing Point.

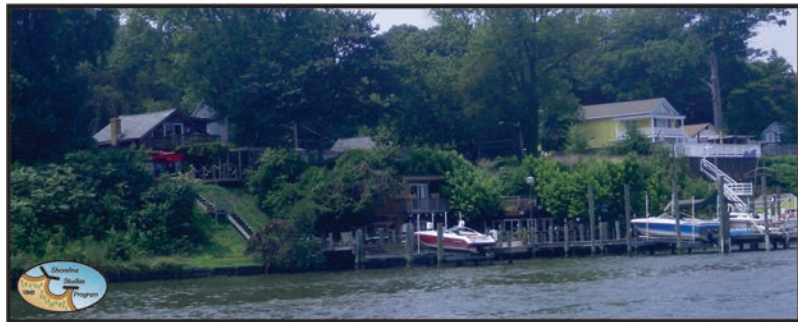
Figure 2-11. The shorelines along this section of shoreline in Reach 2 along the Potomac River has been graded and protected at the base.

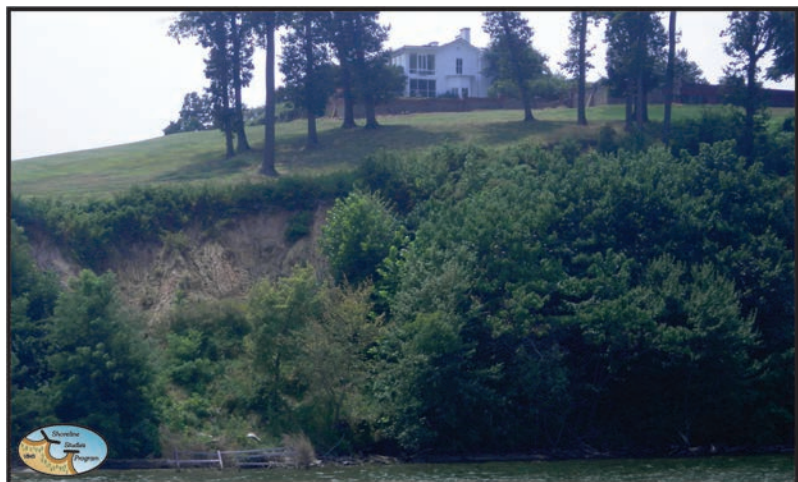
Figure 2-12. Along the Gunston Cove shoreline, the high upland bank is mostly in a natural state and is erosional.

The upland banks rise to 50 and 100 ft along the developed areas of Gunston Cove near Gunston Hall. The banks are generally natural and erosional but heavily vegetated (Figure 2-12). The upland banks drop down to about 5 ft at the boat ramp at Pohick Bay Regional Park where gabions have been installed for shore protection. The upper Pohick Bay and Accotink Bay shorelines occur as low tidal freshwater marsh in front of wooded uplands.

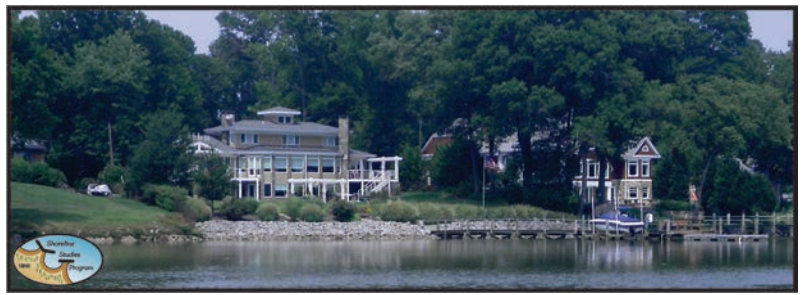
Figure 2-13. Development and shore protection along Dogue Creek.

Beyond the entrance and continuing along the north shore of Dogue Creek, there are developed upland banks with gentle graded banks and hardened shoreline (Figure 2-13). The north coast of Dogue Creek continues to Ferry Point at the confluence with the Potomac River as a highly developed shoreline. Ferry Point is protected with rock (Figure 2-14).

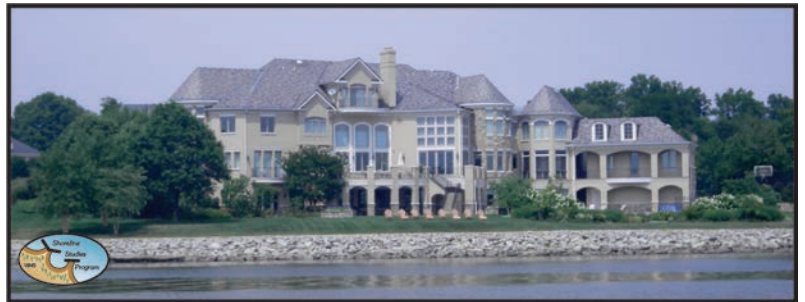
Figure 2-14. Ferry Point differs from other points in Fairfax in that it is developed and protected with a large revetment.

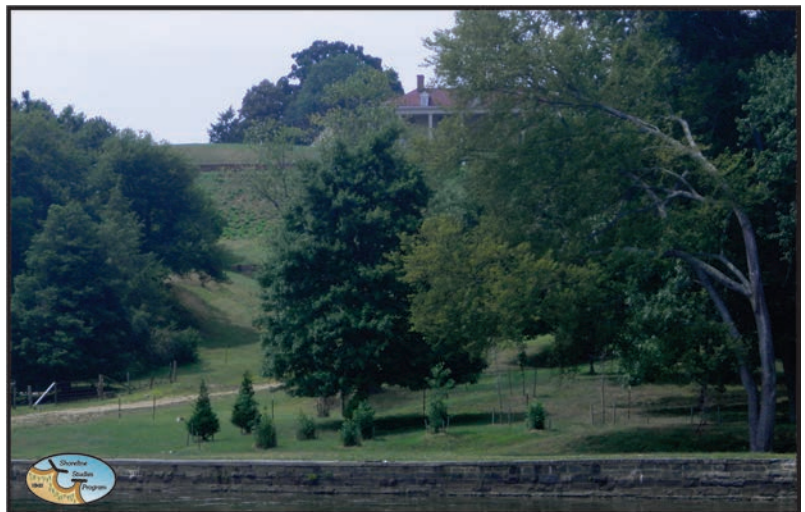
Figure 2-15. The high bank at Mount Vernon has been graded and the shoreline protected with a stone block seawall.

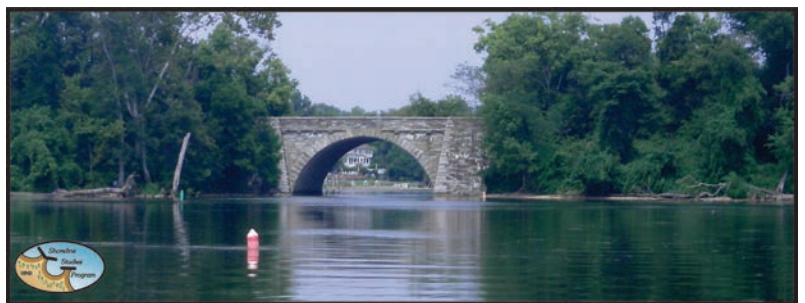
Figure 2-16. The fixed entrance to Little Hunting Creek.

The shoreline north of Ferry Point until the end of Reach 2 at Little Hunting Creek is developed high bank shoreline with two upland drainages intersecting the coast before you reach Mount Vernon. The shoreline occurs as heavily vegetated and natural in some areas while other sections have graded banks with a few defensive shoreline structures. The Mount Vernon shoreline extends for about 0.5 miles along the Potomac before turning into the embayed coast at the entrance to Little Hunting Creek. The Mount Vernon shoreline is mostly low banks then high graded bluff with stone block seawall (Figure 2-15). Beyond the manor house the shoreline occurs as intermittently eroding high bank, heavily vegetated before the Little Hunting Creek embayment. The Little Hunting Creek bay shoreline is low and heavily wooded before reaching the fixed entrance to Little Hunting Creek itself (Figure 2-16) where the George Washington Parkway crosses.

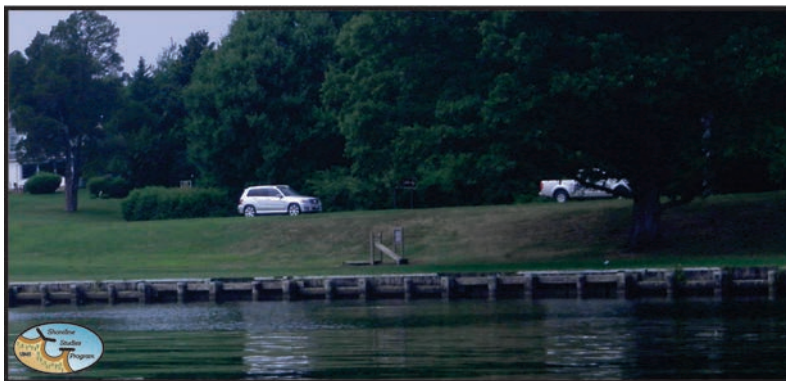
Figure 2-17. The George Washington Memorial Parkway runs along the shoreline in Reach 3.

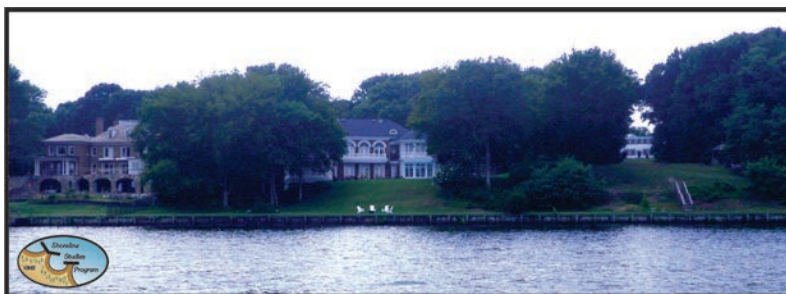
Figure 2-18. Development along Reach 3.

Where the GWP turns away from the shoreline, development of the bank begins again with mostly hardened shorelines and graded banks (Figure 2-18). At Hog Island the shoreline landscape becomes low

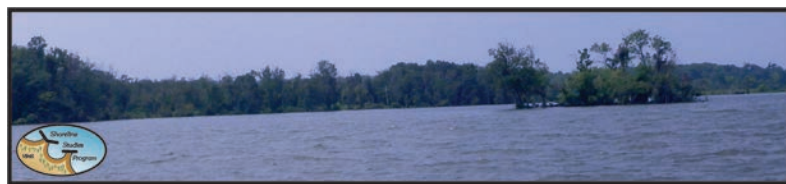
Figure 2-19. Dyke Marsh with wooded upland and occasional treed islands.

and heavily wooded. From there northward along the Potomac River to Belle Haven Marina, the shoreline is a freshwater swamp and tidal freshwater marsh complex called Dyke Marsh. The shoreline is erosive with intermittent wooded islands along the reach (Figure 2-19). Dyke Marsh is currently being considered for extensive restoration. It was once a much larger feature and extensive mining of the gravelly nearshore from 1940 to 1972 reduced its acreage by over 50%. Chronic shoreline erosion has reduced it even more. The restoration plan has several options from complete restoration to protecting what's left.

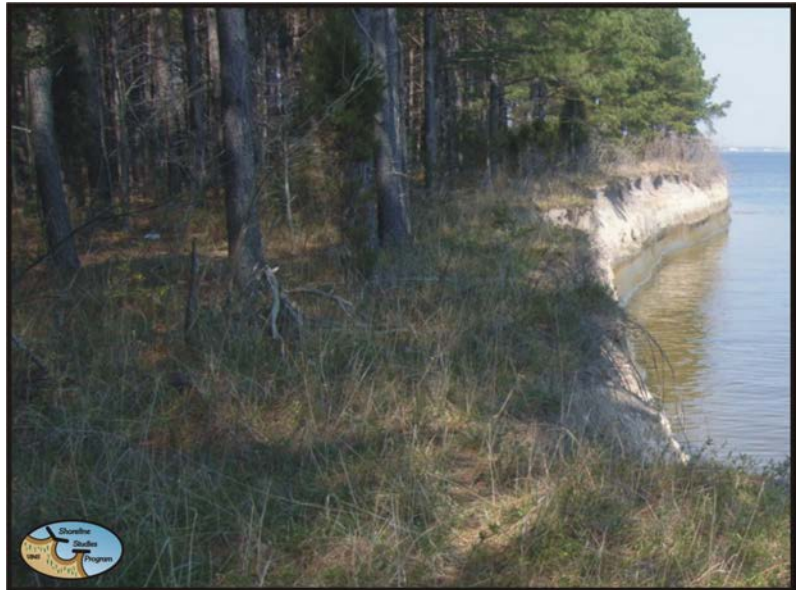
Figure 3-1. One example of forest management. The edge of the bank is kept free of tree and shrub growth to reduce bank loss from tree fall.

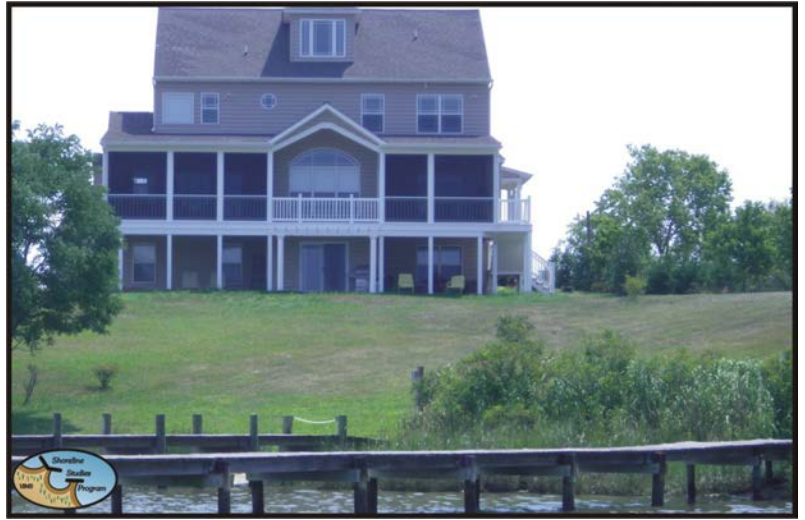
Figure 3-3. Bank grading reduces steepness and will improve growing conditions for vegetation stabilization.

In cases where the bank is unstable, medium or high in elevation, and very steep, bank grading may be necessary to reduce the steepness of bank slopes for wave run-up and to improve growing conditions for vegetation stabilization (Figure 3-3). The ability to grade a bank may be limited by upland structures, existing defense structures, adjacent property conditions, and/or dense vegetation providing desirable ecosystem services.

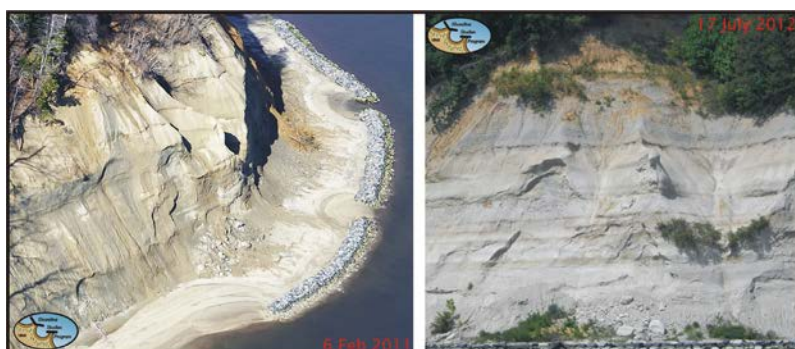
Figure 3-7. High sills built along the Potomac’s high energy, high bank shoreline. The material that slumps from the bank will be caught behind the sills and stabilize the base of the bank by protecting it from wave attack. A more recent photo shows that the slump material is starting to become vegetated.

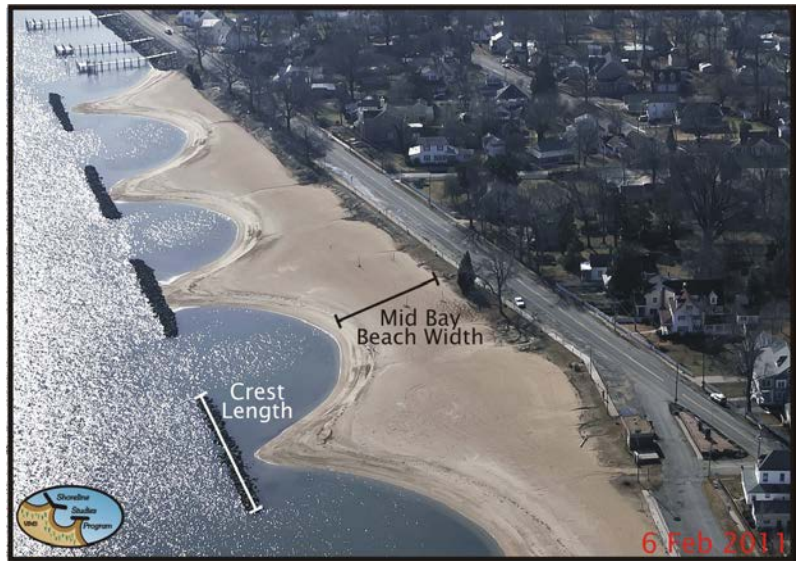
Figure 3-8. The breakwaters at Colonial Beach provide a wide recreational beach as well as storm erosion protection for the residential upland. These structures were installed in 1982.

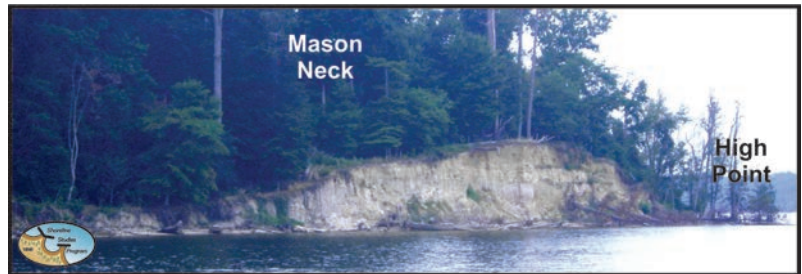
Figure 5-4. Existing conditions at High Point on Mason Neck.

The shoreline along Mason Neck at High Point is a high eroding bank (Figure 5-4). The bank is eroding at -2 to -5 ft/yr. In order to maintain High Point, a series of attached breakwaters are recommended (Figure 5-5). Detached breakwaters were built along a section of the coast in order to capture sand as the banks continued to erode (Figure 2-9). While these structures will eventually fill up with sand to create stable embayments, it is recommended that the breakwaters along High Point be attached in order to maintain the point. A typical cross-section is shown in Appendix 3, Figure 3-3.

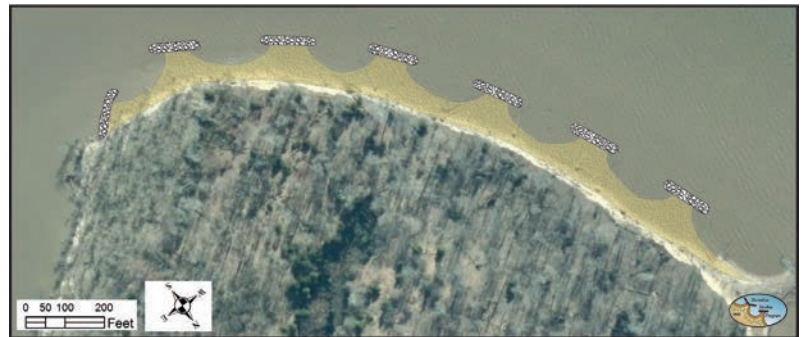
Figure 5-5. Proposed configuration of the breakwater shoreline BMP for High Point.

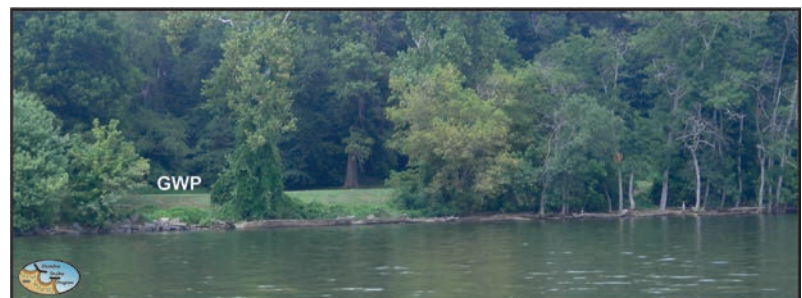
Figure 5-7. Existing conditions at the GWP turnout Area of Interest #2.

The second area of interest is a turnout along the GWP (Figure 5-6). This section of coast has a very low erosion rate (Figure 5-7), less than -1 ft/yr, but the Mount Vernon Trail, a paved multi-use trail that stretches from George Washington's Mount Vernon estate to Theodore Roosevelt Island, is relatively close to the shoreline (Figure 5-8). In addition to providing a buffer along the shore, a sill will create habitat and enhance the view along the turnout. A typical cross-section for a sill at this site is shown in Appendix 3, Figure 3-1.

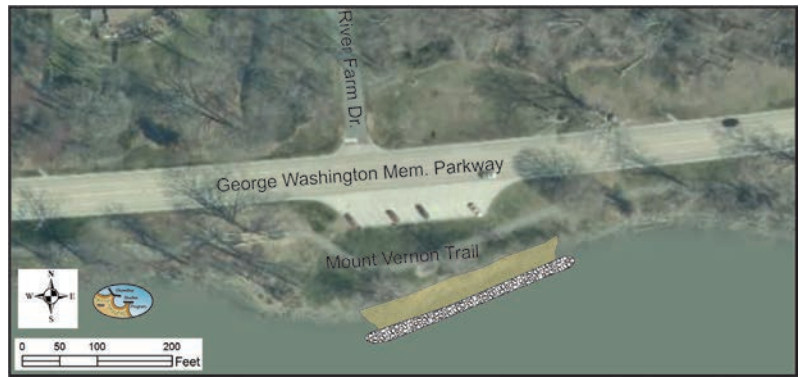
Figure 5-8. Proposed configuration of sill shoreline BMP for Area of Interest #2 along the GWP.

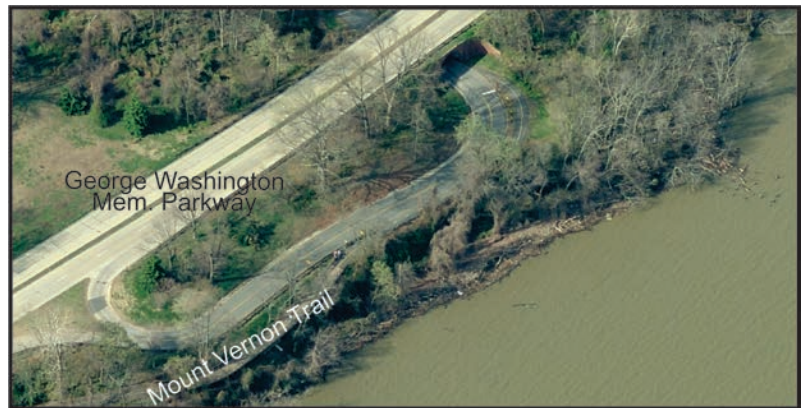
Figure 5-9. Existing conditions at the GWP turnout Area of Interest #3. From Bing Maps.

The third area of interest is also a turnout along the GWP (Figure 5-6). This section of coast has a higher erosion rate, -2 to -5 ft/yr, and the Mount Vernon Trail and turnout are very close to the eroding bank (Figure 5-9). A medium sill will protect the Trail and the shoreline from continued erosion (Figure 5-10). A typical cross-section for a sill at this site is shown in Appendix 3, Figure 3-2.

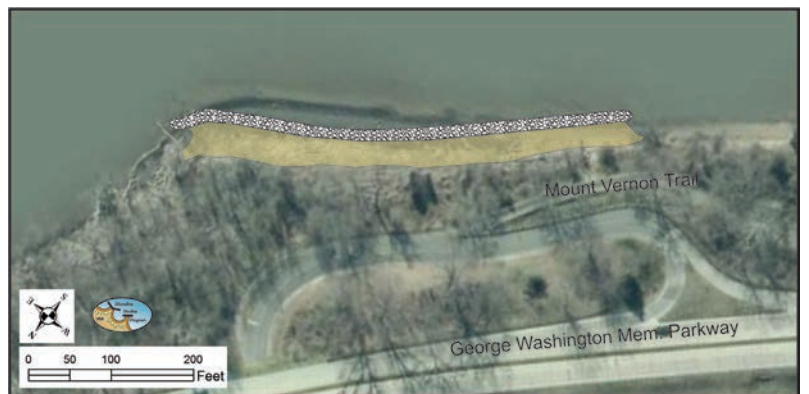
Figure 5-10. Proposed configuration of sill shoreline BMP for Area of Interest #3 along the GWP.
