## Gloucester County Shoreline Management Plan

# *Gloucester County Shoreline Management Plan*

October 2016

*Prepared for  
Gloucester County and  
Virginia Coastal Zone Management Program*

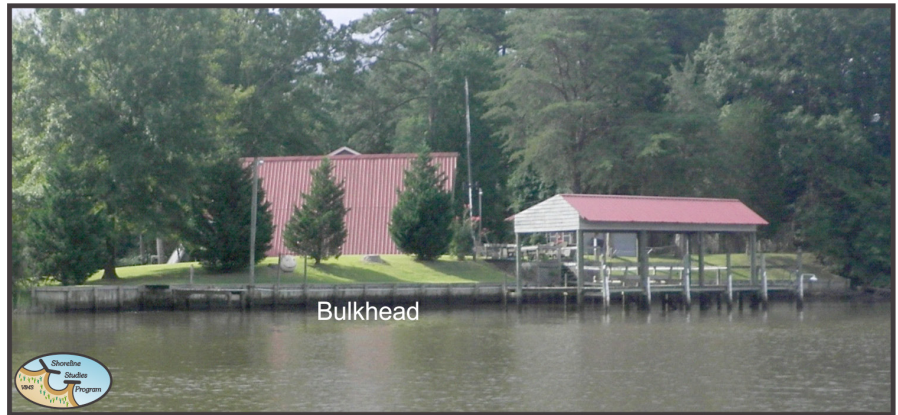
**Figure 2-6.** Low bank and bulkheading on the Poropotank River.

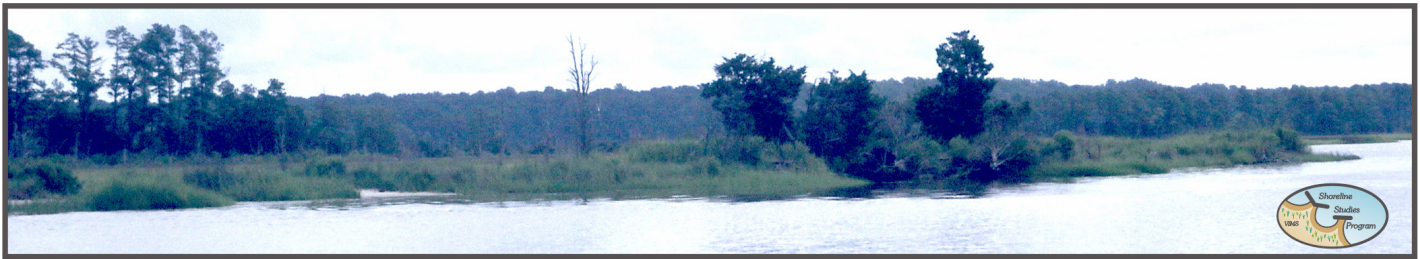
**Figure 2-7.** Low, wide marsh shoreline along Gloucester's upper York River.

At the confluence of the Poropotank and the York River, the marsh shoreline fronting low uplands continues downriver, up Adams Creek, and across Purtan Island (Figure 2-7). With the increased fetch across the York River, shoreline erosion increases dominated by wind driven wave action and the shoreline quickly transitions to actively eroding upland banks (Figure 2-8). For about 2,000 feet downriver of Bland Creek, the mostly 25 foot high upland banks include several residential communities. These shoreline are mostly hardened with bulkheads and revetments. Several breakwater installations also occur along this reach including one at the mouth of Fox Creek (Figure 2-9).

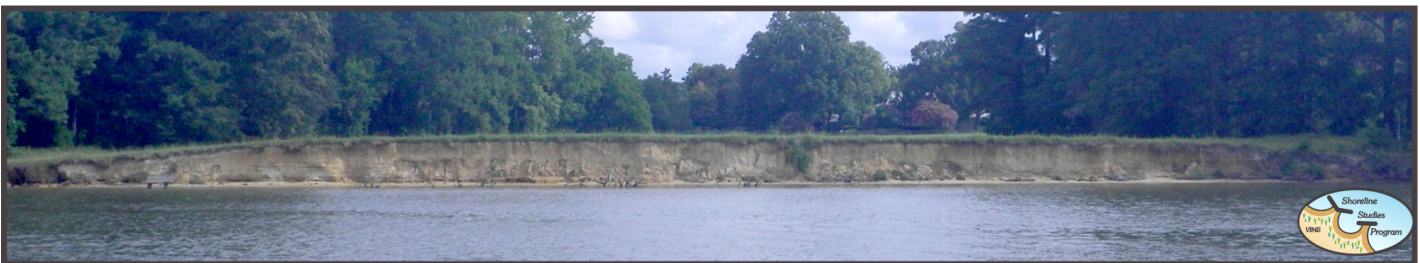
**Figure 2-8.** Low eroding banks in Purtan Bay.

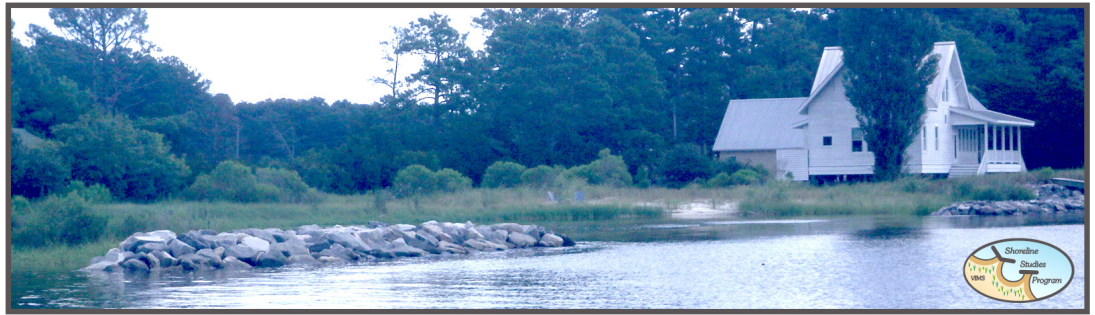
**Figure 2-9.** Breakwaters at Fox Creek in Gloucester County.

al., 2010). Breakwaters were installed at Fox Creek producing a long-term change of +1 to +5 ft/yr (Milligan et al., 2010). Along the shore breakwaters and piers result in man-made accretion with the rate of up to +5 ft/yr.

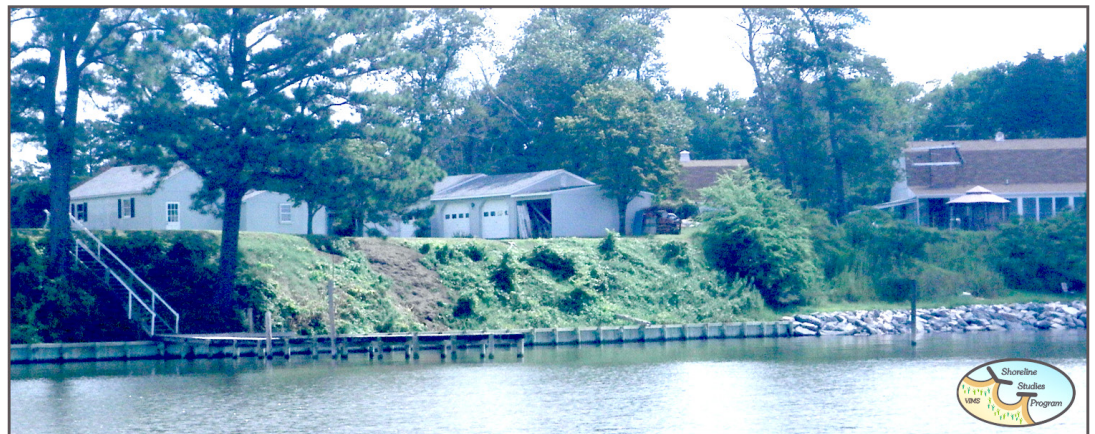
**Figure 2-10.** Eroding upland banks with residential properties on Gloucester's York River that have been hardened with bulkheads and revetments.

Creek (Figure 2-10). A small breakwater system resides at the mouth of Aberdeen Creek which has helped maintain a navigation channel. Farther downriver between Aberdeen Creek and Carter Creek developed upland banks are 15 to 20 feet high and are hardened.

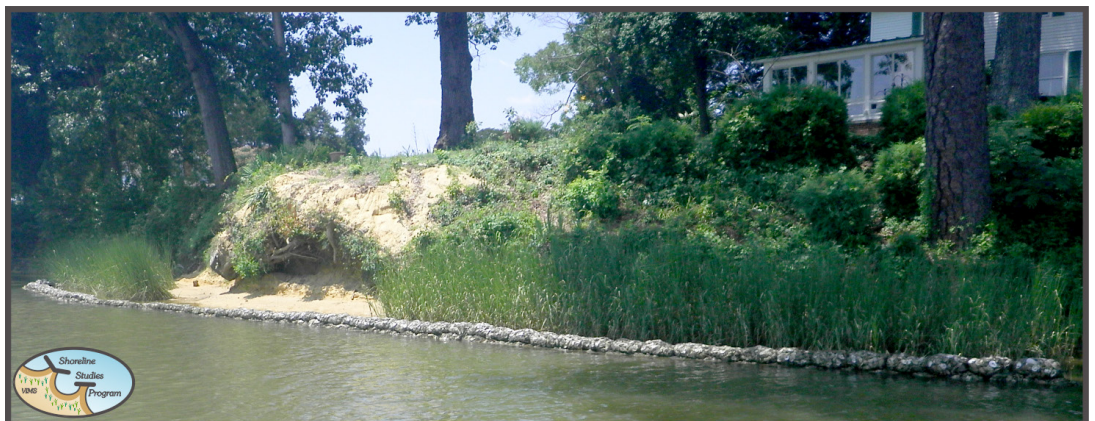
**Figure 2-11.** Eroding upland banks protected with a recently-installed oyster bag sill.

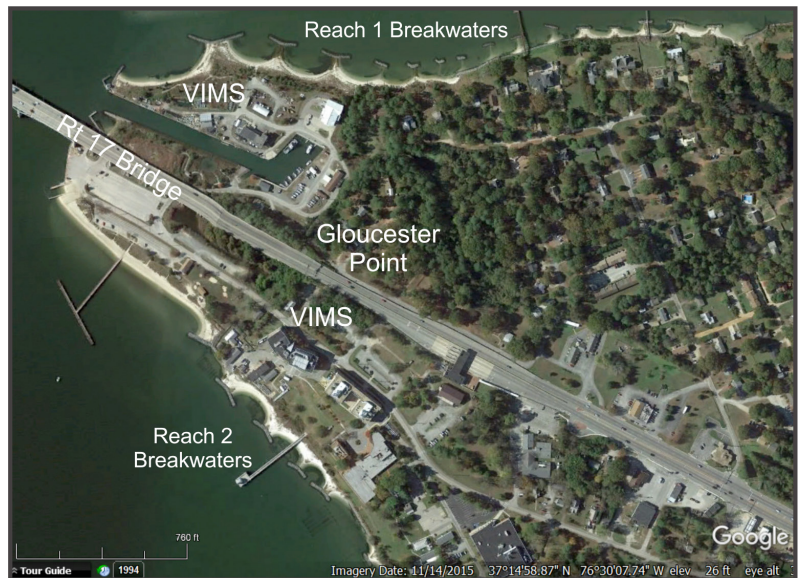
**Figure 2-12.** Google Earth map showing the breakwaters along the York River at Gloucester Point.

From VIMS downriver to Sarah Creek, the high upland banks have been developed and hardened with bulkheads and revetments. However, a breakwater system has been installed along this reach, and near the mouth of Sarah Creek, a gabion breakwater system still persists after over 20 years Here the Suffolk Scarp intersects the shoreline (Figure 2-1). Sarah Creek shorelines are upland banks ranging from 5-15 feet on along the Northwest Branch. The shorelines are mostly developed with a few open areas with narrow marsh fringes and exposed banks. Those residential properties are often hardened with bulkheads and revetments (Figure 2-13). Two marinas also reside in Sarah Creek, Yacht Haven and Jordan Marine, and community docks are located along Dockside Condominiums. Tidemill Road crosses the upper reach of the Northwest Branch where concrete filled bags are used to secure the base of the approach

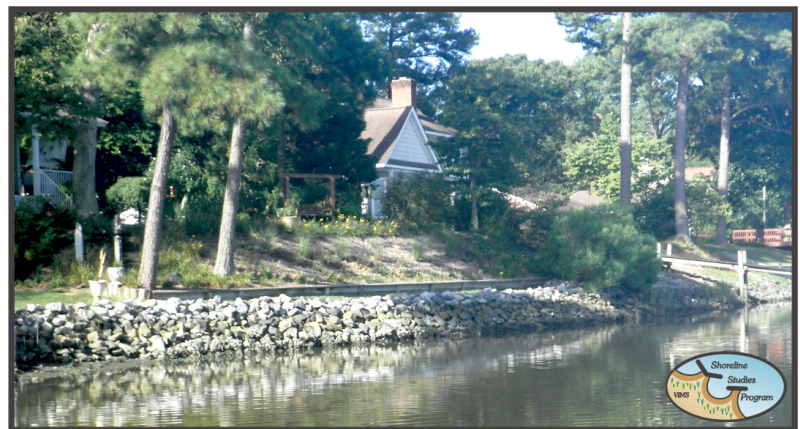
**Figure 2-13.** Shoreline hardening in the low fetch environment of Sarah Creek.

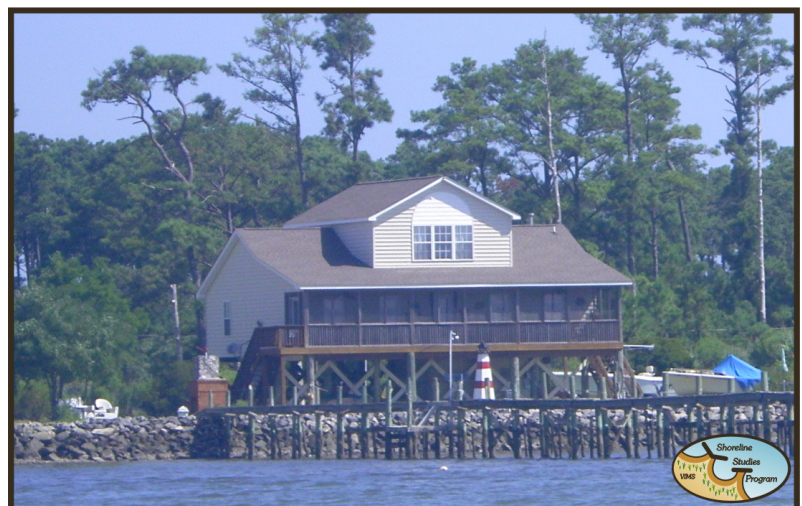
Figure 2-15. Raised houses and shore protection along shorelines that have been significantly impacted by storms.

little shore hardening except at the mouth. From the mouth of the Perrin, eastward along Jenkins Neck and downriver to the Guinea Marshes, this shoreline was severely impacted by Hurricane Isabel's flooding and wave action in 2003. Since then residential development has increased with existing and new waterfront homes being elevated along with shoreline hardening (Figure 2-15).

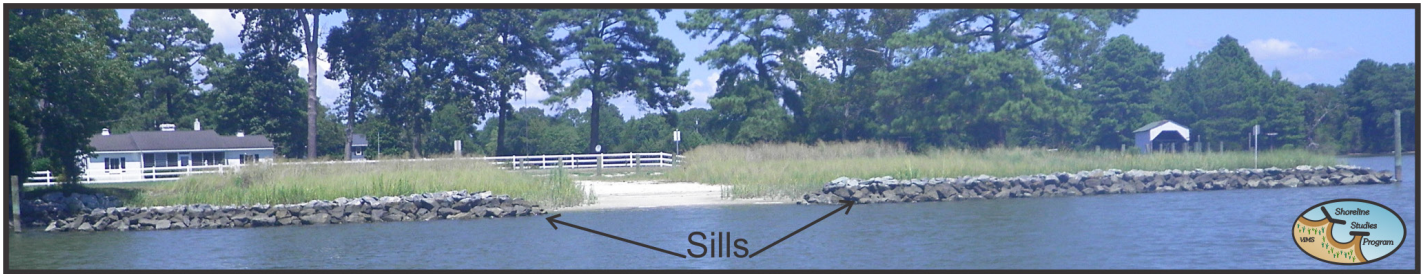
**Figure 2-17.** Living Shoreline sills at Jones Wharf on Free School Creek.

uplands of Guinea (Figure 2-16). There is no residential development along Guinea Neck’s shoreline on Mobjack Bay. The Severn River separates at Stump Point into the Southwest Branch and Northwest Branch. Two marinas and some residential development occurs along the Severn River. Shoreline hardening is usually limited to the more exposed low uplands. Just inside Free School Creek is Jones Wharf, a public landing where a shoreline demonstration consisting of rock and oyster bag sills with wetlands plantings and canoe beach was built (Figure 2-17).

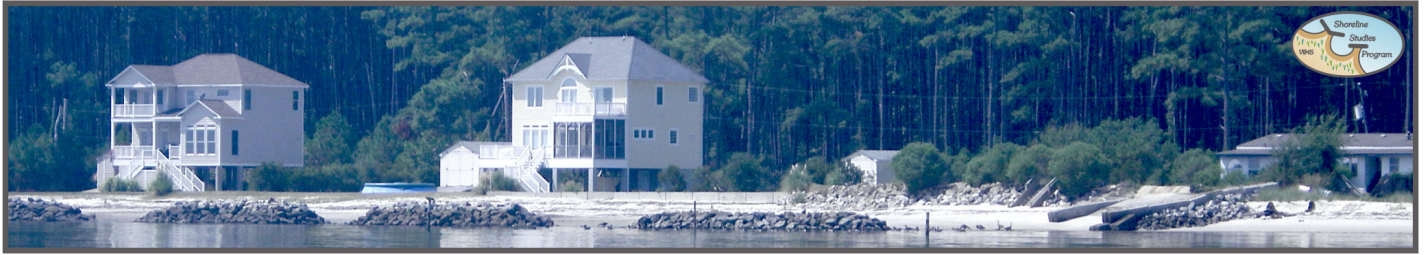
**Figure 2-19.** North River residential properties with a low bank and breakwaters for shore protection.

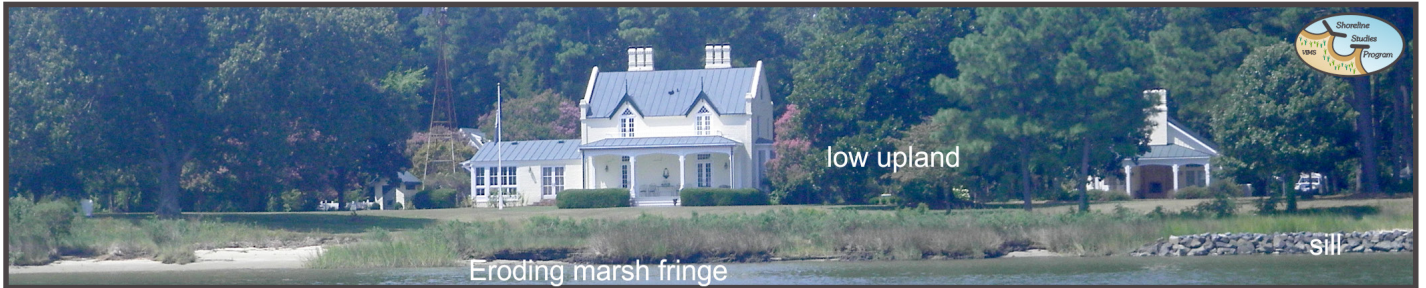
**Figure 2-20.** Low upland residential properties on the North River with eroding marsh fringe and sill for shore protection.

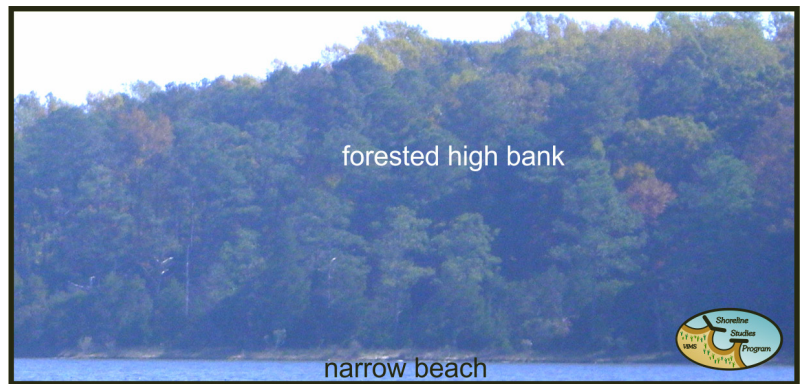
**Figure 2-21.** Forested high bank with narrow beach along the Piankatank River.

Reach 4 extends along the south bank of the Piankatank River from west of Holland Point to the River’s headwaters (Figure 2-5). It has an average long-term erosion rate of -0.5 ft/yr and is relatively fetch-limited. The shoreline begins as an embayed vegetated stable high bank shoreline with a narrow beach (Figure 2-21). West of Dancing Creek, the upland elevation drops down to about 5-7 feet high. This reach of shoreline is mostly residential properties with various types of shoreline hardening such as revetments and bulkheads (Figure 2-22). The Hell Neck coast and those shorelines farther north have both high and low banks that are intermittently developed and hardened. The wider Piankatank River shoreline eventually becomes marsh dominated with a narrow channel.

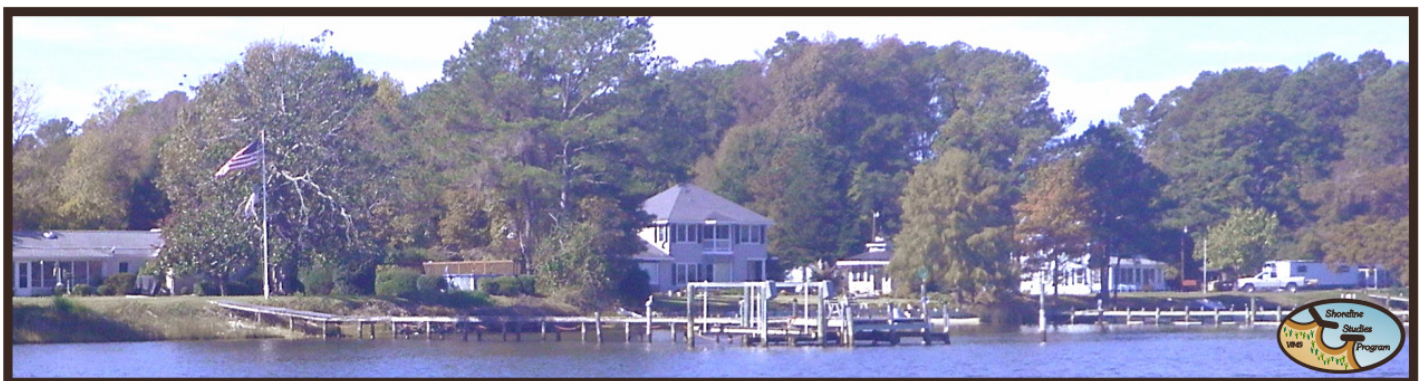
**Figure 2-22.** Low residential properties along the Piankatank River.

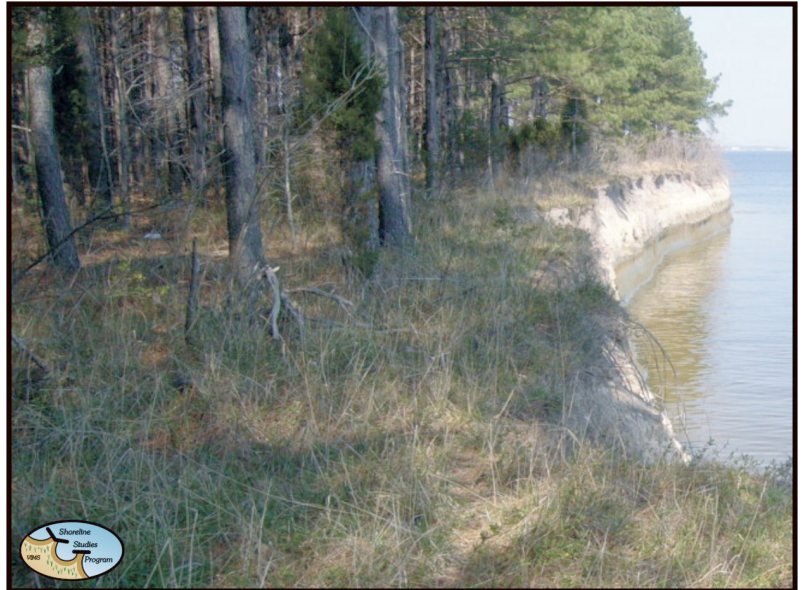
*Figure 3-1. One example of forest management. The edge of the bank is kept free of tree and shrub growth to reduce bank loss from tree fall.*

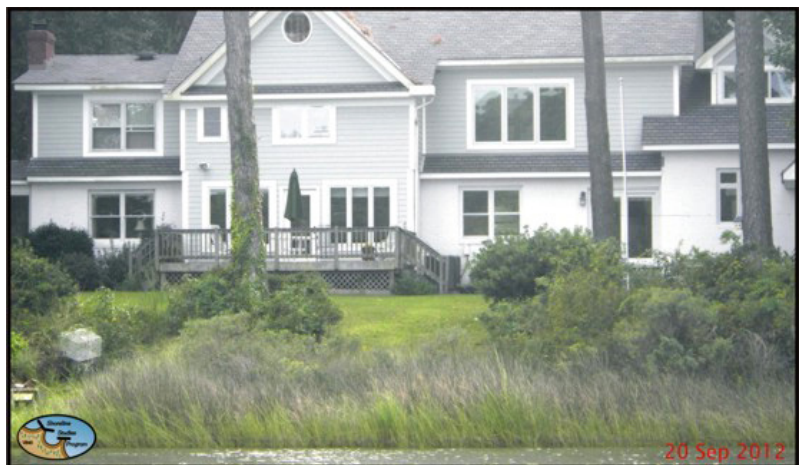
*Figure 3-2. Maintaining and enhancing the riparian and marsh buffers can maintain a stable coastal slope.*

Enhancement of both riparian and existing marsh buffers together can be an effective practice to stabilize the coastal slope (Figure 3-2) from the intertidal area to the upland by allowing plants to occupy suitable elevations in dynamic fashion to respond to seasonal fluctuations, shifts in precipitation or gradual storm recovery. At the upland end of the slope, forest buffer restoration and the planting of ornamental grasses, native shrubs and small trees is recommended. Enhancement of the marsh could include marsh plantings, the use of sand fill necessary to plant marsh vegetation, and/or the need for fiber logs to stabilize the bank toe and newly established marsh vegetation.

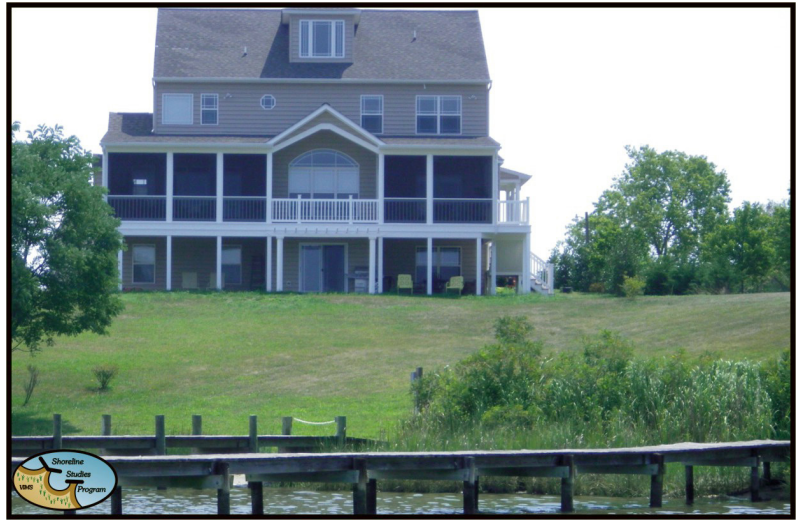
*Figure 3-3. Bank grading reduces steepness and will improve growing conditions for vegetation stabilization.*

In cases where the bank is unstable, medium or high in elevation, and very steep, bank grading may be necessary to reduce the steepness of bank slopes for wave run-up and to improve growing conditions for vegetation stabilization (Figure 3-3). The ability to grade a bank may be limited by upland structures, existing defense structures, adjacent property conditions, and/or dense vegetation providing desirable ecosystem services.

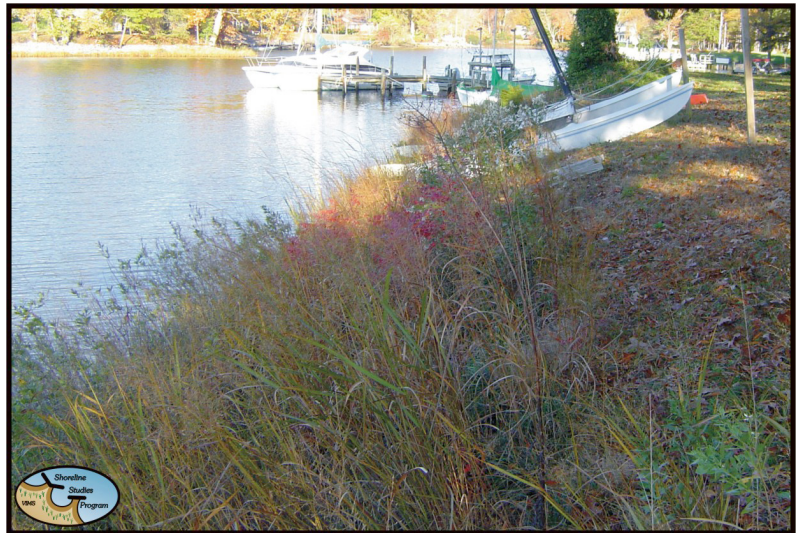
*Figure 3-4. This low-energy site had minor bank grading, sand added, and Spartina alterniflora planted. This photo shows the site after 24 years.*

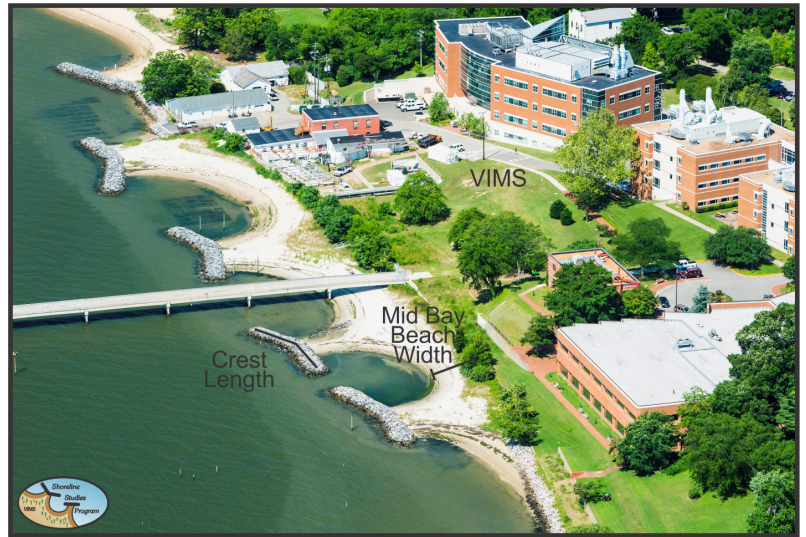
**Figure 3-7.** Breakwaters at VIMS designed to provide a wide beach for storm erosion protection at the campus.

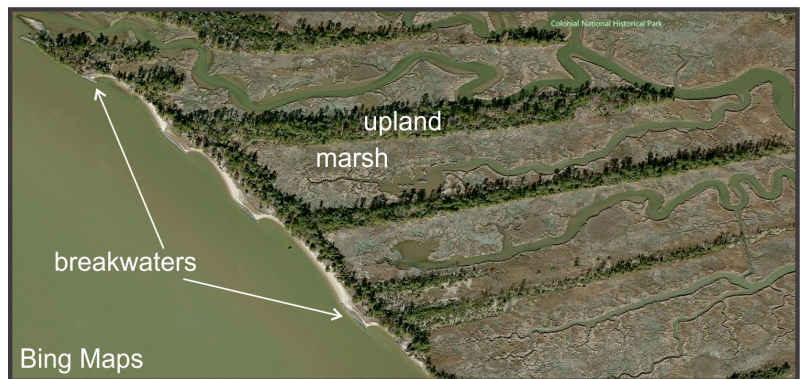
**Figure 3-8.** Bing map showing headland breakwaters that were built along Jamestown Island's James River shore.

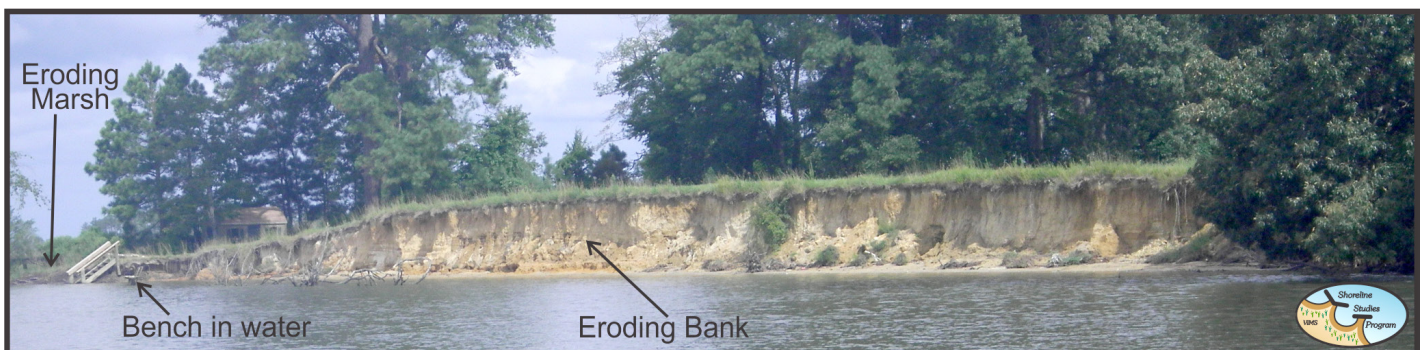
Figure 5-4. Eroding shoreline at Area of Interest 1 on Purtan Bay.

The site is located in a relatively sheltered embayment but it faces southwest across the York River with about a 3.2 mile long fetch. This is a medium wave energy classification of 1 to 5 miles (Hardaway and

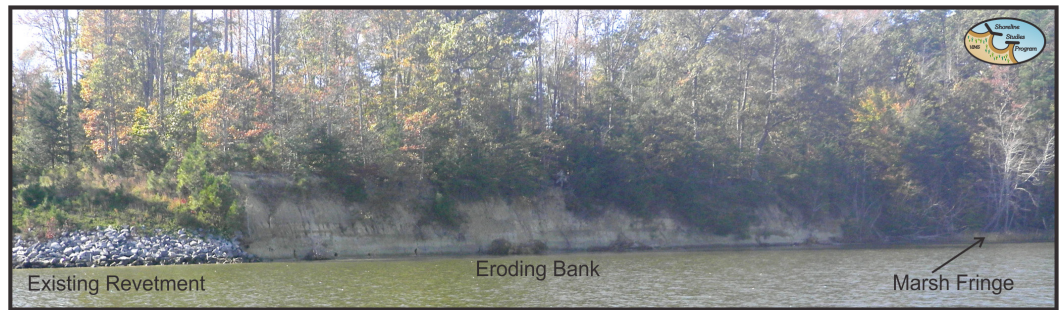
Figure 5-7. Proposed configuration of Shoreline BMP at Chickahominy Riverfront Park.

This site is located on the Piankatank River along the north coast of Hell Neck. The project shoreline is about 300 feet long extending upriver from an existing revetment to a marsh fringe. The upland bank is exposed and eroding and transitions north to a stable bank face behind the marsh fringe (Figure 5-7). The project site faces northeast with an average fetch exposure of about 0.8 miles, a low wave energy shoreline. The tide range is 1.2 feet, and the site has an erosion rate of about 1.2 ft/yr (Milligan *et al.*, 2010). A series of three medium gapped sills are recommended along the eroding uplands due to a relatively deep nearshore making a breakwater system less cost effective (Figure 5-8). Site access must also be addressed. It is deep enough that the site could be accessed by water; however if the structure is built from land, an access road down a graded bank would need to be included in a final plan. The cross-section for a typical sill for this site is shown in Appendix 3, Figure 2.
