Shoreline Erosion in Virginia

SHORELINE EROSION IN VIRGINIA

October 1980

Educational Series No. 31

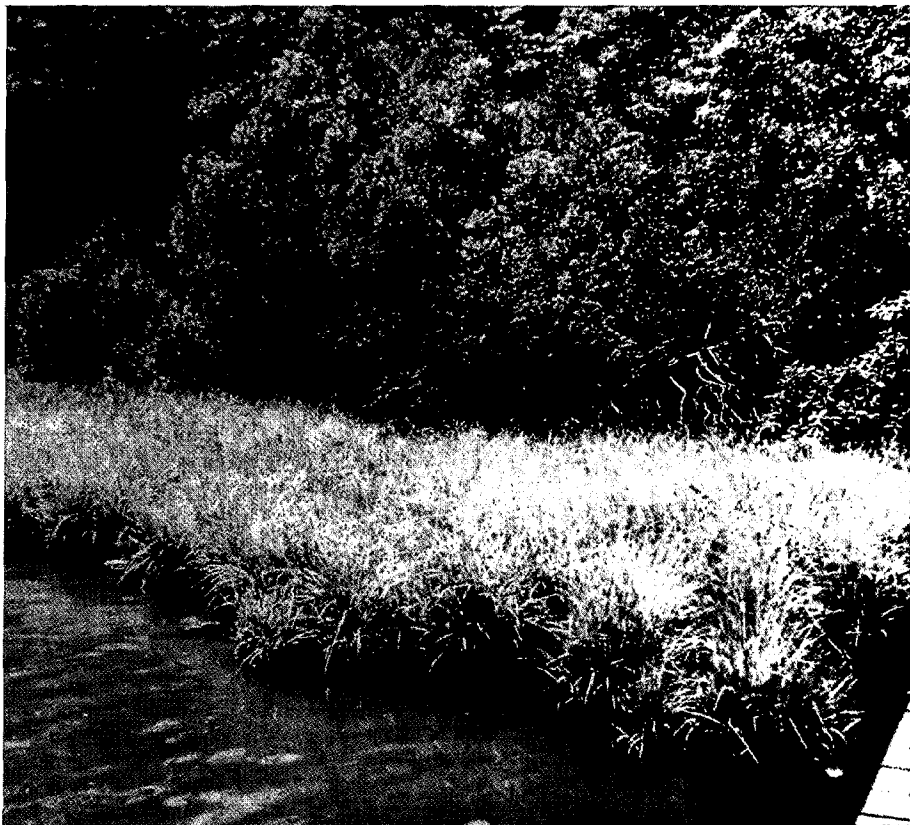
Figure 8 - Vegetative zonation of plant species.

Figure 8 depicts tidal wetlands of Virginia and the vegetative zonation of plant species. There are 212,000-225,000 acres of tidal marshes in Virginia. In addition to their value as an essential link in the estuarine food chain, marshes also act as effective buffers to erosion of the fastland. Their low elevation and matted root system make marshes more resistant to wave erosion than sediment banks exposed to the same fetch conditions.

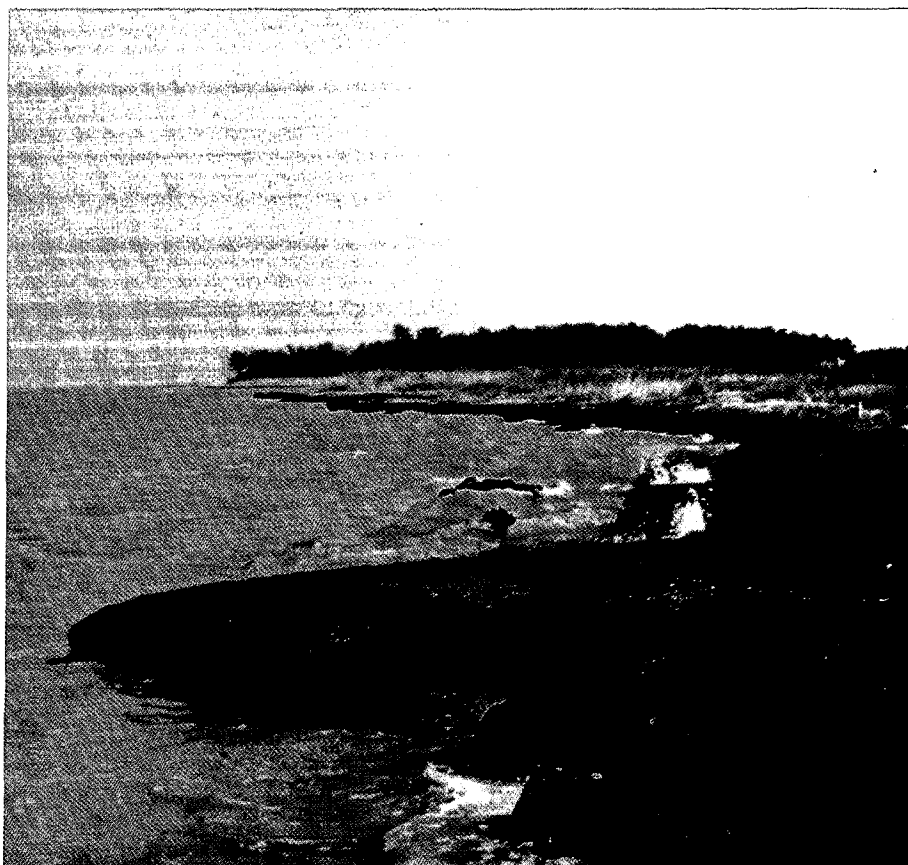
Figure 9 - The factors involved in erosion of the brackish marsh shoreline are illustrated. During low tide, wave action erodes the softer underlying peat (B), undercutting the firm surface layer (A). The peat shelf breaks into blocks that fall into the water, leaving U-shaped notches along the bank.

Extensive marshes act as large sponges to help reduce the flood hazard in some coastal areas. Fringing marshes occurring along sediment banks greatly reduce wave action. Actively eroding marsh shorelines are characterized by exposed and undercut peat banks (Figure 9). Marshes are also valuable to waterfowl as a source of food and habitat.

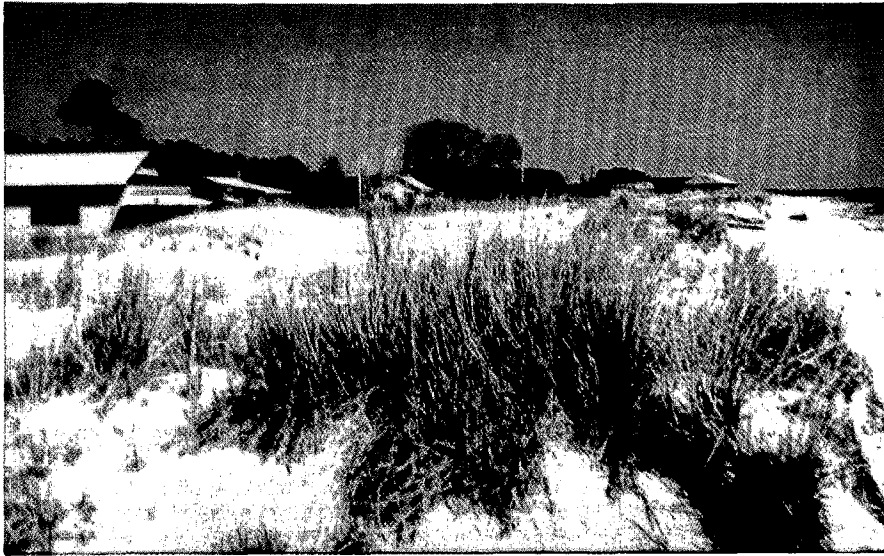
Figure 10 — Extensive low-lying dune shorelines occur along bay shores in Hampton, Mathews County and Northumberland County.

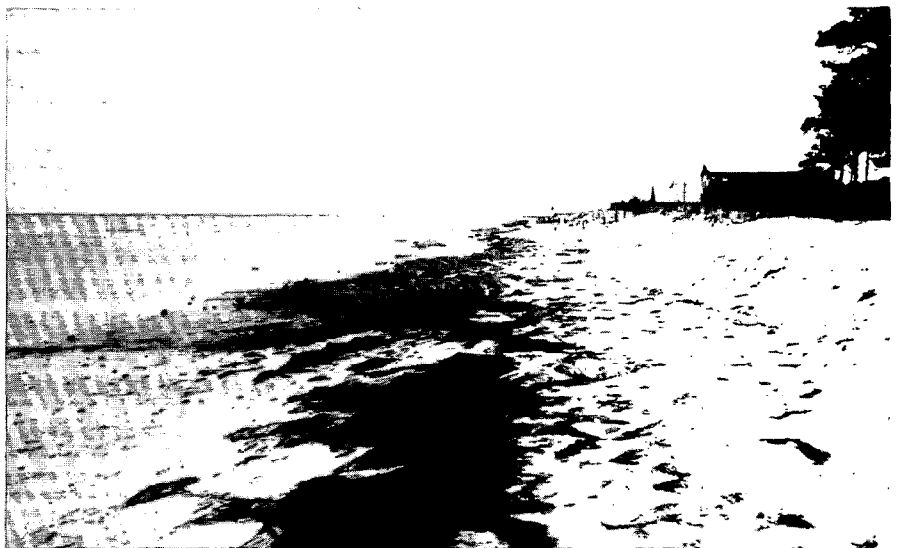
Figure 11 — The dune shorelines recede by washovers during storms. This often exposes a peat horizon which was once a living marsh behind the dune system bayward of its current position.

active beach, forcing the beach to react to a reduced sand supply by retreating. In many instances this retreat exposes the surface of marsh peat covered by previous washovers (*Figure 11*).

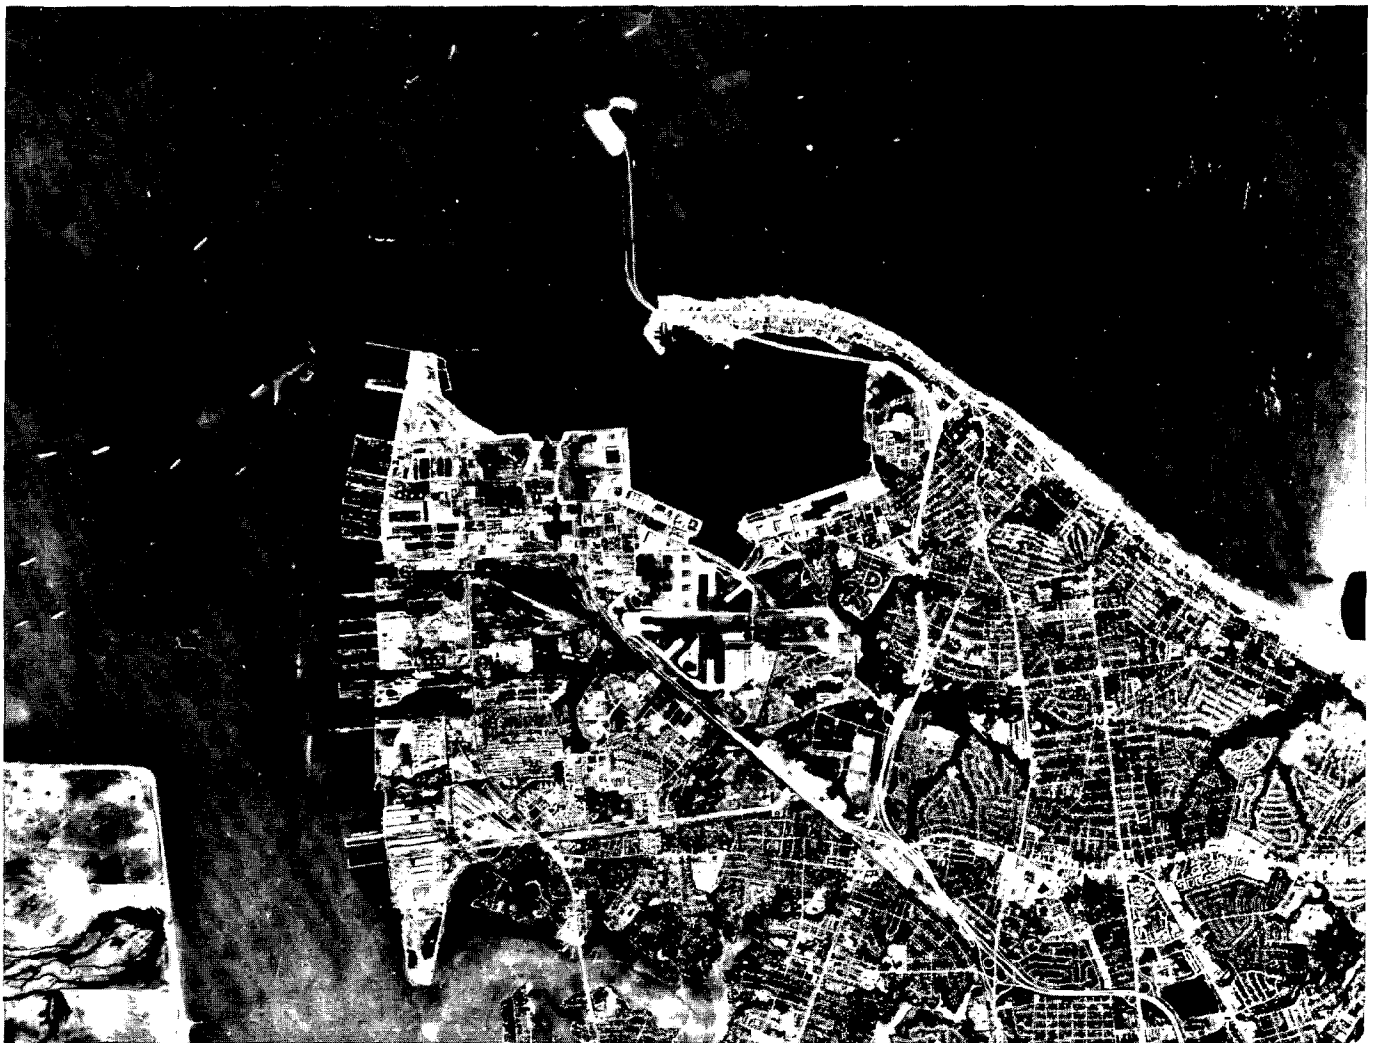
Figure 12 — Willoughby Spit as seen from the air on March 3, 1973.

Spits are active sand features found at the downdrift end of barrier beaches. They are also defined as tongues of sand moving across the mouths of lateral creeks. One example of a spit is Willoughby Spit where the Hampton Roads Bridge Tunnel enters Norfolk. This mile long sand spit is said to have formed in a single hurricane storm in 1806 (*Figure 12*).

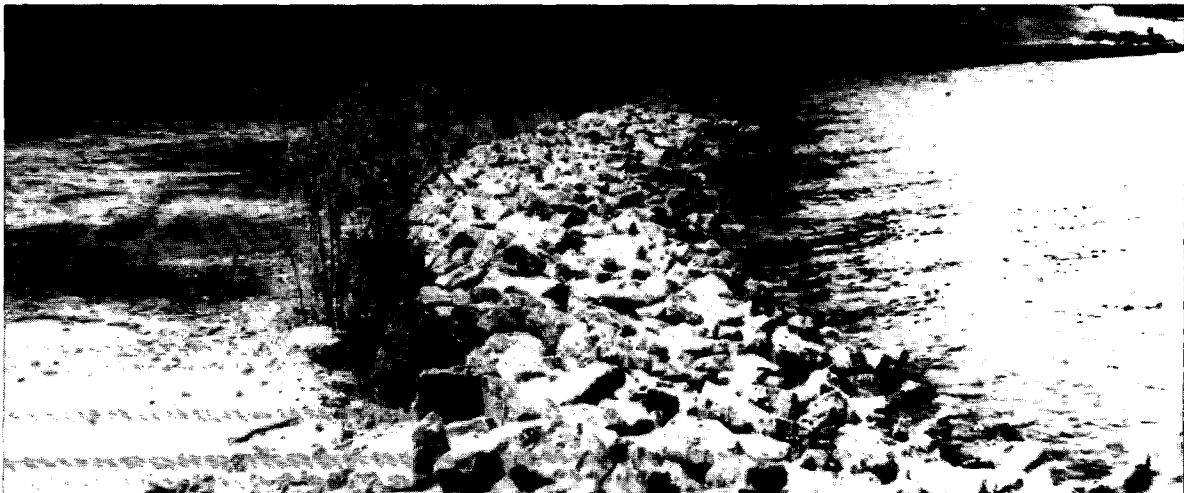
Figure 15 — Concrete seawall (top). Figure 16B (bottom) small riprap revetment. Figure 16A (middle) riprap revetment.

The respective definitions of these structures vary little although different construction materials are sometimes associated with each structure (*Figures 14A & B, 15, 16A & B*). Vertical structures act to retain the fastland material and to prevent wave induced erosion. In one way, they can be thought of as defensive structures. However, in many situations, vertical structures lead to the loss of the beach which may front them.

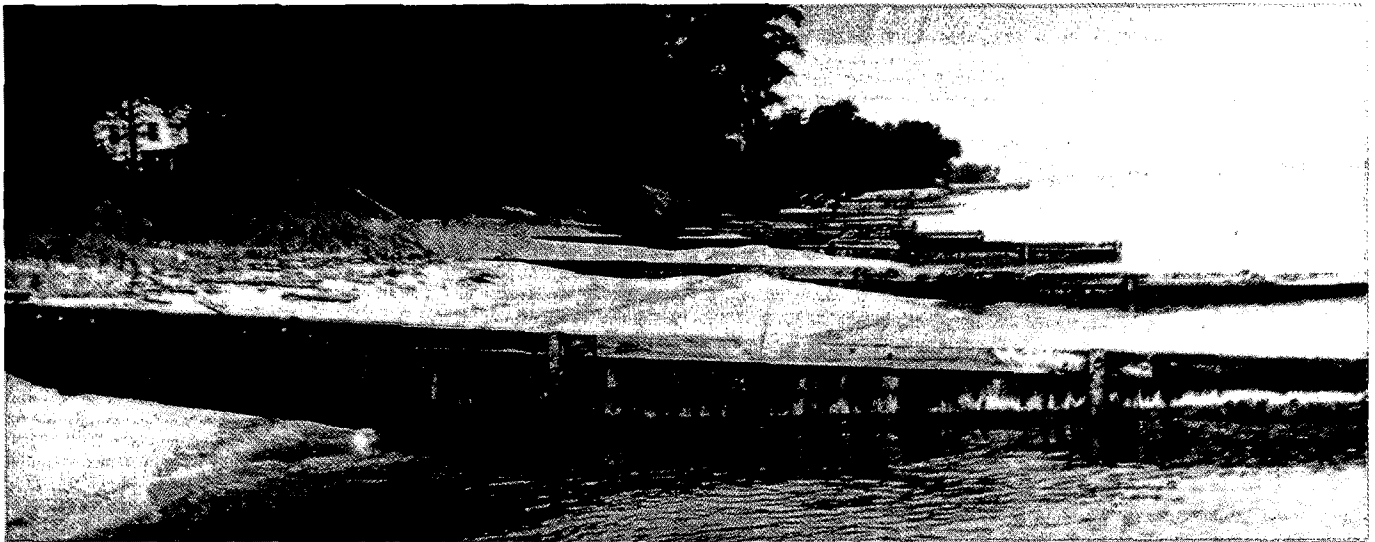
Figure 17A – Groin field. Figure 17B (upper right) Timber sheet-pile groin.

is usually the product of the littoral transport of sand towards and into the inlet. Jetties can also serve to make inlet access easier by reducing wave height (Figures 17A & B).

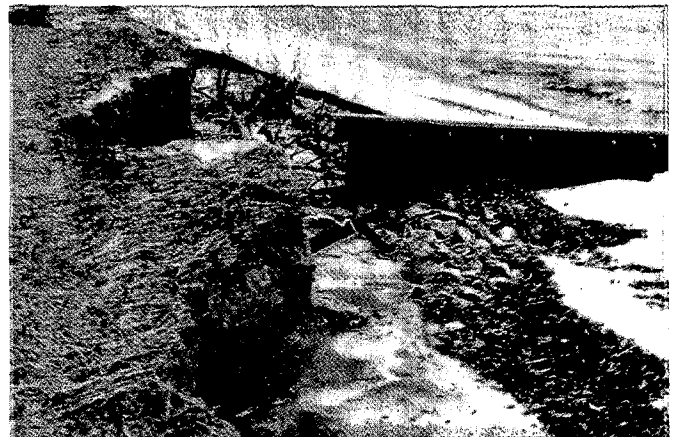
Figure 18 – Groin which has been flanked by severe erosion.

Imperative in the success of groins is an adequate supply of sand to quickly fill the groins and then begin bypassing sand. An inadequate supply of sand can lead to accelerated erosion downdrift of the groin. In some cases, this accelerated erosion can flank the groin rendering it totally useless (see Figure 18).

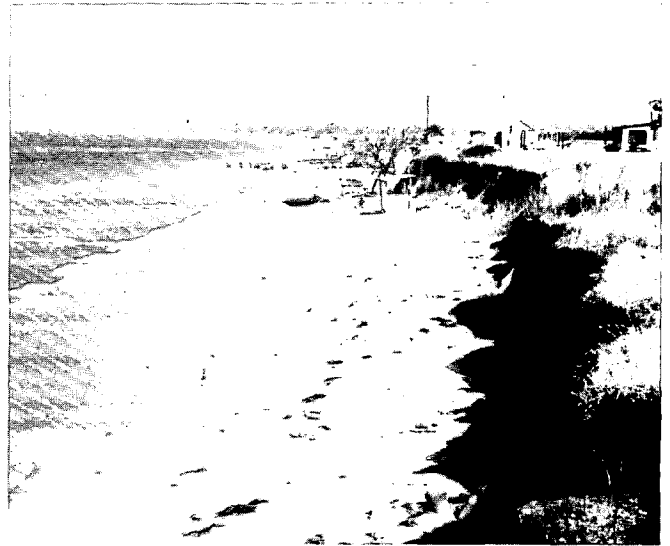
Figure 21A — Sandbag sill.

The principle involved is known as a perched beach. As illustrated (Figures 21A & B) the desired effect is to elevate the profile of the beach. If successful, a protective layer of sand exists at the base of a cliff or bulkhead. Because this layer is significantly higher than the unprotected backshore height, additional protection is afforded during storm elevated water levels. This system offers protection from all wave angles and at higher water levels. In essence, it resembles a "permanent" bar situated at the step of the beach.

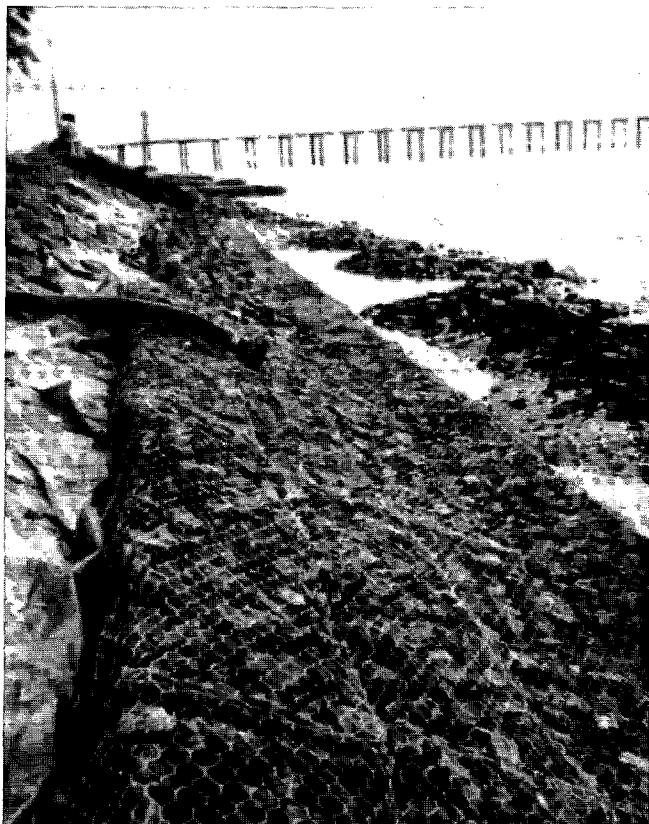
Figure 22 – Gabion revetment.
