## A survey of the effectiveness of existing marsh toe protection structures in Virginia

# **A Survey of the Effectiveness of Existing Marsh Toe Protection Structures in Virginia**

Final Report to the Keith Campbell Foundation for the Environment, Inc.

July 2006

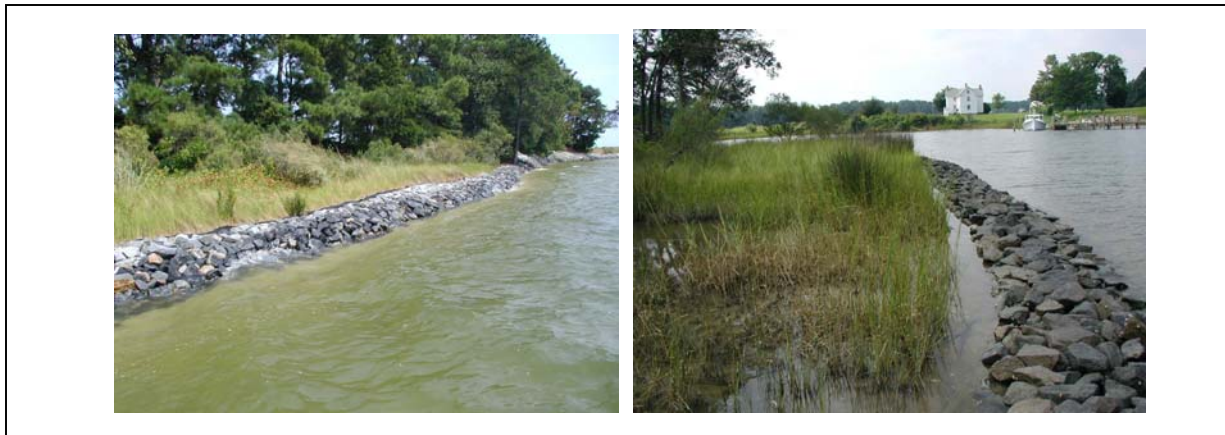
**Figure 1.** The two types of marsh revetments included in this study were “marsh toe revetments” placed directly against the edge of an eroding tidal marsh (left) and “marsh sills” offset from the edge of the marsh vegetation (right) or adjacent to non-vegetated intertidal area. Collectively, these rock revetments are referred to as “marsh revetments” for the purpose of this study.

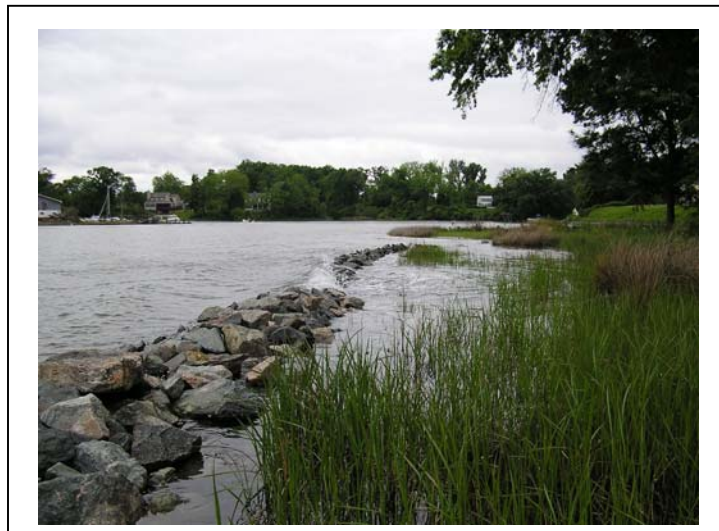
It appears that fetch alone may not be a reliable factor to determine if a structure is necessary to support a vegetated marsh sufficient for erosion protection. Shoreline orientation and boat wakes also have an influence on determining the need for a structure, especially where the marsh is located in close proximity to a navigation channel (Figure 2).

**Figure 2.** Boat wakes were observed washing over this marsh toe protection structure located in close proximity to a navigation channel. Boat wakes influence the wave climate in low energy settings.

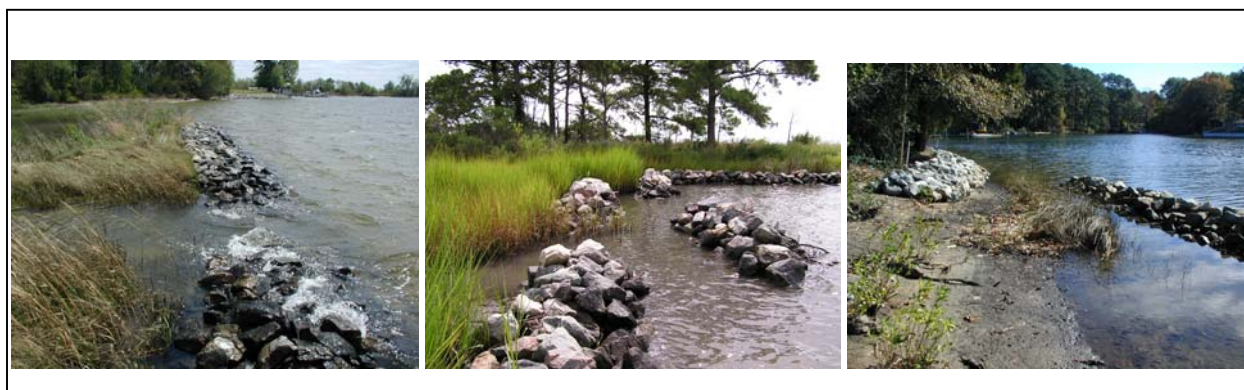
Tidal openings were specifically included in the design of 15 out of 36 projects (Figure 3). These breaks in the revetments are important for reducing the interruption of tidal exchange, which provides nekton access to the marsh and regulates water temperatures in the marsh. Tidal openings were either straight or off-set and overlapping to prevent diffracted wave action and erosion scour at the opening. These openings were strategically placed along the length of long, continuous structures, at the tidal openings to ponds and pocket marshes or at the ends of the structures.

**Figure 3.** Three different types of tidal openings are illustrated, including a straight gap (left), offset gaps at a pocket marsh (center), and an end opening instead of tying into the upland bank or other erosion control structure (right).

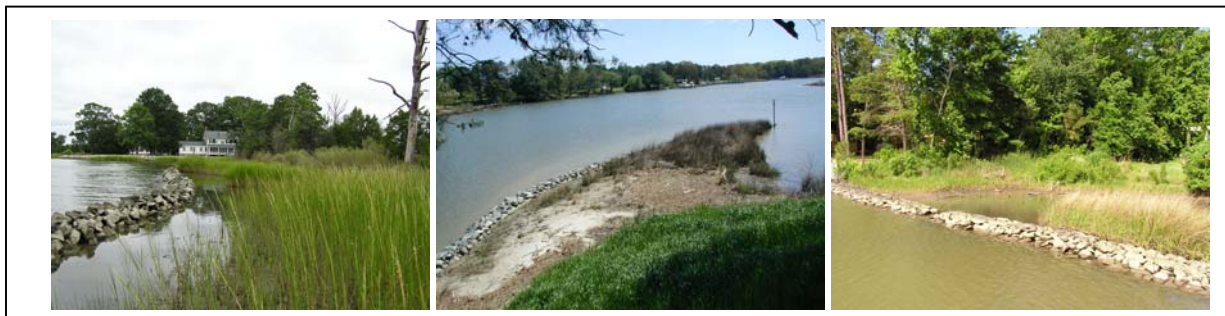
Three different geomorphic types of tidal marshes were targeted by these projects, including fringing marshes (N=18), spit marshes (N=12) and pocket marshes with tidal ponds (N=4) (Figure 4). Fringing marshes were the most common marsh type and most of these were long, continuous features greater than 100 linear feet. There was also one project located in a small tidal channel that connected a larger inland marsh with a major tributary. Only one project involved the complete creation of a tidal marsh where it did not naturally occur (Poplar Grove, MA06).

**Figure 4.** Three different geomorphic types of tidal salt marshes were the targets for erosion protection, including fringing (left), spit (center) and pocket marshes with open tidal ponds (right).

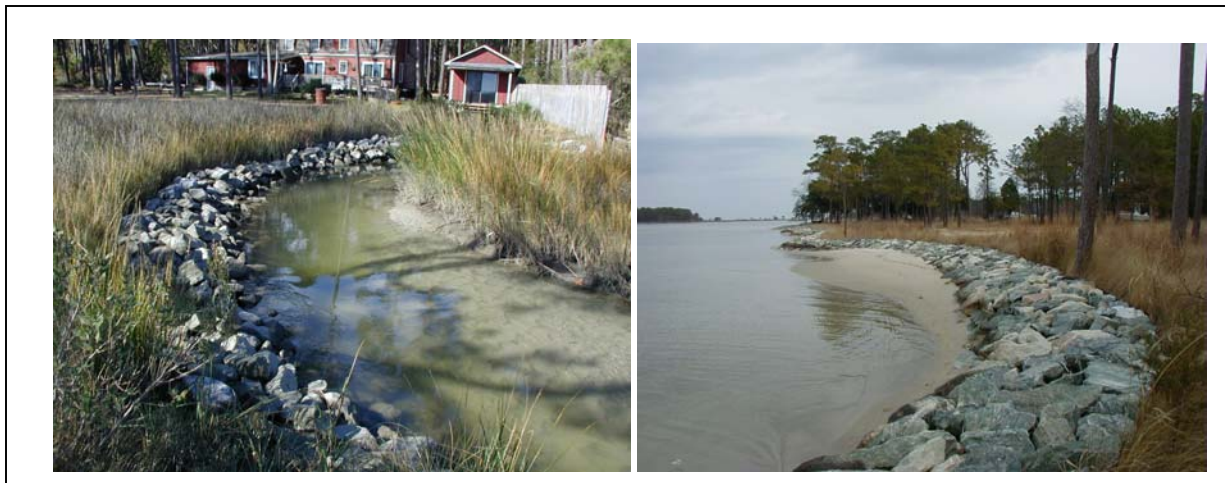
There were 2 cases where the marsh protection structure was considered unnecessary or inappropriate (Figure 5). If a particular shoreline erosion situation can be addressed with either no action or a non-structural solution, then a marsh revetment would be considered unnecessary. One project was considered to be unnecessary for erosion control purposes (MA03). In this case, there was no pre-existing marsh or upland erosion condition due to the protected, very low energy setting in a small tidal channel.

**Figure 5.** Unnecessary and inappropriate applications of marsh revetments are illustrated with these examples. The project on the left was located in a tidal channel and is excessive and unnecessary for erosion control (MA03). The project on the right was designed to perform like an upland revetment (LA07).

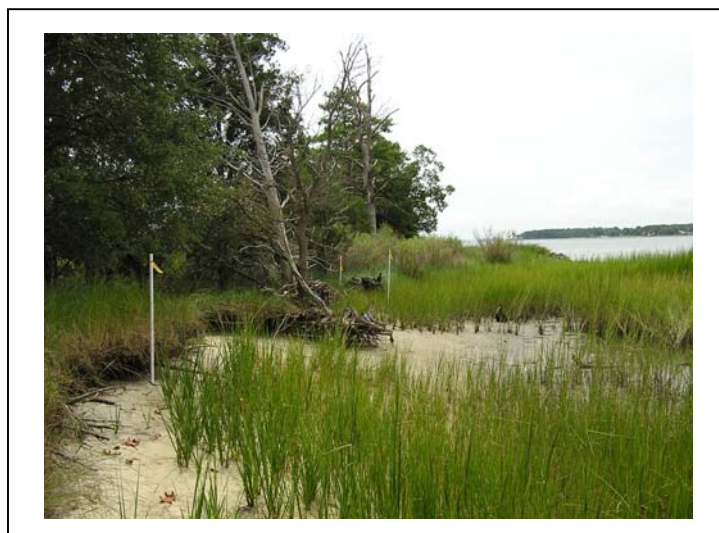
Most of the structures in this study were very effective for erosion control based on reported baseline conditions and the absence of erosion indicators after the structure was installed. Most of the project sites had low banks less than 5 feet high and upland erosion was not always present before installation. Continuing upland bank erosion was observed in 5 cases at medium or high energy settings and where the revetment crest height was less than +1 ft MHW, the marsh width was less than 15 feet, and/or the upland was low and floodprone on a regular basis (Figure 6).

**Figure 6.** Spots of upland bank erosion were observed where the crest height of the marsh toe protection structure was less than +1 ft MHW in a medium energy setting. The white stakes indicate a proposed upland revetment (MA05). Raising the crest height of the marsh toe protection structure was encouraged instead to preserve the natural connections between the upland and wetland habitats.

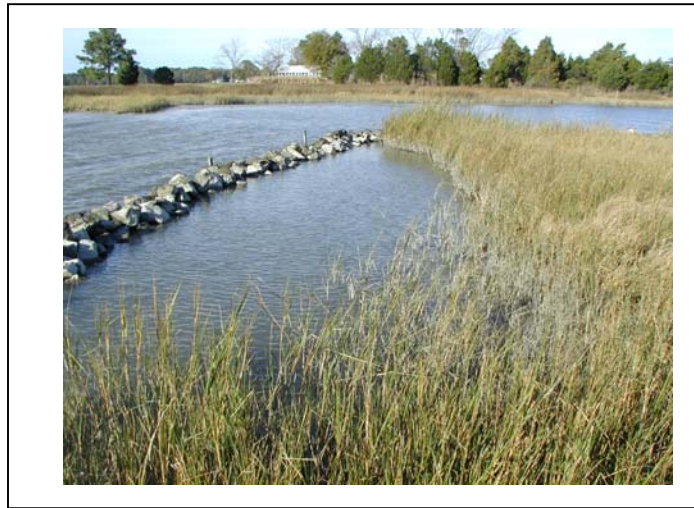
sites, particularly where the off-set distance of the revetment from the marsh edge was greater than 10 feet with open water between the revetment and the marsh edge (Figure 7).

**Figure 7.** Erosion of the marsh edge continued at one section of this project where the offset distance of the marsh sill was greater than 10 feet. There was no erosion observed where the same sill was closer to the marsh edge.

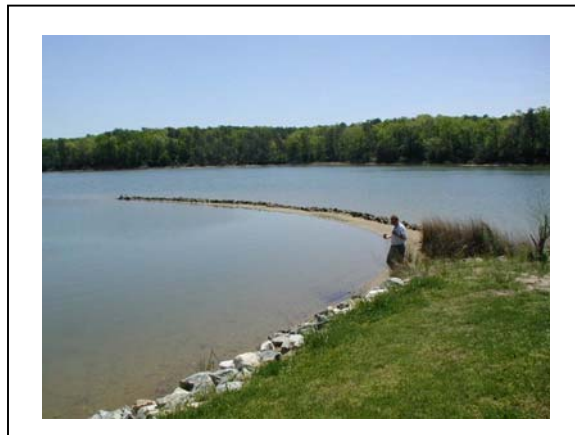
There was only one case of a marsh sill having no apparent effect on the gradual disappearance of a spit marsh (Figure 8). This phenomenon has been observed at other spit marshes and is probably due to the combined effect of gradual sea level rise and sediment supply interruption. Spit marshes depend on sediment supply and transport to maintain suitable elevations for marsh vegetation. “Drowning” spits have been observed and reported by property owners where the adjacent upland sediment supply has been reduced by erosion stabilization projects. The additional marsh revetment structure alone is not always sufficient to reverse this trend.

**Figure 8.** If upland revetments sever the landward end of a marsh spit, then marsh toe protection structures may not reverse the trend of “drowning” spit marshes. This is the only case where the revetment was not at all effective for erosion control (LA06).

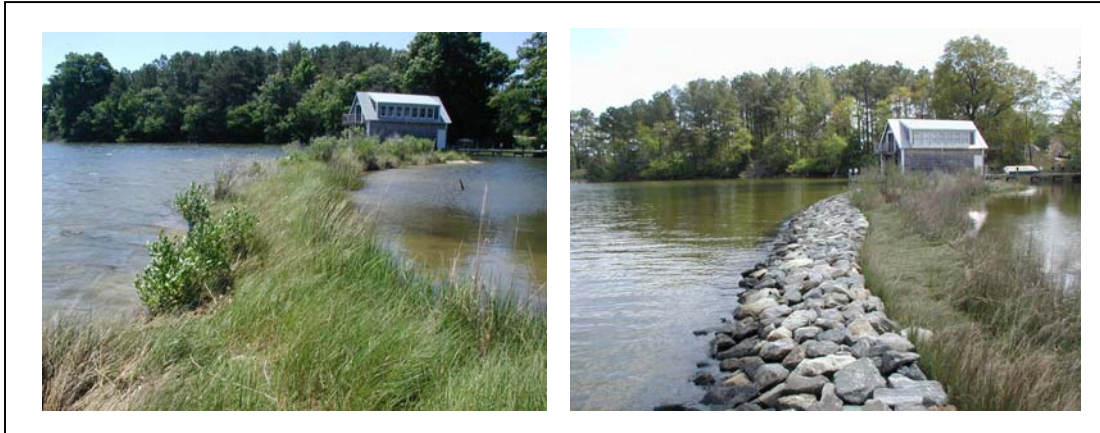
It is also possible that the marsh toe structures interrupt sediment transport along and to the end of the spit (Figure 9). Additional research is needed to evaluate spit marshes and how to preserve these features in the landscape, especially when they are surrounded by erosion stabilization projects and increased boat wake activity.

**Figure 9.** The placement of marsh toe protection structures along the entire length of marsh spits may adversely interrupt the sediment transport process that maintains suitable elevations for marsh vegetation. In this case, the revetment base width also seemed to be excessive (8 ft) compared to the width of the existing marsh (NU08).
