Shoreline Situation Report Westmoreland County

Lynne Morgan
Virginia Institute of Marine Science

Special Report In Applied Marine Science and Ocean Engineering Number 162 of the

VIRGINIA INSTITUTE OF MARINE SCIENCE
Gloucester Point, Virginia 23062

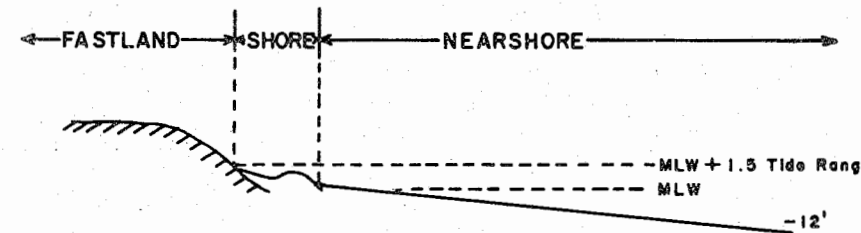
Figure 1

A profile of the three shorelands types.

The shorelands of the Chesapeake Bay System may be considered as being composed of three interacting physiographic elements: the fastlands, the shore and the nearshore. A graphic classification based on these three elements has been devised so that the types for each of the three elements portrayed side by side on a map may provide the opportunity to examine joint relationships among the elements. As an example, the application of the system permits the user to determine miles of high bluff shoreland interfacing with marsh in the shore zone.

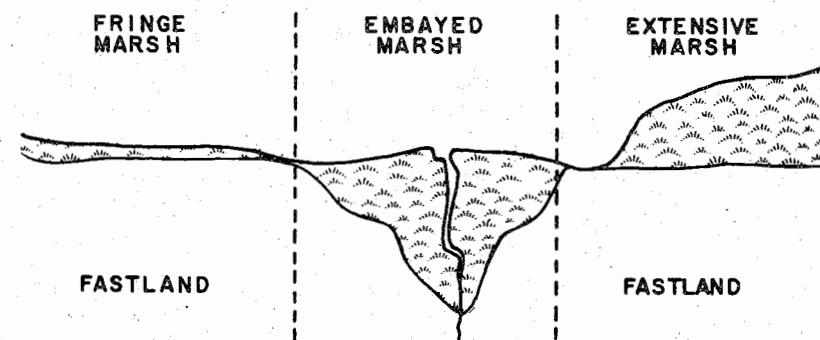
Figure 2

A plan view of the three marsh types.

The physiographic character of the marshes has also been separated into three types (see Figure 2). Fringe marsh is that which is less than 400 feet in width and which runs in a band parallel to the shore. Extensive marsh is that which has extensive acreage projecting into an estuary or river. An embayed marsh is a marsh which occupies a reentrant or drowned creek valley. The purpose in delineating these marsh types is that the effectiveness of the various functions of the marsh will, in part, be determined by type of exposure to the estuarine system. A fringe marsh may, for example, have maximum value as a buffer to wave erosion of the fastland. An extensive marsh, on the other hand, is likely a more efficient transporter of detritus and other food chain materials due to its greater drainage density than an embayed marsh. The central point is that planners, in the light of ongoing and future research, will desire to weight various functions of marshes and the physiographic delineation aids their decision making by denoting where the various types exist. The classification used is:

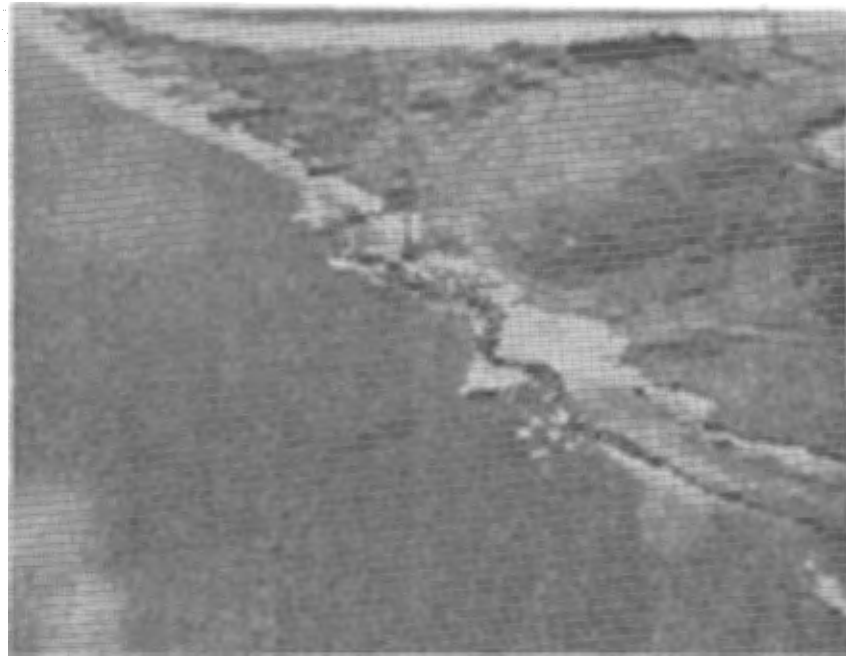
FIGURE 3

FIGURE 3: Lynch Point area, Segment 3. Notice the eroding shoreline. The entire area has been bulkheaded since the photograph was taken.

SHORE PROTECTIVE STRUCTURES: Most of the shoreline from Lynch Point to Sandy Point is artificially stabilized with bulkhead or riprap. Previous attempts to stabilize the Lynch Point area have failed and a considerable amount of erosion took place before the next structure could be installed. Groins have been used in conjunction with bulkhead along the Sandy Point area. Most of these structures have been successful in trapping sand and combatting erosion.

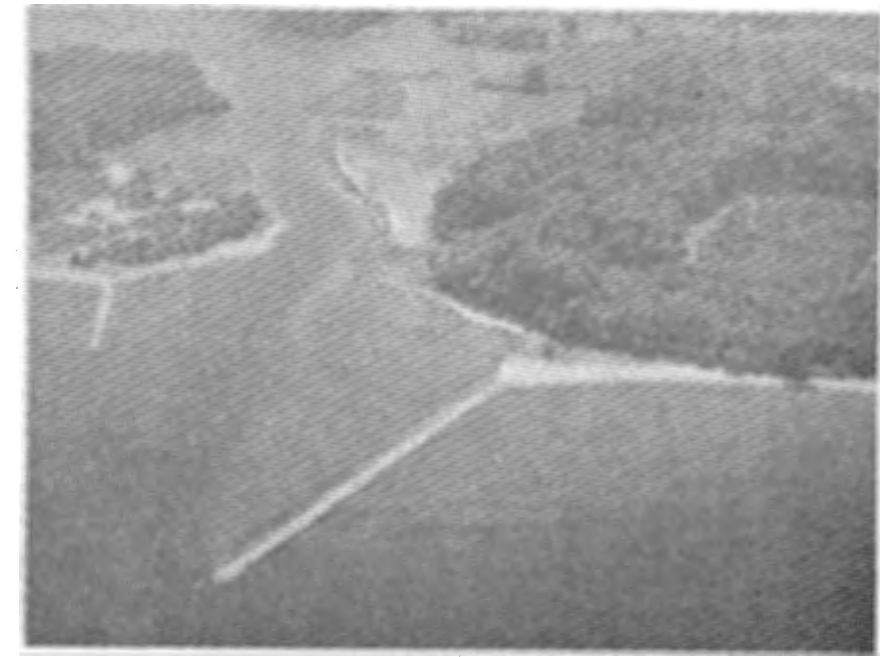
FIGURE 4

FIGURE 4: Bottom Creek overview, Segment 4. The rip-rap jetties at the creek mouth seem to be effective at keeping the creek entrance open. Notice the sand build-up at the landward end of the long jetty.

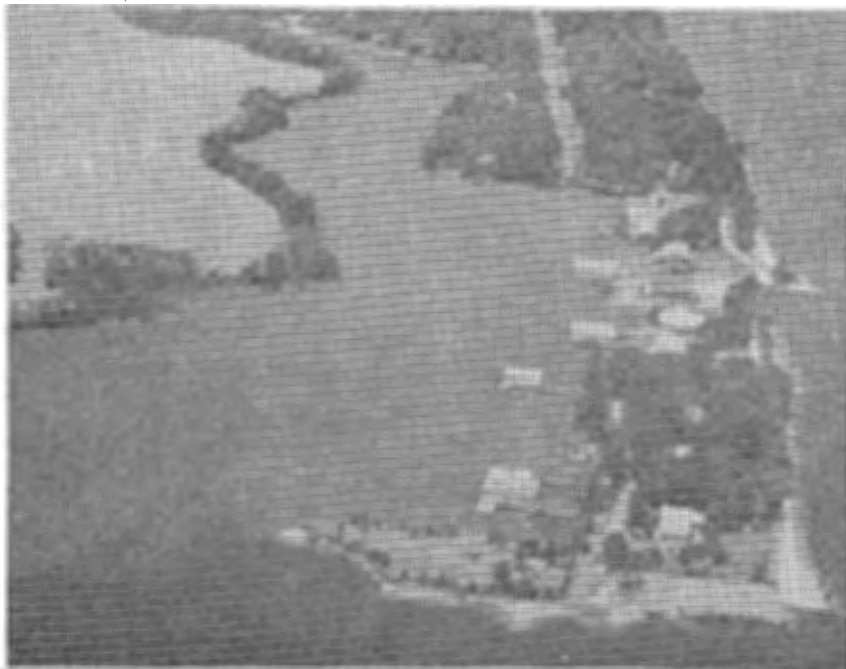
FIGURE 5

FIGURE 5: Mouth of Gardner Creek, Segment 4. The peninsula has average elevations of five feet. Abnormally high water could cause flooding here, damaging the structures. Notice the fillets of sand trapped by the groin system.

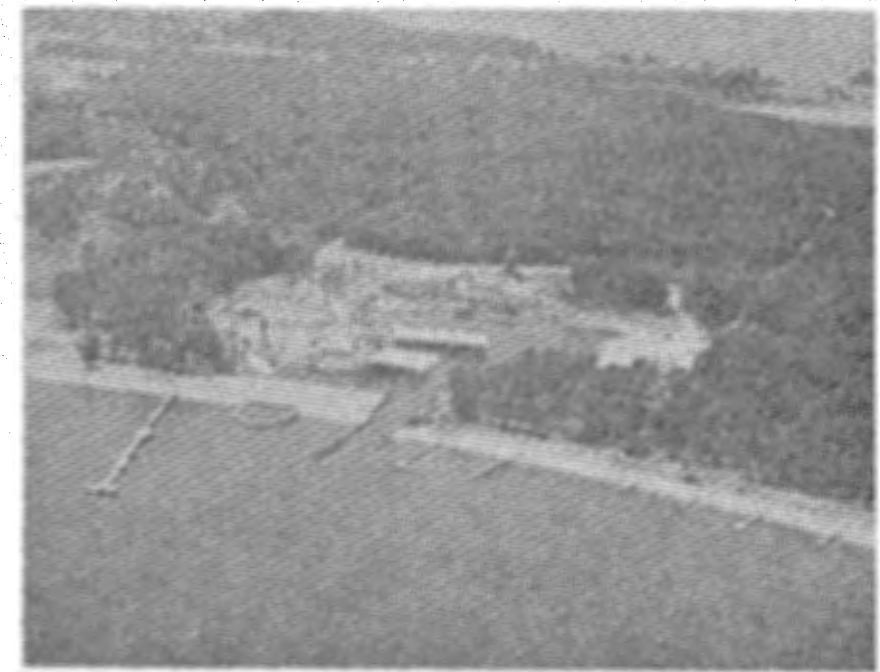
FIGURE 6

FIGURE 6: Marina at Ragged Point Beach, Segment 4. The dredged and bulkheaded opening to the marina is fairly recent. Notice the sand beaches along the shoreline.

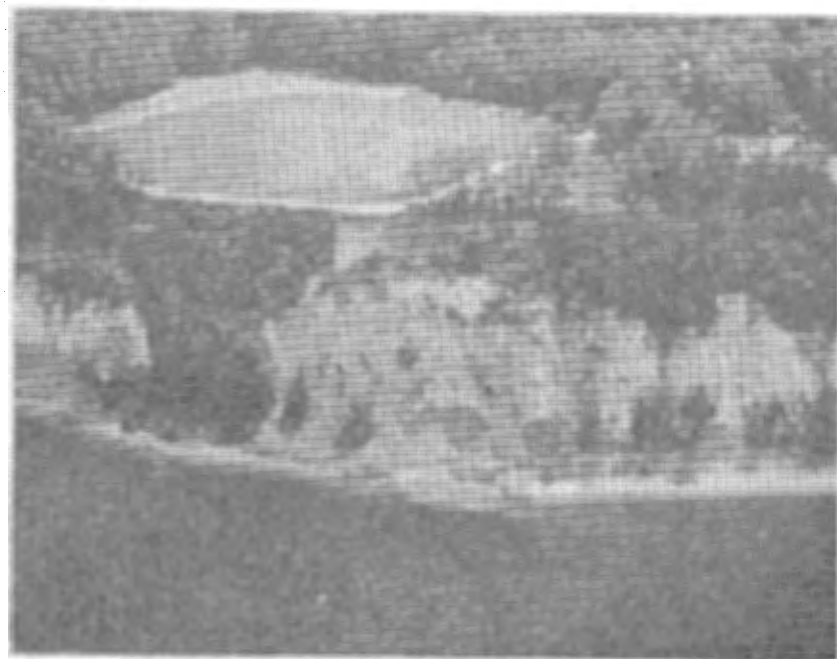
FIGURE 8

FIGURE 8: Horsehead Cliffs, Segment 9. The cliffs reach elevations up to 150 feet. Erosion due to downhill rain runoff is a problem in this area.

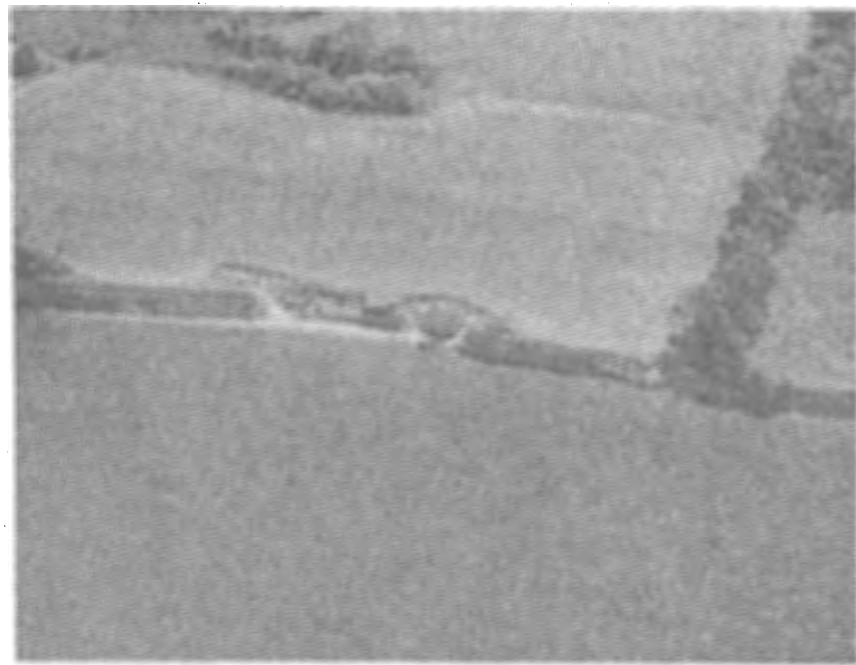
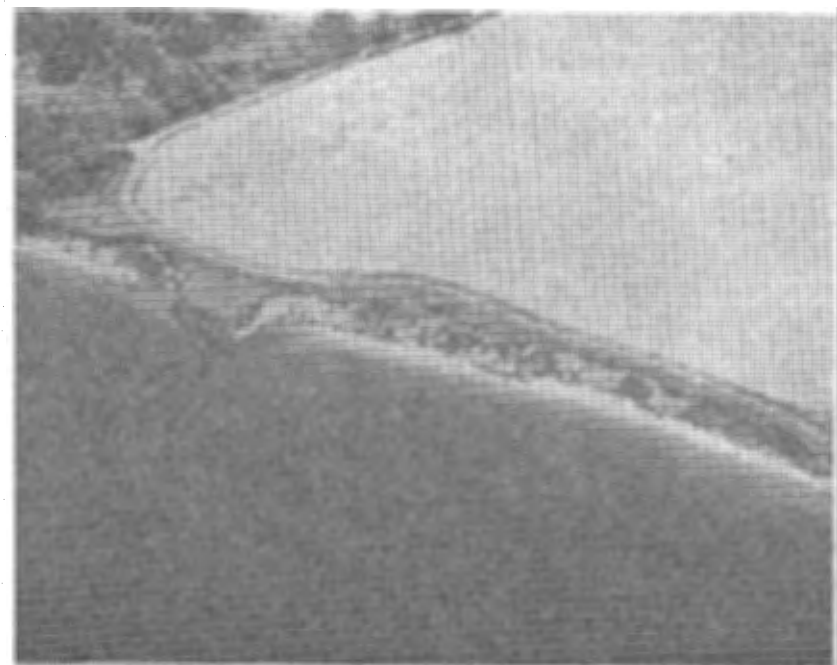
FIGURE 9

FIGURES 9 and 10: Near Church Point, Segment 10. These agricultural areas experience continuing erosion; however it would be a very costly proposition to try to stabilize them.

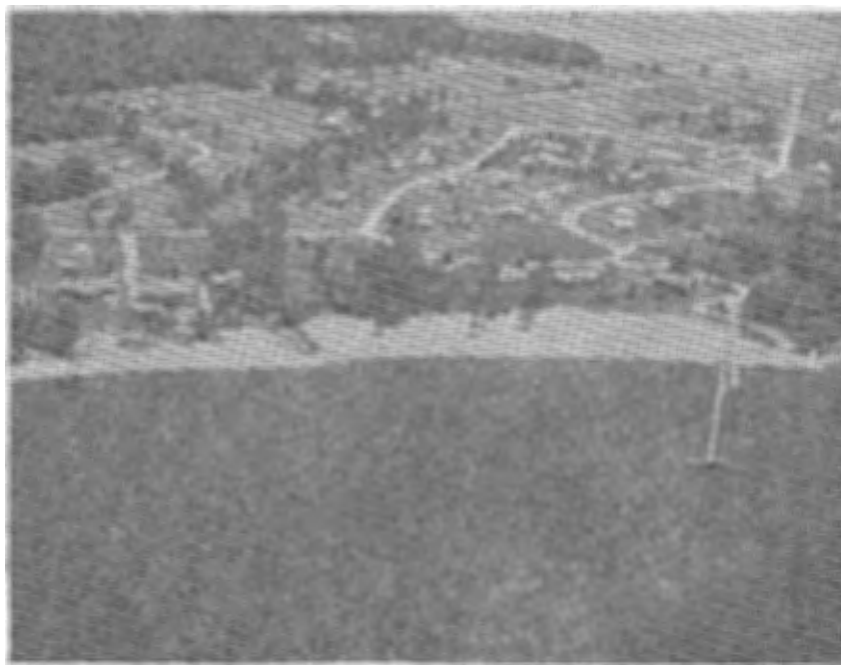
FIGURE 11

FIGURE 11: Along the south bank of Mattox Creek, Segment 11. This new housing development is not typical of most along Westmoreland's shoreline, as the development extends inland for several thousand feet instead of concentrating along the shoreline. Notice the wide sand beach.

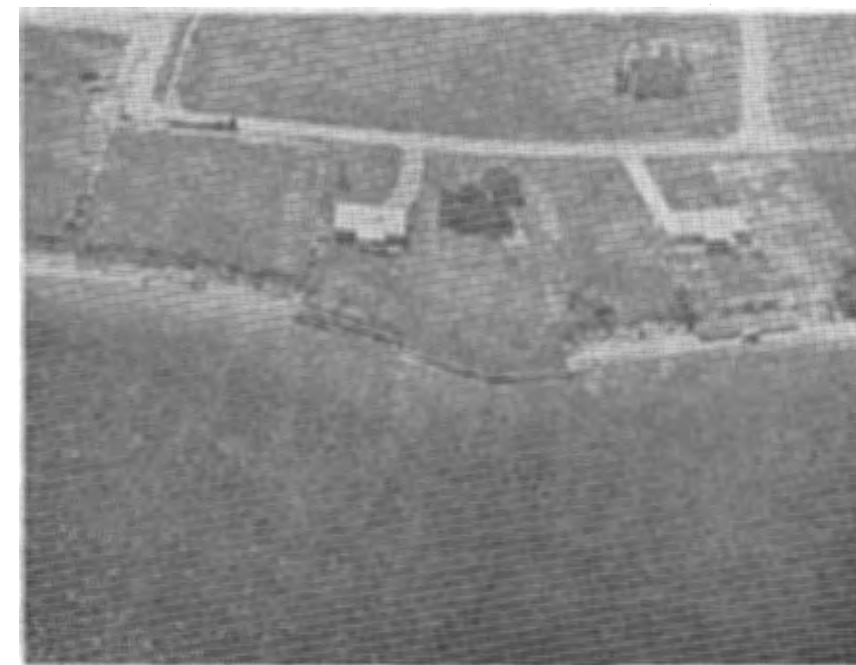
FIGURE 12

FIGURE 12: South of Monroe Bay, Segment 11. Erosion is very evident here, as stabilized areas protrude into the water.

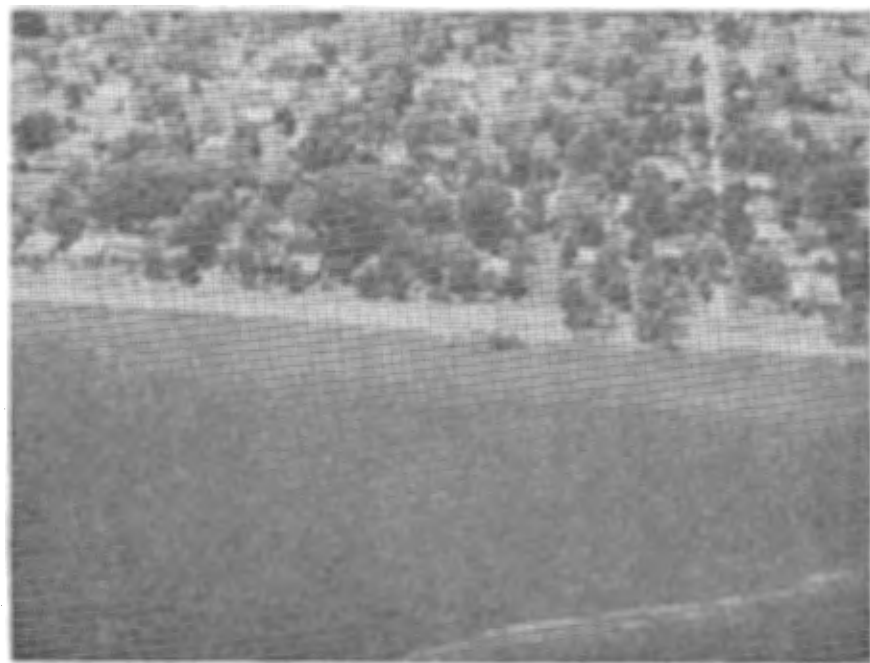
FIGURE 13

FIGURE 13: Colonial Beach, Segment 12. The shoreline is protected by concrete slabs acting as a seawall.

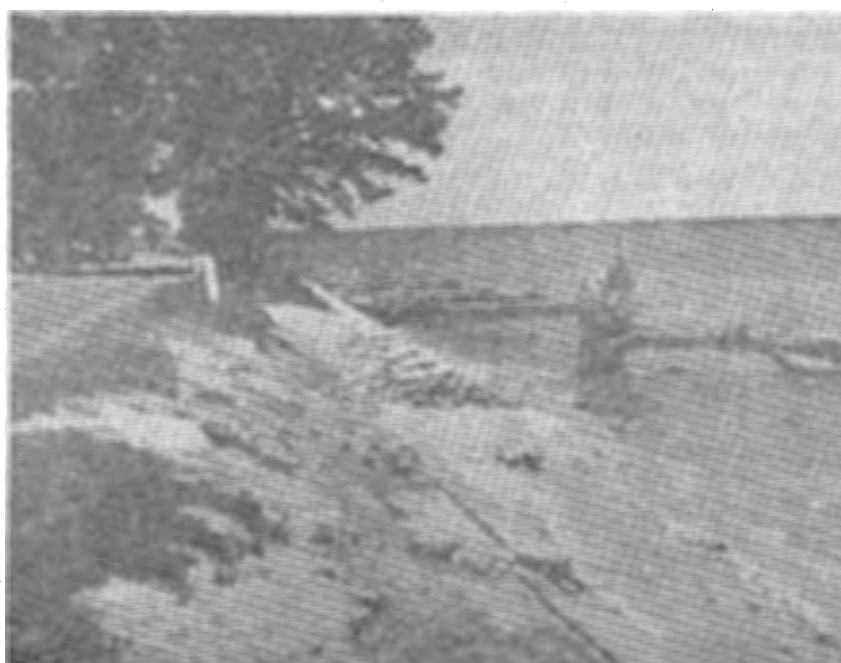
FIGURE 14

FIGURE 14: Colonial Beach, Segment 12, ground view. The bluff in the foreground is eroding due to downhill rain runoff. The groins are of concrete bags.

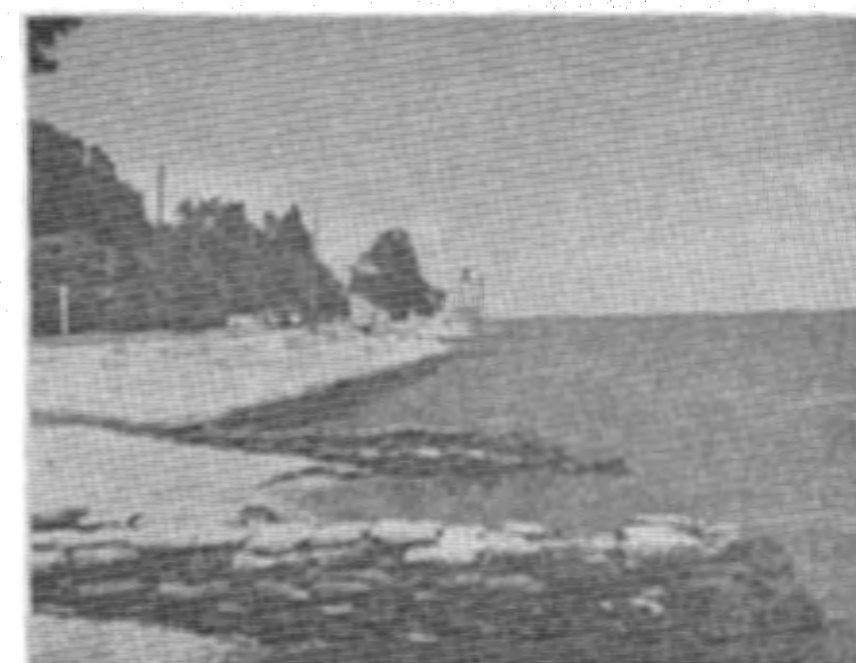
FIGURE 15

FIGURE 15: Colonial Beach, Segment 12, ground view. Closeup of concrete bag groins and concrete slab seawall.
