## Rehoboth Bay, Delaware Shoreline Inventory Report Methods and Guidelines

**Comprehensive Coastal Inventory Program  
Center for Coastal Resources Management  
Virginia Institute of Marine Science, College of William and Mary  
Gloucester Point, Virginia  
April, 2013**

Special report in Applied Marine Science and Ocean Engineering No. 435 of the Virginia Institute of Marine Science

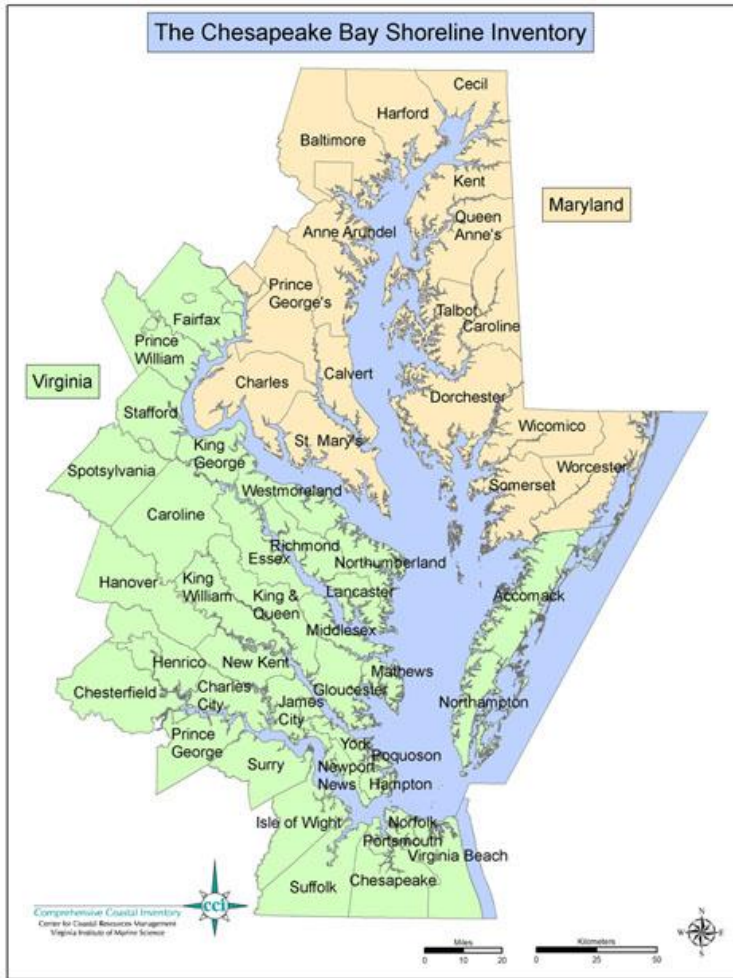
Figure 1a. Shoreline Inventory Website

[http://ccrm.vims.edu/gis\\_data\\_maps/shoreline\\_inventories/index.html](http://ccrm.vims.edu/gis_data_maps/shoreline_inventories/index.html) (Figure 1a.), by clicking first on the Delaware Bay insert (Figure 1b) and then Rehoboth Bay on the map or list of watersheds. The format for this inventory includes a map viewing tool rather than individual maps as in previous inventories. The map viewer allows users to interact with the datasets within a familiar “google” type map service that was developed in a Flex/Flash framework. Here they can view data of their choice and customize map products for printing themselves. Access to the GIS data, summary tables and methods report is also available through this website.

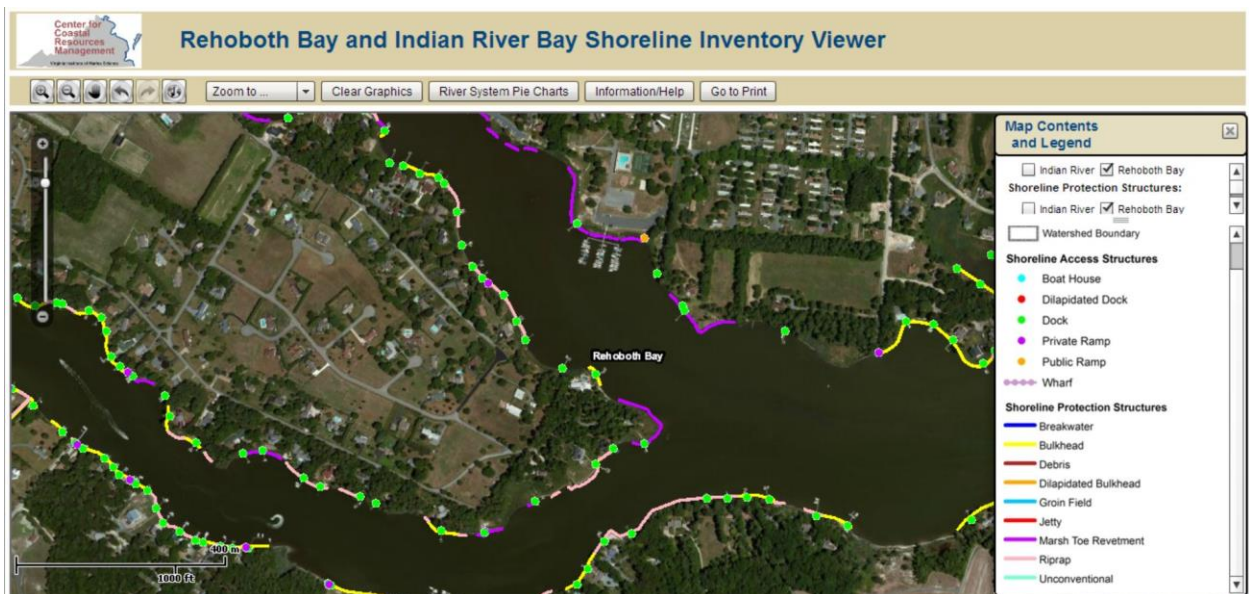
Figure 5. Map Viewer illustrates Shoreline Access and Shoreline Protection Structures.

In Figure 5 Shoreline Access Structures, and Shoreline Protection structures have been selected along with the boundary. Shoreline Access structures are point features that includes

piers and boat ramps. The actual footprint of these structures is not measured; only their location. Shoreline Protection Structures are line features and are mapped and illustrated in the viewer to show where they occur along the shoreline. Figure 6 illustrates riparian land use.
