## Shoreline Situation Report Essex County, Virginia

# Shoreline Situation Report ESSEX COUNTY, VIRGINIA

Special Report In Applied Marine Science and Oceanic Engineering Number 135 of the

VIRGINIA INSTITUTE OF MARINE SCIENCE  
Gloucester Point, Virginia 23062

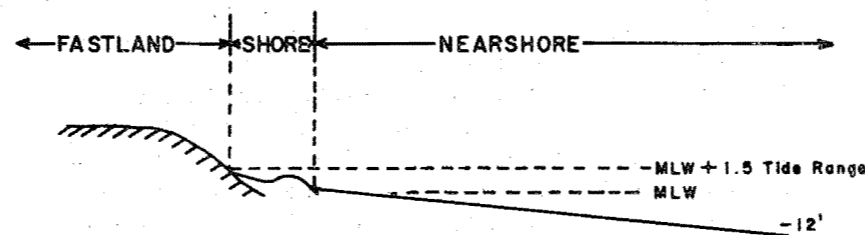
Figure 1

A profile of the three shorelands types.

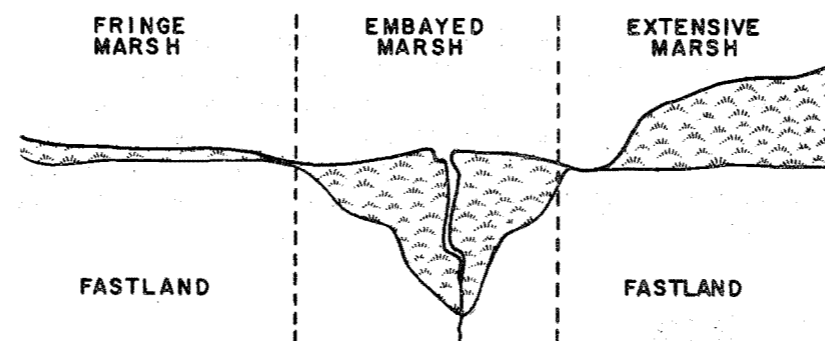
Figure 2

A plan view of the three marsh types.

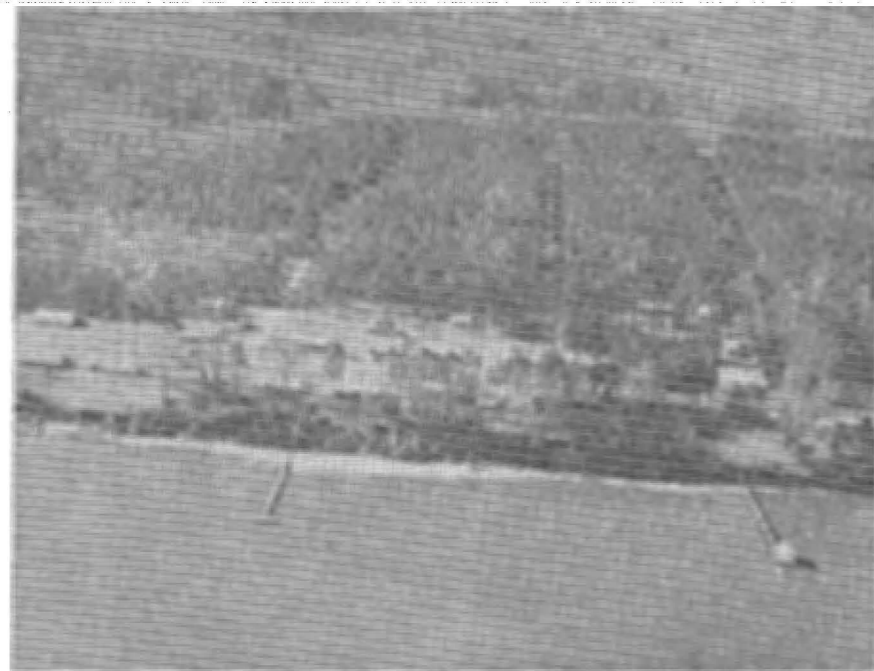
FIGURE 4

FIGURE 4: View of Mark Haven Beach, Subsegment 1A. Like much of the county's shorelands, a thin strip of land adjacent to the shore has been developed for residential use while the remaining lands are undeveloped. Notice the erosion of the bluffs in this section.

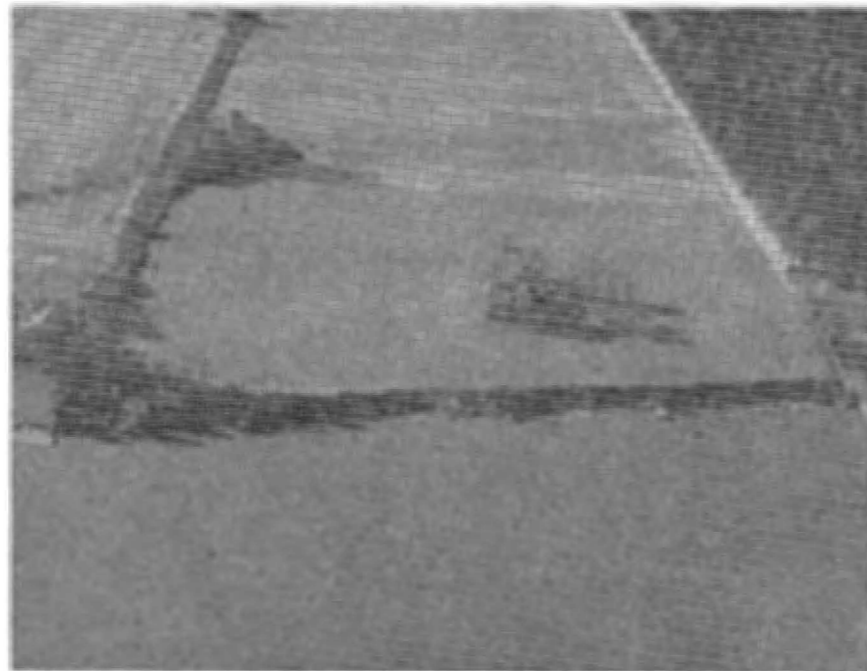
FIGURE 6

FIGURE 6: View between Browns Point and Wares Wharf, Subsegment 1B. Erosion of the bluffs in this area, besides causing the loss of valuable farmlands, is also a cause of non-point source pollution to the Rappahannock River. Rain runoff carries a variety of fertilizers and pesticides into the river. In order to reduce erosion of such farmlands, a "green zone" (an area that is planted in grasses, bordering the shoreline) should be established. Along the Essex County shoreline, a green zone fifty feet wide should be sufficient.

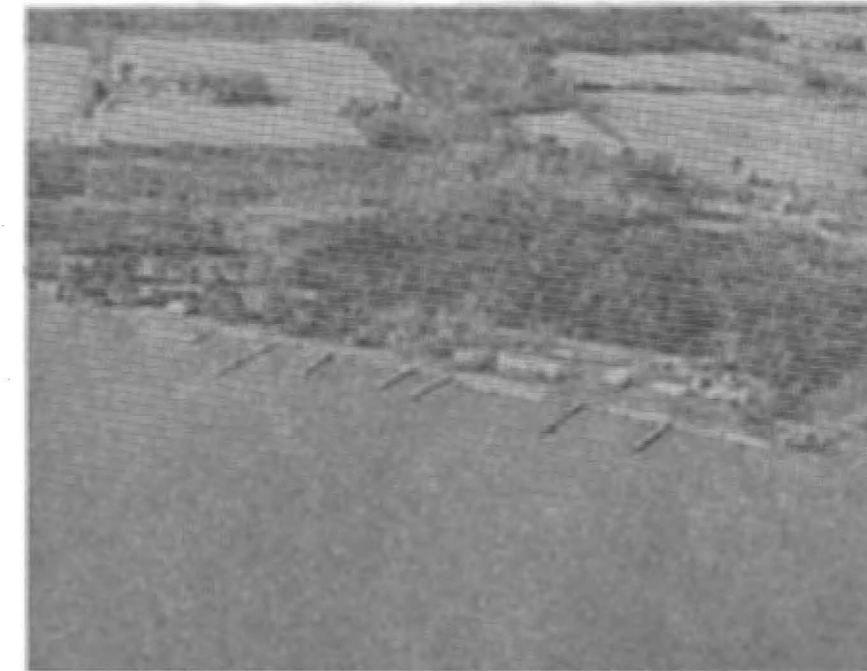
FIGURE 7

FIGURE 7: South of Lowery Point, Subsegment 1B. The numerous groins have not been successful in creating beaches in front of the bulkhead in this area.

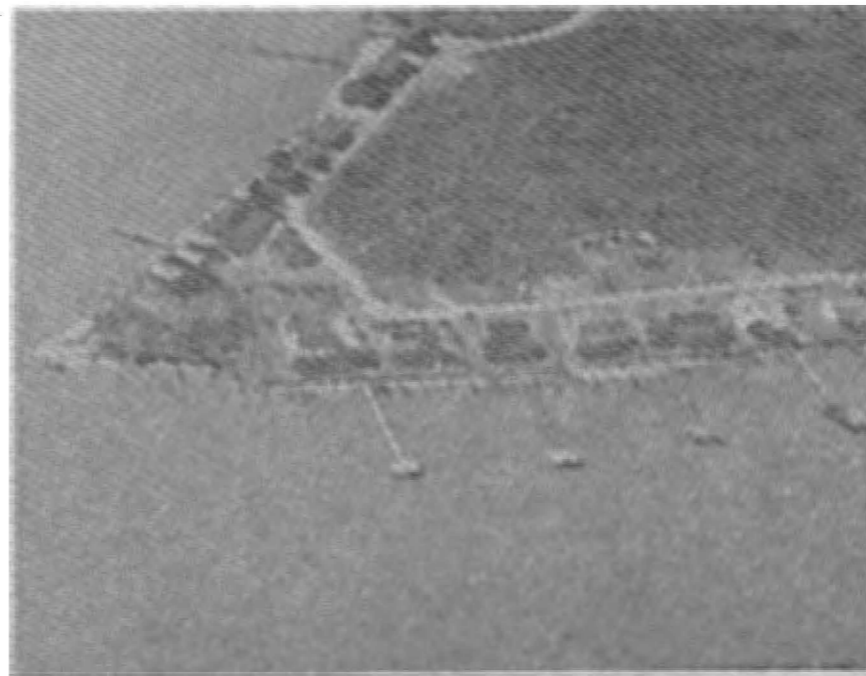
FIGURE 8

FIGURE 8: Lowery Point, Subsegment 1C. These residences were built on artificial fill dumped on the marsh. The groins of cement bags have not been effective in building up a buffer beach in front of the bulkhead.

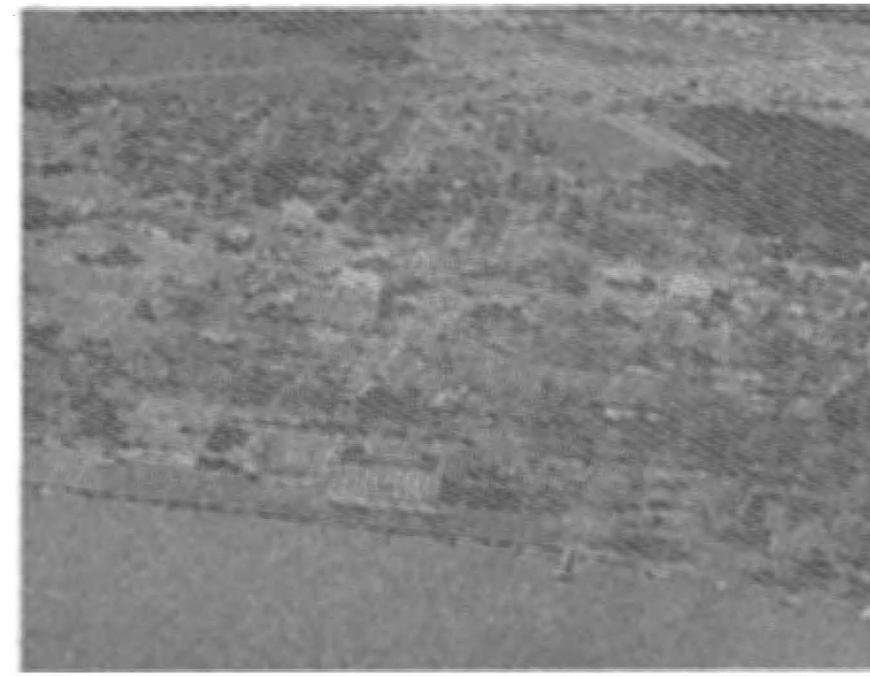
FIGURE 9

FIGURE 9: Tappahannock, Subsegment 4A. Tappahannock is the only town located along the shorelands in Essex County. The entire shoreline has been artificially stabilized in this area. Again, the groins have not been effective in trapping a buffer beach.

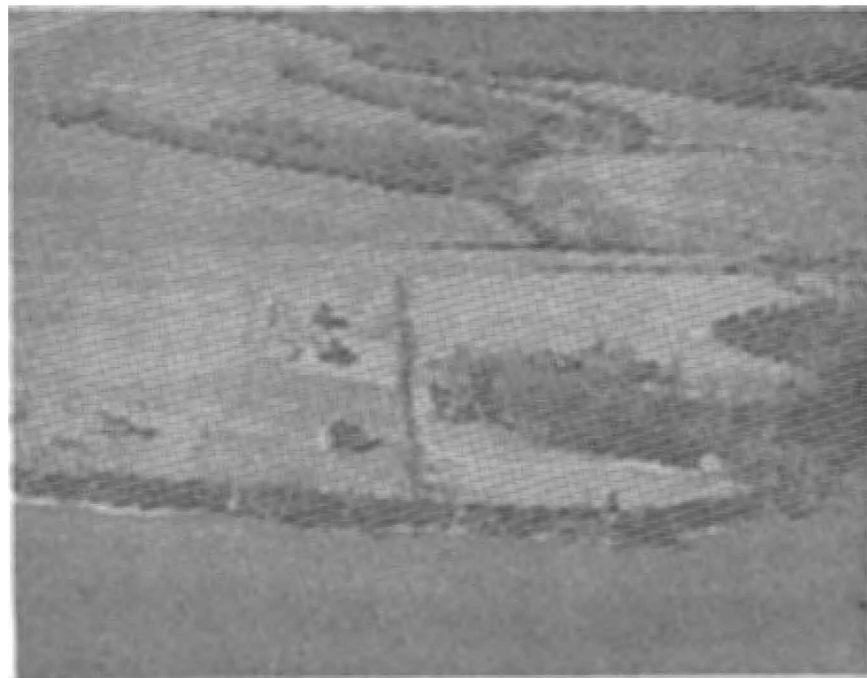
FIGURE 10

FIGURE 10: East of Mount Landing Creek, Subsegment 4A. Erosion is a problem for the shoreline in this area. As can be seen from the photo, a small housing development is being constructed in this section.

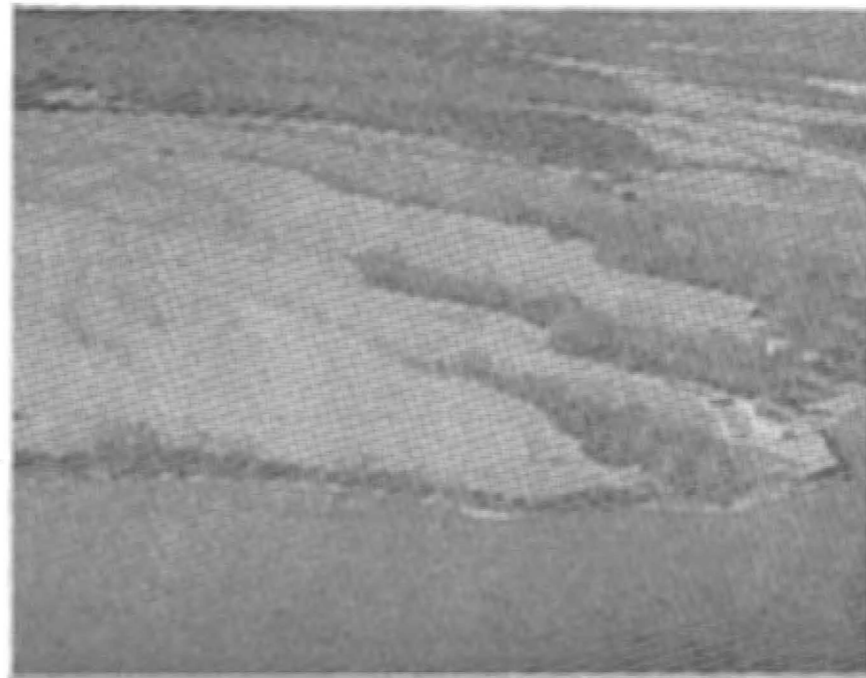
FIGURE 11

It was observed that several agricultural areas have been plowed perpendicularly to the shoreline (see Figure 11). Such plowing encourages rain runoff erosion and is a prime contributor to non-point source pollution. The sediments suspended in the rain runoff contain large amounts of fertilizers and pesticides which contribute to seasonal water quality problems. Most runoff erosion and the ensuing pollution from agricultural areas could be eliminated by; 1) plowing parallel to the shoreline, and 2) leaving a "green zone" along the shoreline (A "green zone" is a buffer area planted with grasses between the field and the shore. In Essex County, a buffer of fifty feet should be sufficient). Proper use of the shorelands would do much to control runoff erosion of the agricultural lands and the pollution of the river. The other two types of erosion are dependent upon the location of the area, the type of nearshore zone, and many other variables.

FIGURE 11: Daingerfield Landing, Subsegment 6A. The agricultural fields have been plowed perpendicular to the shoreline, which encourages rain runoff erosion. Plowing should be parallel to the shore with a fifty foot buffer zone along the shoreline.
