Shoreline Situation Report Accomack County, Virginia

Shoreline Situation Report ACCOMACK COUNTY, VIRGINIA

Special Report In Applied Marine Science and Ocean Engineering Number 80 of the

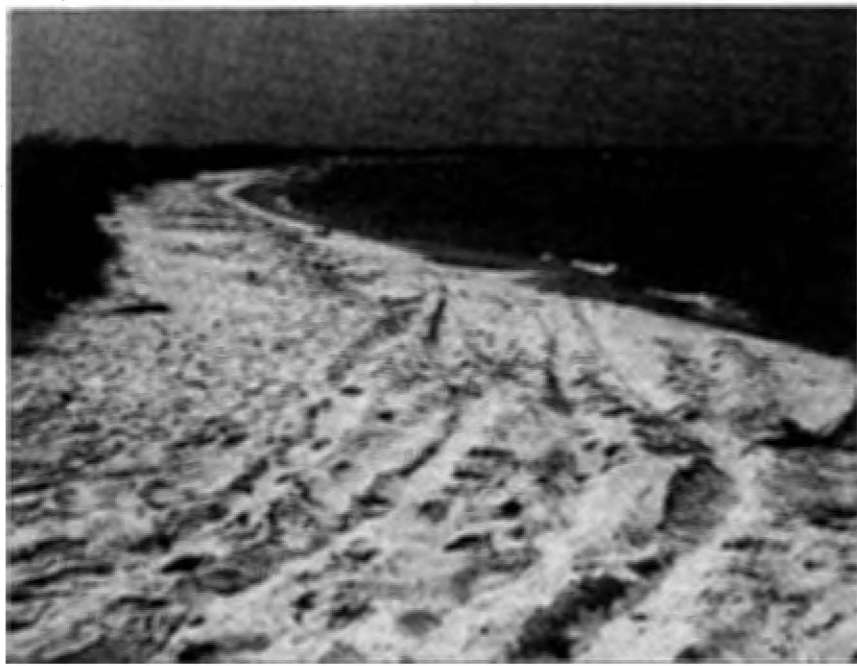
Figure 3

Figure 3: Mason Beach on Hack Neck. One of Accomack County's few open beaches on Chesapeake Bay.

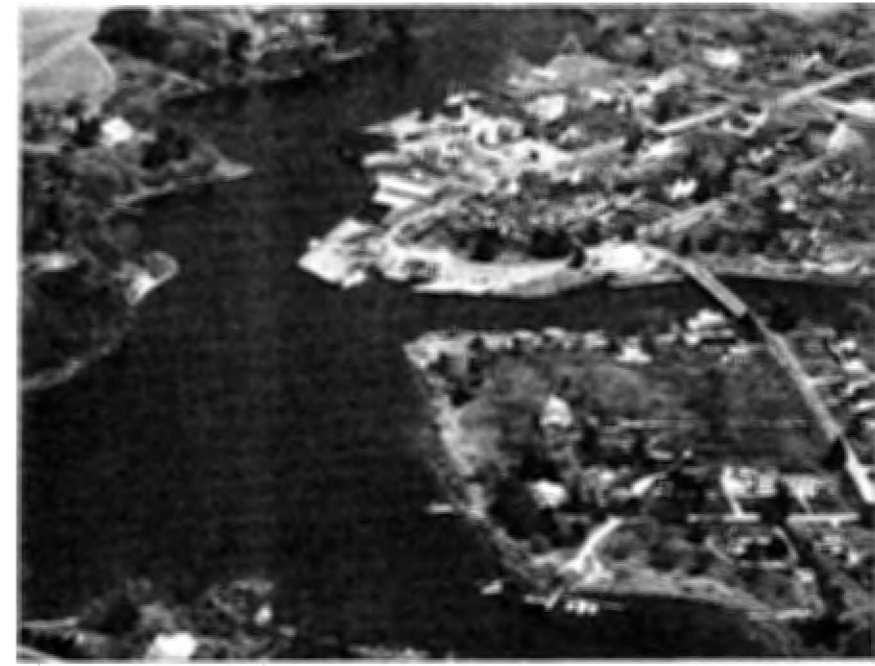
Figure 5

Figure 5: Onancock Creek and the town of Onancock (Segment 7). Natural tidal streams, such as Onancock Creek, have the greatest use and greatest use potential of the county's lands near the Bay. The area is far enough from the Bay to be relatively free of storm damage, yet it offers good access to the water.

Figure 9: The Deep Creek area (Segment 9) is a developed area on a tidal stream similar to that shown in Figure 5.

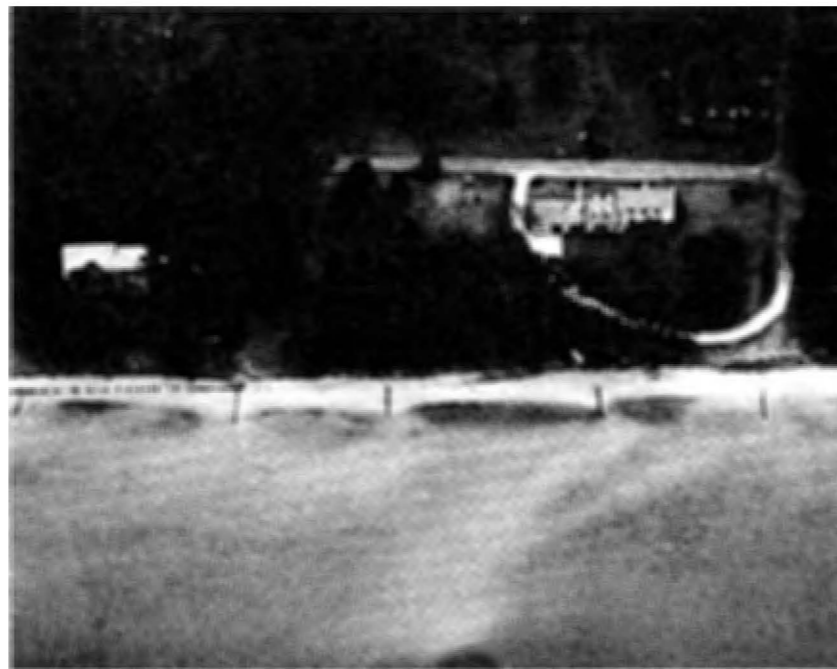
Figure 6

Figure 6: East Point on Onancock Creek. Although the groins shown in the aerial photograph appear to be trapping some sand, their offset from the shore indicates that they have not been totally effective in stopping erosion.

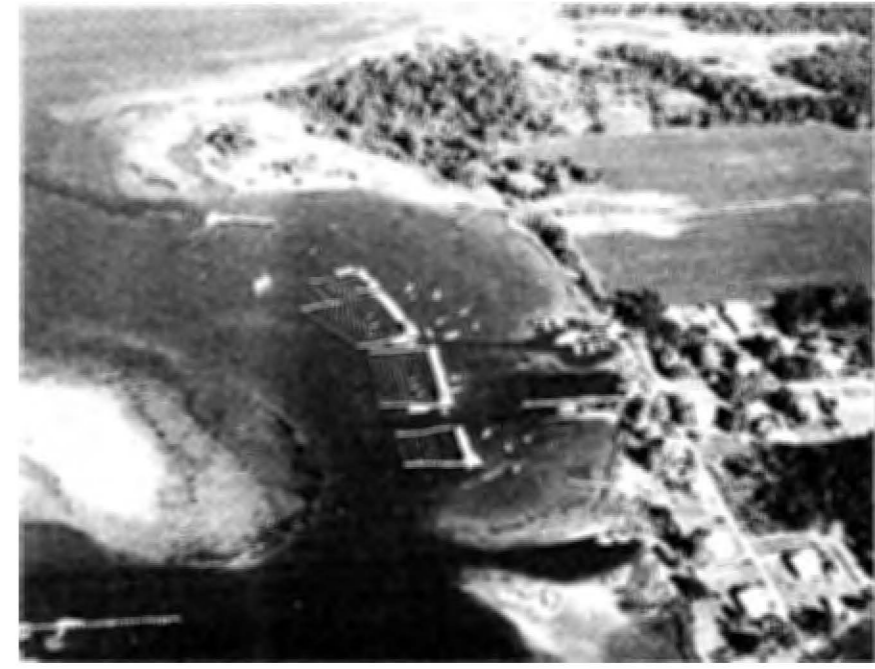
Figure 7

Figure 7: An aerial photograph of a commercially used portion of Chesconessex Creek.

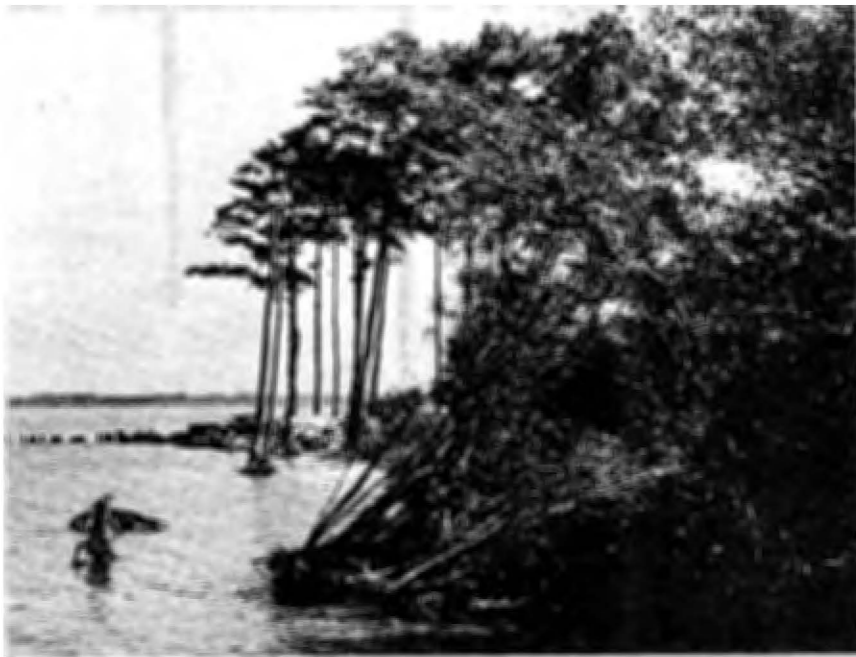
Figure 11

Figure 11: East of Flag Point Landing (Subsegment 11B), one of the few areas of severe erosion on the western shore of the county. Carefully planned and coordinated shore protection efforts would be more successful and pleasing than the hastily constructed stopgap measures often employed in the area.

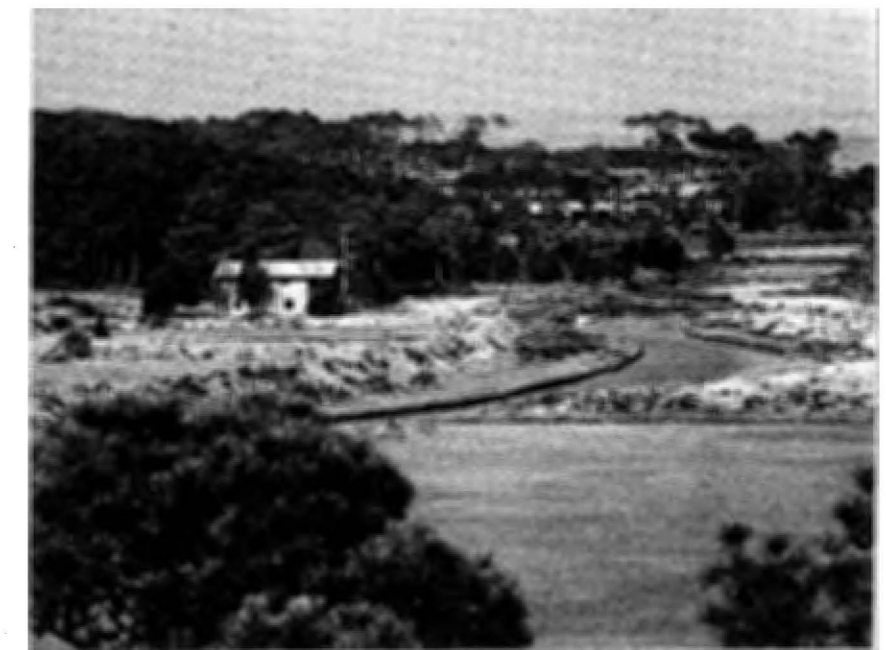
Figure 12

Figure 12: The dredged canals and spoil area of the Fox Grove area (Segment 16).

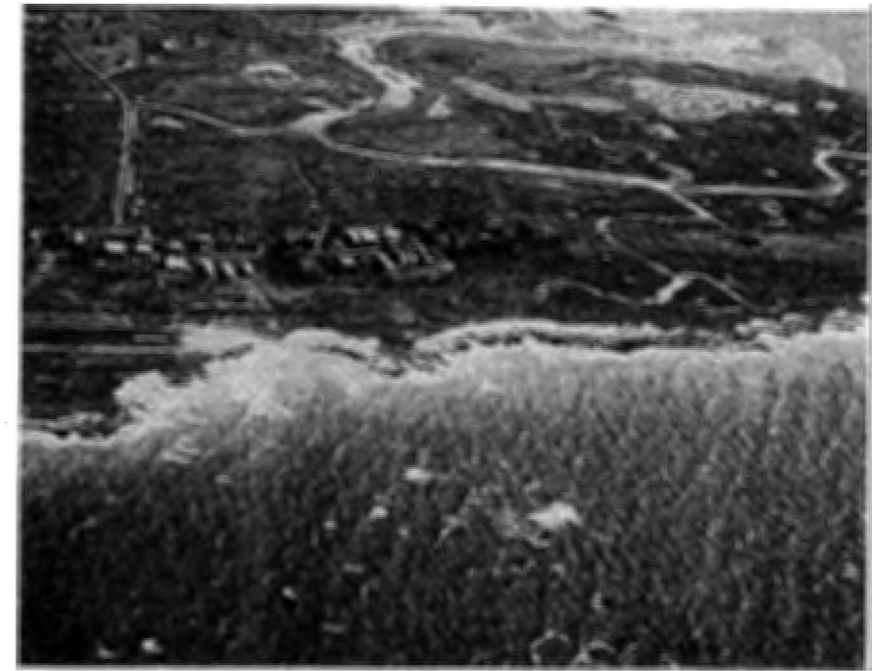
Figure 14

Figure 14: The western face of Tangier Island has a very severe erosion problem. Average long term erosion rates are over 15 feet per year. Since this photograph was taken in December, 1972, the shoreline has retreated to the runway pavement.

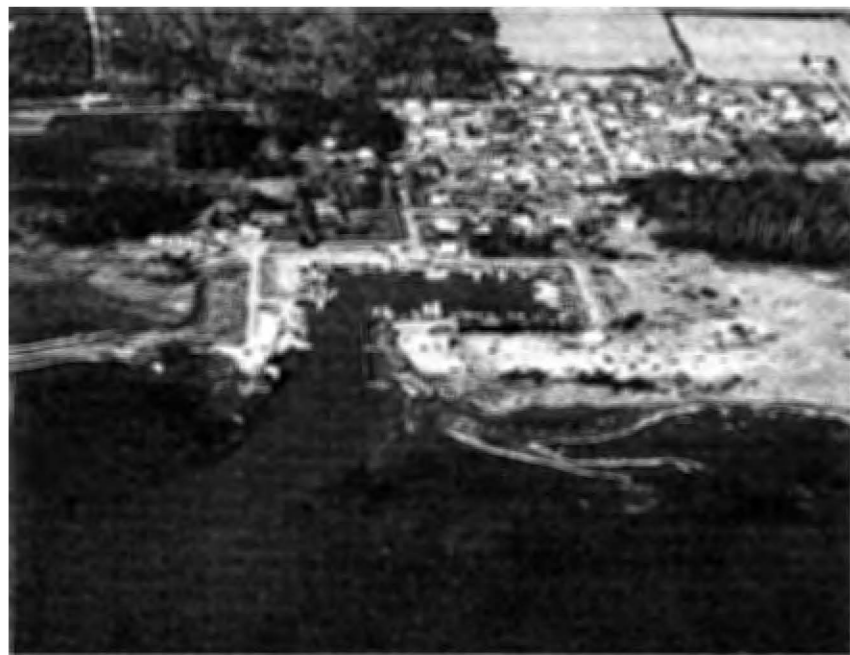
Figure 15

Figure 15: The dredged harbor at Quinby in the southeastern portion of the county. The ocean-side interior shoreline of Accomack County has a very high development potential with its several good harbors and easy access to the ocean.

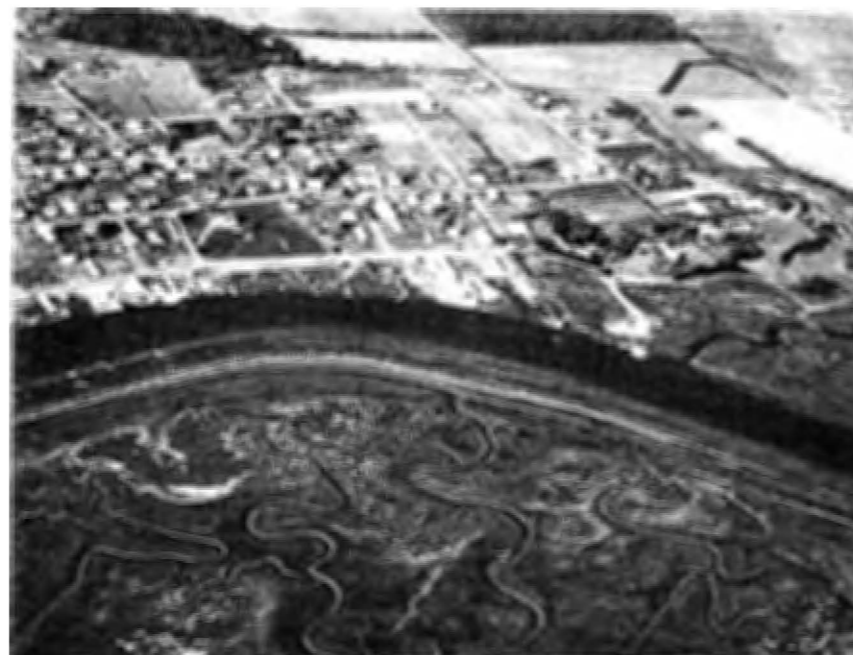
Figure 16

Figure 16: The northern part of the town of Wachapreague and the wide, deep channel which provides ready access along the shore and to the ocean.

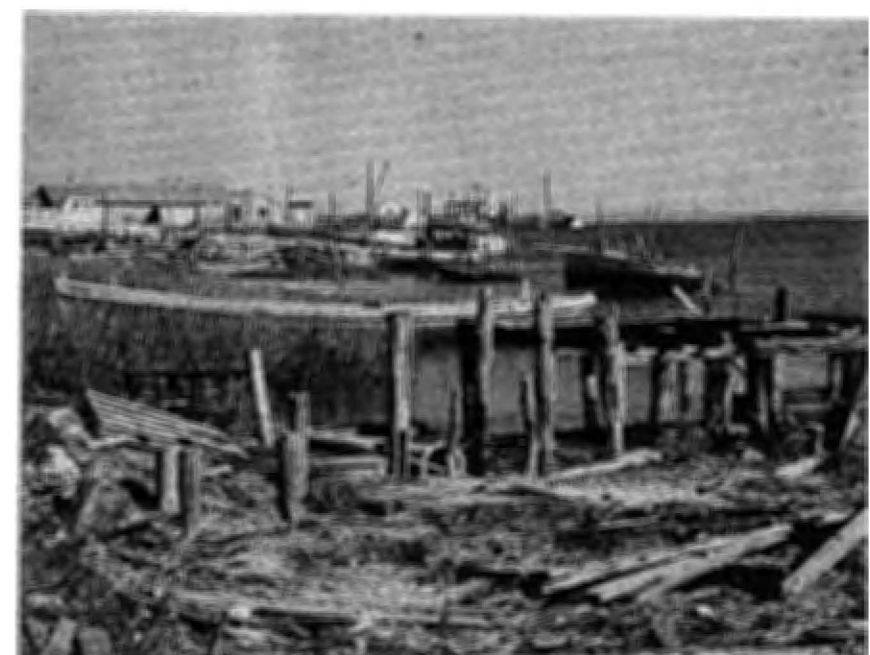
Figure 17

Figure 17: The Wachapreague waterfront.

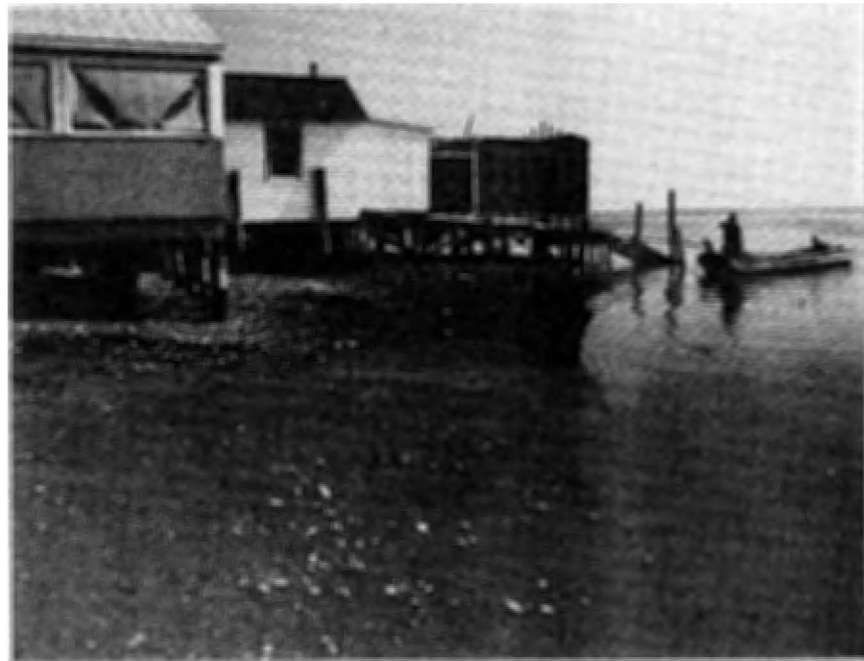
Figure 18

Figure 18: The low tide waterfront at the end of Route 766 at Watts Bay (Segment 17).

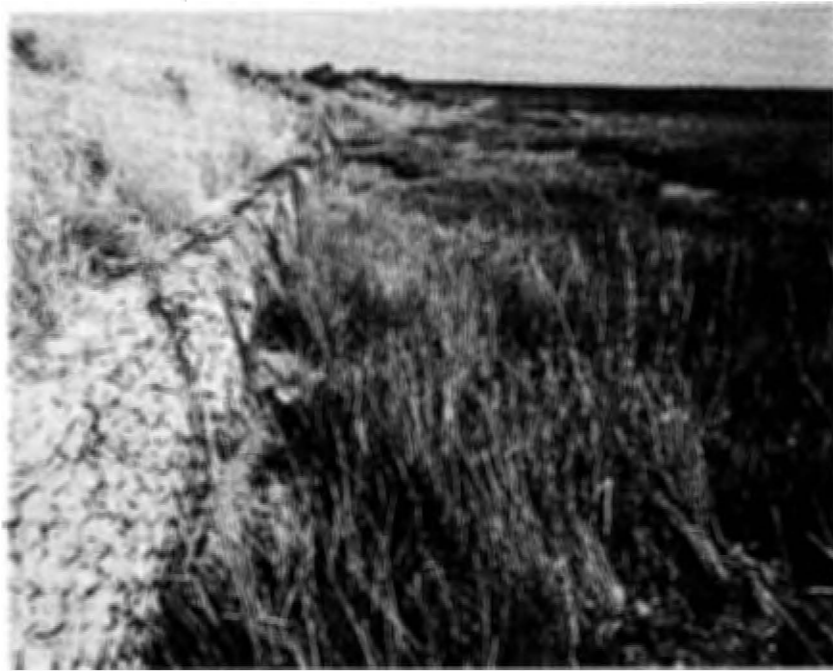
Figure 19

Figure 19: A gabion bulkhead behind the marsh in the Captains Cove area of Segment 18. The type and location of the structure is frequently recommended because of its low cost and relative lack of environmental degradation.

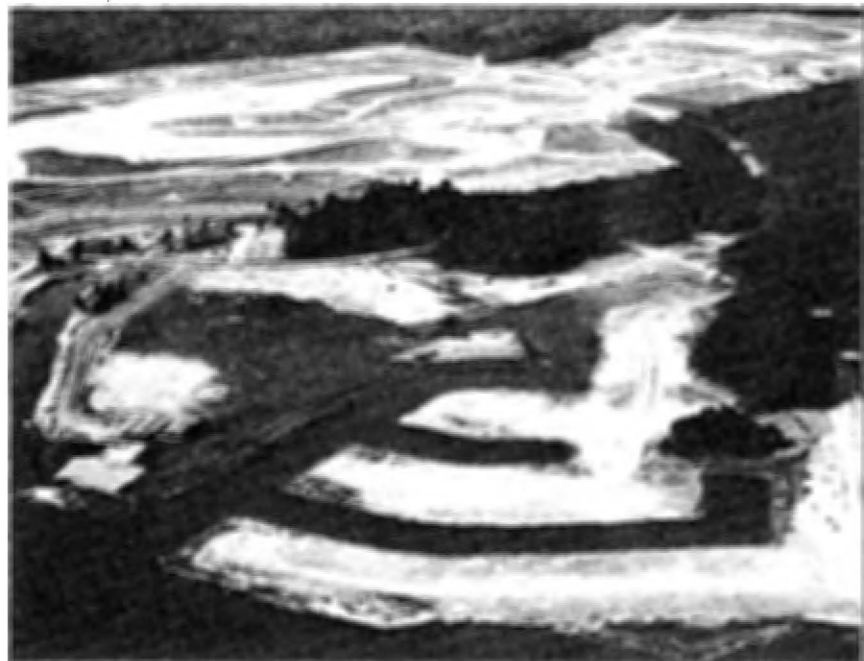
Figure 20

Figure 20: A dredged canal and filled marsh area in northern Accomack County. The development has been forced to modify its original designs in order to decrease and rectify environmental damage. The lack of good circulation in the canals can result in significant water quality problems.

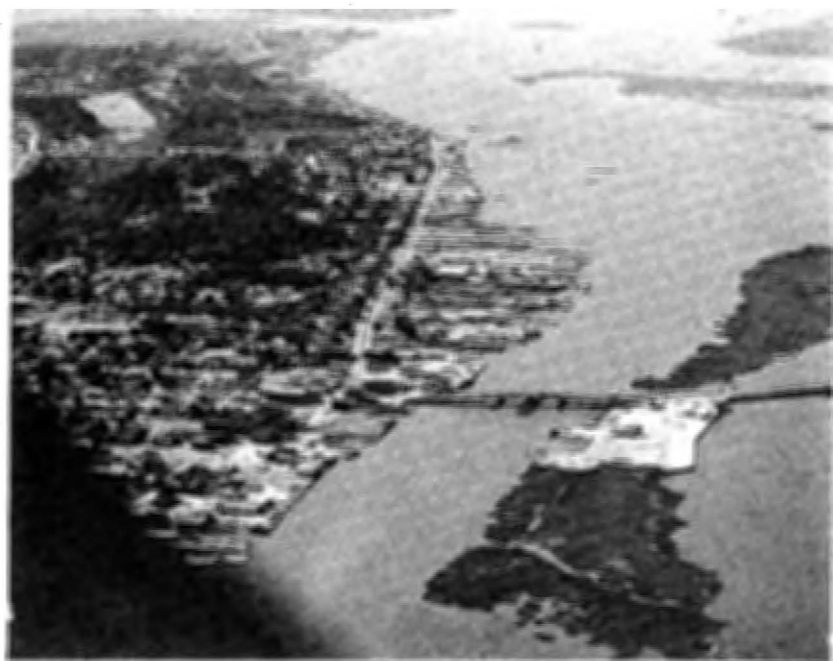
Figure 21

Figure 21: An aerial view of Chincoteague, one of Virginia's more widely known vacation areas. Its easy access to deep water and proximity to ocean beaches make it a popular summer haven.
