Stafford County Shoreline Management Plan

Virginia Institute of Marine Science
College of William & Mary
Gloucester Point, Virginia

November 2015

**Prepared for
Stafford County and
Virginia Coastal Zone Management Program**

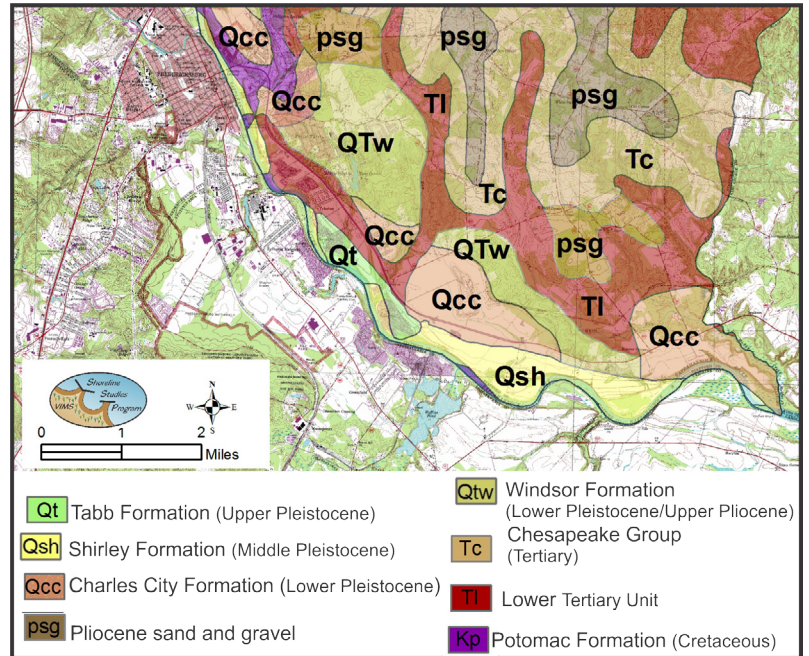
Figure 2-1. Geology of Stafford County along the Rappahannock River (Mixon et al., 1989).

Stafford County lies in the coastal plain of Virginia. Like many coastal localities, the County boundaries are defined by creeks, rivers and watershed. The Rappahannock River bounds the south side of the County, and the Potomac River much of the east side (Figure 1-1). The Rappahannock River is tidal up to Fredericksburg and occurs as a meandering river set within the ancient watershed where the river banks are composed of sediments from the Lower to Middle Pleistocene in age (Figure 2-1). On the Potomac River and laterally connected tidal creeks, the shoreline banks are mostly Middle to Upper Pleistocene except for the south banks along Aquia Creek that have older strata of the Potomac Formation (Upper Cretaceous) and Lower Tertiary deposits (Oligocene) (Figure 2-2).

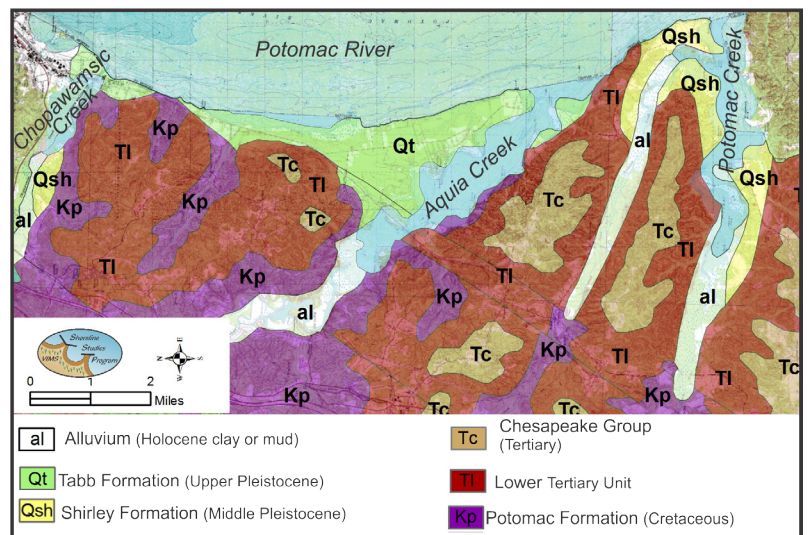
Figure 2-2. Geology of Stafford County along the Potomac River (Mixon et al., 1989).

a few residential properties exist. Some sections of shore are low, but most of the shoreline is high eroding bank. This section has very hard material outcropping along the shoreline (Figure 2-2) which breaks off into rocks that stay along the shoreline until they erode and provide some shore protection (Figure 2-18). The Quantico Marine Corps Base was the subject of a site-specific shoreline management plan (Shoreline Studies Program, 2011) and will not be discussed here.

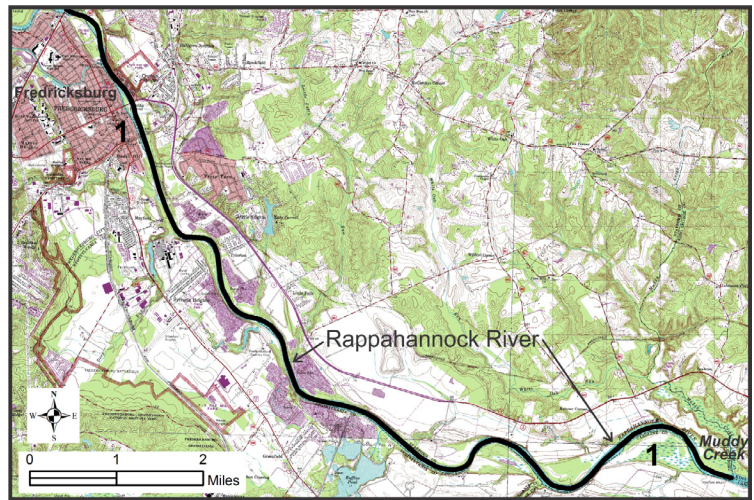
Figure 2-3. Topographic sheet of the Rappahannock River in Stafford County. Also shown is the Reach 1 designation.

Present-day coastal morphology/landscape is a function of the underlying geologic history. All of Stafford's Potomac River shoreline is tidal while two-thirds of the Rappahannock River is tidal. The County coast can be classified into reaches that are shown on Figure 2-3 and Figure 2-4: Rappahannock River (Reach 1), Potomac Creek (Reach 2), open Potomac River (Reach 3 and 5), and Aquia Creek (Reach 4).

Reach 1 along the Rappahannock River has tidal shoreline that extends from Fredericksburg downriver to Muddy Creek (Figure 2-3). The river is navigable up to Fredericksburg with a narrow channel averaging about 10 feet deep. The shoreline is mostly tree-lined and occurs as low to high banks undercut by tidal action. Several gravel pits occur in the floodplain, and little development exists directly on the Stafford County side of the river. As such there

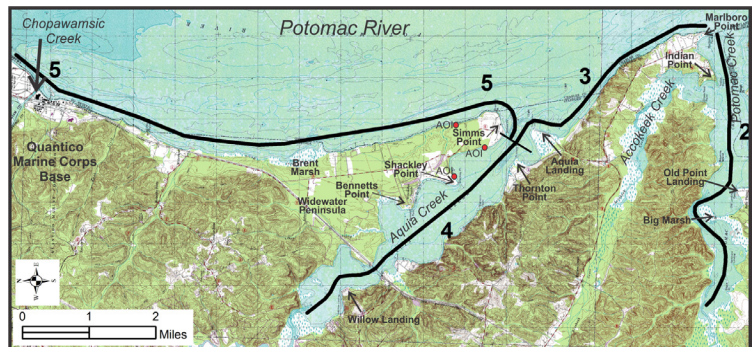
Figure 2-4. Topographic sheet of the Potomac River section of Stafford County. Also shown are the reach designations and Areas of Interest (AOI).

Reach 2 starts on the south shoreline of Potomac Creek near Old Point Landing which is near the Stafford County/King George County boundary (Figure 2-4). The shoreline is residentially-developed and has a low bank which has mostly been hardened with bulkheads (Figure 2-6). The shore transitions to Big Marsh which is a marsh point. Farther into Potomac Creek, residential land use occurs and much of the shoreline is bulkheaded as well. Potomac Creek narrows quickly and proceeds westward as a very narrow meandering channel. The north side of Potomac Creek is undeveloped and slightly erosional with high wooded banks. On the north side, Accokeek Creek enters near the mouth of Potomac Creek. The upland is lower and transitions to a marsh shoreline on the west side of the mouth of Accokeek Creek. Indian Point, on the east side of the mouth of Accokeek Creek, has a low bank with residential development that is mostly protected by wood bulkheads.

This section describes several areas of concern and/or interest in Stafford and demonstrates how the preferred alternative from the SMM could be adopted by the waterfront property owners. The location of the areas of interest (AOI) are shown on Figure 2-4. No areas of concern exist in Stafford County. Areas of Interest demonstrate how the previously discussed goals of Living Shoreline management could be applied to a particular shoreline.

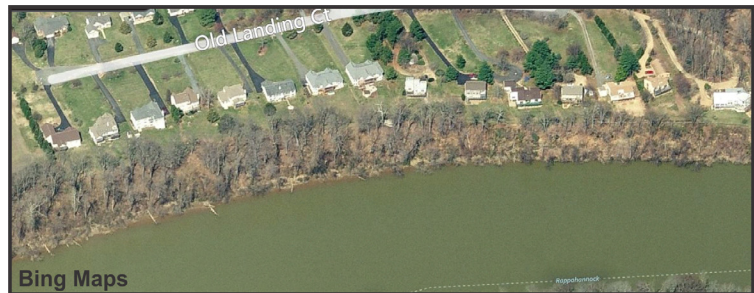
Figure 2-5. Reach 1, Bing map of the eroding high banks along the Rappahannock River in Stafford County.

are no shore protection structures even though the high banks are slightly erosive (Figure 2-5). Historical erosion rates are very low.

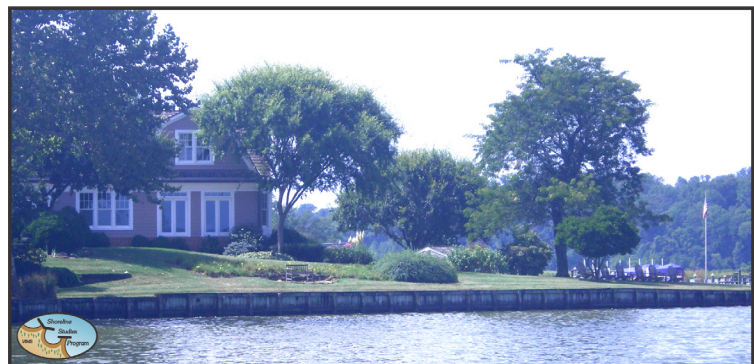
Figure 2-6. Reach 1, residential shoreline with low banks and bulkheads on Potomac Creek.

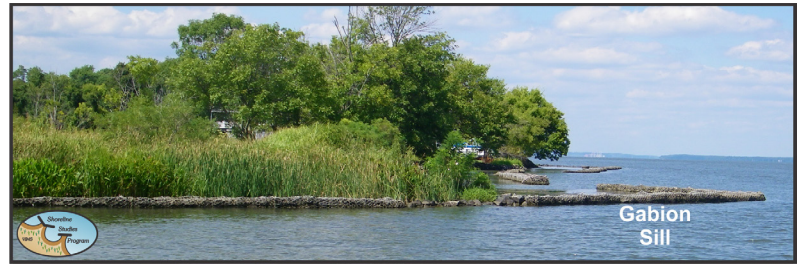
Figure 2-7. Reach 2, at the mouth of Potomac Creek, a gabion sill that has protected the shoreline for 20 years.

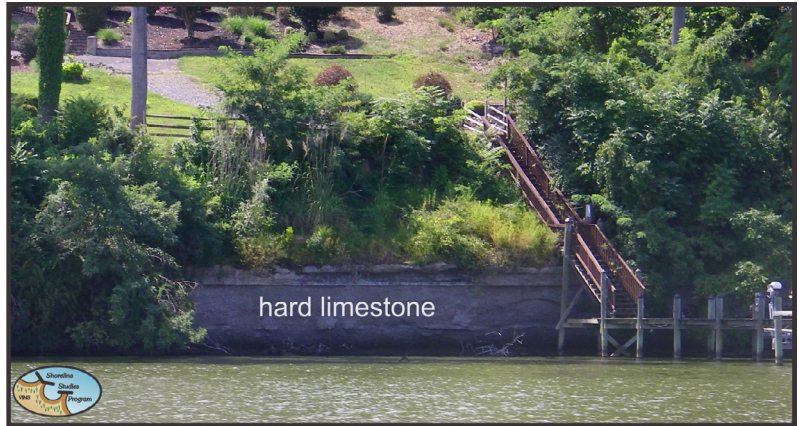
Figure 2-8. Reach 3, Potomac River high bank shoreline with a hard, erosion resistant limestone base of bank.

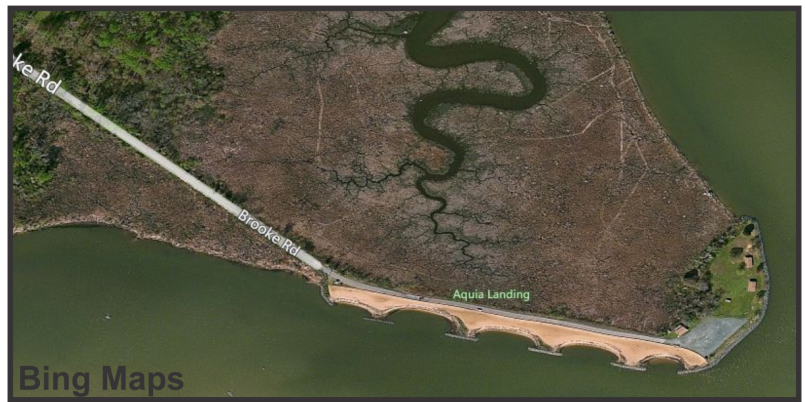
Figure 2-10. Reach 3, Bing map showing Aquia Landing Park and the breakwaters and beach fill that have been providing shore erosion control since 1987.

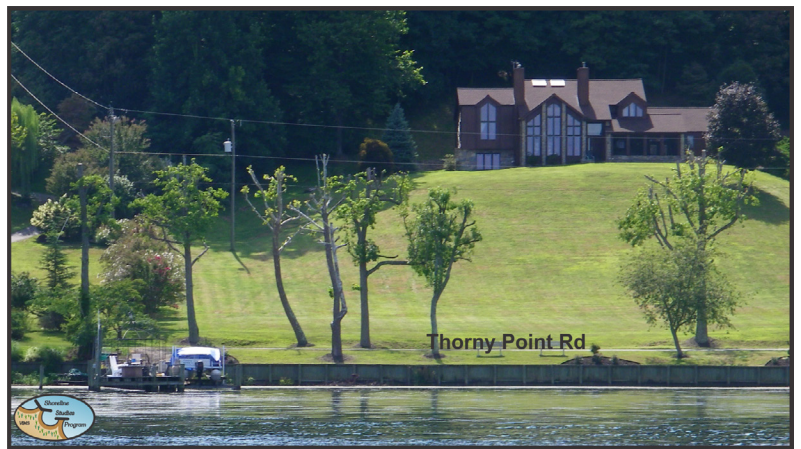
Figure 2-11. Reach 4, the shoreline is protected by a bulkhead in order to protect the road that runs along the shoreline between Aquia Landing and Thornton Point.

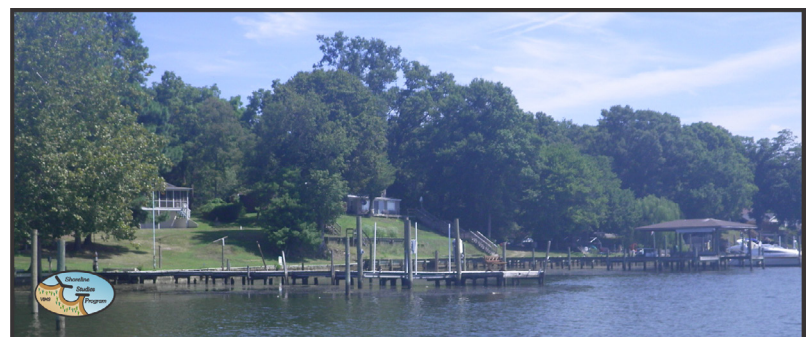
Figure 2-12. Reach 4, shorelines with a low bank and residential landuse. The shoreline has wood bulkheads for protection.

in landuse with extensive bulkheading and numerous piers along about 4,000 feet of shore to Shackley Point (Figure 2-12). The shoreline transitions to low banks and marsh at Shackley Point. Downriver of Shackley Point the shoreline is low (10ft) wooded and more erosive downriver to the mouth of Aquia Creek and Simms Point.

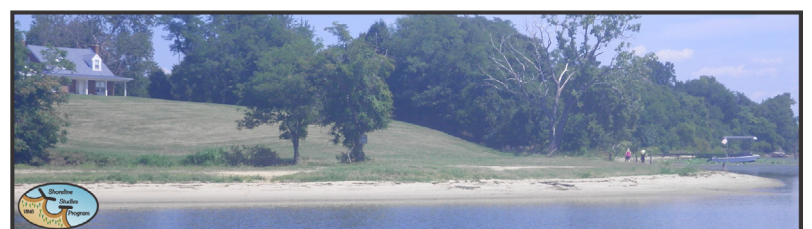
Figure 2-13. Reach 4, Simms Point at the confluence of Aquia Creek and the Potomac River.

Simms Point is a low sandy spit, a product of eroding bank sediments accumulating at the mouth of Aquia Creek (Figure 2-13). The low sandy shoreline between Simms Point and Brent Marsh (**Reach 5**) represents the distal end of the Widewater Peninsula. The Potomac River side of the peninsula extends north almost three miles to Brent Marsh. The shoreline is eroding high bank (Figure 2-14) with sparse development; however, one landowner installed gabion baskets as a low breakwater units over 30 years ago (Figure 2-15). They are still in fairly good shape due, in part, to the relatively fresh water setting. Hardaway (1988) determined that gabions used in more saline estuarine waters had a limited life span due to corrosion of the gabion wire basket. The main residential development along this section of shoreline is mostly hardened with stone revetments and wood bulkheads. An old, wood hull is located offshore and is home for some hardy shrubs (Figure 2-16). At the upriver end of the residential reach the shoreline continues as an eroding upland bank for 1,000 feet before transitioning to the eroding marsh shore of Brent Marsh.

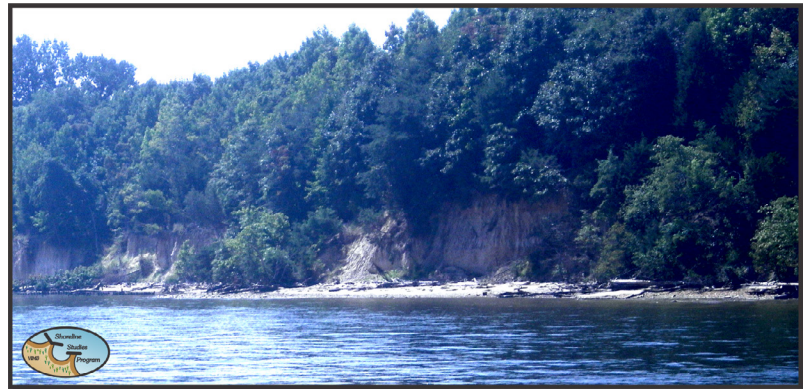
Figure 2-14. Reach 5, eroding banks along the Widewater Peninsula on the Potomac River.

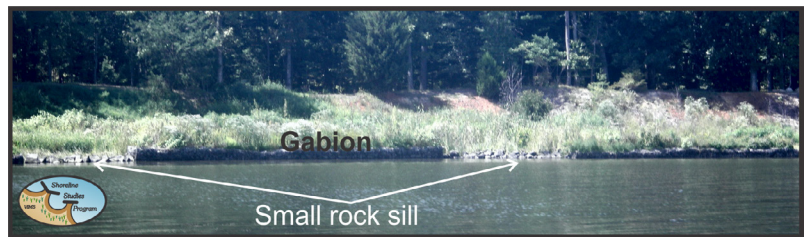
Figure 2-15. Reach 5, gabions along the shoreline that are providing effective shore protection along the Potomac River.

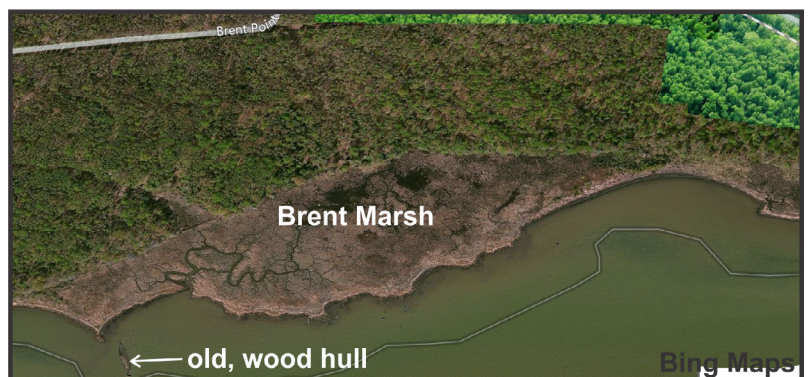
Figure 2-16. Reach 5, Brent Marsh on the Potomac River.

Brent Marsh extends about 1 mile along shore and although actively eroding, is still wide enough to provide a wave buffer to the adjacent upland banks (Figure 2-16). North of Brent Marsh several commercial fishing interests occur. In addition, along this reach, railroad tracks come close to the river, within 50 feet in several areas. The railroad is presently protecting one section of the shoreline with a stone revetment (Figure 2-17). Along the rest of Stafford's shoreline to the Quantico Marine Corps Base, only

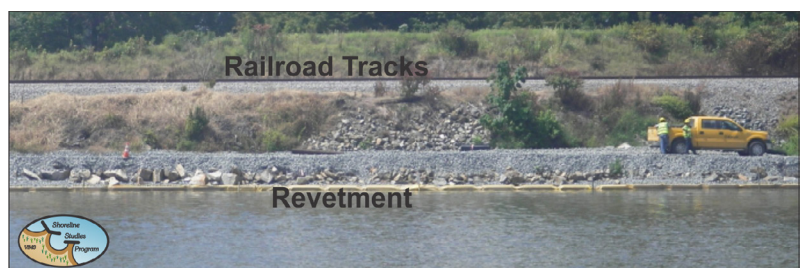
Figure 2-17. Reach 5, construction of a new revetment along the Potomac River that will protect the eroding shoreline that is very close to railroad tracks which are still used daily to carry passengers and freight.

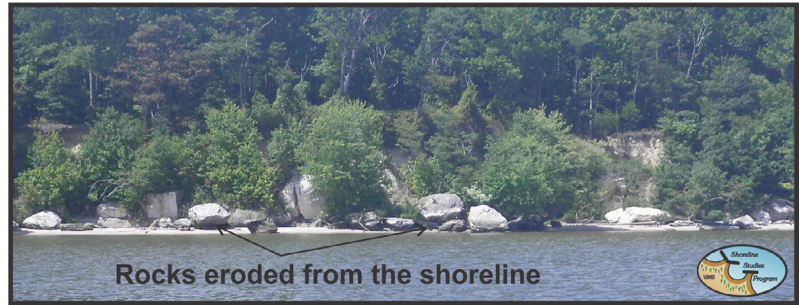
Figure 2-18. Reach 5, very hard rocks that have broken off from the bank along the Potomac River shoreline

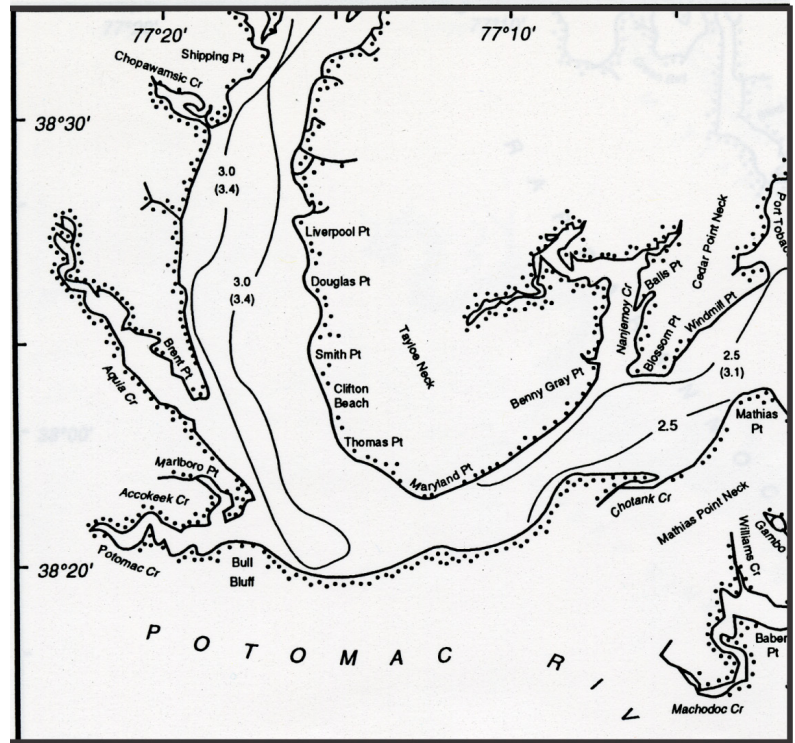
Figure 2-19. Wave climate map for the upper reaches of the Potomac River (from Basco and Shin, 1993).

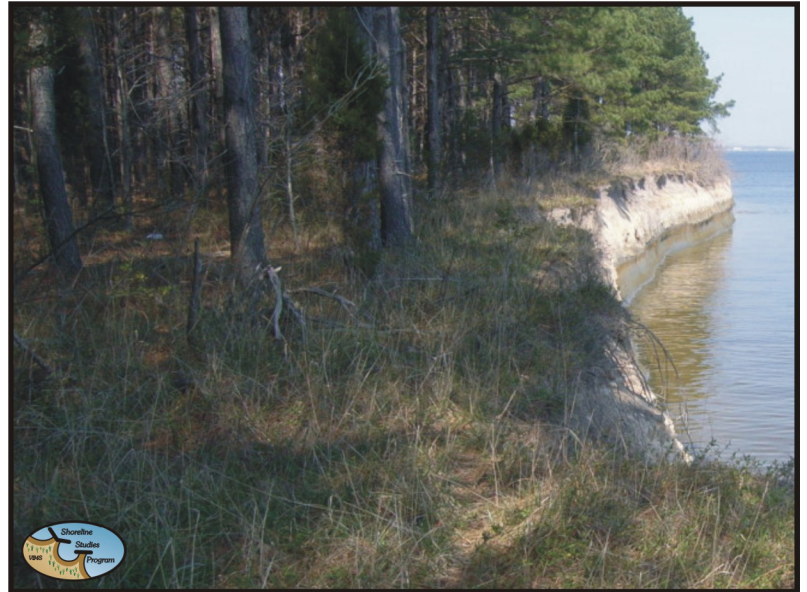
Figure 3-1. One example of forest management. The edge of the bank is kept free of tree and shrub growth to reduce bank loss from tree fall.

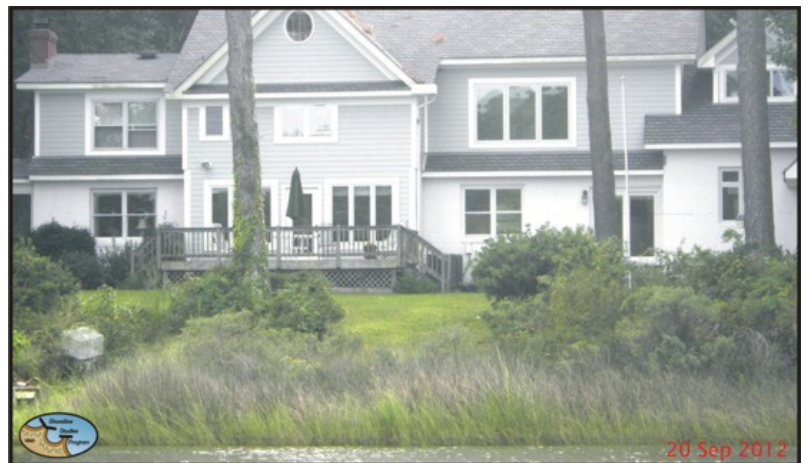
Figure 3-2. Maintaining and enhancing the riparian and marsh buffers can maintain a stable coastal slope.

Enhancement of both riparian and existing marsh buffers together can be an effective practice to stabilize the coastal slope (Figure 3-2) from the intertidal area to the upland by allowing plants to occupy suitable elevations in dynamic fashion to respond to seasonal fluctuations, shifts in precipitation or gradual storm recovery. At the upland end of the slope, forest buffer restoration and the planting of ornamental grasses, native shrubs and small trees is recommended. Enhancement of the marsh could include marsh plantings, the use of sand fill necessary to plant marsh vegetation, and/or the need for fiber logs to stabilize the bank toe and newly established marsh vegetation.

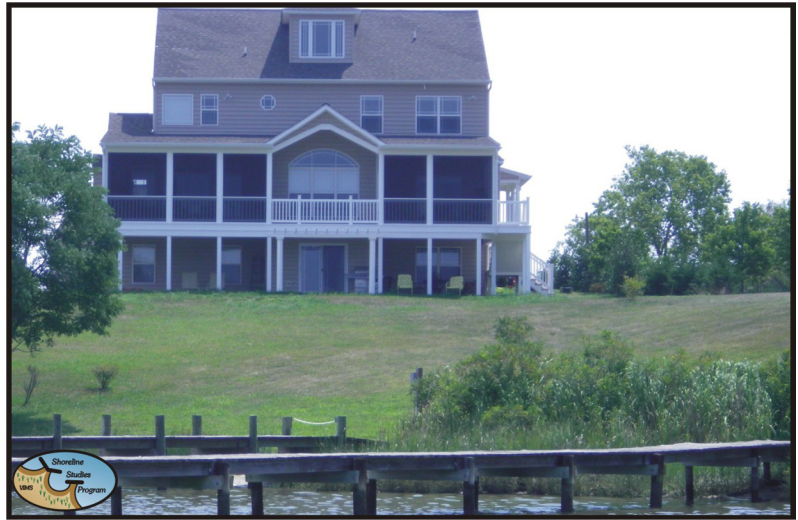
Figure 3-3. Bank grading reduces steepness and will improve growing conditions for vegetation stabilization

In cases where the bank is unstable, medium or high in elevation, and very steep, bank grading may be necessary to reduce the steepness of bank slopes for wave run-up and to improve growing conditions for vegetation stabilization (Figure 3-3). The ability to grade a bank may be limited by upland structures, existing defense structures, adjacent property conditions, and/or dense vegetation providing desirable ecosystem services.

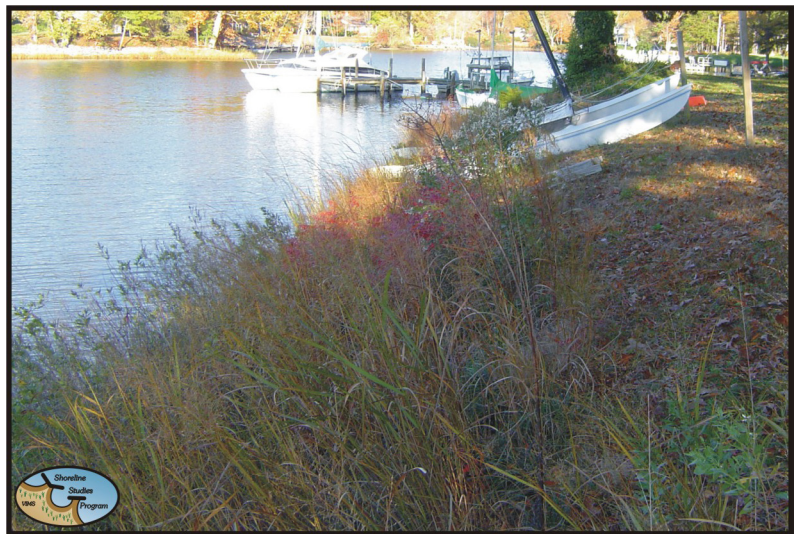
Figure 3-4. This low-energy site had minor bank grading, sand added, and *Spartina alterniflora* planted. This photo shows the site after 24 years.

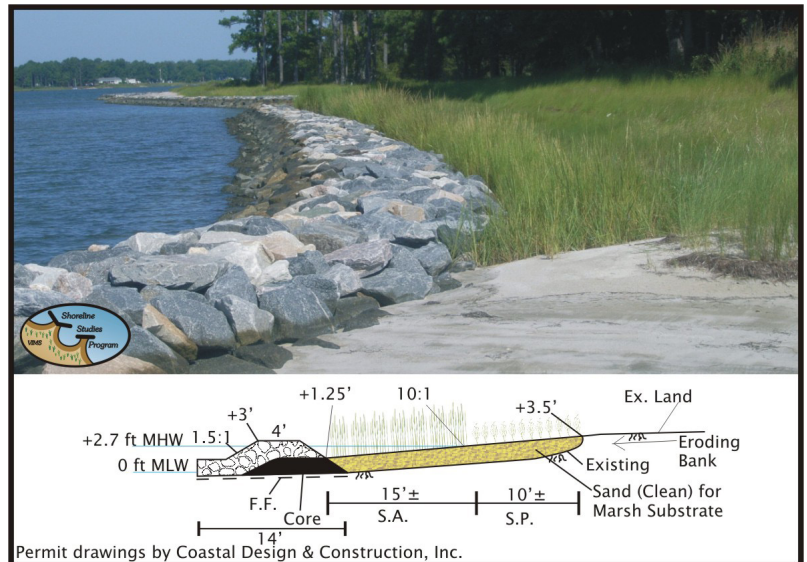
Figure 3-5. Sand fill with stone sills and marsh plantings shown six years after installation and the cross-section used for construction (From Hardaway *et al.*, 2010).

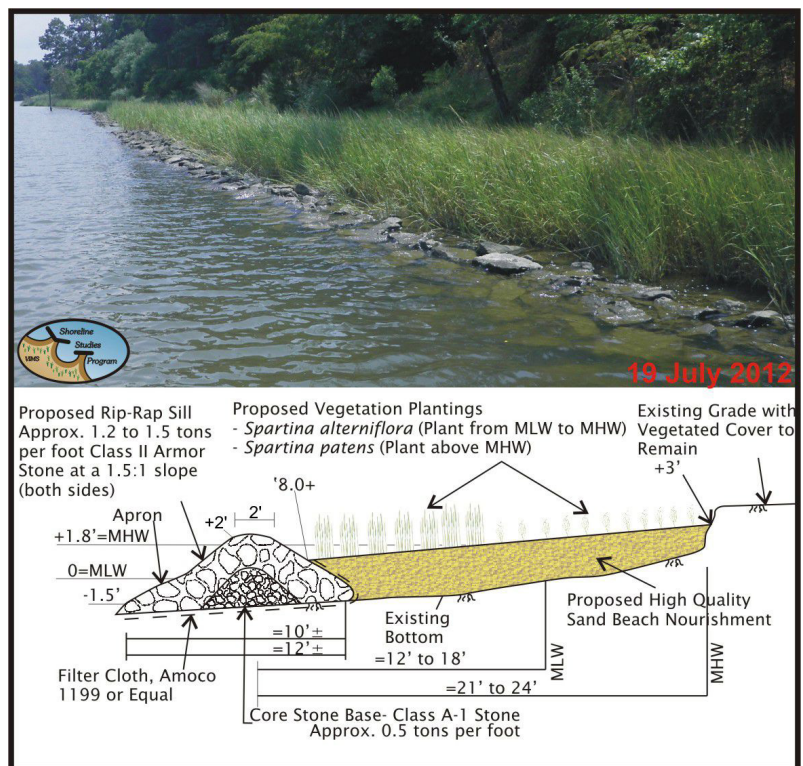
Figure 3-6. Longwood University's Hull Springs Farm four years after construction and the cross-section used for construction (from Hardaway et al., 2010).

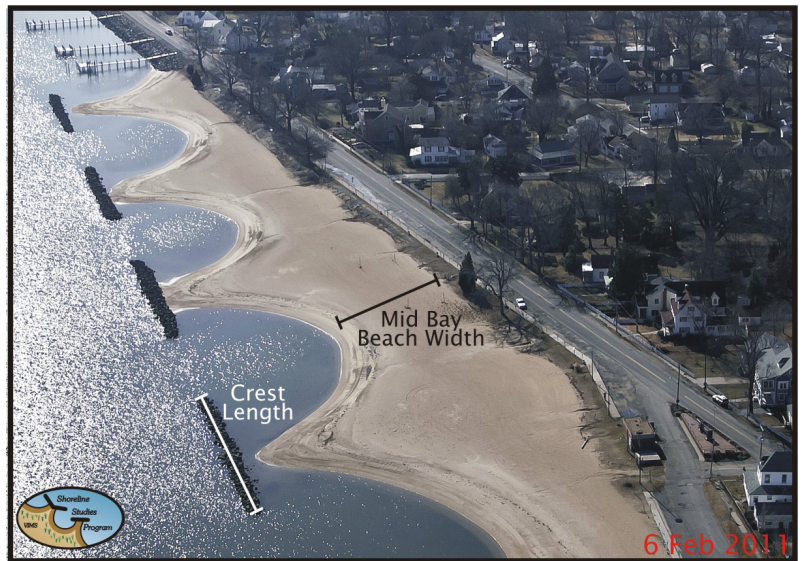
Figure 3-7. Breakwaters at Colonial Beach designed to provide a recreational beach as well as storm erosion protection for the Town.

Hardaway and Byrne (1999) suggest that breakwater systems in medium energy environments should utilize at least 200 feet of shoreline, preferably more, because individual breakwater units should have crest lengths of 60 to 150 feet with crest heights 2 to 3 feet above mean high water. Minimum mid-bay beach width should be 35-45 feet above mean high water. On high energy coasts, the mid-bay beach widths should be 45 to 65 feet especially along high bank shorelines (Figure 3-7). Crest lengths should be 90 to 200

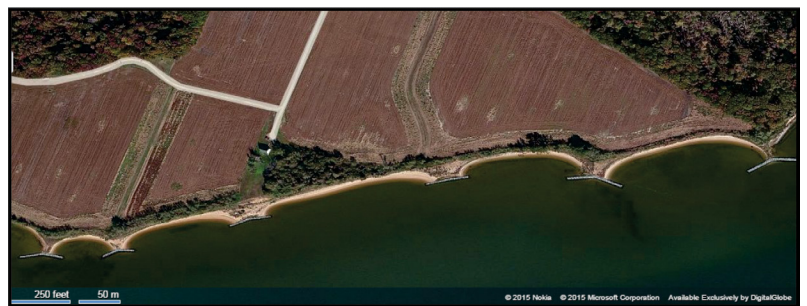
Figure 3-8. Headland control on the Potomac River in Maryland. Widely-spaced, shore-attached breakwaters are placed along eroding farm land to provide shore protection. The coast between the structures will erode into a stable embayment over time. (from Bing Maps).

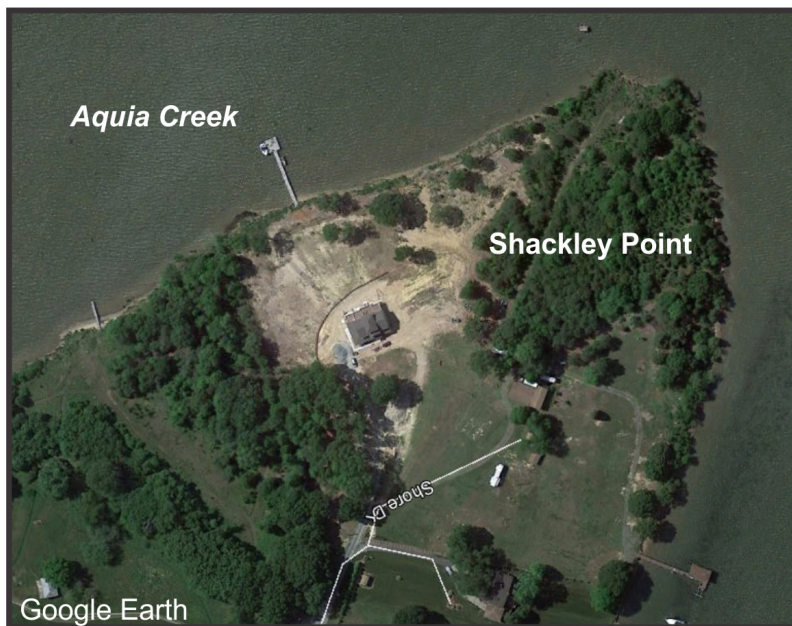
Figure 5-4. Recent clearing of woodland and conversion to residential property at Shackley Point on Aquia Creek shown in Google Earth.

The south side of Shackley Point in Aquia Creek has been eroding since 1967 (Milligan *et al.*, 2015). What was once wooded upland recently has been converted to residential (Figure 5-4). This low bank shoreline has a very small amount of existing marsh fringe (Figure 5-5). This stretch of shoreline generally is protected from large waves, but it is exposed to a southeasterly wave climate through the mouth of Aquia Creek. The maximum fetch distance is 6.5 miles. The SMM recommends a sill with marsh plantings along this stretch of shore. In order to hold the point of land and stop erosion of the property, about 500 feet of shoreline can be protected with a low sill (Figure 5-6). The cross-section for a typical sill for this site is shown in Appendix 3, Figure 1.

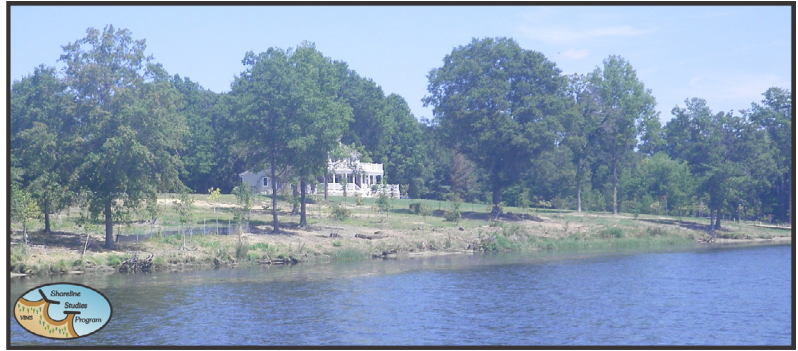
Figure 5-5. Existing conditions at the area of interest in Aquia Creek. The new residential property has a sparse fringe marsh that could be enhanced with a low sill.

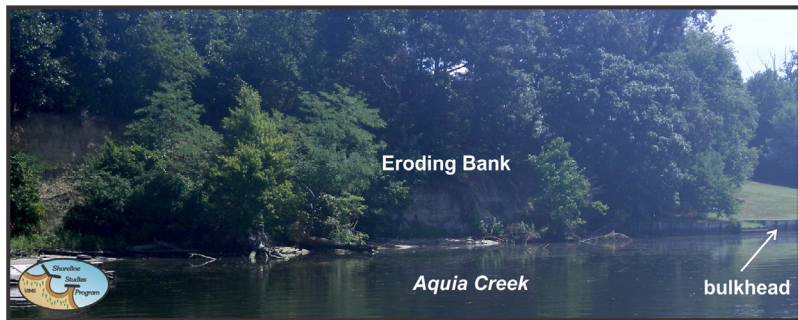
Figure 5-7. Existing conditions at the area of interest near Simms Point along Aquia Creek. The property with the eroding bank is situated between two defensive shore protection structures.

This site is located on Aquia Creek north of Simms Point and has an exposed eroding bank (Figure 5-7). The site sits between two existing bulkheads and was chosen to illustrate the applicability of sills to this type of shoreline. The shoreline has a very low erosion rate (Milligan *et al.*, 2015), but because it is presently undeveloped and sits

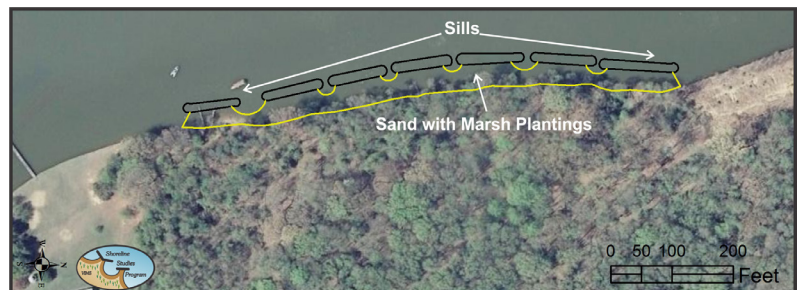
Figure 5-8. Proposed conceptual design planform of the medium sill BMP.

between two bulkheads, it was chosen as an area of interest. The SMM recommends a sill with marsh plantings along this stretch of shore. Because of the higher bank, a medium sill is depicted in the design for the approximately 800 feet between the two existing structures (Figure 5-8). The cross-section for a typical sill for this site is shown in Appendix 3, Figure 2.

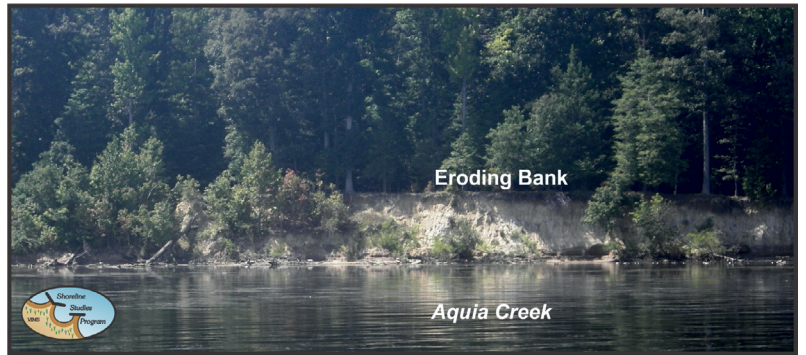
Figure 5-9. Eroding bank along the Potomac River area of interest.

The shoreline along the Potomac River between Simms Point and Brent Marsh has a low to medium erosion rate (Milligan *et al.*, 2015). This stretch of shoreline has low density residential development, but the 1,400 feet of shoreline that is the area of interest is not developed. However, properties to the south and north have shore protection structures. To the south, a revetment exists along the shoreline and to the north gabions were placed along the shoreline as gapped sills/breakwaters (Figure 2-15). This is a relatively high energy area on the Potomac River with an eroding bank at heights up to 10 feet (Figure 5-9). The top of the bank is wooded, and a narrow beach exists. The SMM recommends breakwaters for this site so four offshore breakwaters are conceptualized to protect the base of bank and provide recreational access (Figure 5-10). The design also includes a spur that interfaces the system with the revetment to the south. The cross-section for a typical sill for this site is shown in Appendix 3, Figure 3.

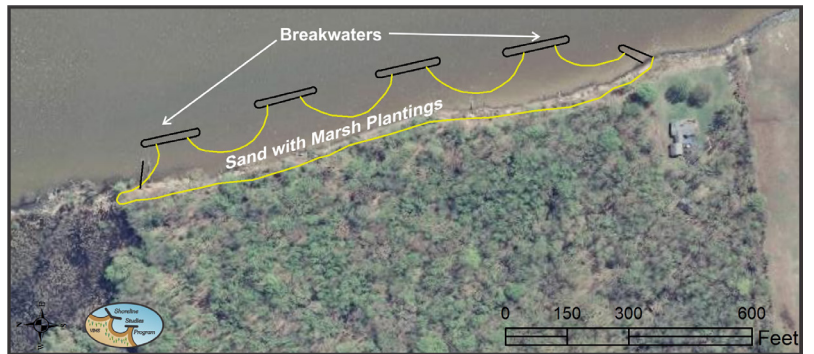
Figure 5-10. Proposed conceptual design planform of the breakwater BMP along the Potomac River.

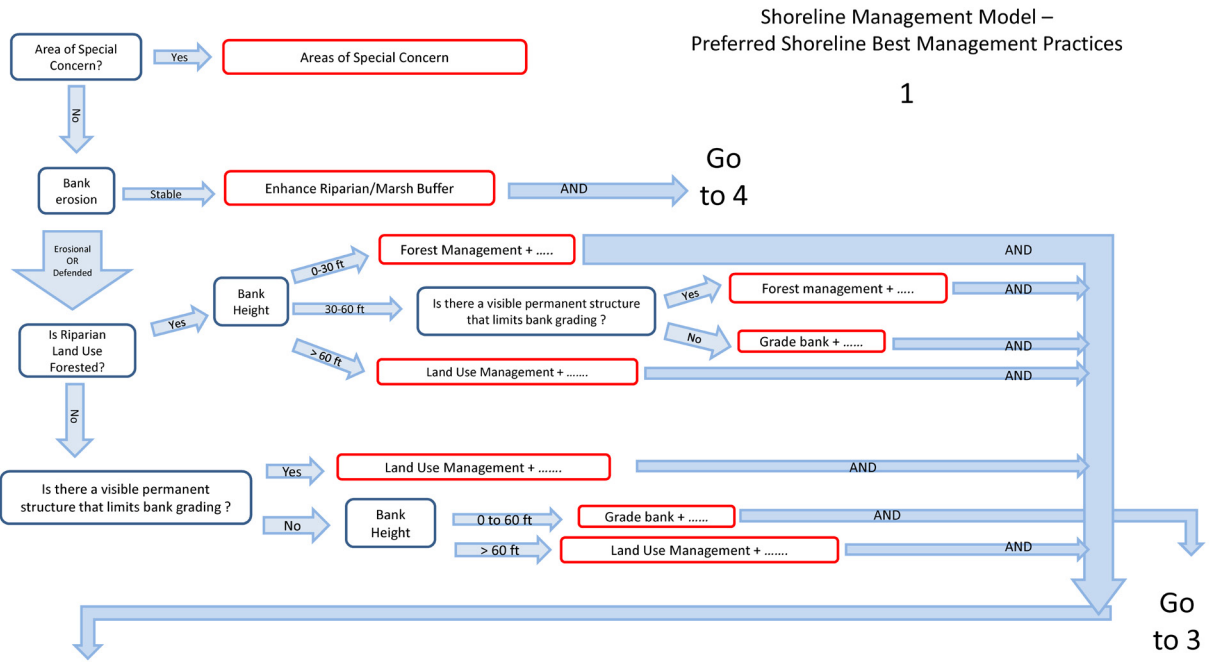
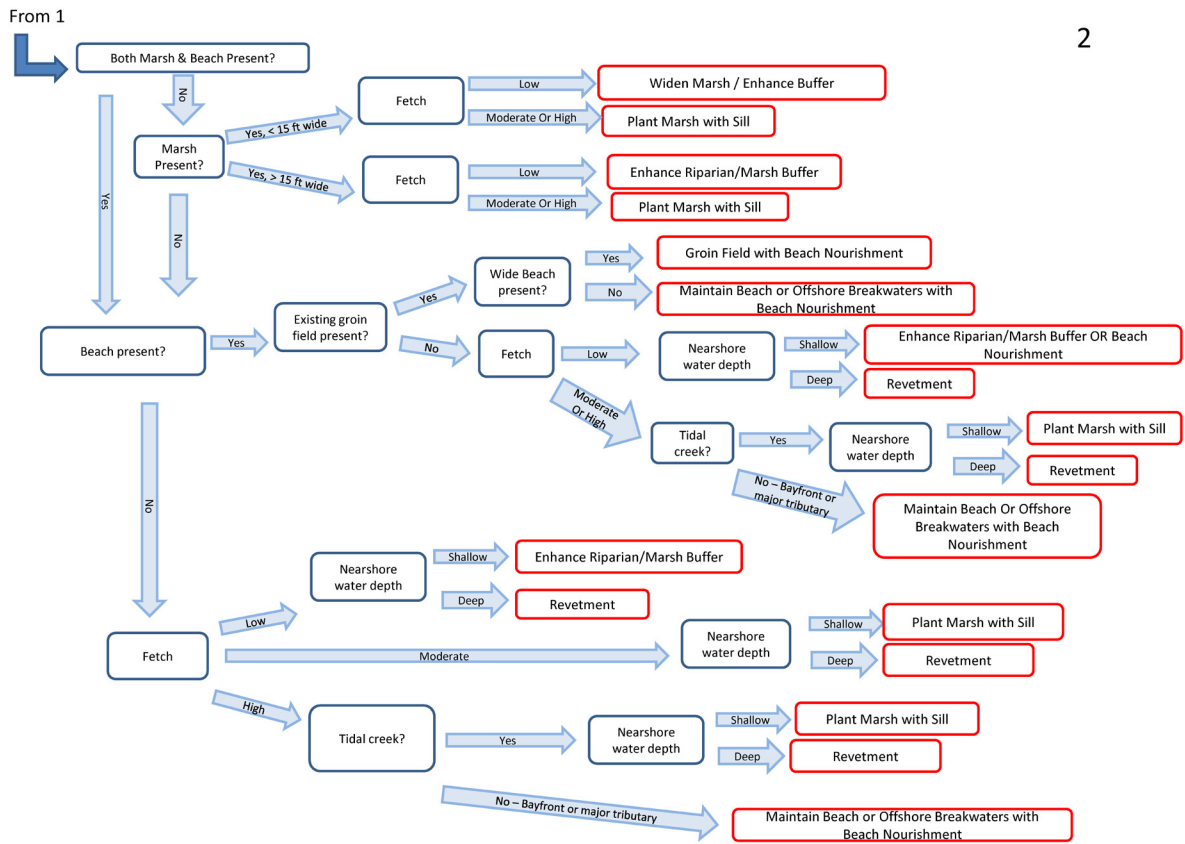
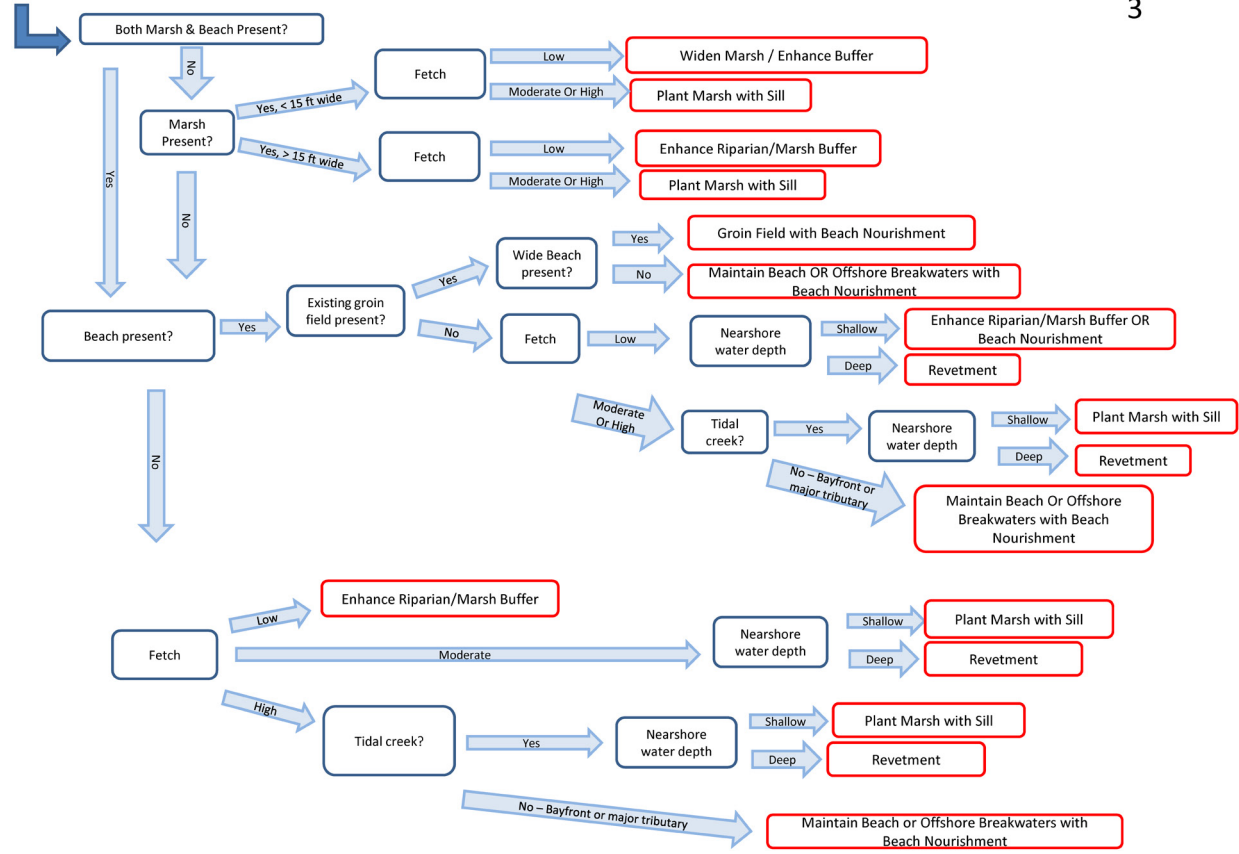
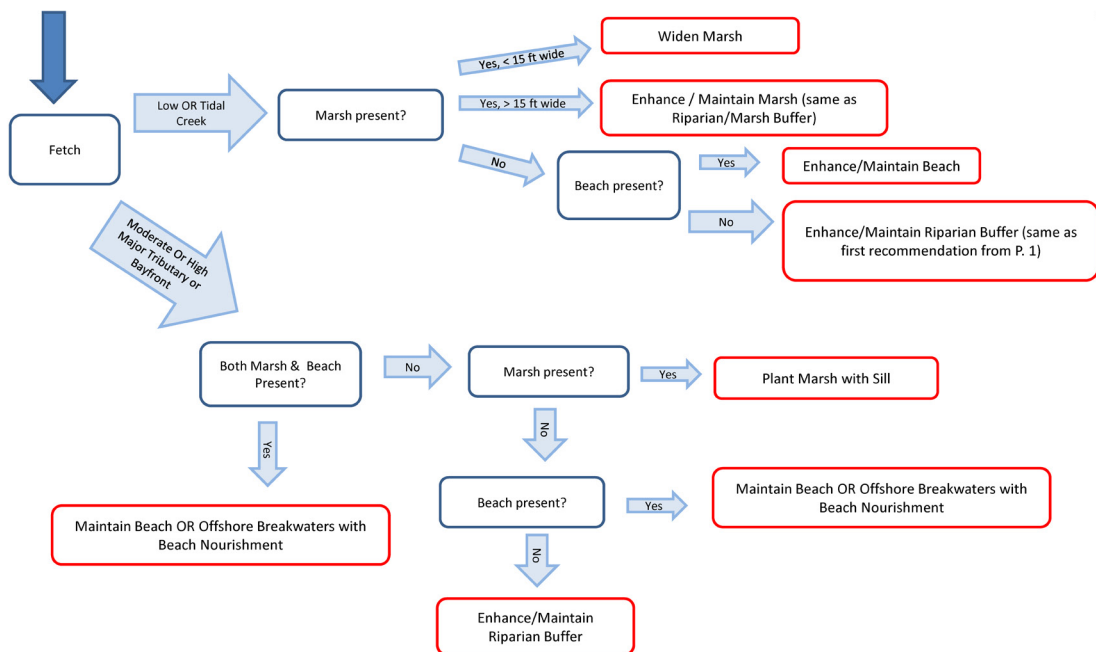
Shoreline Management Model Flow Diagram

responses to questions that determine onsite conditions. Along the upland and the bank, the model queries a site for bank stability, bank height, presence of existing infrastructure, land use, and whether the bank is defended to arrive at an upland management strategy. At the shore the model queries a site for presence and condition of beaches, marshes, the fetch, nearshore water depth, presence of specific types of erosion control structures, and creek setting to drive the shore recommendations. Appendix 1 illustrates the logic model structure.

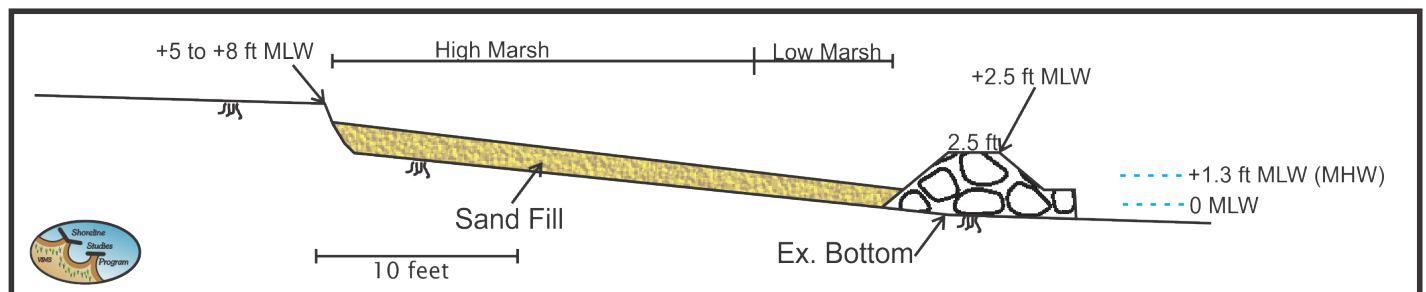
Figure 1. Typical cross-section for a low sill that is appropriate for low to medium energy shorelines of Stafford County. The project utilizes clean sand on an 10:1 (H:V) slope, and the bank can be graded to a (minimum) 2:1 slope, if appropriate.

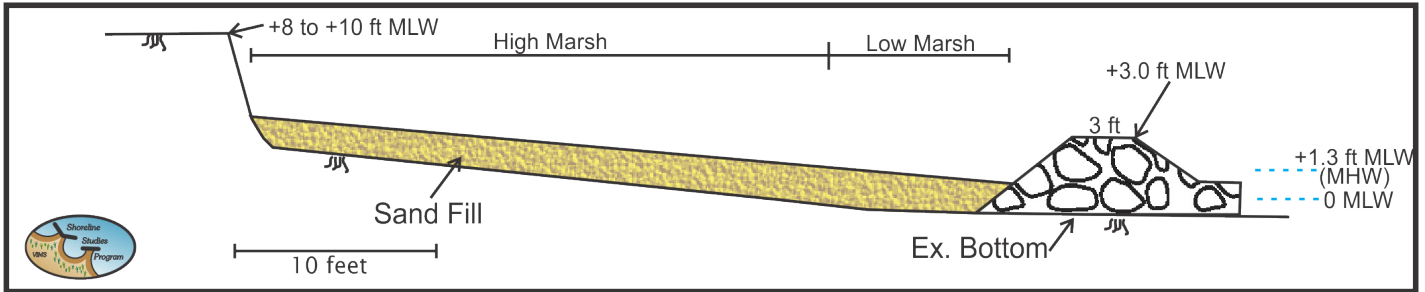
Figure 2. Typical cross-section for a medium sill that is appropriate for the medium to high energy shorelines of Stafford County. The project utilizes clean sand, and the bank can be graded to a (minimum) 2:1 slope, if appropriate.

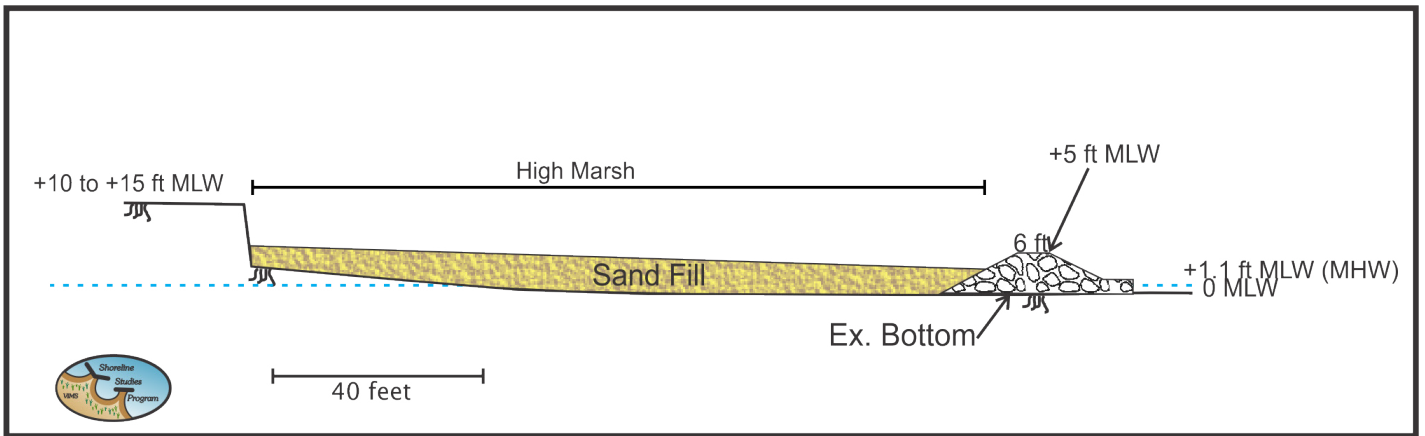
Figure 3. Typical cross-section for a breakwater that is appropriate for shore protection along the medium to high energy shorelines of Stafford County. The project utilizes clean sand, and the bank can be graded to a (minimum) 2:1 slope, if appropriate.
