Chesterfield County and the Cities of Colonial Heights, Petersburg, and Richmond, Virginia - Shoreline Inventory Report: Methods and Guidelines

Chesterfield County and the Cities of Colonial Heights, Petersburg, and Richmond, Virginia Shoreline Inventory Report: Methods and Guidelines

Special report in Applied Marine Science and Ocean Engineering No. 464 of the Virginia Institute of Marine Science

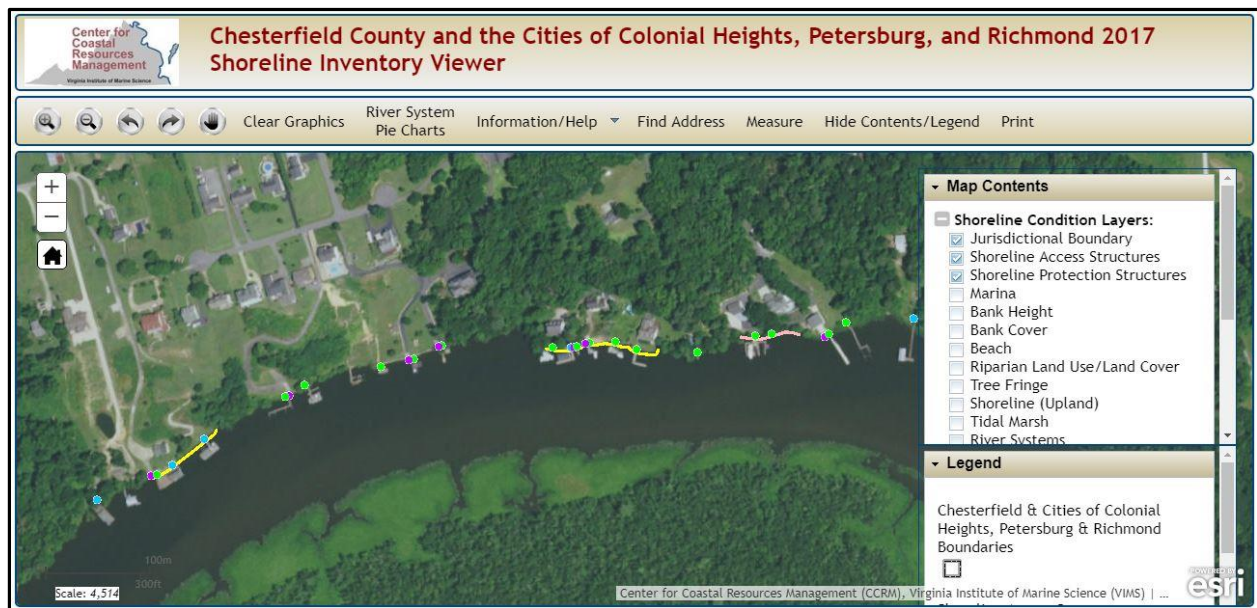
Figure 4. Map Viewer illustrates Shoreline Access and Protection Structures for a section of Chesterfield County.

In Figure 4 Shoreline Access Structures, and Shoreline Protection structures are selected. Shoreline Access structures are point features that includes piers and boat ramps. The actual footprint of these structures is not measured; only their location. Shoreline Protection Structures are line features and are mapped and illustrated in the viewer to show where they occur along the shoreline. Figure 5 illustrates riparian land use in the riparian zone for the same section of the County.
