Richmond County, Virginia - Shoreline Inventory Report: Methods and Guidelines

**Richmond County, Virginia
Shoreline Inventory Report
Methods and Guidelines**

**Prepared By:
Comprehensive Coastal Inventory Program
Center for Coastal Resources Management
Virginia Institute of Marine Science, College of William and Mary
Gloucester Point, Virginia
September 2018**

Special report in Applied Marine Science and Ocean Engineering No. 470 of the Virginia Institute of Marine Science

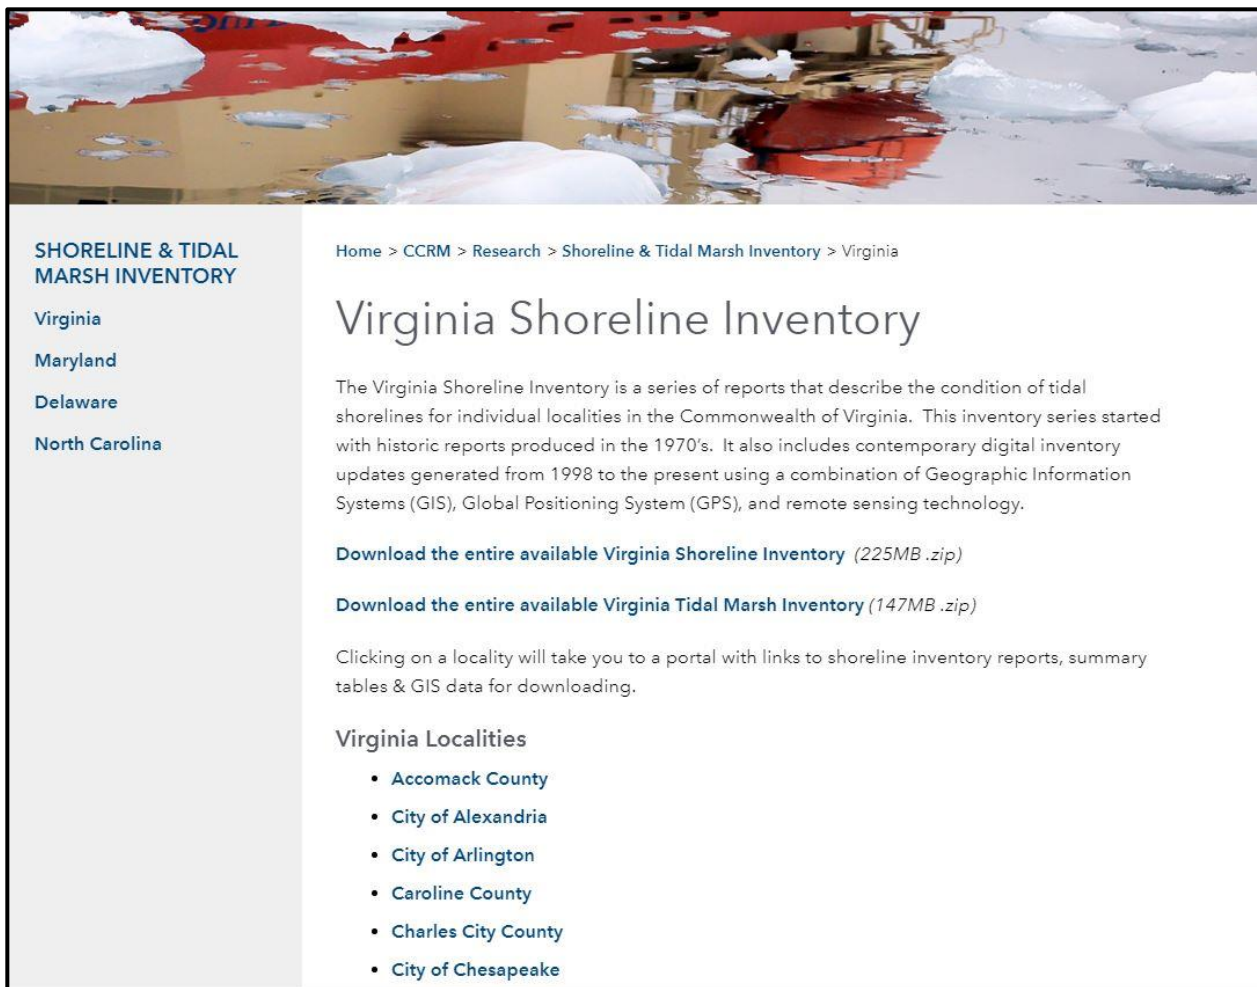
Figure 1. Shoreline Inventory Website

The map viewer allows users to interact with the datasets within a familiar “google” type map service that was developed with Javascript. Here they can view data of their choice and customize map products for printing themselves. Access to the GIS data, summary tables and methods report is also available through this website.

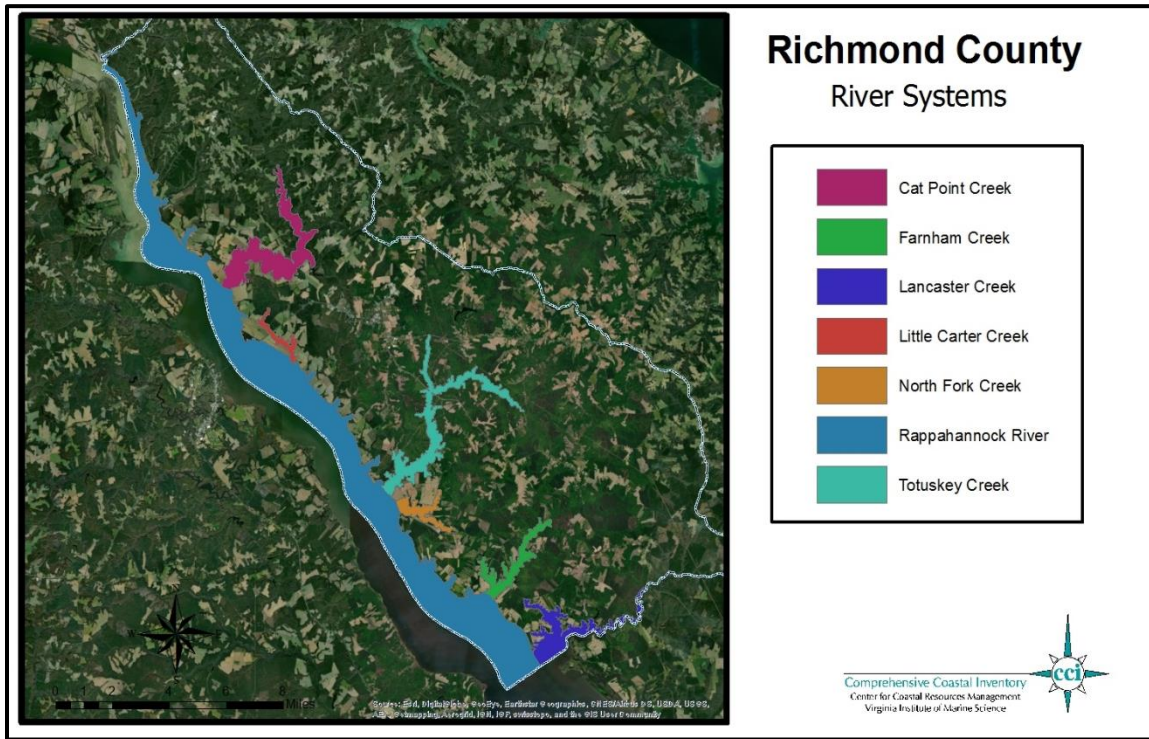
Figure 2. River Systems in Richmond County

Summary tables (Tables 4-7) quantify conditions observed on the basis of river systems (Figure 2). Refer to Figure 2 for the location of these rivers systems. Note, river systems do not correspond to watershed boundaries. They were developed for convenience in reporting data.

The top toolbar also includes tabs to access some important status information for the locality. By clicking on the “River System Pie Charts” button, users can obtain a statistical summary distribution of the riparian land use and amount of hardened shoreline for a specific water body selected from the drop down menu in the upper left (Figure 7). More detailed results in table format can be found by clicking the Richmond County Summary PDF button also in the window. The summary statistics are reported by river systems (Figure 2).

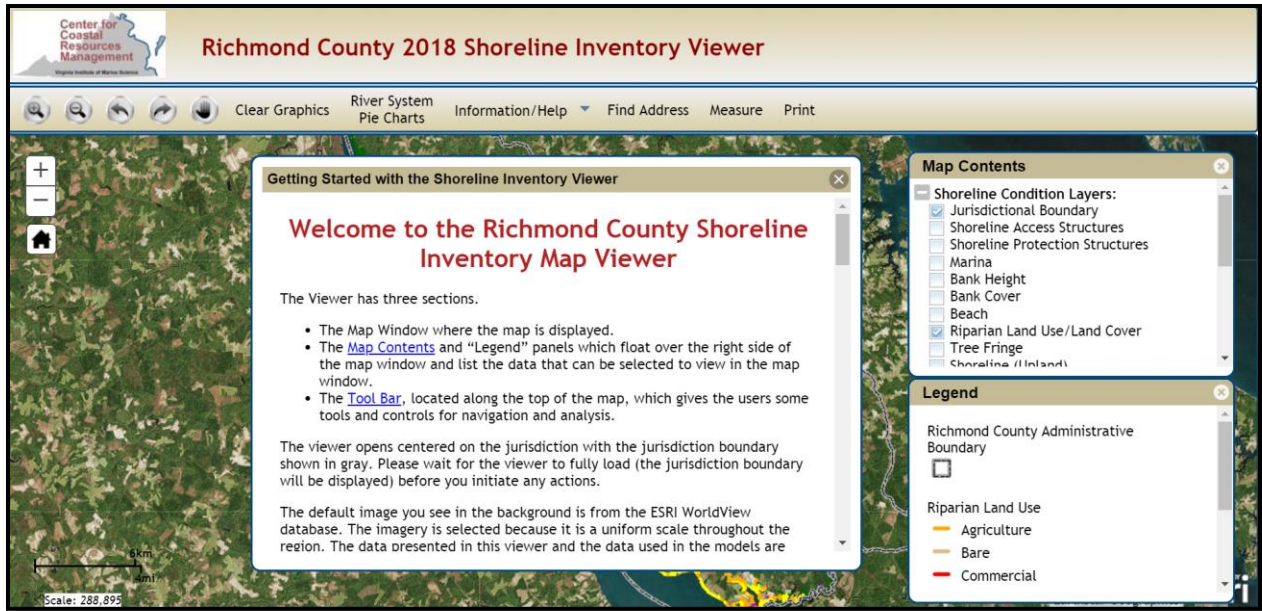
Figure 3. Opening page for the Richmond County Shoreline Inventory Viewer

The Viewer has two panels: “Map Window”, where the map is displayed and “Map Contents and Legend”, where data that can be selected and viewed in the map window are listed. A tool bar is located along the top of the “Map Window” which gives users some controls for navigation and analysis (Figure 3.).

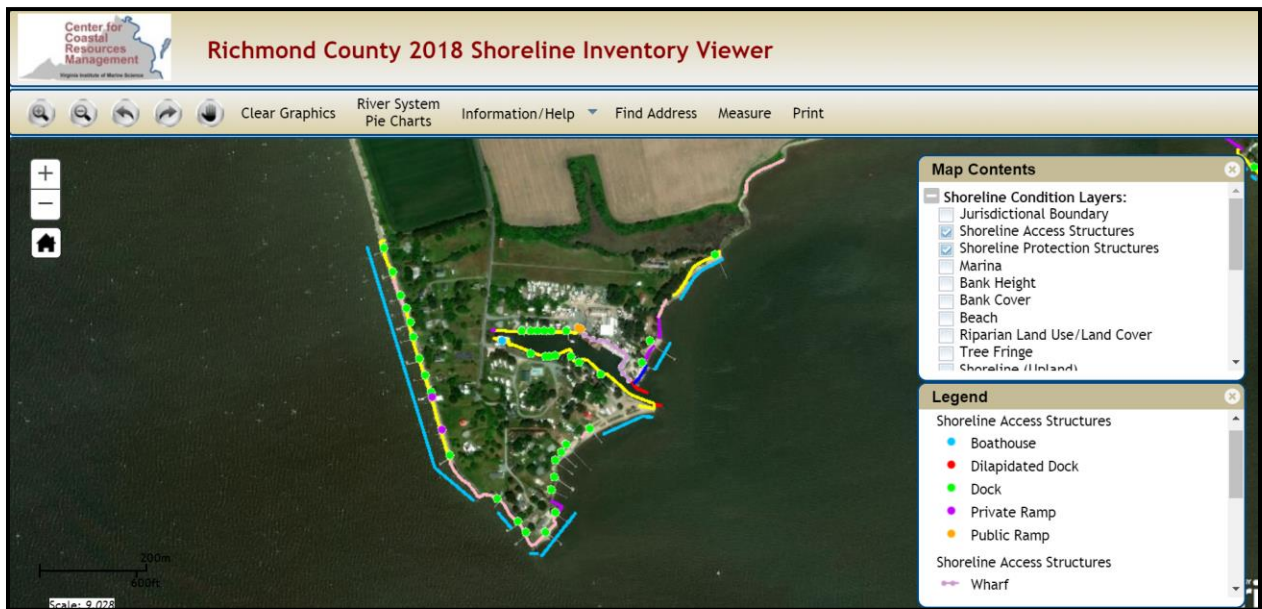
Figure 4. Map Viewer illustrates Shoreline Access and Protection Structures for a section of Richmond County.

In Figure 4, Shoreline Access Structures and Shoreline Protection structures are selected. Shoreline Access structures are point features that includes piers and boat ramps. The actual footprint of these structures is not measured; only their location. Shoreline Protection Structures are line features and are mapped and illustrated in the viewer to show where they occur along the shoreline. Figure 5 illustrates riparian land use in the riparian zone for the same section of the County.

From the “Map Contents” the user may check various attribute layers on or off. The user must use the scroll bar on the far right to see the complete list of layers available. When layers are turned on, the corresponding legend appears in the “Legend” panel, and the data are displayed in the “Map Window” (Figure 4).

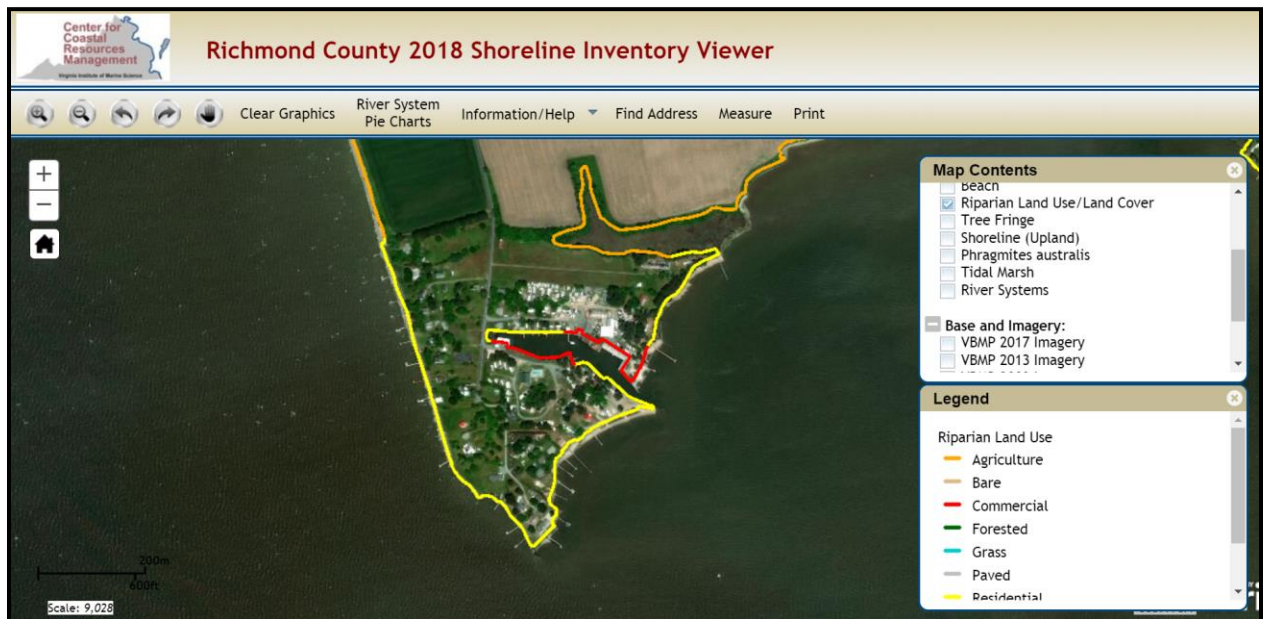
Figure 5. Distribution of land use in the riparian zone is displayed for this region of Richmond County.

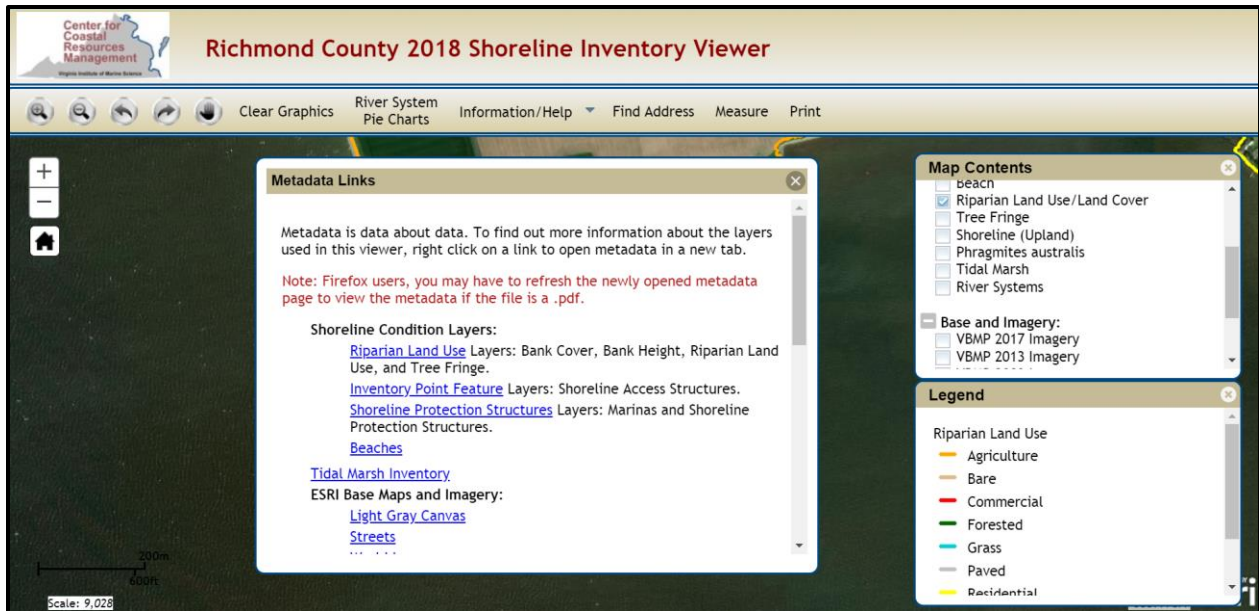
The user can use the zoom and pan tools from the top toolbar or the slide bar on the left side of the map window to change their map extent. If the map resolution is exceeded the window will become illegible. Detailed information can be obtained about the data by selecting the “Information/Help” tab at the top of the map viewer. From here the inventory glossary and metadata records can be easily accessed. In Figure 6 the selection for metadata has been made and 5 possible records can be retrieved.

Figure 6. Link to Metadata records has been selected from the top Information tab in the toolbar.

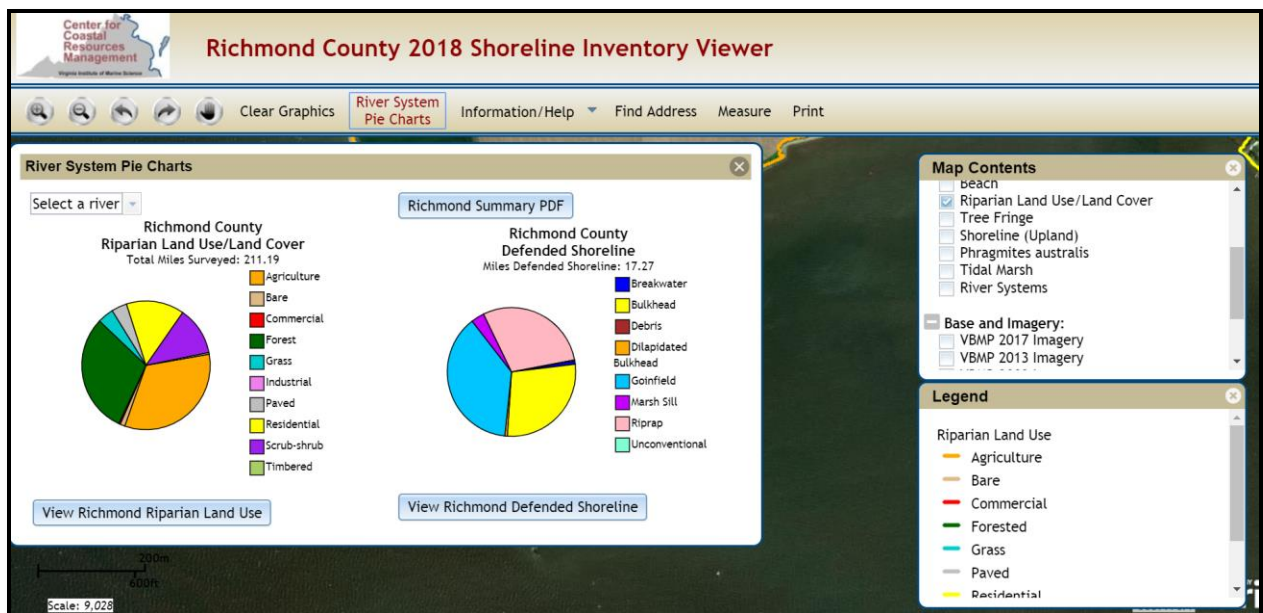
Figure 7. Pie charts display land use and shoreline hardening statistics for each tributary.

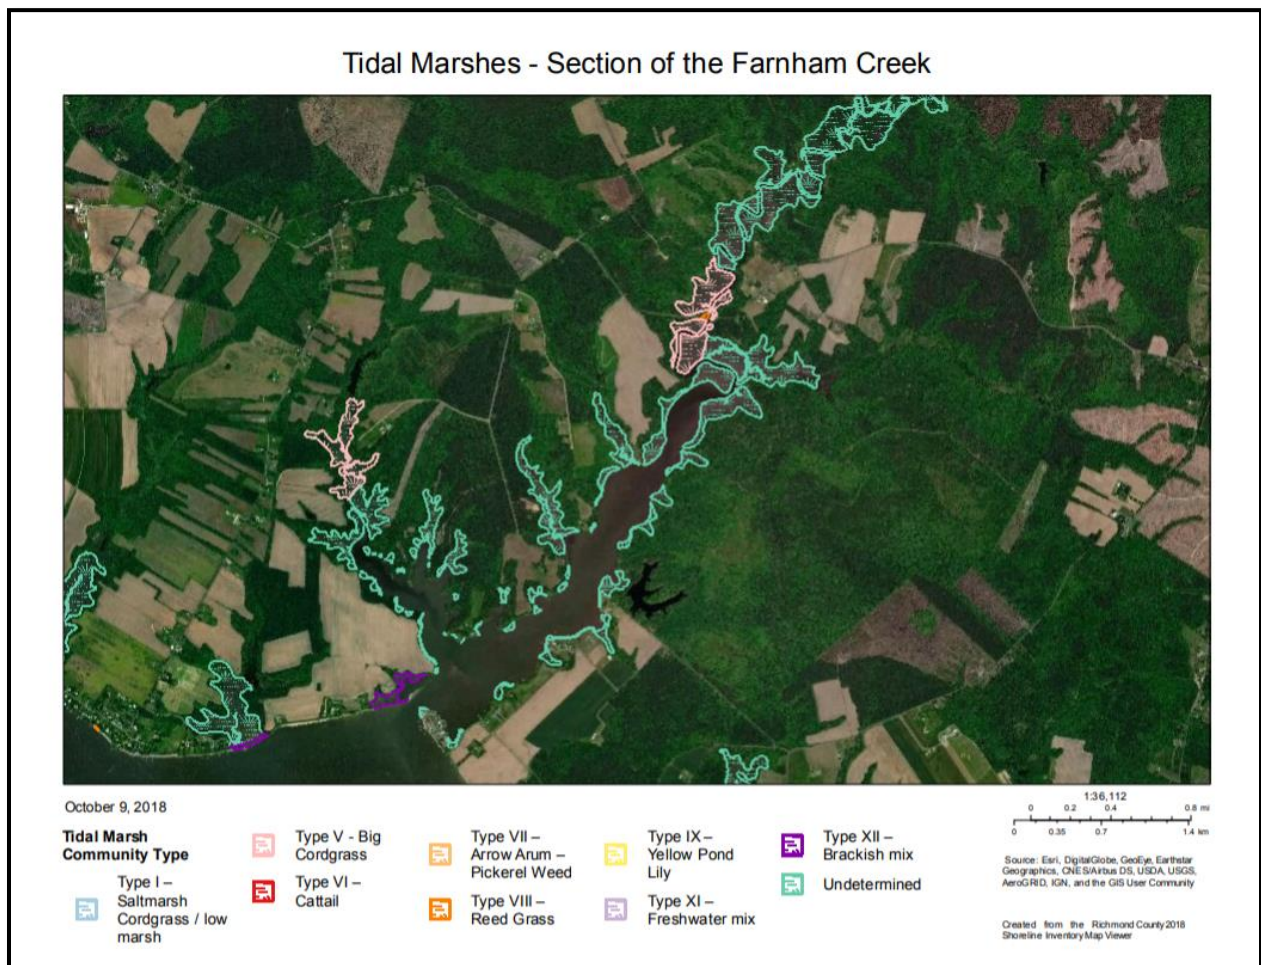
Figure 8. Customized print window for a section of Farnham Creek

Finally, users have the option to personalize their own maps (i.e. map extent, data displayed, map title, etc.) and save them as a pdf file by clicking “Select Print Layout” button. The page can be set up for printing to 8.5 x 11 portrait or landscape style. Figure 8 is an example of a customized map generated for a section of the Farnham Creek. Here the tidal marsh communities are displayed, and the community type is reported in the legend beside the illustration.
