Caroline County, Virginia - Shoreline Inventory Report: Methods and Guidelines

Caroline County, Virginia Shoreline Inventory Report Methods and Guidelines

Special report in Applied Marine Science and Ocean Engineering No. 471 of the Virginia Institute of Marine Science

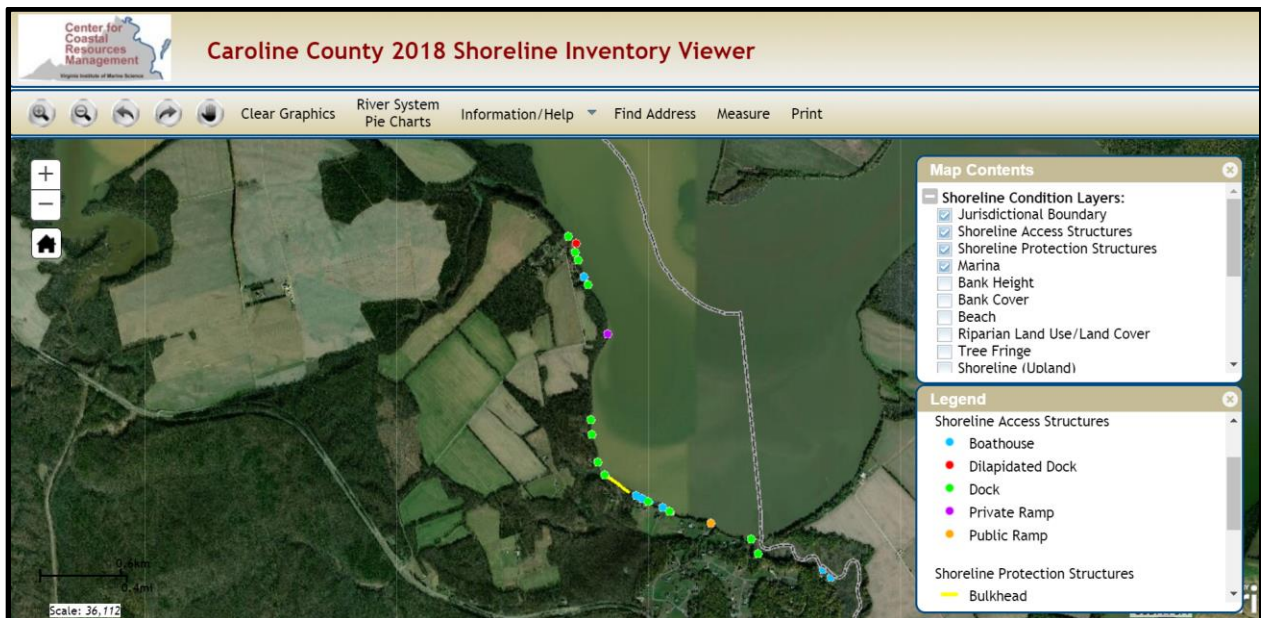
Figure 4. Map Viewer illustrates Shoreline Access and Protection Structures for a section of Caroline County.

In Figure 4 Shoreline Access Structures, and Shoreline Protection structures are selected. Shoreline Access structures are point features that includes piers and boat ramps. The actual footprint of these structures is not measured; only their location. Shoreline Protection Structures are line features and are mapped and illustrated in the viewer to show where they occur along the shoreline. Figure 5 illustrates riparian land use in the riparian zone for the same section of the County.

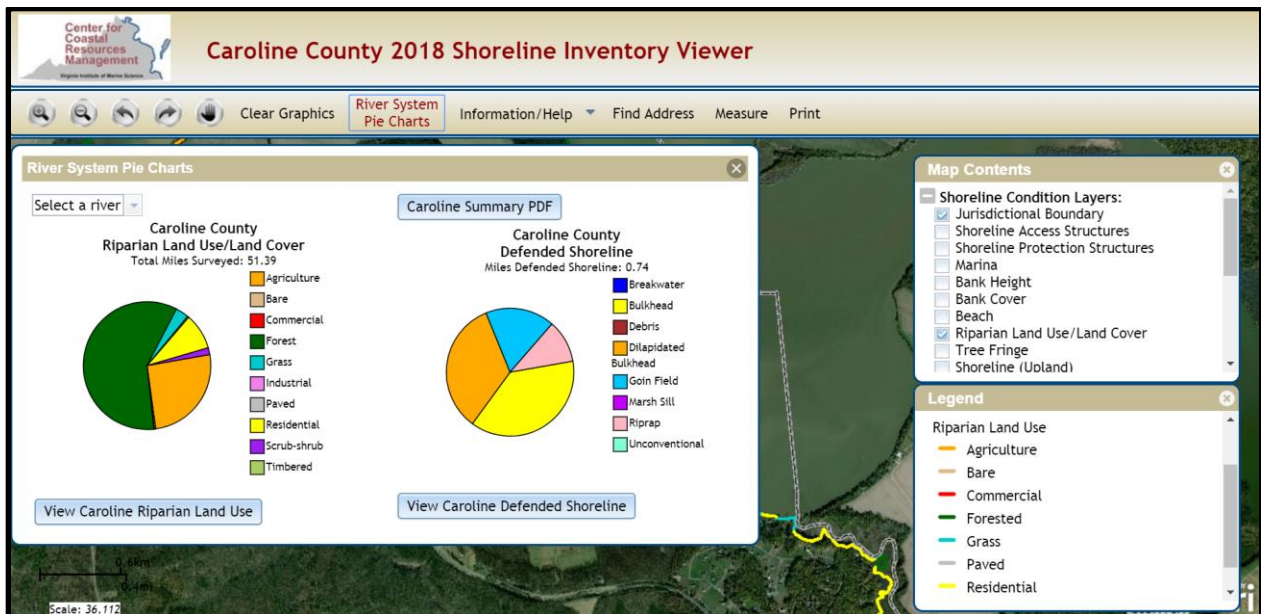
Figure 7. Pie charts display land use and shoreline hardening statistics for each tributary.

The top toolbar also includes tabs to access some important status information for the locality. By clicking on the “River System Pie Charts” button, users can obtain a statistical summary distribution of the riparian land use and amount of hardened shoreline for a specific water body selected from the drop down menu in the upper left (Figure 7). More detailed results in table format can be found by clicking the Caroline County Summary PDF button also in the window. The summary statistics are reported by river systems (Figure 2).

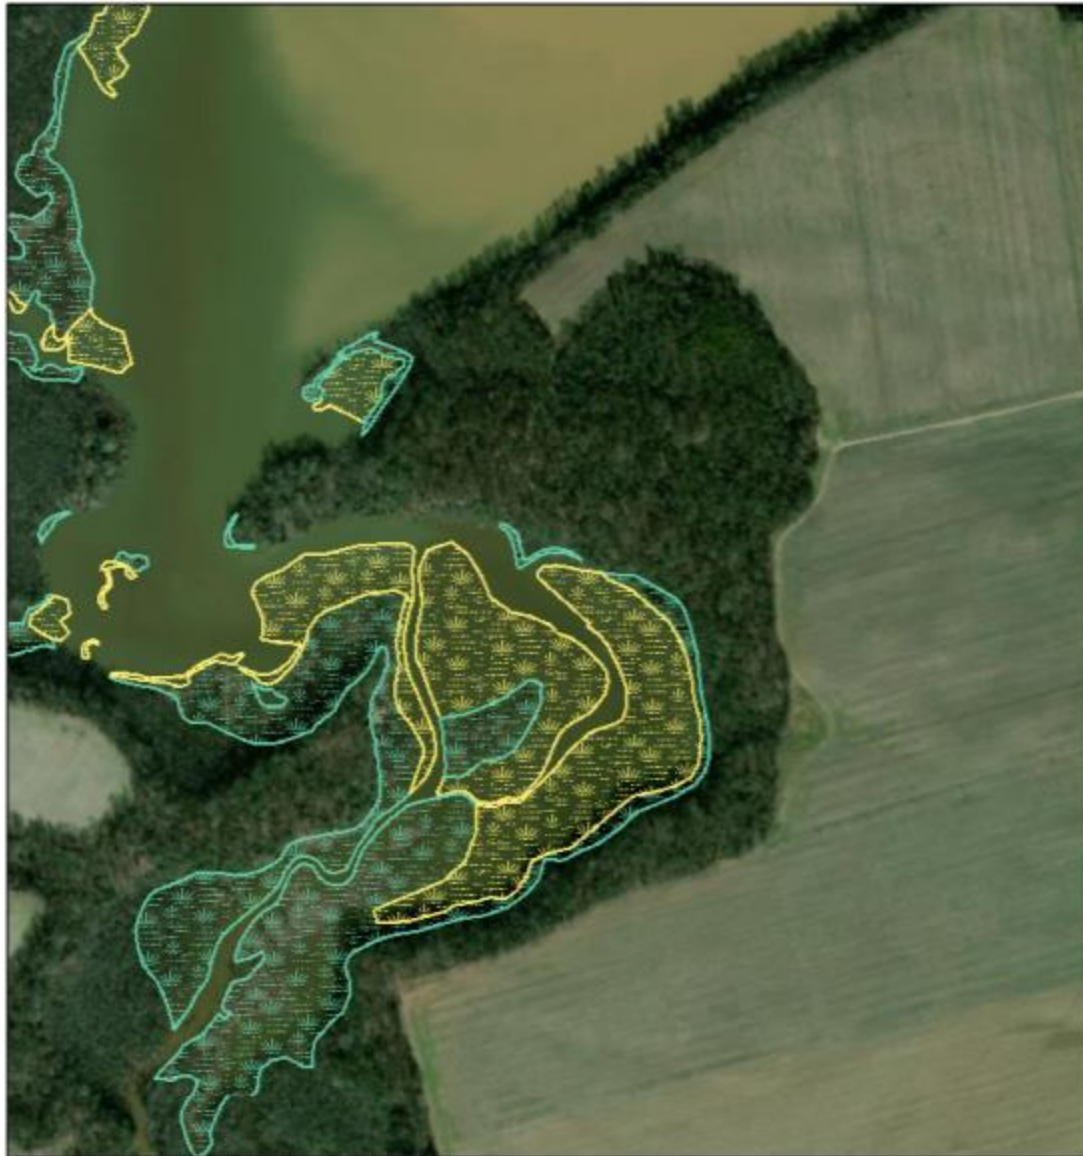
Tidal Marshes - Section of the Peumansend Creek

Tidal Marsh Community Type
