Arlington County, Virginia - Shoreline Inventory Report: Methods and Guidelines

Arlington County, Virginia Shoreline Inventory Report Methods and Guidelines

Prepared By:
Comprehensive Coastal Inventory Program
Center for Coastal Resources Management
Virginia Institute of Marine Science, College of William and Mary
Gloucester Point, Virginia
December 2018

Special report in Applied Marine Science and Ocean Engineering No. 473 of the Virginia Institute of Marine Science

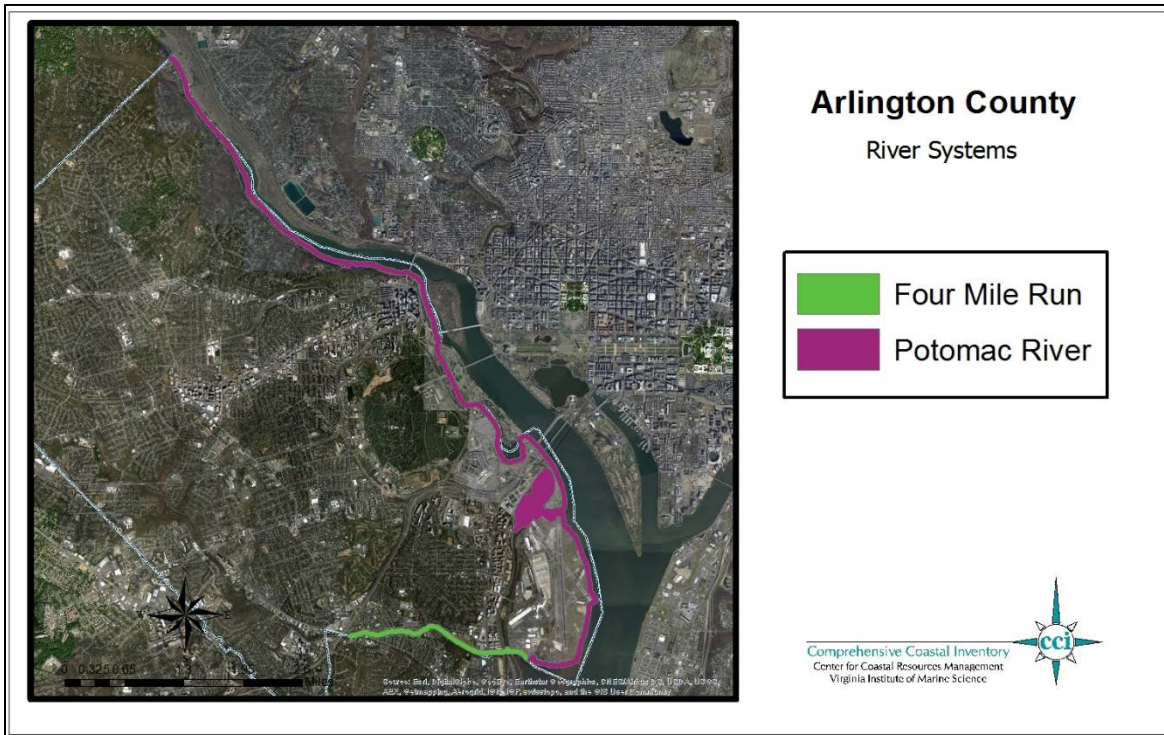
Figure 2. River Systems in Arlington County

Summary tables (Tables 4-7) quantify conditions observed on the basis of river systems (Figure 2). Refer to Figure 2 for the location of these rivers systems. Note, river systems do not

correspond to watershed boundaries. They were developed for convenience in reporting data.

The top toolbar also includes tabs to access some important status information for the locality. By clicking on the “River System Pie Charts” button, users can obtain a statistical summary distribution of the riparian land use and amount of hardened shoreline for a specific water body selected from the drop down menu in the upper left (Figure 7). More detailed results in table format can be found by clicking the Arlington County Summary PDF button also in the window. The summary statistics are reported by river systems (Figure 2).

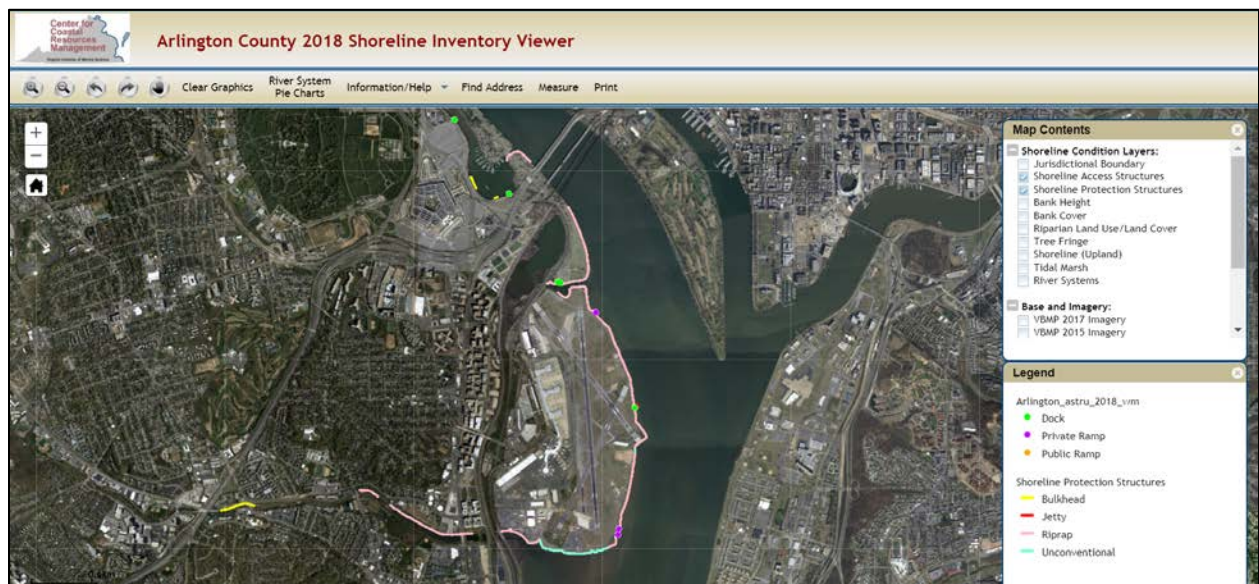
Figure 4. Map Viewer illustrates Shoreline Access and Protection Structures for a section of Arlington County.

In Figure 4 Shoreline Access Structures, and Shoreline Protection structures are selected.

Shoreline Access structures are point features that includes piers and boat ramps. The actual footprint of these structures is not measured; only their location. Shoreline Protection Structures are line features and are mapped and illustrated in the viewer to show where they occur along the shoreline. Figure 5 illustrates riparian land use in the riparian zone for the same section of the County.

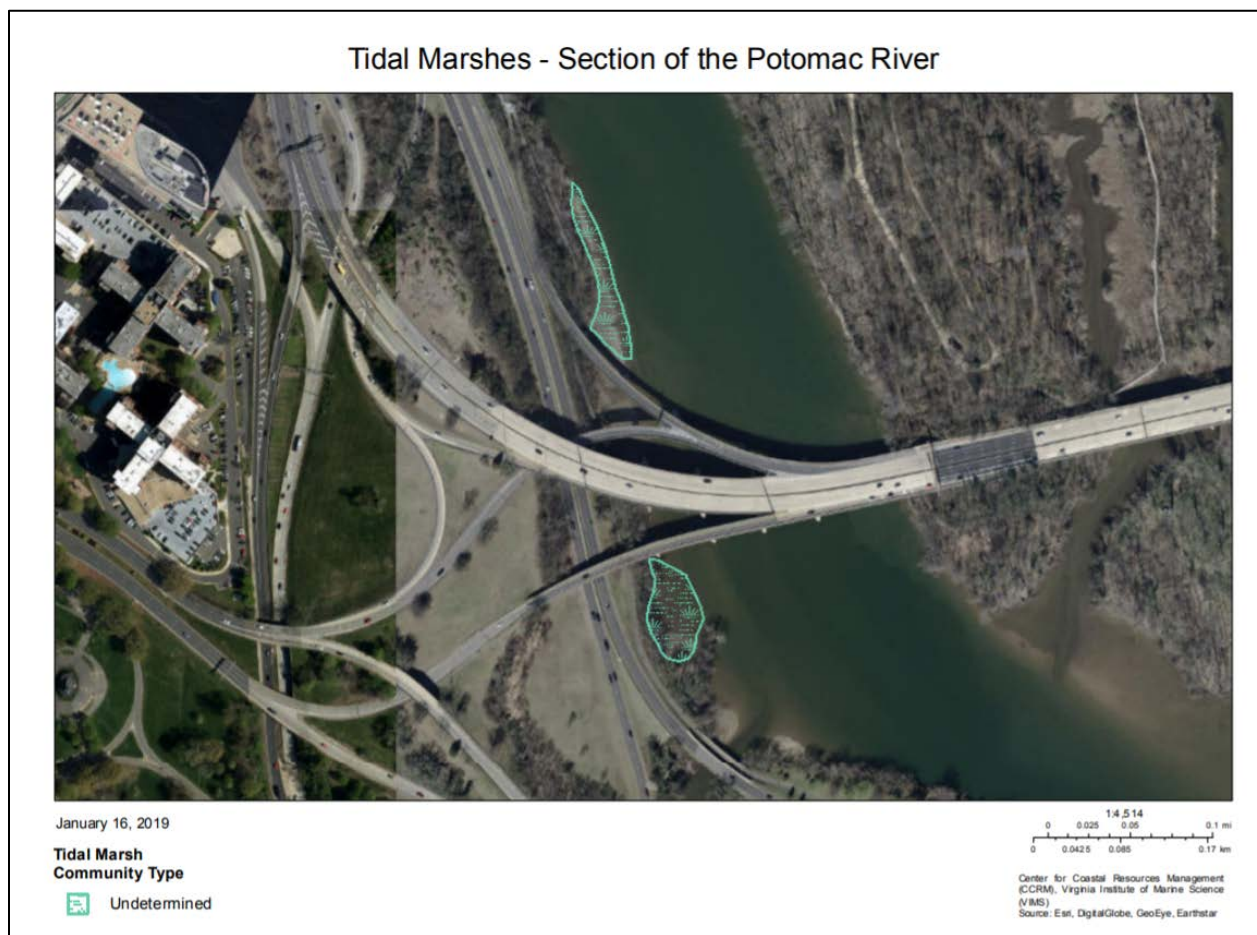
Figure 8. Customized print window for a section of Potomac River

button. The page can be set up for printing to 8.5 x 11 portrait or landscape style. Figure 8 is an example of a customized map generated for a section of the Potomac River. Here the tidal marsh communities are displayed, and the community type is reported in the legend beside the illustration.
