## Shoreline situation report, James City County, Virginia

# Shoreline Situation Report JAMES CITY COUNTY, VIRGINIA

Chesapeake Research Consortium Report Number 15  
Special Report In Applied Marine Science and Ocean Engineering Number 81 of the

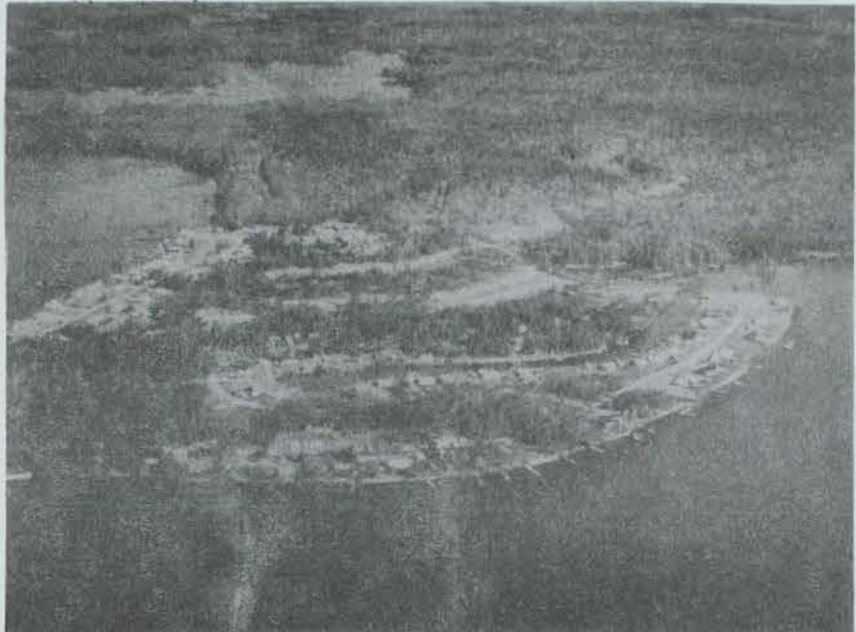
FIGURE 4

Figure 4: Chickahominy Haven, one of the most intensely developed shoreline areas in James City County. Recent environmental legislation limits the construction of dead-end canals such as those that exist here.

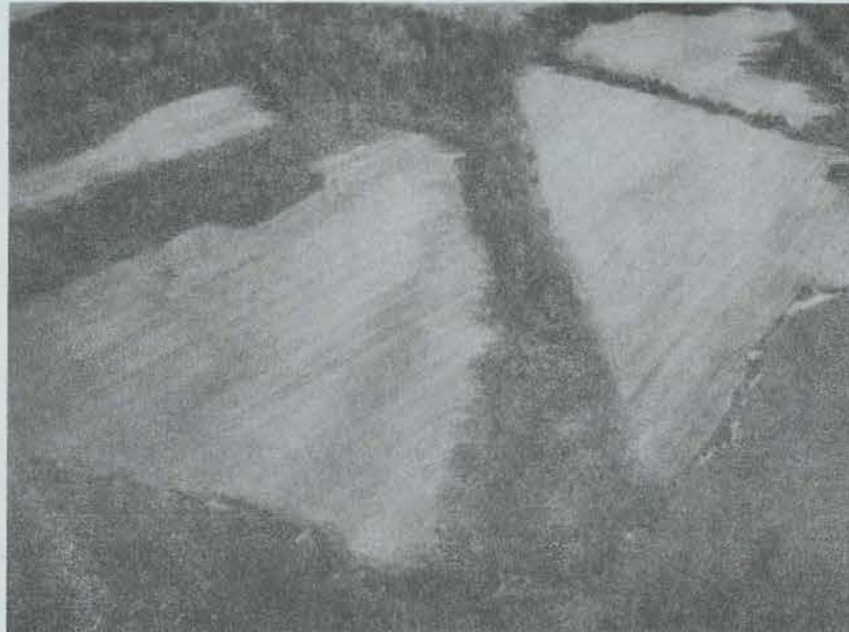
FIGURE 5

Figure 5: The erosion of the agricultural area along the James River near the mouth of the Chickahominy might be decreased by not plowing or working the area within 10 feet of the bank. This type of passive shore protection would allow the growth of large plants with root structure that would help stabilize the bank, thus slowing the erosion.

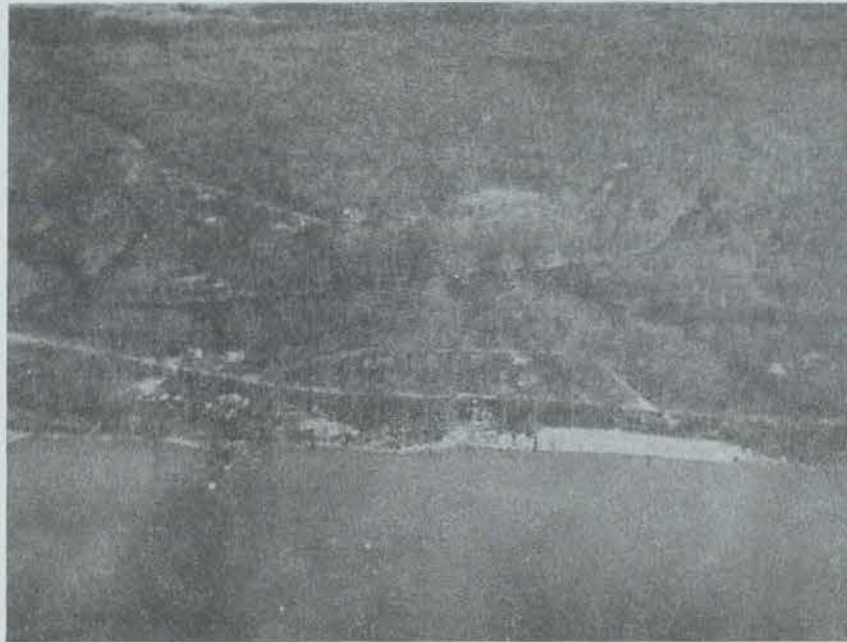
FIGURE 6

Figure 6: First Colony, a residential development on the James River. The area has low bluffs with a clay substrate. Erosion is severe in the unprotected areas, where the bluff is retreating at a rate of approximately a foot a month. This area desperately needs a unified shore protection plan, especially as many of the individual attempts at shore protection have either caused more problems or have been less successful than desired.

The real area of shoreline erosion problems in James City County is the area upstream of Jamestown Island. Some portions of the First Colony development show erosion rates of over ten feet per year. Areas of present and planned dwellings should be protected and protection should be constructed on an area rather than a cadastral basis. Construction of shore defense structures on the basis of individual properties with different contractors and different methods and at different times causes greatly increased cost and reduced effectiveness. It appears that bulkheading is the most successful tool in protecting this stretch of shoreline. Proper landscaping, that is slope reduction and proper vegetation, can significantly aid the effectiveness of the bulkhead. Also, the great clay content of the bluff and resulting impermeability of the soil require that the bulkhead be carefully constructed with a filter cloth backing and weep holes. The top of the bulkhead should be high enough to prevent frequent overtopping by waves. It is very important that any water behind the bulkhead be allowed a free channel through the wall; otherwise the increased hydrostatic pressure on the back of the wall will hasten failure and the great volume of water trapped behind the bulkhead will soften the ground creating the potential for muddy ponds behind the bulkhead. The addition of a channel of coarse, permeable backfill material behind the

wall is strongly recommended.

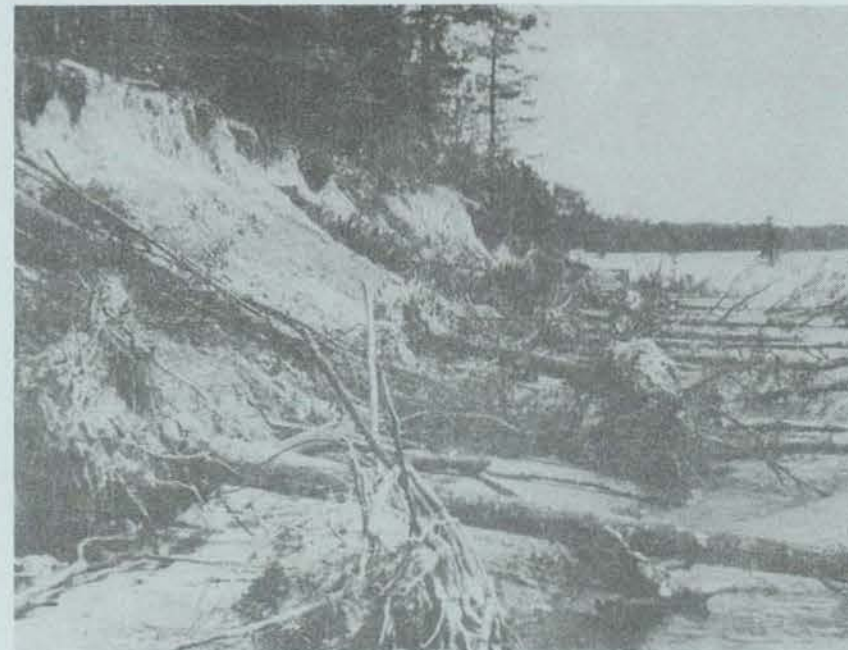
FIGURE 8

Figure 8: View downstream along First Colony. The fallen trees are clear evidence of the magnitude of the erosion. The bluff is approximately 20 feet high and consists primarily of clay. The erosion problem probably could best be managed by the use of properly designed and installed riprap or bulkheads, terracing and fill with permeable material, and vegetation.

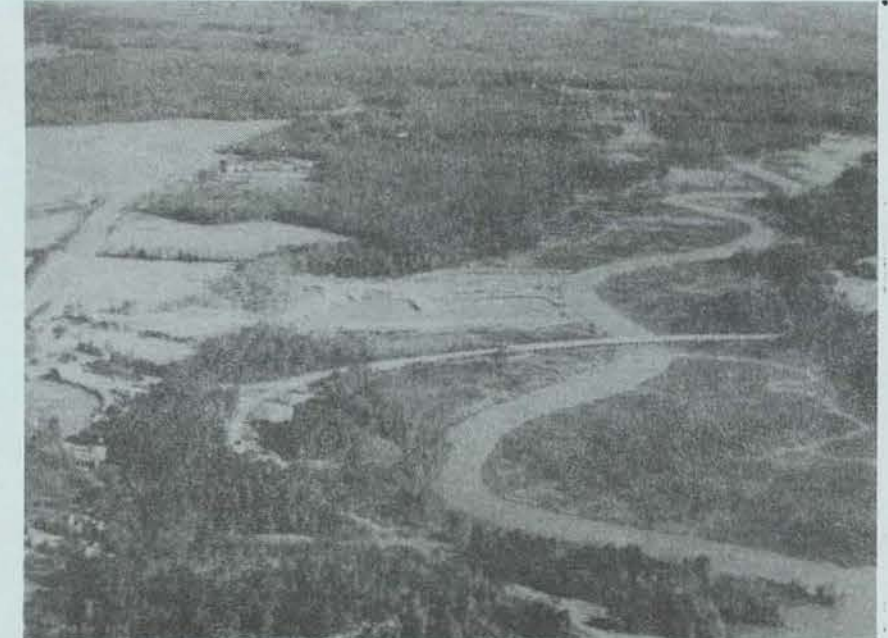
FIGURE 11

Figure 11: A view up Powhatan Creek. The creek is protected from rough waters and is easily navigable, making it a haven for many small pleasure boats.

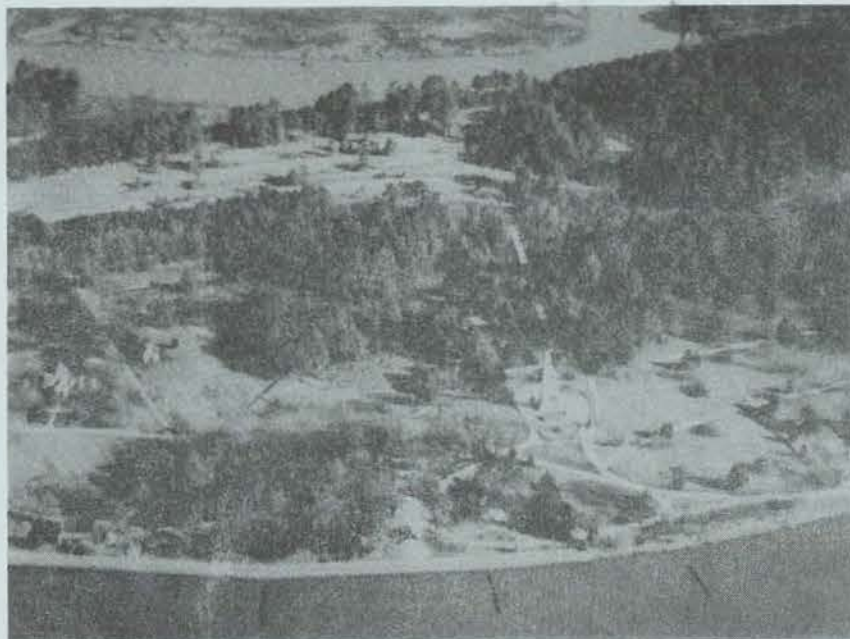
FIGURE 12

Figure 12: Jamestown Island National Historical Park. The James River shoreline, foreground, is protected by concrete revetment and riprap. The separation of the groins from the shoreline indicates earlier great rates of erosion and the general ineffectiveness of groins in this area. Revetments are an effective means of controlling shoreline retreat, although they are quite costly and frequently preclude the maintenance of a beach.

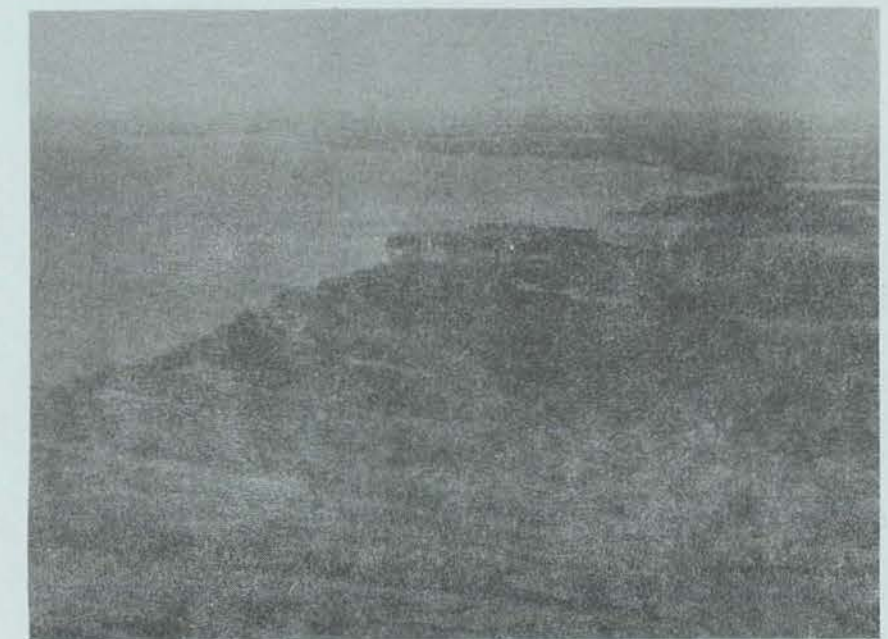
FIGURE 13

Figure 13: View upstream across Jamestown Island. The linear tree covered features in the foreground probably are old beach ridges.
