Reports on Chile Tsunami, May 24, 1960

著者	Noh Toshio, Fukui Hideo, Watanabe Yoshio, Hasegawa Norio
雑誌名	The science reports of the Tohoku University. 7th series, Geography
巻	10
号	1
ページ	95-118
発行年	1961-09
URL	http://hdl.handle.net/10097/44829

Reports on Chile Tunami, May 24, 1960

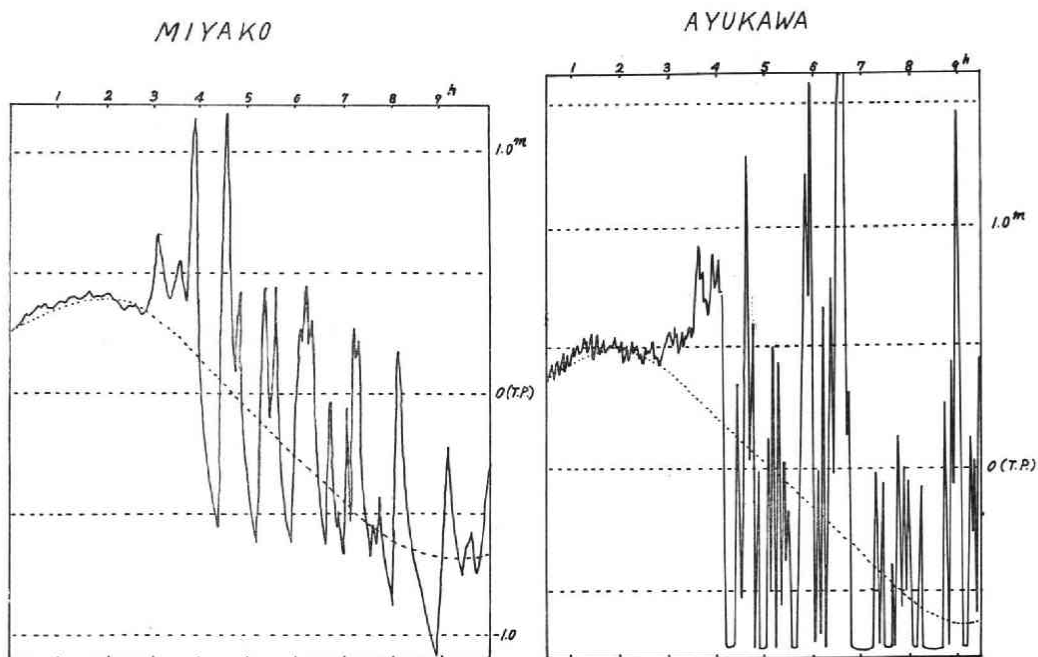
Fig. 1 Marigrams₂ at May 24th, 1960.

Tsunami, based on the marigrams. (Fig. 1). The arrival time is the time when the wave height begins to change greatly from the normal curve of the changes of the tidal level. The first wave on the Sanriku coast appeared as the form of the up-wave. The earliest was 2^h37^m at Eno-shima and the latest was 3^h22^m at Shio-gama. The time was earlier on the coast facing the ocean and at the island, and was later at the bay head. The amplitudes of the first waves were within the range of about 46–99 cm.

Fig. 2 shows the distribution of the arrival time of the first wave of the

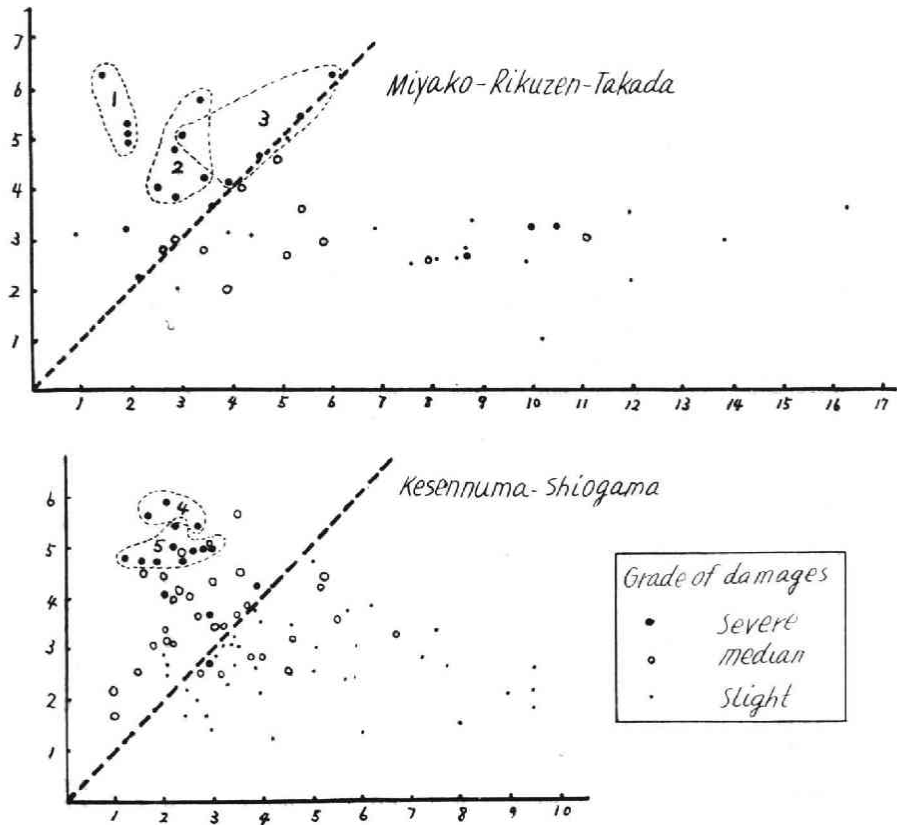
the damages, and are plotted in Figure 10, using the maximum heights of Tsunami waves in 1933 and 1960. According to the figure, it is reasonably understood that the settlements suffered severer where the maximum heights of Tsunami waves in 1960 were higher than in 1933, though the absolute maximum heights were not so high. The damaged areas in 1960 were different from those in 1933, and they were

Fig. 10. Classification of settlements according to the grades of damages and wave heights of Tsunami.

located at the heads of deep embayments.

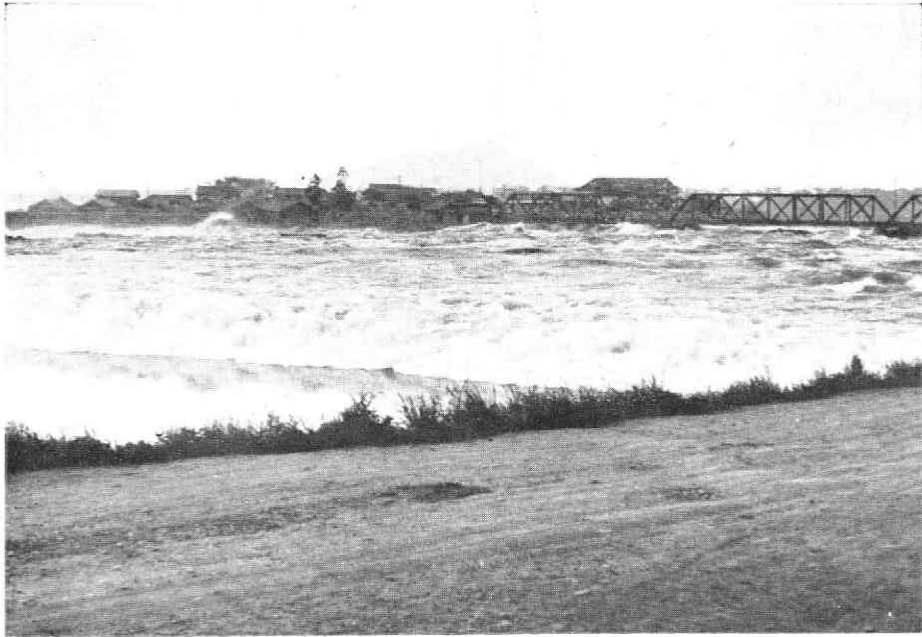
Photo. 1. The tip of tongue of the first Tsunami flowing upstream the Kesen River.

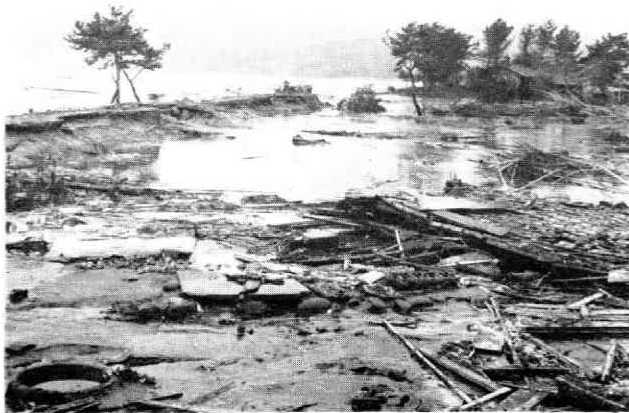
Photo. 2. Destroyed sand-dune with pine trees at the head of Hirota bay.

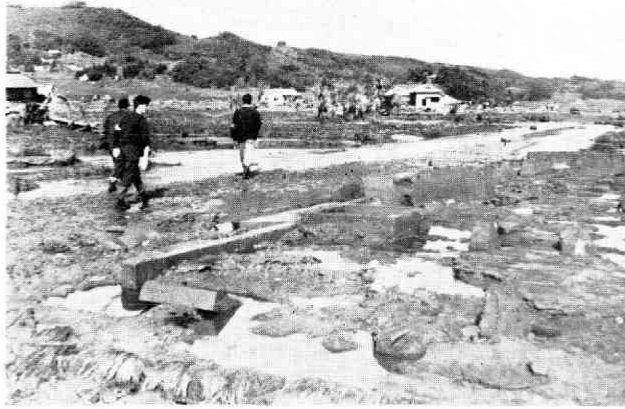
Photo. 3. At Ryogae located at the head of Hirota bay, settlers' houses were destroyed severely and their foundation-stones were only remained.

Kesen-numa bay and Shiogama bay. Especially at the settlements located on deep submarine valleys or their branches, most of houses was destroyed or washed away, leaving their foundation stones only, as observed at Akazaki (Ofunado bay) and Ryogae (Hirota bay).

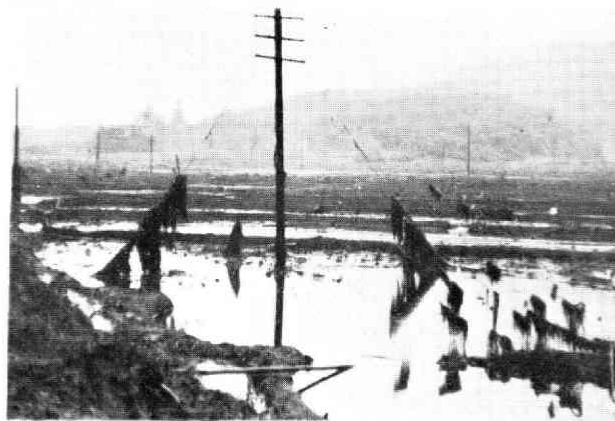
Photo. 4. Paddy fields of Otomo area, Hirota bay, after the flood of sea water.

transplanting plants were soaked in the sea water as well as suffered from the salt in the soil. Thus the rice culture suffered from the salt damage, and the amount of the damage on rice plants was by far larger than that of the destruction of arable land. The areas severely damaged by salt were Miyako bay, Oozuchi bay, Oofunado bay Hirota bay and Kesen-numa bay.

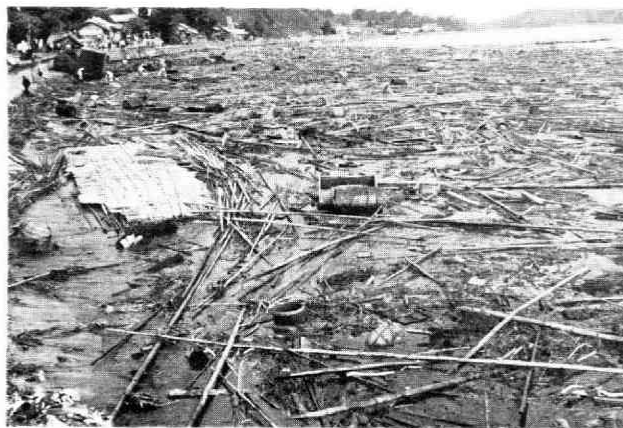
Photo. 5. Agglomerated materials of oyster culture. Oofunado bay.

Almost all wooden frames for oyster culture were carried away, especially in Oofunado bay, Hirota bay, Kesen-numa bay and Shizugawa bay. At the fishing villages engaged in oyster culture, owing to the low tide-break, many workshops were overthrown or destroyed, and houses were flooded above floor by 2 meters.

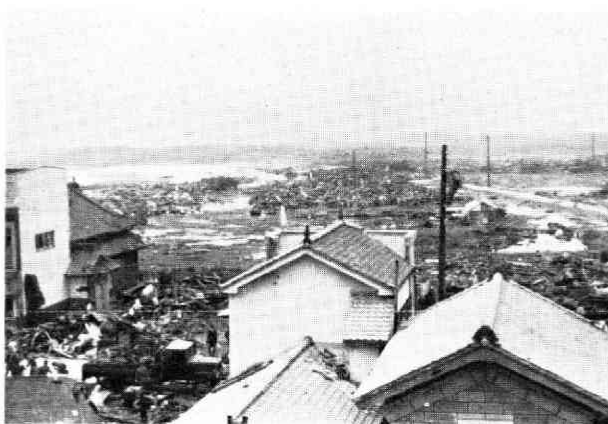
Photo. 6. Oofunado city was damaged severely by Tsunami.

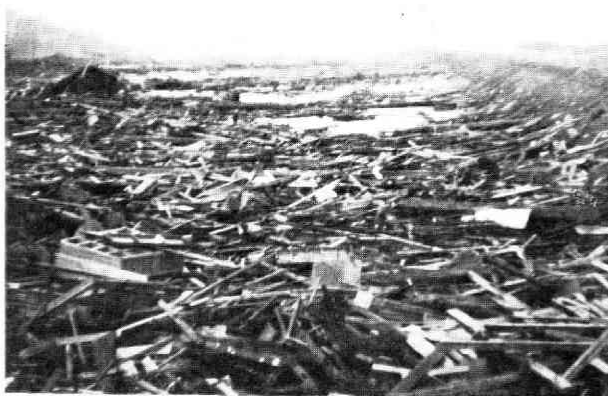
Photo. 7. Accumulated materials of houses flowed by Tsunami on the field at Sano, Oofunado bay.

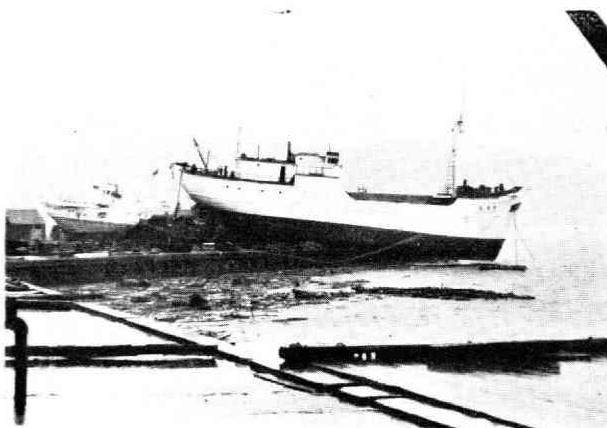
Photo. 8. Fishing boat driven high and dry on the quay of the port of Oofunado.

constructed on the land reclaimed from the foreshore of a delta. However, the Tsunami waves were so strong that large fishing boats were given a hoist over the wharf, and the freight cars near fish market were wrecked. Generally the water force of Tsunami was stronger at the ebb of the tide than at the rise of the tide, therefore the inner foundation of the tide-break and the quay-walls of ports were excavated by the ebb-tide from backside. In this way, the quay-walls were destroyed at Oofunado, Hachinohe, Kamaishi, etc., together with destruction of the houses by the same operation.

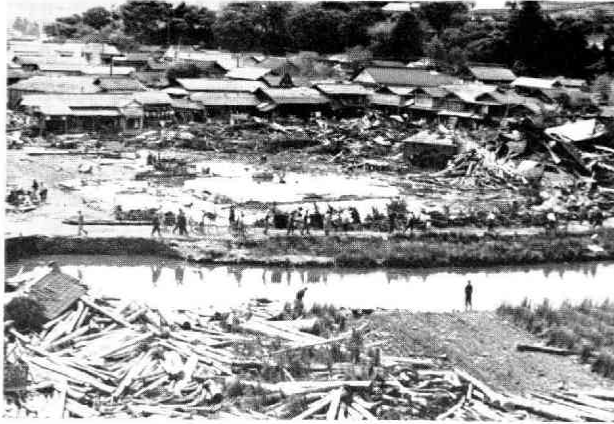
Photo. 9. Destroyed area of a river side at Shizugawa.

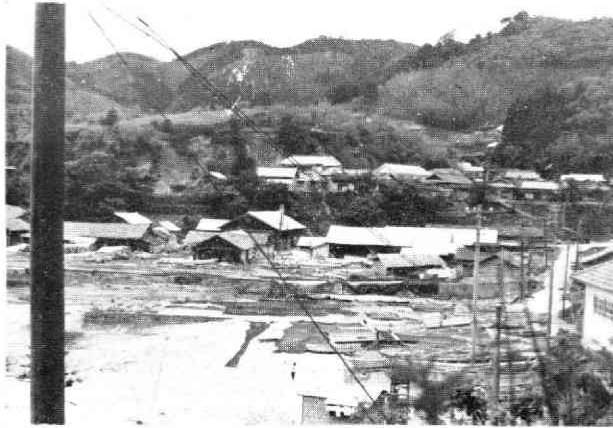
Photo. 10. At port of Ryori, the settlements once moved on high marine terrace were safe from the last Tsunami, whereas the houses located lower part were damaged by the Tsunami.

On the other hand, some of the settlements in this areas had moved inland to the higher places after the attacks of Tsunami in 1896 and 1933. However, some of them moved back to the lowland along the coast such as Ryori, Ryoishi, Koshirahama and Hongo. For the small scale fishermen, to live in higher places was very inconvenient for their activity. They suffered from the damages both in 1933 and 1960, though, fortunately, the damage was rather slight in 1960 thanks to the low wave heights.
