The Damage and the Rehabilitation Process after 1990 Luzon Earthquake

— Some Cases of La Union and Nueva Ecija —

Yoshiyuki MURAYAMA and Shin-ichi HIRANO

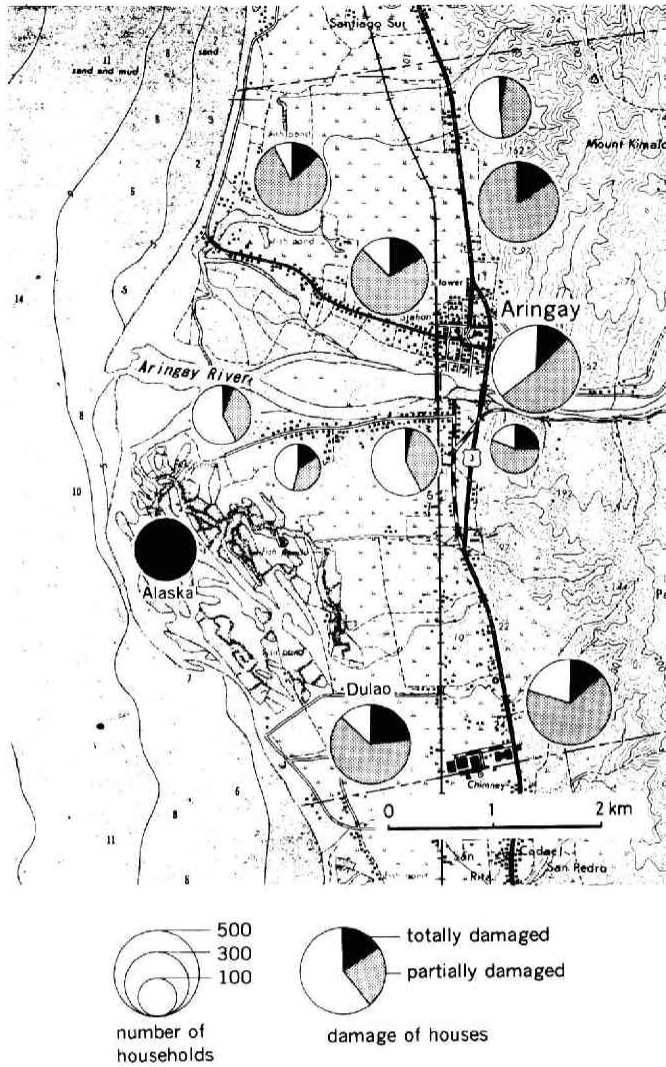
Fig. 3A

Fig. 3 The damage rates of houses in the coastal area of the three municipalities in La Union.

(A: Aringay Municipality, B: Agoo Municipality, C: Santo Tomas Municipality)

The data about affected houses of each barangay are provided by the DSWD office of each municipality. The number of households of each barangay is used for graphing, because the number of houses is not available. The number of households of each barangay is after 1990 census.

Many sand boils were observed in the coastal area (Tores *et al.*, 1992, Yanagisawa *et al.*, 1993b), and many houses were severely affected (Figs. 3A, 3B and 3C). At some settlements there, the ground subsided so far as buildings have sunk into the sea. In the barangays (the smallest political units) of Narvacan, Santo Tomas and Alaska, Aringay, almost all the houses were sunk, in some sitios (small settlements in barangay) in the barangays of Raois, Santo Tomas and Dulao, Aringay, many houses were also sunk in the sea. Narvacan is located on the tip of the sand spit, Raois is on the shore of the mainland (Photo 5), opposite side of the sand spit, and Alaska and Dulao are on the delta of the Aringay River. Heavily damaged settlements are those which are next to the fish ponds or surrounded by them. It is supposed that liquefaction causes subsidence and lateral spreading simultaneously in large scale (Yanagisawa *et al.*, 1993b). The people of the settlements were forced to evacuate, and some of them could not return because there was no land to live.

Alaska is located on the delta of the Aringay River. All the houses sank in the main sitio that had more than 90 percent of the houses of Alaska (Fig. 3A) (Photo 1). About a half of the people who had lived there moved to the other sitio which is the only place for them to resettle in this barangay. They built houses there with the materials donated by the Red Cross. The land is possessed by ex-captain of the barangay and his relative, and the resettlers are not claimed to vacate. However, they have neither electricity supply nor water supply. The remainders moved to other barangays. Some of them were called by their acquaintances who had moved from Alaska before the earthquake, asking for the accessibility to highway and the convenience of water (Fig. 7).

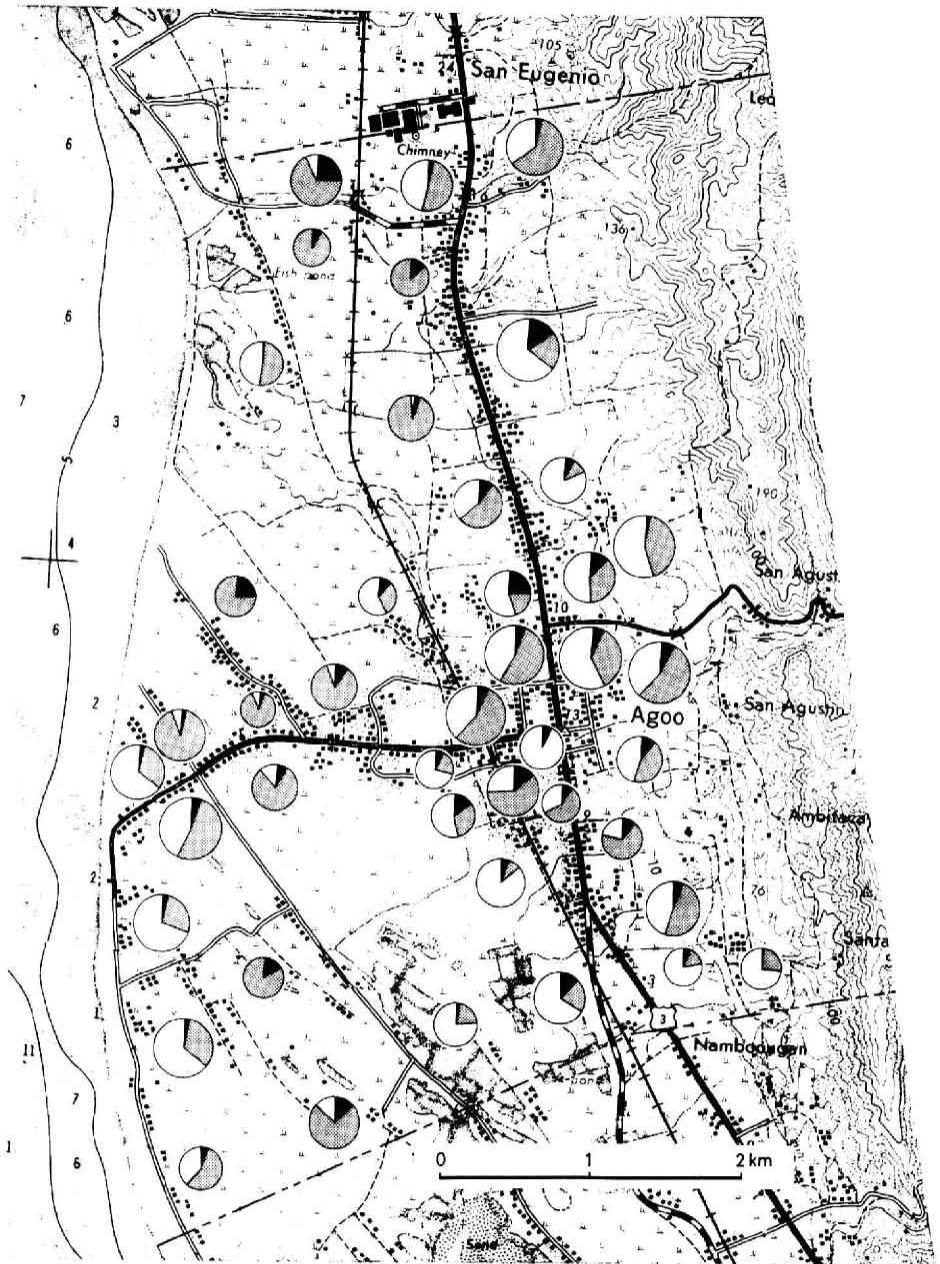
Fig. 3B Agoo Municipality

Fig. 3 The damage rates of houses in the castal area of the three municipalities in La Union.

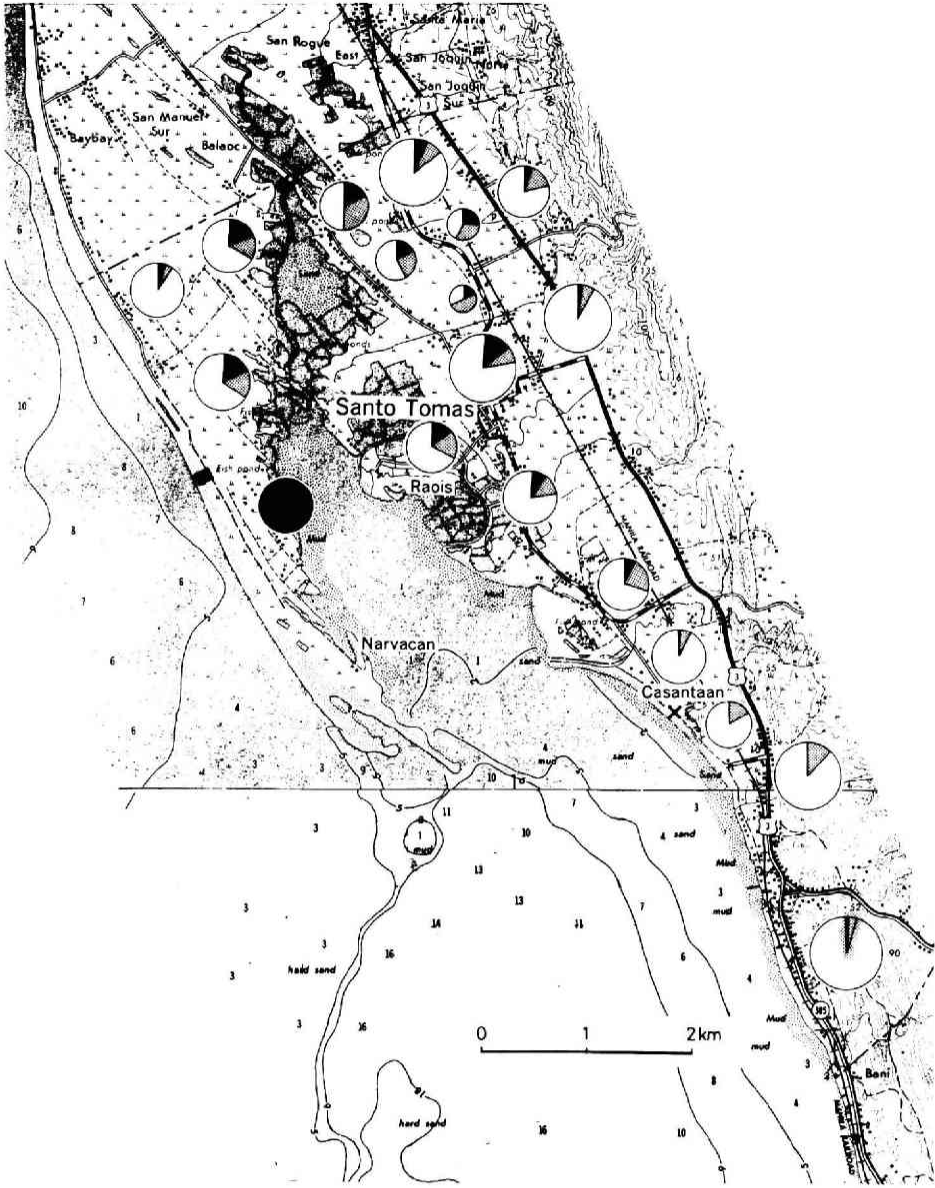
Fig. 3C Santo Tomas

Fig. 3 The damage rates of houses in the castal area of the three municipalities in La Union.

- × : new settlement built by the people from Narvacan
- : NHA project area

This barangay is located on the tip of a sand spit. In almost all part of the barangay, ground level sank 1-2 meters due to large liquefaction (Fig. 3C) (Photos 6 and 7). The people were forced to evacuate totally right after the earthquake, and then more than a half of them has returned to the area in the northern part of Narvacan where the land had remained to be resided. Some of the remainders built a new settlement in the southern part of Casantaan Barangay which is located on the shore of the mainland, where the barangay captain lives with 60 families. The rests have settled in the other barangays.

NHA (National Housing Authority) develop a new residential area of 1.5 ha for resettlement of Narvacan people. The NHA project area is located on the outer shore of the sand spit to the north of Narvacan (Fig. 3C). The land clearance and infrastructural works completed in January 1993.

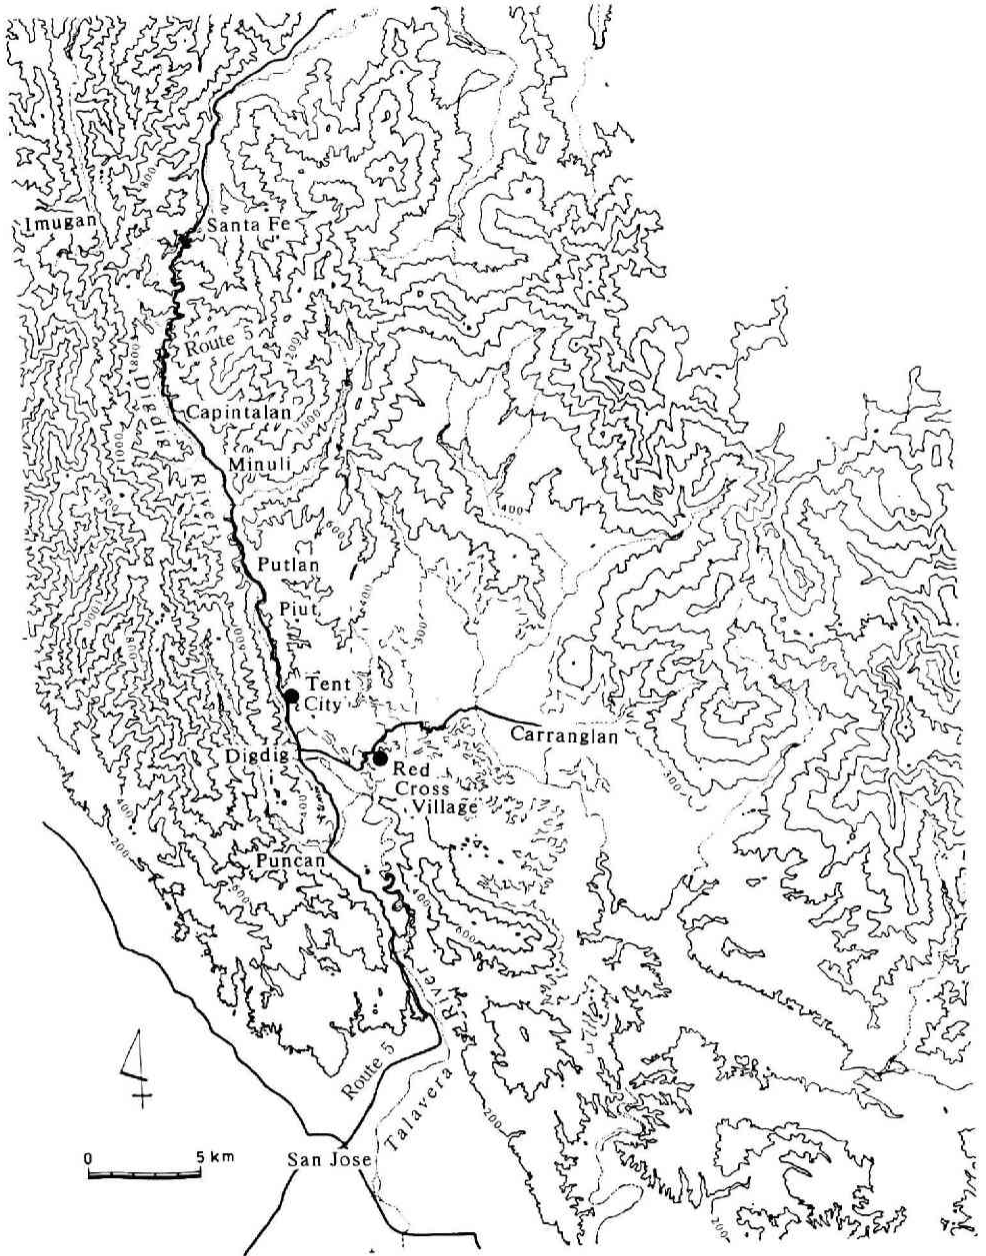
Fig. 4 Contour map of around the Digidig River, Nueva Ecija.
Contour interval is 200 m.

The Digdig Fault is one of the most distinguished active faults. It stretches with high certainty in the direction of NW-SE or NNW-SSE. In the southern part of Nueva Ecija, it separates the mountain area on the northeastern side from the Luzon Central Valley on the southwestern side (Figs. 1 and 4).

People of this sitio moved to the area in the south of Piut, and they built a new settlement called "Tent City" (Fig. 4) (Photos 16 and 17). According to the people, this area is the only place where there were no hazards. As people moved into the Tent City from the other sitio of Piut, the population of the Tent City has increased. People of the Tent City have made plan for new settlement. However, the land is held by the Land Bank, people have to negotiate with the Bank about land use for their housing. There was neither electricity supply nor water supply in the Tent City. DSWD (Department of Social Welfare and Development) or the Red Cross recommends them to move to the Red Cross Village, but they do not want to hear (Fig. 7). The people think that they cannot make livelihoods there.

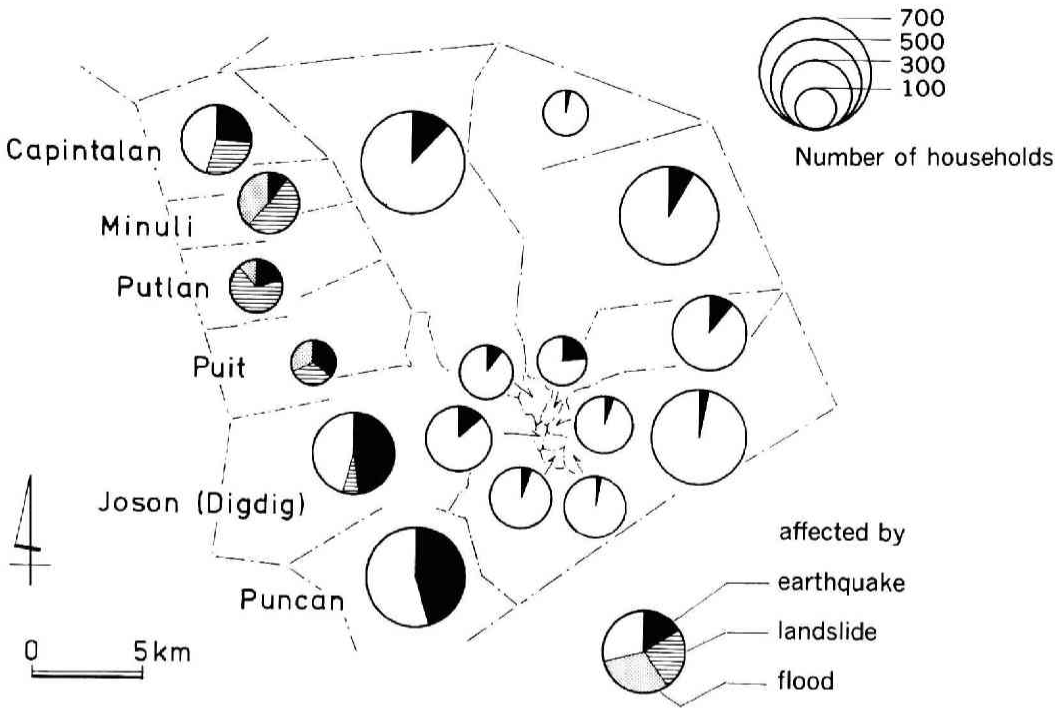
Fig. 5 The damage rates of houses in the mountain area of the Carranglan Municipality, Nueva Ecija. The data about affected houses of each barangay are provided by DSWD office of the Carranglan Municipality.

the distance from the drainage basin of the Digdig River is less than 10 percent (Fig. 5).

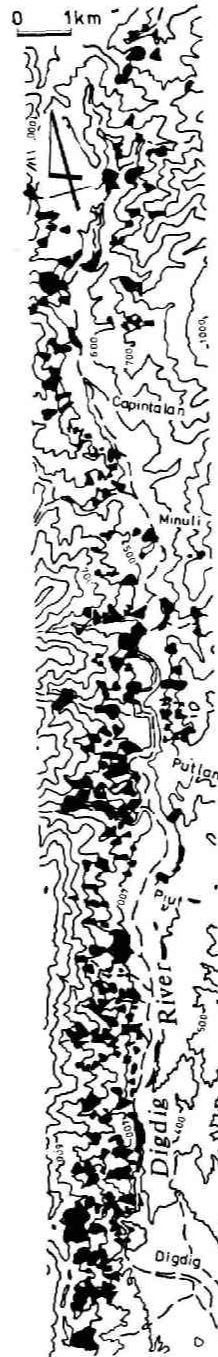
Fig. 6 Landslides distribution along the Digdig Fault.
(after Arboleda and Regalado, 1992)

Moreover, many landslides occurred by strong shock, especially on the right bank of the Digdig River (Fig. 6). This area is located along the Digdig Fault. The lost houses from landslides amount to over 50 percent in the barangay of Minuli and Putlan, and it amounts to approximate 30 percent in the barangay of Capintalan and Puit. On the other hand, there are no houses lost by landslides at central Carranglan.

On 27 July 1990 and 26 August 1990, two typhoons hit the Luzon Island, and much precipitation flooded many rivers. The farmland and houses along the Digdig River were washed out or buried by flood sediments. There are approximately 30 percent houses lost by the flood in Minuli and Puit, but there are no houses lost in Capintalan, Digdig and Puncan (Fig. 5). Around middle reaches of the Digdig River, there are many landslides caused by earthquake shaking and heavy rain (Fig. 6), so the river channel of the Digdig River was filling up and overflowing in Minuli, Putlan and Puit.

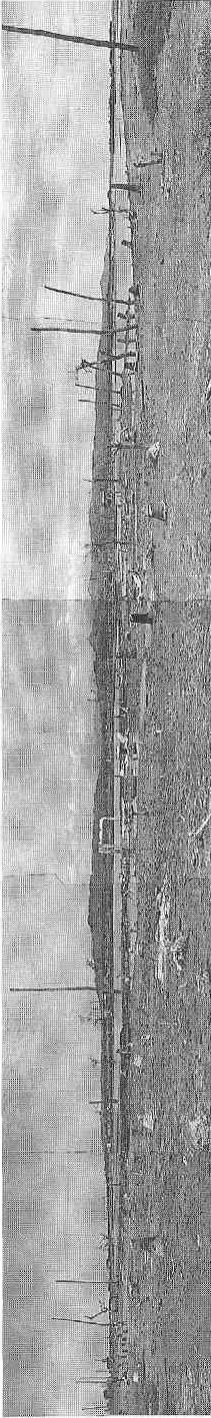
Photo 1 Sitio Centro, abandoned settlement, in Barangay Alaska

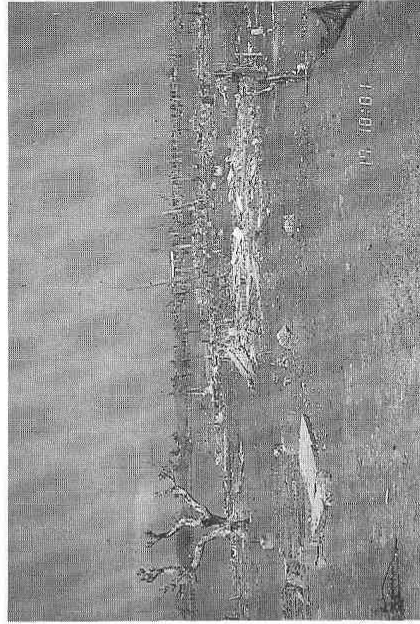
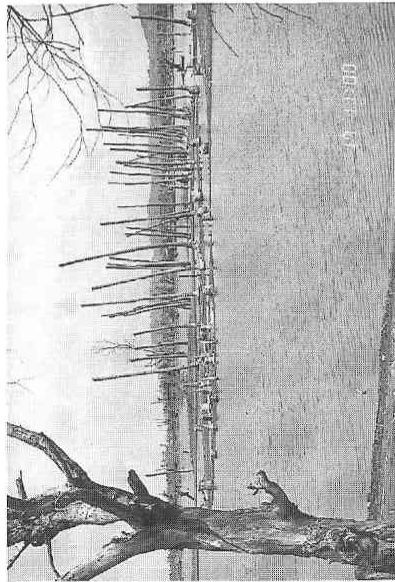
Photo 3 Sitio Hawaii, abandoned settlement, in Barangay Dulao

Photo 2 Sitio Yaris, abandoned settlement, in Barangay Dulao

Dulao is also located on the delta along the Aringay River. The residential areas are sited on beach ridges. Between these beach ridges, there had been many fish ponds, some of them were destroyed by liquefaction. In some of sitios in this barangay, Hawaii Sitio, Yaris Sitio and Berlin Sitio, most of houses sank (Fig. 3A) (Photos 2 and 3). The people evacuated from these areas to the railway track right after the earthquake, and then most of them moved to new settlement that was developed near Centro Sitio. The barangay captain asked the administrator for "imminent domain" of the land, and asked the Red Cross for housing material. The people who moved into the new settlement built houses by their own (Photo 4). People who came from the same sitio were allotted plots for housing as a group (Fig. 7).

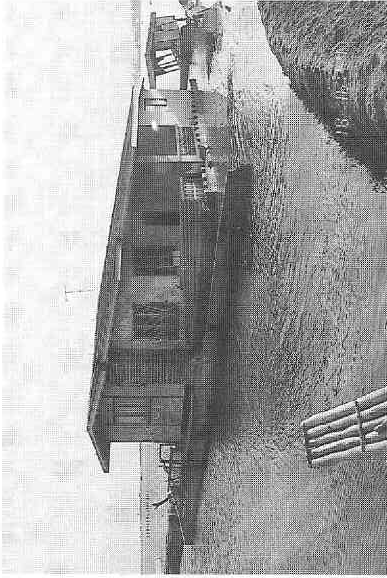
Photo 5 Abandoned house in Barangay Raóis

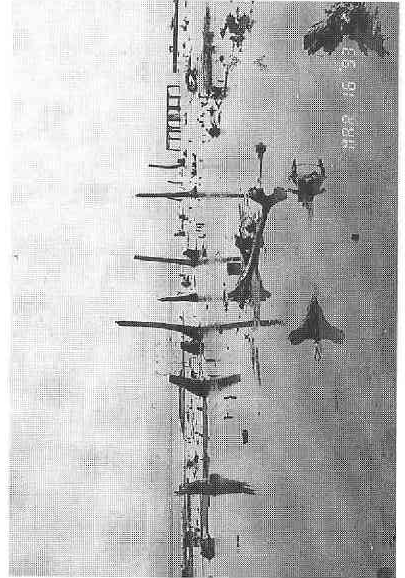
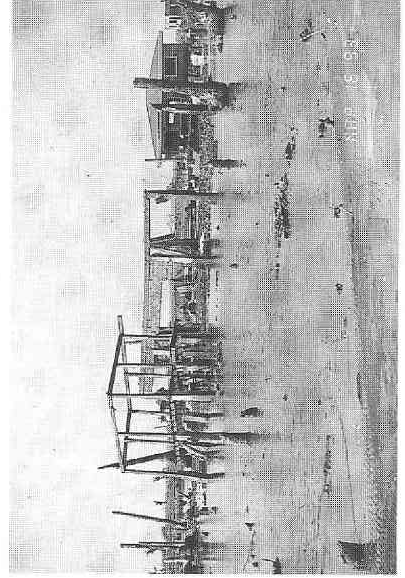
Photo 6 Barangay Narvacan, abandoned settlement

Photo 7 Barangay Narvacan, abandoned settlement

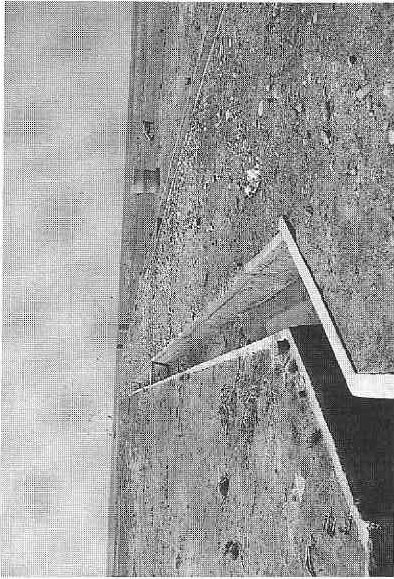
Photo 8 NHA Project Area, to the north of Barangay Narvacan
There are drain and wells, but no houses.

However no one lives there in March 1993. This area had been known to people of Narvacan as the place prone to flood, and was really affected by storm in December,

1992 under construction (Photo 8).

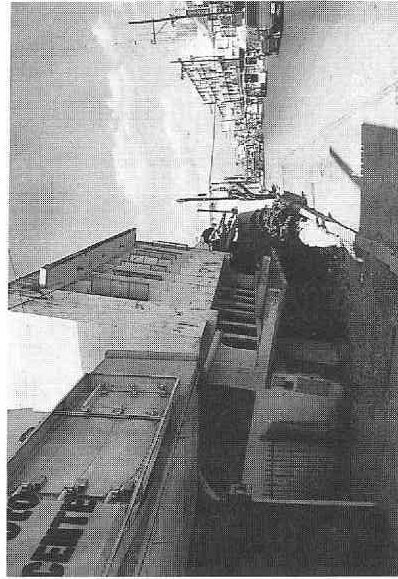
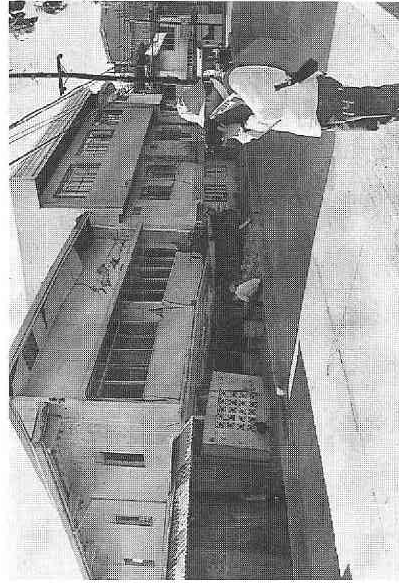
Photo 11 Tilted and subsiding building in Dagupan City

Photo 10 Tilted and subsiding building in Dagupan City

Dagupan City, Pangasinan, is located on the southern shore of the Lingayen Gulf, and is on the new fluvial sediments or even on the reclaimed land on the marsh. Lateral spreading alongside the Pantal River, land subsidence, sand boils, and many buildings tilting and/or subsiding were observed as the effects of liquefaction in Dagupan City (Photos 10 and 11) (Tores *et al.*, 1992, Yanagisawa *et al.*, 1993a)¹⁾.

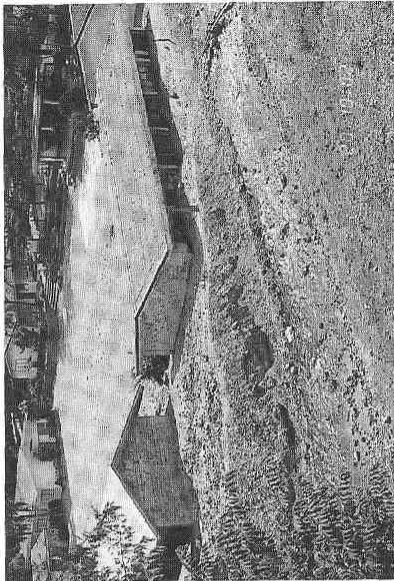
Photo 12 Santa Fe, school building burried by flood deposits

In consequently, farmland and houses were covered with flood materials. On the other hand, there were few landslids around the most upper stream area of the Digdig River, so that the river bed was not buried. Around the down stream area, fine material was carried away by the flood, or boulder was trapped in the middle reach, so the land was not buried with sediments (Photos, 12, 13, 14, 15 and 21).

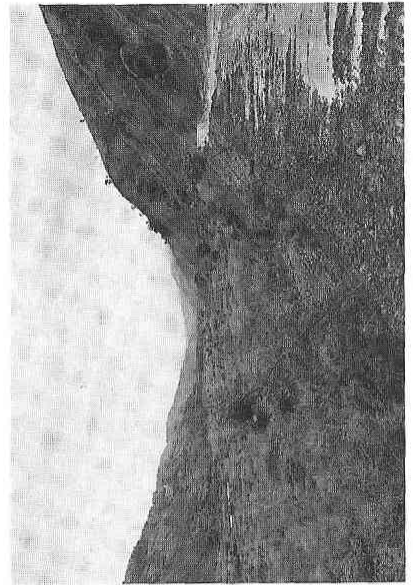
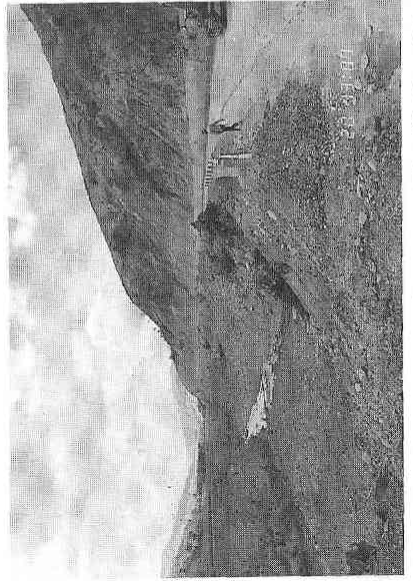
Photo 15 Northren part of Barangay Piut (20 Mar. '93)

Photo 14 Northren part of Barangay Piut (Aug. '90)

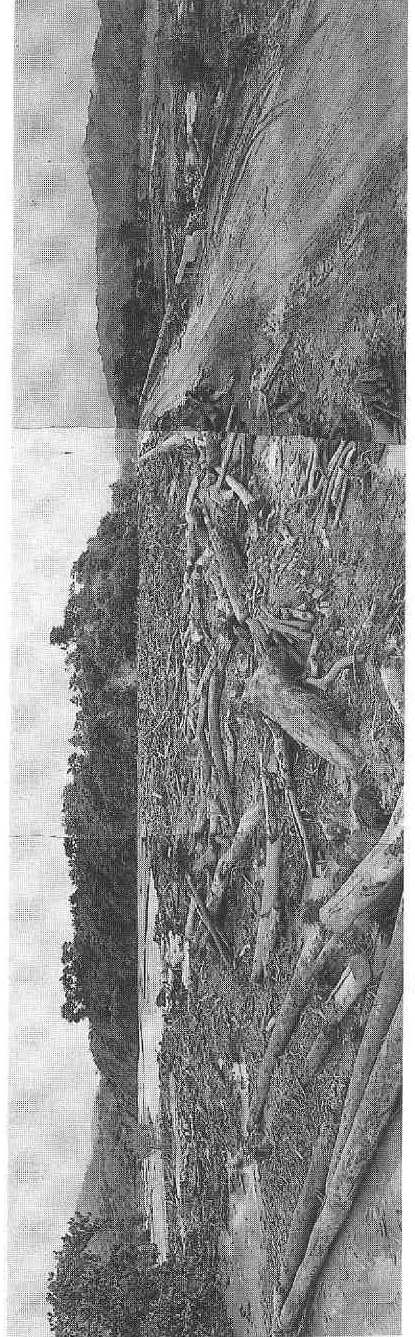
Photo 21 Dammed up by driftwood at Puncan Bridge (Aug. '90)
