**Landslides and Terraced Paddy Fields in the Western
Middle Mountains of Nepal :
A Case Study for a Perspective of Watershed
Environmental Management**

Toshikazu TAMURA

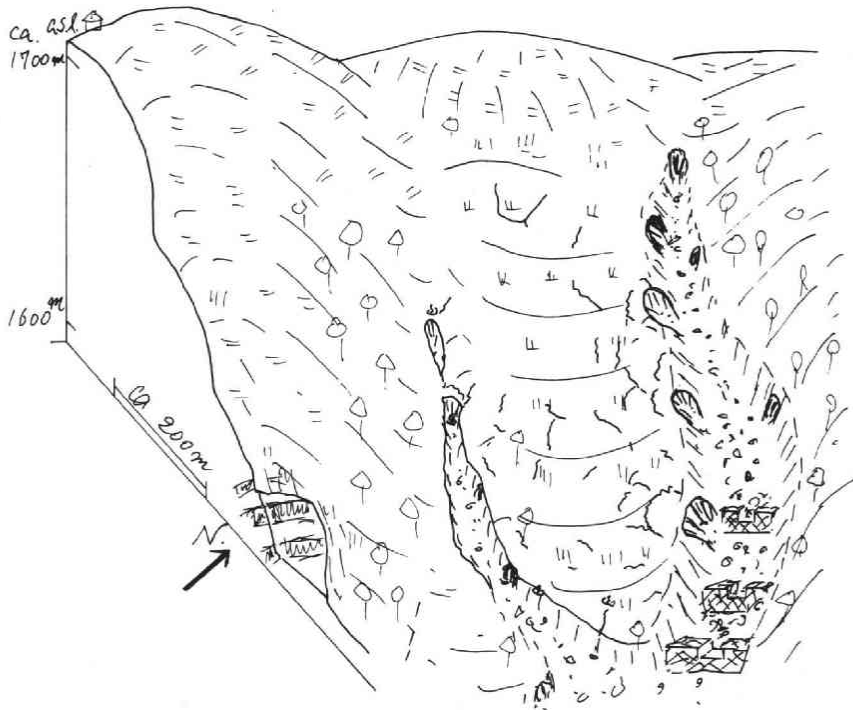
Fig. 6 An explanatory illustration of landform, geology, land-use, and deep-seated slide at Kuhire Kateri Samsire, Parbat. Surface cracks and gabion-type check dams are shown. Other keys are the same as those of Fig. 4.

Terraced paddy fields are distributed on the east-faced slope around 25 degrees bordering the gentle crest slope on which the settlement of Kuhire Kateri Samsire, Durlung VDC, Parbat District, is located (Fig. 3 and Photo 8). Water springs observed at various parts of the paddy terrace area are utilized for irrigation. Gray soft clayey soil with mottles also seems to provide suitable condition for paddy rice cultivation. However, considerable parts of the paddy terraces have been abandoned because of extending cracks (Photo 9). Residents have noticed the cracking since the late 1970s. Moreover, active gullying and associated surface slides on the paddy-terraced slope have produced much debris to be transported downstream (Fig. 6 and Photo 10).

Residents are constructing many hand-made check dams of gabion-type in gullies by themselves (Fig. 6 and Photo 10). Design of dams are drawn up by soil conservation officers. Stone material is obtainable on site. Internationally-aided cement and wire are supplied through Parbat District Soil Conservation Office. This work is thus considered a successful example of residents' self effort for land environmental protection. The efforts are, however, the measures only to shallow regolith slides and small debris flows along and in gullies, and are not effective for stabilizing deep-seated

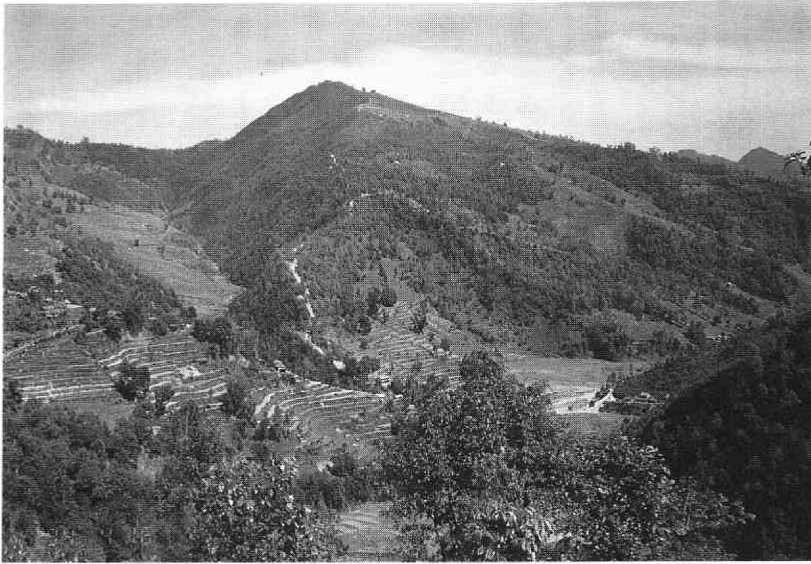
Photo 1 Structurally controlled slopes and differentiated land-use on them in the Middle Mountains, east of Pokhara. (Photo by T. Tamura ; April, 1994)

Settlements and cultivated lands tend to be located on gentle dip-slopes of the mountains controlled by the structure of schist/phyllite, while steep scarp slopes are extensively occupied by forest (Photo 1). Cultivated land on the slopes inevitably takes the form of terraces which are traditionally classified into *bari* and *khet*²⁾.

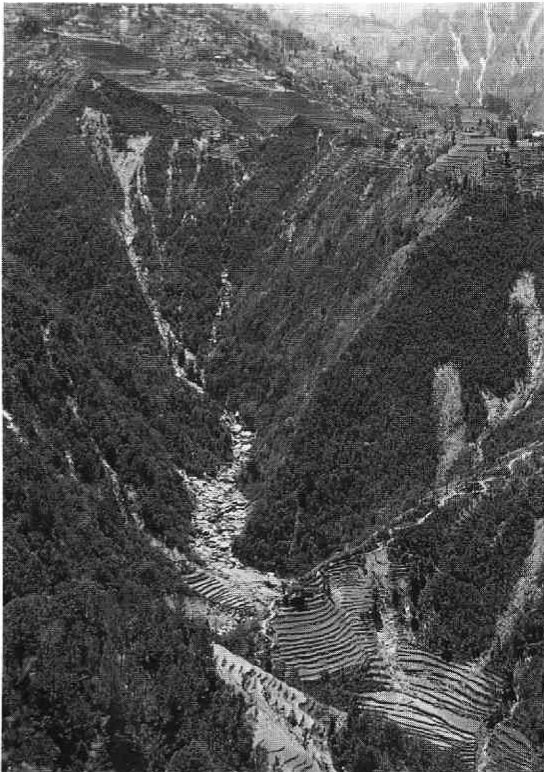
Photo 2 Concentrated regolith slides and debris flows on cultivated and forested hillslopes in the Middle Mountains, west of Kathmandu. (Photo by Tamura ; April, 1994)

Terraced fields are in some areas affected by shallow regolith slide and induced debris flow (Photo 2). The phenomena have been frequently considered as a consequence of deforestation, as introduced in Ives and Messerli (1989). In addition, several other types of landslides take place in relation to geologic and geomorphic conditions.

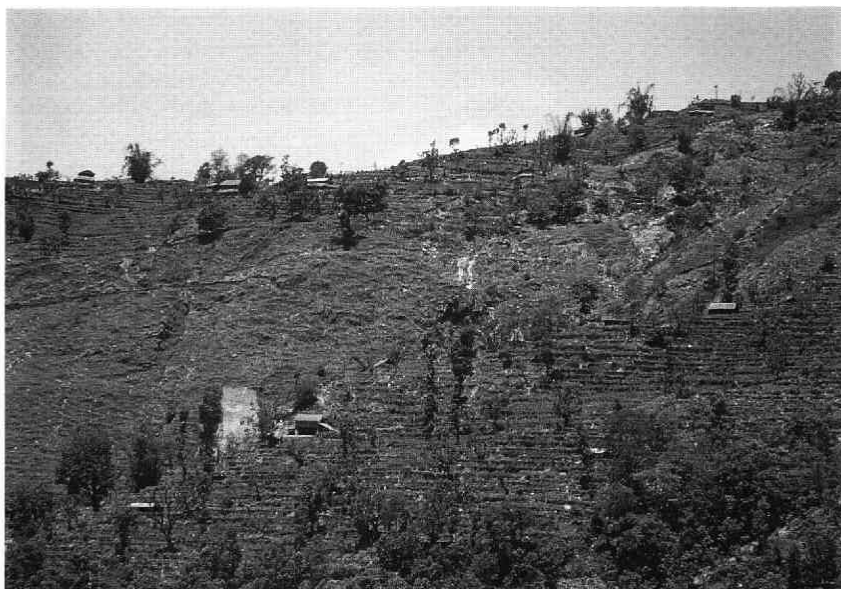
Photo 3 The hillside covered by paddy terracettes, partly abandoned, at Smaili, west of Pokhara. (Photo by T. Tamura ; May, 1994)

At Smaili in Kaskikot VDC⁴, Kaski District, about 10 km west-northwest of Pokhara (Fig. 2), a dipslope around 25 to 30 degrees and more than 1 km long is composed of resistant and impermeable schist. The bedrock extensively exposed and some streams flow down on it without entrenching. Very thin stony soil less than 30 cm thick on the bedrock slope is artificially accumulated to construct innumerable very small paddy terracettes one to a few meters across (Photos 3 and 4).

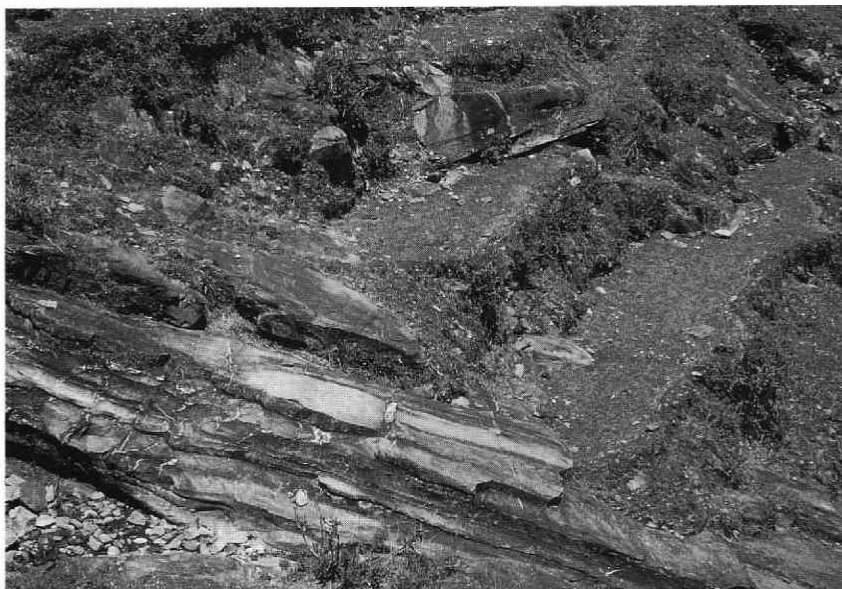
Photo 4 Paddy terracettes and a rock-bed stream at Smaili, west of Pokhara. (Photo by T. Tamura ; May, 1994)

Although slope and soil condition for cultivation is very poor, it is rather easy to conduct water from streams flowing on impermeable rock floor to adjacent paddy terracettes (Photo 4). On the other hand, very thin soil resting on impermeable rock readily produces saturation by water in the case of heavy rain. The terracettes are thus eroded off almost every rainy season. Debris produced by the destruction of paddy terracettes flow downslope to attack dry fields which were recently constructed on alluvial cones and floodplains by immigrants from the upper hillsides to the footslopes (Photo 5).

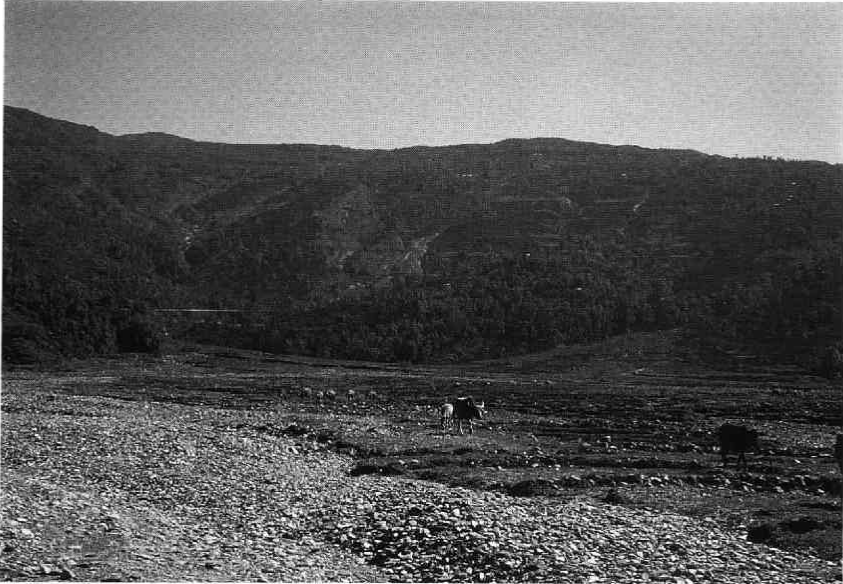
Photo 5 Recently constructed fields on floodplains and alluvial cones at the foot of Smaili, west of Pokhara. (Photo by T. Tamura ; May, 1994)

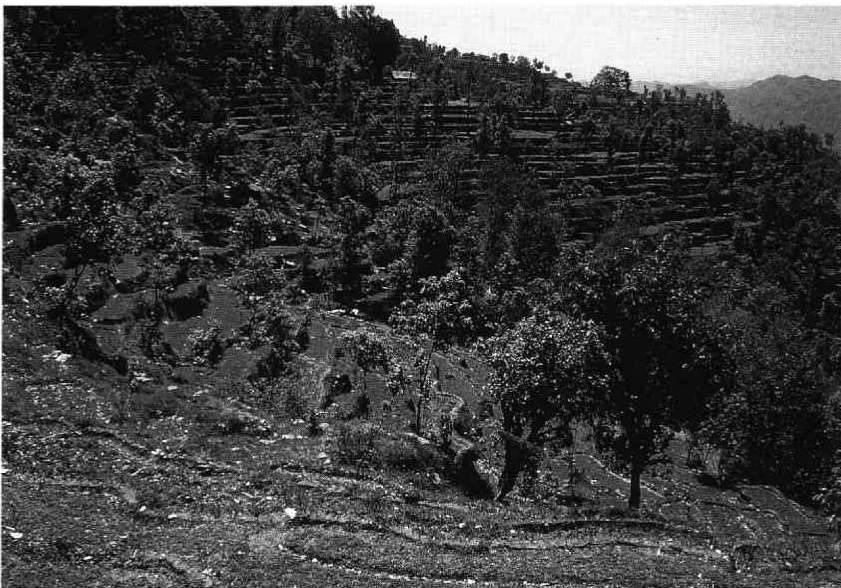
Photo 6 Relatively fertile paddy terraces with thick soil in a deep-seated slide zone at Banpali, west of Pokhara. (Photo by T. Tamura ; May, 1994)

In a part of Banpali in the Kaskikot VDC, 13 km west-northwest of Pokhara (Fig. 2), paddy terraces are extended on the hillslope about 30 degrees (Photo 6). Conditioned by thick soil over 2 m and continuous supply of surface and shallow subsurface water, paddy rice cultivation had been steadily continued during more than 50 years on the hillslope. However, many cracks and some shallow slides have been recently appeared on the paddy terraces which had been more fertile than neighboring fields (Photo 7). In addition to this, rat activity seems to enlarge and elongate the cracks in part. Irrigation water, manure and fertilizer are lost through the cracks and the productivity has been thus lowered on the affected fields. Taking notice of the earth-surface phenomena, an owner of the affected fields has stopped cultivation and has planted trees on his damaged terraces.

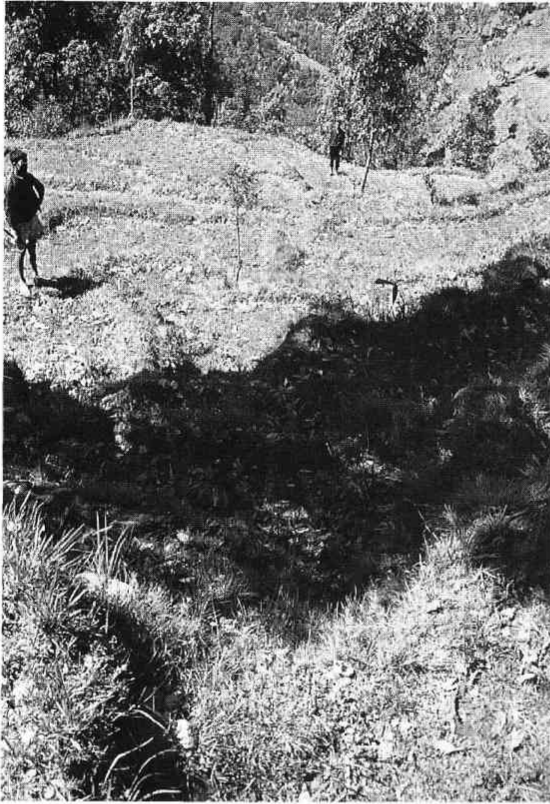
Photo 7 A crack and a small shallow slide at its end on paddy terraces in a deep-seated slide zone at Banpali, west of Pokhara. (Photo by T. Tamura ; May, 1994)

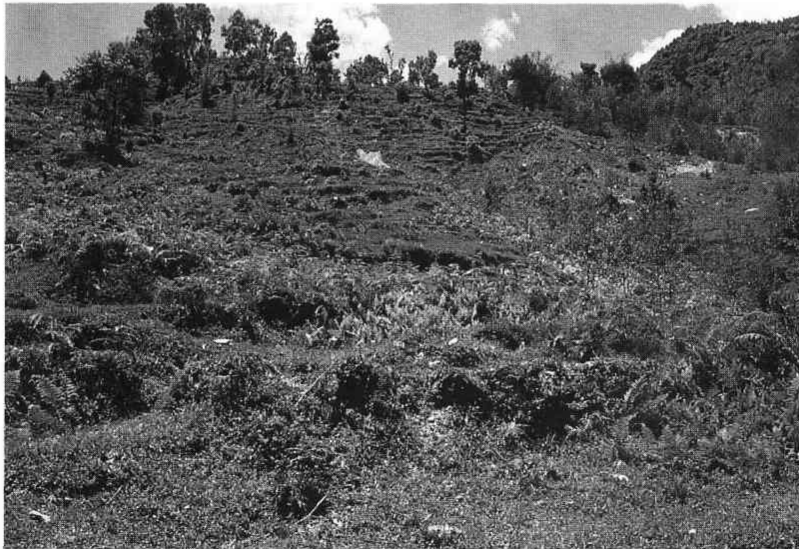
Photo 8 Terraced paddy fields, mostly abandoned, in a deep-seated slide zone at Kuhire Kateri Samsire, north of Kusma. (Photo by T. Tamura ; May, 1994)

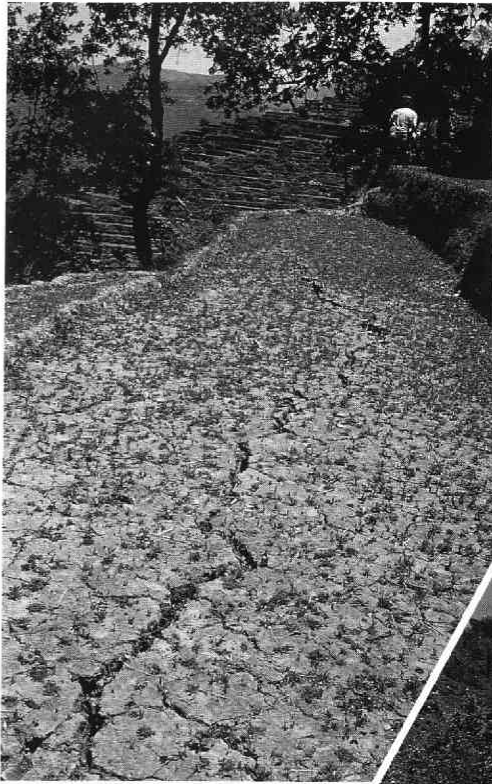
Photo 9 Cracks on abandoned paddy terraces in a deep-seated slide zone at Kuhire Kateri Samsire, north of Kusma. (Photo by T. Tamura ; May, 1994)

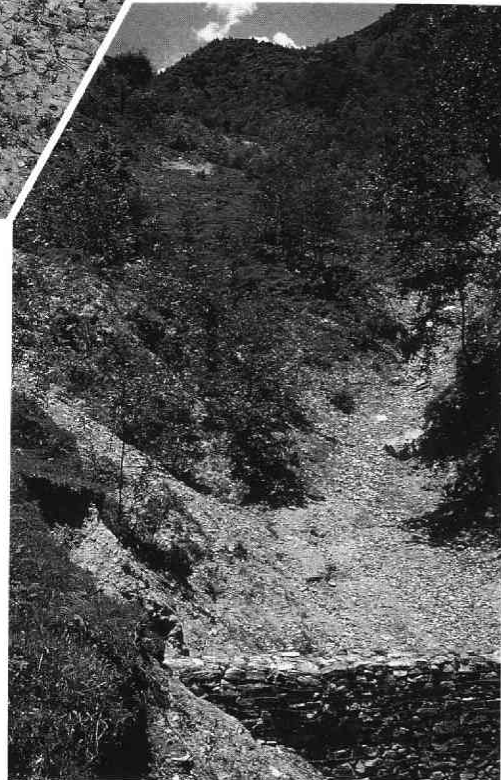
Photo 10 Shallow slides and a gabion-type check dam in a deep-seated slide zone at Kuhire Kateri Samsire, north of Kusma. (Photo by T. Tamura ; May, 1994)
