Detection And Evaluation Of Existing Pavement System With Brick Base

**DETECTION AND EVALUATION OF EXISITING PAVEMENT SYSTEM
WITH BRICK BASE USING GROUND PENETRATING RADAR**

A thesis submitted in partial fulfillment of the requirements
for the degree of Master of Science
in the Department of Civil and Environmental Engineering
in the College of Engineering and Computer Science
at the University of Central Florida
Orlando, Florida

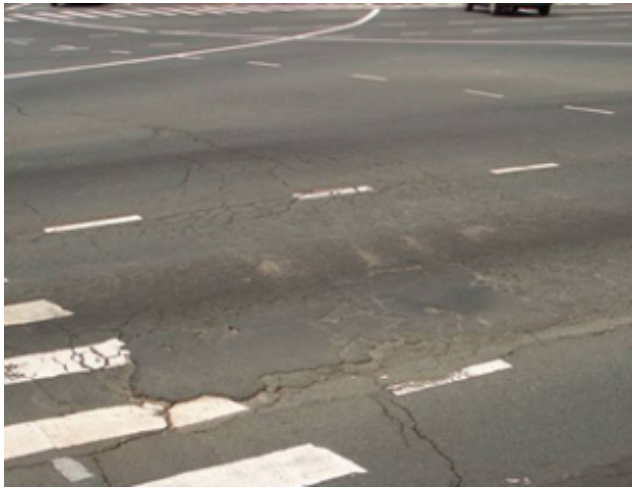
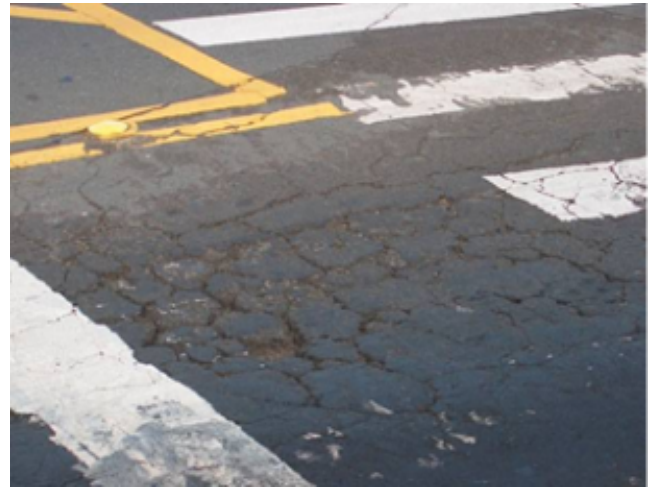
Fatigue or Alligator cracking is caused by a series of interconnecting cracks caused by fatigue failure of asphalt surface, or under repeated traffic loading. It comprises of two successive stages of crack initiation and crack propagation (Uzan, 1997). The cracking of the asphalt is initiated at the bottom of the asphalt course or where the tensile stress or stain is highest under a wheel load and the crack propagate to the surface as one or more longitudinal parallel cracks as shown in Figure 1 (a). Due to the repeated traffic, cracks start to connect forming many shape angled and sided pieces that portrays the skin of an alligator, hence the name. This is seen in Figure 1 (b). Alligator cracks are considered a major structural distress (Haung, 1993).

Figure 1. Fatigue Cracking (Pavement Distress, 2003)

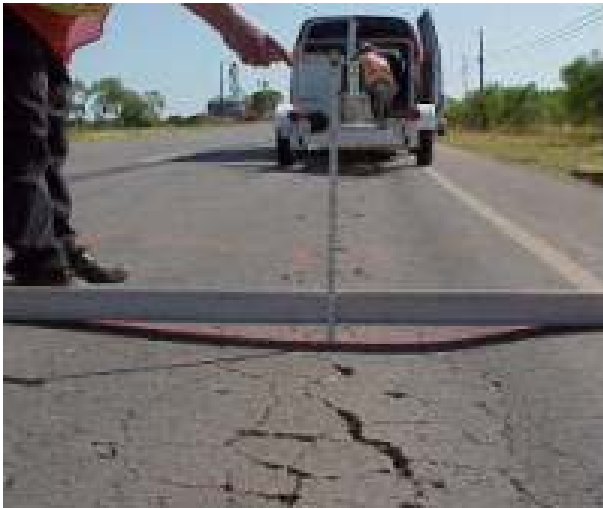
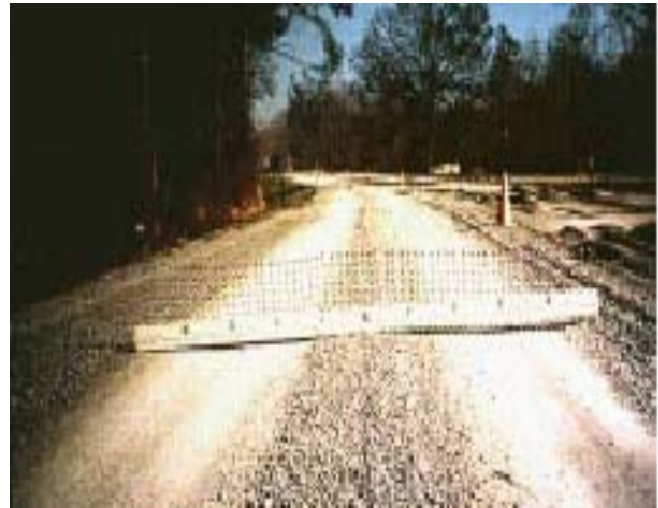
Rutting or permanent deformation in pavement systems occur when pavement surface areas have elevations slightly less than the elevation due to wheel path compared to the surrounding pavement. Much of rutting occurs due to rainfall as the wheel paths fills up with water, which may cause hydroplaning of vehicles. Depressions may also be caused by improper construction, or foundation settlement. Rutting may also be caused by plastic movement asphalt mix in hot weathers. Rutting can lead to major structural failures (Haug, 1993). Figure 9 depicts depression or rutting caused by vehicular paths.

Figure 2. Rutting (Kestler, 2000)

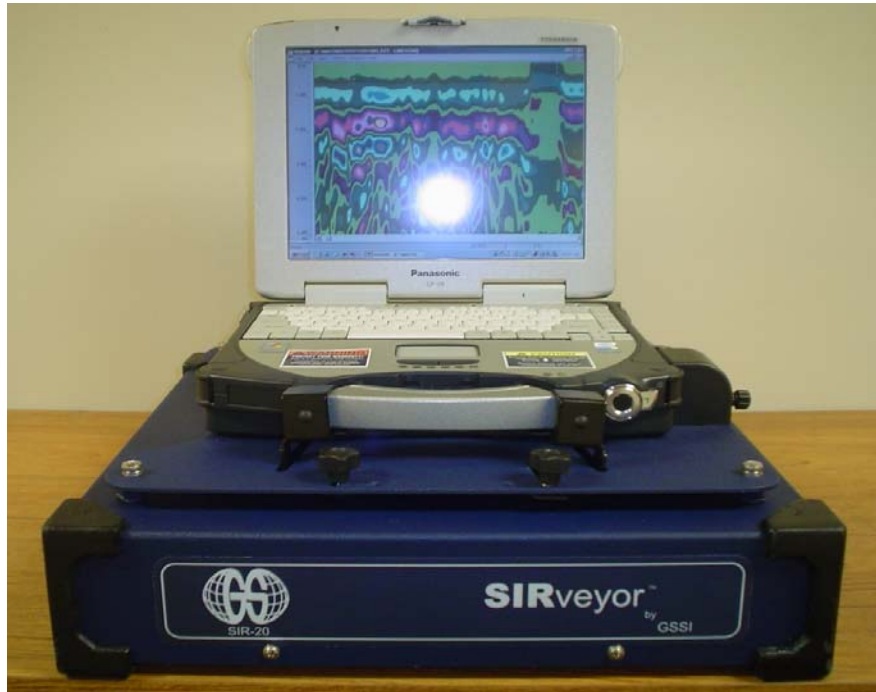
The equipment employed in this study is the Subsurface Interface Radar (SIR-20) System manufactured by Geophysical Survey Systems, Inc. (GSSI). The SIR-20 equipment shown in Figures 5 and 6 consists of a control unit, a “Toughbook” laptop, transmitting and receiving antenna of 900 MHz, and a 200 feet long cable. The antenna can be pulled along the surface of the strata by hand or it can be towed behind a vehicle for long distances, and a 12-volt DC battery may provide the power for this system.

Figure 3. SIRveyor SIR-20

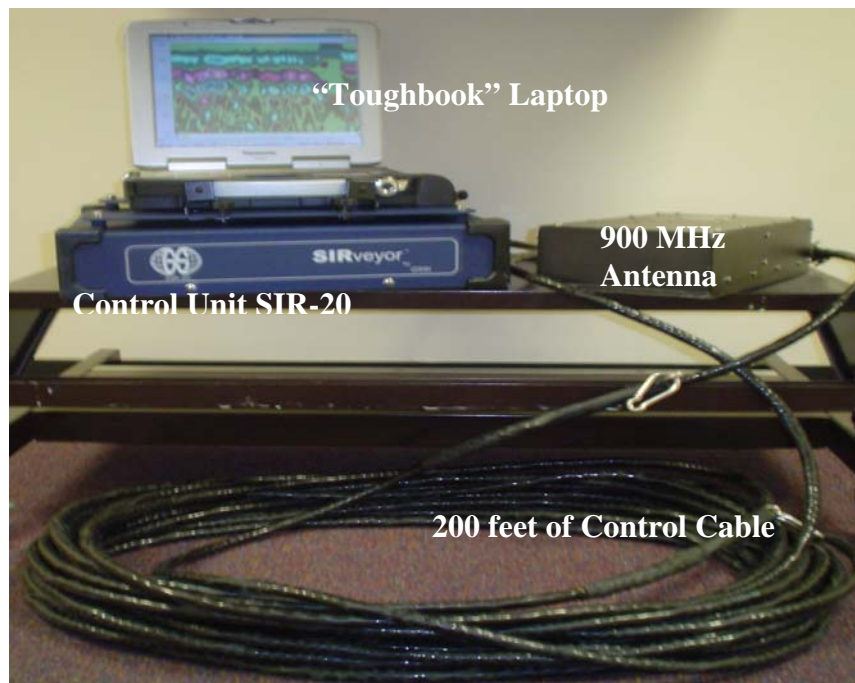
Figure 4. Equipment Layout with 900 MHz antenna

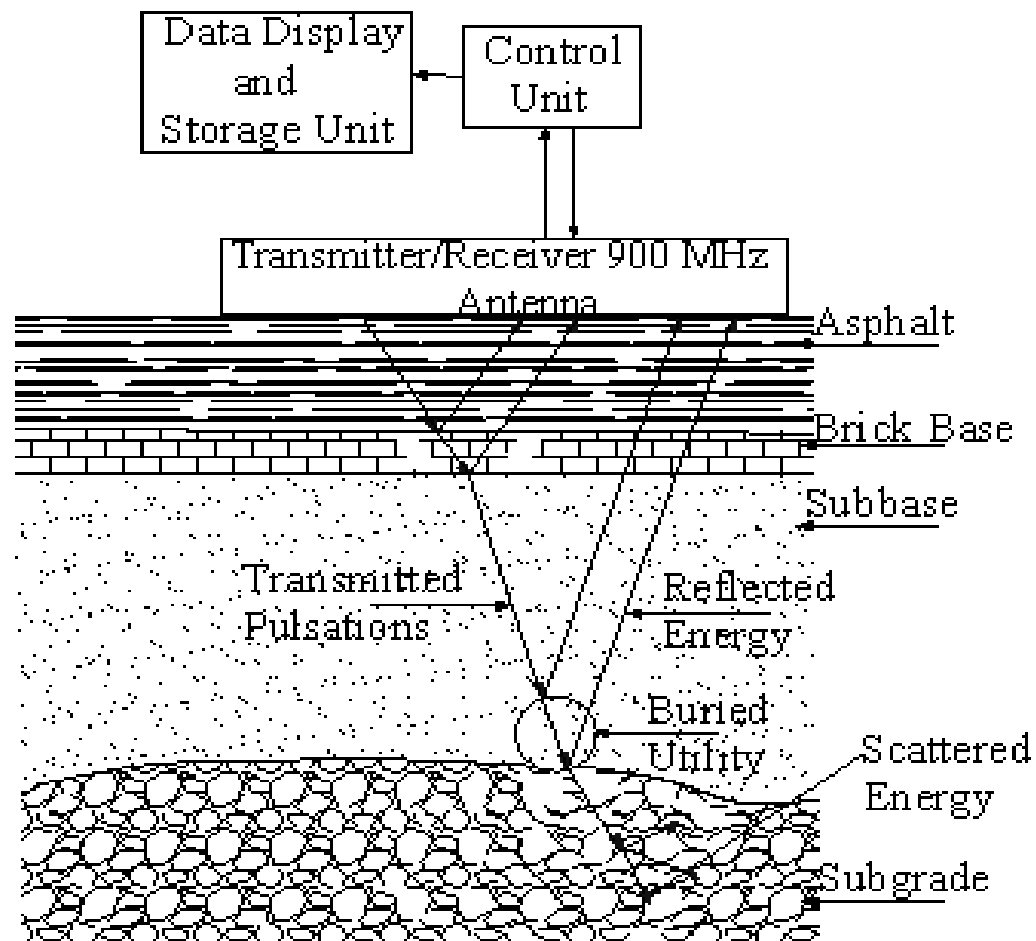
For the duration of the each cycle, a fast acting control unit creates a time-limited signal, which is sent directly to the antenna. The transmitted pulsations travel through the subsurface until it reaches the soil interface. Depending on the electrical characteristics of the interface, a section of the transmitted pulsation reflects back to the surface, and is then received by the system antenna as depicted in Figure 2.3. The strength of the reflected wave, which travels at the speed of light, is indicated by the intensity of the receiving signal. Thus, the reflected field strength between two materials is described by the reflection coefficient r as given by Equation (5):

Figure 5. Reflection of Radar Signals

Furthermore, if the values of dielectric constants of two materials vary tremendously, then the reflection coefficient is approximated to be one while most of the incident energy continuous through the interface and ultimately projects a strong signal. Conversely, if the dielectric constant of the materials is same for both materials, the reflection coefficient is approximately to be zero. This means there is no reflection of signal. For this instance, most of the incident energy is transmitted through the interface, and vaguely appears on the GPR profile. The received signals are then amplified using a time-domain sampling technique to construct a waveform of similar shape of the actual signal received, but with a rather long time base. The vertical and horizontal scales indicate the time delay from the received signals and the position of the antenna, respectively (Chen et al., 2001). The traces of the processed waveforms are displayed by oscilloscope on the control unit (Sweeney, 1986). The subsurface features appear in reflected bands of several colorations, and delay in time determines the depth of the interfaces.

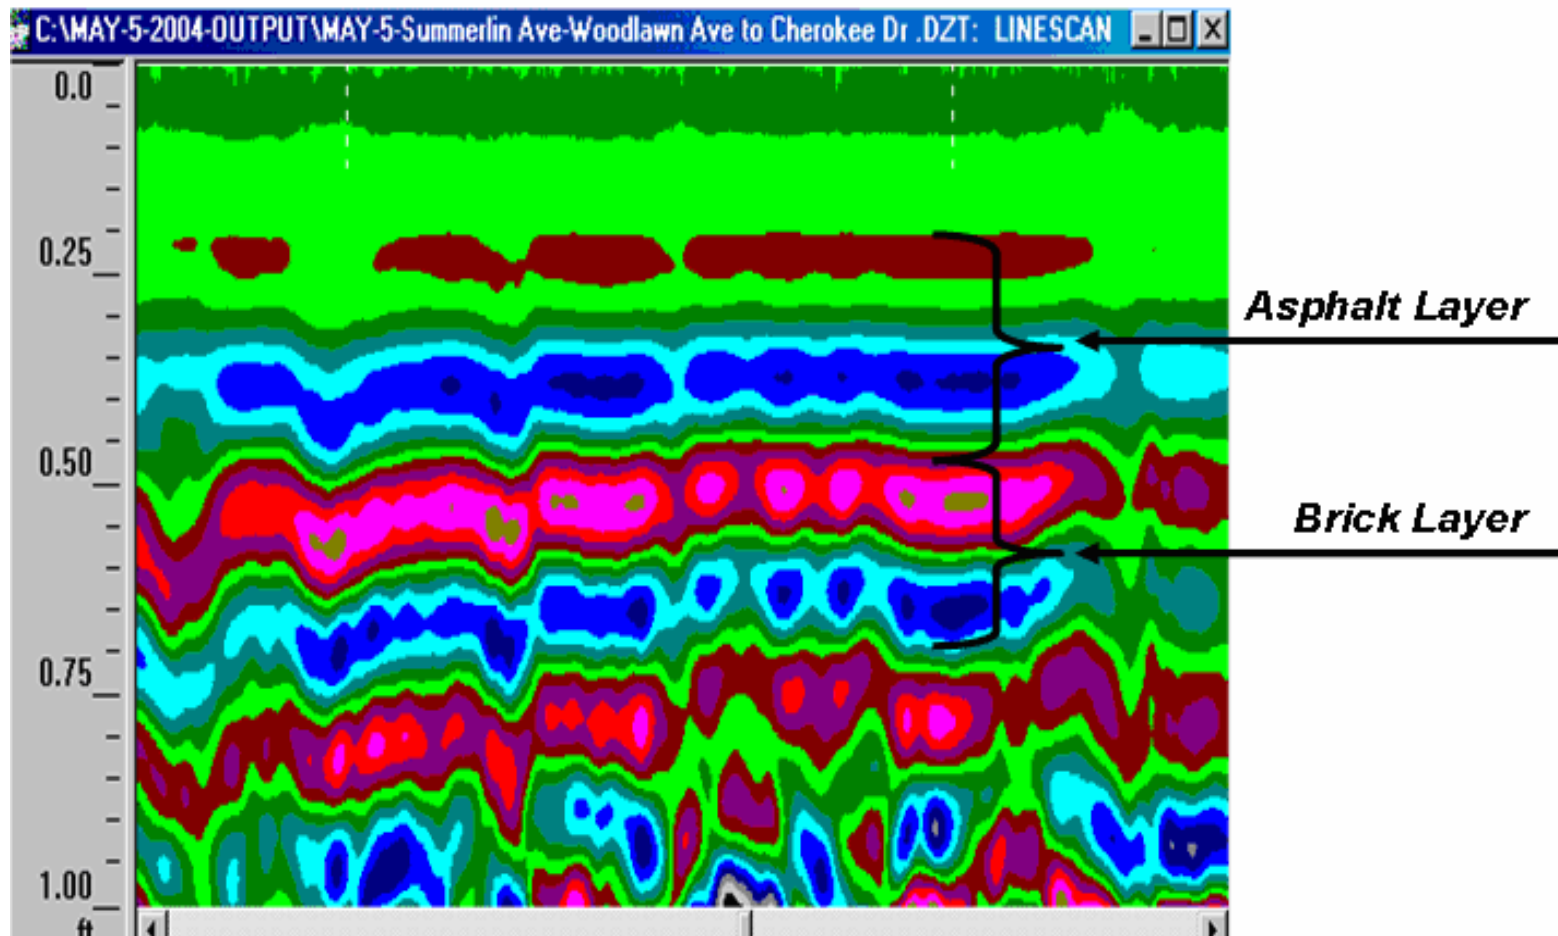
Figure 6. Typical GPR Profile of Asphalt Overlaying Brick base on Summerlin Avenue

Referring again to Figures 6 and 7, in both figures the top most layer of a solid and continuous band is the transmitted pulsations that travel through the receiver and serve as time reference in the units of nanoseconds (ns). The surface reflection for both figures is the asphalt

layer, which are the second and third bands in both figures. The fourth and the fifth fatal bands reflect of the bricklayers, which is the interface reflections. One of the major differences between the asphalt and bricklayers is that the state of the profile being discontinuous or broken bands from the bricks that are individually distinguishable. Sometimes, it becomes difficult to distinguish between the interface layers as is easily noticed in both reference Figures 6 and 7. The multiple bands are caused by oscillation of the pulse reflections between two interfaces, such as the asphalt and bricks or asphalt and limerock base. The oscillation effect is to limit the ability of the system to distinguish between two closely spaced interfaces that lie within two feet of each other. Thus, the reflection signals for both interfaces are superimposed on each other (Tannous, 1987). The interface subsequent to the brick base represents soil or the subbase layer that is discontinuous, indicating a break in the layer.

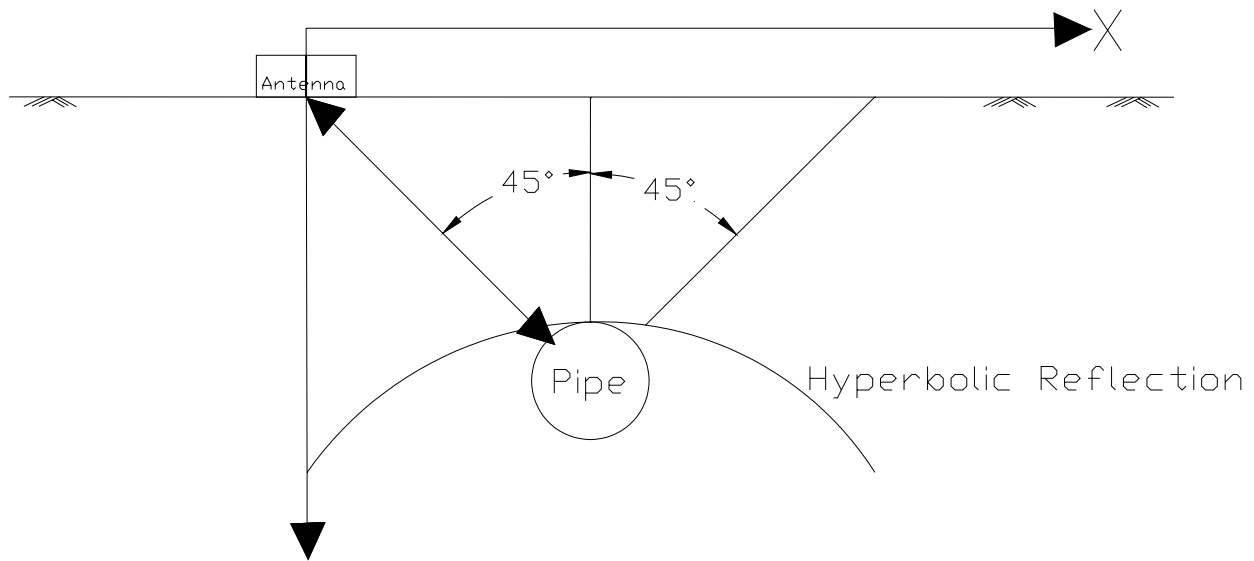
The radiated impulses penetrate into the ground and form a conical beam cross-section if it is over a circular shape anomaly (Daniels, 1996). The beam forms a front to back angle of approximately 90 degrees and a side-to-side angle of 60 degrees. Once the signals are transmitted through the ground, the pulsation strikes the interface at a 90-degree angle. In case of a horizontal layer, if the object is parallel to the path of the antenna, the radar will only detect the object when the antenna is directly on top of it. For the case of round objects such as pipes, a section of the curved surface is perpendicular to the path of the antenna, and the reflection is collected before and after the antenna crosses over the pipe or the curved surface. Thus, a hyperbolic reflection profile is exhibited. Figure 8 depicts the radar transmission phenomenon over a pipe with reflected hyperbolic reflected profile.

Figure 8. Hyperbolic reflection from a circular structure in (X, Z) Plane (Daniels, 1996 and Tannous, 1987)

First, the pipe reflection is received as the antenna approaches 45-degree angle with in a vertical line passing through the center of the pipe. Streams of reflections are continuously received by the antenna until the antenna travels a twice the distance from its initial point. The apex of hyperbola representing the true depth of the pipe is formed (Sweeney, 1986 & Tannous, 1987).

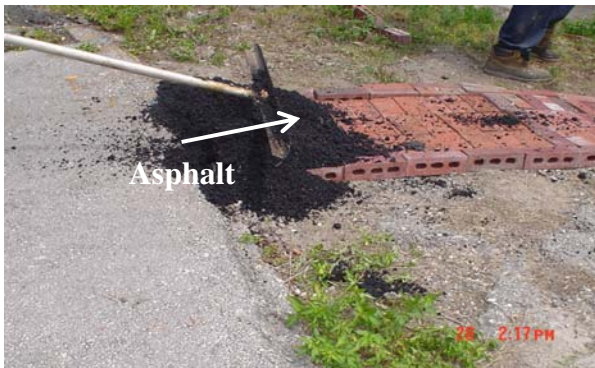
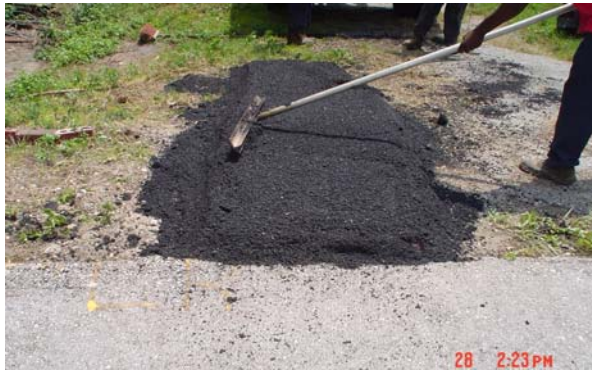
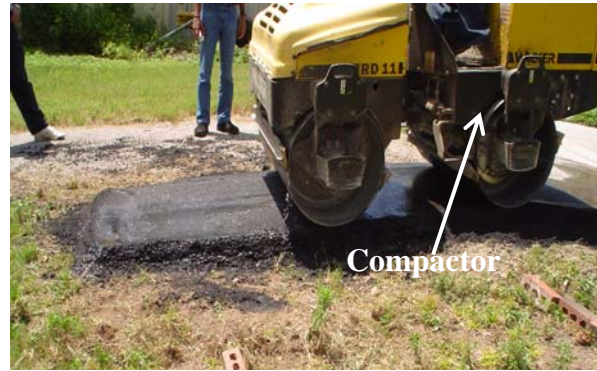
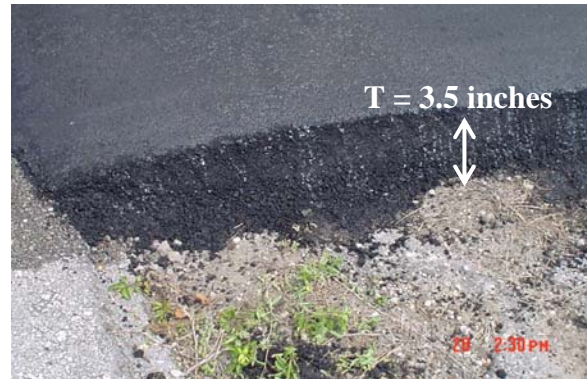
Figure 9. Construction of Test Pit

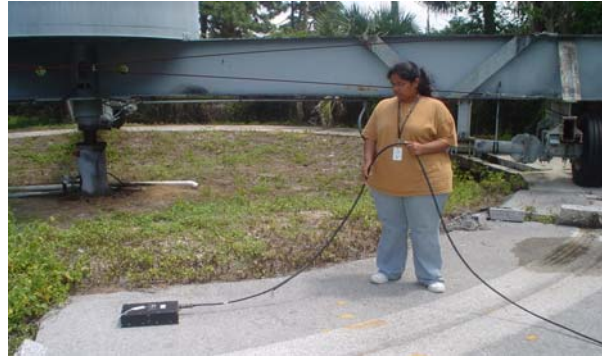
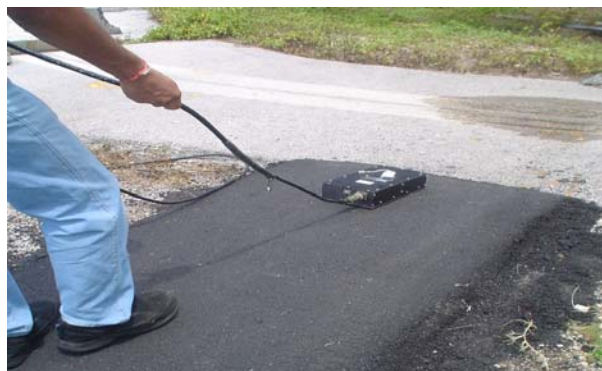
The field GPR survey of the test pit consisted of several GPR traverses on the brick base asphalt as well as the existing limerock based asphalt pavement and the bridge deck. The location of the test pit is presented in the Appendix A. The test pit GPR profiles are presented and discussed in Results of Study in Chapter 5. The distance between each mark on the GPR profile was spaced with 10 feet, typically. The 900 MHz antenna was hand-pulled in all traverses at a walking speed. The maximum depth of 1 foot of GPR penetration was calibrated based on a range of 6 to 13 dielectric constant and saved as a control program. A few vertical dashed lines on the GPR profiles reflect the changes in ground surface anomalies, such as bricks, concrete, grass, manholes, etc. The double-dashed or triple-dashed vertical lines show the beginning and end of each traverse.

Figure 10. GPR Survey of Test Pit

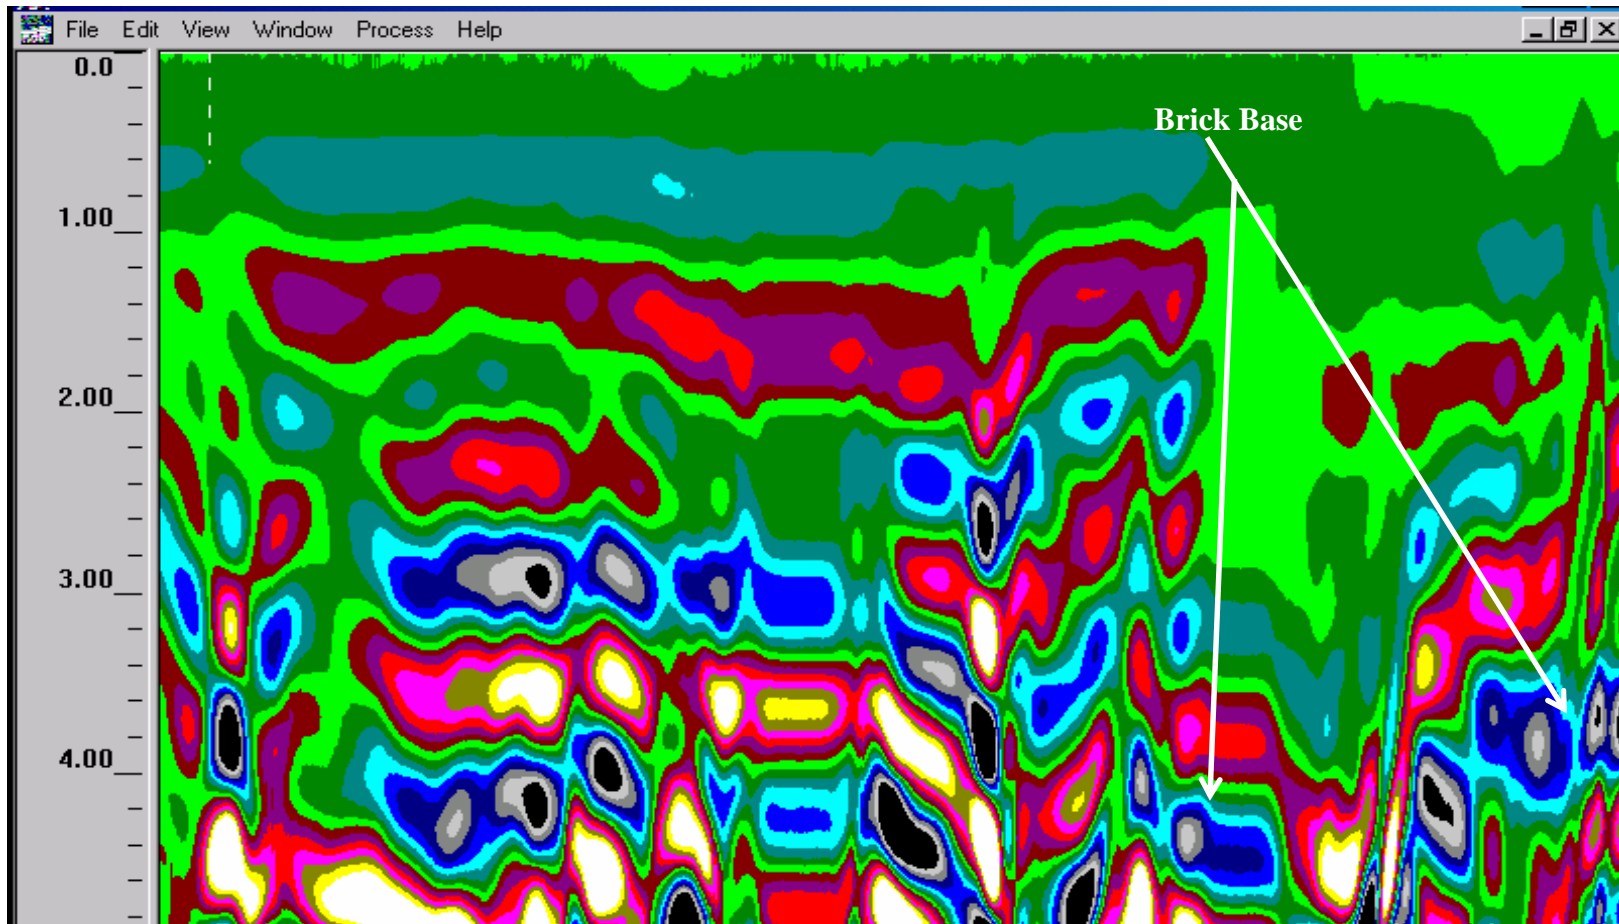
In detection of asphalt concrete using GPR, researchers have used a dielectric constant of 13, and the recommended dielectric constant of asphalt by GSSI Inc. was six. Therefore, GPR profiles with dielectric constants of 6 through 13 were also collected, which are also discussed thoroughly in Chapter 5. Seven traverses were performed with dielectric constants of 6 through 13. Furthermore, three additional profiles were obtained by pulling 900 MHz antenna at slow and faster walking pace, and one with a 15 ns two way travel time or simply 2 feet of calibrated depth. GPR survey on test pit is shown in Figures 10 (a) – (c). A typical GPR profile of brick base at test pit is shown in Figure 11.

Figure 11. GPR Profile of Brick Base at Test Pit

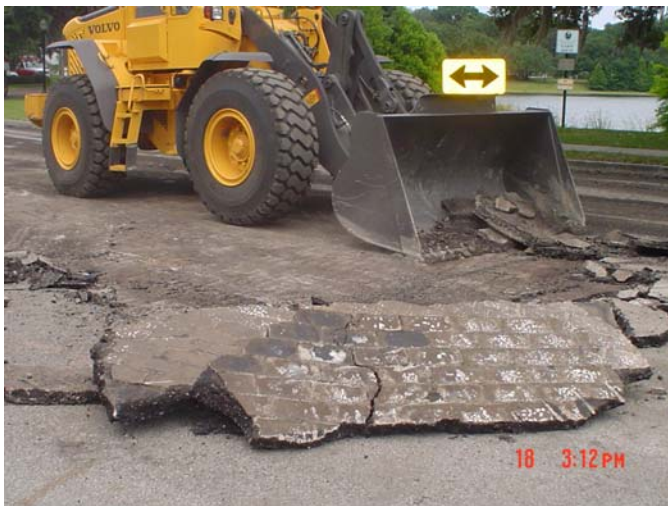
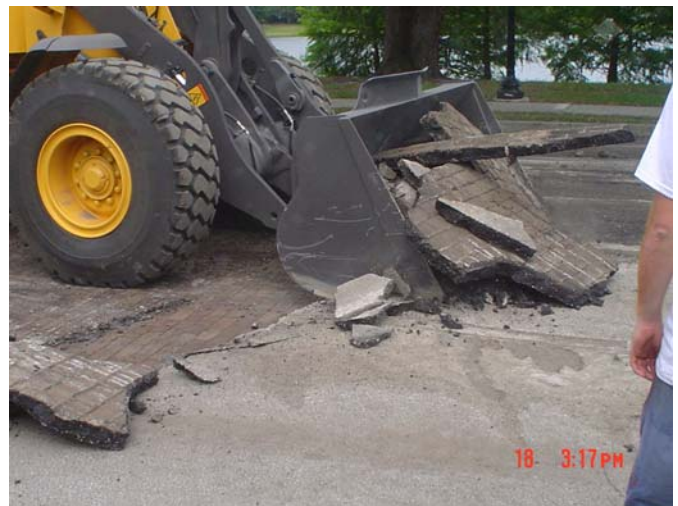
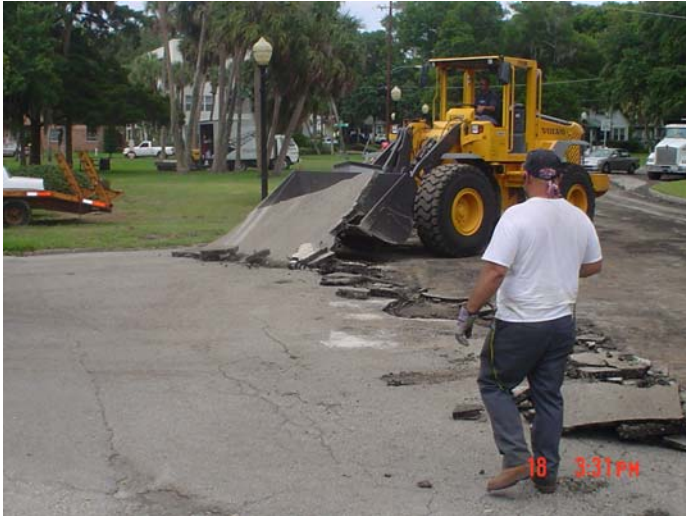
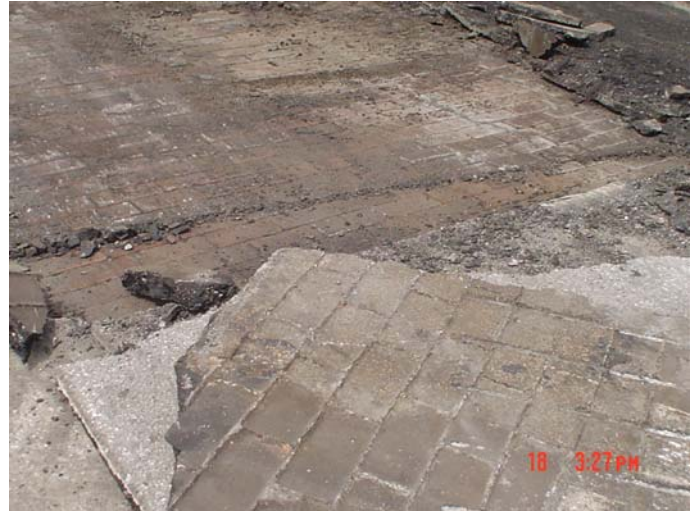
South Summerlin Avenue as given the first priority as it served as a major route through the downtown area. The process of brick removal began on May 18, 2004 on this street. Photographs of asphalt remover for Summerlin Avenue are shown in Figures 15 (a) – (d). Following Summerlin Avenue, restoration of bricks resumed on Cherokee Drive starting mid July, and Church Street, for which was unannounced to the research team at the University of Central Florida.

Figure 15. Removal of Asphalt on Summerlin Avenue

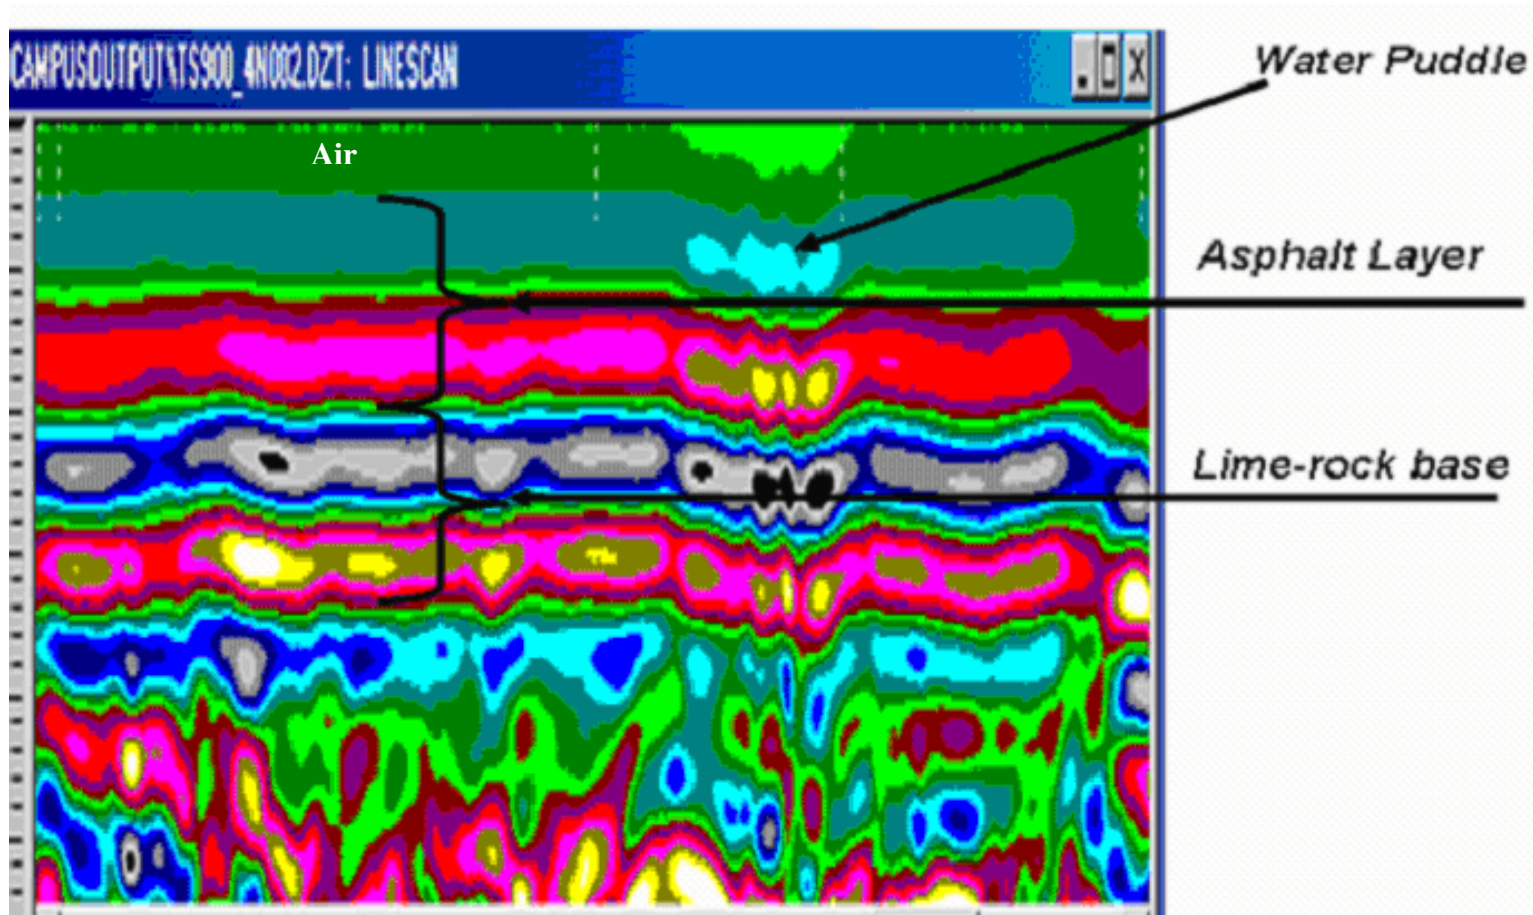
The multiple bands are caused by oscillation of the pulse reflections between two interfaces, such as the asphalt and bricks or asphalt and limerock base. The oscillation effect is to limit the ability of the system to distinguish between two closely spaced interfaces that lie within two feet of each other. Thus, the reflection signals for both interfaces are superimposed on each other. The interface subsequent to the brick base represents soil or the subbase layer that is discontinuous, indicating a break in the layer.

Figure 17. GPR Profile from Lime Rock Base Pavement at Test Pit
