Detection And Evaluation Of Existing Pavement System With Brick Base

**DETECTION AND EVALUATION OF EXISITING PAVEMENT SYSTEM
WITH BRICK BASE USING GROUND PENETRATING RADAR**

A thesis submitted in partial fulfillment of the requirements
for the degree of Master of Science
in the Department of Civil and Environmental Engineering
in the College of Engineering and Computer Science
at the University of Central Florida
Orlando, Florida

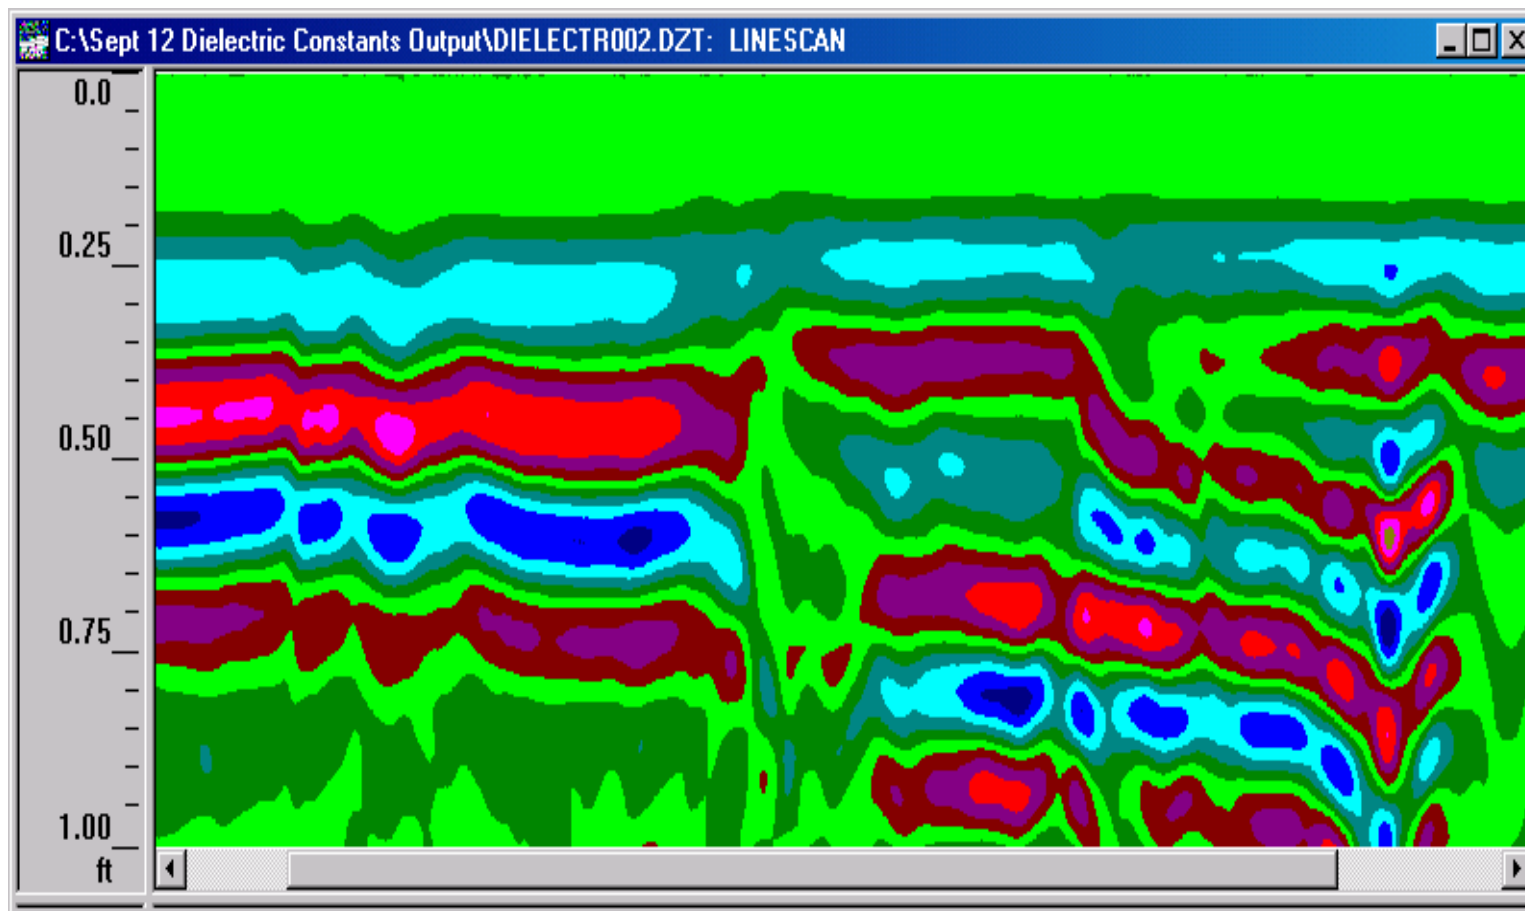
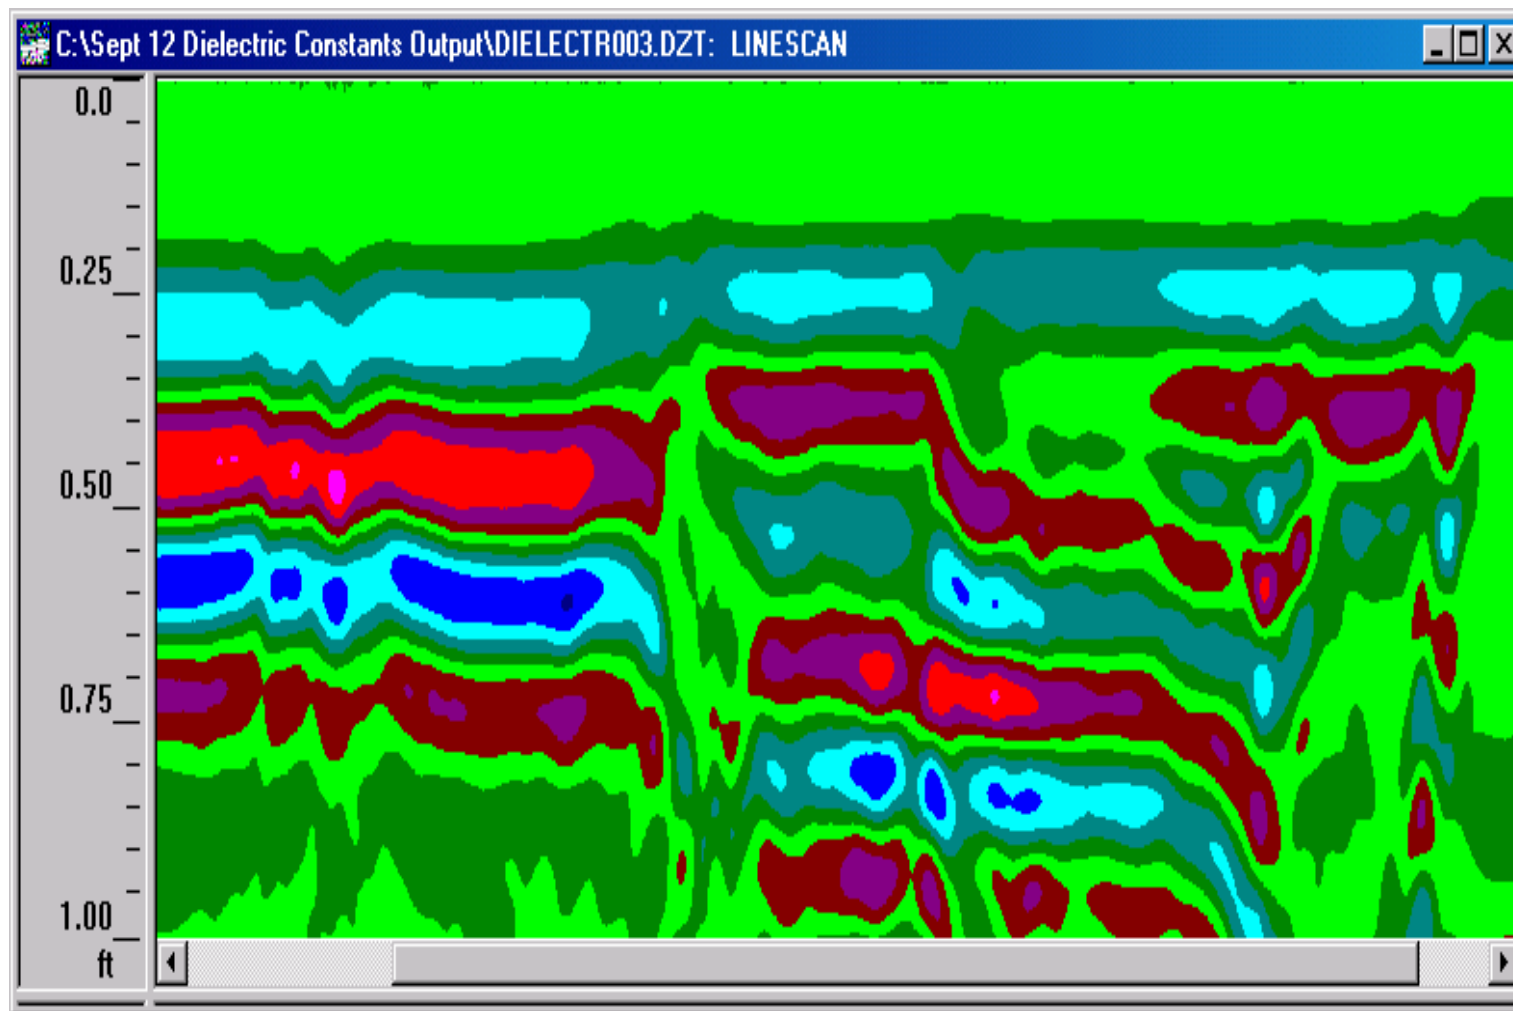
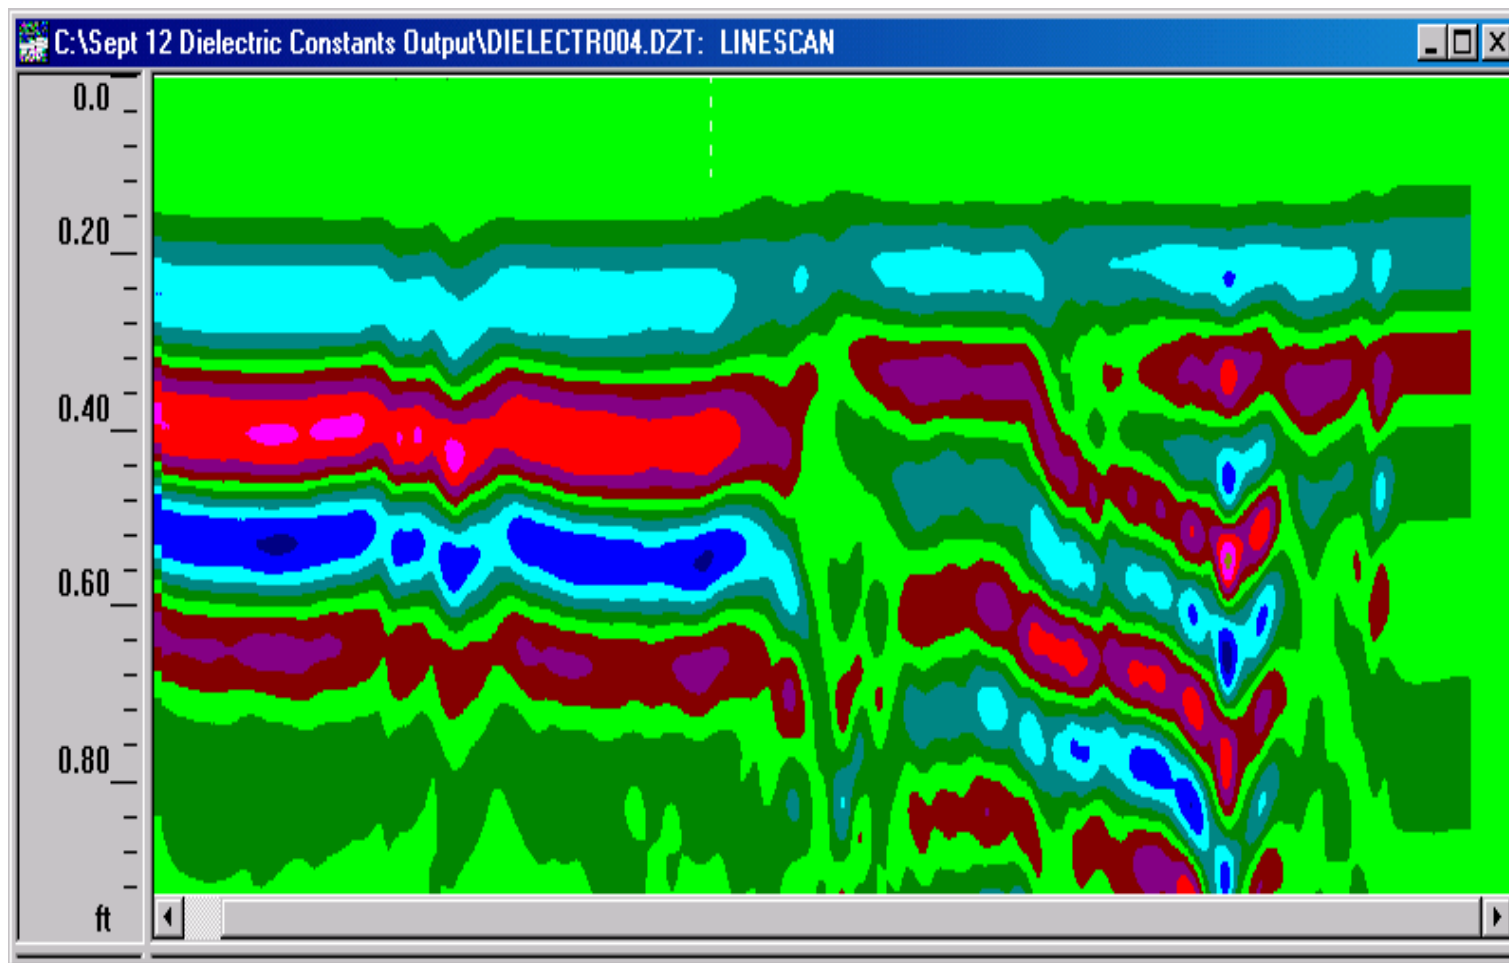
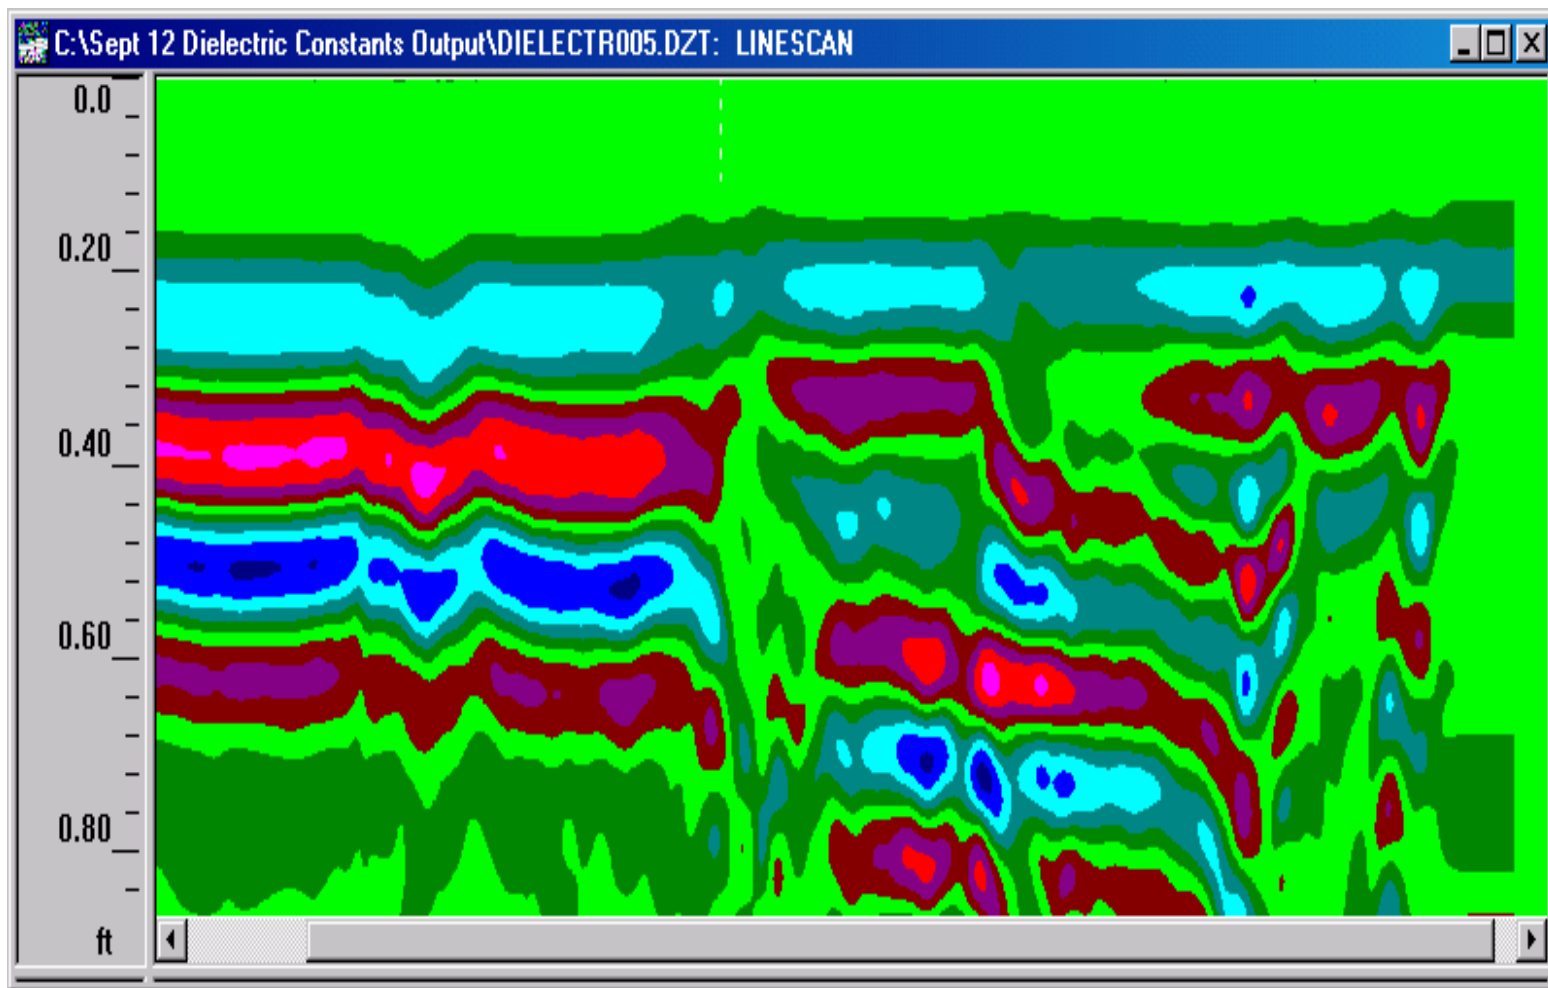
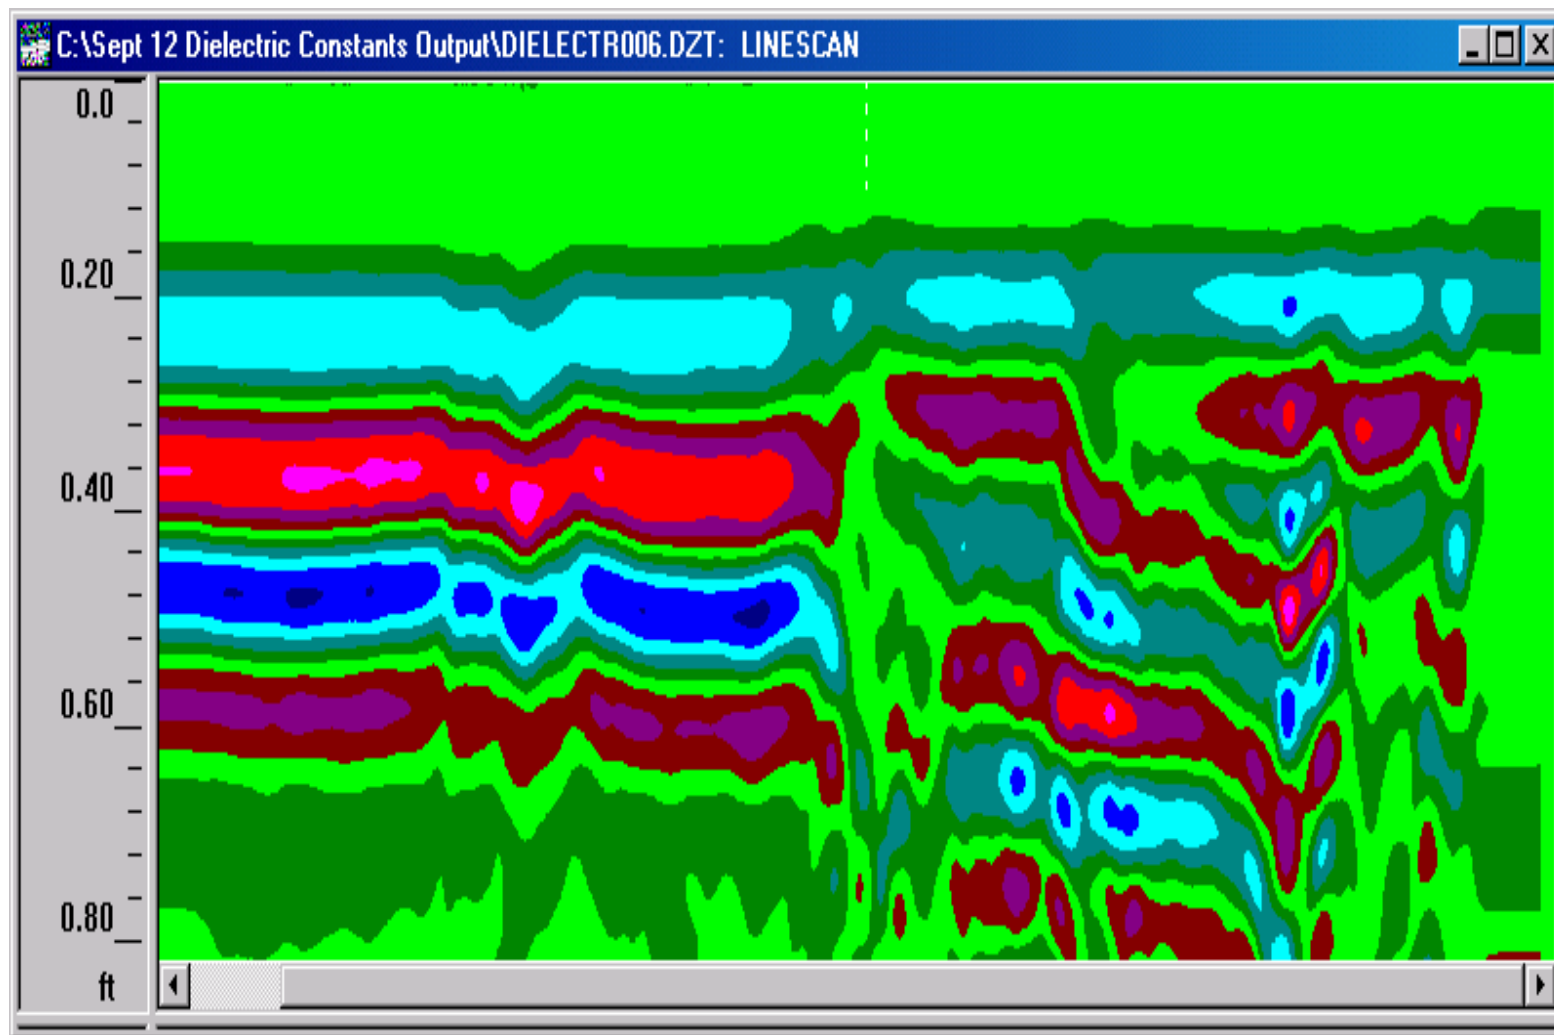
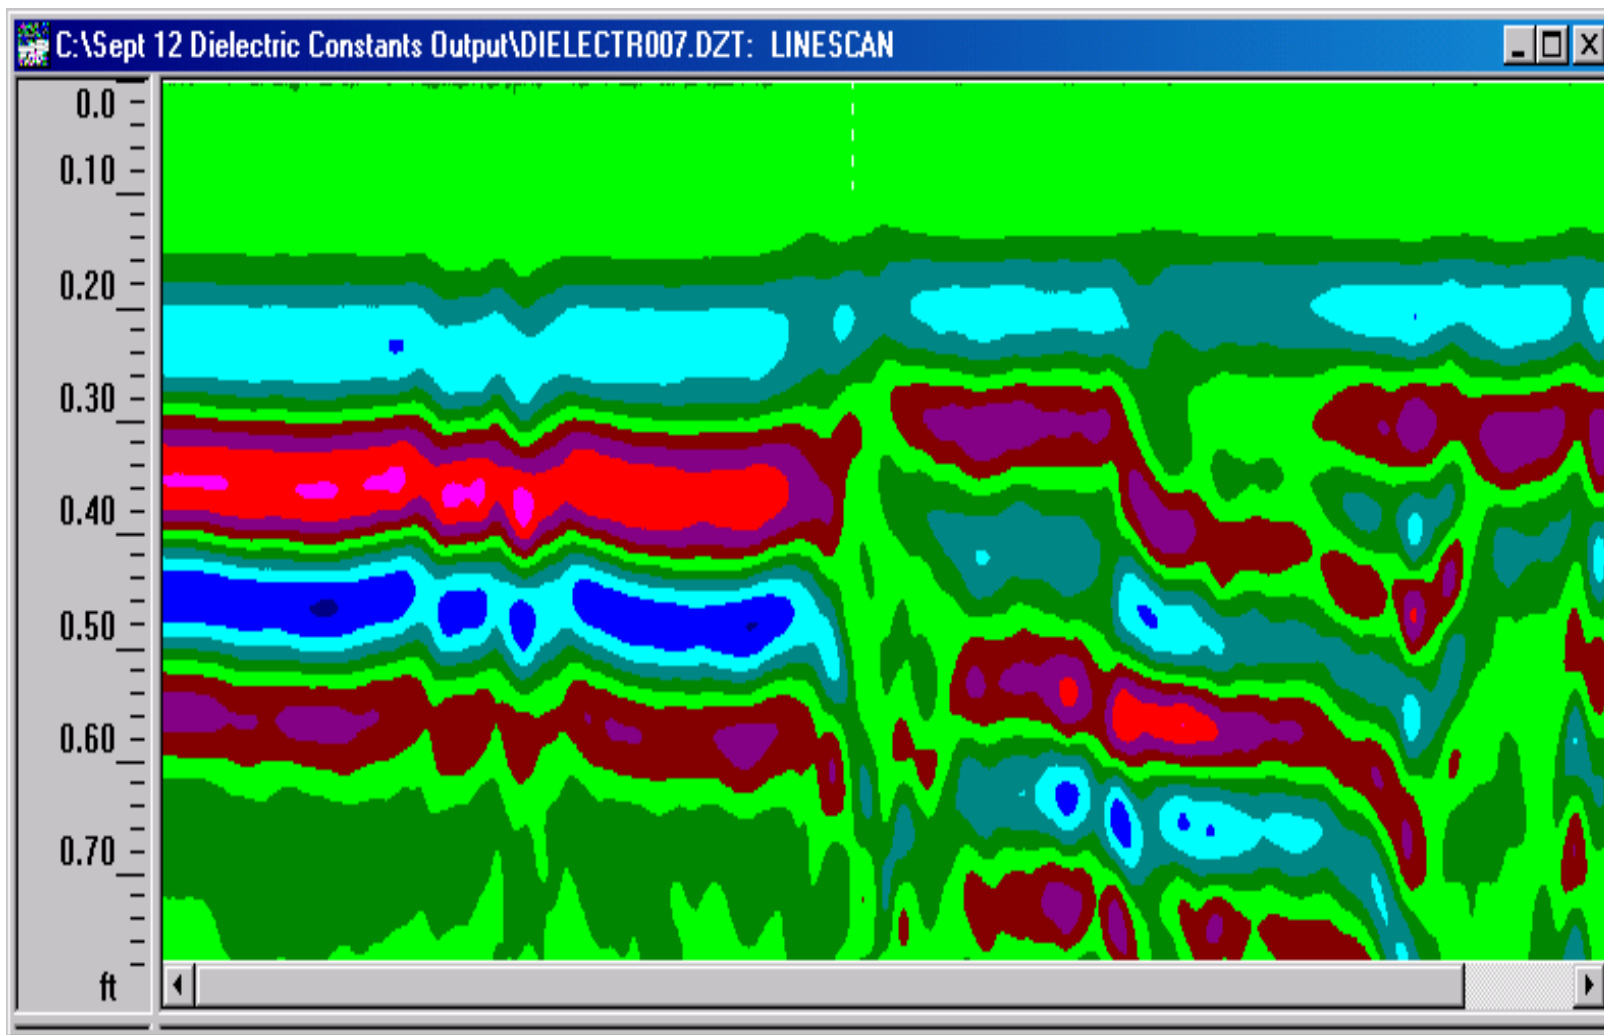
By closely observing the first seven profiles, it is easily seen that GSSI recommended dielectric constant of 6 was indeed the best choice. It is also observed that as the dielectric constant increased, the capability of the radar system to capture and produce distinguishable image of buried anomalies was dissipated. By carefully comparing all seven profiles, it was concluded to use the dielectric constant of 6. Pace of walking as pulling the antenna also had significant effect on the GPR profiles, as is seen in Figures 27 and 28. The faster or normal walking speed produces a profile with individualized bricks, which is not observed in the slower speed. In this case, the brick signals are elongated giving no indication of individuality. It was also observed that a range of 5-7 ns or 1.02 to 1.45 feet of penetration depth gave a better sense of location bricks in GPR profiles.

Figure19. GPR Profile of Test Pit using 900 MHz antenna with Dielectric Constant of 6

Figure 20. GPR Profile of Test Pit using 900 MHz antenna with Dielectric Constant of 7

Figure 21. GPR Profile of Test Pit using 900 MHz antenna with Dielectric Constant of 8

Figure 22. GPR Profile of Test Pit using 900 MHz antenna with Dielectric Constant of 9

Figure 23. GPR Profile of Test Pit using 900 MHz antenna with Dielectric Constant of 10

Figure 24. GPR Profile of Test Pit using 900 MHz antenna with Dielectric Constant of 11

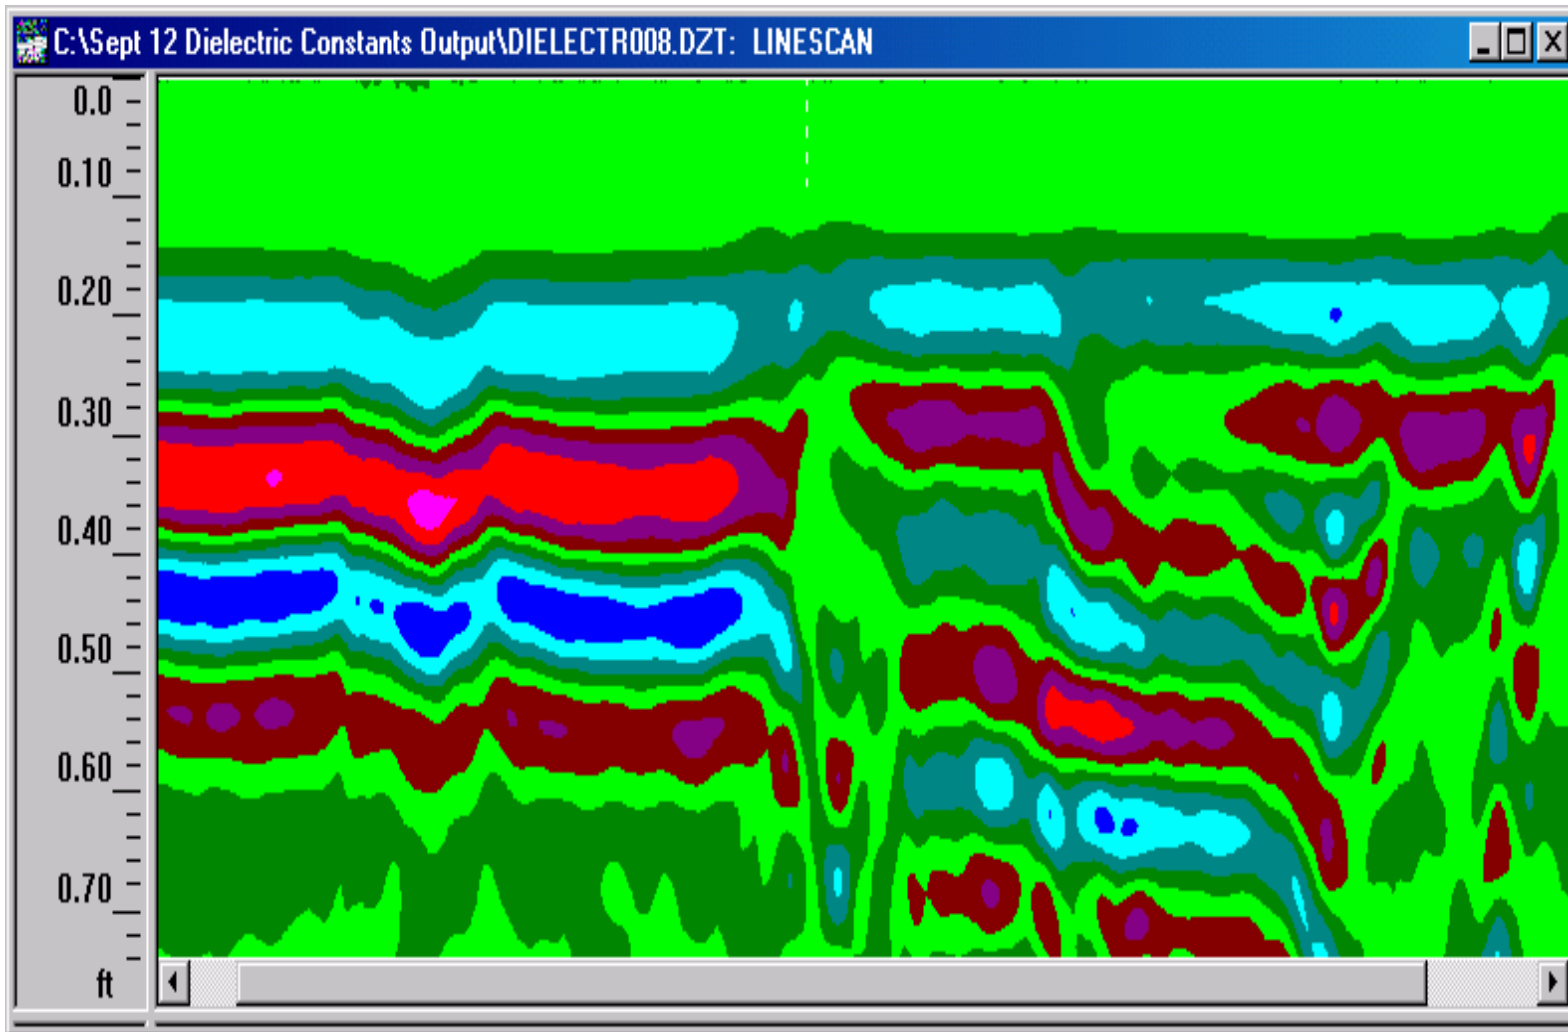
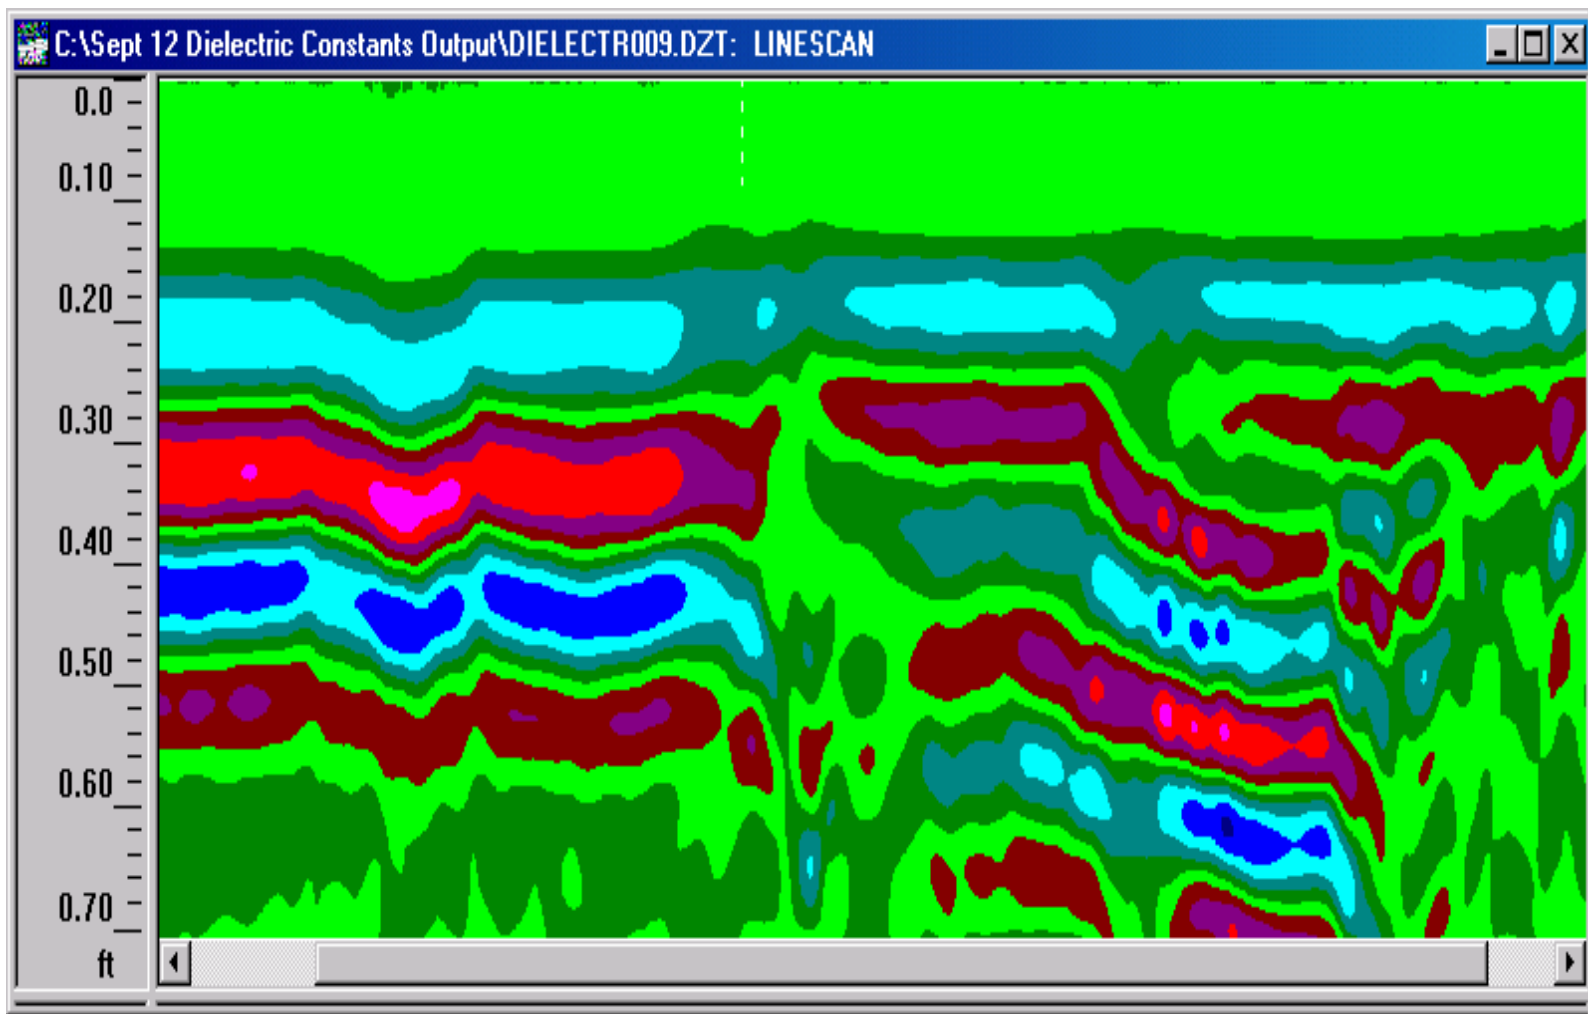
Figure 25. GPR Profile of Test Pit using 900 MHz antenna with Dielectric Constant of 12

Figure 26. GPR Profile of Test Pit using 900 MHz antenna with Dielectric Constant of 13

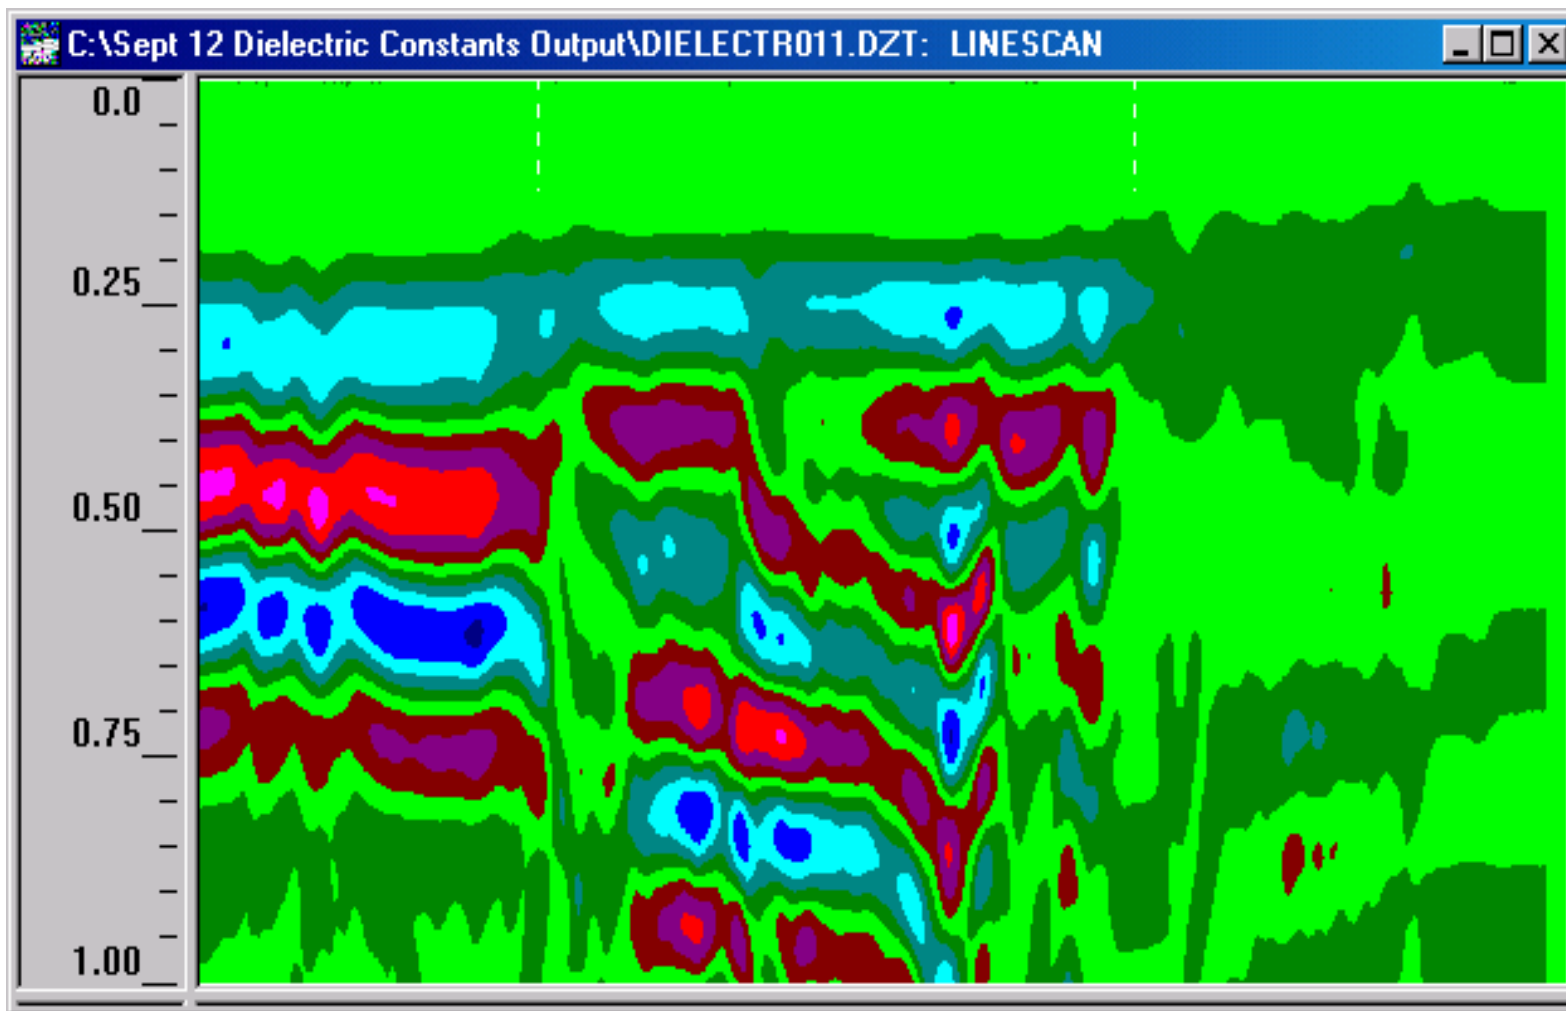
Figure 27. Profile of Test Pit using 900 MHz antenna with Dielectric Constant of 6 at fast walking speed

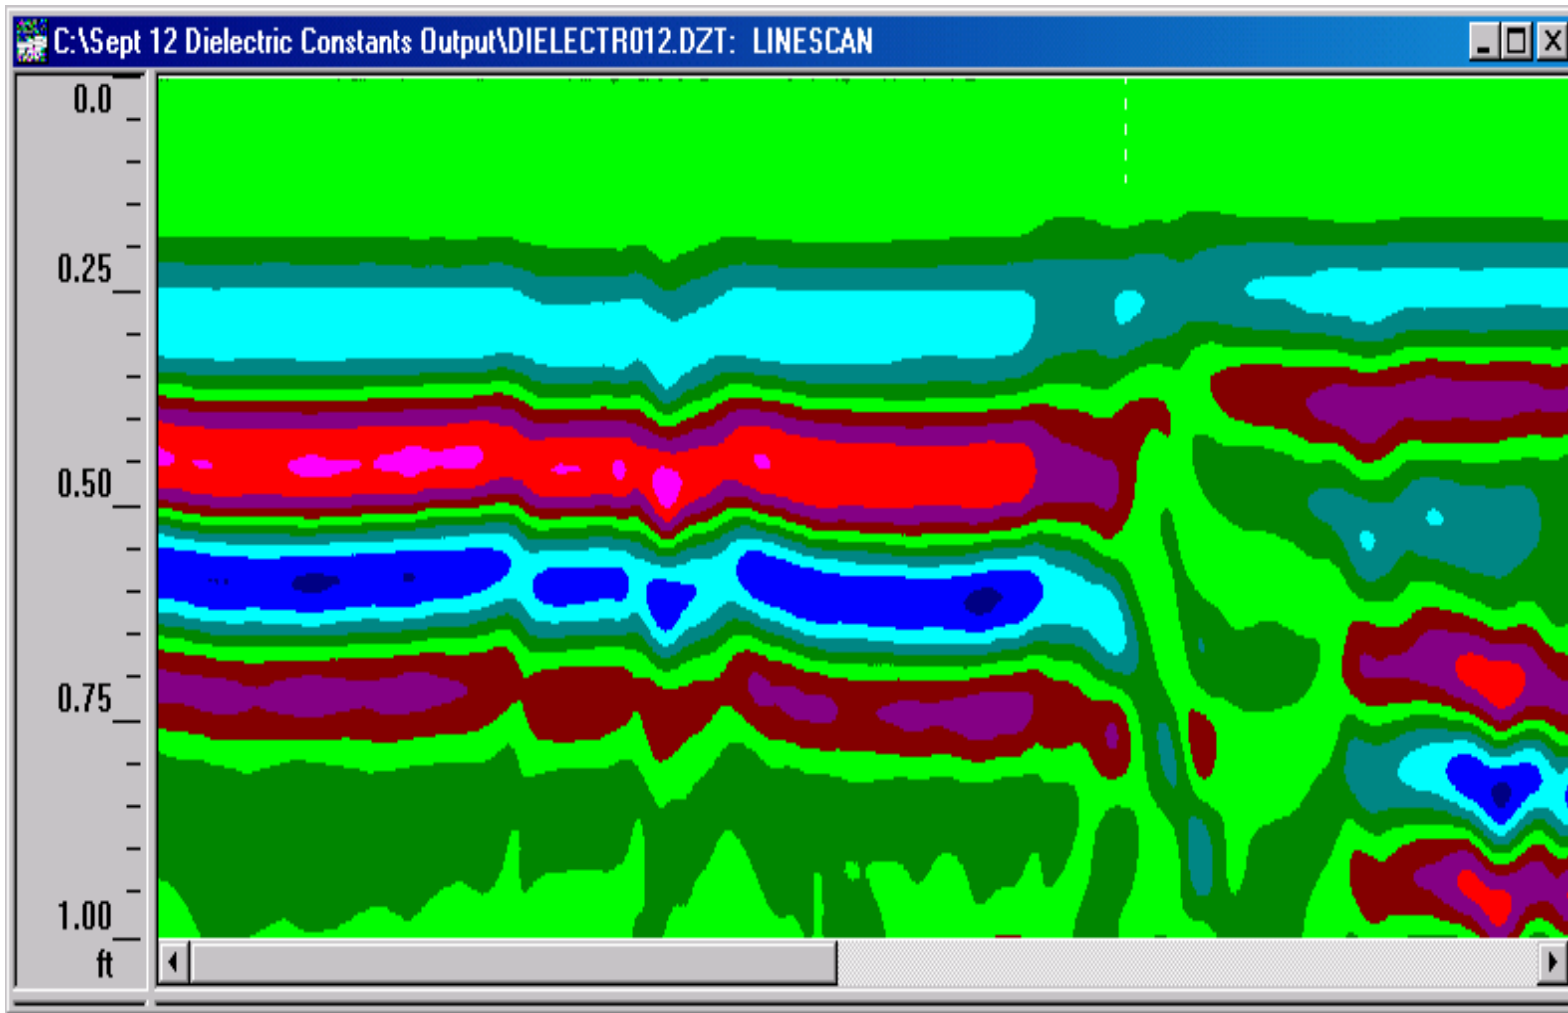
Figure 28. GPR Profile of Test Pit using 900 MHz antenna with Dielectric Constant of 6 with slow walking speed

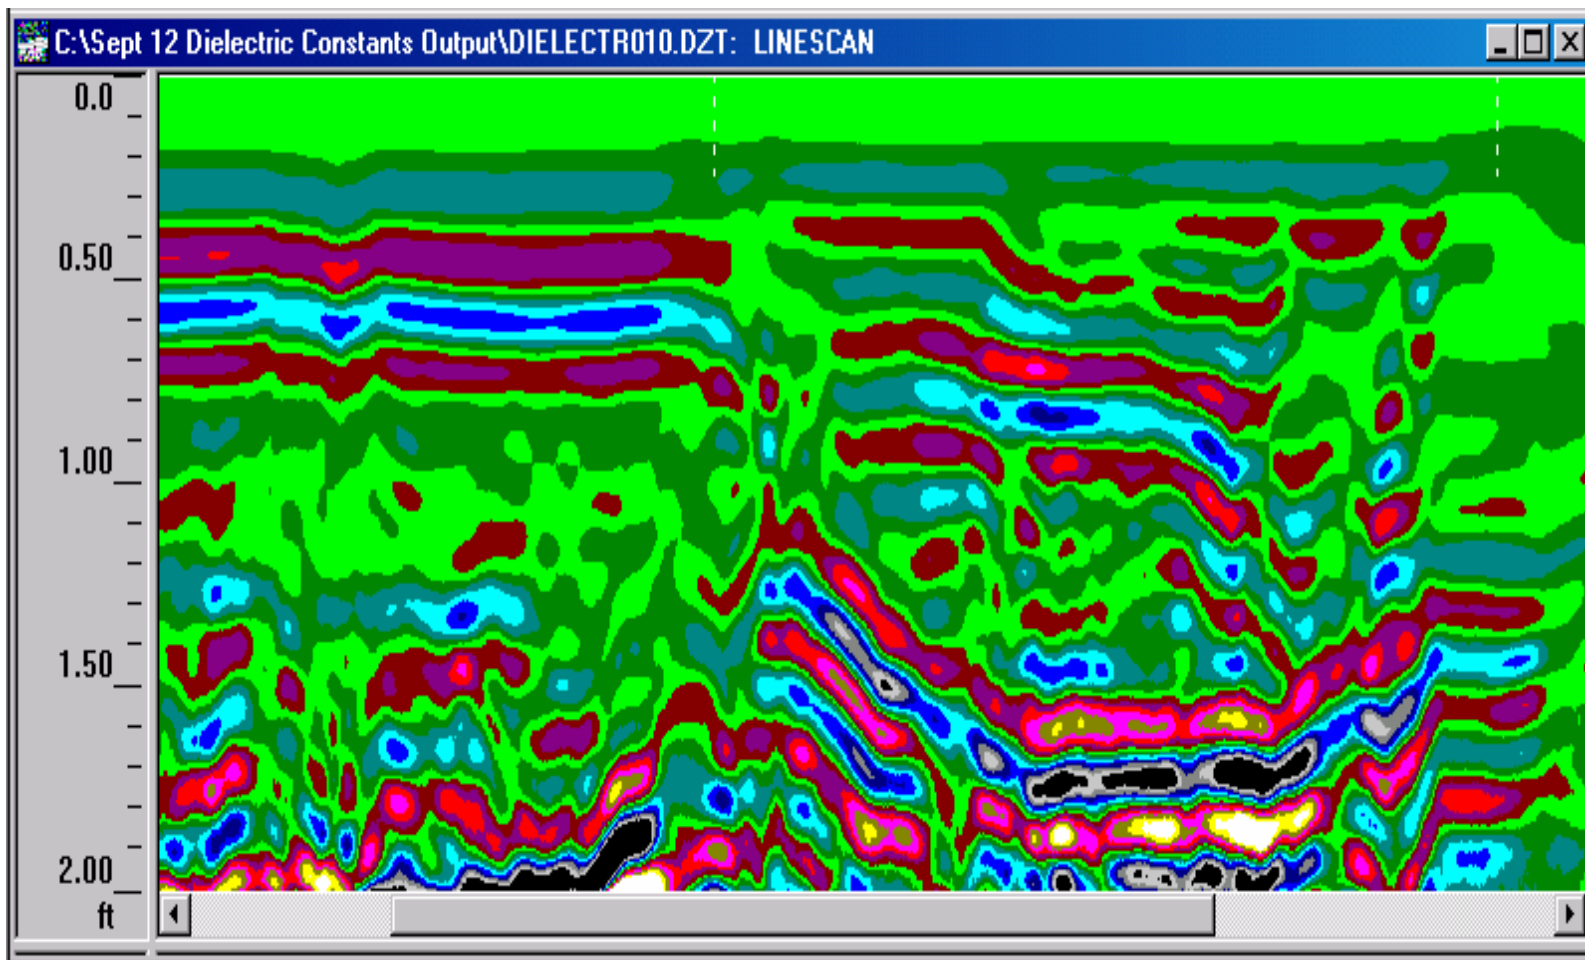
Figure 29. GPR Profile of Test Pit using 900 MHz antenna with Dielectric Constant of 6 with 15 ns or 2 feet depth

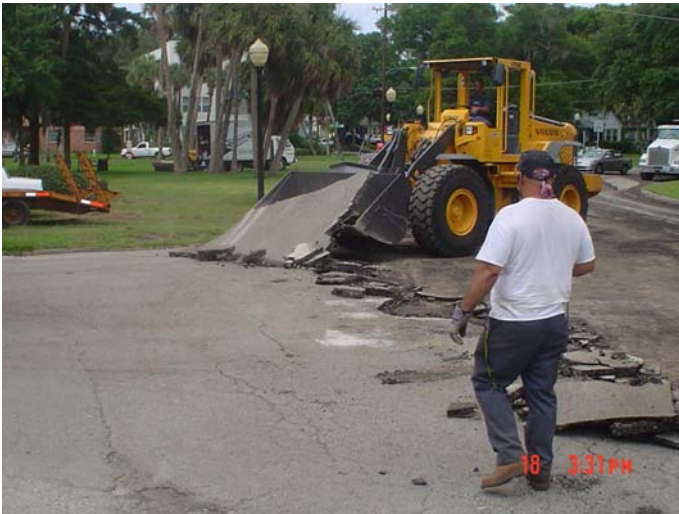
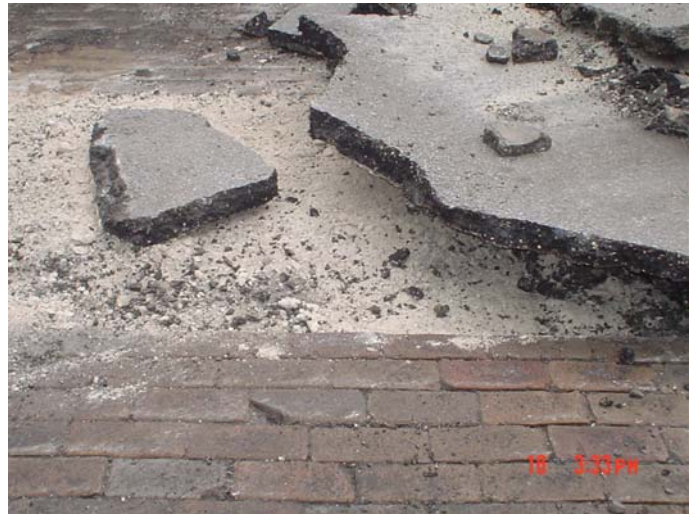
Avenue and Cherokee Drive). This area was measured to be 188 square feet (17ft x 4ft) after the existing asphalt was removed from Summerlin Avenue. The operation of asphalt removal is shown in Figures 30 (a) and (b), and GPR profile reflected to this area is shown in Figure 31. None of brick signals were observed from the GPR profile for this area. In spite of this section, bricks were detected on the entire section surveyed on Summerlin Avenue including a few inches over the new asphalt. A typical GPR profile for Summerlin Avenue with brick base is presented in Figure 32.

Figure 30. Removal of Asphalt at the Curb

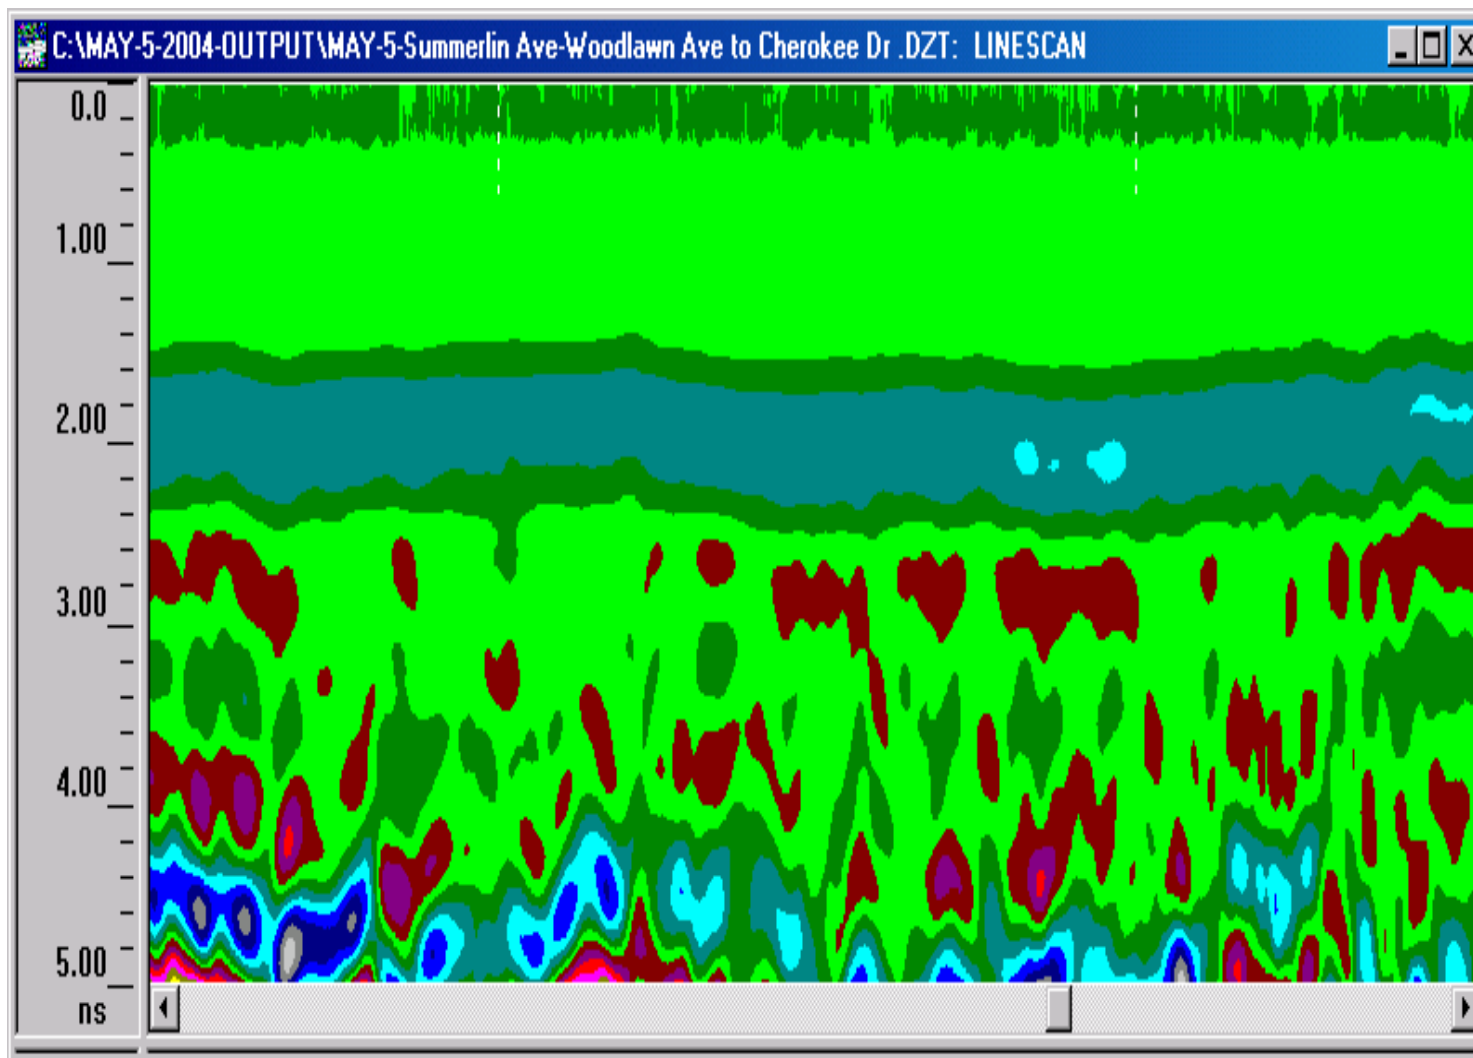
Figure 31. GPR Profile without brick base at the intersection of Summerlin Avenue and Cherokee Drive (North Curb)

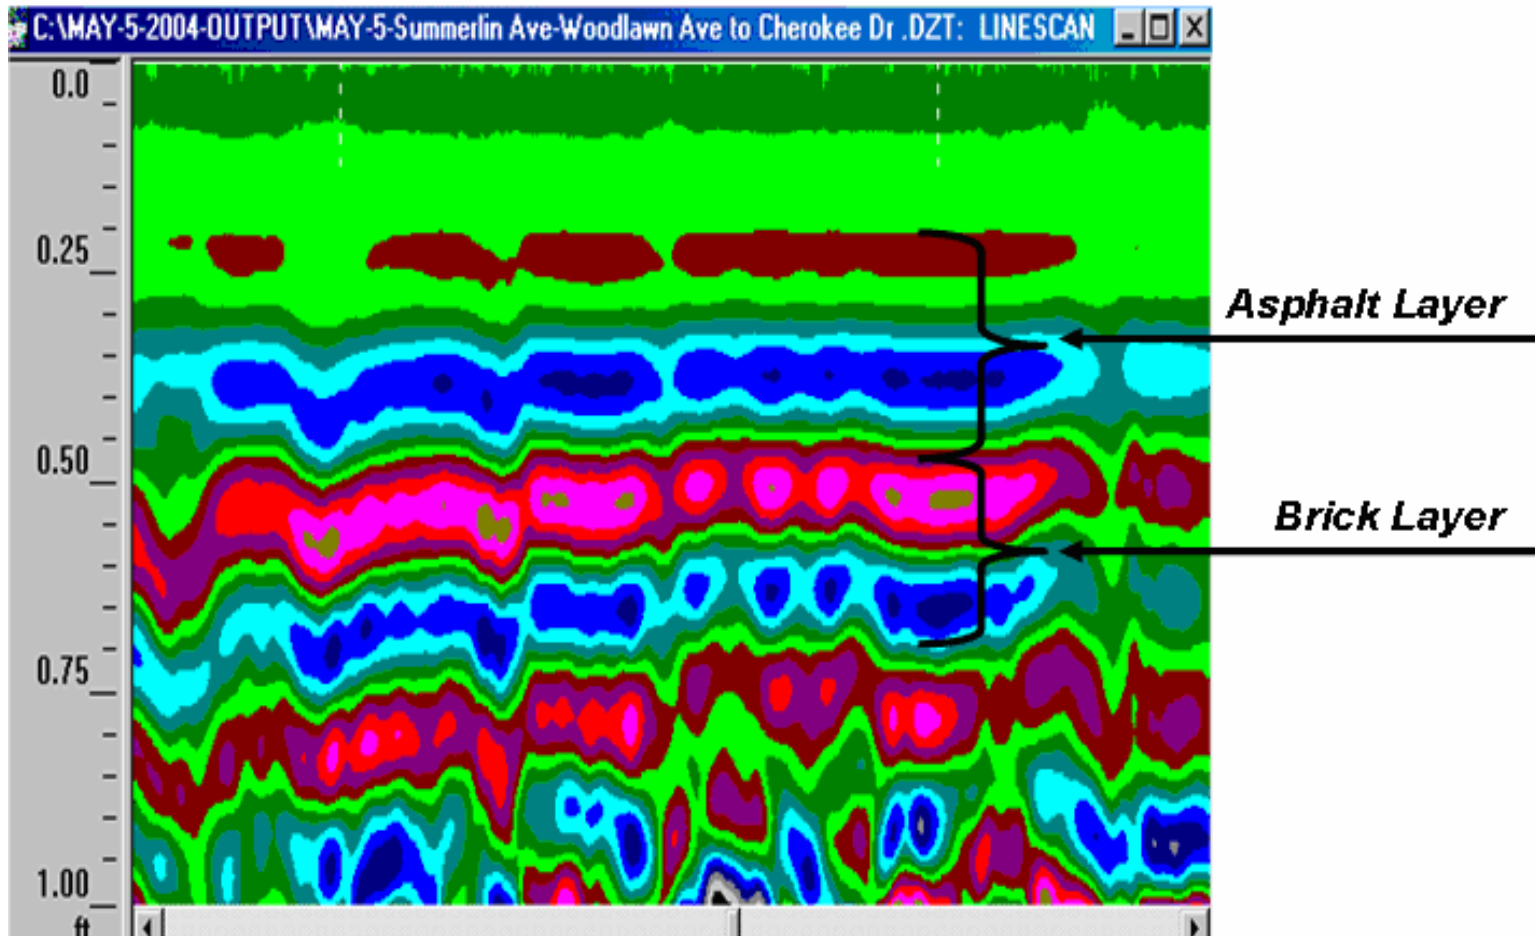
Figure 32. GPR Pavement Profile for Summerlin Avenue with Brick Base

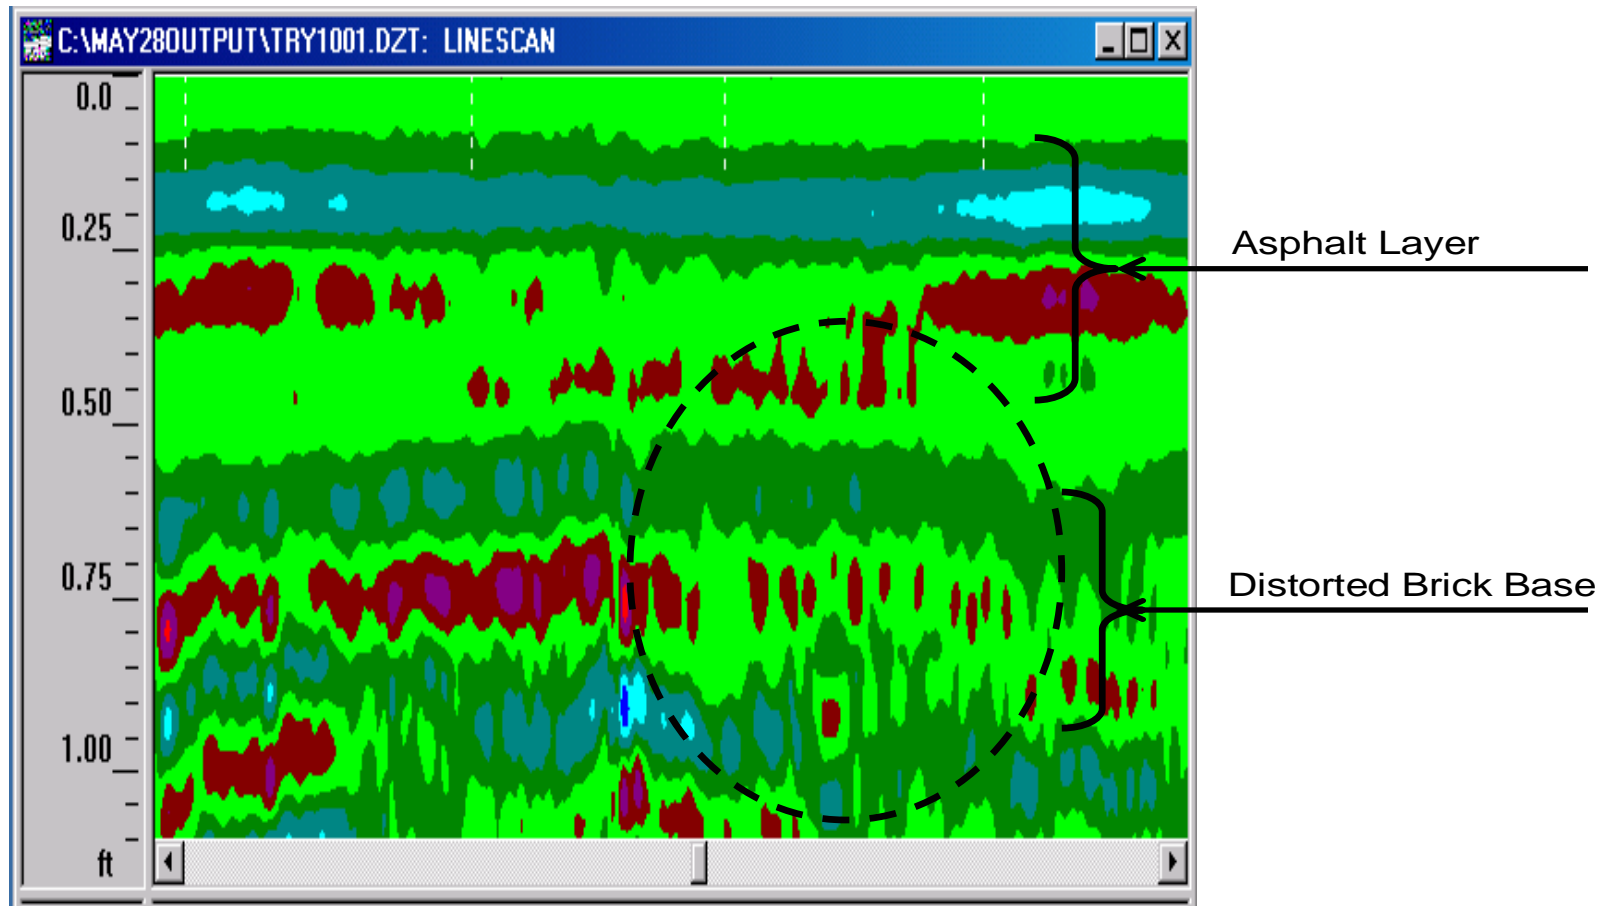
Figure 34. GPR Profile on Cherokee Drive with no Bricks
