Detection And Evaluation Of Existing Pavement System With Brick Base

**DETECTION AND EVALUATION OF EXISITING PAVEMENT SYSTEM
WITH BRICK BASE USING GROUND PENETRATING RADAR**

A thesis submitted in partial fulfillment of the requirements
for the degree of Master of Science
in the Department of Civil and Environmental Engineering
in the College of Engineering and Computer Science
at the University of Central Florida
Orlando, Florida

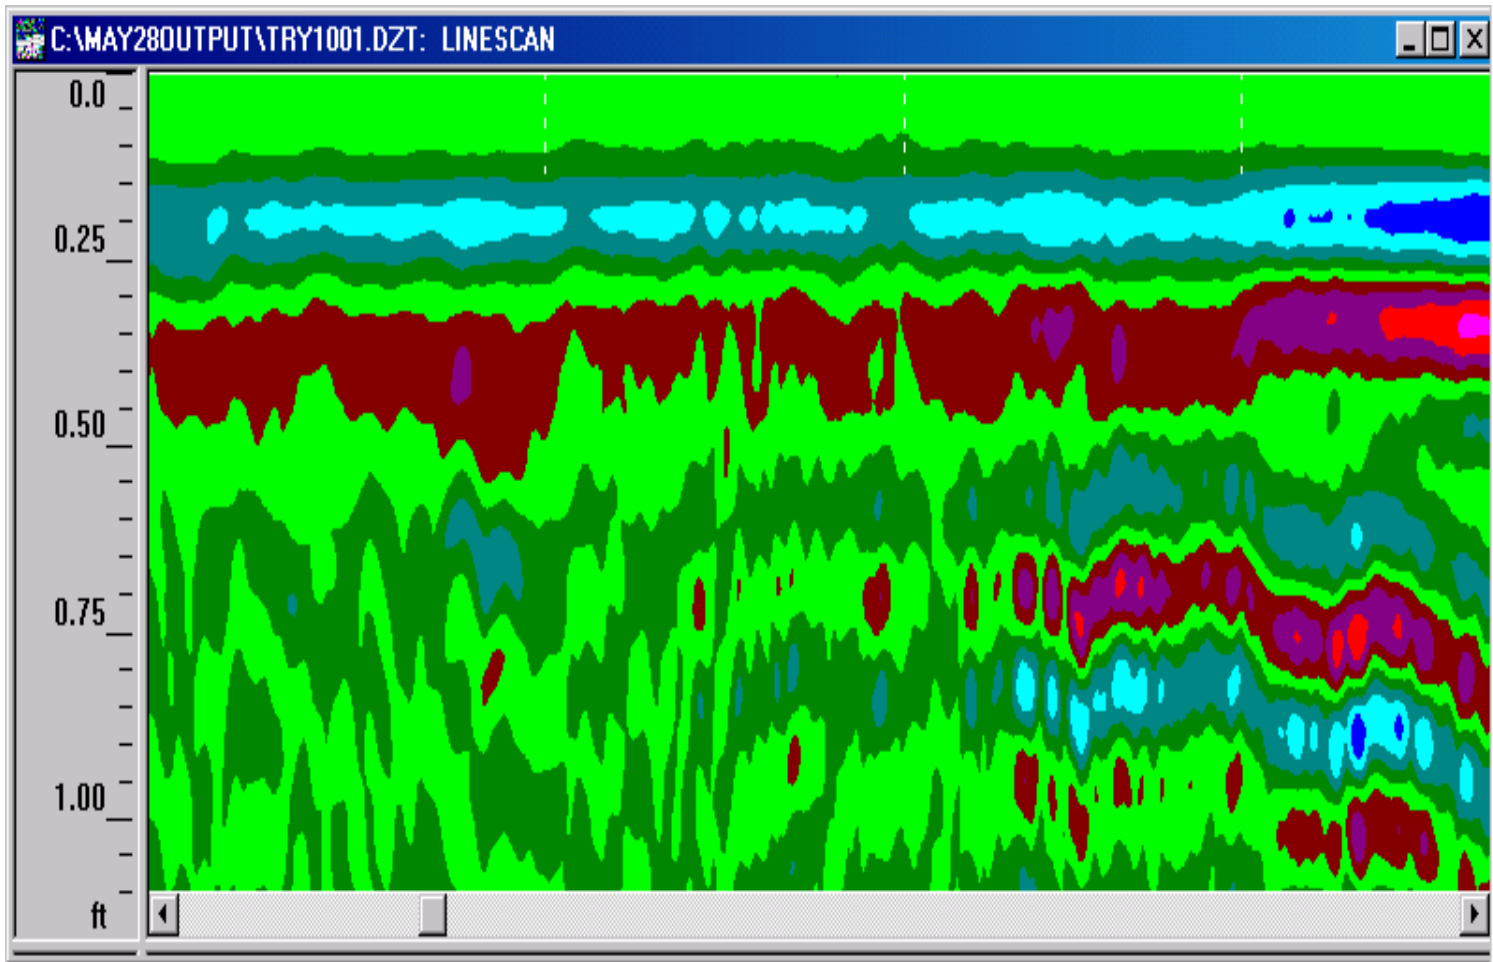
Figure 35. Typical GPR Profile on Cherokee Drive with No brick base

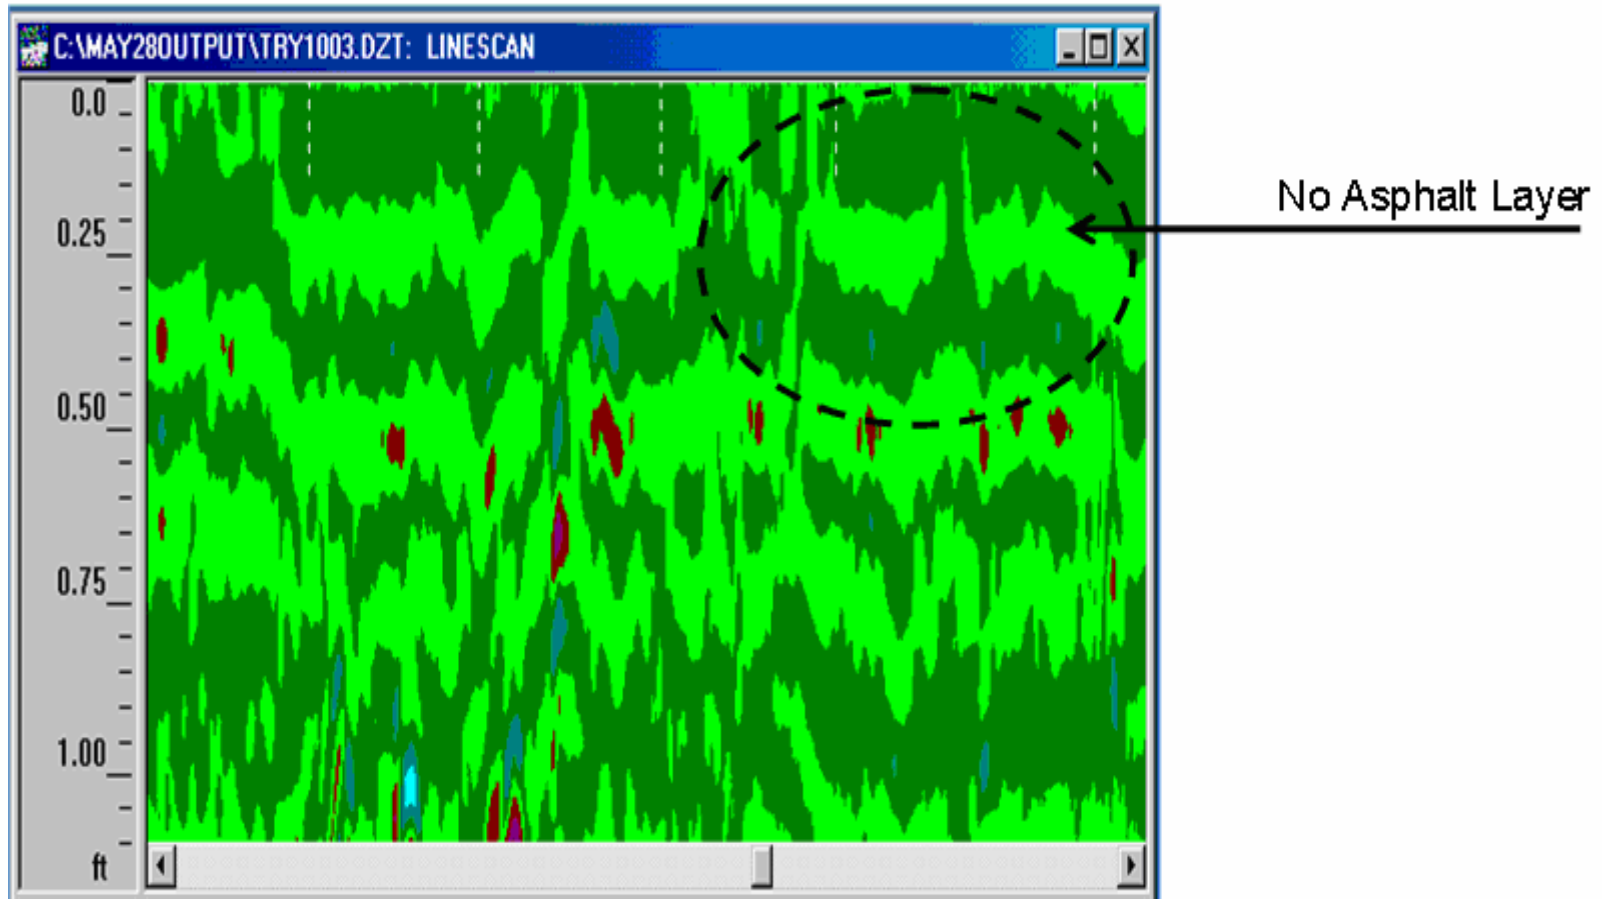
Figure 36. GPR Profile on Center of Cherokee Drive with Signal Break

The loss of radar signals in this project may be attributed to reasons of motor vehicles driving by, power lines situated overhead, or utility cables that are buried within a few inches of the surface. Furthermore, utility lines, depressions, change in subgrades, or loose soils may also have caused interruptions in the antenna's signal. Depression was spotted at approximately 625 feet and 813 feet from Summerlin Avenue to Delaney Avenue on Cherokee Drive, which is clearly seen in Figure 39. Bricks were spotted over the entire roadway system; however, it was observed that several areas with distorted subbase (Figures 34, 39, and 40) were in between 1380 feet – 1400 feet and 1650 feet to 1670 feet from starting point at the intersection of Cherokee Drive and Summerlin Avenue. This could have taken place due to high moisture or high contamination that dramatically increased the conductivity of the subgrade material or simply due to an increase of seepage flow.

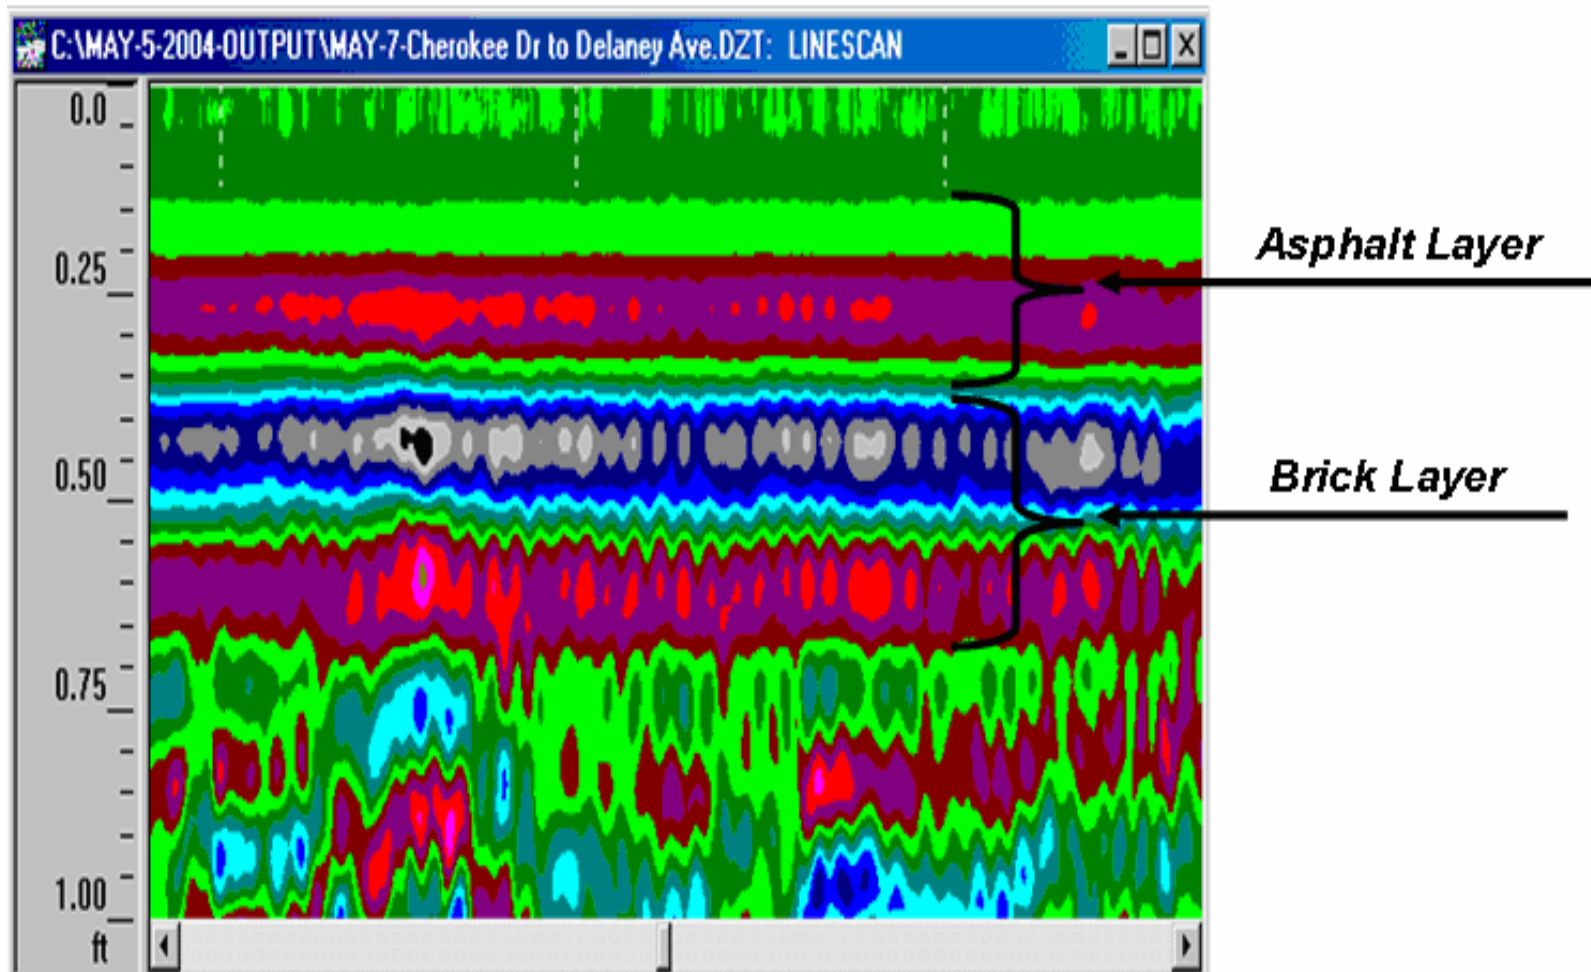
Figure 37. GPR Profile on Cherokee Drive with Brick Base

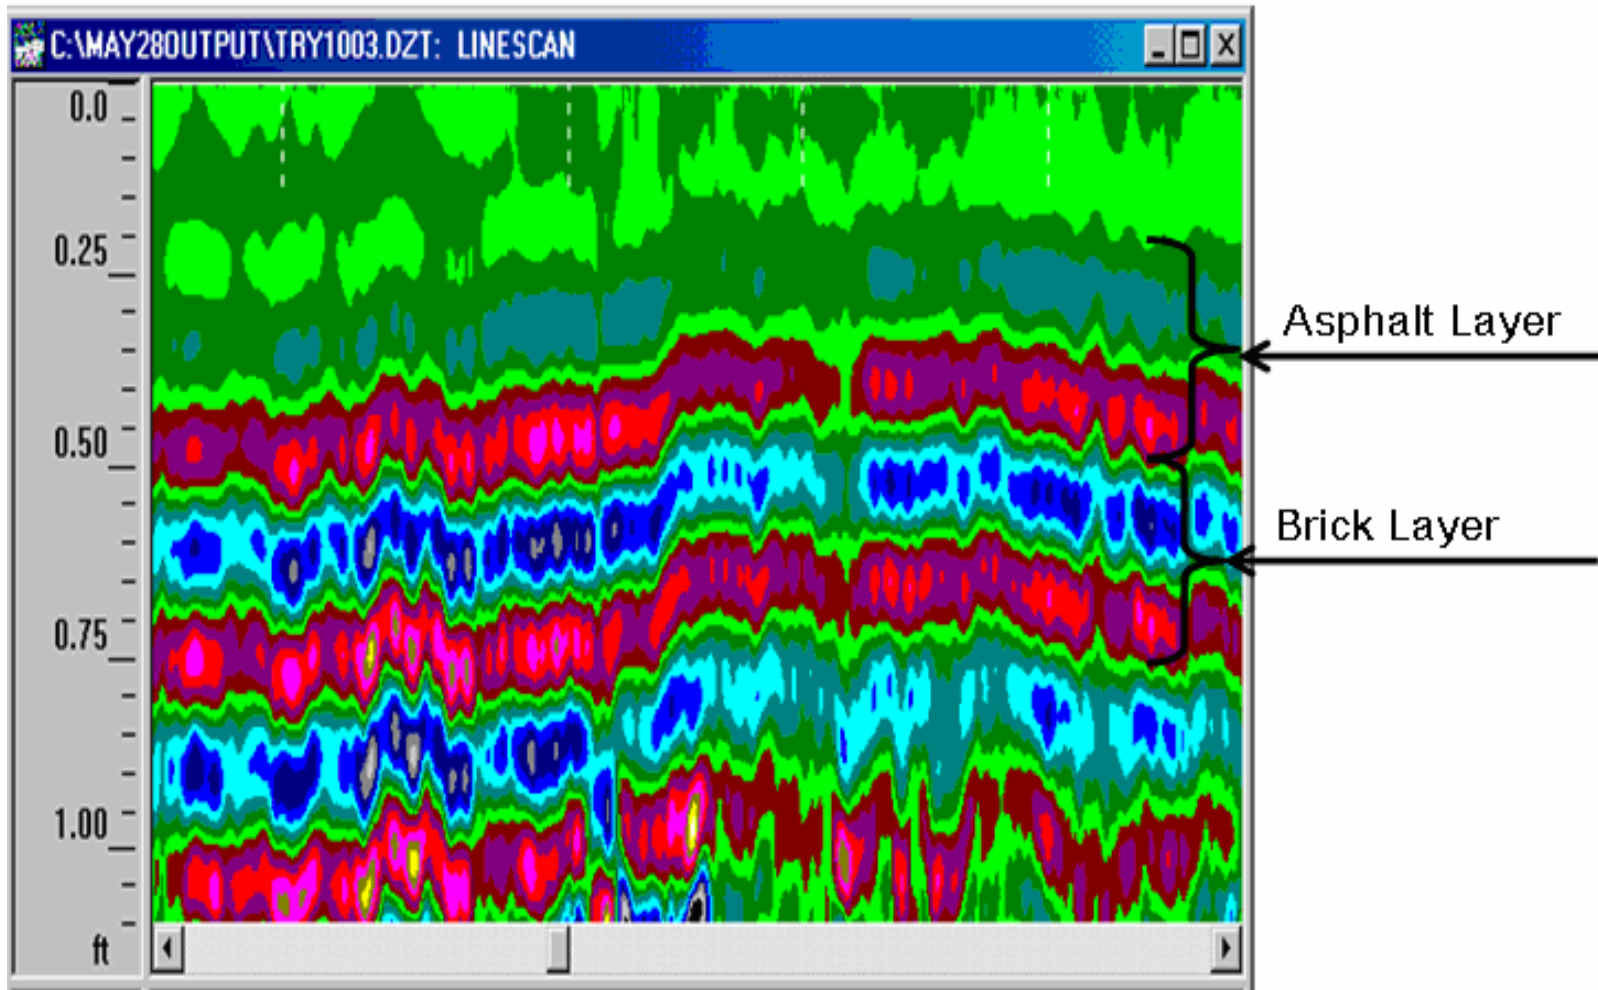
Figure 38. GPR Profile on Center of Cherokee Drive with Brick Base

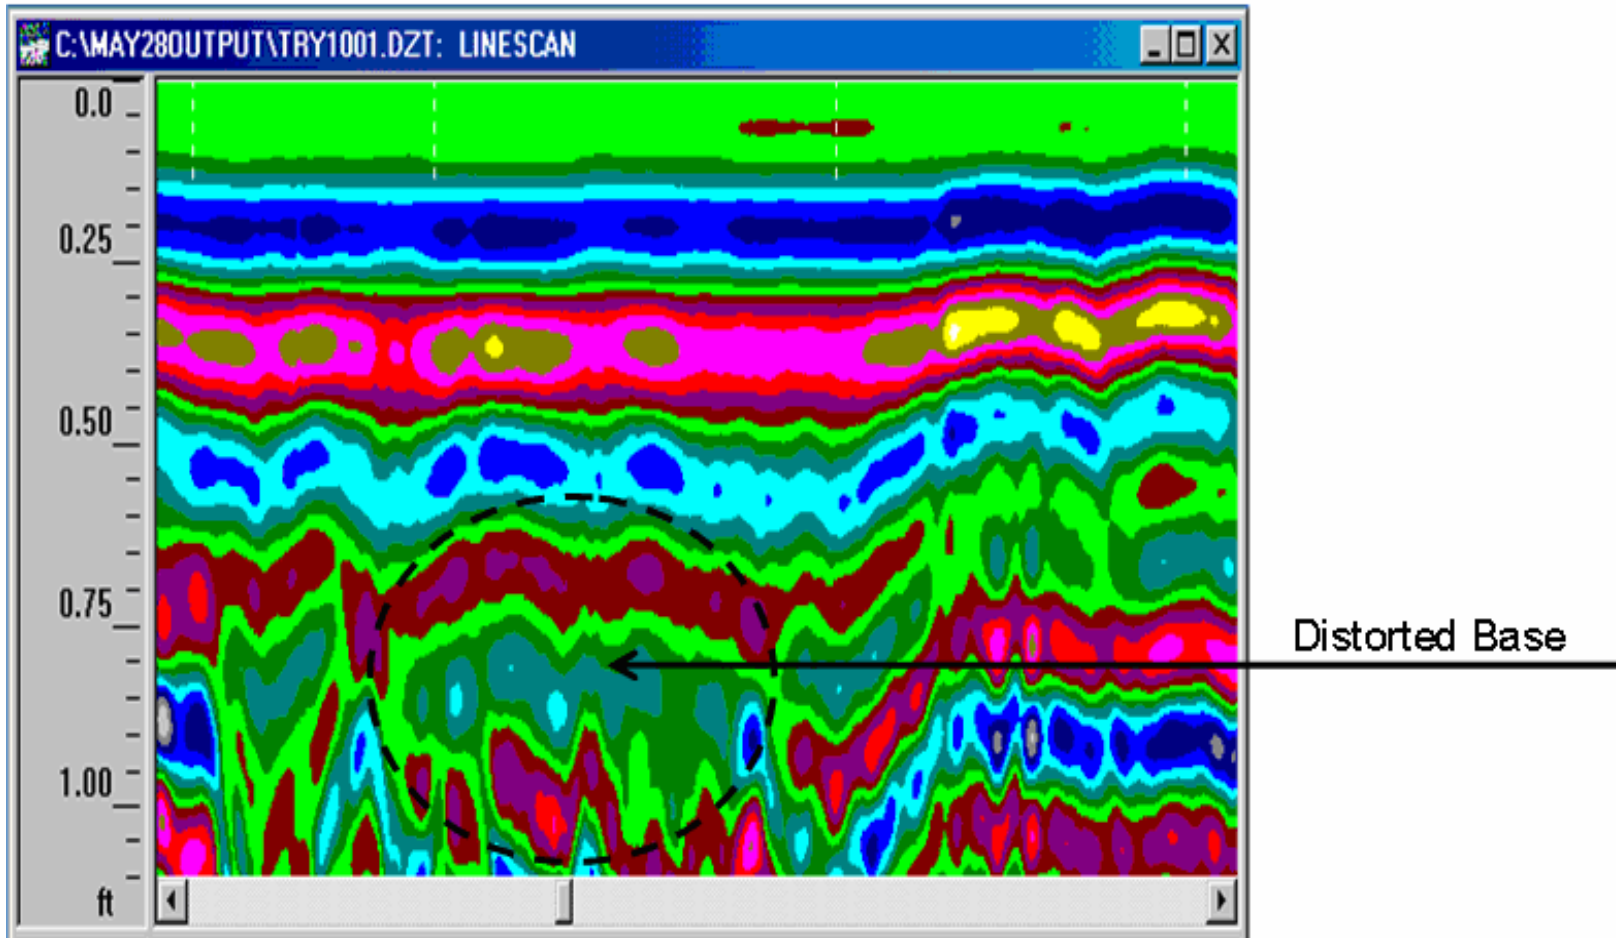
Figure 40. GPR Profile on Right Edge Cherokee Drive with Depression

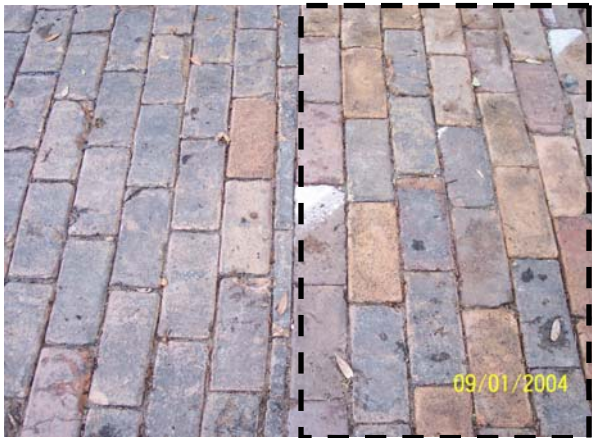
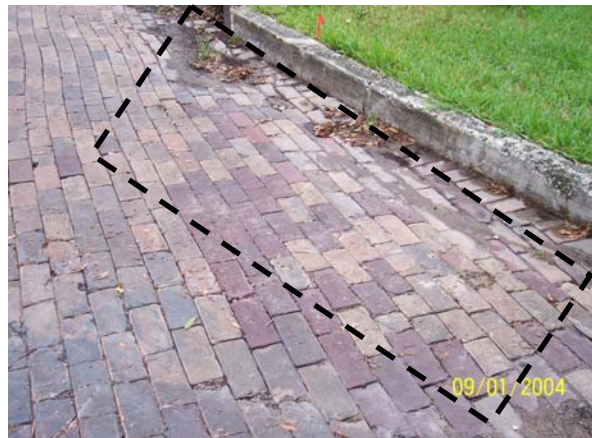
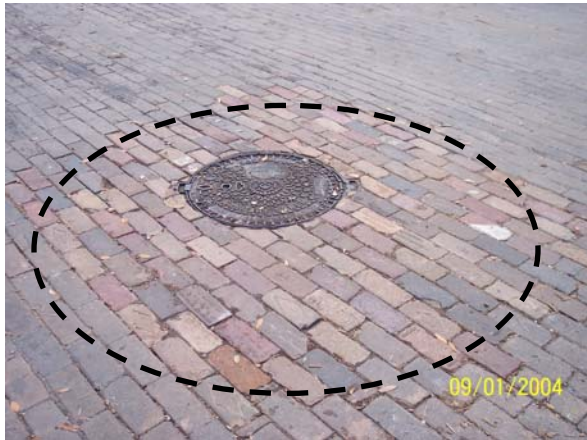
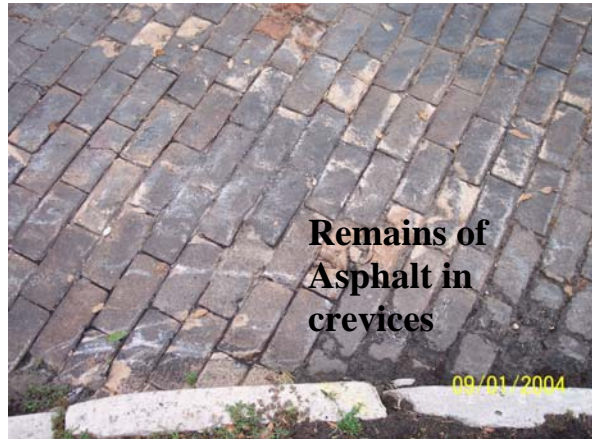
Figure 41. Areas of Cherokee Drive after Asphalt Removal and Replacement of Areas without Bricks

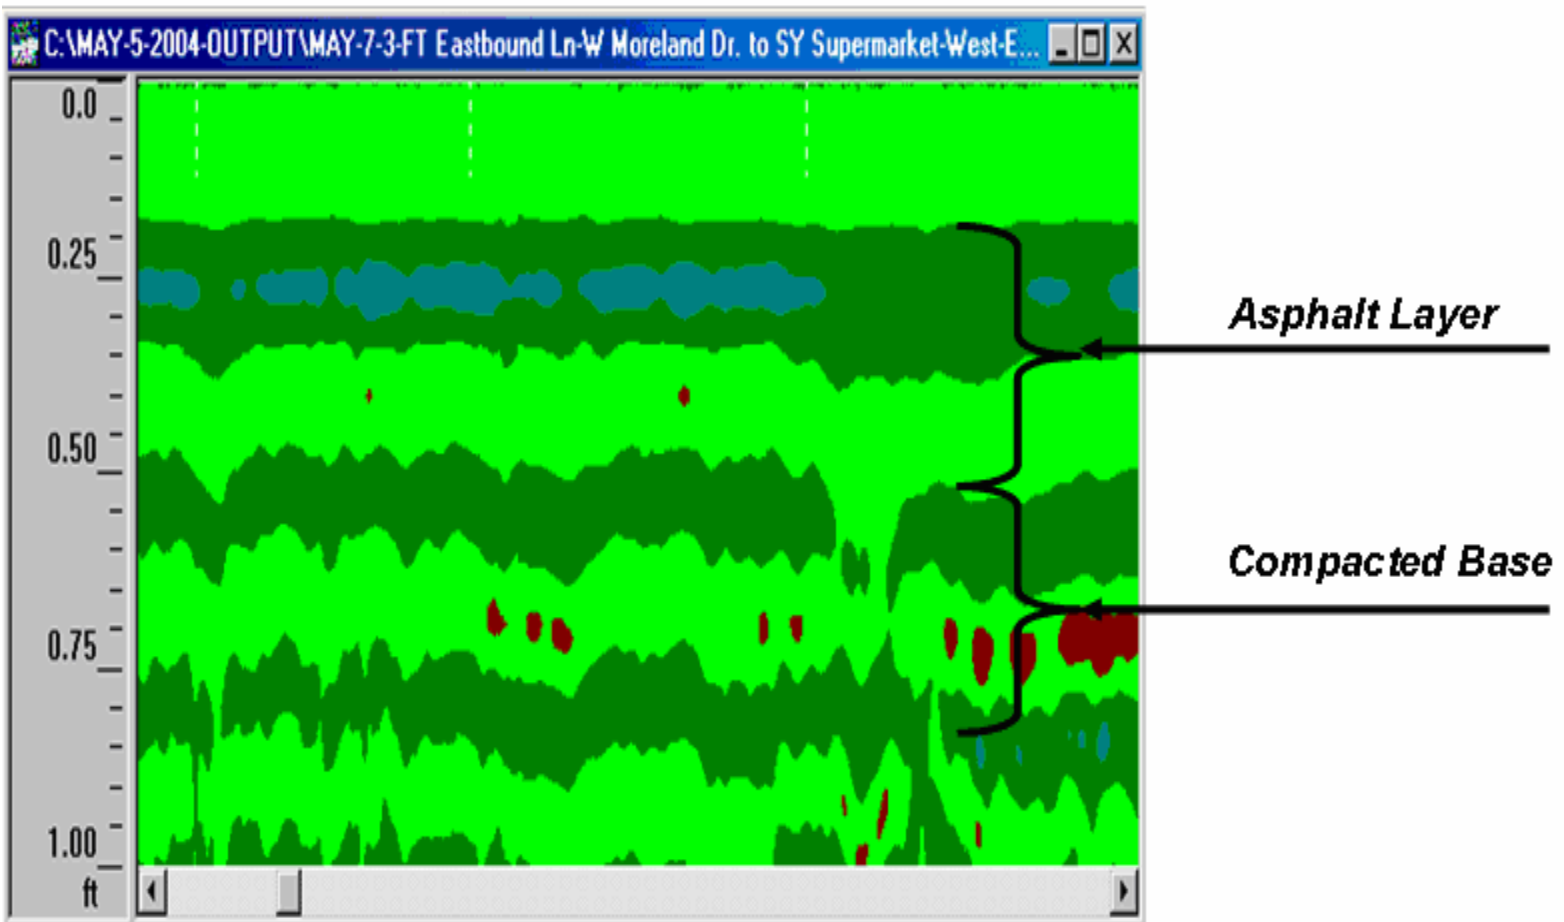
Figure 43. GPR Profile on Church Street without Brick Base 3 Feet from the Edge of Pavement

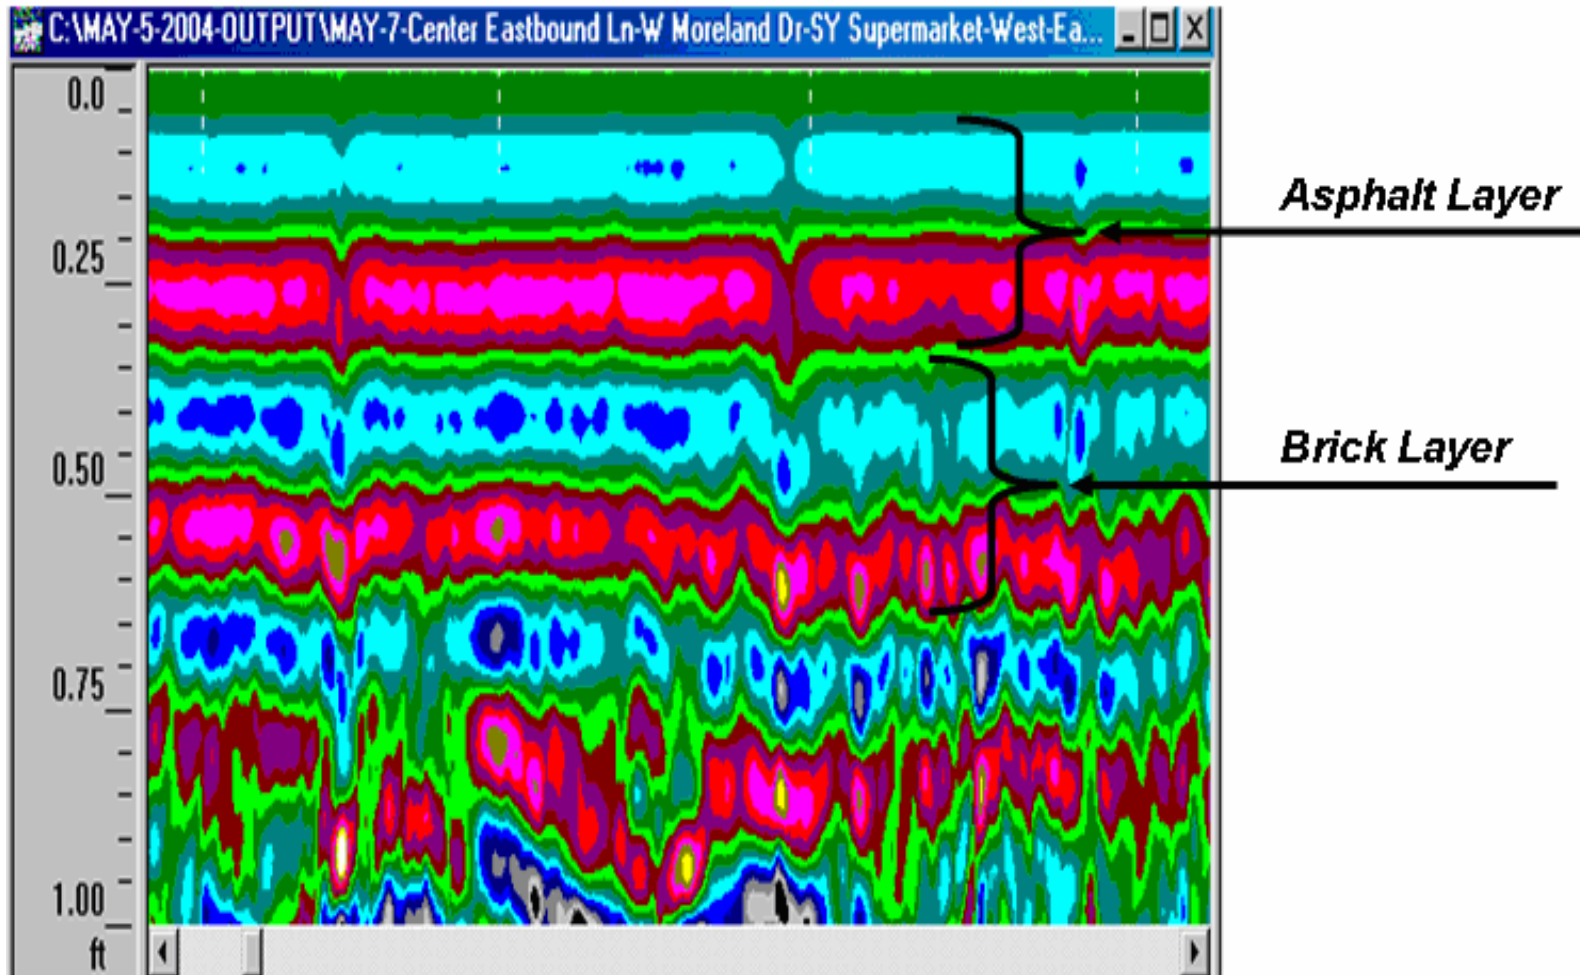
Figure 44. Typical GPR Profile on Church Street with Brick Base

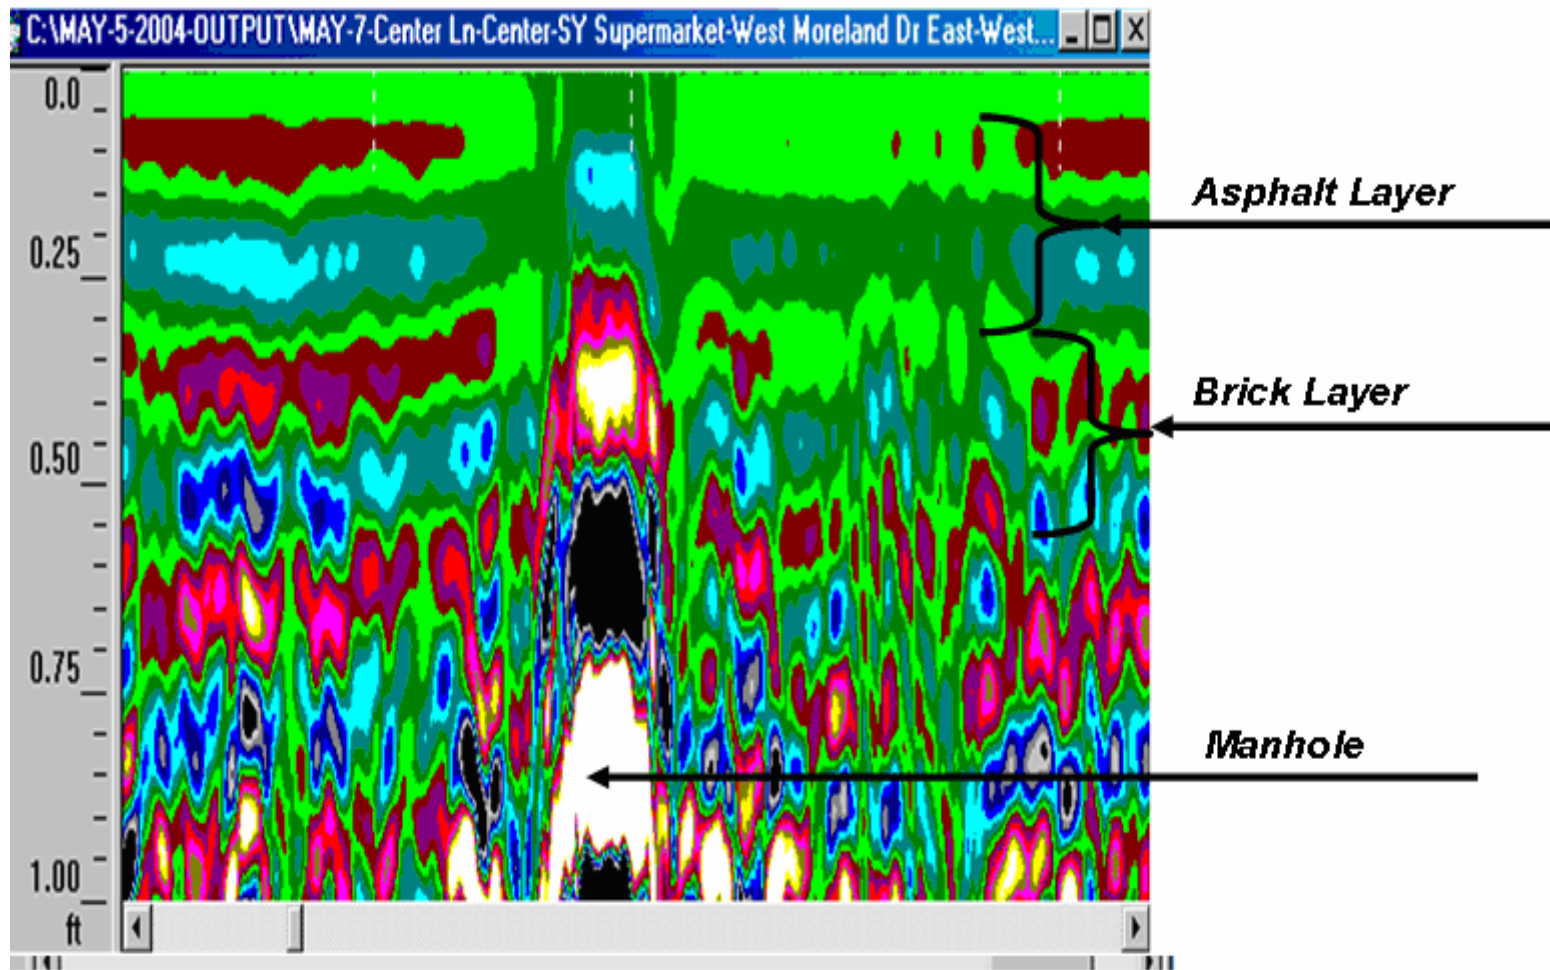
Figure 45. GPR Profile on Church Street with Brick Base and Manhole

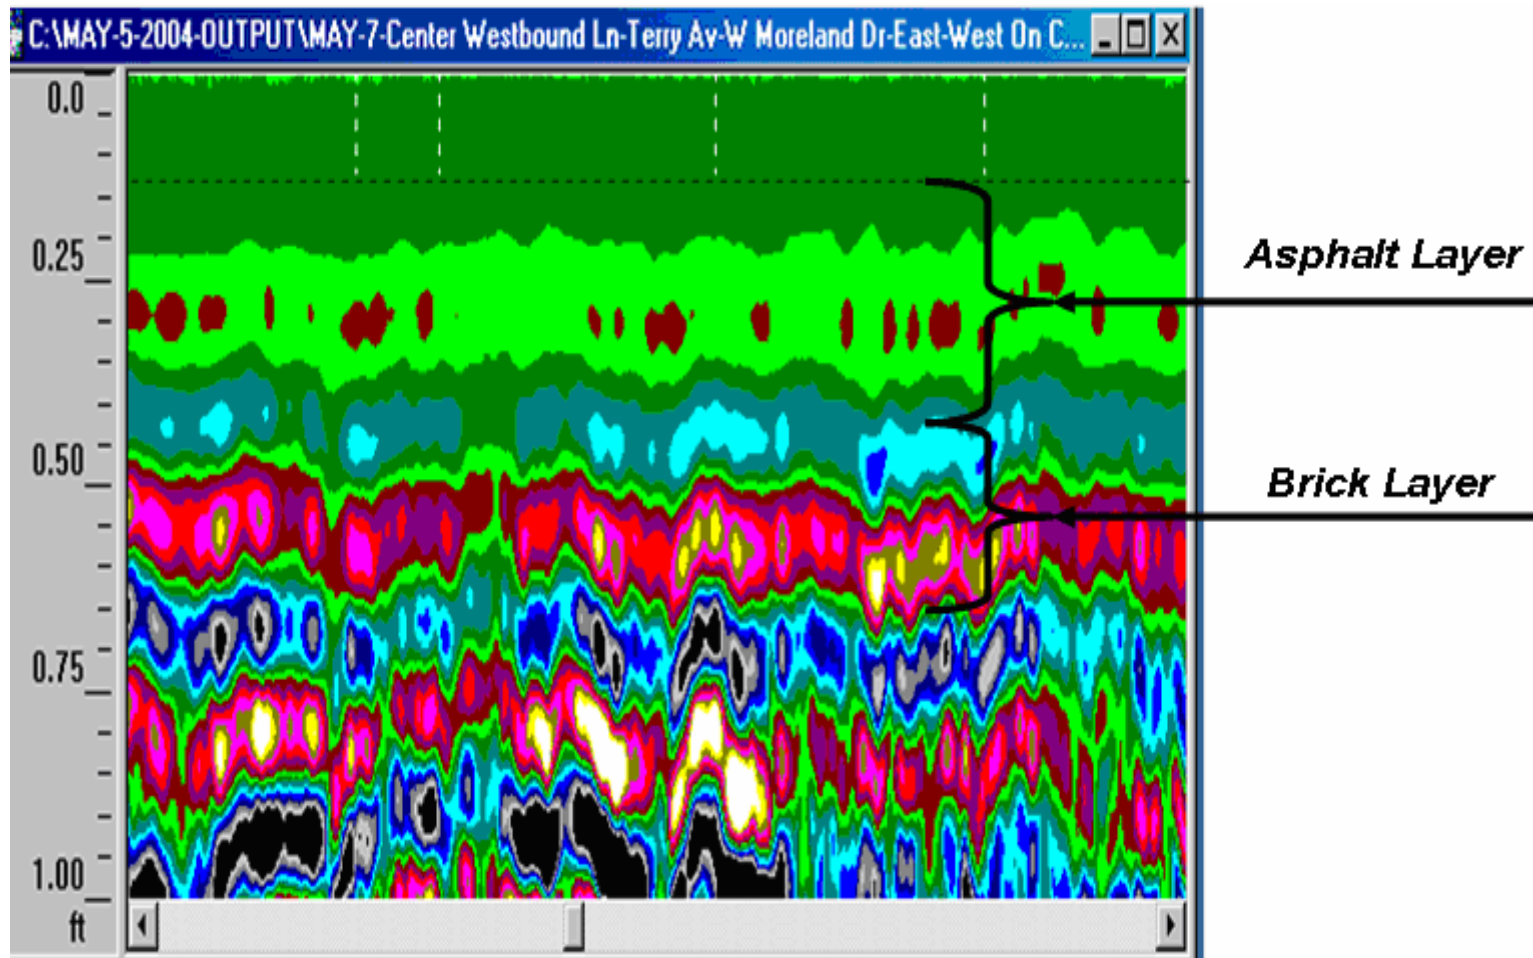
Figure 46. GPR Profile on Church Street with Brick Base with along the Center lane

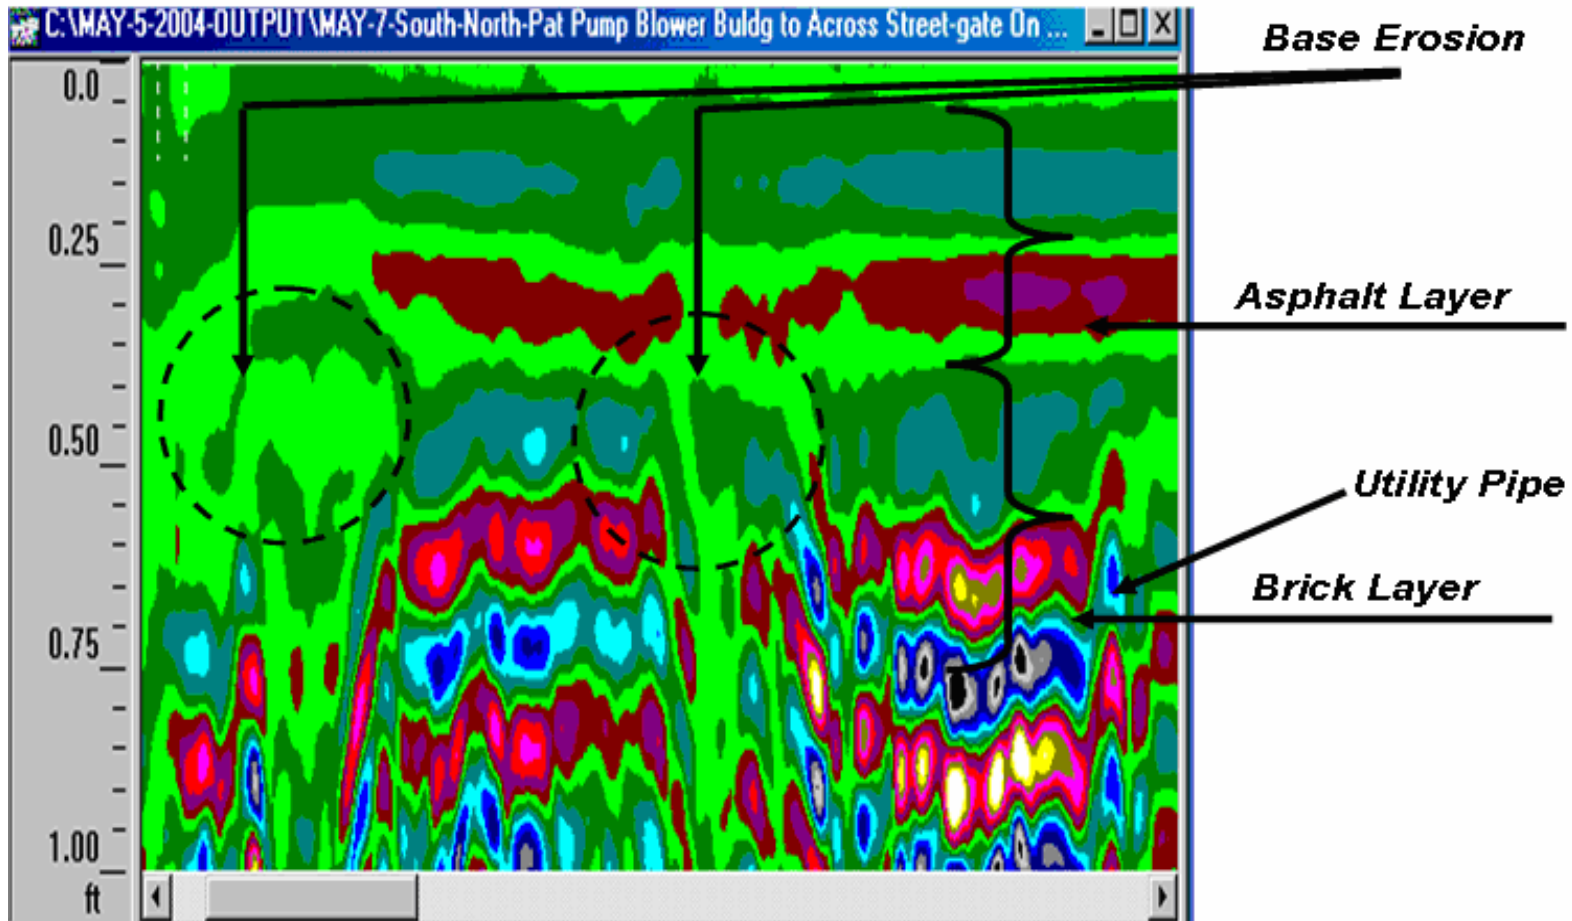
Figure 47. Cross-section GPR Profile on Church Street
