## On The Use Of Polyurethane Matrix Carbon Fiber Composites For Strengthening Concrete Structures

ON THE USE OF POLYURETHANE MATRIX CARBON FIBER  
COMPOSITES FOR STRENGTHENING CONCRETE STRUCTURES

A thesis submitted in partial fulfillment of the requirements  
for the degree of Master of Science  
in the Department of Civil, Environmental and Construction Engineering  
in the College of Engineering and Computer Science  
at the University of Florida  
Orlando, Florida

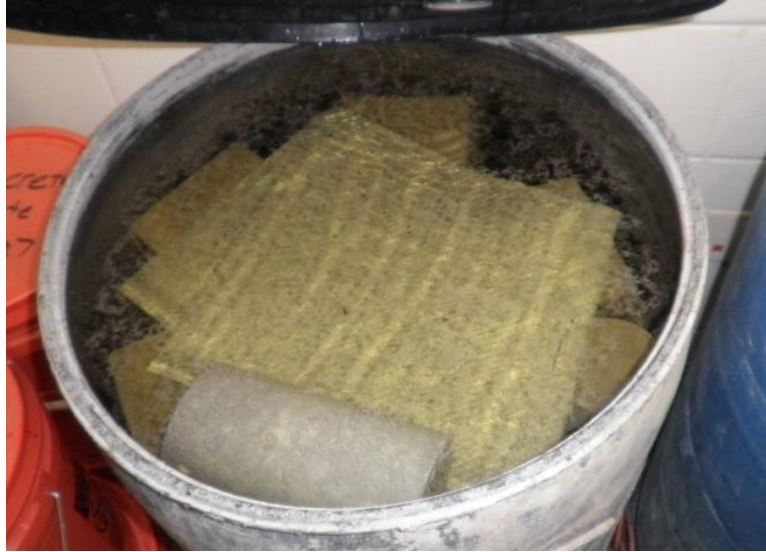
**Figure 12. Concrete Leachate Conditioning Environment**

Research has shown that water absorbed into the micro-pores of concrete can chemically react with the cement paste and create a high pH (>12) solution. Therefore, it was determined that the polyurethane strengthening system under investigation be able to withstand such an environment. A high-pH concrete leachate solution was created by letting concrete specimens and cylinders soak in H<sub>2</sub>O while monitoring solution pH. pH was measured using a hand held Extech PH60 pH/temperature pen. Prior to taking measurements, the pen was calibrated using a two-point pH7 buffer and pH-10 buffer calibration. A plot of pH vs. time can be seen in Figure 11. The pH of the leachate solution reached a steady-state value of approximately pH  $\approx$  12. A photo of the concrete leachate conditioning environment can be seen in Figure 12.

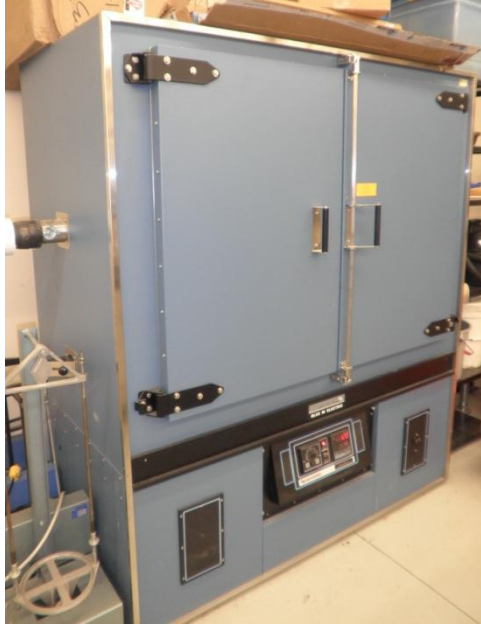
Figure 13. Dry Heat Oven

In order to provide constant and continuous dry heat, specimens were placed in a Blue M 146 Series industrial oven (refer to Figure 13 and Figure 14). A schematic of specimen location within the oven can be found in Figure 15. The oven temperature was set at 120 °F. During the first week of conditioning, oven internal, specimen concrete, and CFRP temperatures were monitored with a Westword 2ZB46 laser temperature measurement device to determine whether steady-state operation was being achieved. It was determined that the oven was not producing a steady-state environment due to overheating. In order to achieve steady-state operation, the oven's exhaust was adjusted until the internal temperature of the oven stabilized. Temperature measurement prior to and once steady-state operation was achieved can be found in Table 13/Table 14 and Table 15/Table 16 respectively. The average concrete and CFRP surface temperatures (steady-state) were determined to be 126.2 °F and 126.1°F respectively.

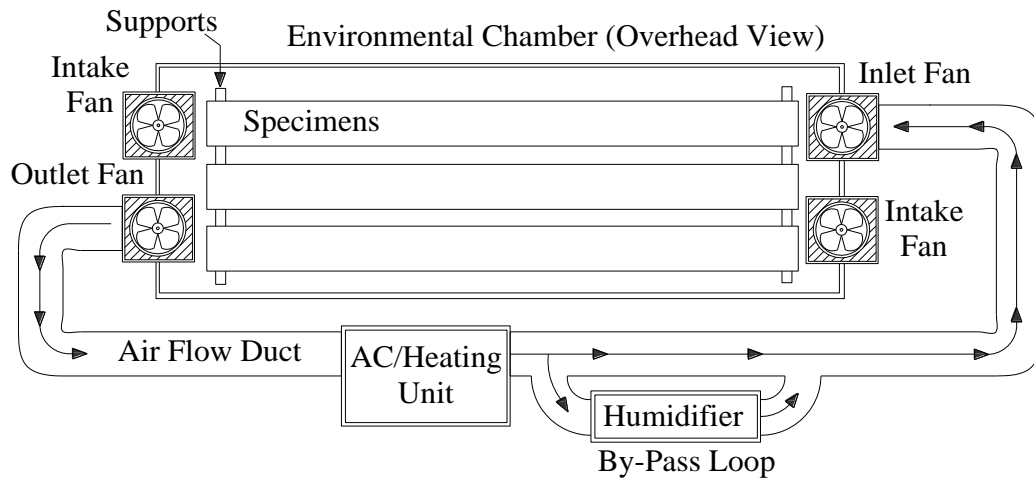
3) *Cycle Controller* – A Watlow SD Series controller was used to control the environmental cycles for the chamber.

Figure 21. Environmental Conditioning Chamber

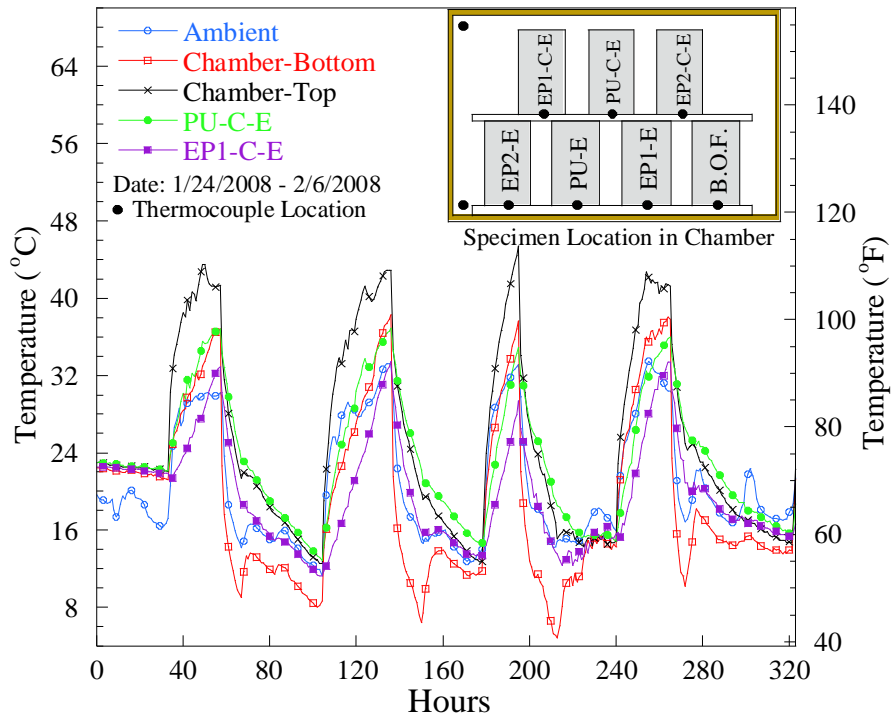
Figure 22. Conditioning Chamber Sample Data

To measure the thermal performance of the conditioning chamber, thermocouples (type-K) were installed on the tension surface of each beam specimen during conditioning, on the top and bottom of the chamber, and outside the chamber (ambient). Temperature and humidity data was acquired continuously during the conditioning period. A multi-day sample of temperature data can be found in Figure 22. It can be observed that the chamber produced internal ambient temperatures between 40 and 115°F and beam surface temperatures between 55 and 100°F. The humidity range achieved was between 19% and 89%.

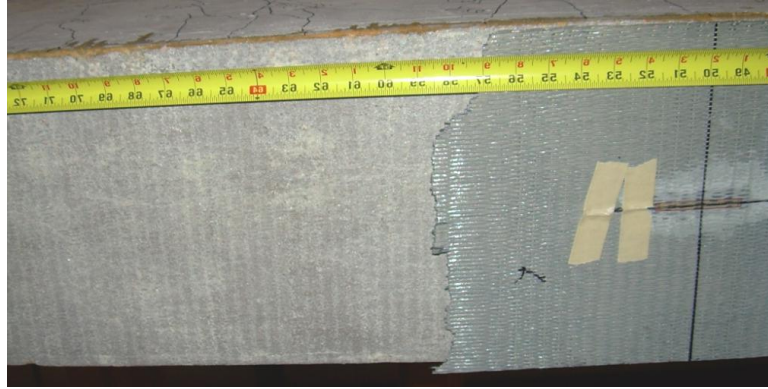
**Figure 107. PU Baseline CFRP Rupture Plane**

The PU baseline specimen was tested to failure on 2/6/2007. During the load testing, there were no observed problems with DAQ or the test set-up. Therefore the load test was completed in a single run. Loading was paused at 26.3, 39.5, and 52.6 kips for cracks to be marked. Failure of the PU baseline specimen ultimately occurred at 74.3 kips ( $\Delta=1.82''$ ). The failure mode was determined to be CFRP rupture followed by laminate debonding. During the final three minutes of the load test, a video was recorded to capture the beam's failure. Figure 106 shows two frames from the video taken. The first frame where failure was evident (initial CFRP rupture) is denoted to have a time interval of  $t = 0\text{sec}$  for reference. The initial rupture occurred approximately 50'' from the north support (between SG2 and SG3). Immediately after the CFRP rupture, laminate debonding occurred. It should be noted that debonding failure occurred within the urethane adhesive layer. Figure 107 shows a close-up picture of the debonding surface. It can be observed that a whitish colored layer of material (urethane) remains on the concrete substrate, supporting the conclusion of cohesive failure within the adhesive layer.
