Non-destructive Evaluation Of Concrete Structures Using High Resolution Digital Image And Infrared Thermography Technology

A thesis submitted in partial fulfillment of the requirements
for the degree of Master of Science
in the Department of Civil, Environmental, and Construction Engineering
in the College of Engineering and Computer Science
at the University of Central Florida
Orlando, Florida

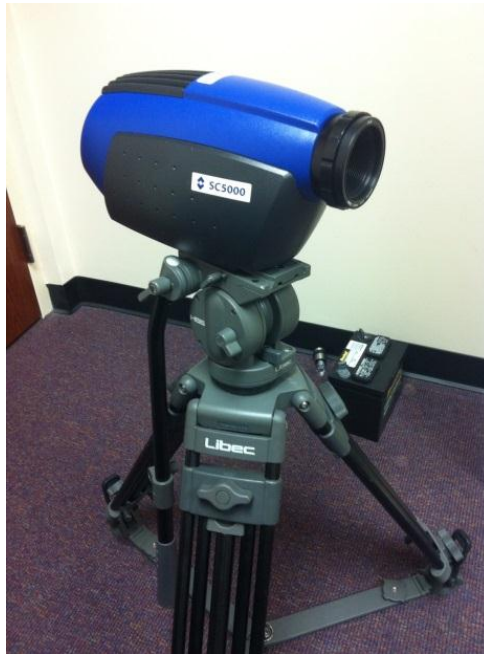
Figure 2: Infrared Camera

Infrared thermography image technology in this thesis is a non-destructive evaluation technology to locate possible delamination and spalling of concrete subsurface through the monitoring of temperature variations on concrete surface using high-end infrared camera (Figure 2). The camera used in this technology is FLIR SC5600. The advantage of this IR technology is to enable inspectors to identify likely delaminated, spalled and inner void areas from a distance of up to 60 meters. Due to this advantage, there is no need for inspectors to move closer to objects using ladders or snooper trucks. Moreover, the result of the thermography images, which are screening of potential concrete defects on concrete subsurface, reduce the amount of time to inspect compared to sounding test, since there is no need to inspect spot by spot.

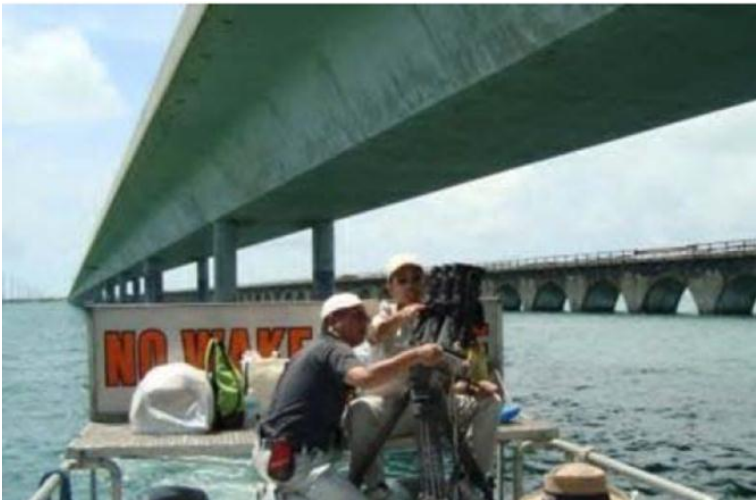
Figure 11: Bridge Inspection using High Definition Video Camera

bridge elements are photographed by motion-controlled digital camera from the fixed locations (Automatic Camera System), or high definition video cameras through mobile carriers such as the inspectors, vehicles, or boats (HDV System). The digital camera used in this system is “Nikon D3s” and the high definition video camera is “Canon XH GIS (1440×1080). This technology enables inspectors to identify cracks on concrete on the photos taken even from a distance. Due to this, there is no need for inspectors to move closer to objects using ladders or snoopers trucks. Figure 10 shows detectable crack width from each distance. Figure 11 shows the field data collection by high definition video cameras through mobile carriers. As shown in the picture, it is possible to detect cracks of a bridge over a river with the use of a boat. Figure 12 shows the field data collection by motion-controlled digital camera. Once the target area is set up using the software, the camera automatically takes images of that adjusting a focus and light quality. Once the field data collection process is finished, software stitches the images collected from different angles at different distances and presents normal views of all structural surfaces, usually arranged as a single high-resolution composite image of the combined individual frames. The composite digital image is analyzed by image processing to detect cracks on the concrete surface in terms of crack size, location and distribution. Innovative crack identification algorithms can identify concrete cracks as narrow as 0.008 inch or 0.2mm. This size exceeds FHWA criteria, since current FHWA inspection criteria for crack detection requires to 0.01inch, or 0.25mm. Additionally, the crack size and length are determined by computer software and these quantitative characteristics are summarized in spread sheet format. The obtained crack maps and supporting data are provided to engineers for their subsequent structural diagnosis and rehabilitation planning. A special advantage of this HRDI crack detection technology, with

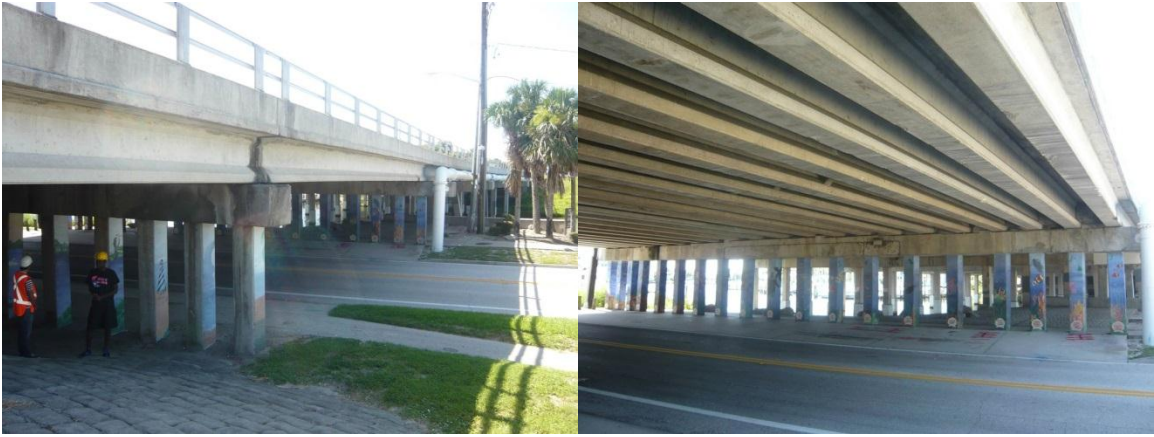
Figure 13: Sample Bridge in Melbourne

FDOT District 5 provided some candidate concrete bridges and one of them was selected for the project ,since it is found that the bridge was deteriorated to some extent and there was enough space for the demonstration based on the field survey. The bridge is No.700006 on US-1 in Melbourne (Figure 13). The bridge was built in 1959 and reconstructed in 1990. The number of lanes is seven and the total length is 380 ft. They also provided their parking garage as a test structure (Figure 14).

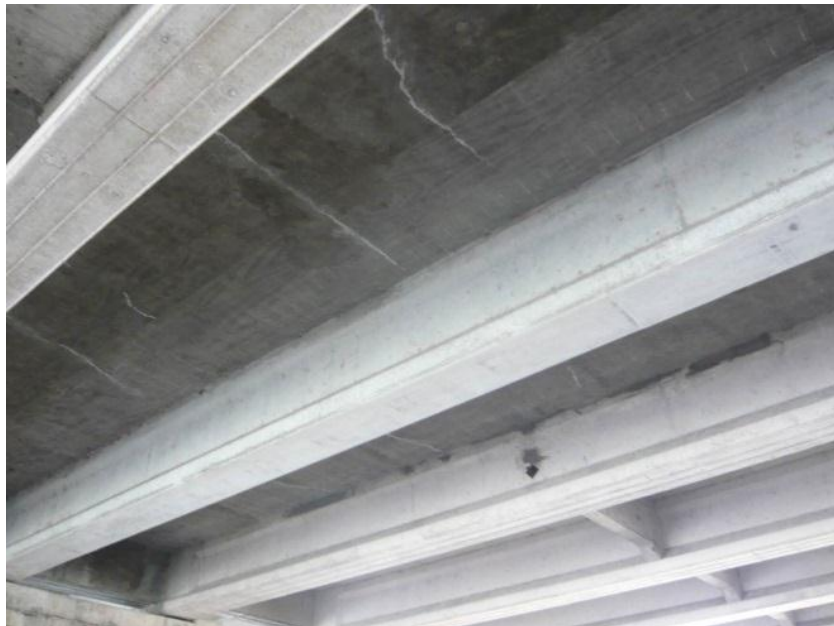
Figure 15: Underside of the Bridge Deck

In this project, the underside of the concrete bridge deck (Figure 15) and parking garage at FDOT (Figure 16) were inspected using motion-controlled digital camera and infrared camera. The photographed images were analyzed using special software for these technologies. The detected cracks were categorized into three ranks depending on their widths (Rank 1: ≤ 0.010 ” (0.25mm), Rank 2: 0.010.” (0.25mm) to 0.030.” (0.76mm), Rank 3: 0.030.” (0.76mm) or greater) (Figure 17). The detected inner voids, delamination, and spalling were categorized into three ranks (Critical (crack exists on concrete surface and immediate attention is required), Caution (crack exists within 2cm from the concrete surface and close monitoring is recommended) and Indication (Currently satisfactory)) (Figure 18).

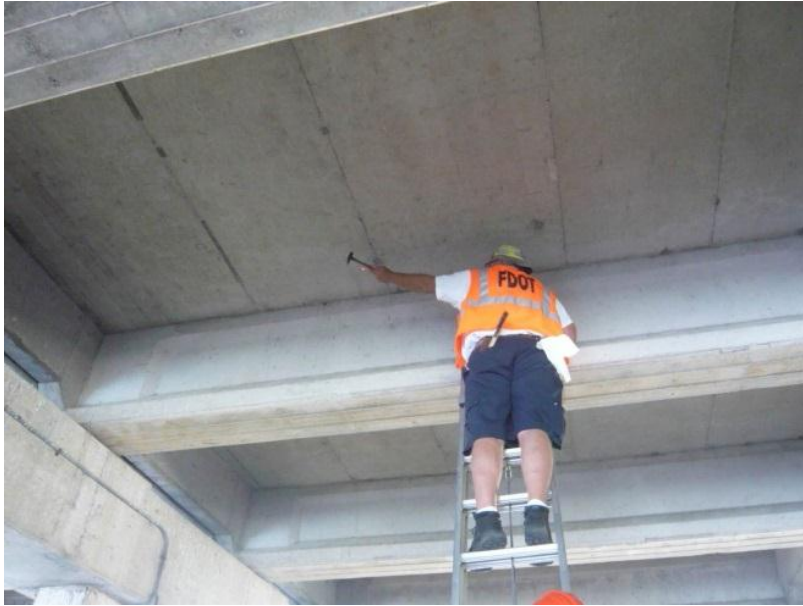
Figure 23: Hammer Sounding by FDOT Qualified Inspector

Figure 19-22 Show the result of the inspection using HRDI technology and IR technology. Table 2 and Table3 show the potential spall area obtained from IR technology software. After obtaining the result from both technologies, the FDOT certified bridge inspector provided the hands-on inspection using a crack width ruler and a hammer in order to evaluate the accuracy of the new bridge assessment method (Figure 23). Figure 24 shows the result measured by the inspector. It presented that the widths of cracks detected from the high resolution digital image matched with the actual hands-on measurement by crack width ruler for all the evaluated cracks. Additionally, after sounding test of one of the critical location, hidden plastic sheet appeared from beneath the mortar (Figure 25). The result indicates that the infrared thermography could successfully detect the subsurface defects which could not be seen from the concrete surface by regular visual inspection.

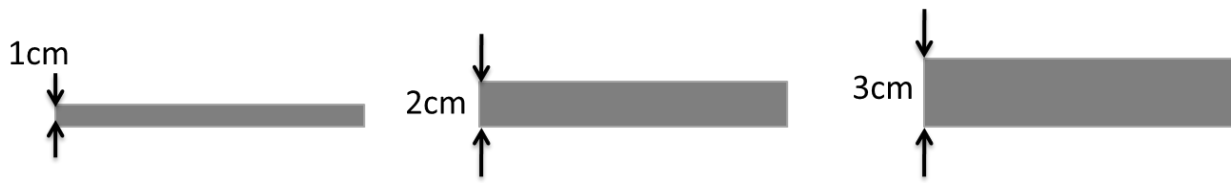
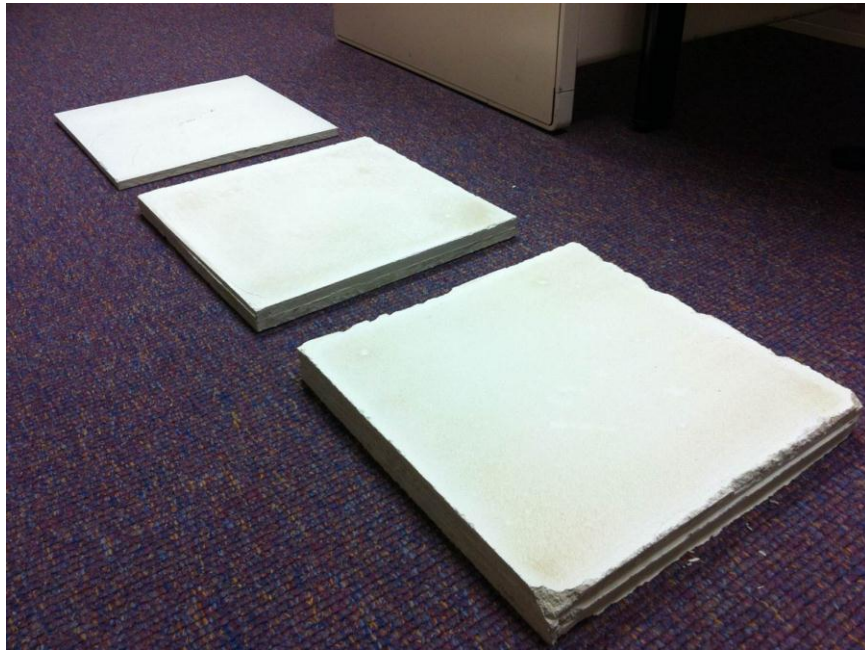
Figure 38: Concrete Test Pieces (Different Thickness)

Concrete test pieces in three different thicknesses were used. Each thickness is 1cm, 2cm and 3cm, which simulates delamination in the depth of 1.0cm, 2.0cm and 3.0cm from the concrete surface (Figure 38). In addition to that, concrete test pieces in three different depths of delamination were prepared to explore the difference of temperature variation in terms of the delamination volume (Figure 39). The delamination exists at 1cm from the concrete surface and each delamination depth is 0.5cm, 1.0cm and 1.5cm.

Experiments and results mentioned above are about same volume of delamination but different depths from the concrete surface, which are 1cm, 2cm and 3cm (Figure 38). Meanwhile, in this section, experiments and results about the same depth from the concrete surface, but different volumes of delamination are investigated (Figure 39). Figure 120 shows concrete test pieces used in this experiment. Delamination of all concrete test pieces locates in a depth of 1cm from the surface. Delamination of the left-hand piece is very thin and others are 0.5cm, 1.0cm and 1.5cm depths of delamination as shown in the figure. These concrete test pieces were placed

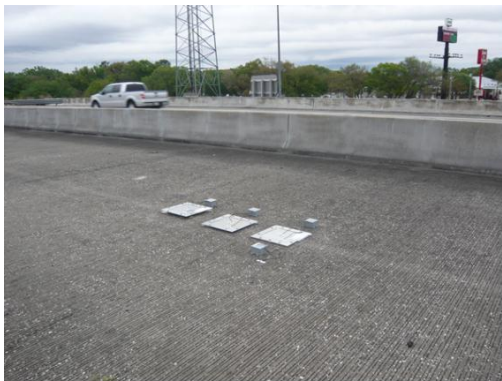
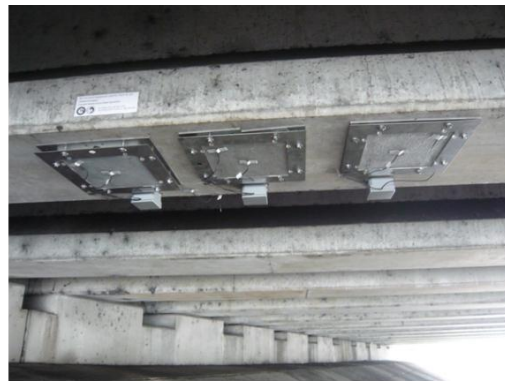
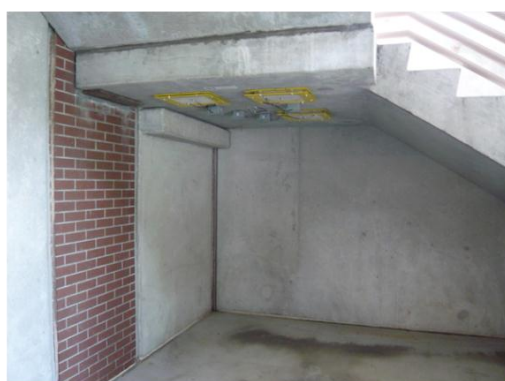
Figure 40: Data Acquisition

Figure 40 shows the data acquisition at each field. Concrete test pieces of three different thicknesses were attached to the surface of each target area and collected temperature variation for a certain period of time in March and April 2013. Concrete test pieces of three different volumes of delamination were placed at parking area in the university and explored the difference of temperature variation in terms of the delamination volume. Temperature measurement sensors were attached to the delaminated area and sound area on each concrete test piece, and the ambient air temperature was collected as well.

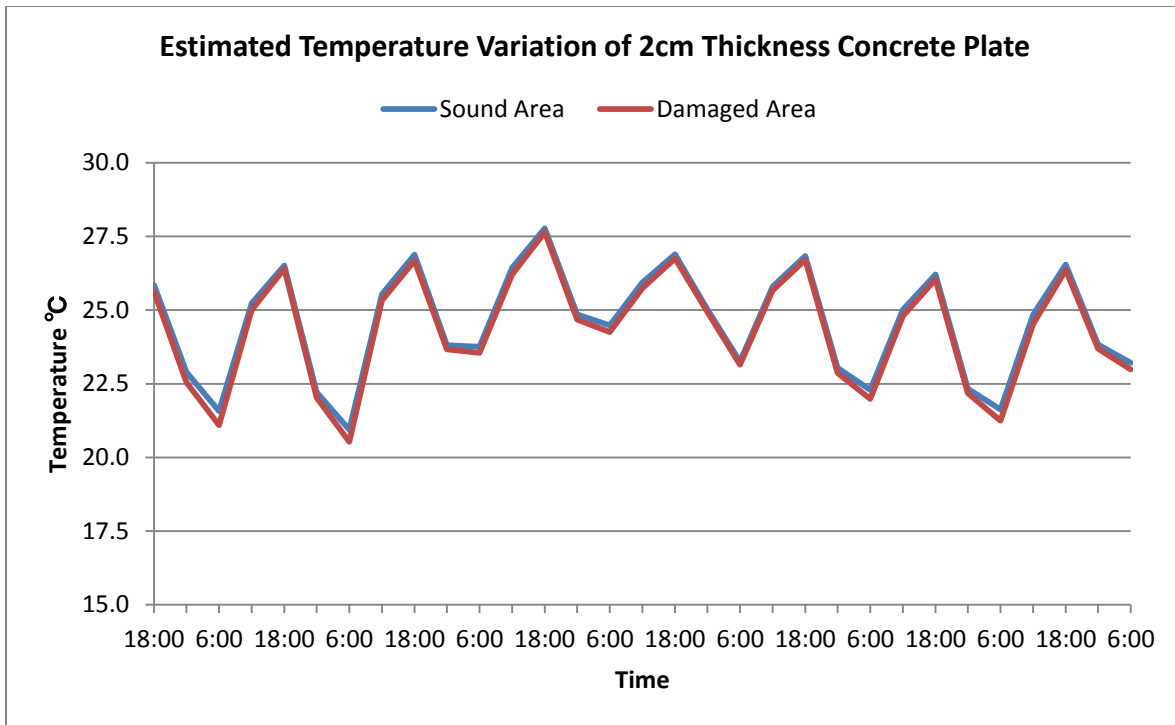
Figure 117: Estimated Temperature Variation of 2cm Thick Concrete Plate

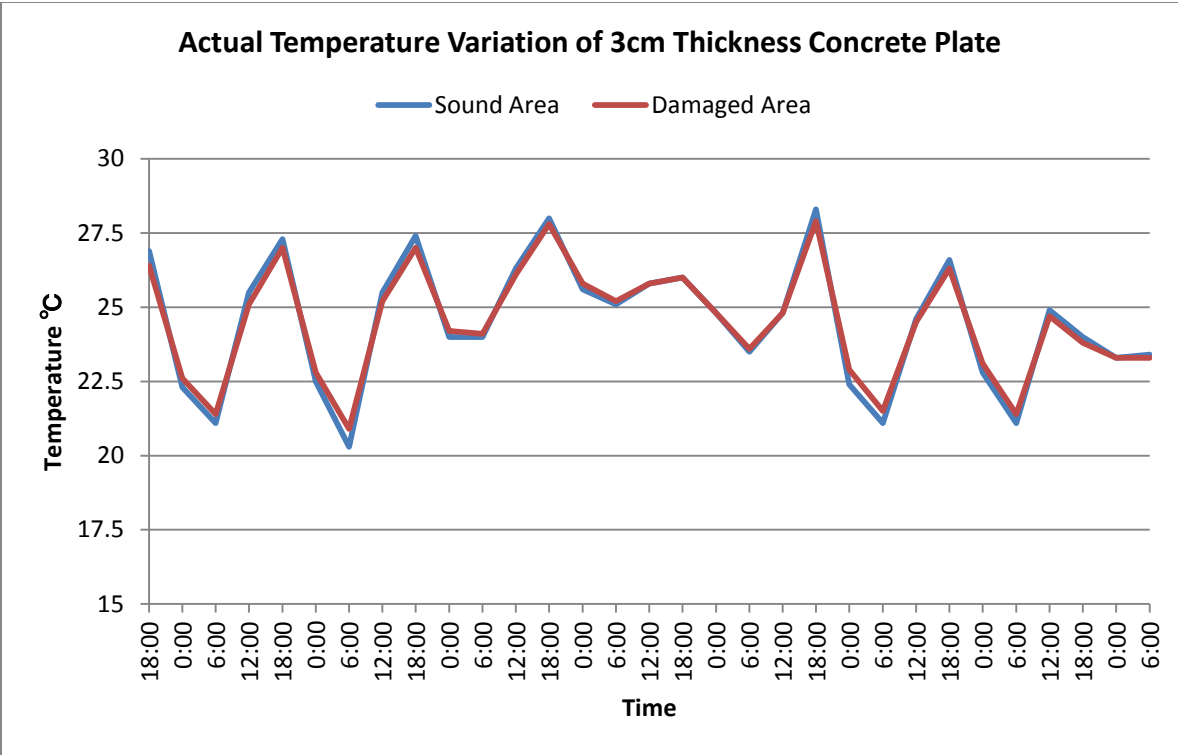
Figure 118: Actual Temperature Variation of 3cm Thick Concrete Plate
