Evaluation Of Space Shuttle Tile Subnominal Bonds

EVALUATION OF
SPACE SHUTTLE TILE
SUBNOMINAL BONDS

A thesis submitted in partial fulfillment of the requirements
for the degree of Master of Science
in the Department of Mechanical, Materials, and Aerospace Engineering
in the College of Engineering and Computer Science
at the University of Central Florida
Orlando, Florida

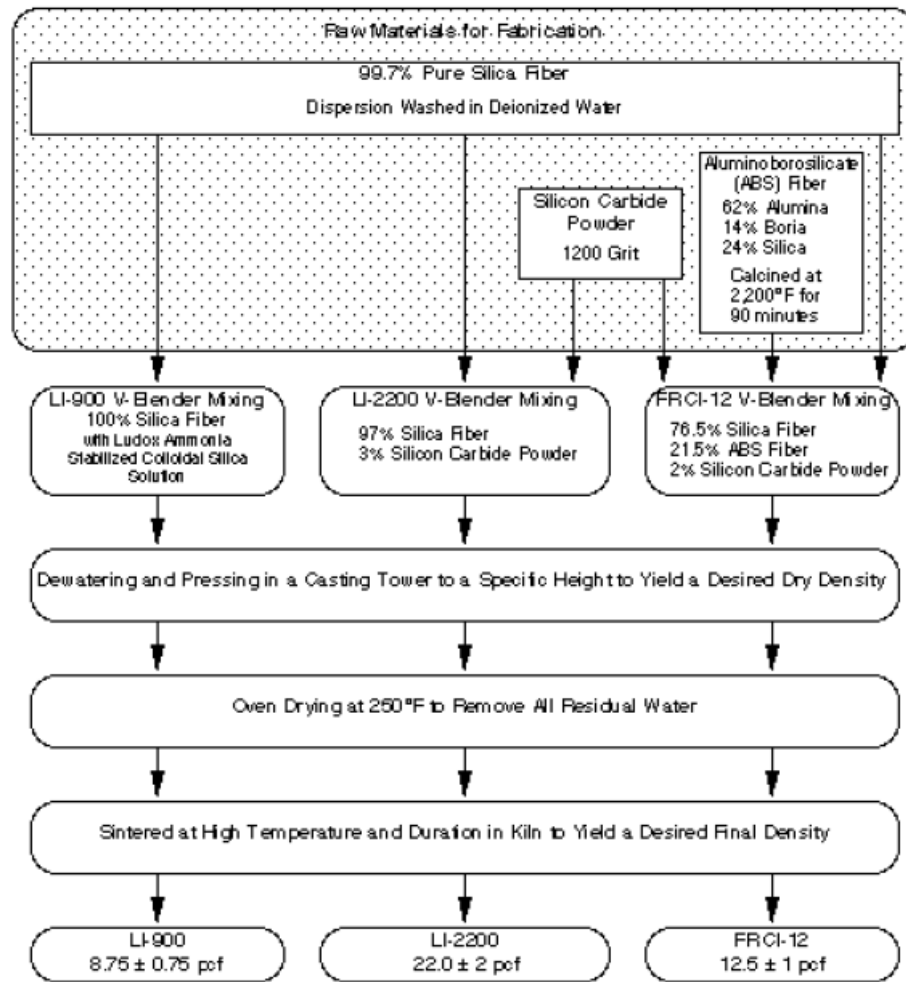
Figure 5 - Fabrication Schematic for RSI Tile Substrate Materials

There are five RSI tile substrate materials currently used on the orbiter, 9 and 22 pcf Lockheed Insulation (LI-900 and LI-2200), 12 pcf Fibrous Refractory Composite Insulation (FRCI-12), 8 pcf Alumina Enhanced Thermal Barrier (AETB-8), and 18 pcf Boeing Rigidized Insulation (BRI-18). The LI-900 and LI-2200 materials are comprised of high-purity amorphous silica fiber (LI-2200 adds a small amount of silicon carbide powder) made rigid by ceramic bonding. The FRCI-12 material is similar to the LI-2200 except aluminoborosilicate fiber is added to the silica fiber and silicon carbide powder. The FRCI-12 material is made rigid by boron fusion at the fiber junctions. The AETB-8 and BRI-18 are similar composition but are coated with an impact resistant Toughened Unifibrous Insulation (TUFU). This high impact coating helps protect the tile from being damaged from an impact. The fabrication of all five materials is similar, and is shown in *Figure 5*.

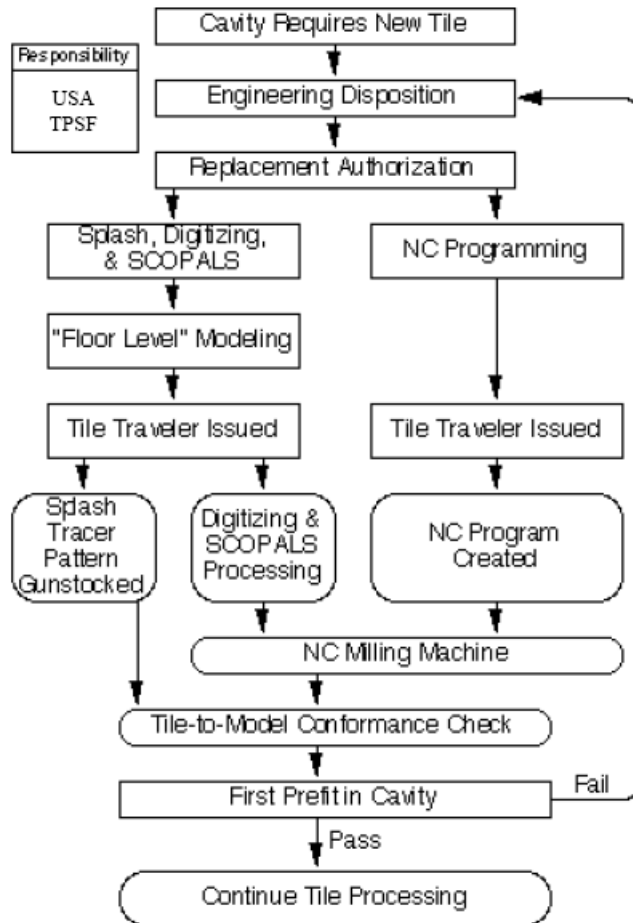
Figure 6 - RSI Tile Modeling and Machining Flow Diagram

In accordance with the standard process for the installation of replacement RSI tiles (ML0601-9024 process 301), the coated, undensified tile is sent to the USA technicians for prefit into the cavity and is evaluated for conformance with the installation step and gap criteria outlined in the ML0601-0001 specification and engineering drawing. If the tile is acceptable per this evaluation, the tile fabrication process continues with IML densification, waterproofing, and SIP bonding. If the evaluation indicates the tile is not within the installation requirements, the tile is sent to engineering for further disposition. Refer to *Figure 6* for a graphical representation of the modeling, machining, and evaluation processes.

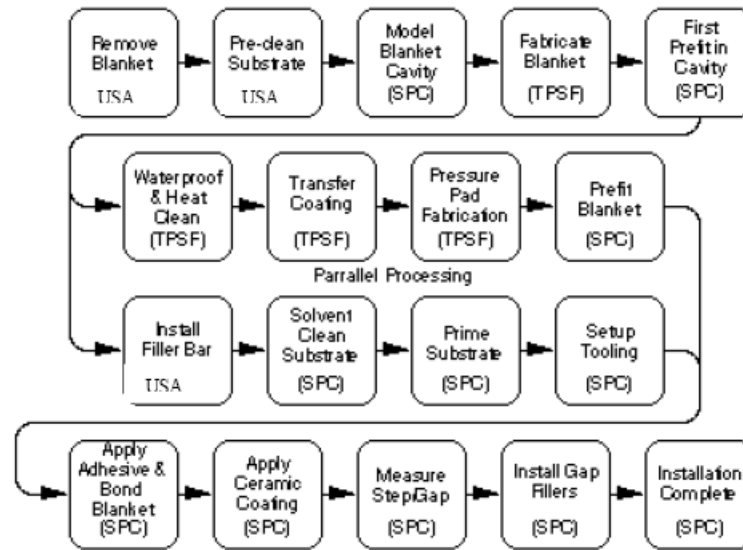
Figure 9 - FI Blanket Replacement Flow Diagram

The installation of the FI blanket per ML0601-9024 process 501 is depicted in *Figure 9*. The part cavity is pre-cleaned following the removal of the previous part. The cavity is modeled using a template. Following the fabrication of a blanket to the template, the blanket is prefit into the cavity. Ramping or other sub-insulation is installed under pressure using RTV silicone adhesives on a solvent cleaned and primed substrate. The cavity and peel test coupon plate are solvent cleaned, primed, and coated with 0.006 to 0.010 inches of RTV silicone adhesive. The transfer coated surfaces on the sub-insulation are wiped with 1,1,1-trichloroethane and allowed to dry for 2 to 24 hours prior to bonding. The blanket is bonded to the cavity and the peel test coupon is bonded to the plate under 1.5 to 3 psi pressure. Following the cure, the peel test coupon is cut into 1-inch wide strips. A 90° pull test is performed with a force gauge on at least 4 of the strips. The average peel strength of the pulls must be greater than 4 pounds per inch to provide a confidence with the blanket bond.

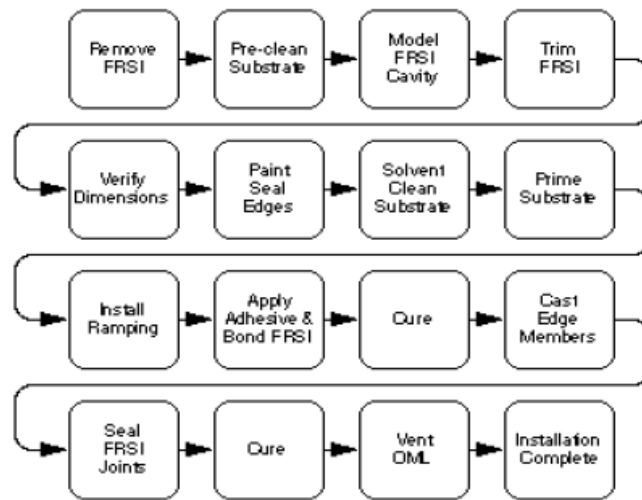
Figure 10 - FRSI Detail and Replacement Flow Diagram

FRSI panels protect most of the upper surface of each vehicle where temperatures are less than 750°F. FRSI is composed of two materials, a heat treated Nomex felt and a vented white silicone elastomer coating. A typical FRSI component is depicted in *Figure 10*. Additional layers of FRSI or Nomex felt ramping can be used between the FRSI and structure to allow the installation to fair into adjacent installations. FRSI does not require post-flight rewaterproofing because the Nomex polymer is hydrophobic by nature and the silicone elastomer coating inhibits water intrusion into the felt.

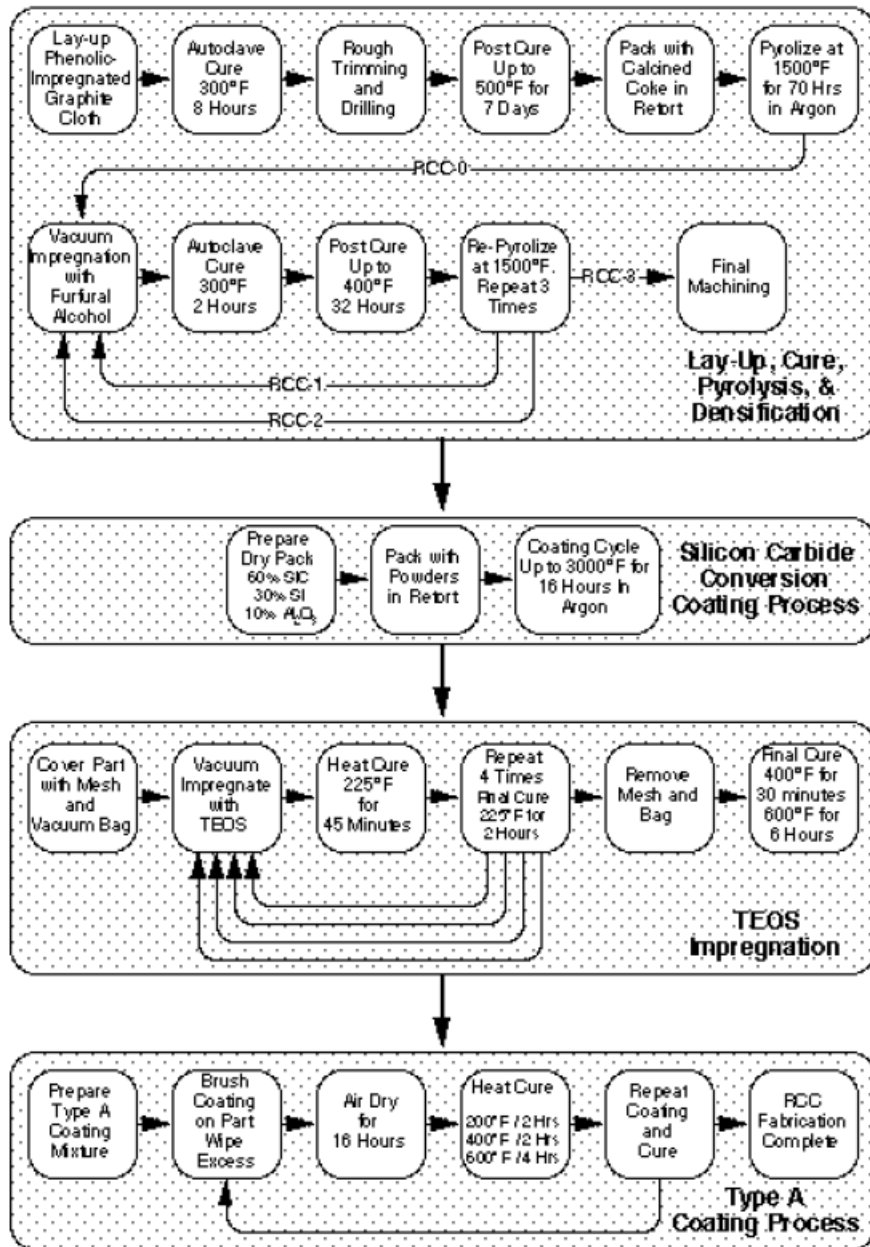
Figure 11 - RCC Fabrication Flow Diagram

RCC is a structural composite consisting of two discrete carbon-based components, a high-strength substrate and an oxidation protection coating system. The fabrication of RCC is a four-part process as shown in *Figure 11*.

The final fabrication step is to apply Type A sealant to fill any porosity or craze cracks on the RCC part. The Type A sealant is a mixture of silicon carbide powder and a sodium silicate water glass. The mixture is prepared and is brushed on the part. The part is then air dried for 16 hours and heat cured at 200°F for 2 hours, 400°F for 2 hours, and 600°F for 4 hours. The application and subsequent curing is repeated. Once the fabrication is complete, the part is ready for installation.

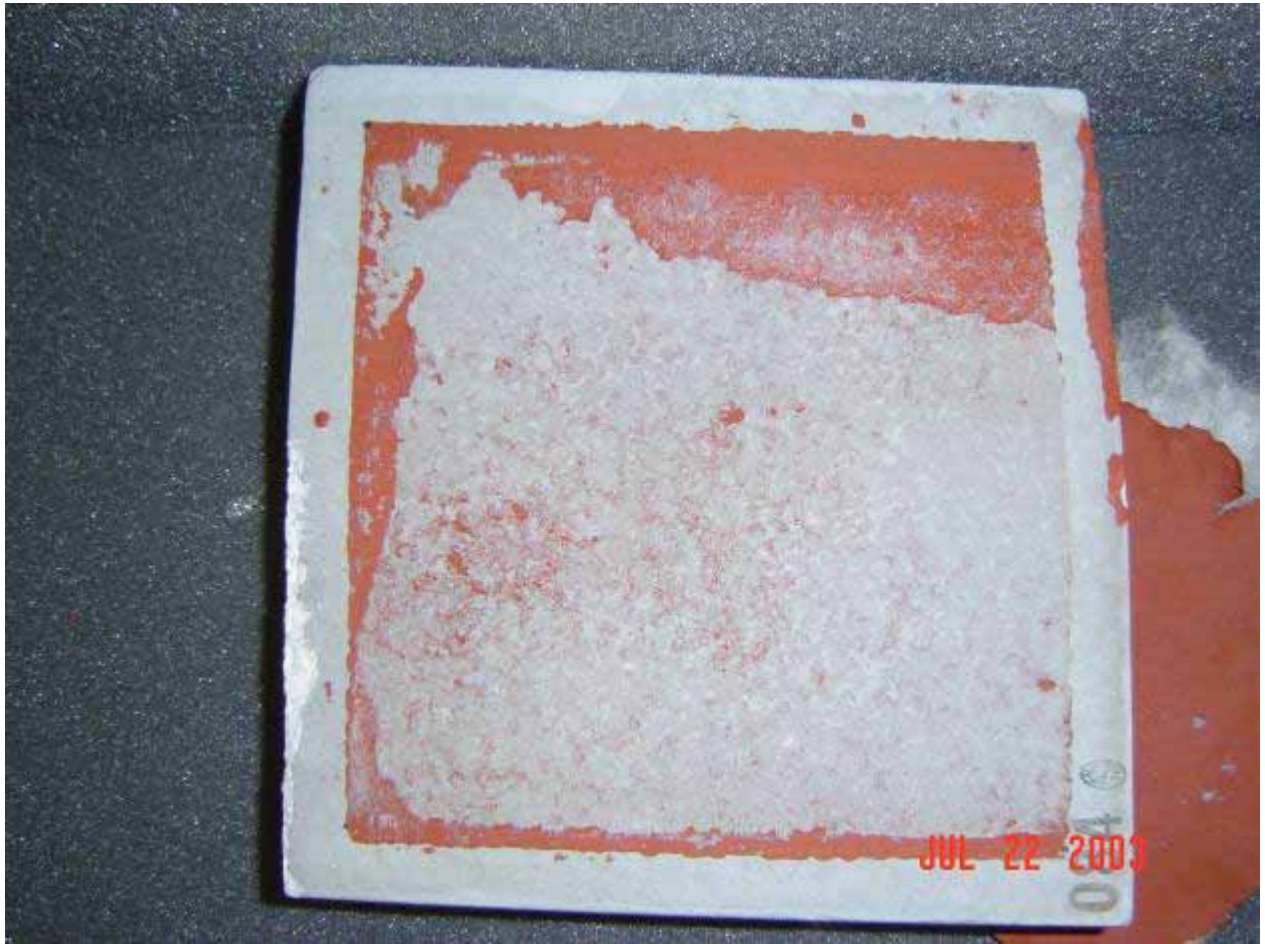
(RTV) was peeling adhesively from the Inner Mold Line (IML) on the surface of the tile shown in *Figure 22*. An adhesive peel, explained in Appendix C, is considered a subnominal bond condition, and is referred to as a subnominal SIP/IML adhesive bond. A nominal SIP to tile bond should have a coat of red RTV on the surface of the tile once the SIP is removed as shown in *Figure 23*.

Figure 22 - OV-105 Subnominal Bond Condition

The document review demonstrated that no single process deviation or material issue was the source of the subnominal SIP/IML adhesive bonds discovered on OV-105. Based on the process variables eliminated after completion of the historical document review, engineers were able to reduce possible failure causes to an unknown contaminant, a process anomaly, or degradation over time.

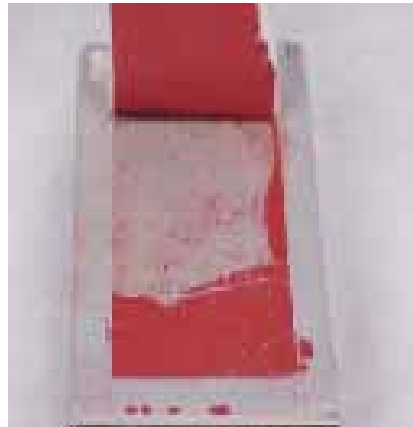
Figure 24 - Similar OV-103 Subnominal SIP/IML Adhesive Bond

The original subnominal bond investigation arose from OV-105. While picture records indicate that some tiles removed from OV-103 in October 2002 have similar subnominal SIP/IML adhesive bonds as those discovered on some tiles removed from OV-105, the OV-103 anomaly was not thoroughly analyzed (Refer to *Figure 24*). No engineering investigation occurred.

Check all removed tiles for indications of a subnominal SIP/IML adhesive bond anomaly to monitor the problem over time. If the problem begins to emerge at an increased rate, a more extensive study of age degradation will be necessary. Continue research on this issue, to include monitoring OV-103's possible subnominal SIP/IML adhesive bonds.

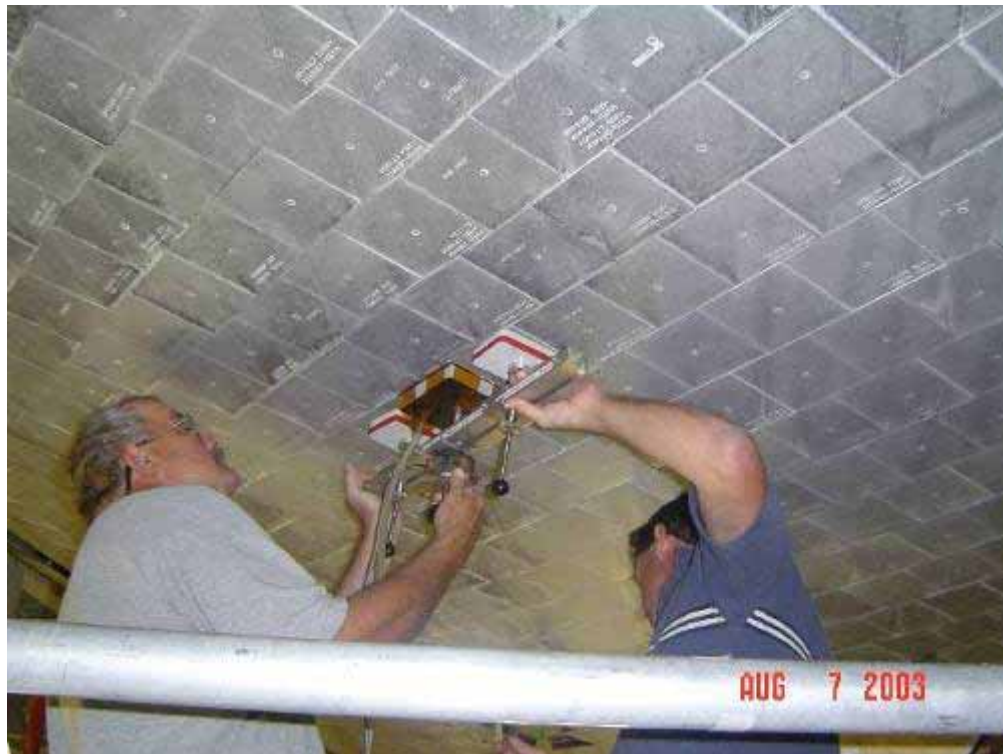
Figure 25 - Bond Verification Check Setup

Additional subsets of tiles were removed based on the historical document review and vehicle location, and Bond Verification (BV) tests were performed to assess their system strength as shown in *Figure 25*. Ten psi BV checks were conducted using a vacuum applied to the surface of the tile, and 20 psi BV checks required bonding of the BV chuck to the tile Outer Mold Line (OML) in order to accomplish the higher loading with stress concurrence.

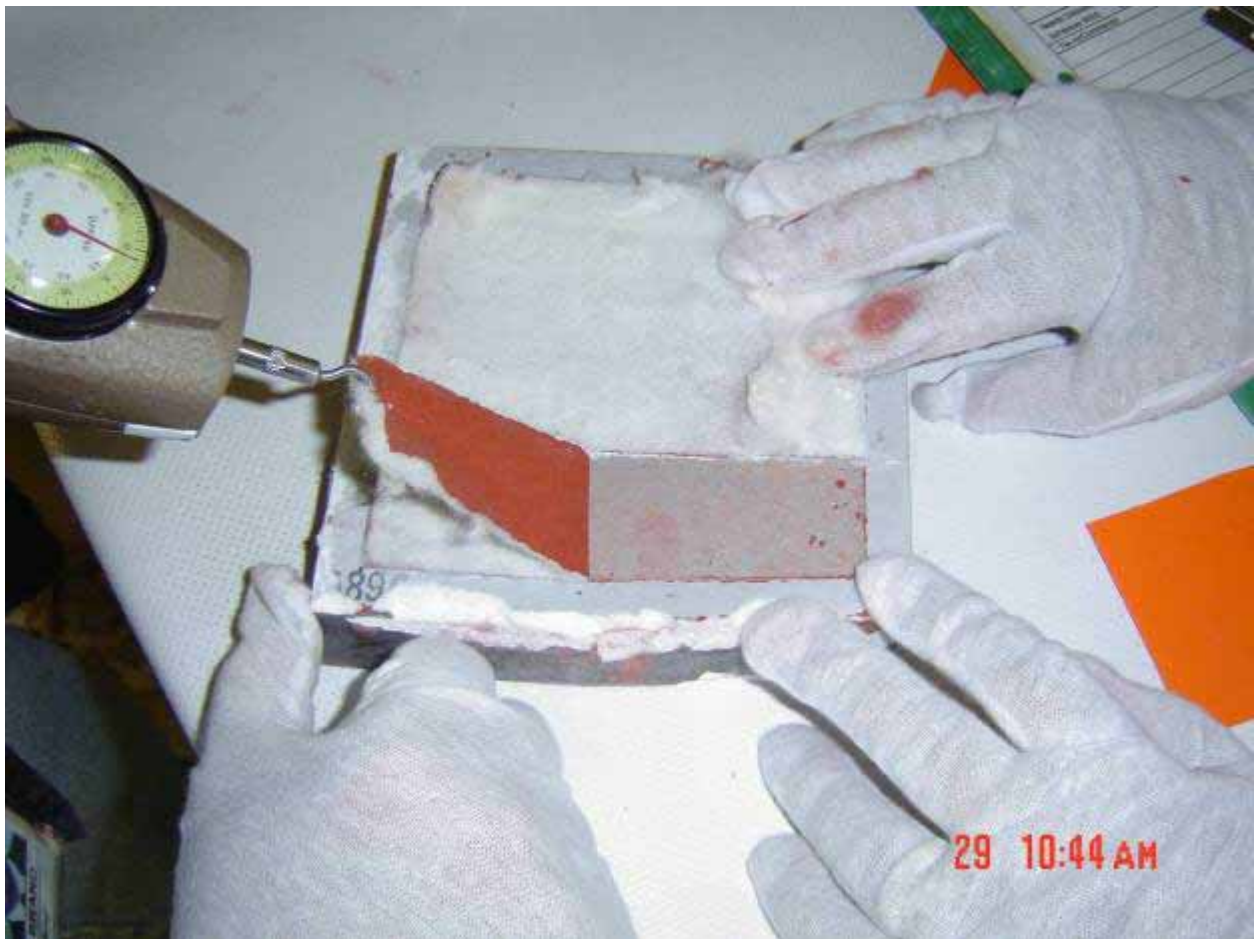
Figure 26 - SIP Peel Test Being Performed on Subnominal Bond Tile

As there is no RTV adhesive peel requirement, this was an engineering evaluation only: a peel value greater than $4\text{lb}/\text{in}$ was considered acceptable. The peels were performed using a chatillion force gauge attached with a hook to pull 1 inch strips of SIP normal to the tile IML as shown in *Figure 26*.

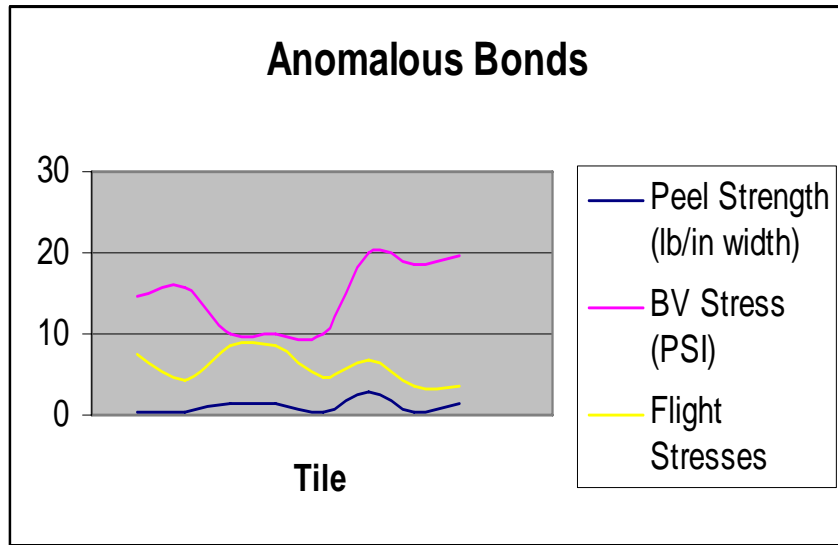
Figure 27 - Comparison of Tensile Strength in Tile during BV, Flight Loads, and Peel Strength

BV strength against the peel strength of the SIP and also the flight stresses that the tile sees can be found in *Figure 28*. Full peel strength results are in Appendix B.

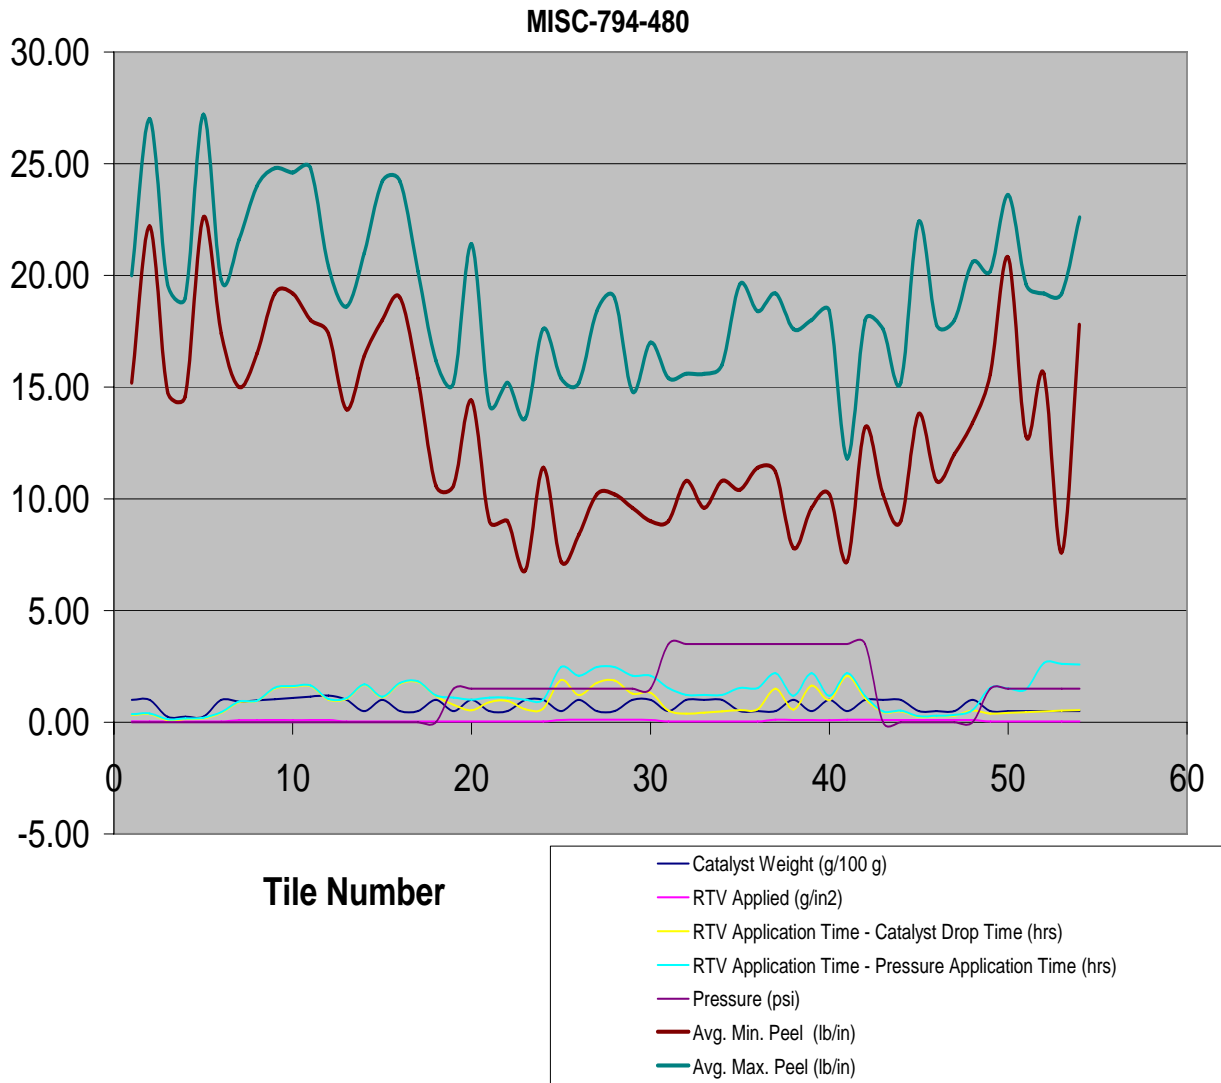
Figure 29 - Results of Changing Process Variables to SIP Bond Strength

The catalyst weight had no effect on the peel strength, but decreasing amounts of RTV applied, RTV application time, and application pressure decreased the peel strength on a batch of tiles processed per MISC-794-480. The effect of decreased pressure produces the most extreme results. The graphical results of these tests are found in *Figure 29*. *Figure 30*, *Figure 31*, *Figure 32*, *Figure 33*, and *Figure 34* contain the individual results for each of the tests which were ran and included in *Figure 29*.

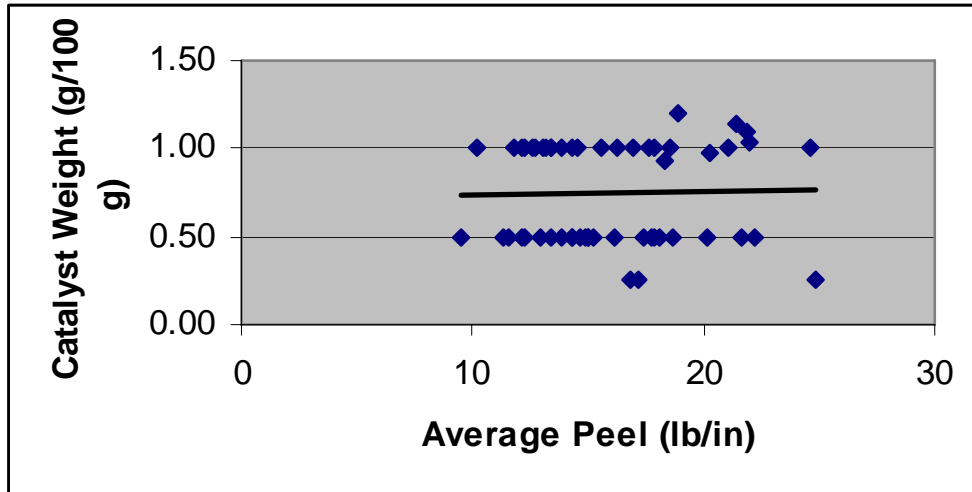
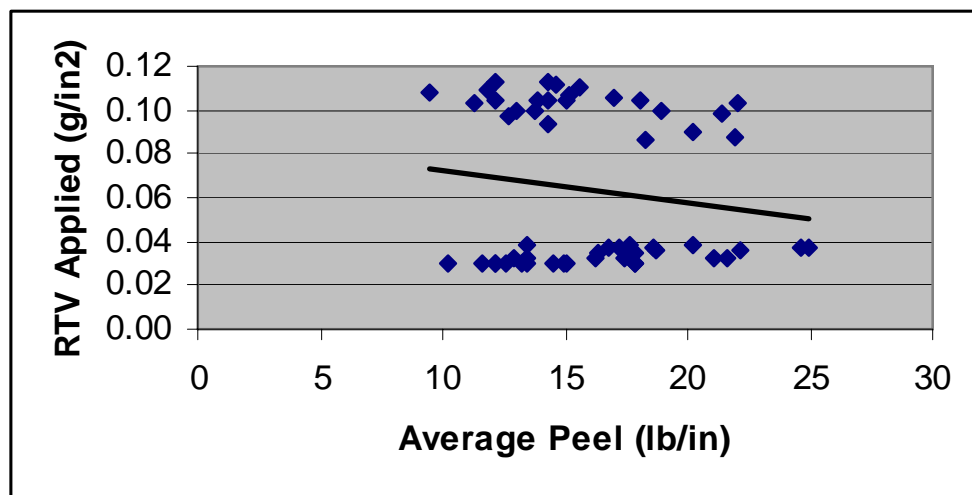
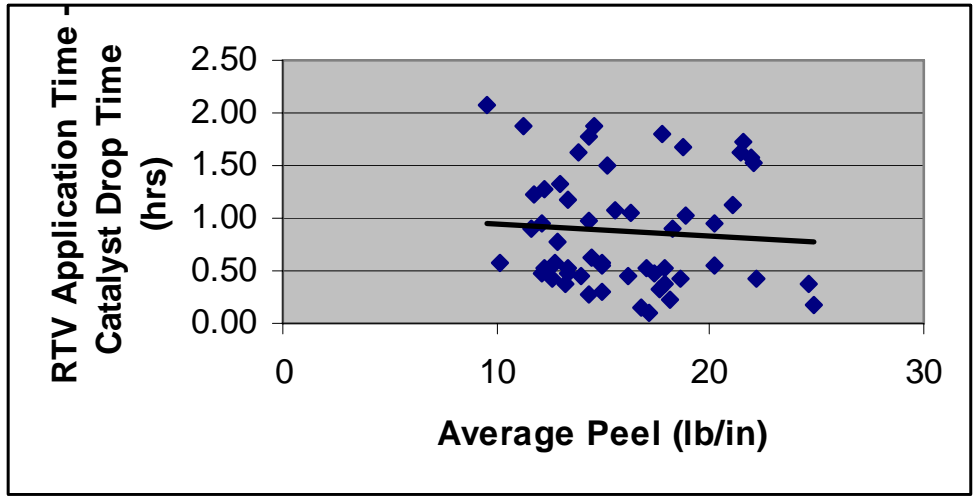
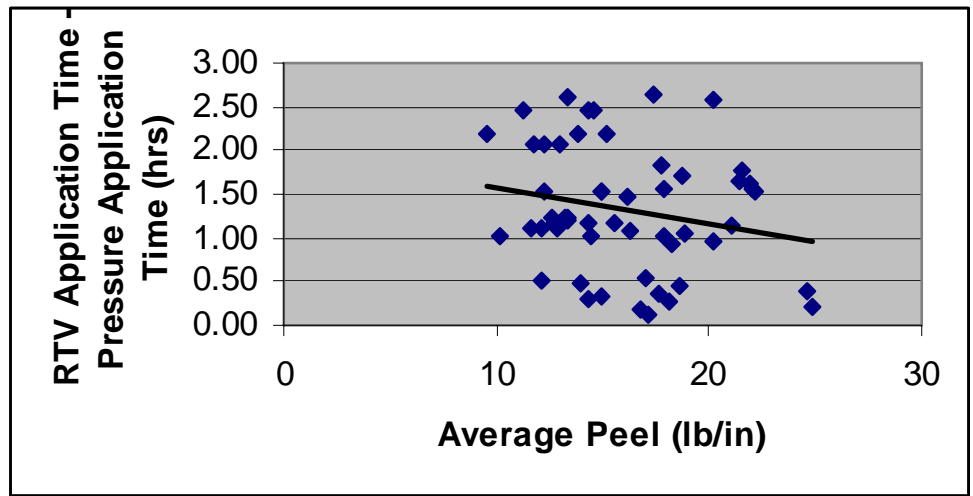
Figure 30 - Catalyst Weight vs. Average Peel Strength

Figure 31 - Amount of RTV Applied vs. Average Peel Strength

Figure 32 - RTV Application Catalyst Drop Time vs. Average Peel Strength

Figure 33 - Pressure Application vs. Average Peel Strength

Figure 34 - Pressure vs. Peel Strength

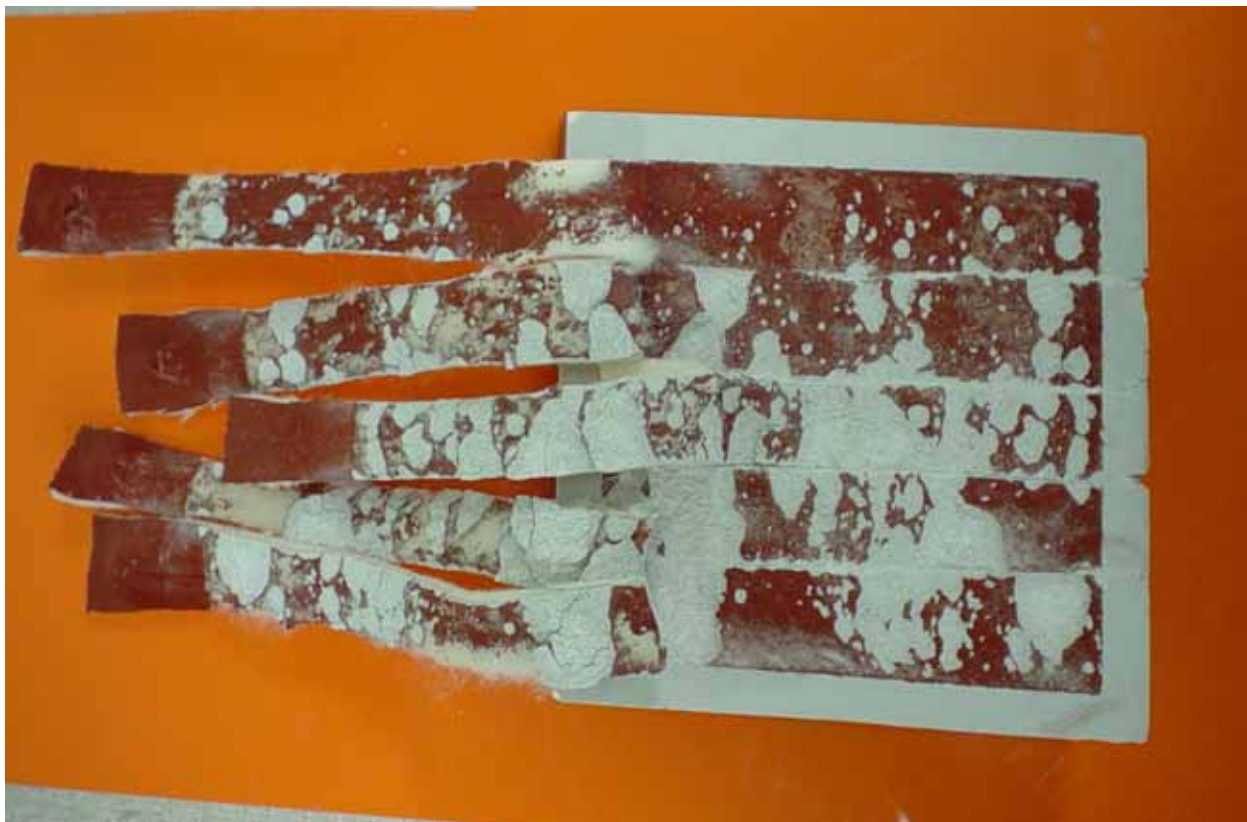
An option that can be eliminated as a possible cause of a subnominal SIP/IML adhesive bond is that the oven pumps malfunctioned, causing inadequate waterproofing. While poor waterproofing does reduce the peel strength, applying no waterproofing at all does not produce peel strengths that even approach the low value of the subnominal peels observed on OV-105.

Figure 38 contains a photo of a tile with no waterproofing installed. As can be seen in the photo the subnominal condition is not similar to the one identified on OV-105.

Figure 38 - Peel without Waterproofing; Average Peel 13.5 lb/in

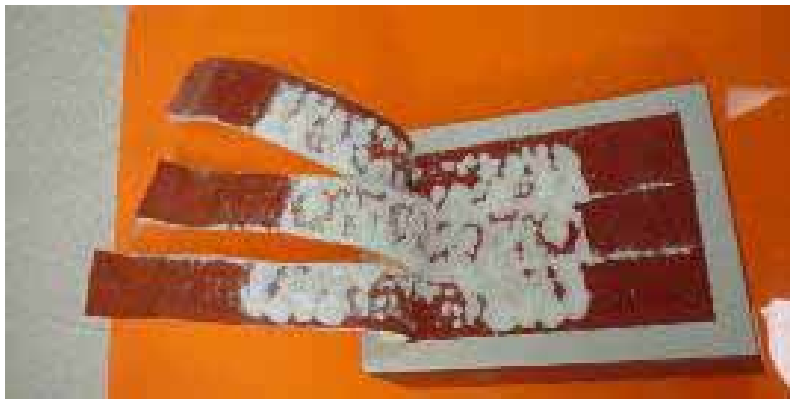
The silane used in the factory waterproofing process could have been impure. This remains an option as silane is an integral part of producing a nominal SIP/IML bond as demonstrated in the test peels for MISC-794-479. However, the peel strength values are still not nearly as low as those observed in the subnominal SIP/IML adhesive bonds on OV-105.

Figure 39 - SIP Peel Test without Silane Average Peel 6 lb/in

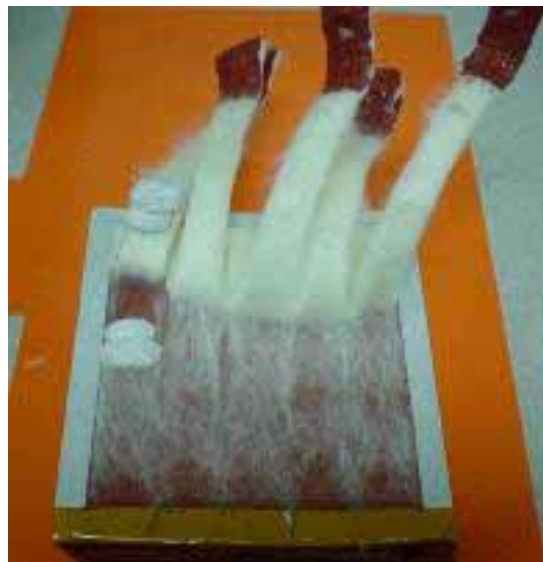
Figure 40 - Normal Peel Test Average Peel 22 lb/in

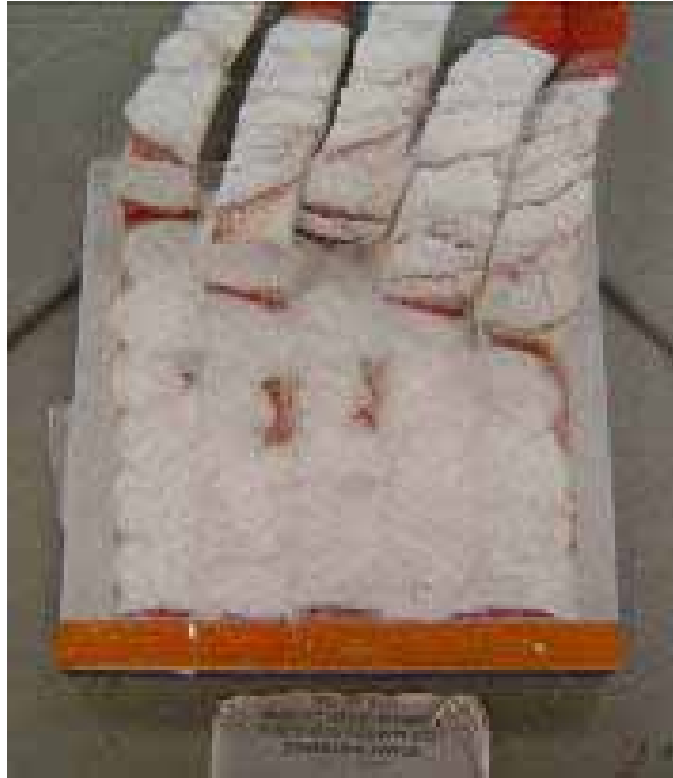
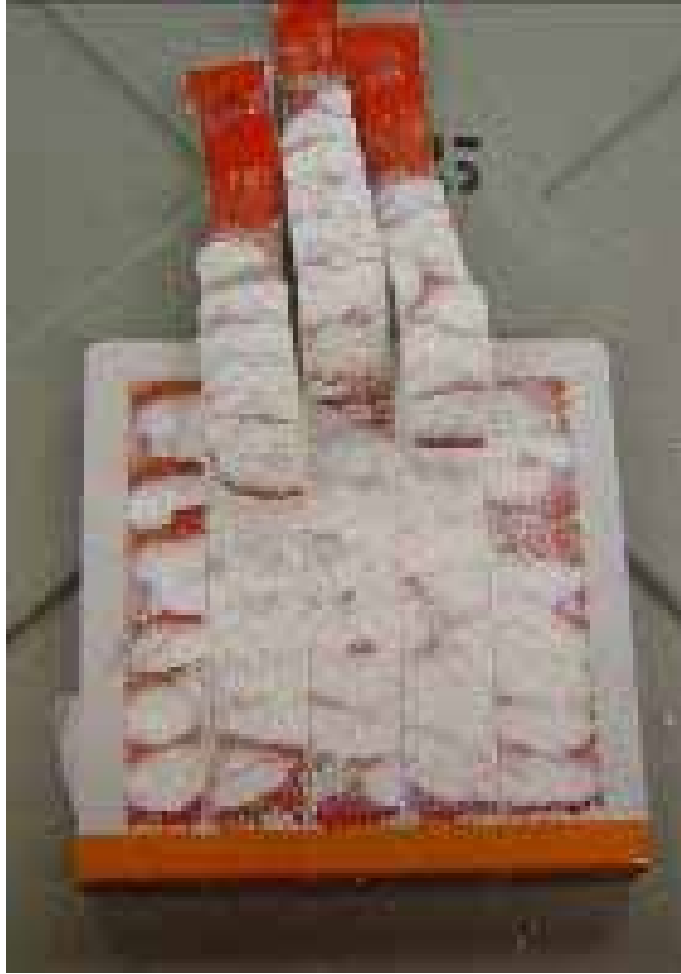
identified on OV-105. Several photos showing the different amounts of RTV application can be seen in *Figure 42* and **Error! Reference source not found.**

Figure 42 - SIP Peel Test with 3.61g of RTV Applied

Figure 43 - SIP Peel Test with 0.78g of RTV Applied

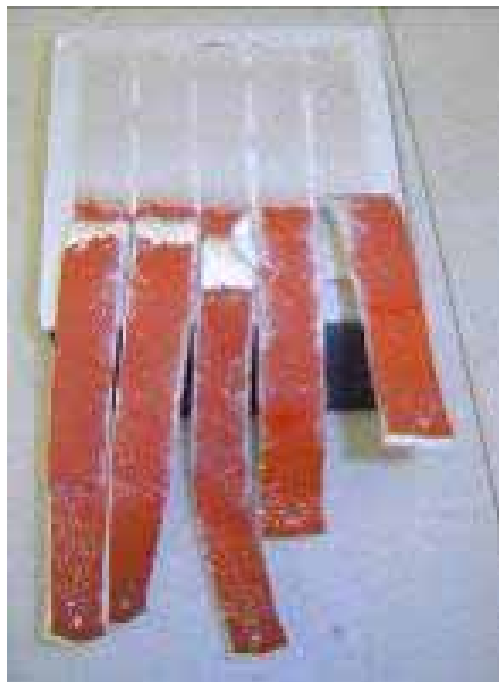
Waterproofing workmanship contamination and SIP bond process contamination could have the same results as brush contamination. Krylon 1201 Spray Starch and MS-143 Mold Release Agent are two contaminants that are common in tile processing facilities and therefore could have tainted the purity of the tile IML. Both of these contaminants reduced peel strength to levels similar to those observed when the adhesive failure anomaly was seen on OV-105. Based on information available, such contamination is the most likely cause of the adhesive bond failure. The SIP peel test which was performed with the Krylon 1201 spray starch can be seen in *Figure 44*. The SIP peel test which was performed with MS-143 mold release agent is identified in *Figure 45*.

Figure 44 - SIP Peel Test with Krylon 1201 Spray Starch

Figure 45 - SIP Peel Test with MS-143 Mold Release Agent

If Krylon 1201 Spray Starch or MS-143 Mold Release Agent were the cause of the subnominal SIP/IML adhesive bond, it is most likely that they were introduced to the system by a contaminated brush. The current densification procedure calls for brush cleaning before slurry application. The procedure should be modified to include an additional brush cleaning after slurry application to prevent used brushes from becoming further contaminated by lying around, covered with slurry, for an indefinite time between applications. Additionally, guidelines should be added to outline how often the cleaning alcohol bath should be replaced in all situations. A log should be created to help technicians track when the alcohol bath is changed.

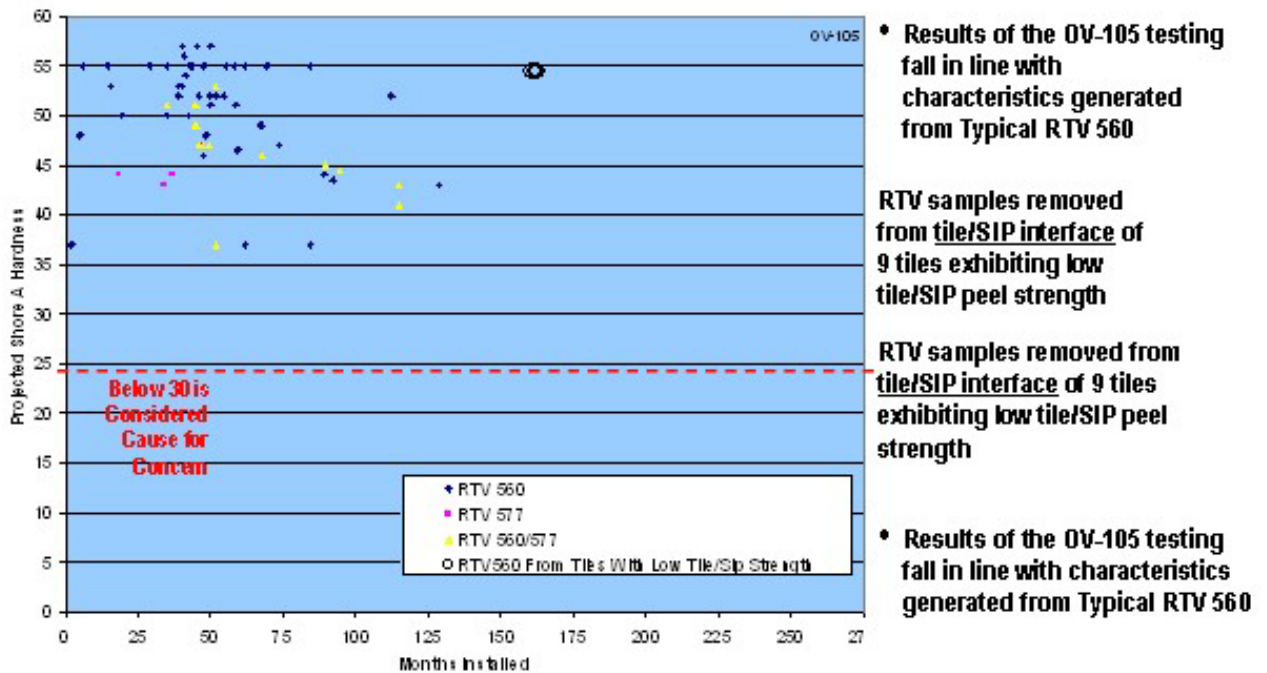
Analysis and document review has neither eliminated nor advanced the possibility that the SIP bond degraded over time. The chart identified in *Figure 46* compares the Shore A hardness of a typical tile removal against the Shore A hardness of the RTV removed from the OV-105 subnominal bond tiles. The Materials and Processes of TPS had determined during the early parts of the program that anything that shows a Shore A hardness of below 30 is a cause for concern in the TPS system. As seen in the chart all of the samples that had subnominal bonds had Shore A hardness near 55.

Figure 46 - Shore A Hardness of Typical RTV vs Subnominal Bond RTV

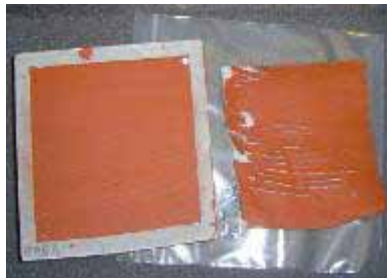
Cohesive bond failure mode:

This is the expected result when the SIP and IML are debonded. It reflects the optimal strength.

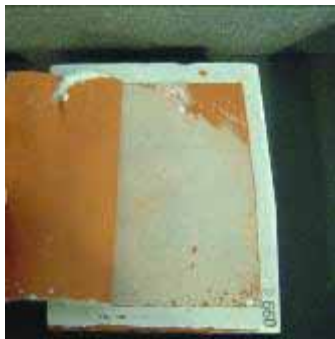
Adhesive bond failure mode:

The subnominal bond anomaly addressed in this paper is an occurrence of an adhesive failure.

This failure is identified by reduced peel strength, unknown tensile properties, and low ($< 4 \text{ lb/in}$) peel strength.

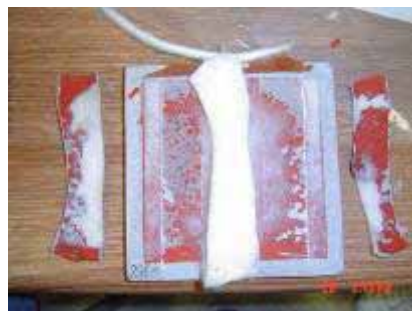
Mixed bond failure mode:

This is a combination of the adhesive and cohesive failure modes. There is some densification damage on SIP removal. The mixed failure mode is distinguished from the adhesive failure mode as it has less than 50% adhesive failure.
