## Investigation Of Ground Penetrating Radar For Detection Of Leaking Pipelines Under Roadway Pavements And Development Of Fiber-Wrapping Repair Technique

INVESTIGATION OF GROUND PENETRATING RADAR FOR DETECTION OF LEAKING  
PIPELINES UNDER ROADWAY PAVEMENTS AND DEVELOPMENT OF FIBER-  
WRAPPING REPAIR TECHNIQUE

A thesis submitted in partial fulfillment of the requirements  
for the degree of Master of Science  
in the Department of Civil and Environmental Engineering  
in the College of Engineering and Computer Science  
at the University of Central Florida  
Orlando, Florida

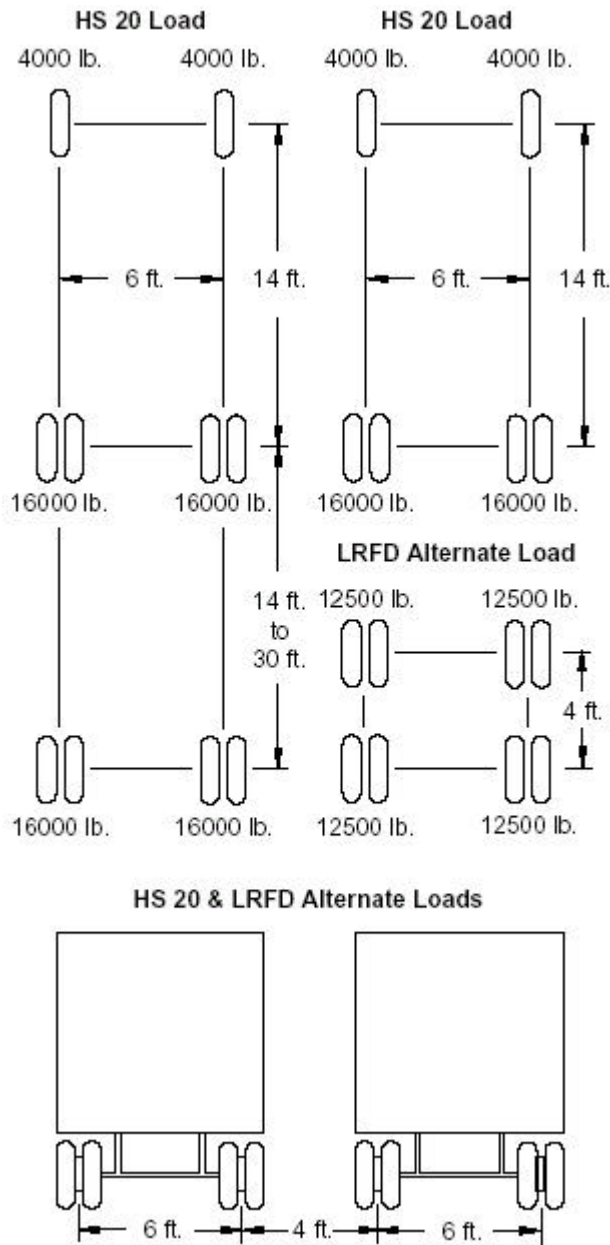
Figure 5: AASHTO Wheel Loads and Wheel Spacing

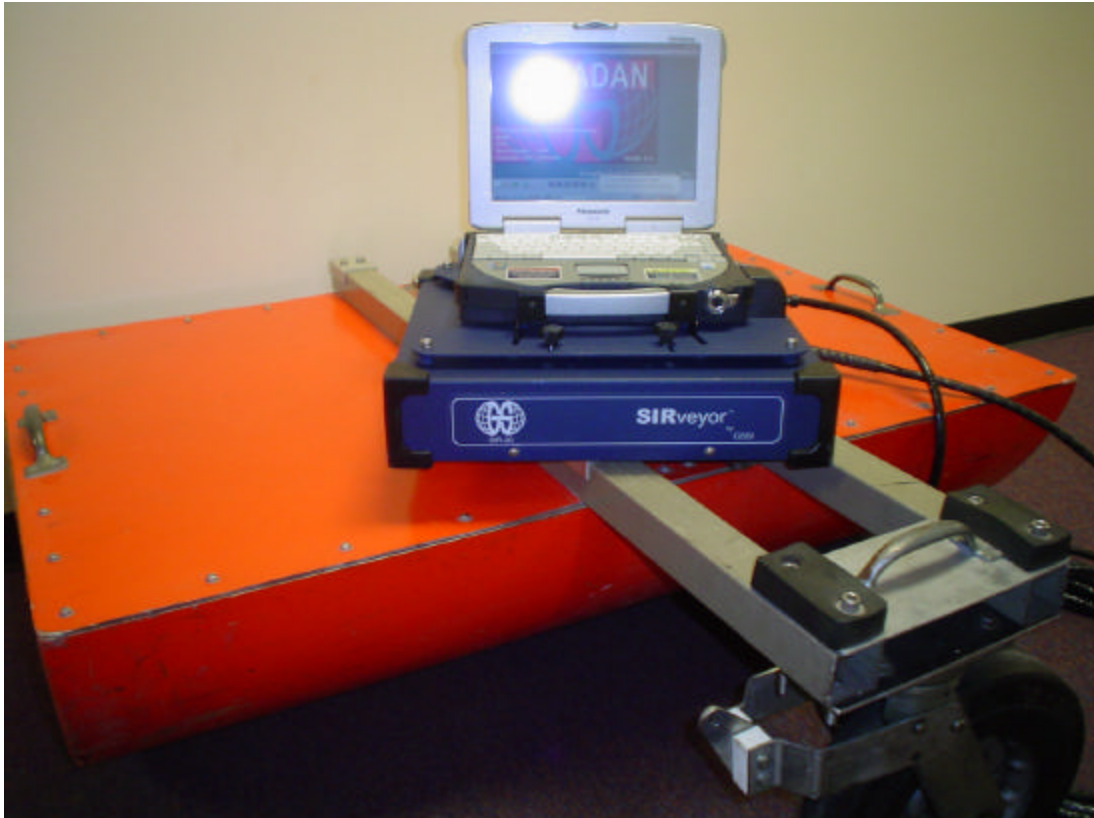
Figure 12: The SIRveyor SIR-20 and 80MHz Antenna

32; transmit rate of 32 KHz; and; stacking equal to 32 scans. All subsurface profiles shown in this study has been depicted using the parameters previously mentioned.

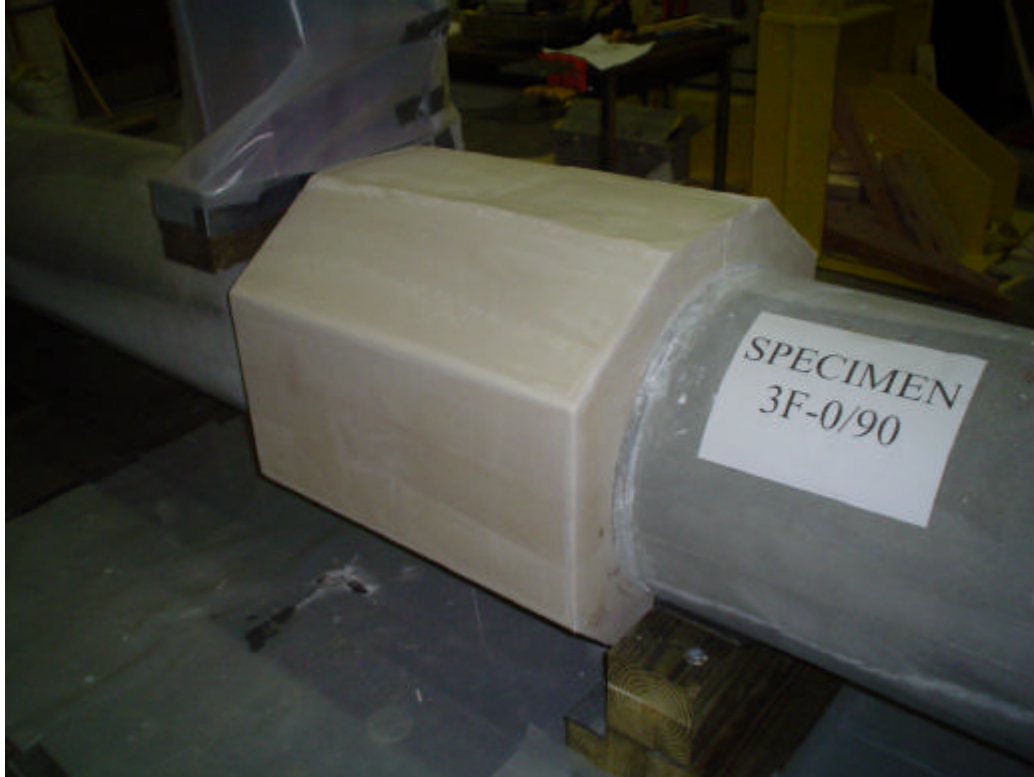
Figure 14: Hydro-Stone rim around pipe joint

Hydro-Stone Gypsum cement is a high strength plaster with high water absorption resistance used in novelty castings, molds and figurines. Since the bell and spigot ends created a joint with an uneven surface that made difficult to wrap the saturated carbon fabric around the joint, a Hydro-stone Gypsum Cement rim was constructed around the joint itself creating a level surface for the wrapping of the FRP as pictured in Figure 14. Technical properties of Hydro-Stone are listed in Table 11.

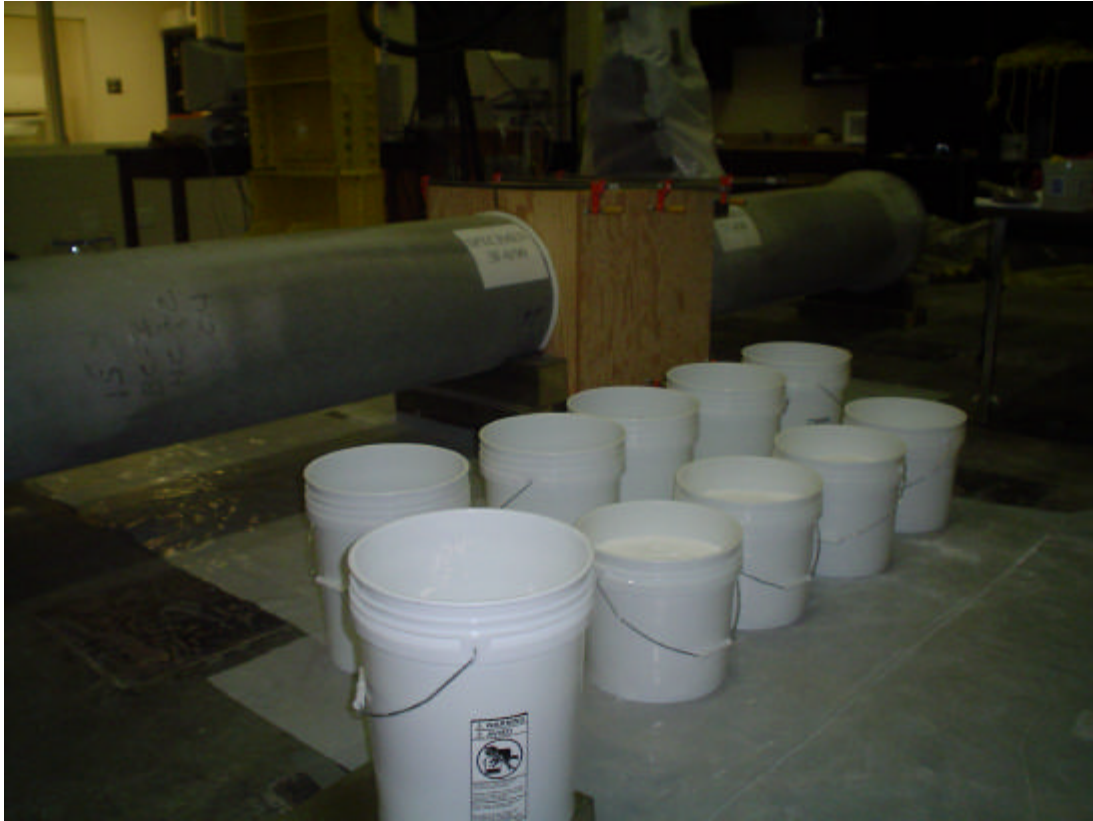
Figure 15: Mixing of the Hydro-Stone in a batch process

The product was mixed by a batch process. The mixing was done in 10 different portions; each of them in a 5 gallon bucket with 30 lbs of Hydro-Stone and 10 lbs of water as shown in Figure 15.

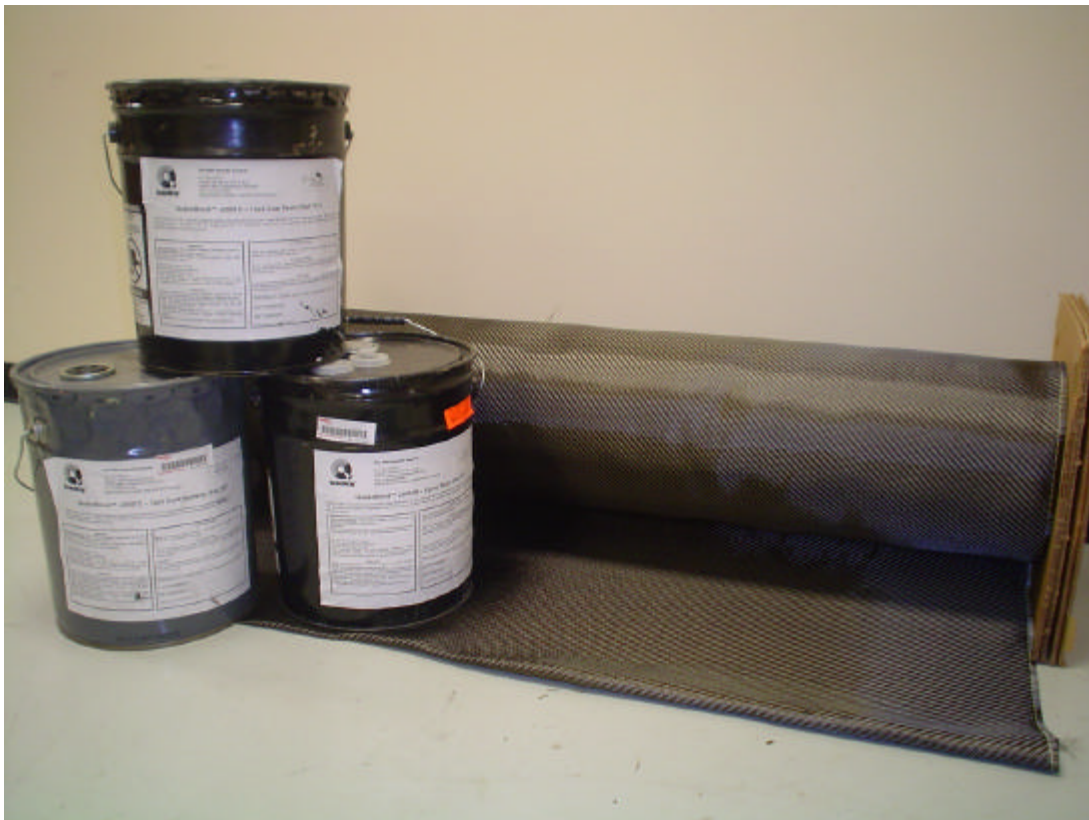
Figure 17: QuakeWrap™ and QuakeBond™ J300-SR

The composite material used in this study was created by saturating a carbon fiber sheet with a epoxy resin. The carbon fabric and saturating epoxy resin referred herein as QuakeWrap<sup>TM</sup> and QuakeBond<sup>TM</sup> J300-SR respectively are trademark materials of QuakeWrap

Inc, in Tucson, AZ. Both materials are pictured in Figure 17. It is important to mention that the author of this study does not endorse the use of QuakeWrap™ and QuakeBond™ J300-SR; the mentioned materials have been just used for practical purposes in the development of this investigation. Properties of QuakeWrap™ and QuakeBond™ J300-SR are summarized in Tables 12 and 13 respectively.

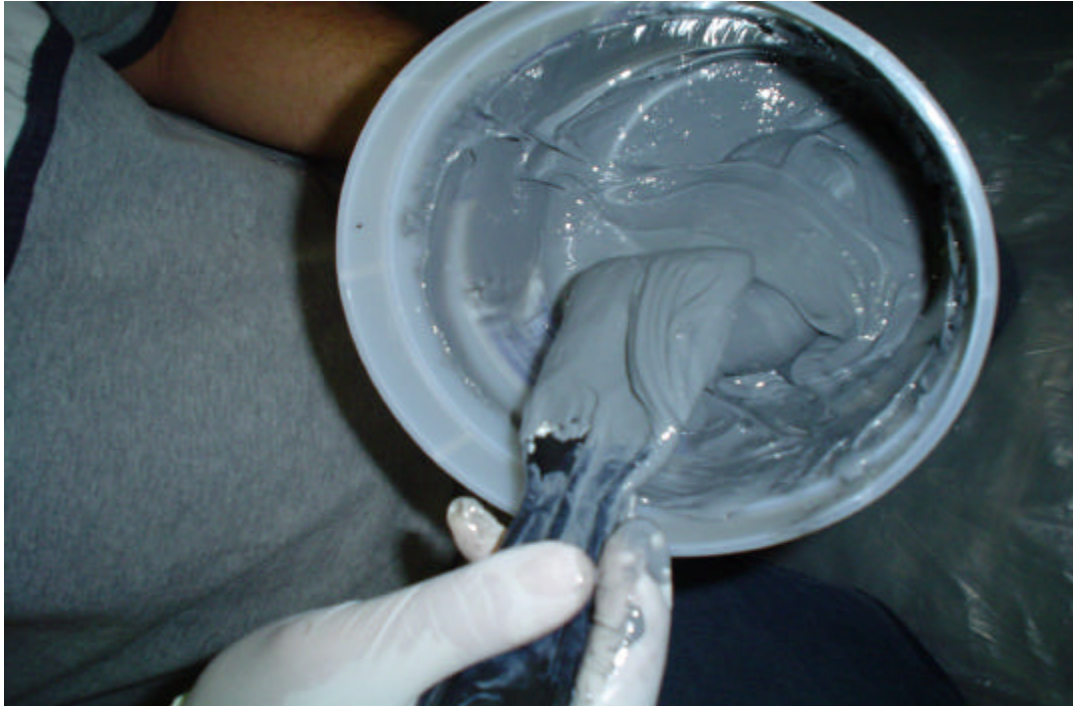
Figure 18: Mixing of QuakeBond J200TC

over the clean surface using a putty knife until a thickness of 40 mil was achieved. The tack coat would remain workable for about 2 hours (Quakewrap Inc.)

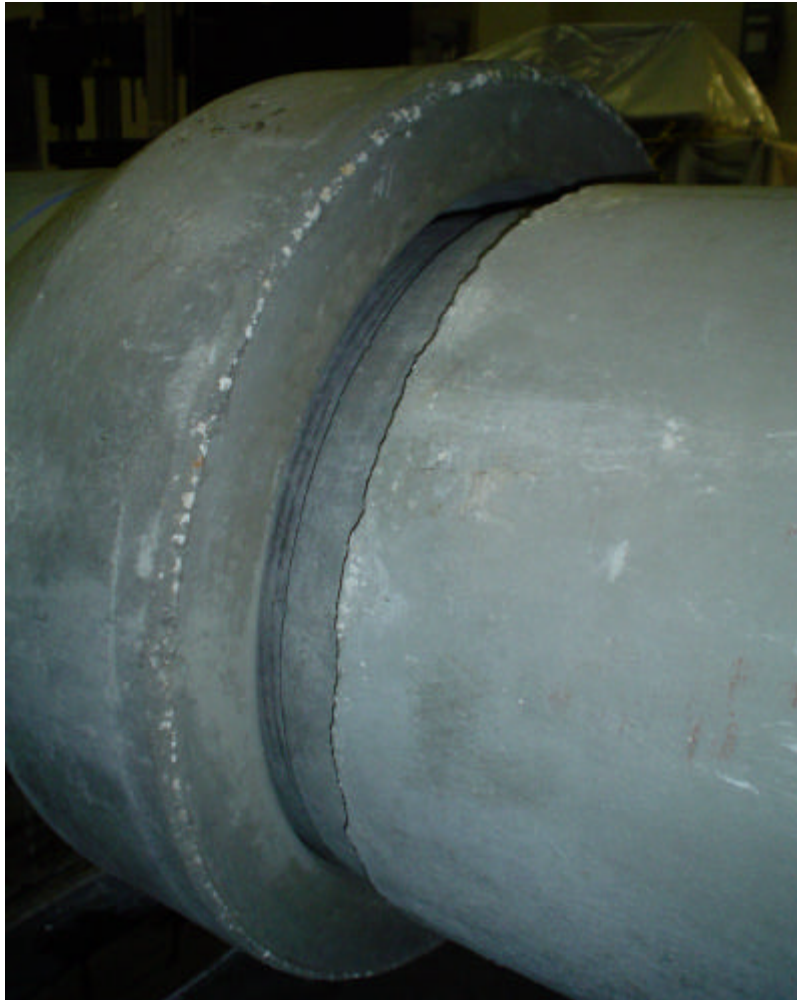
Figure 20: Displacement of the spigot from its regular position

1. Two pipes were assembled and placed under the portal load frame as pictured in Figure 19. The pipes were supported by timber cradle blocks, which had one face curved to match the outer diameter of the pipe barrel. The rubber gasket in the joint was intentionally withdrawn and the spigot end inside the bell was pulled back one and a half inch approximately from its standard position in order to simulate a faulty joint. Figure 20 shows the disjointing in between the bell and spigot ends.

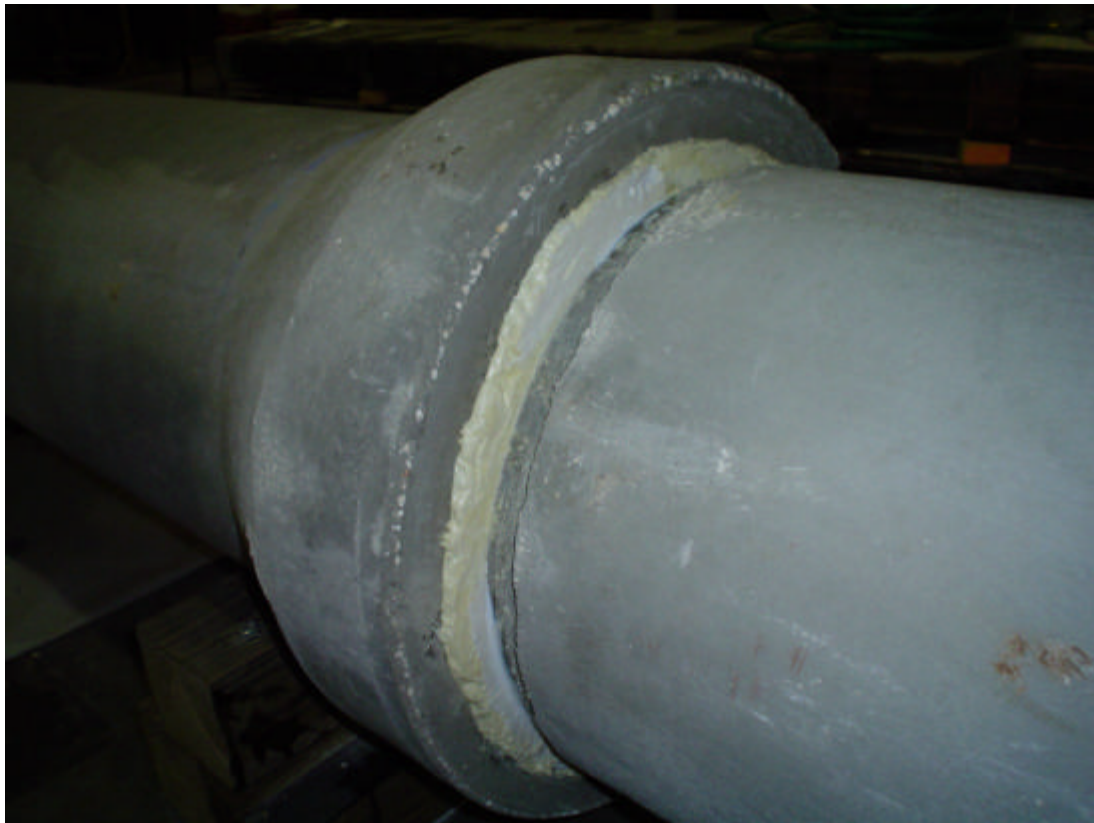
Figure 21: Sealing of the pipe joint

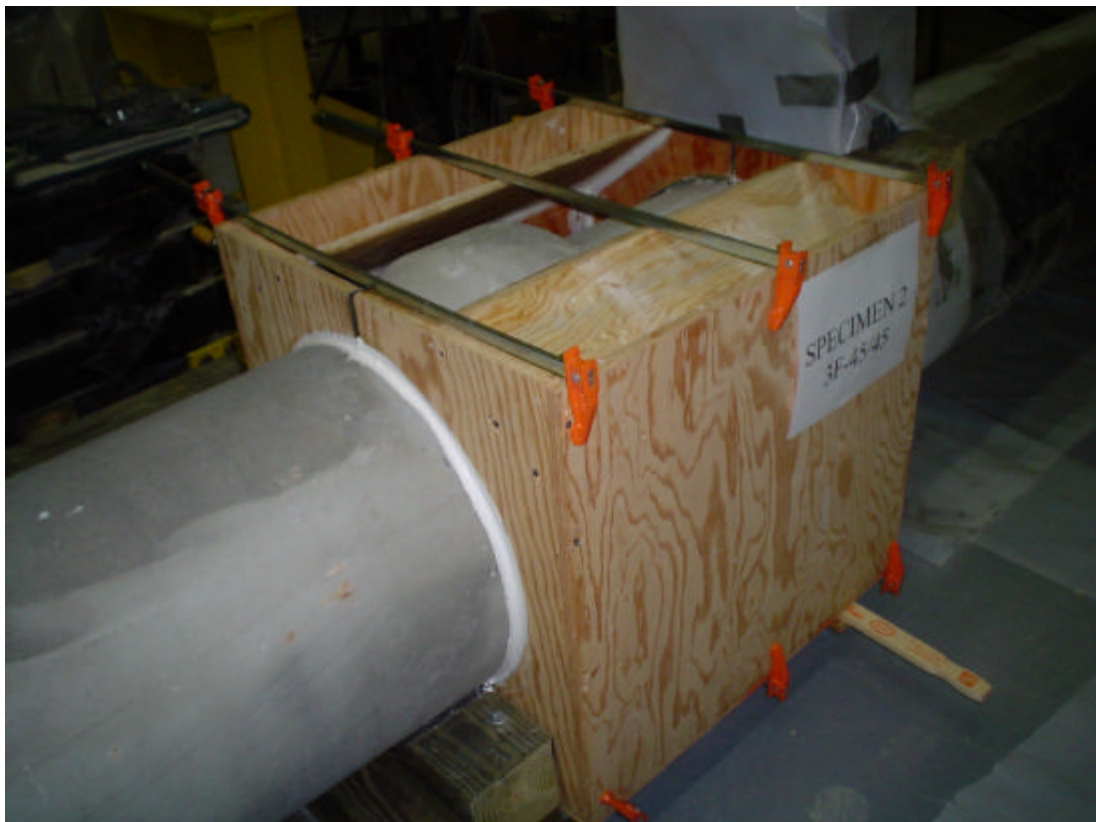
Figure 22: Installation of formwork for Hydro-Stone casting

3. The octagonal formwork was placed around the joint and the Hydro-stone poured into the mold as shown in Figure 22. Dimensions of the formwork are shown in Figure 23. The design, mixing and cured of Hydro-stone were carried out as previously described at the beginning of this chapter in “Hydro-stone Mix Design, Casting and Cured”. Two hours later the formwork was removed and the hydro-stone casting provided a uniform surface to wrap the FRP around the joint as referred in Figure 24.

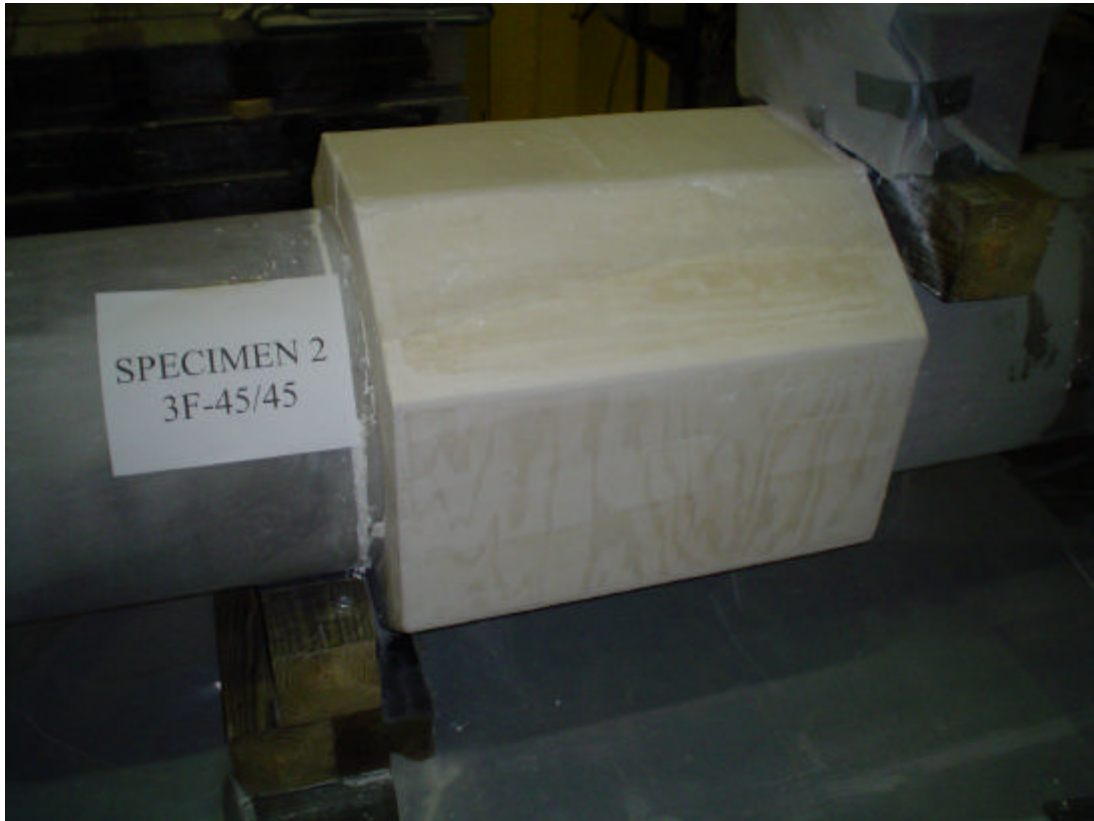
Figure 24: Hydro-stone rim around the joint

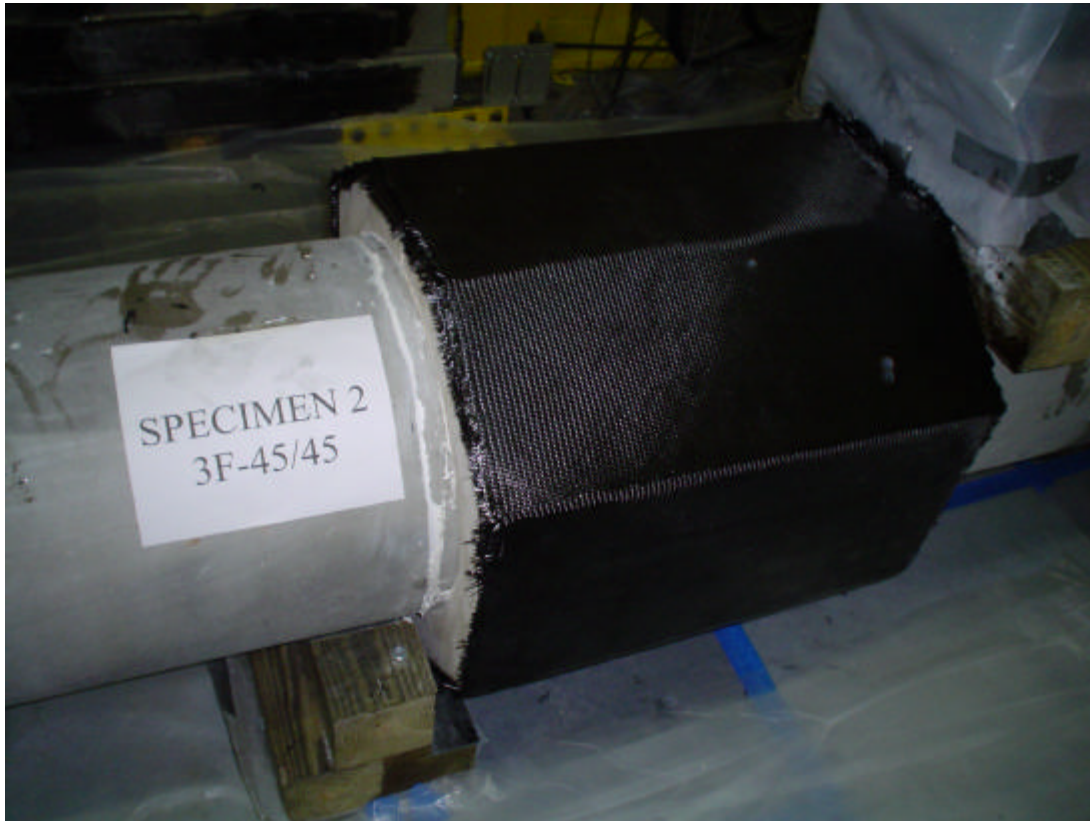
Figure 25: FRP straps wrapped around the restored joint

5. The FRP straps were wrapped around the hydro-stone rim immediately after the application of the tack coat QuakeBond J200TC achieving a thickness of three plies as pictured in Figure 25. Preparation and application of FRP was performed as explained previously in this chapter under section “Preparation and Installation of FRP”. As recommended by the manufacturer, the time for total cured of the FRP was set in 48 hours. After wrapping the joint with FRP in specimen 3F-0/90, the carbon fibers described orientations of 0 and 90 degrees with respect to the longitudinal axis of the pipeline while specimen 3F-45/45 described orientations of -45 and +45 degrees.

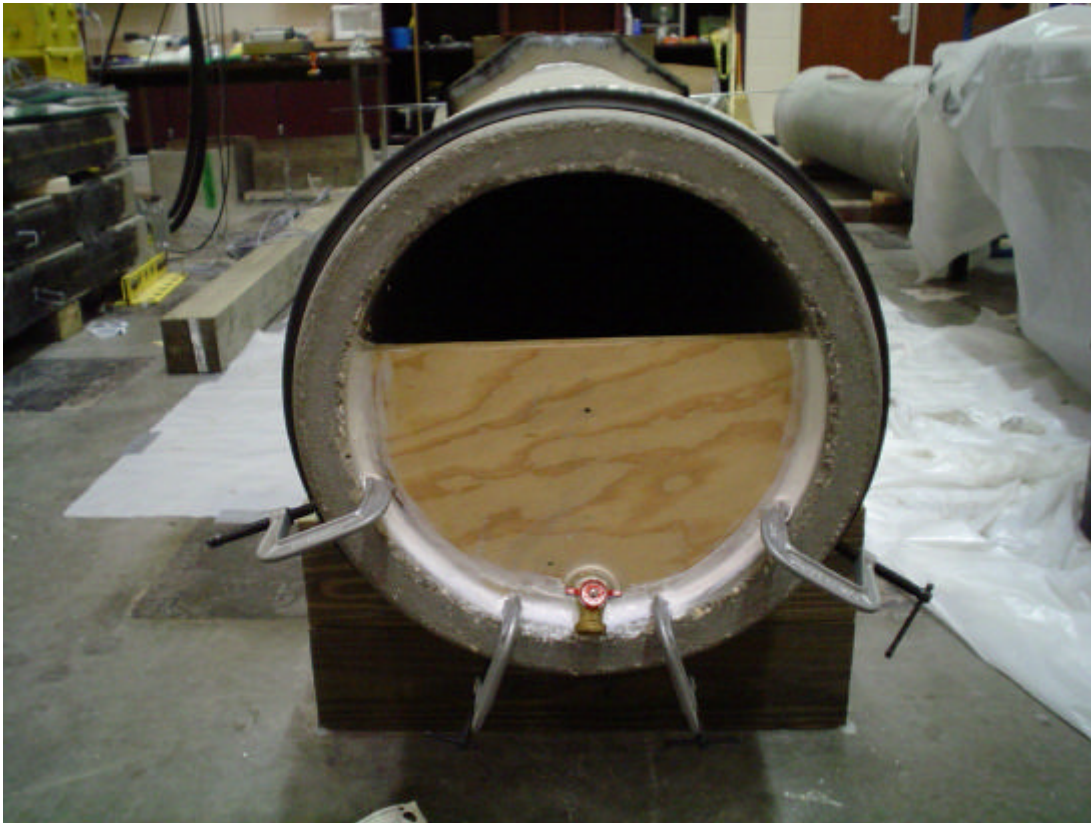
Figure 26: Capping of pipe ends

6. Followed, strain gauge rosettes were attached to each specimen as described further under “Test Instrumentation”.
7. Both free ends of the pipes were capped using wooden lids to further fill them up with water as part of the experimental tests to which the specimens were subjected. Figure 26 illustrates one of the pipe ends capped with the wooden lid.

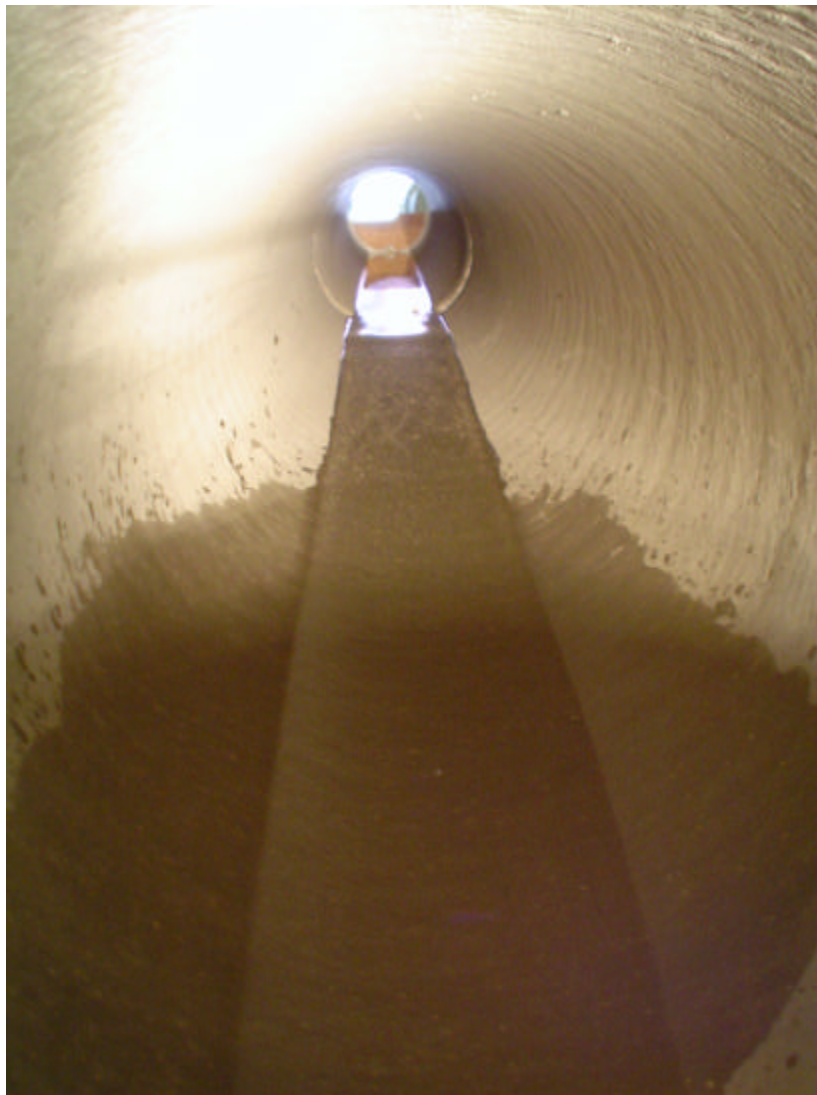
Figure 29: Filled of the pipes to determine watertightness of the joint

the test joint until the total differential load (R), including the weight of the pipe, would be 4,000 pounds per foot of pipe diameter. Figure 28 illustrates the layout of the specimen and the locations of the test force, F, and the required reaction, R; as required by the ASTM standard under section 13, which refers to joint shear test. Both parameters have been calculated and presented in Appendix A. Once the specimen was ready for testing, the actuator was initiated and the actuator's piston was watchfully pulled down until it reached the top of the timber block; at that moment the piston displacement was stopped. Subsequently, the test load (F) estimated in 5,600 lbs was applied to the unsupported spigot of the joint for one minute. The specimen was loaded to the required test force (F) at a constant rate of 0.10 inches per minute in a displacement control mode. Later, in order to determine the watertightness of the repaired joint after subjected to the test load (F), the pipes previously capped were filled with 75 gallons of water inundating only half of the pipe section as shown in Figure 29.

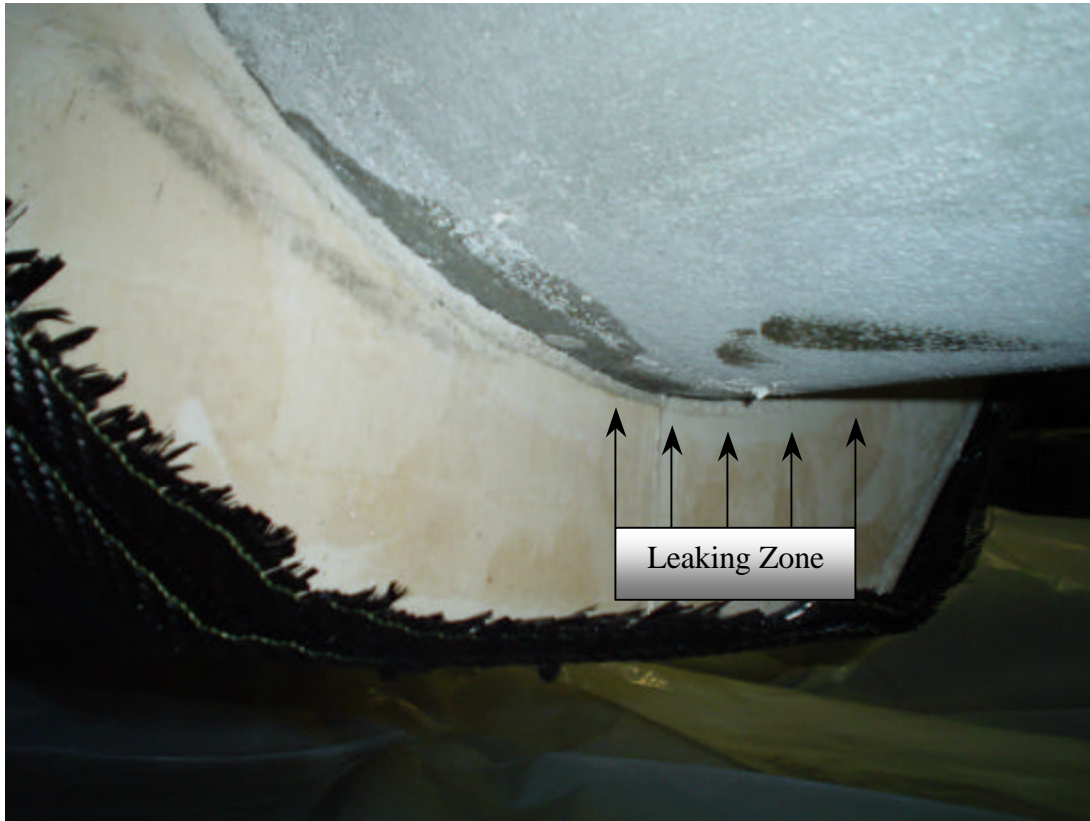
Figure 30: Leaking Area.

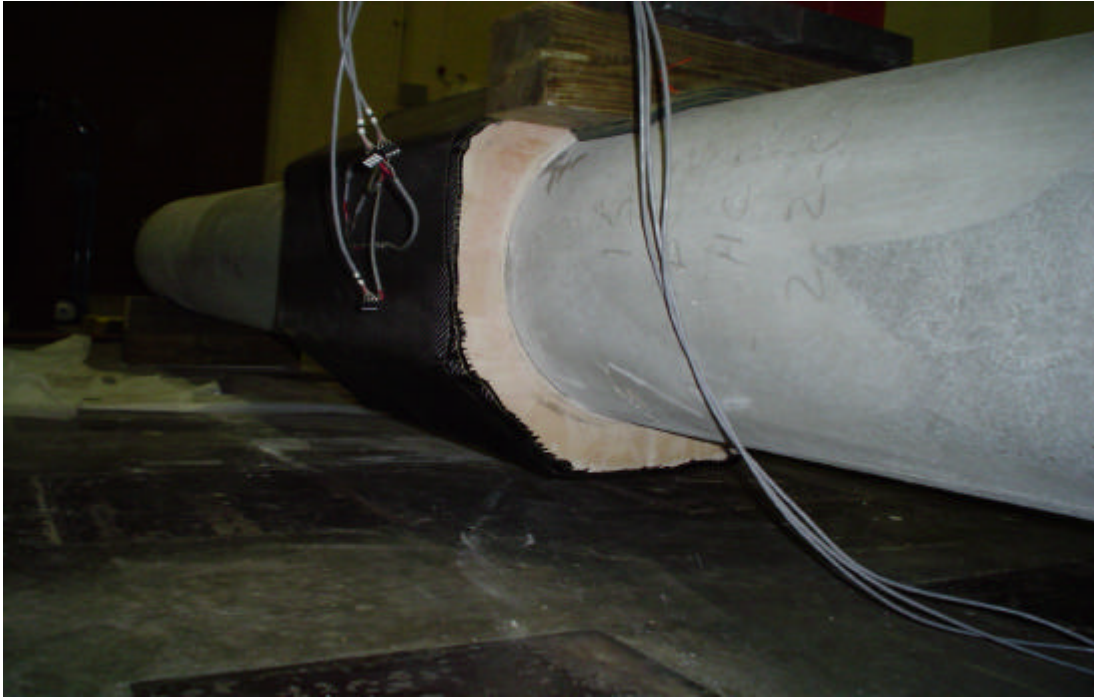
Figure 31: The support near the joint was removed

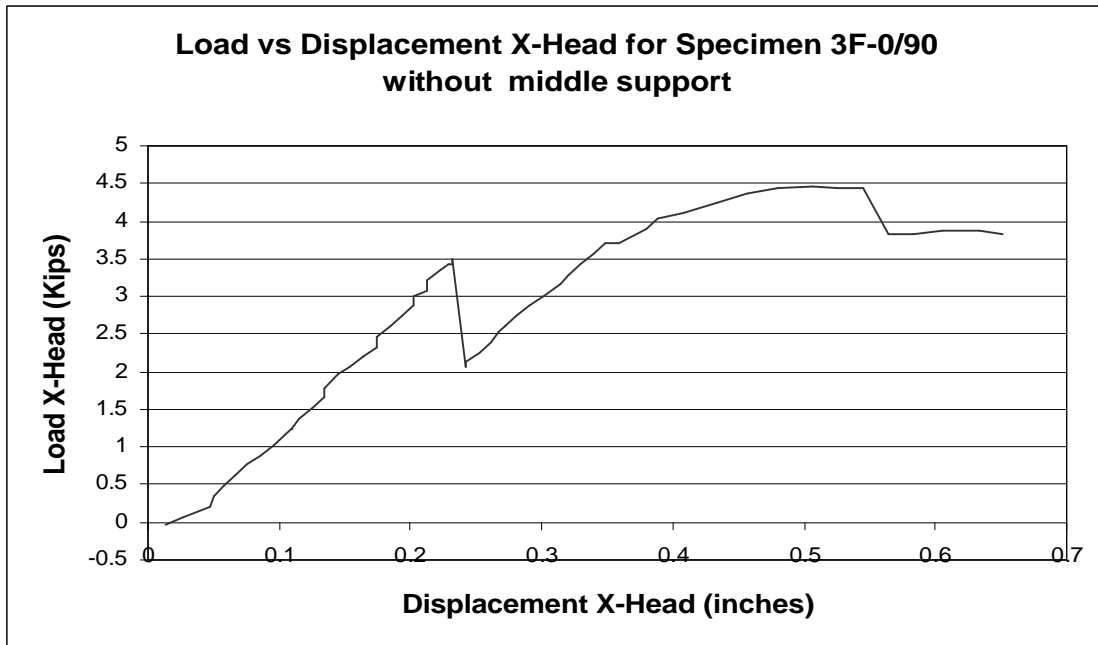
Figure 32: Load vs. Displacement X- Head for Specimen 3F – 0/90 without middle support

Obviously, this new support configuration created a bending or flexure testing where the same lateral force ( $F$ ) would induce compressive stresses on top of the specimen and tensile stresses at the bottom. Once initiated the application of the test force the specimen failed at a load of 3, 500 lbs. at which point the load dropped significantly, but then stabilized as shown in Figure 32.

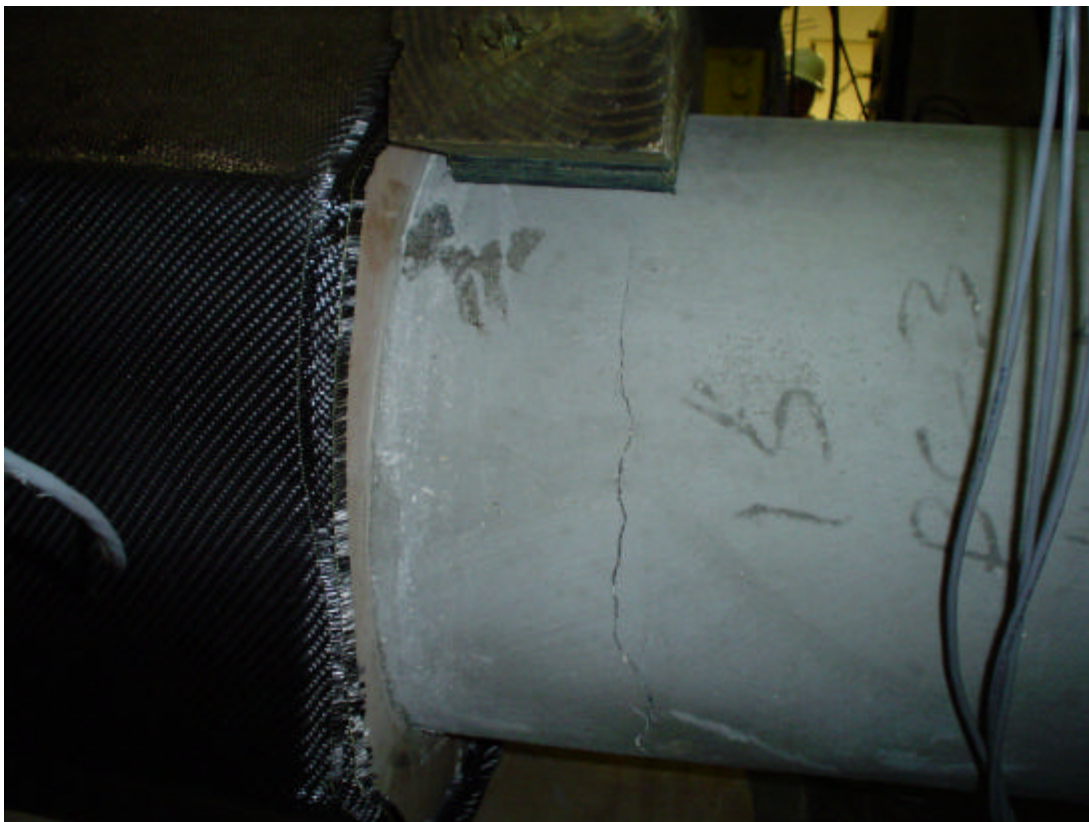
Figure 33: Mode of failure for Specimen 3F-0/90 after removing center support

The pipe barrel cracked right by the cradle block used to transmit the shear force from the actuator to the pipe as shown in Figure 33. The Strain gauge oriented longitudinally on top of the pipe reported the largest reading corresponding to the strain resulted from the compressive bending stresses acting on top of the pipe because of the positive bending moment. Neither the FRP jacket nor the Hydro-Stone showed any signal of deterioration.

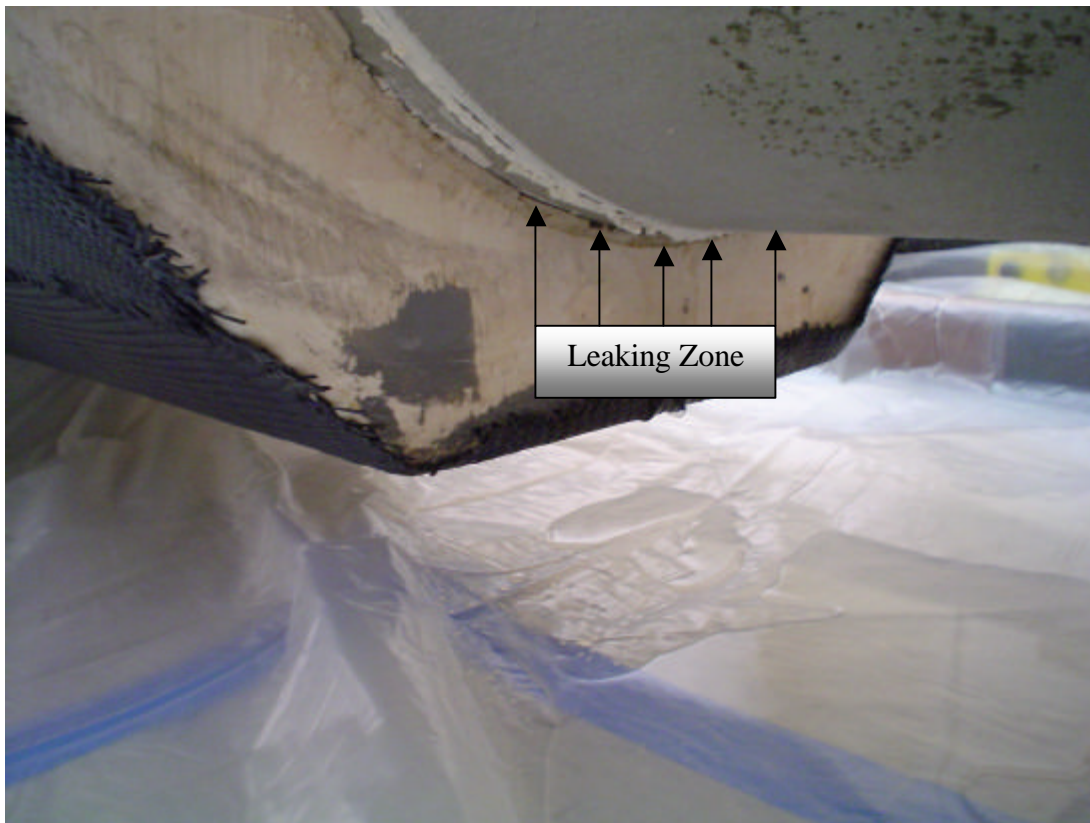
Figure 34: The Leak Emerges from the Interface in Between the Pipe and Hydro-stone

with specimen 3F-0/90, water emerged from the border line in between the pipe and the Hydro-Stone immediately after the pipe was filled with water as pictured in Figure 34.

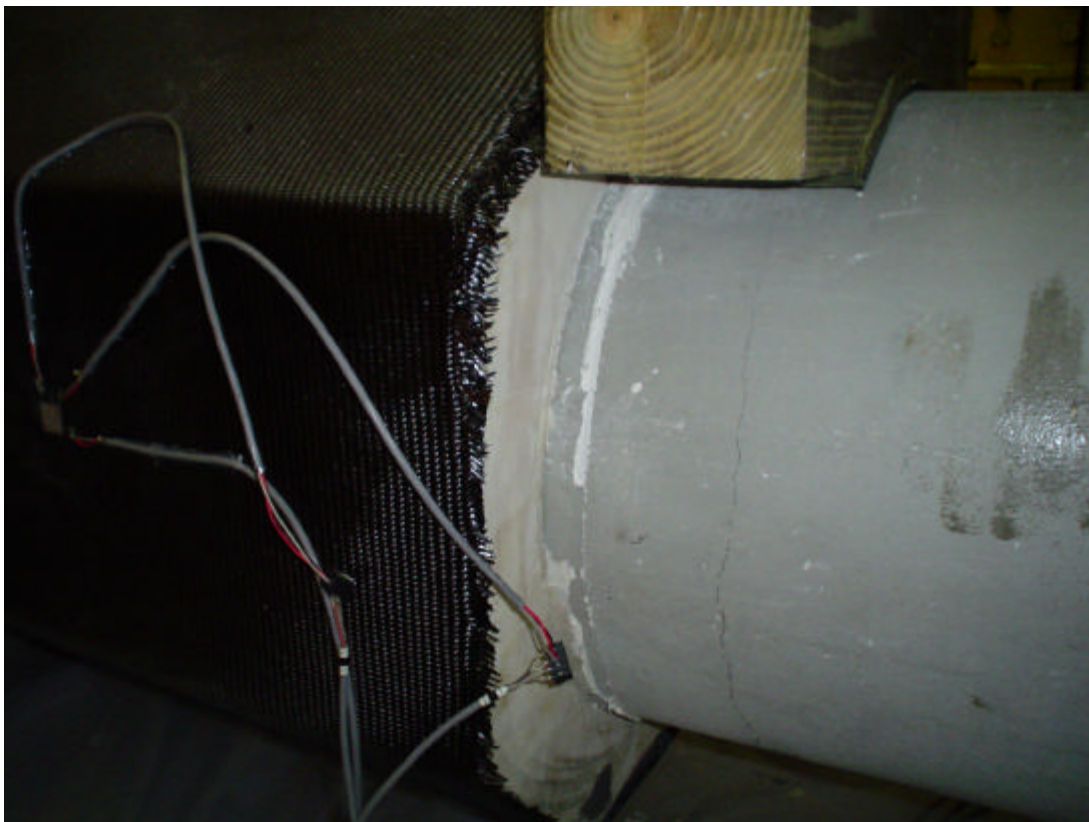
Figure 35: Failure Mode of Specimen 3F-45/45

additional strength than the provided by the pipe to support the differential load induced across the joint. Obviously, no visible indication of deterioration of the FRP jacket or Hydro-stone rim was present. Therefore, it was decided to reload the specimen to failure. Upon reloading it failed at 17 Kips. At this moment the pipe barrel cracked right by the timber support as shown in figure 35. Moderate strain values were measured over the FRP.

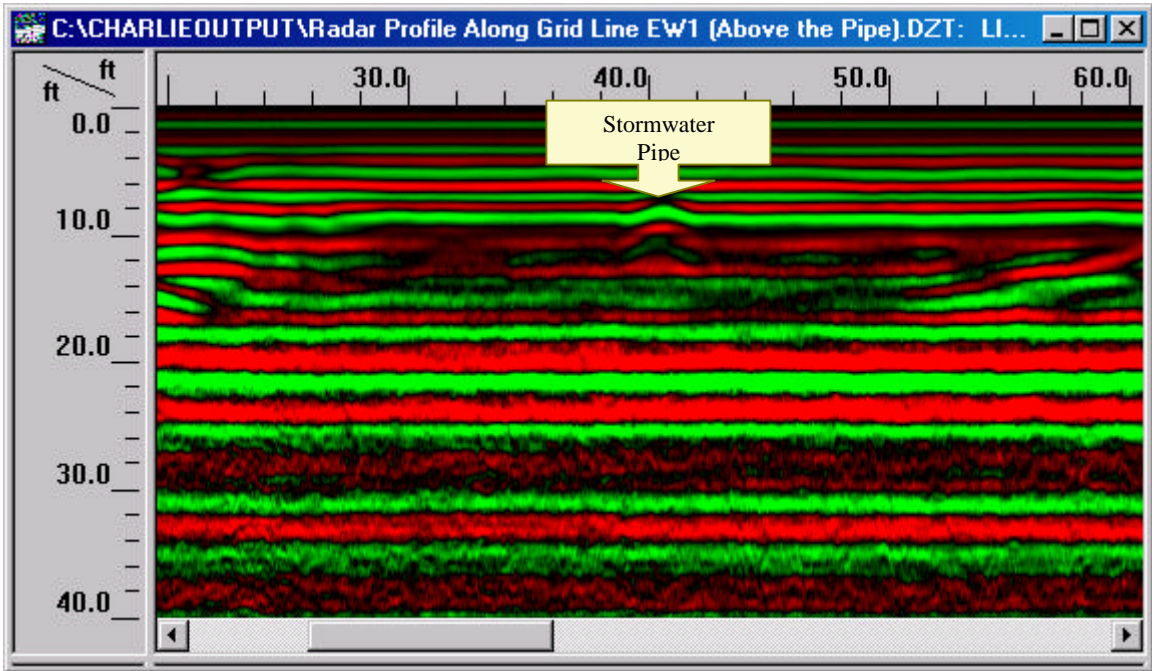
Figure 36: GPR Profile along grid line EW1 (Above Sewer Pipeline)

Figure 37: GPR Profile along grid line EW1 (Above Sewer Pipeline)

The radar profile obtained along the grid line EW1 (above pipeline) using the 80 MHz antenna is shown in Figure 36 and 37. In the field, the GPR survey along the mentioned grid line was performed in a continuous base. Because of the extensive of the profile, it has been divided into two different figures. The graphic representation of the reflected radar signals shows clearly several anomalies along the surveyed area. First of all, two series of hyperbolic reflections represent two buried pipes oriented along the north-south direction, which is perpendicular to the surveyed grid line. Each series of hyperbolic reflections show clearly the top of the pipe (upper red stripe), the water way area (green stripe) and the bottom part of the pipe (second red stripe); the remaining hyperbolic bands are multiple reflections from the previous stripes.

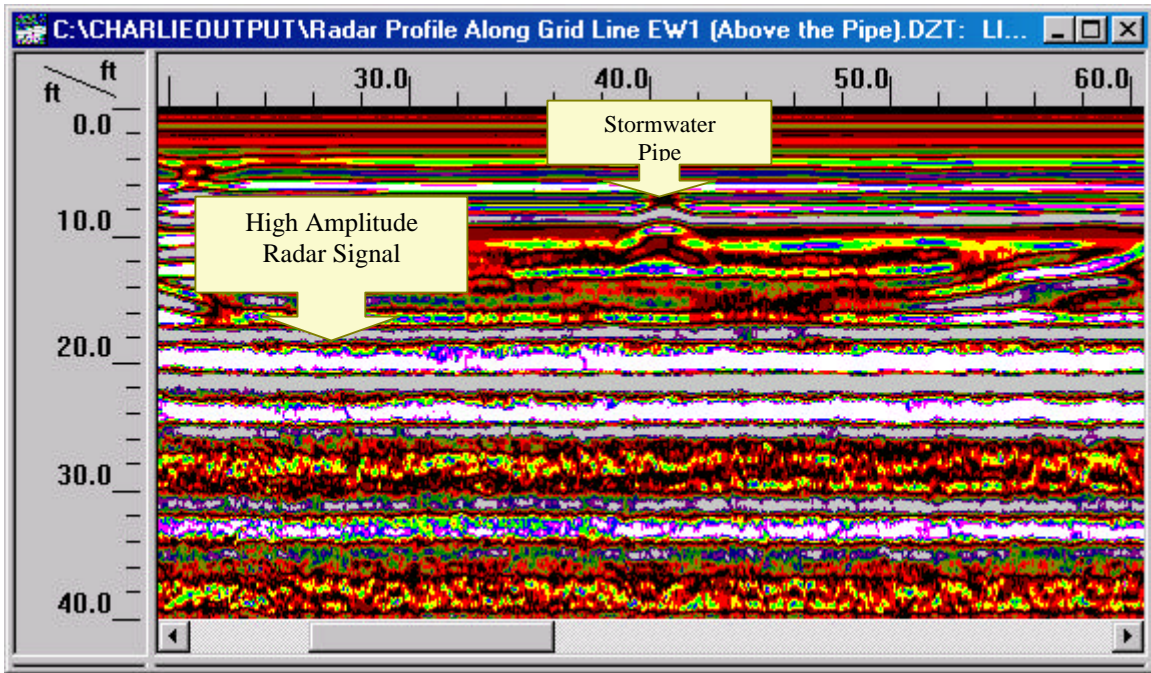
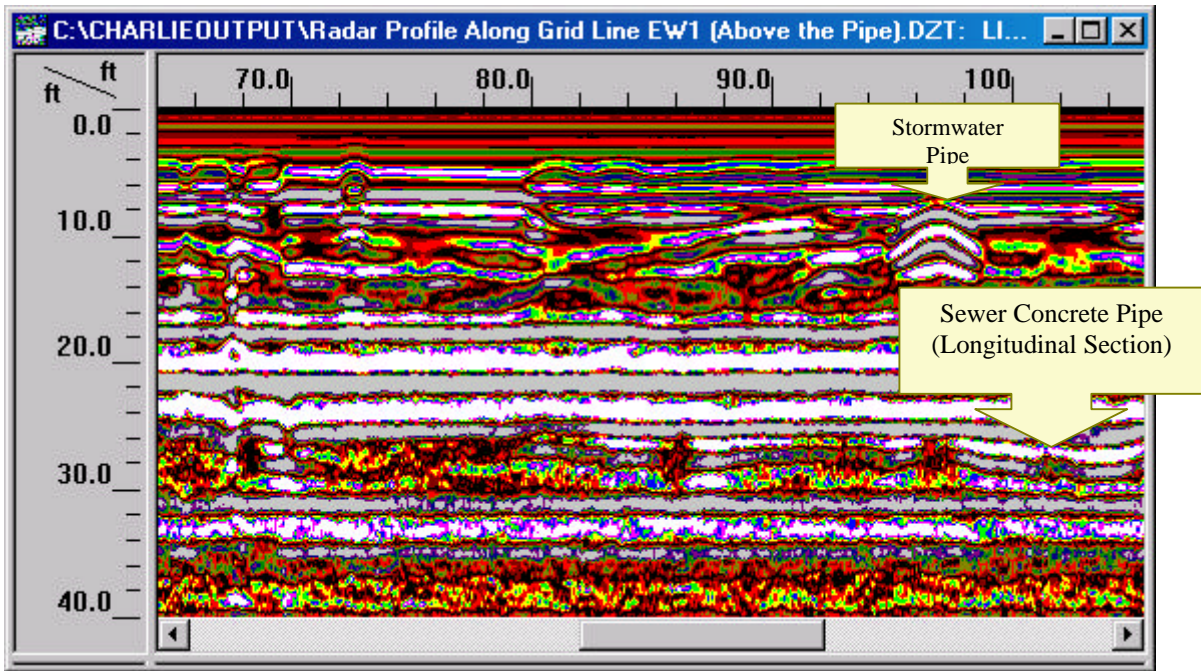
Figure 38: GPR Profile along grid line EW1 (Above Sewer Pipeline) using a different color code

Figure 39: GPR Profile along grid line EW1 (Above Sewer Pipeline) using a different color code

When using GPR a convincing evidence of the existence of a leakage (infiltration/exfiltration) in pipes are changes in the frequency of radar signals. In a colored profile as the presented herein, changes in the frequency are represented by suddenly changes in color in large uniform pattern. One of the advantages of RADAN in processing raw data is the existence of several standard display color tables that allow to perceive easily changes in the amplitude of the recorded radar signal. Therefore, the same profile obtained along the grid line EW1 (above pipeline) is now presented in Figure 38 and 39 using another color code to facilitate the perception of any change in color (variation in the amplitude of the radar signal) along the pipeline. These changes in the amplitude of radar signal are caused by changes in the dielectric constant of the transmitting medium, for instance, due to the presence of water from a leak along the pipeline.

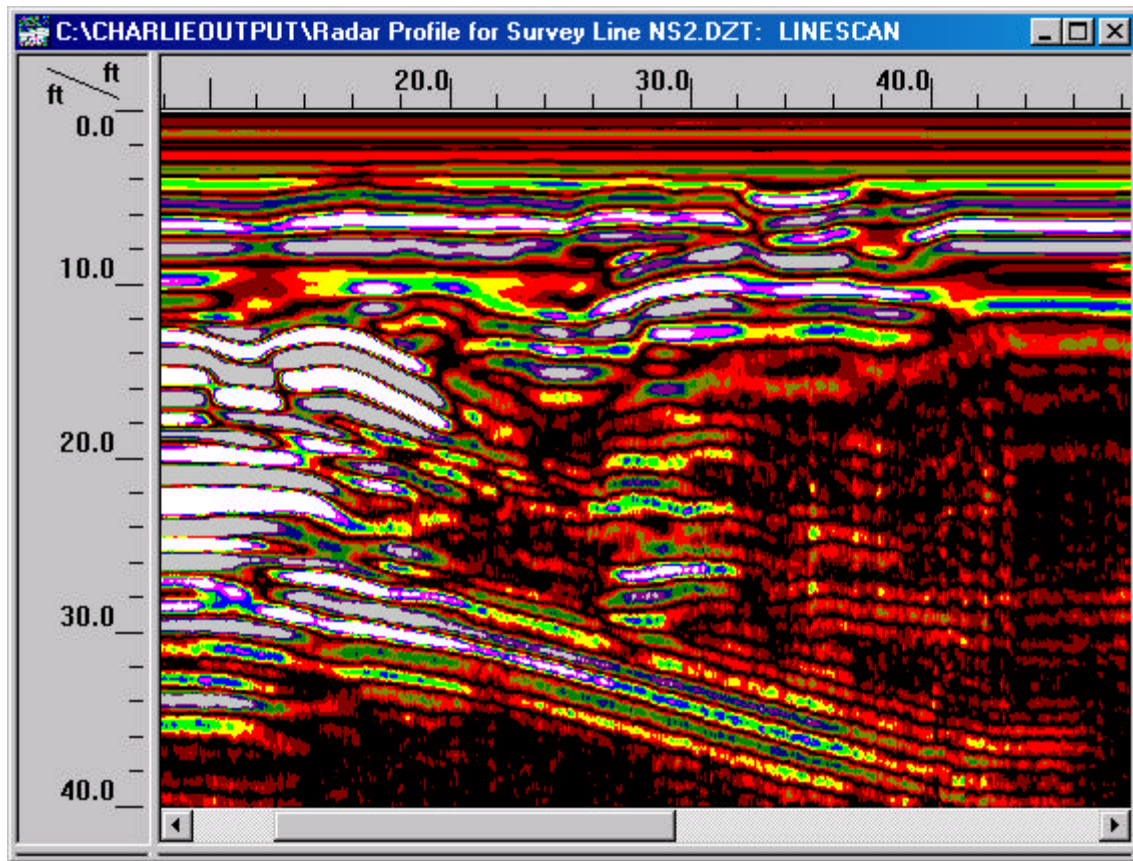
Figure 40: GPR profile along grid line NS2 obtained using 80MHz antenna

Figure 40 was obtained out of the suspected area of the leak. As seen in the profile, no subsidence of the pavement surface is present on it. A small hyperbolic reflection is noticed at a depth of 12 feet at the left side of the figure, it corresponds to a concrete pipe placed parallel to the curve, which is believed to be a storm water pipe. Moreover, Figure 40 shows several inclined bands relatively uniform in thicknesses that correspond to strata with different electric behavior (dielectric constant) given the changes in color. The dark area seen in the lower part of the profile is believed to be a material with a low dielectric constant as a homogeneous sand deposit. No evidence of the sewer pipe is provided by the profile.
