## Investigation Of Ground Penetrating Radar For Detection Of Leaking Pipelines Under Roadway Pavements And Development Of Fiber-Wrapping Repair Technique

INVESTIGATION OF GROUND PENETRATING RADAR FOR DETECTION OF LEAKING  
PIPELINES UNDER ROADWAY PAVEMENTS AND DEVELOPMENT OF FIBER-  
WRAPPING REPAIR TECHNIQUE

A thesis submitted in partial fulfillment of the requirements  
for the degree of Master of Science  
in the Department of Civil and Environmental Engineering  
in the College of Engineering and Computer Science  
at the University of Central Florida  
Orlando, Florida

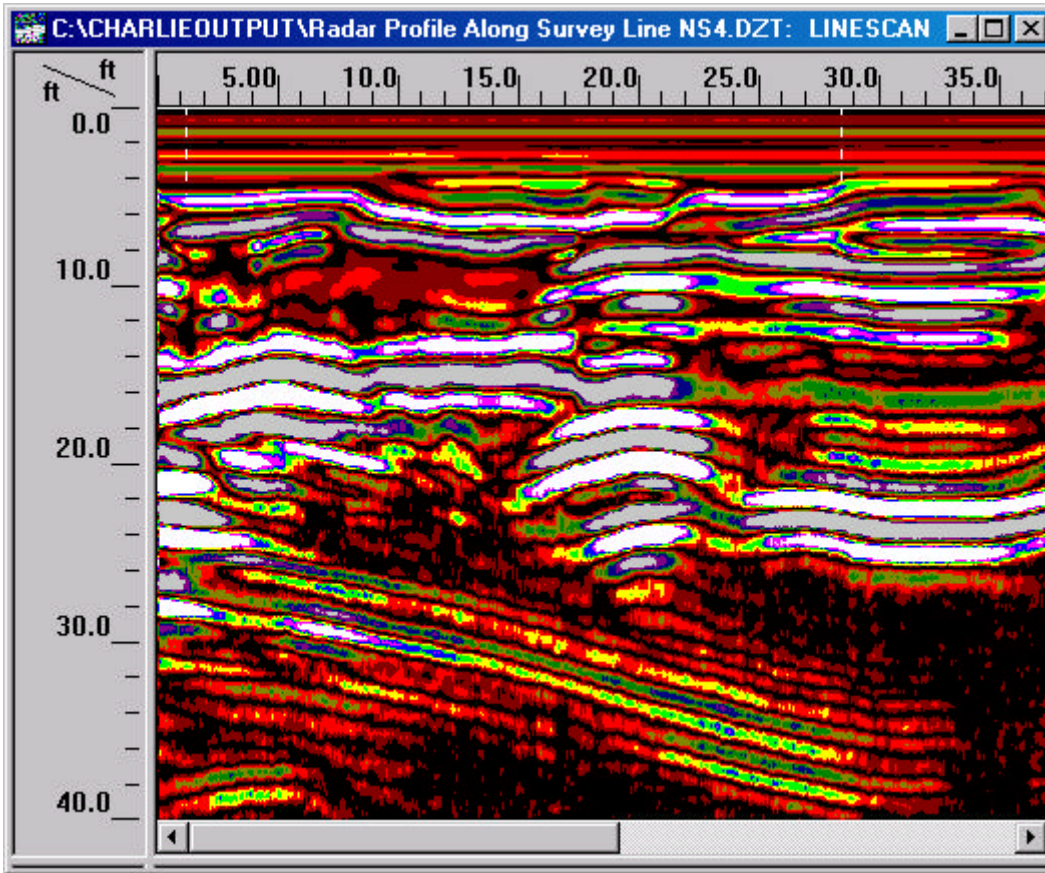
Figure 41: GPR profile along the grid line NS4 obtained using the 80MHz antenna

Figure 41 shows the radar profile obtained along the grid line NS4 located within the area where the pipe leak is suspected to be. In the upper part of the profile a noticeable subsidence of the pavement surface within the white marks is evident. Even two distinguishable layers from asphalt batching repairs can be seen over the pavement depression. The profile in Figure 41 appears very consistent in regarding of the subsurface information featured in the previous profile 40. The same inclined uniform bands and darken zone in the lower part of the profile make think the predominance of sandy soil underneath. As in others profiles obtained during the GPR survey the attenuation of the radar signal is present.

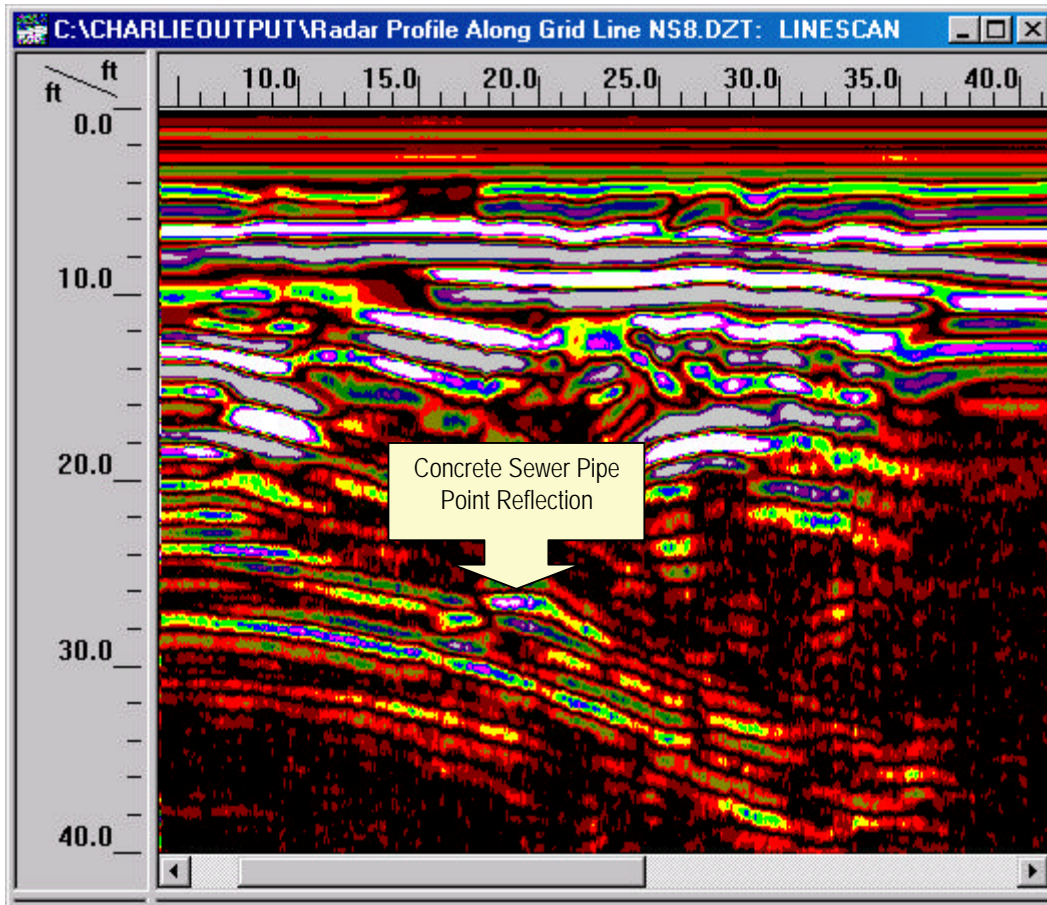
Figure 42: GPR profile along the grid line NS8 obtained using the 80MHz antenna.

In Figure 42 a point reflection at a depth of 25 feet is believed to be the sewer pipe. Due to attenuation of the radar signal the hyperbolic shape is not fully displayed in the profile. The same point reflection signal was obtained in three other profiles confirming the existence of the concrete pipe. Since significant loss of signal occurs at the pipe depth, it is difficult to identify any anomaly around the sewer pipe. In order to facilitate the recognition of the radar reflection caused by the sewer pipe, the same profile along the grid line NS8 shown in Figure 42 has been depicted in Figure 43 using a different color code. No evidence of leakage is perceived from the mentioned profile across the pipe.

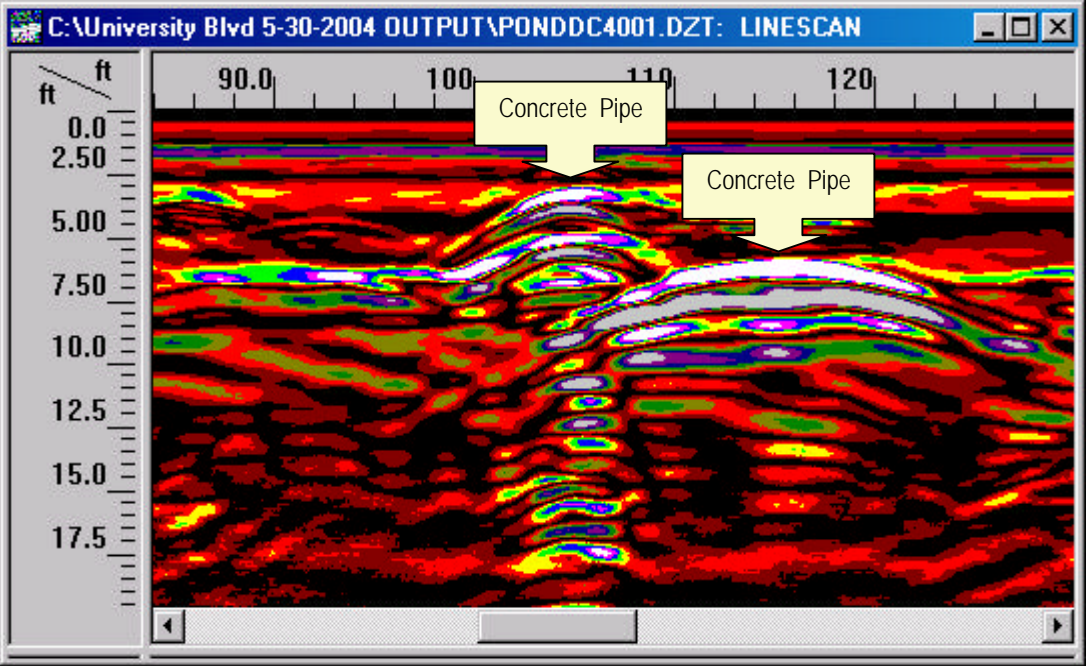
Figure 44: GPR profile from adjacent side of University Boulevard Westbound obtained using the 80 MHz antenna

It is important to mention that signal reflections generated by buried pipelines in other areas such as stormwater pipes on UCF campus and drainage pipelines at road side of University Boulevard as shown in Figure 44, were clearly detected. The latter makes to believe that the significant attenuation of the radar signal at the area of study is due to the extreme high conductivity of soils which have been severely contaminated by the leakage of sewage from the distressed sewer pipeline.

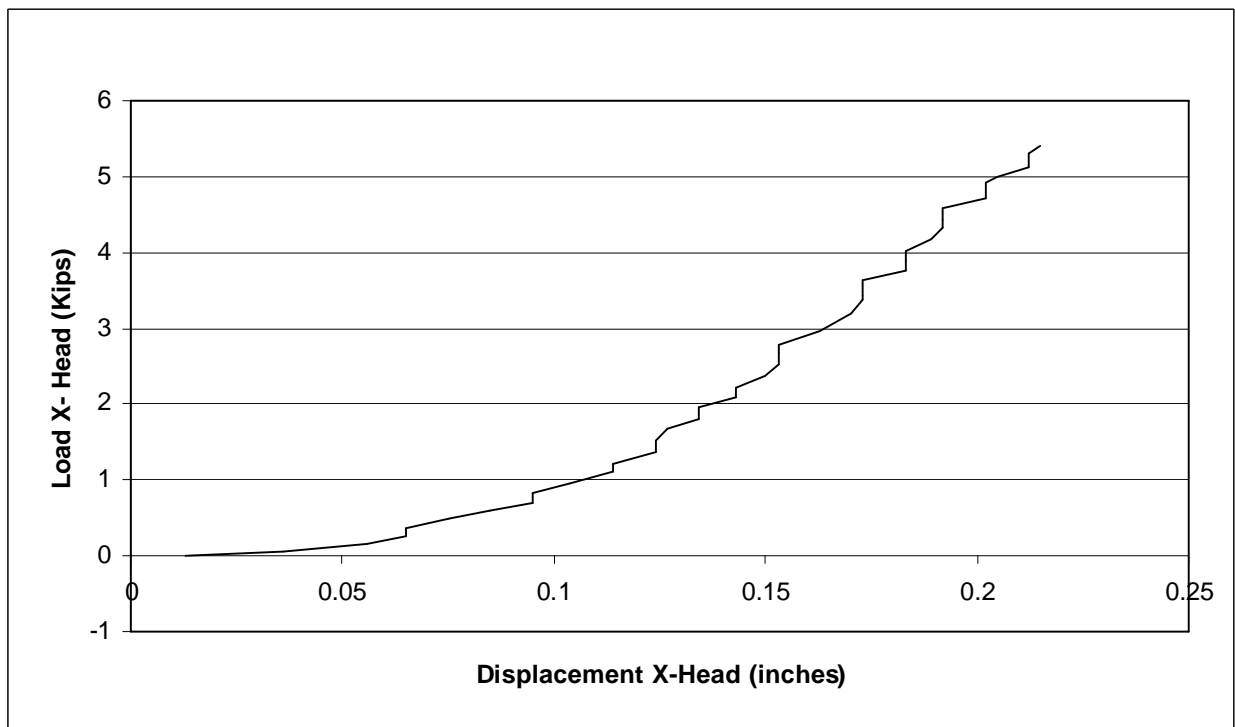
**Figure 45: Load vs. Displacement X-head for Specimen 3F-0/90**

At this point the pipe barrel cracked since it no longer resists the deflection (bending) imposed for such a load. Therefore, the structural capacity of the repaired joint in resisting bending has exceeded the capacity of the pipe itself. It is important to mention that strains gauges over the FRP surface exhibited again negligible strain values since most of the stresses withstanding the bending effect are generated by the Hydro-stone rim . Based on the previous evaluation of the capacity of the repaired joint, it can be affirmed that the faulty joint has been effectively strengthened throughout the construction of the Hydro-stone jacket. The role of the FRP in the repair technique would be to hold together the hydro-stone rim once it failed (cracks) under the effect of significant external forces. At this point the FRP jacket becomes effective as a hoop tension band, and the only restrain against catastrophic failure

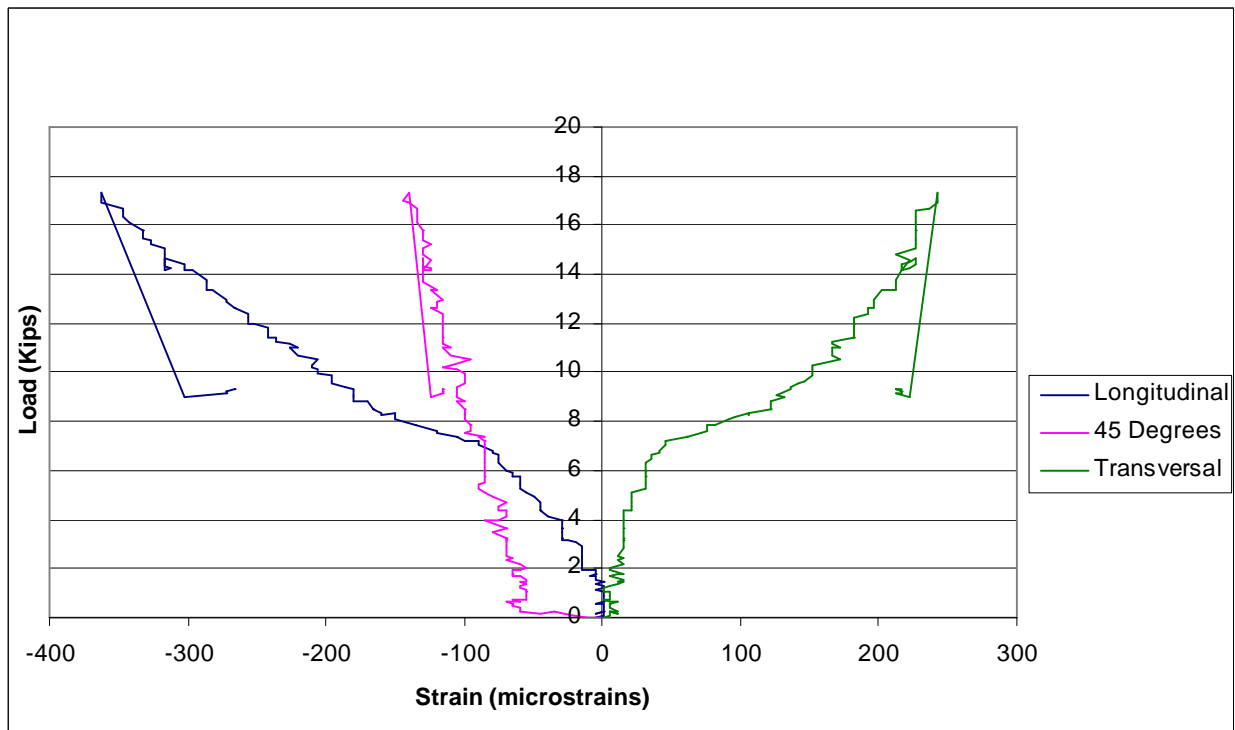
Figure 46: Strain Readings from Top of Specimen 3F-45/45 when Loaded to Failure
