FIELD TEST OF A NOVEL NONDESTRUCTIVE TESTING DEVICE ON WOOD DISTRIBUTION POLES

Abstract. In July 2015, a field test was performed on 50 utility poles that had been removed from service. The poles were nondestructively tested with a novel device, the PoleXpert device. The poles were then destructively tested. Results indicated that the device's output correlated well with the actual bending strength of the utility poles. Therefore, it appears that the device has the potential to identify weak or structurally compromised poles. Seventeen of the poles were reinstalled in the ground and tested. The other 33 poles were tested horizontally in a pole-testing fixture. The device demonstrated positive correlation in both situations.

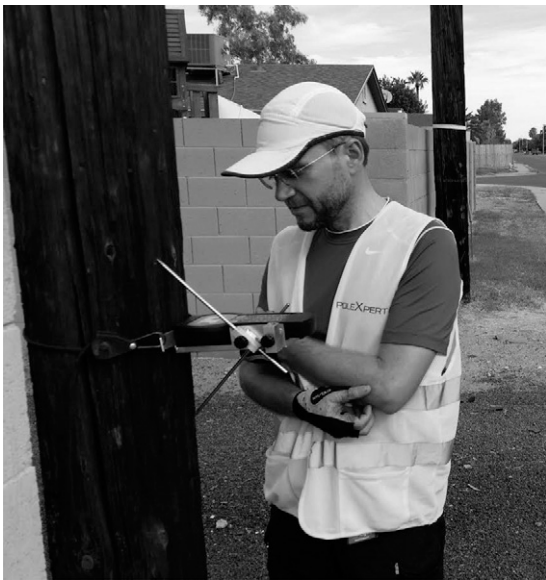
Figure 1. A PoleXpert specialist affixes the PX device, which is used to nondestructively evaluate an in-service wooden utility pole, at approximately 1.22 m above the ground line.

Once on-site at the MSU Laboratory, each pole was measured with the PX device again. For this action, 17 of the poles were reinstalled in the ground and tested vertically in a manner consistent with a modified American Society for Testing and Materials (ASTM) D 1036 standard (ASTM 2012). Then, the PX device was placed on the surface of the utility pole approximately 1.22 m above the marked ground line, and the pole was hit (accelerated) with a 0.907-kg hard rubber mallet (Fig 1). These 17 poles were measured for strength and stress properties but not stiffness. Breaking force was taken as the cosine of the angle of the cable attached to the pole, compared with a level horizontal line. In this manner, an actual perpendicular force was estimated. The stress was measured by taking into account the moment of inertia of the pole section at the point of breakage, as well as the distance from the breaking point to the attachment of the cable. The remaining 33 poles were tested destructively by bending as per ASTM (2012) in horizontal orientation and secured in a pole-testing fixture. In the field, all of these

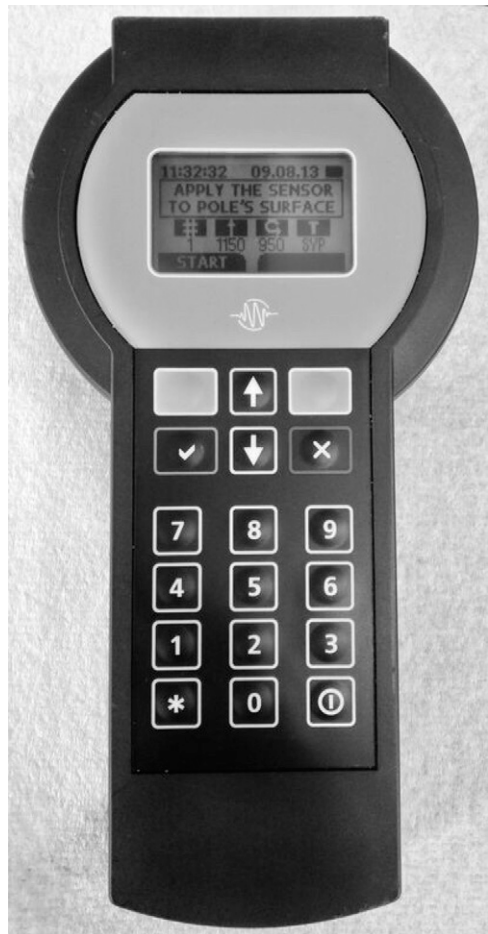
Figure 2. The PoleXpert device used to nondestructively evaluate in-service wood utility poles.

Many studies have used acoustic approaches to assess utility poles for detection of decay or weakened structure (Rabe et al 2004; Freitas et al 2013; Senalik et al 2013; Ross 2015), but limited research has been conducted using both acoustic and vibrational analyses. A novel device for assessing the performance and residual life of in-service utility poles has been developed by PoleXpert LLC (2015) (PX; PoleXpert LLC, Carson City, NV). The PX device uses a combination of acoustic and vibrational analyses along with pole size characteristics for an assessment. The PX device testing technology is based on the measurement and analysis of the natural acoustic frequencies of an installed utility pole (considered as a cantilever beam). In this process, the PX device is affixed to the pole at approximately 1.22 m above the ground line (Figs 1 and 2). Next, the standing in-situ pole is tapped (accelerated) with a 0.907-kg hard rubber mallet. The acoustic pulses produced by the tapped mallet are then captured, subsequently processed, and interpreted by the PX device. This computational process takes 3-5 s. The PX device is then relocated 120° from the initial orientation, and the process is repeated. Then, it is relocated 240° from the initial orientation, and the process is repeated for a third time to determine an average reading. In this manner, the device develops information about the entire circumference of the utility pole. By determining the

natural frequencies, the PX device calculates the average sound velocity throughout the global timber fibers for the tested pole. The presence of any decay, deterioration, checks, holes, unbalanced external static loads, or other internal anomalies, which decrease the mechanical properties of the pole, compared with a sound, on-grade pole, can lead to a decrease of its bending strength and stiffness (ASC 2015). Consequently, the decrease of average sound velocity throughout timber fibers is, in theory, detectable. A device that can detect a decline or deviation in acoustic performance of standing poles may ultimately be able to detect the poles that should be taken out of service. This field test compared results from this PX device with the actual bending test data for poles that had been identified as unsound by the electric power cooperative and subsequently removed from service. The poles that were taken out of service and subsequently tested herein should have had strength performance less than that of sound, on-grade new poles. The objective of this study was to conduct field tests in an effort to determine the potential for using and adopting

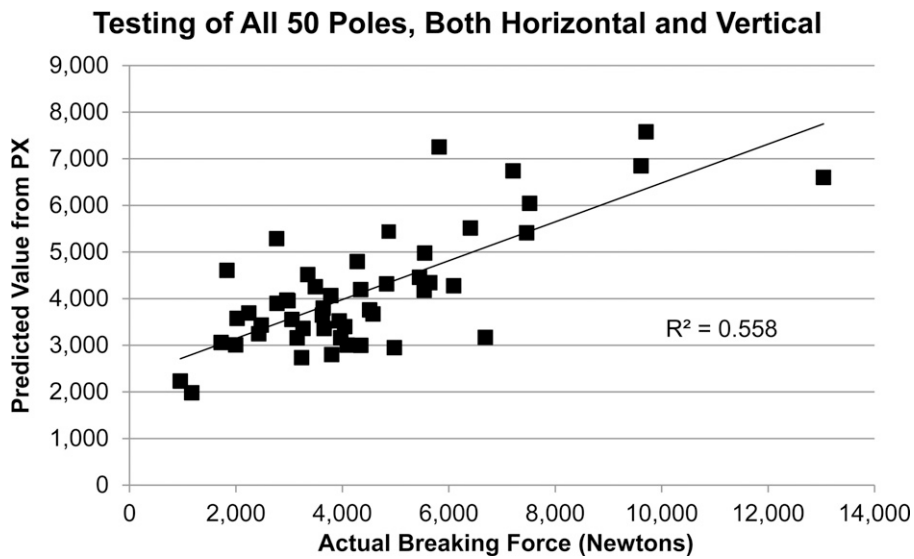
Figure 3. Correlation between actual and predicted maximum bending loads (Newtons) for all poles (50), including those tested upright and set in the ground as well as those tested horizontally in a fixture.

On the basis of these descriptive statistics from the MSU testing in July 2015, the poles had less than half of the tip load required for class 4 poles, ie 1088.62 kg (Table 1). Next, the actual values (from MSU testing) vs the predicted values (from the PX device) were correlated. The r^2 value between the actual tip load and the predicted load, per the PX device was 0.5580 (Fig 3). The r^2 value for only those 17 poles that were tested upright was 0.7298 (Fig 4). The poles that were tested horizontally (33 poles) had an r^2 value of 0.5448 (Fig 5). Most probably, this relationship was seen because these poles were tested by the PX device and then broken (tested destructively) under similar conditions at the MSU Laboratory yard on the same day as opposed to the horizontally broken poles (tested destructively by bending as per ASTM [2012]) that were tested by the PX device in the field 6 mo before the test in the laboratory.

The correlations between the actual and predicted bending strengths were reasonably good. As a means of comparison, r^2 values in the 0.50-0.70 range are commonly observed when testing the stress of in-grade structural lumber. Erickson and Wood (1960) recorded that most of the coefficients of correlations were about $r^2 = 0.7$. It was reasonable to infer that if the

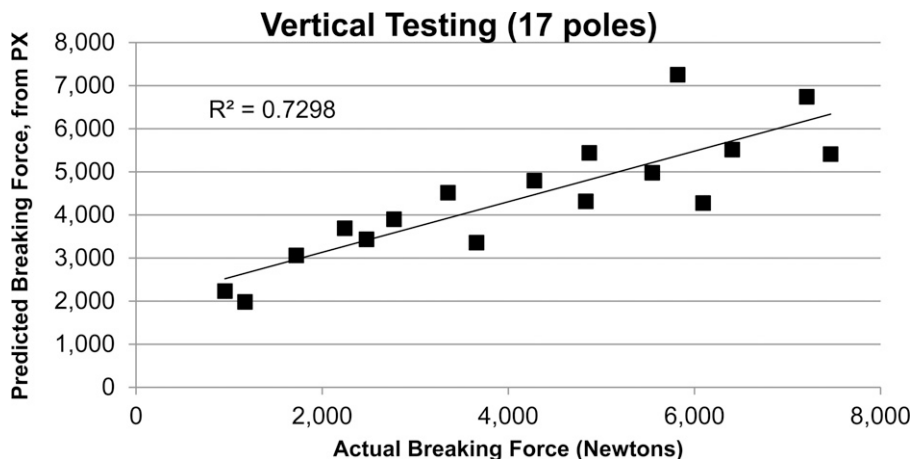
Figure 4. Correlation between actual and predicted maximum bending loads (Newtons) for 17 poles. Only those poles tested in the upright/reinstalled in the ground condition.

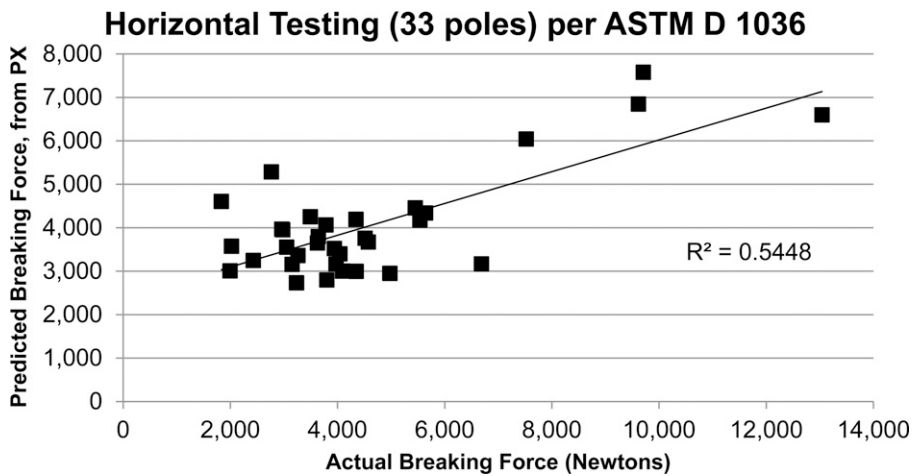
Figure 5. Correlation between actual and predicted maximum bending loads (Newtons) for 33 poles. Only those poles tested in the horizontal pole-testing fixture, per ASTM (2012).
