THE USAGE OF TLS AND PHOTOGRAMMETRY DURING THE RESTORATION PROCESS OF SPANISH NATIONAL MONUMENT

KEY WORDS: TLS, Photogrammetry, Cultural Heritage, Restoration methodology, Vaults restoration, Restoration survey.

Santo Domingo de Orihuela School represents one of the most relevant architectural ensemble of the sixteenth century in the Comunidad Valenciana, not only because of its original plans, but also because of its execution quality. The building was designed by the architect Jerónimo Quijano in 1552 and three quarters of the original plans are preserved, but unfortunately the part where the Refectory is placed today is missing.

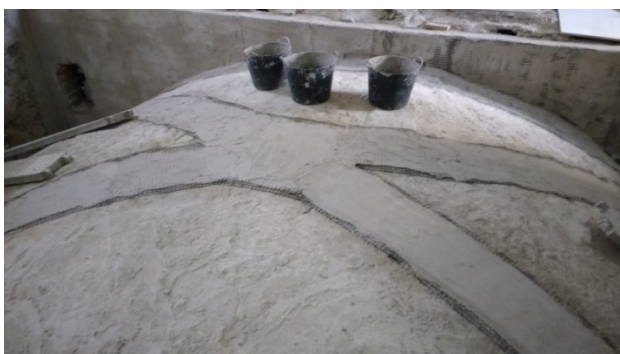
Figure 2: Reinforcement with Planitop HDM and fiberglass Mapei

2.3. The outside wall has been stabilized and consolidated by injecting fluid lime mortar. The existing cracks in vaults and arches have been sealed with special lime mortars, and some stitching with fiberglass rods has been made. For the purpose of binding the walls closing the refectory, steel braces system has been prepared. The vaults extrados has been reinforced using rendering with two-component mortar fiber-reinforced PLANITOP HDM, restoration reinforced with fiberglass mesh from the Mapei brand.

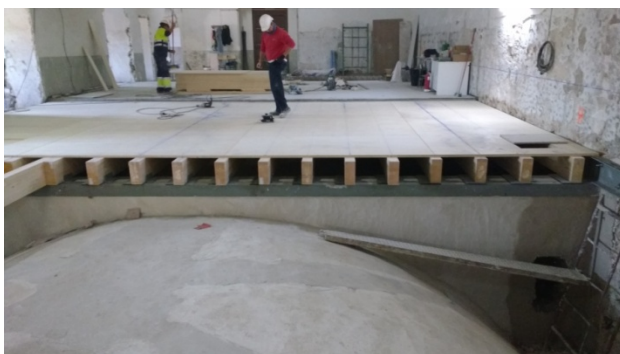
Figure 3: Reinforcement on wall ribs

2.4. Subsequently, we have followed with the placing of the new horizontal half-timbered on the second floor (forged on the refectory) with unidirectional slabs using wooden laminated beams with waterproof double board beam filling and compression layer of 80 mm thickness lightweight concrete with electrowelded lath. Slabs with beams-joists of reinforced concrete carried out in situ are made in the outer area among buttresses. All of them bound on the perimeter by means of reinforced concrete and metal framing, in order to create a lattice on the perimeter binding all the slabs on the arches and walls limits.

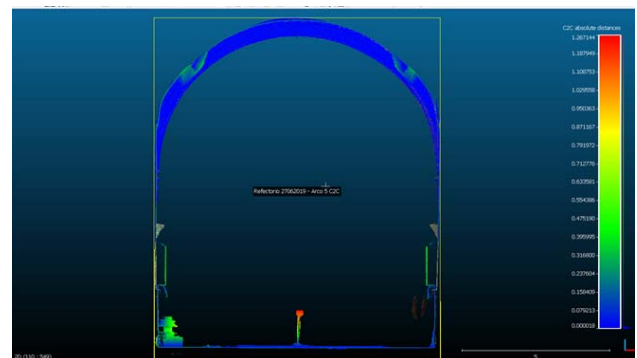
Figure 11: comparing cloud to cloud with Cloudcompare. Deformation study en arch 5
