Computational Simulation of a Femoral Nail Fracture

COMPUTATIONAL SIMULATION OF A FEMORAL NAIL FRACTURE

A Thesis submitted in partial fulfillment of the
requirements for the degree of
Master of Science in Biomedical Engineering

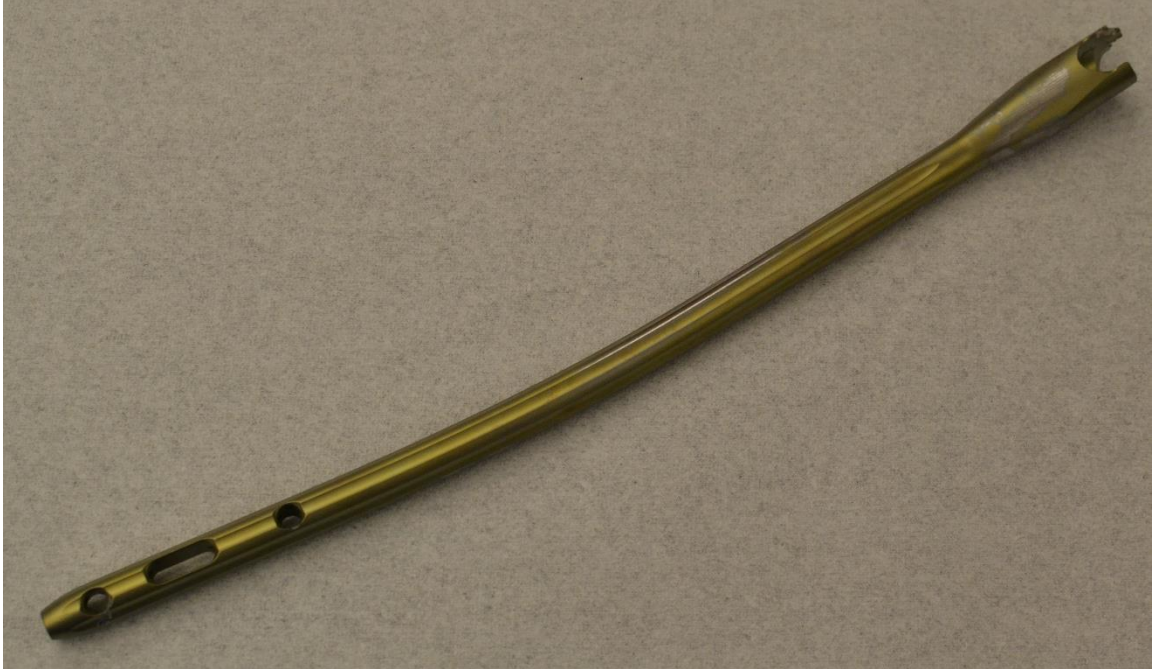
Figure 2.1.1 Distal portion of the failed nail.

It was established that the device was implanted in August of 2017. The patient did not appear to have any issues for about three months. In December of 2017 the patient came in complaining of pain from the fracture site. X-rays showed that the device failed and was surgically removed. The device came into the school's possession in January of 2018. The device was in five separate parts (Figures 2.1.1-2.1.4). The failed nail was in two pieces fractured along the thin walls on the proximal portion. The other three pieces of the device were a self-tapping helical screw and two screws that secured the distal portion of the nail in vivo. Other than the timeframe for the device being in vivo, no other patient information, such as demography and radiological reports, were available for examination.

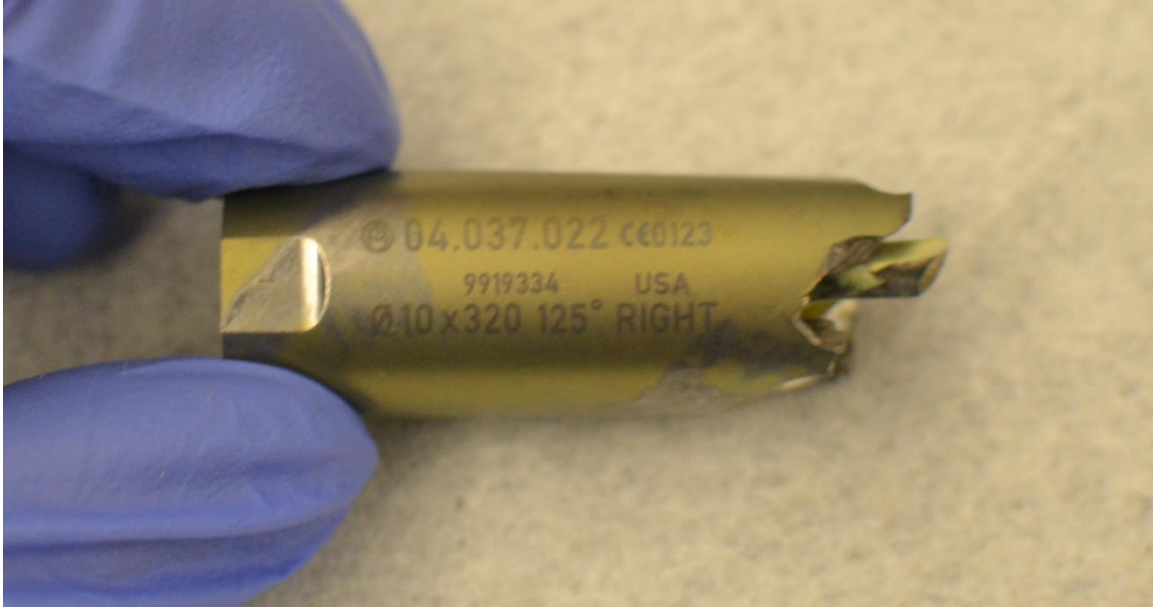
Figure 2.1.2 Proximal portion of the failed nail.

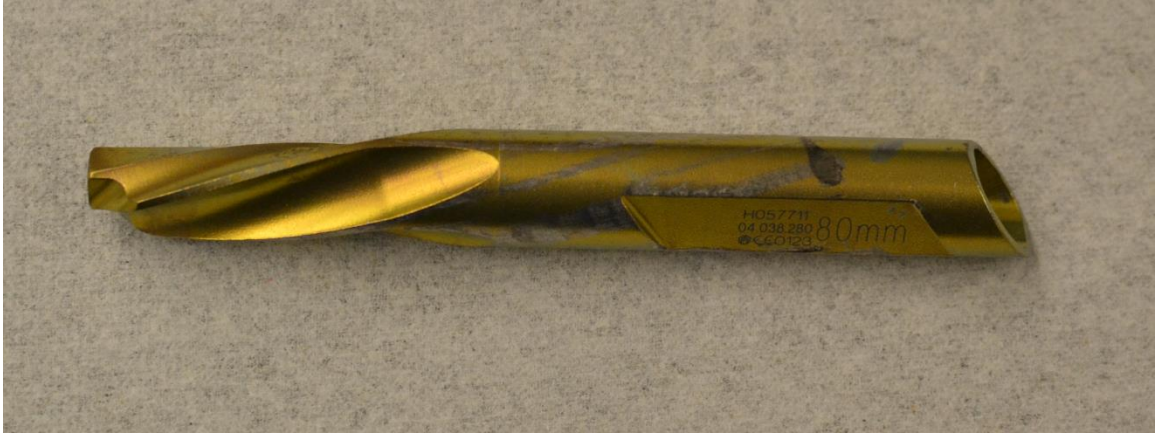
Figure 2.1.3 Self-tapping helical screw.

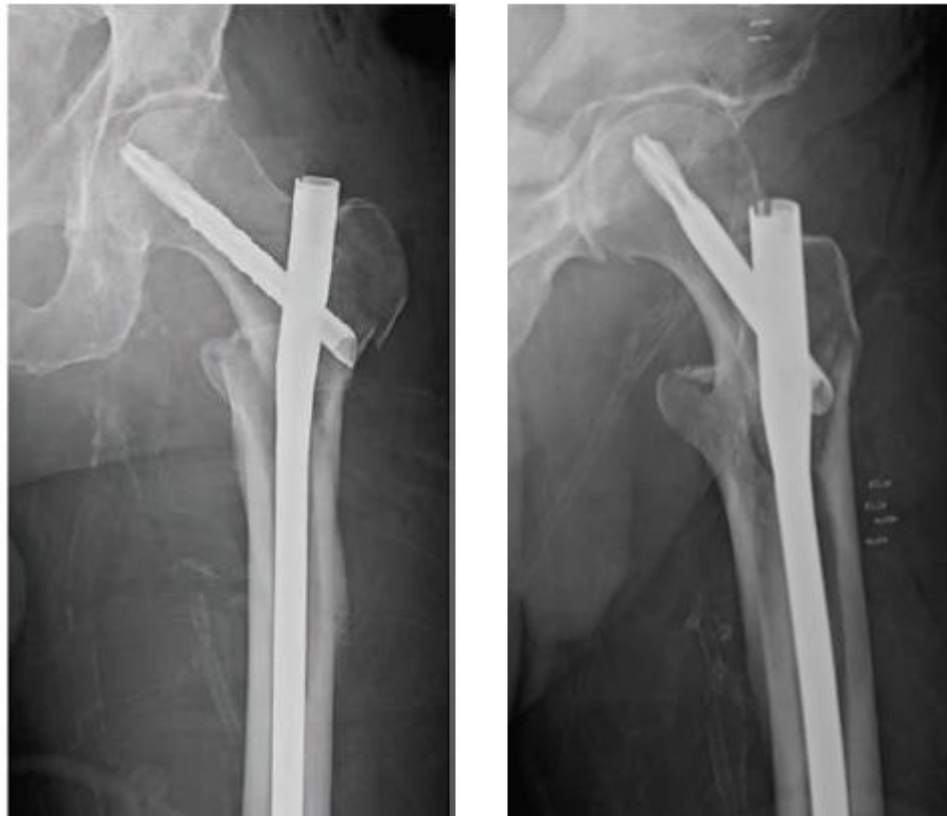
Figure 2.2. Intramedullary nail in vivo. Retrieved from [12]

Internal fixation devices cover a broad spectrum of device types. They can include metal plates, pins, nails, screws, and even wire [59, 6, 11, 1, 19, 3]. The internal fixation device investigated during this project is an intramedullary nail. Intramedullary nails work by being implanted within a fractured long bone and secured with a series of pins and or screws [56, 57] (Figure 2.2.1). The body of the nail provides stability to the long bone while being able help support external weight [17, 55]. These features allow the patient mobility that one could not find using a cast or splint [38]. Following hip replacement surgery today, patients are sometimes able to move on their own in as quickly as the day following surgery.

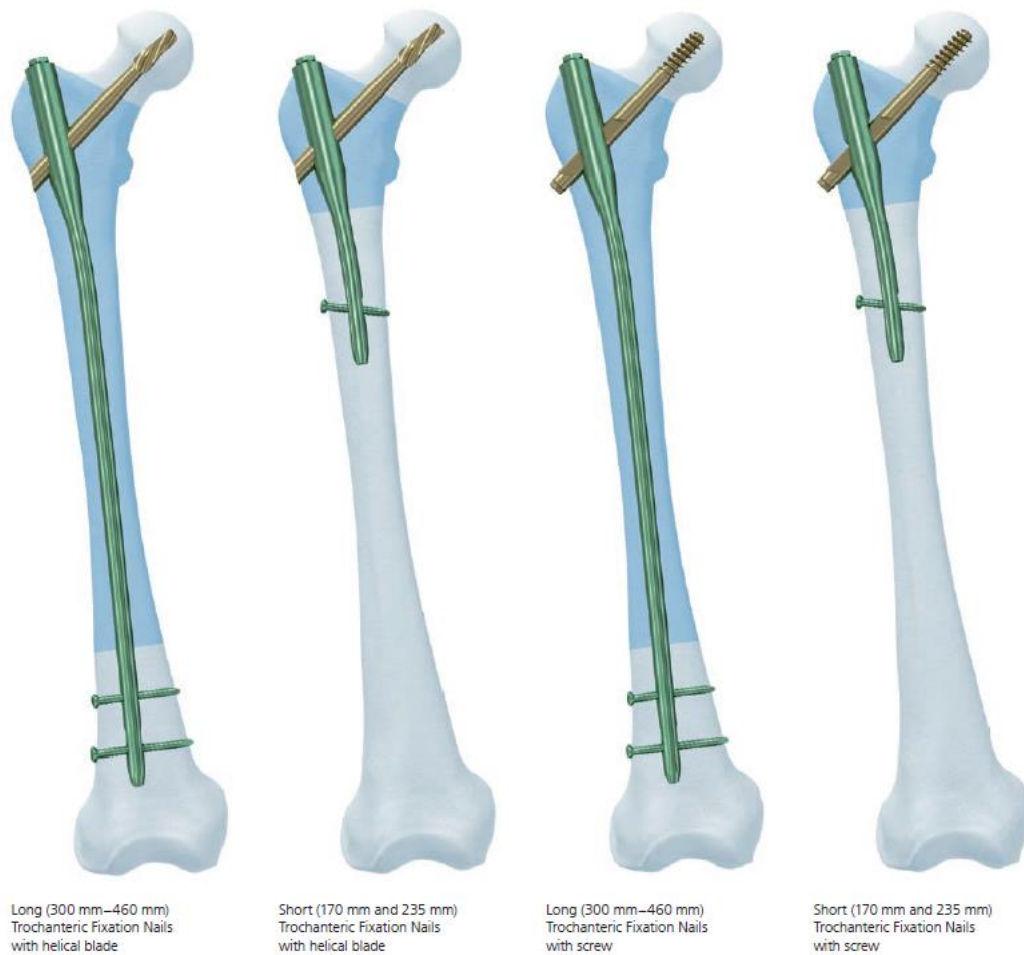
Figure 2.2.2 Different types of cephalomedullary nails. Retrieved from [12].

The specific type of nail we received was a cephalomedullary nail (Figure 2.2.2). What makes this nail different from other types of nail is the use of one or more large self-tapping screws. Unlike other screws, this screw is used only to gain purchase to the bone, these large screws provide load-bearing support to the nail as well as purchase to the bone. The self-tapping screws are inserted through the nail at an angle between 125° - 135° (Figure 2.2.3). The screw cuts into medullary cavity of the femoral head gaining purchase to the bone. The screw is then locked into place and the nail is capped. These screws are what transfer

weight of the body from the head of the femur to the nail body. The failed nail we received was a right side, 10mm diameter by 320mm long nail that mated with 80mm long screw at 125°. The nail was made of the titanium alloy Ti-15Mo and the other device composites were made of the alloy Ti-6Al-7Nb. The failure was in the section where the nail and the self-tapping screw mated.

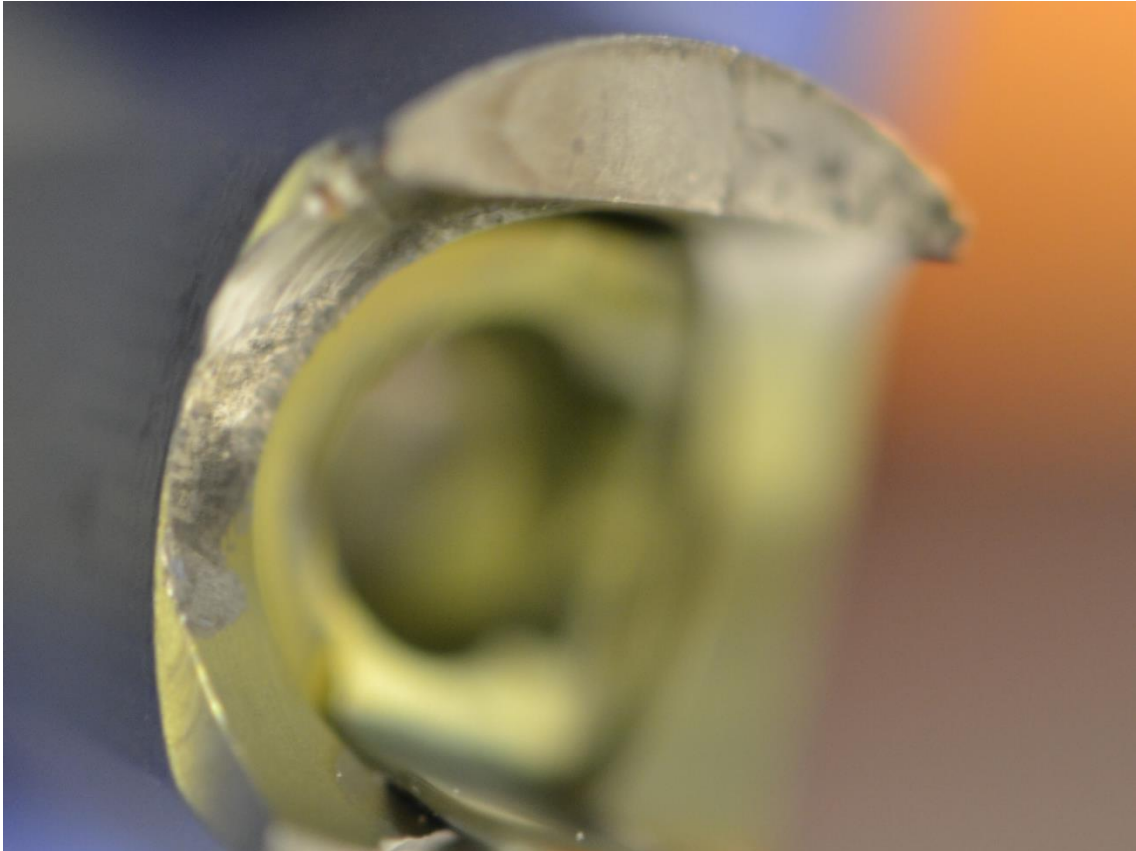
Figure 3.1.1 Close-up photo of the fracture surface.

This project began with a simple visual examination of the failed device. The purpose of doing this was to catalog the parts and find areas of interest for further, more rigorous examination. The parts were visually inspected and photographic evidence was collected. When examining the fractured surfaces of the nail, there appeared to be ripples across the surface moving from one direction to another and transitioned into a rougher looking texture. There was also some discoloration of the metal along the interior surface of the nail (Figure 3.1.1). When examining the self-tapping helical screw, there was also some discoloration on the outer edge of flutes and along the body of the screw (Figure 3.1.2).
