Case Report

Conservation of a Wooden Tomb-Marker from the Jewish Cemetery of Algarrobos in Argentina

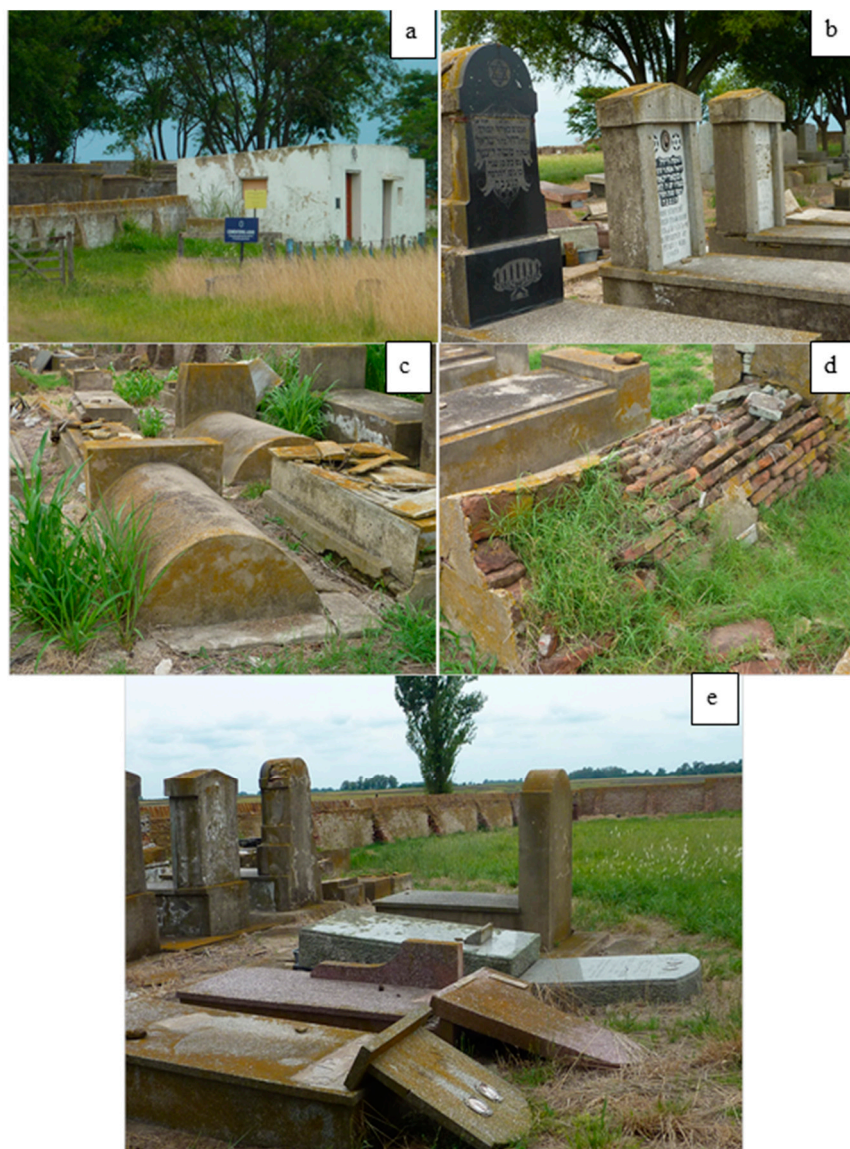
Figure 2. Conditions of the Algarrobo Cemetery: (a) view of the premises located in the front of the cemetery; (b) detail of tombs: stones with marble is observed; (c) view of the sector of the graveyard with tombs built in shape of vault; (d) detail of one of the tombs made with common ceramic bricks; and (e) view of some tombs affected by vandalism and the wall surrounding the cemetery.

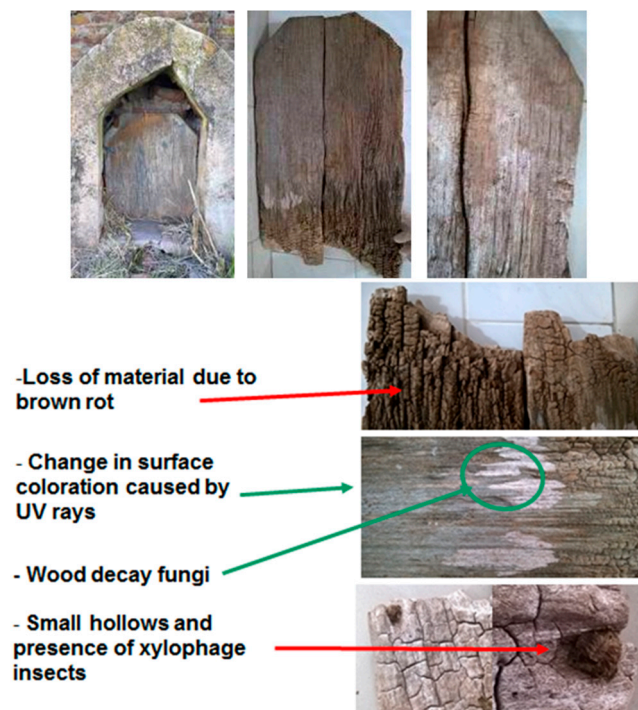
The wood tomb-marker studied was in a state of advanced deterioration; the wood had a major crack that divided it into two parts, as well as other fissures and longitudinal and transverse cracks of lesser magnitude.

In addition, in the lower part there was a loss of material, which was the product of brown rot fungi decay, as well as grey surface coloration caused by exposure to UV rays of sunlight; black rot indicated the deterioration caused by imperfect fungi and small cavities belonging to xylophage insects (see Figure 4). The whole set of pathologies found would justify the loss of structural stability observed, as well as the impossibility of a correct reading of the reliefs and epitaphs

Figure 4. State of deterioration of a wooden tomb-marker, in which there is loss of material and a large biological decay belonging to a decay fungus covering it.

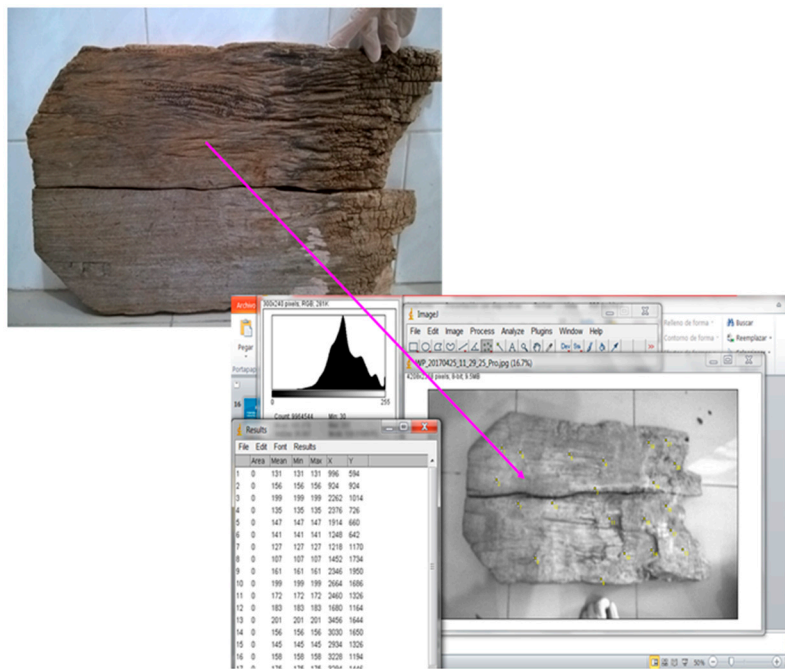
Characterization and measurement of the degree of deterioration of the wood asset were studied using images analyzed with ImageJ software, in order to determine the degree of affection of the wood to be treated. The measurement is according to grey's difference: the lighter wood represents greater degradation relative to the whole piece. The result was that the wood had a 60% material degradation (see Figure 5).

Figure 5. Determination of wood degradation using ImageJ analysis.

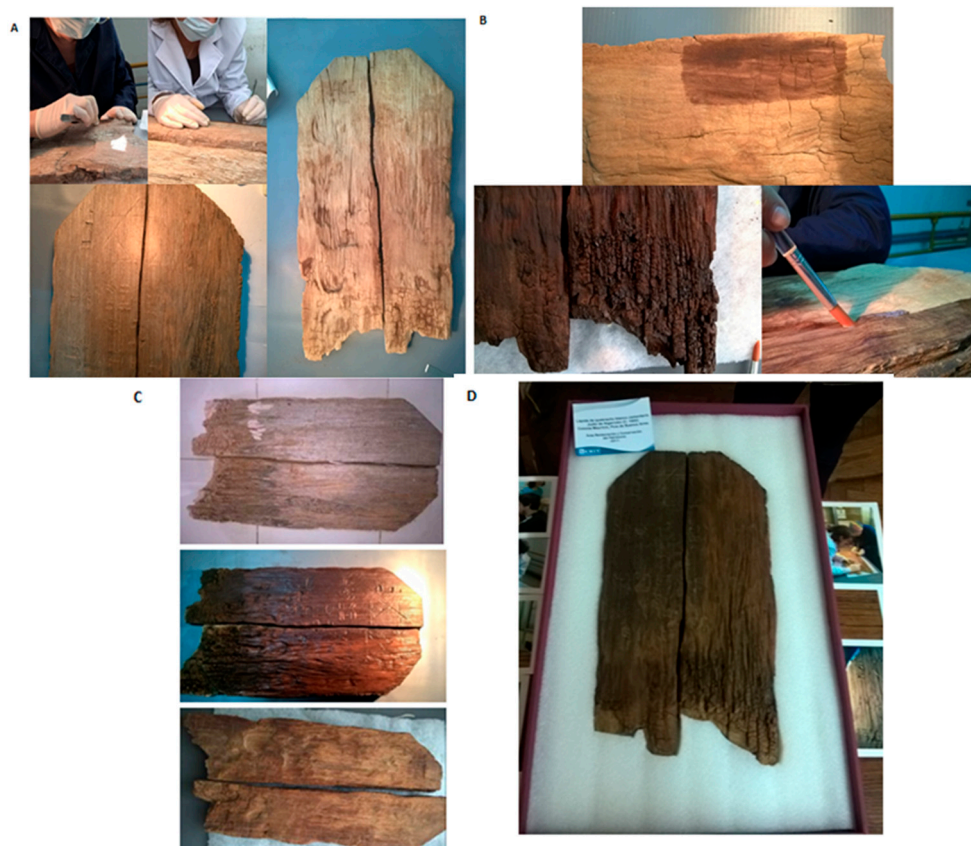
In order to conserve and consolidate at the beginning of the enhancement of tomb-markers, the appearance of the wood changed radically, with only a removal of superficial environmental impurities. After cleaning, protective system was applied. It was an impregnant treatment that penetrated deeply without forming a film or occluding natural hollows of the wood (see Figure 6A,B).

As a main result, rehydration was observed, generating an improved aesthetic appearance, as well as the sealing the cracks and micro cracks. In addition, the structural consolidation of the part most compromised by the brown rot mentioned was observed. Altogether, this allowed one to observe the detachment of material and the appearance of natural veins. In addition, an improvement in the reading of the epitaphs and reliefs was achieved (see Figure 6C,D).

Figure 6. Appearance of a tomb-marker in different stages of conservation: (A) cleaning; (B) treatment application; (C) the difference between the wood condition when it was collected and when it was treated (in order **up** and **down**); and (D) the tomb-marker finished and packed to be given to the Municipality.

Cleaning and surface preparation was carried out with the traditional methods of cleaning, and surface preparation was used, generating a soft abrasion and tow. The cleaner formulation was applied with semi dry oakum, rubbing softly to remove surface dirt. The tow was only used for the removal of environmental fungi deposited on the surface (mold, imperfect, etc.). The cleaning procedure was applied on one of the faces, leaving it stationary for 4 days. Then, the same technique was applied on the other side of the tomb-marker, since the latter had graffiti and epitaphs.

- (i) In the first application, the above-defined protective formulation was diluted with turpentine 50/50% *v/v* formulation/turpentine.
- (ii) The following two successive applications were (1) the formulation diluted 25/75% *v/v* formulation/turpentine and (2) protective formulation without dilution.
- (iii) The face of the tomb-marker without graffiti and epitaphs was first exposed to treatment. The drying time between the applications was 24 h. Once the treatment of the face was completed, it was exposed to the seven day drying phase before the treatment of the other face was started. The treatment of the face with graffiti and epitaphs was done in accordance with the same methodology.
- (iv) Finally, the tomb-marker was exposed to controlled conditions of temperature and humidity for three weeks to allow correct curing (sol-gel).

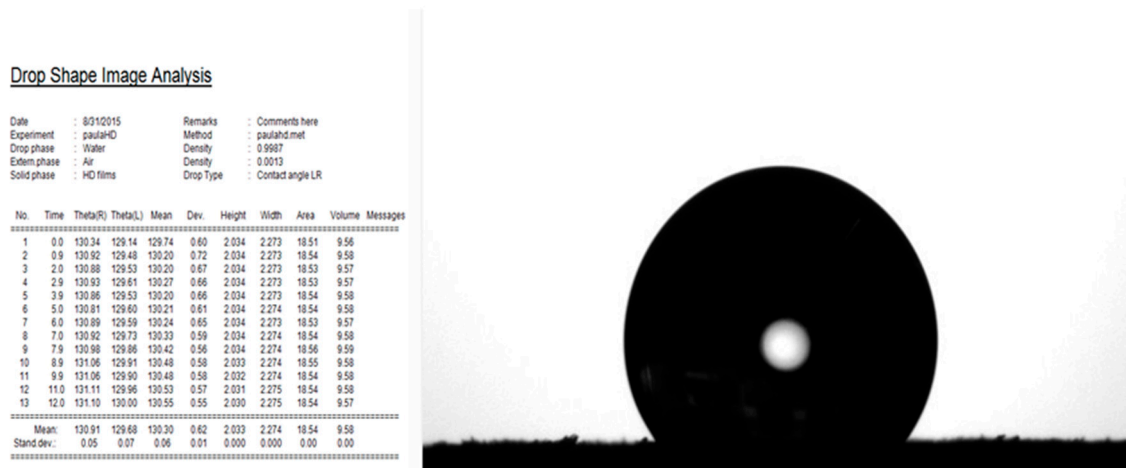
The contact angle measurement was 130° , which translates into a hydrophobic material, verifying greater water repellency of the treatment (see Figure 7).

Figure 7. Results of the contact angle test, which demonstrates the hydrophobicity of the treatment.
