# Structural Monitoring System for proactive detection of corrosion and coating failure

Jawwad Latif<sup>1</sup>, Zulfiqar A Khan\*<sup>1</sup>, Keith Stokes<sup>2</sup>

<sup>1</sup>Bournemouth University, Department of Design and Technology, NanoCorr Energy and Modelling (NCEM) Research Group

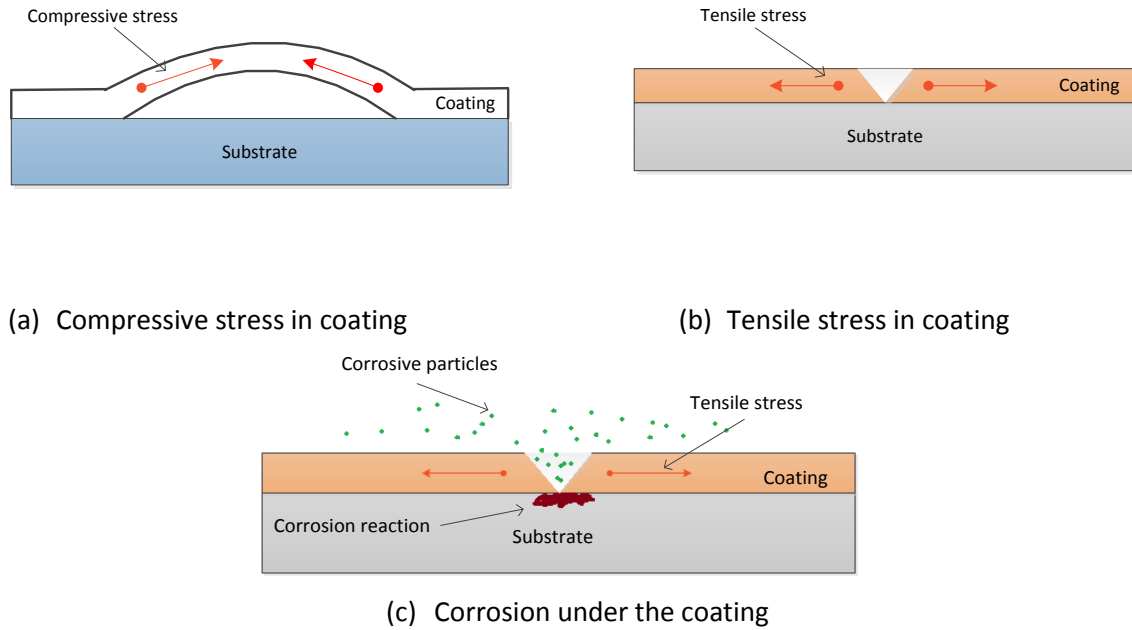
Figure 1 Coating failure and corrosion phenomena

The residual stresses within the coating-substrate system are one of the major factors for coating failure in the form of blistering and micro-crack opening as shown in Figure 1. The stresses could be tensile and compressive depending on material properties and temperature gradient. According to past experimental study, the coefficient of thermal expansion (CTE) property of coating and substrate is responsible for the occurrence of tensile and compressive stresses, depending on change in temperature [2]. The tensile stress opens the cracks on the coating and allows corrosive particles to diffuse into the coating-substrate interface, subsequently resulting in corrosion under the coating as shown in Figure 1. The compressive stresses control the number of corrosive particles which diffuse through the coating due to contraction and they can also generate blisters if they exceed a critical level [6]. Several methods are applied to measure residual stresses which are characterised as Non-destructive, Semi destructive and Destructive techniques [16]. X-ray diffraction, Neutron diffraction, Ultrasonic and Barkhausen noise methods lie within the Non-destructive category. Hole-drilling, Ring core and Deep-hole methods are semi-destructive techniques while Sectioning and Contour methods are destructive techniques used for residual stress measurement.

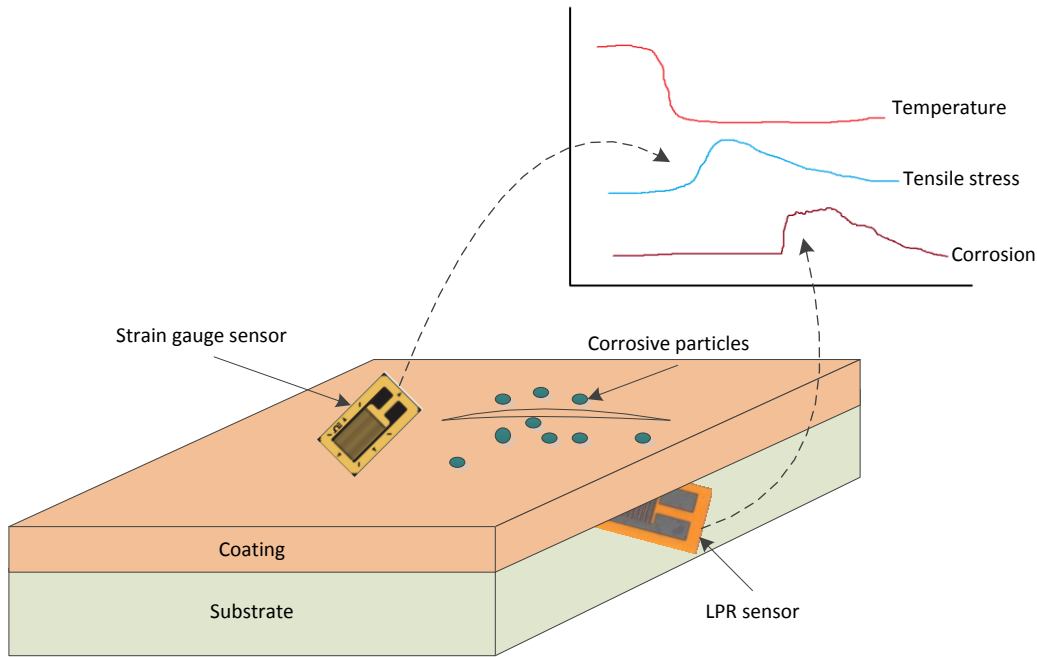
Figure 2 Proposed structural monitoring system

The Tank Museum, Bovington, Dorset is located near the English Channel in Dorset where large military vehicles are exhibited and operated for various purposes. The presence of high amounts of salt particles in the atmosphere combined with wind speed, rain, relative humidity and temperature are causing a potential threat to their structural integrity. It has been established in the literature that the stresses within a coating control the compression and opening of micro-cracks that allows corrosive salt particles to diffuse into the interface of coating and substrate [2, 10]. The proposed system monitors the mechanical and chemical changes through  $\mu$ -strain gauge and  $\mu$ LPR sensors. The  $\mu$ -strain gauge sensors are used to monitor the behaviour of stresses over the coating due to change in temperature, whilst the  $\mu$ LPR sensors are used beneath the coating to monitor any corrosion reactions that occur due to the diffusion of salt particles through micro-cracks. The proposed structural monitoring system is shown in Figure 2.

Consider a coating-substrate system where the applied coating has a higher value of coefficient of thermal expansion than the substrate. In past studies, It was observed that when the temperature drops, the coating tries to shrink but the substrate, having the lower value of coefficient of thermal expansion (CTE) restricts contraction of the coating. As a result the coating experiences tensile stress which opens the crack and allows corrosive particles to diffuse through [2], as shown in Figure 2. As stated, the current sensor suite contains temperature, strain and  $\mu$ LPR sensors, where the temperature sensor monitors change in temperature, the strain gauge monitors the development of residual stresses and the  $\mu$ LPR sensor detects any corrosion reaction. The complete structural monitoring system consists of a terminal unit with various sensors and software at a remote base station.

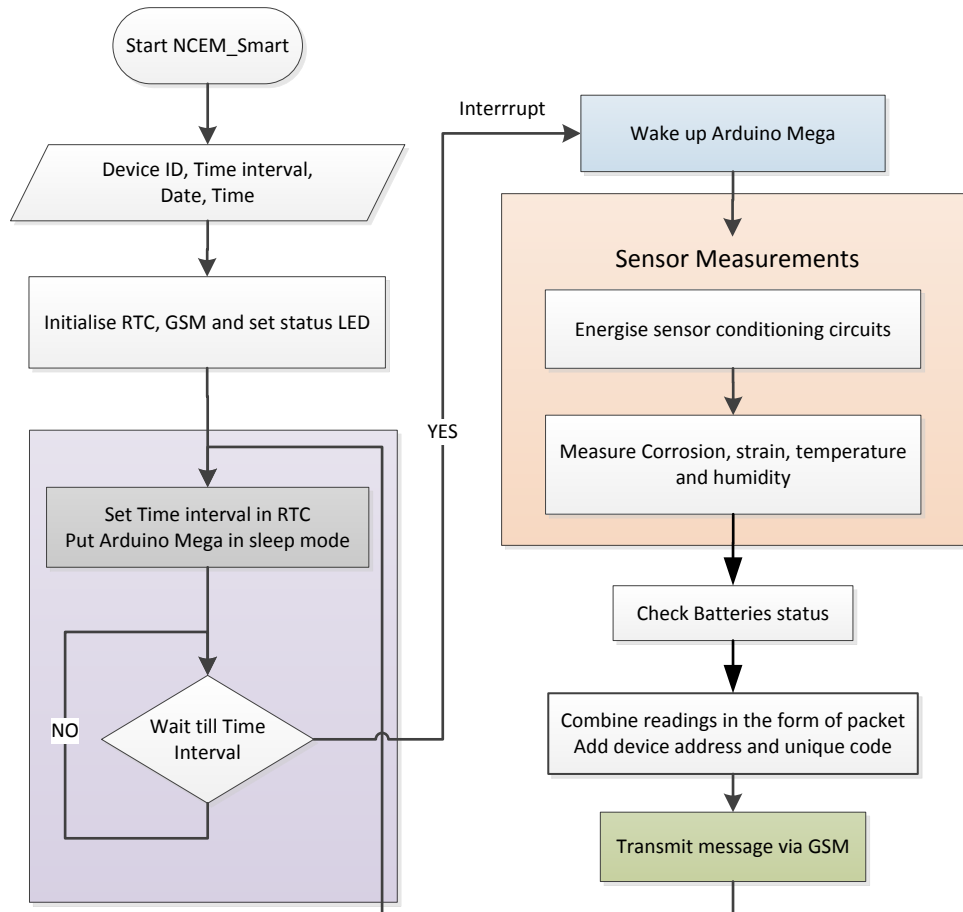
Figure 3 Flowchart for RTU

Large metal structures are comprised of large and complex geometrical configurations, therefore various types of sensors are required at critical locations on the structure. Arduino Mega 2560 Rev3 is used to develop the remote terminal unit (RTU). The Arduino boards are an open source and programmable electronic circuit board which consists of microcontroller. It can be programmed using Integrated Development Environment (IDE) software to design customise embedded systems for various applications. The RTU has various channels for corrosion, strain gauge, temperature and humidity sensors. The architecture of RTU is described through the flow chart in Figure 3.

The RTU must be synchronised with the current time and date. The interval between data sampling is adjusted depending on the sensitivity and environmental conditions of the structure. The external Real Time Clock (RTC) is embedded within the Arduino Mega 2560 Rev3 and adjusts the time interval for activating the sensors for measuring and transmitting data to the base station. The Global System for Mobile communications (GSM) is used for wireless transmission and allows both stationary and mobile structures to be monitored.

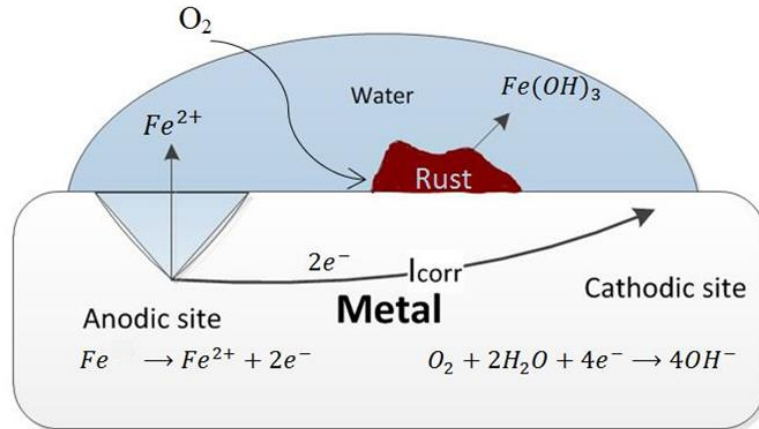
Figure 4 Corrosion reactions

~~The corrosion reaction occurring on steel in the presence of water is shown in the Figure 4.~~

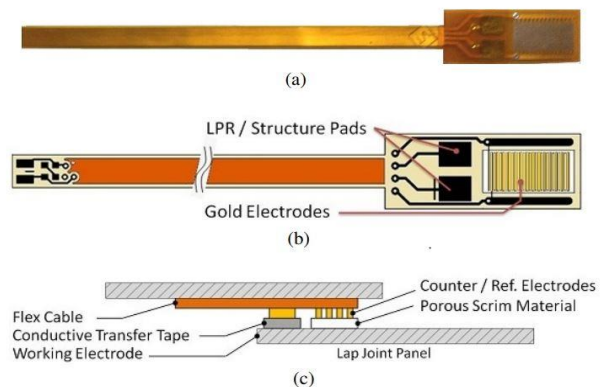
Figure 5 Structure of  $\mu$ LPR sensor [13]

The  $\mu$ LPR sensor is based on three electrode system theory and includes working, counter/auxiliary and reference electrodes. The working electrode is in electrical contact with the structure to be monitored and acts as the anode. The counter electrode completes the circuit and acts as the cathode. The reference electrode has a stable known potential. The basic architecture of the  $\mu$ LPR is shown in Figure 4. The  $\mu$ LPR sensor developed by ANALATOM as shown in Figure 5 has been utilised for corrosion detection in the current work and has been previously discussed [13].

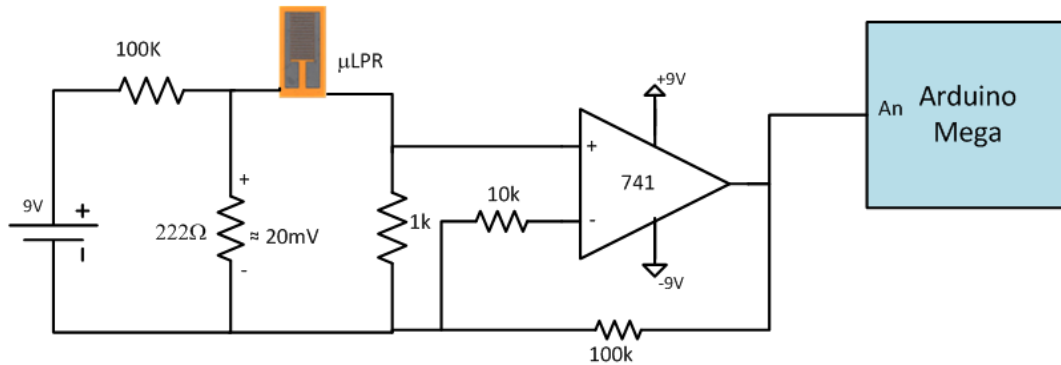
Figure 6 Electronic circuit for  $\mu$ LPR sensor

Figure 6 shows the electronic circuit for a  $\mu$ LPR sensor that is connected to the Arduino Mega. Corrosion occurring on the sensor causes a change in resistance which then results in a change in voltage. As the magnitude of voltage is very low, it requires amplification and this is achieved using the IC-741. The gain can be calculated using the following relationship:

$$G = 1 + \frac{R_f}{R} \quad \text{IV}$$

Where the value of  $R_f = 100k$  and  $R = 10k$ , respectively. The measured voltage is converted into corrosion current using mathematical relations programmed in the Arduino Mega.

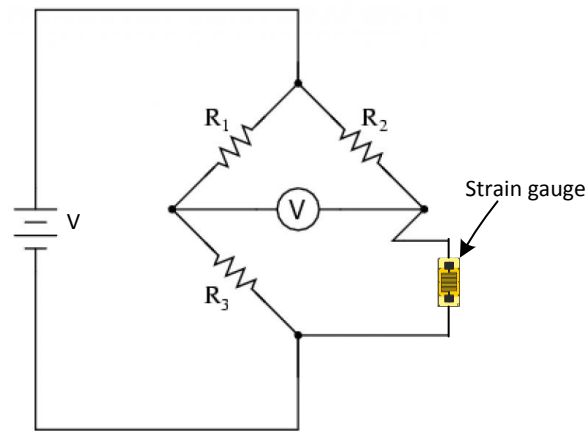
Figure 7 Wheatstone bridge with strain gauge sensor

gauge into a Wheatstone bridge which is used to determine the unknown resistance in the electrical circuit. The circuit diagram of the strain gauge connected into the Wheatstone bridge is shown in Figure. 7. The data acquisition unit contains a Wheatstone bridge and a strain gauge is connected in a quarter bridge configuration.

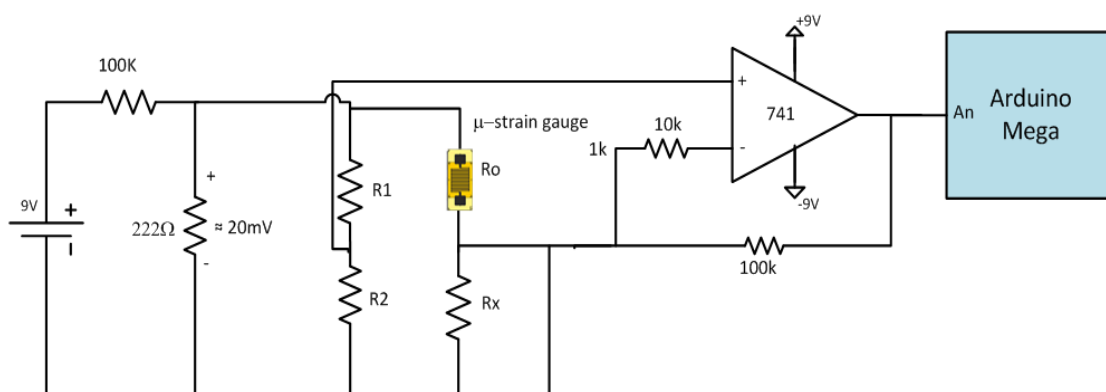
Figure 8 Electronic circuit for  $\mu$ -strain gauge sensor

Figure 8 show the electronic circuit for a  $\mu$ -strain gauge sensor that is connected to the Arduino Mega. The change in strain causes a change in resistance, which then results in a change in voltage level. The magnitude of the current is very low; therefore it is amplified using the IC-741. The  $\mu$ -strain gauge sensor is connected as a resistance within the Wheatstone bridge and it follows the following relationship:

$$\frac{R_1}{R_2} = \frac{R_0}{R_x} = 1 \quad \text{V}$$

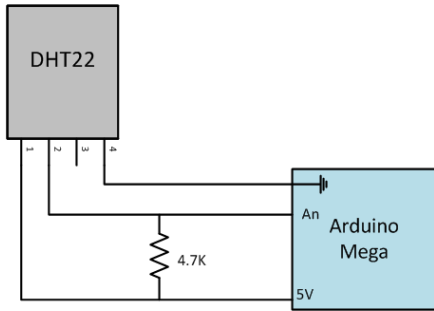
Figure 9 Electronic circuit for DHT22 sensor

The DHT22 sensor as shown in Figure 9 is used for temperature and humidity measurements. The RTU also monitors battery life using the electronic circuit shown in Figure 10.

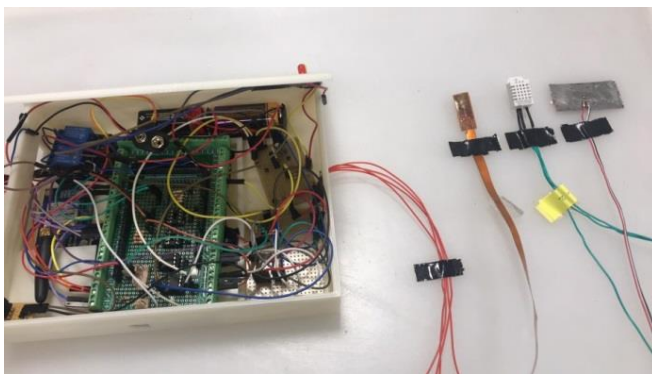
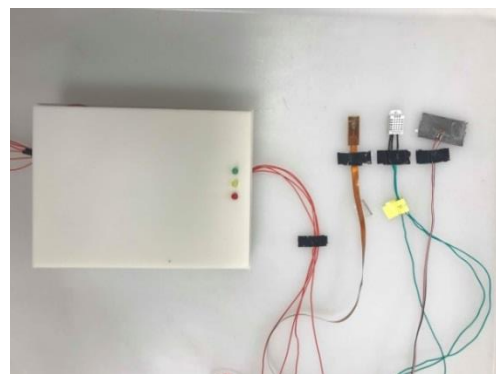
Figure 12 RTU system with sensors

(a) Internal view

(b) External view

The RTU transmits the data packet to the remote base station with all required information as shown in Figure 11. A unique code acts as an address for the device and validation of the message from the RTU. It also contains date and time stamps associated with the sensor measurements. The complete RTU system is shown in Figure 12.

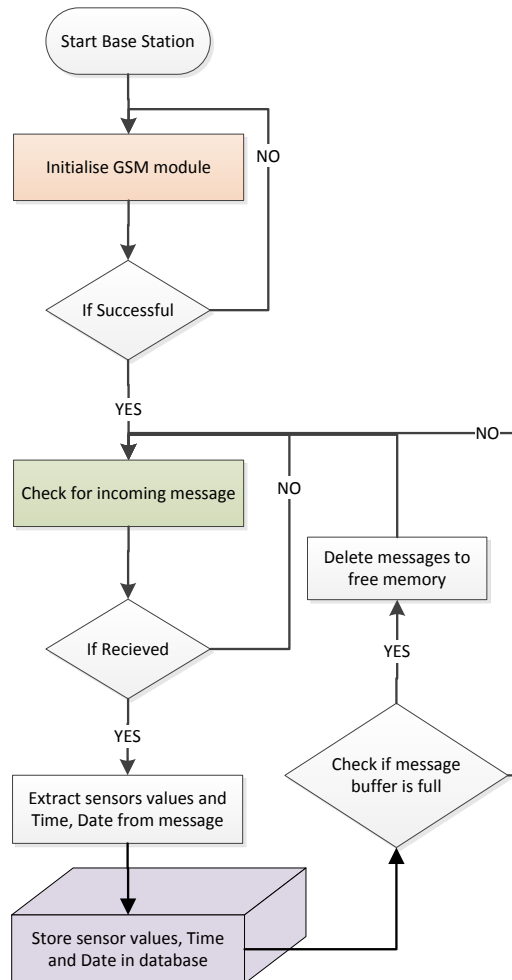
Figure 13 Flow chart for Base Station

The software at the base station is configured to the GSM module in order to communicate to the RTU's. The flow chart shown in Figure 13 demonstrates how the base station receives a data packet from the RTU and processes them for further analysis. The information is extracted from the data packet one by one and operations are performed accordingly. It starts by identifying the structure

using a unique address of RTU. The sensor values associated with time and date are extracted and stored in the corresponding database of the structure. The threshold for any critical value can also be defined to show live critical status on the Graphical User Interface. The complete system at the base station which contains software and GSM is shown in Figure 14.

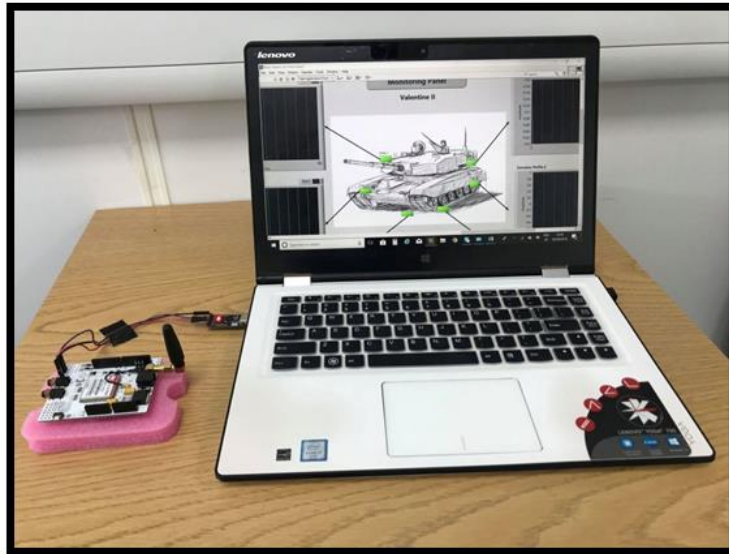
Figure 14 Base station system

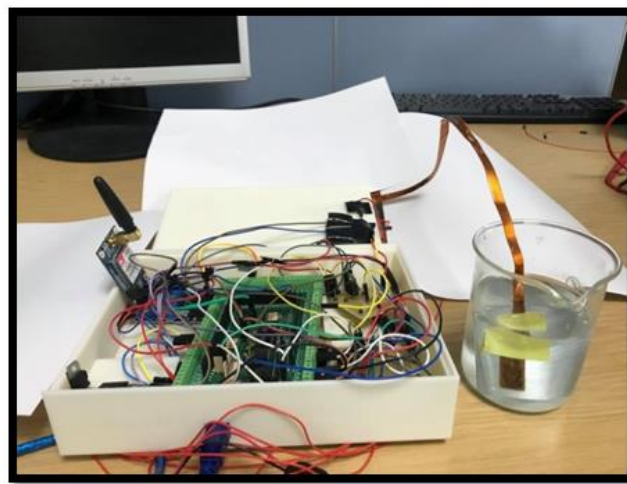
Figure 15 Inserting a corrosion sensor in salt solution to validate the corrosion detection

In order to verify the wireless communication and response of the sensors, the system was repeatedly tested in salt solution and an accelerated corrosion environment inside the laboratory as shown in Figures 15 and 16. The salt spray chamber provided an accelerated corrosion environment using salt solution. The sensors were kept inside the chamber and the response of these sensors and the wireless communication was monitored at the base station.

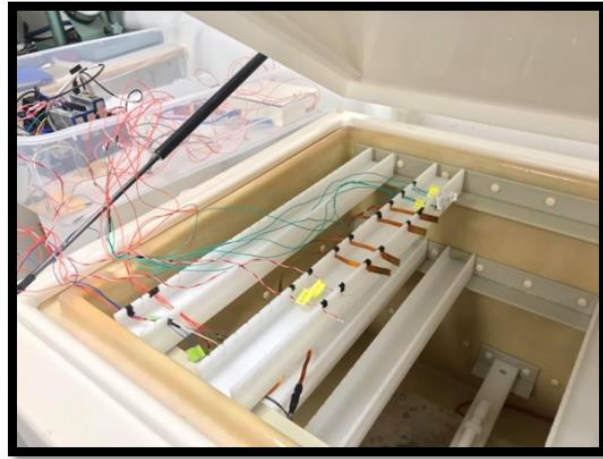
Figure 16 Sensors inside the salt spray chamber

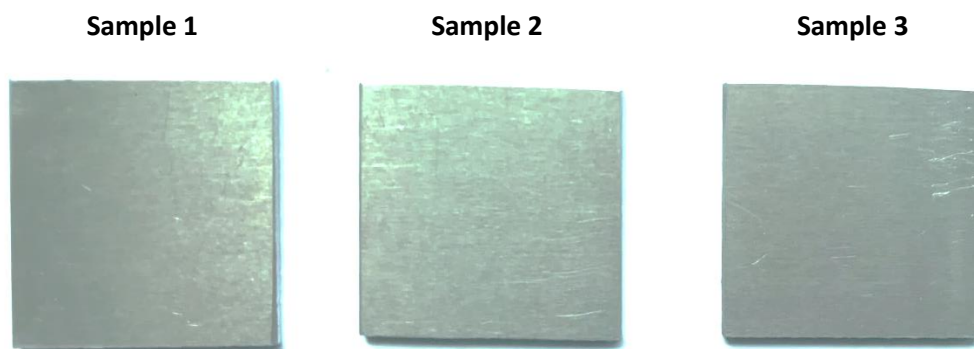
Figure 17 Samples after polishing

The interfaces of the aluminum 6082 samples were polished with an emery paper of 80 grit size and are shown in Figure 17. The samples were washed with deionised water following polishing. The roughness of the interfaces after polishing was measured at 8 different points using Optical Interferometry. The average roughness of each sample is given in the Table 1.

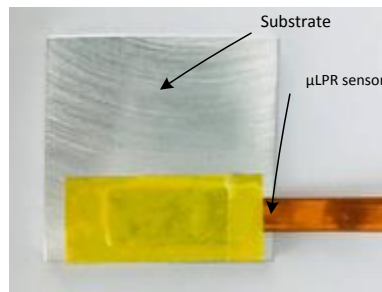
Figure 18 Sample with  $\mu\text{LPR}$  sensor

The  $\mu\text{LPR}$  sensor, with dimensions 40mm x 20mm x 0.1mm, was then attached to the sample interface ensuring electrical contact to the working electrode of  $\mu\text{LPR}$  sensor. Adhesive tape was used to keep the  $\mu\text{LPR}$  sensor in place before the coating is applied, as shown in Figure 18. The  $\mu\text{LPR}$  sensor is connected to the RTU which converts the electrical signals into digital signals and forwards the data to the base station.

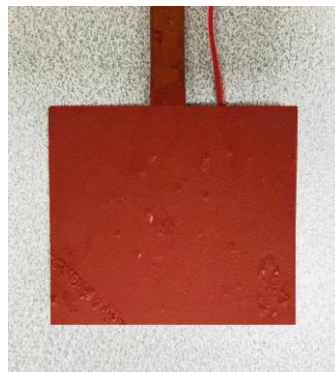
Figure 19 Coated sample with  $\mu\text{LPR}$  sensor

The red oxide primer, with a coefficient of thermal expansion of  $21 \times 10^{-6} \text{K}^{-1}$  and a Modulus of Elasticity of 6.14 GPa, was applied on the sample with a conventional spray gun at a temperature of 300K. The coated sample was allowed to dry for 24hrs before the next coating was applied. The red oxide primer was applied three times and completely covered the sample as shown in Figure 19.

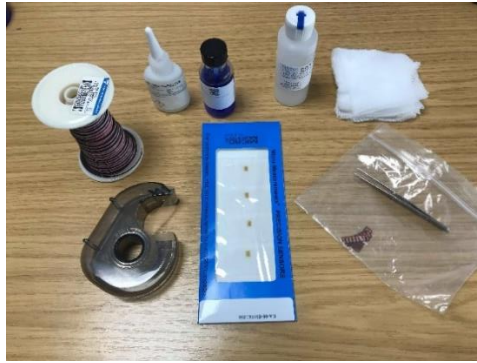
Figure 20 Accessories for installation of  $\mu$ -strain gauge sensor

After applying the primer, the  $\mu$ -strain gauge sensor was installed on top of the sample as shown in Figure 20. This requires careful placing, sticking and soldering of its terminal with wires. The coated sample with the attached  $\mu$ -strain gauge sensor is shown in Figure 21.

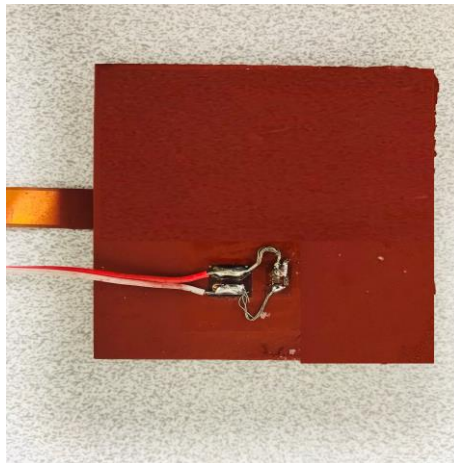
Figure 21 Sample with  $\mu$ -strain gauge sensor

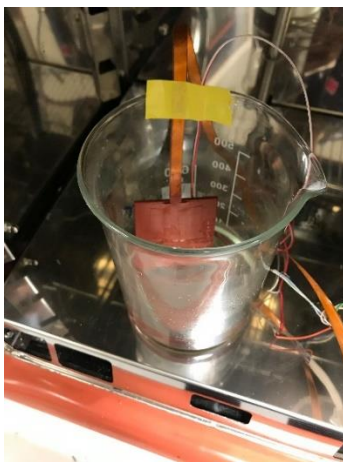
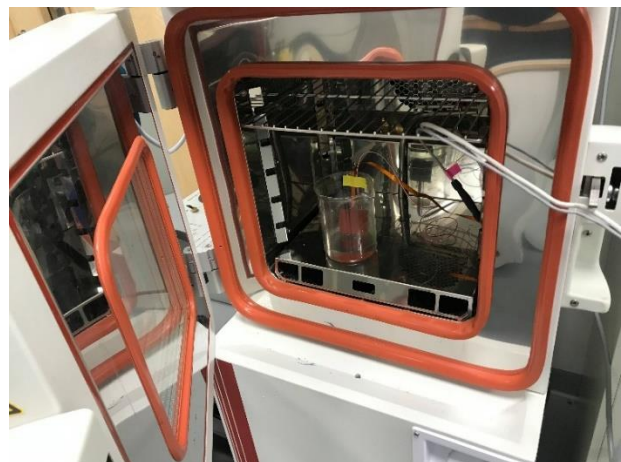
Figure 22 Sample inside environmental chamber

A series of experiments were performed in an environmental chamber which provided harsh environmental conditions. The sample was immersed in 10% salt solution except where the  $\mu$ -strain gauge sensor was attached in order to avoid short circuit problem. The sample along with sensors inside the environmental chamber is shown in Figure 22.

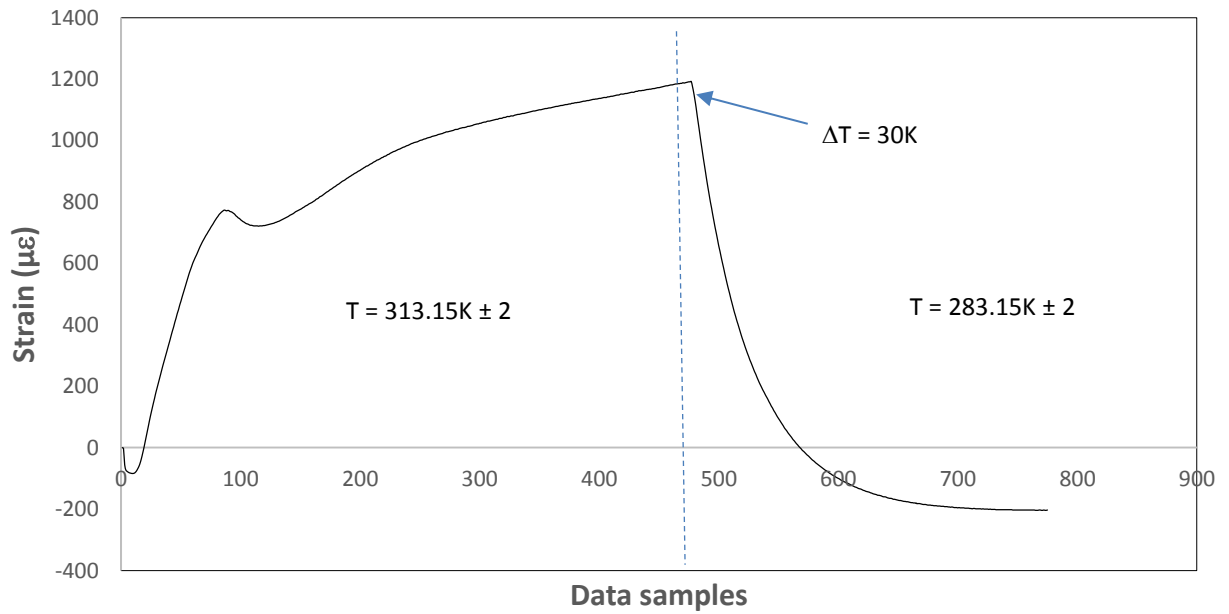
Figure 23 The measurements of  $\mu$ -strain gauge sensor during 1<sup>st</sup> experiment

Various experiments have been performed to validate the response of the proposed RTU system with  $\mu$ LPR and  $\mu$ -strain gauge sensors. The stress/strain behaviour was observed by providing small and large temperature gradients. In the first experiment, the sample was kept in solution to detect the corrosion reaction under the coating and the development of stresses was observed by providing a large temperature gradient. The sensor measurements were recorded continually with a 30s interval for strain monitoring and 1 min interval for monitoring any corrosion development. The experiment was started at a temperature of  $313.15 \pm 2\text{K}$  and after 3hrs the temperature was decreased to  $283.15 \pm 2\text{K}$ . It was observed that the tensile strain/stress continued to increase as the temperature was raised from room temperature to  $313.15 \pm 2\text{K}$ , as shown in Figure 23. The initial value of strain recorded was considered as being an offset that was produced during the application of the sensor. This offset value was deducted from subsequent strain measurements in order that the initial measurement started from zero on the graph. The value of tensile strain started from  $0\mu\epsilon$  and reached a maximum of around  $1200\mu\epsilon$ . When a large negative temperature gradient of  $\Delta T = -30\text{K}$  was applied, the  $\mu$ -strain gauge sensor experienced compressive strain and a very sharp change in the behaviour of sensor measurements were observed from around  $1200\mu\epsilon$  to  $-200\mu\epsilon$ . The  $\mu$ LPR sensor under the coating detects the corrosion reaction and. In the absence of corrosion, it recorded a maximum linear polarisation resistance of  $5\text{x}e^6$ . The sensor face connected to the substrate acts as the working electrode. The resistance decreases in the presence of corrosion in the substrate. The results presented in Figure 24 show the detection of the corrosion reaction as the sample was dipped into the salt solution. The detection of corrosion also confirms the weak coating barrier due to the presence of micro-cracks that allowed the salt solution to penetrate.

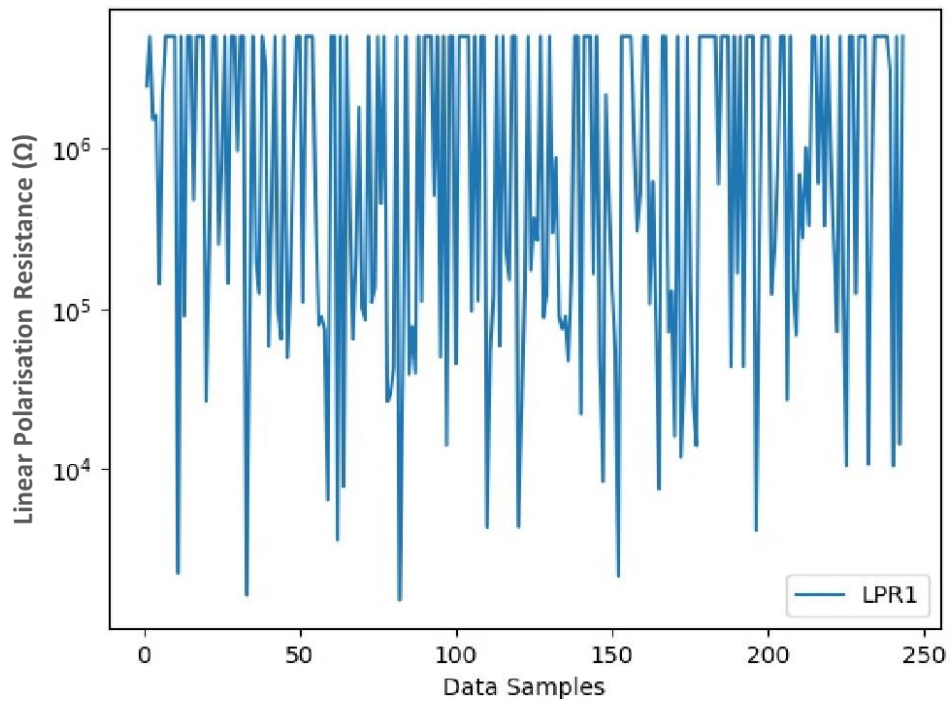
Figure 24 The measurements of  $\mu$ LPR sensor during 1<sup>st</sup> experiment

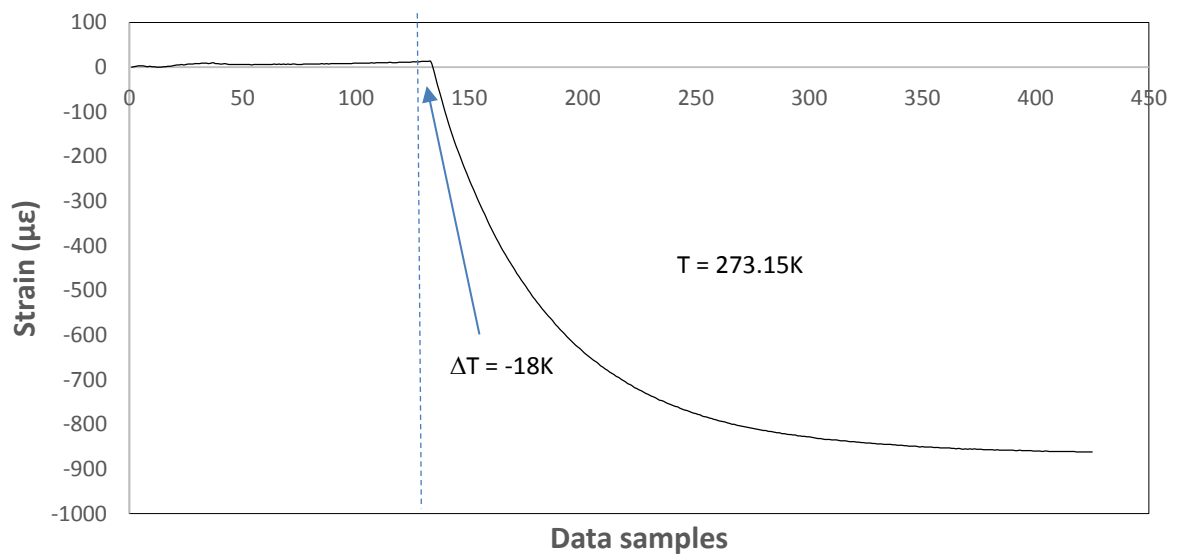
Figure 25 The measurements of  $\mu$ -strain gauge sensor during 2<sup>nd</sup> experiment

In the second experiment, a negative temperature gradient was applied, although the gradient was low when compared to the previous experiment. The strain measurements recorded during the second experiment are presented in Figure 25. Initially, the environmental chamber was set at room temperature for 30mins and there was no significant change in strain as measured by the  $\mu$ -strain gauge. When a negative temperature gradient of  $\Delta T = -18\text{k}$  was applied, a compressive strain developed, which decreased from  $0\mu\epsilon$  to  $-900\mu\epsilon$ . In addition, a sample was kept out of the salt solution for the initial 30 mins in order to observe if any corrosion occurs under the coating in the absence of the salt solution. No significant corrosion was detected in these first 30 mins, as shown in Figure 26. Corrosion on the substrate under the coating did start as the sample was dipped into solution, as shown by the decrease in linear polarisation resistance.

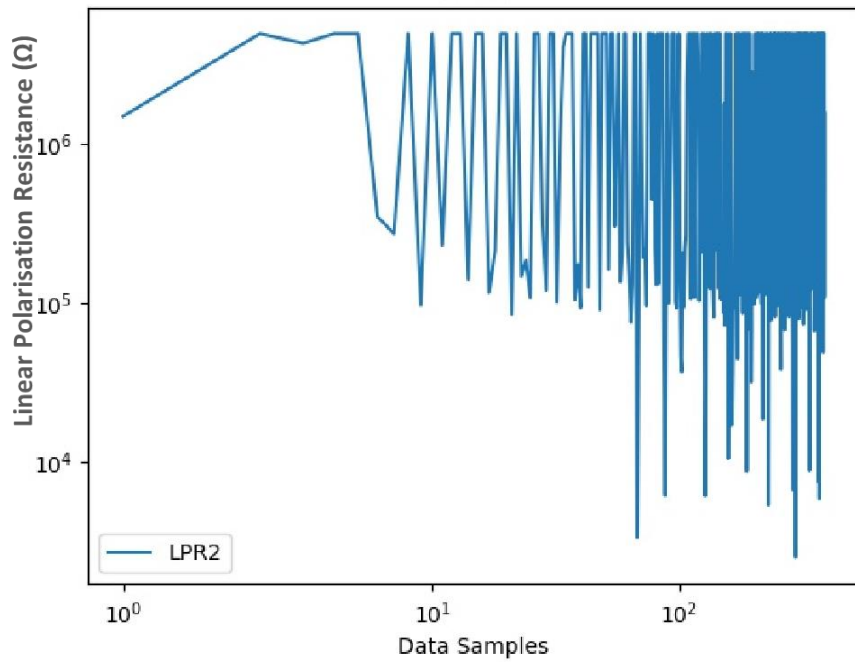
Figure 26 The measurements of  $\mu$ LPR sensor during 2<sup>nd</sup> experiment

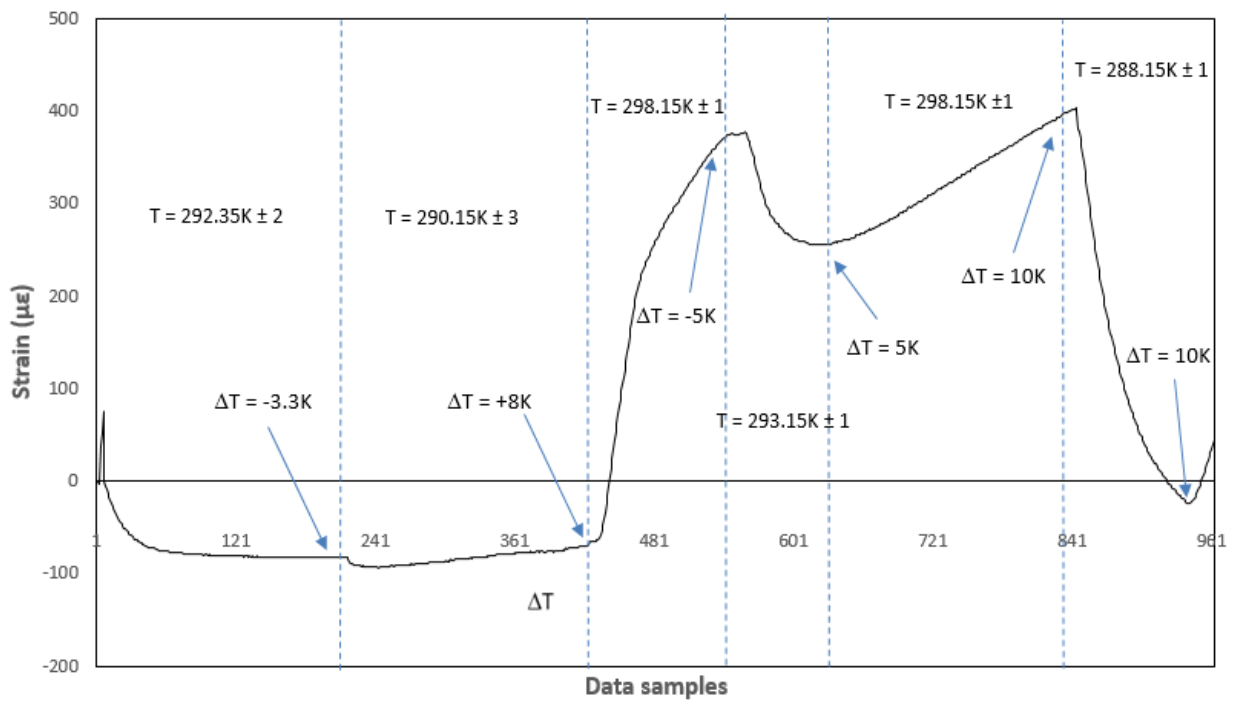
Figure 27 The measurements of  $\mu$ -strain gauge sensor during 3<sup>rd</sup> experiment

In the third experiment, the temperature gradient was applied in both the positive and negative directions including a small variation in temperature gradient, as shown in Figure 27. The initial temperature of  $292.35 \pm 2\text{K}$  produced a compressive strain and a small temperature gradient of  $\Delta T = -3.3\text{K}$  can also be observed, which is resulted in a slight increase in compressive strain. The temperature was increased after 2.8hrs which resulted in tensile strain and the value of strain increased. The corrosion showed interesting behaviour which can be linked with the development of stresses within the coating, based on literature [2, 21]. During the negative change in temperature during the first 2.8hrs of the experiment, the corrosion detected was low when compared to that observed after 2.8hrs, which had the highest corrosion rate throughout as shown in Figure 28. It was concluded that the negative temperature during the cycle before 2.8hrs resulted in compressive

stresses within the coating which reduces the diffusion of the salt solution. The positive temperature gradient of  $\Delta T = 8K$ , however, resulted in tensile strain which expanded the micro-cracks within the coating and allowed greater diffusion of salt solution which resulted in a high corrosion rate.

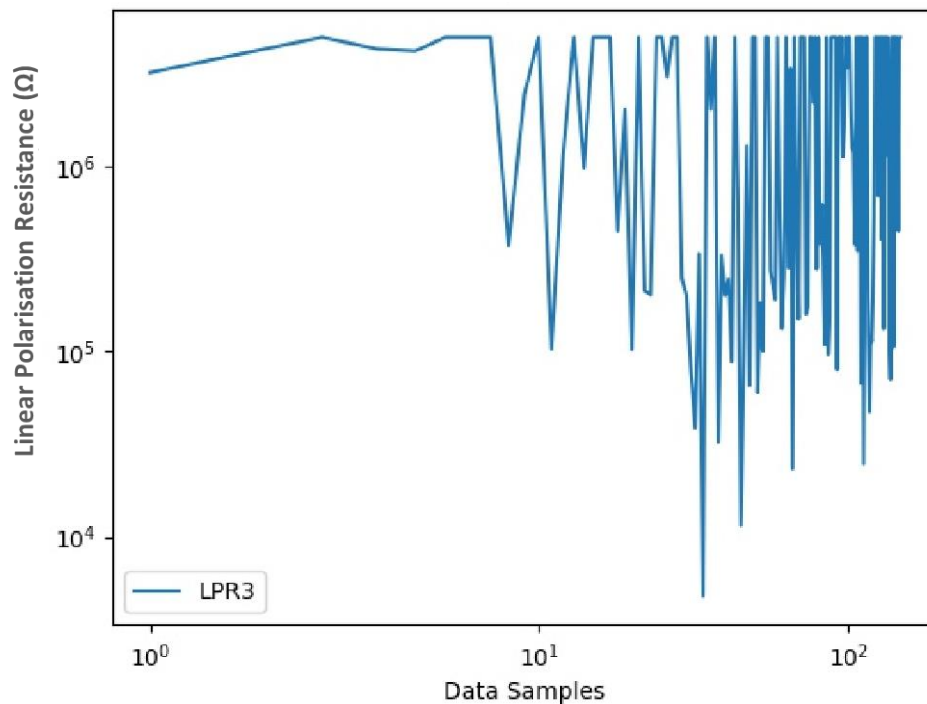
Figure 28 The measurements of  $\mu$ LPR sensor during 3<sup>rd</sup> experiment
