Raw-Rees, S, Pesce, GLA, Ball, RJ & Fodde, E 2012, 'Characterization of binders in the historic lime mortars and plasters from 1A Royal Crescent, Bath', *Journal of the Building Limes Forum*, vol. 19, pp. 28-37.

# The Journal of the Building Limes Forum

# Characterization of binders in the historic lime mortars and plasters from 1A Royal Crescent, Bath

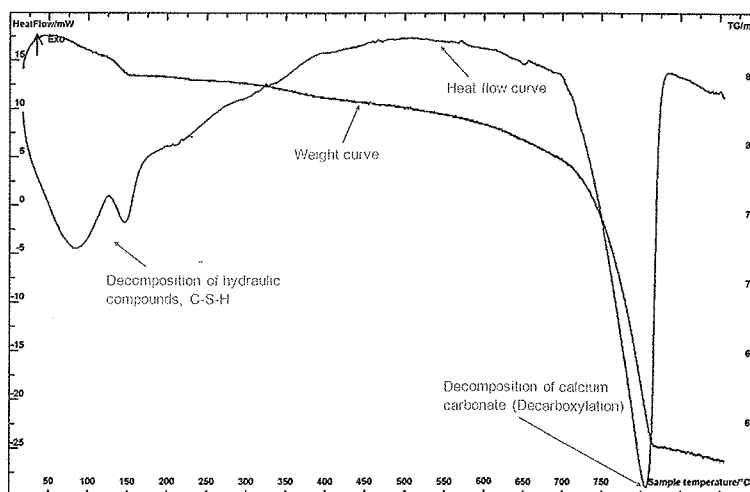
**Figs 4** TGA analysis of the lump.

To investigate the binder used in this mix, a lump of pure lime was extracted from the sample. The TGA analysis of the lump is shown in Figure 4. The initial increase in weight is attributed to a buoyancy effect within the furnace.<sup>54</sup> In the range 50 to 125°C an endothermic peak and a weight loss is observed due to absorbed water. An endothermic peak in the temperature range 650 to 850°C is characteristic of calcium carbonate. The corresponding weight loss was used to calculate the calcium carbonate content using the method described in Ball et al.,<sup>55</sup> which was 64%. The absence of an endothermic peak at about 500°C indicated that Ca(OH)<sub>2</sub> was not present, which is also verified by the XRD data shown in Figure 5, and indicates the material was completely carbonated. A subtle reaction can be seen within the range 125 to 150°C,

which defines the decomposition temperature of both gypsum and hydraulic compounds such as the CSH. However, the negligible amount of sulphur detected by the EDX analysis, Figure 6, does not support the presence of gypsum and suggests the presence of hydraulic compounds. Furthermore, according to Moropoulou and other researchers,<sup>56,57</sup> the weight loss between 200 and 600°C appears to confirm the presence of hydraulic compounds. Moreover, the high percentage of  $\text{CaCO}_3$  and the shallow gradient seen from the TGA analysis indicate that the sample was feebly hydraulic.

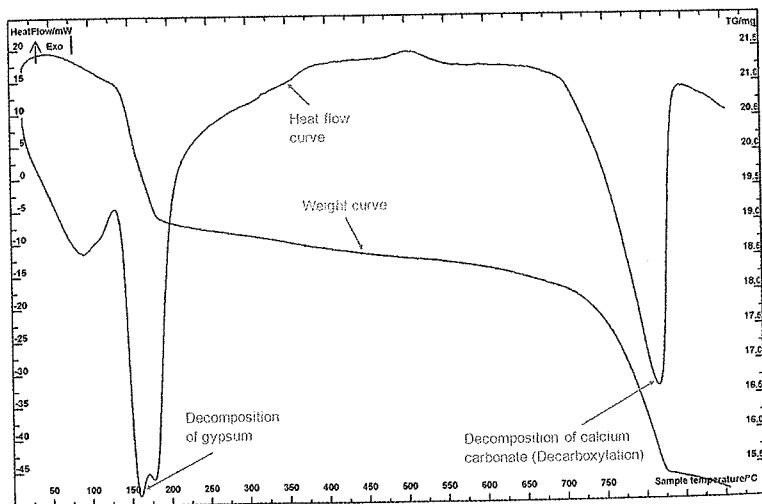
Fig. 8 Thermogravimetric analysis.

Results of a thermogravimetric analysis on Sample 18 are presented in Figure 8 and show a significant weight loss in the temperature range 130 to 250°C due to the dehydration of gypsum. The same procedure that was employed with Sample 14 was used to calculate the percentage of gypsum in the sample, which was 48.3%. In the manner of Sample 14, a shallow gradient was observed in the TGA curve between 200 and 600°C, which implies that some hydraulic compounds were contained within the sample. The endothermic peak at about 850°C corresponds to the decomposition of 31.5% of the total weight of calcium carbonate. The small endothermic peak at about 500°C suggests the presence of a reaction that does not affect the sample weight and, consequently, may be recognized as a phase change or the decomposition of a very small amount of organic material such as hair fibres. Dark brown hair fibres were, in fact, identified in Sample 18 during the visual analysis (Table 3).<sup>58</sup> In Figure 9a a low-magnification SEM image of the hair fibre is shown.
