Enhancing water security in Southern Africa by tackling nitrate contamination of aquifers and unraveling links to climate change and sanitation: A case from Ramotswa, Botswana

Bonnie McGill and Karen G. Villholth

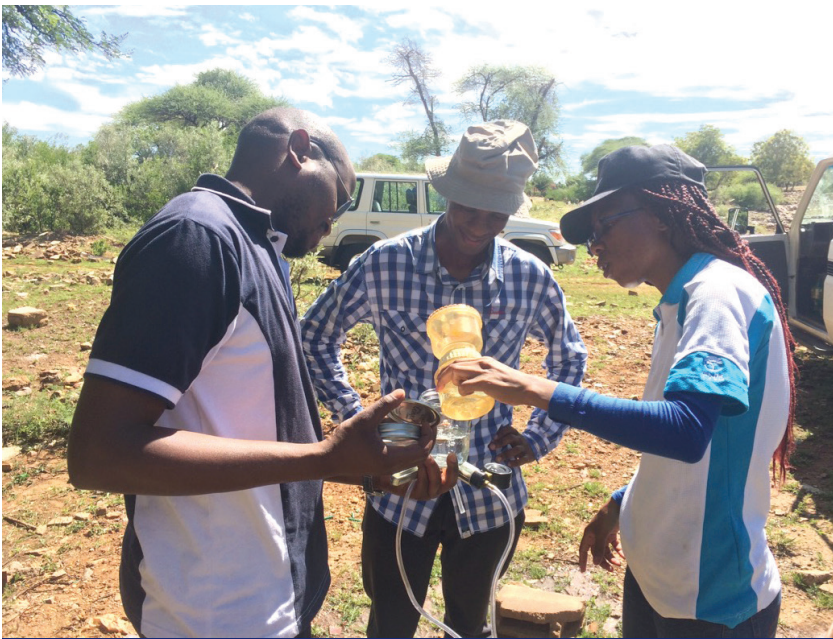
Pheмо Moleje (Botswana Geoscience Institute), Pheмоlo Makoba (Department of Water Affairs) and Kgabi Gaboutloeloe (University of Botswana) filtering a groundwater sample in January 2017 (photo: Bonnie McGill).

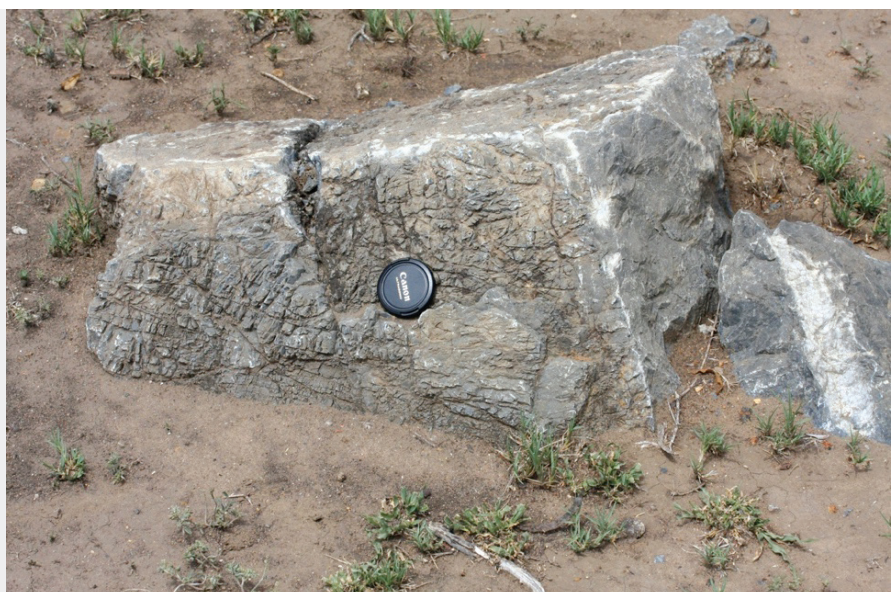
FIGURE 2. Outcrop of dolomite rock in Ramotswa (with lens cap for scale). The “elephant skin” texture is the result of weathering away of the rock. The same process creates channels below the surface allowing recharge water (or leaking pit latrines) to quickly infiltrate the aquifer.

Ramotswa (Figure 1) is a town located on an outcrop of the transboundary Ramotswa aquifer (an underground natural storage of water held between rocks and sediments). An outcrop is an area where the aquifer formation emerges at the Earth's surface (Figure 2). This aquifer spans parts of Botswana and South Africa, and is the most important groundwater resource for the urban and peri-urban settlements of southeast Botswana. The aquifer is vulnerable to contamination from the surface, especially in the outcrop areas where there are no overlying geological layers protecting the aquifer. Nitrate concentrations up to 29 mg L⁻¹ as nitrogen have been found in the area (Figure 3[b]). The World Health Organization (WHO) standard for drinking water is 10 mg L⁻¹ nitrate as nitrogen (or 45 mg L⁻¹ nitrate as nitrate), although new research suggests nitrate at even lower concentrations can increase the risk of some forms of cancer. The mean depth to the water table in Ramotswa is 14 m. Recharge of the aquifer occurs mainly through cracks and channels eroded into the dolomite formation constituting the aquifer, where water from the surface or holes dug into the ground, such as pit latrines, rapidly pour into the aquifer. The lack of significant soil or sediment layers means there is little to no natural filtration and purification of the recharge water. Lined pit latrines help prevent human waste from infiltrating into the aquifer. In Ramotswa, there are thousands of pit latrines (Figure 4), but it is unknown how many are lined. When a pit latrine fills, the resident can choose to build a new one (pairs of pit latrines are a common sight [Figure 4]) or pay the water utility company USD 50 to pump and empty the waste from the pit latrine, which is then taken to the sewage treatment ponds.

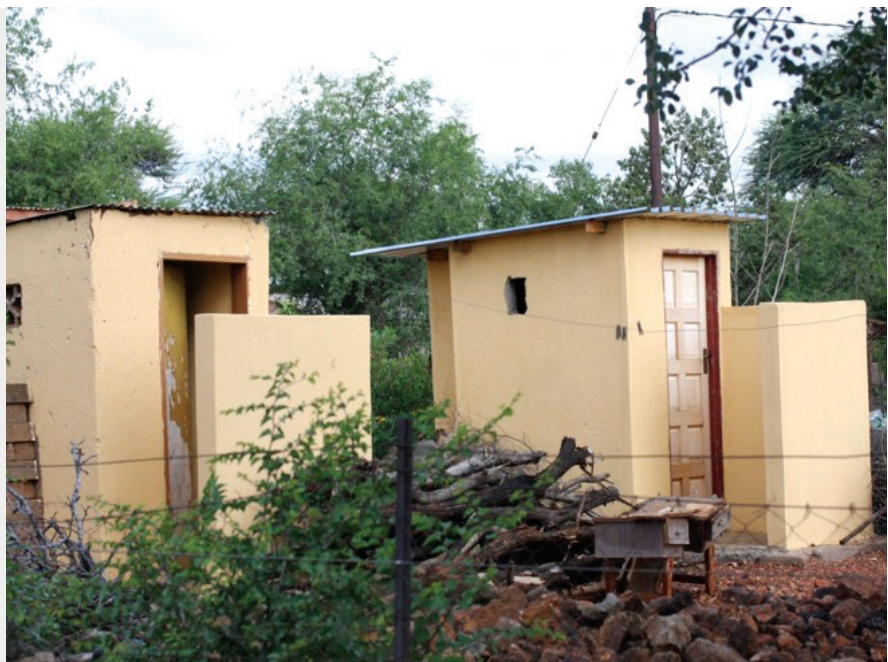
FIGURE 4. Pit latrines in Ramotswa. Pairs of pit latrines are common; as one fills up, a new one is built rather than pumping out the pit latrine that is full.
