Sulfate Resistance Study of Carbonated Low-Calcium Silicate Systems

R. Tokpatayeva and J. Olek

J. Jain, A. Seth and N. DeCristofaro

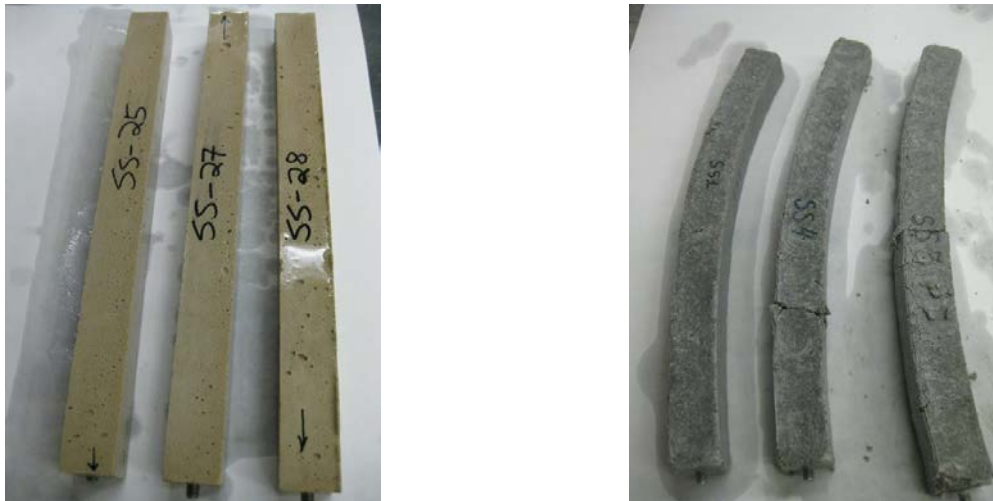
Fig. 2. Appearance of the mortar bars exposed to sodium sulfate (SS): left – SC mortar bars after 18 months of exposure; right – OPC mortar bars after ~9 months of exposure

As it can be seen from Fig.2, the appearance of the SC mortar bars did not change during the entire (i.e. 18 months) exposure period. However, the mortar bars made from the OPC and exposed to the sodium sulfate solution developed severe bending, which ultimately led to two of them becoming completely broken after 9 months of exposure. On the other hand, in case of the OPC mortar bars exposed to magnesium sulfate solution such symptoms as exfoliation, formation of brucite deposits (white precipitates) and slight bending were observed (right part of Fig. 3). The SC mortar specimens exposed to magnesium sulfate solution (left side of Fig. 3) initially developed hairline cracks along the length of the bars which, over time, spread toward the end corners of the bars (Fig. 4). The summary of visual observations of the conditions of the bars is presented in Table 2.

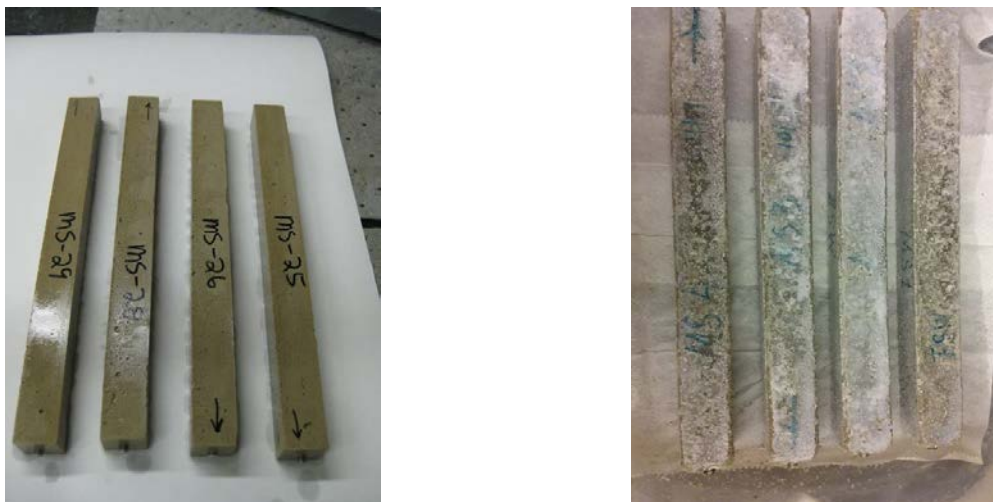
Fig. 3. Appearance of the mortar bars exposed to magnesium sulfate (MS): left – SC mortar bars after 18 months of exposure; right – OPC mortar bars after ~9 months of exposure.

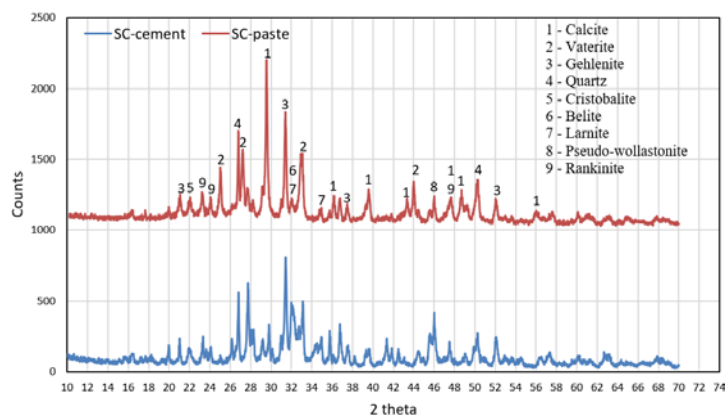
Fig. 15. The XRD patterns of SC cement (lower trace) and carbonated SC paste (upper trace)

As seen in Fig. 15 (lower trace) the main reactive crystalline phases present in SC cement before carbonation include rankinite, pseudo-wollastonite and larnite/belite. The main non-reactive phases include gehlenite (melilite family) and feldspars. After carbonation, peaks of calcium carbonate minerals appear as well as the peak intensity of the reactive phases decrease (see Fig. 15 upper trace). Fig.16 shows the XRD pattern of SC mortar specimens exposed to de-ionized water, sodium sulfate and magnesium sulfate solutions. The results of the XRD analysis didn't show any significant differences in the mineralogy of the specimens immersed in de-ionized water and sodium sulfate solution (other than decrease in the height of the calcite peaks in specimens exposed to SS). This might be attributed to the dissolution of calcite phase which was evidenced by SEM results as an appearance of less dense area close to the

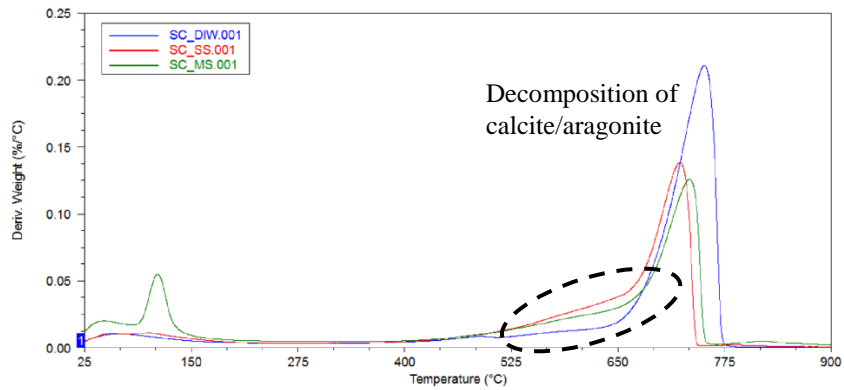
Fig. 17. The TGA curves of SC mortar samples: first derivative of weight (%) vs. temperature (key: DIW – de-ionized water, SS – sodium sulfate, MS – magnesium sulfate)

The results of the thermogravimetric analysis (TGA) of the SC mortar specimens are given as a first derivative of weight change thermogram in Fig. 16. According to the curves, there is a reduction in the quantity of highly crystalline calcium carbonate (present in the temperature range of 650°-900°C) in mortar bars exposed to both sodium and magnesium sulfate solutions compared to the same mortars immersed in de-ionized water. This reduction is manifested by the shift of the TGA curve in the direction of lower temperature range and the appearance of the humps in between ~520°-650°C (encircled by the black dashed line in Fig. 17). The value of this reduction was estimated to be in the range of 30-35% (compared to the DIW

(reference) sample). As mentioned above, the decomposition humps observed in the temperature range of ~520°-650°C might be attributed to the decomposition of less crystalline types of calcium carbonate and calcium bearing silica phases. In addition, the total amount of mass loss in the range of ~525°-900°C is lowest in case of the specimen exposed to magnesium sulfate solution. This implies that part of the calcium bearing phases was consumed during gypsum formation. The weight loss at the temperature of about 70°-150°C, visible in the curve of SC bars exposed to the magnesium sulfate, is attributed mainly to the dehydration of gypsum.

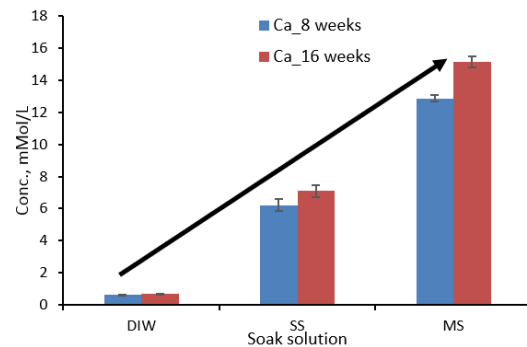
Fig. 19. Levels of calcium ions (Ca^{2+}) ions in various soak solutions in contact with the SC mortar bars for a period of 8 and 16 weeks (key: DIW – de-ionized water, SS – sodium sulfate, MS – magnesium sulfate)

The graphs shown in Figs. 19 and 20 illustrate how the type of sulfate solution influences the amount of calcium and silica that can be leached out from the carbonated SC system. As seen in Fig. 19, the highest amount of calcium leached out of SC specimens exposed to magnesium sulfate solution. This can be explained by higher dissolving potential of the magnesium sulfate solution.

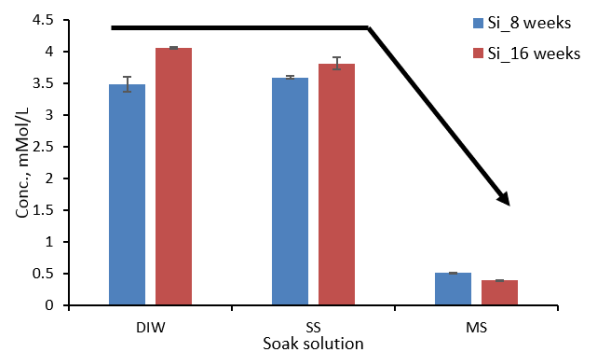
Fig. 20. Levels of silica (Si) in various soak solutions in contact with the SC mortar bars for a period of 8 and 16 weeks (key: DIW – de-ionized water, SS – sodium sulfate, MS – magnesium sulfate)

As for leaching of silica from the carbonated SC system after exposure to sulfate solutions, the

amount present in the magnesium sulfate solutions was significantly (~8 times) lower compared to reference condition (i.e. the SC bars immersed in de-ionized water). This may indicate the presence of some chemical reactions which result in binding of silica in the microstructure.
