Load-bearing Capacity of Corroded Reinforced Concrete Structures Caused by Carbonation and Exposed to XC4

E. Sistonen

Aalto University, Department of Civil Engineering, Aalto, Finland

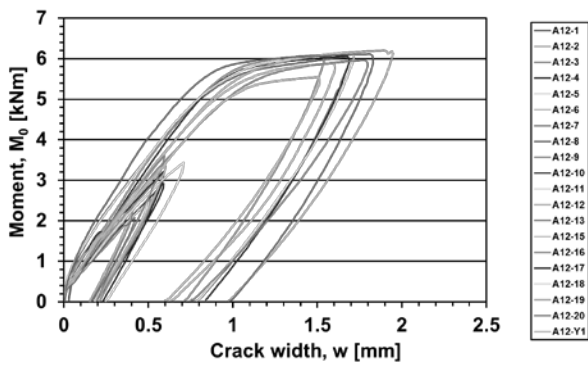
Fig. 2. Example of making cracking of beams before durability tests: weldable hot-rolled ribbed steel bar (A12)

concrete specimens. The cracks in the beam specimens were made by three-point bending so that the bars yielded with different loads (Fig. 1 and Fig. 2).

Load-bearing tests were performed on all beam specimens exposed to tap water. These were done in order to accurately determine the effect of corrosion on the developed cracks and the extent of cracking developed further due to corrosion. Examples of crack width-moment curves after 16 years of exposure are presented in Fig. 6, and Fig. 7. These examples are comparable to Fig. 1 and, Fig. 2, respectively.

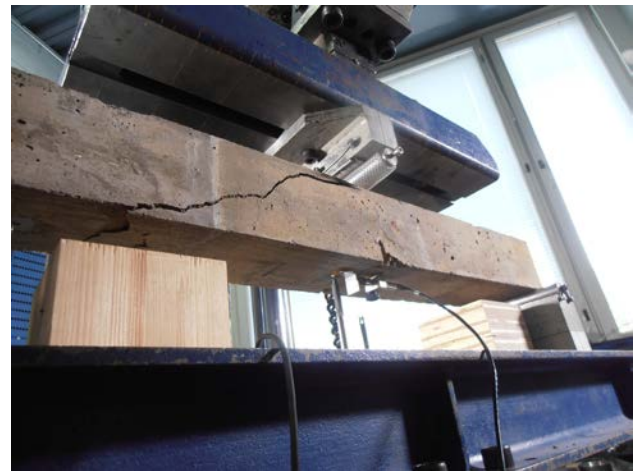
Fig. 3. Example of load-bearing capacity test by three-point bending: weldable hot-rolled ribbed steel bar, hot-dip galvanised (A8Zn-13), failure by shear

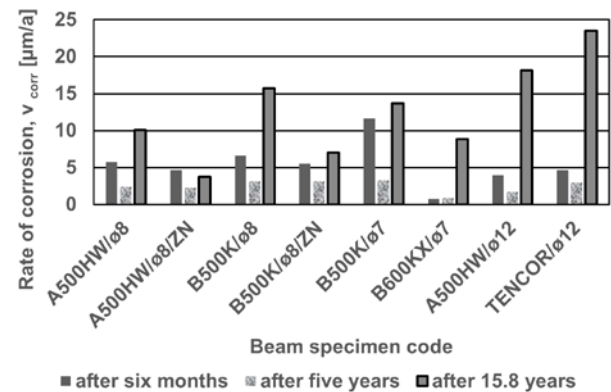
Fig. 4. Rate of corrosion of the beam specimens exposed to tap water

The electrochemical measurements of the beam specimens were performed after approximately six months, five years, and 15.8 years of exposure. The rates of corrosion were calculated according to the corrosion current values and are shown in Fig. 4.

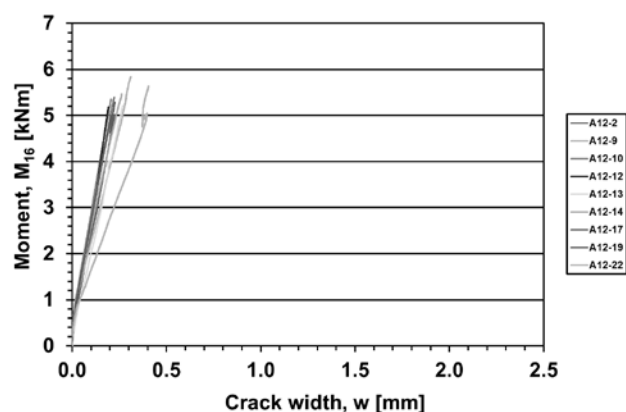
Fig. 7. Example of load-bearing test result of beams after durability tests: weldable hot-rolled ribbed steel bar (A12), failure by shear

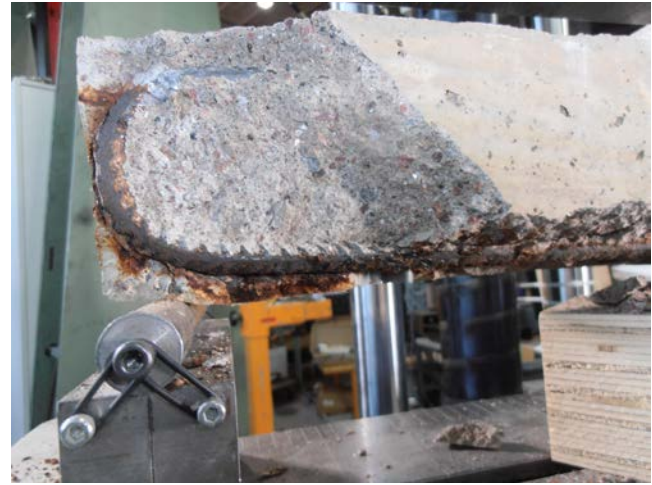
Fig. 8. Example of severe corroded beam after load-bearing capacity test by three-point bending: weldable hot-rolled ribbed steel bar (A12-22), failure by shear and anchorage

Failure mechanisms of beams based on load-bearing tests is presented in Table 4. Bending was realised in 62 % of beams tested, and shear failure in 38 %, respectively. Totally, 22 % with dimension 12 mm bars (types A12 and C12) were also failure by anchorage (Fig. 8). That was strongly affected by the recognised longitudinal cracking that also influenced on transversal crack width and rate of corrosion values.

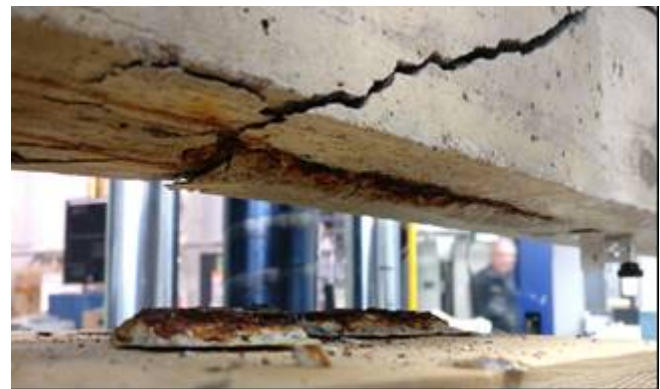
Fig. 9. Example of longitudinal cracking of severe corroded beam after load-bearing capacity test by three-point bending: weldable hot-rolled ribbed steel bar (A12-17), failure by shear

Example of longitudinal cracking of severe corroded beam after load-bearing capacity test by three-point bending is presented in Fig. 9. As a logical result, that cracking is concentrated on types A12 and C12 beams that produce more spalling forces to the concrete cover. In addition, hot-dip galvanised beams did not cause longitudinal cracking. The main corrosion product of zinc, zinc oxide (ZnO), occupies 1.5 times the volume of the original zinc (Yeomans, 2004; Porter, 1991). However, the volume of zinc oxide is approximately 1/3 less (Yeomans, 1993) than the volume of the corrosion products of ordinary steel. Corrosion products are friable, loose, and powdery minerals. The products are able to migrate away from the bar and into the adjacent porous concrete matrix, where they fill small voids and micro-cracks (Hoke *et al.*, 1981; Yeomans, 1993). In that case the local tensile stresses in the concrete are also lower and zinc corrosion products do not exactly cause the concrete cover to deteriorate. That was realised afterwards with opened beams (Fig. 10).
