Study of the Deterioration of Concrete Incorporating Sulfide-Bearing Aggregates

J. Duchesne and B. Fournier

ABSTRACT

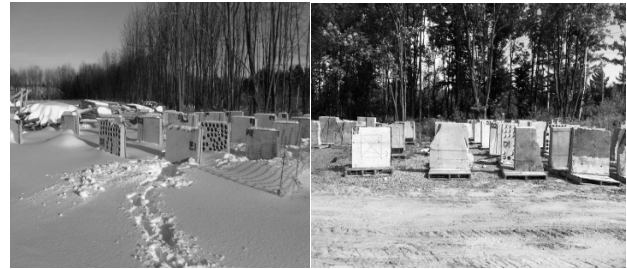
Fig. 1. Configuration of the outdoor exposure site located in Trois-Rivières North

Figure 1 illustrates the configuration of the concrete blocks on the outdoor exposure site. Metric blocks, with different levels of deterioration, were extracted from residential foundations and installed on this site. Deterioration levels were based on visual inspection of structures and range from level 0 (no visible cracking) to level 3 (high damage with crack opening of 2 to 12 mm). Ratings 1 (low) and 2 (medium) indicate intermediate levels of damage. In total, five series of five blocks (5 blocks per house of deterioration level 0, 1, 2, 3 (2x)) were instrumented on the site to perform annual monitoring of expansion, cracking index and cracking density.

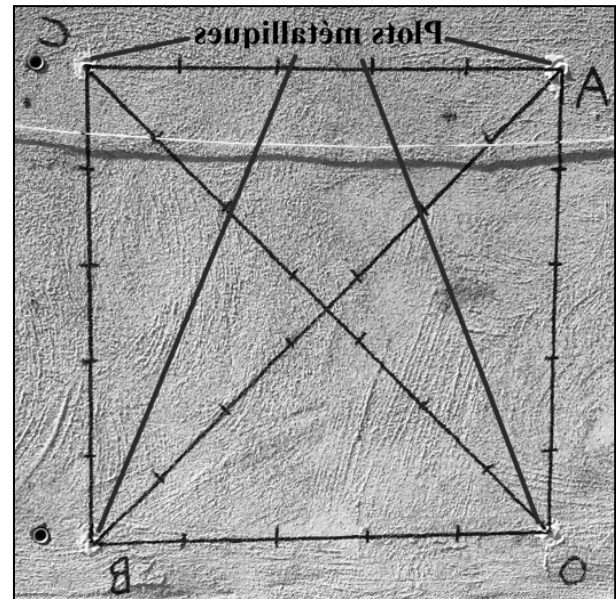
Fig. 2. Metal studs and grid established on the surface of the blocks

Quantification of concrete cracking is performed using the Cracking Index Method (LCPC 1997). This method consists in measuring, using a crackmeter, a transparent plastic card with lines of different thickness, the opening of all the cracks intercepting one of the six axes of the lines traced on the surface of the metric blocks (Fig. 2). Metal studs were inserted into the concrete blocks to form the 500-mm grid. These studs were also used for expansion measurements.

All cracks with a width greater than 0.05 mm are measured using the crackmeter perpendicular to their direction following the grid lines. All measurements taken are then reported in a table giving a value of the Cracking Index (CI) in mm/m used to quantify the importance of cracking according to the method proposed by LCPC (1997).

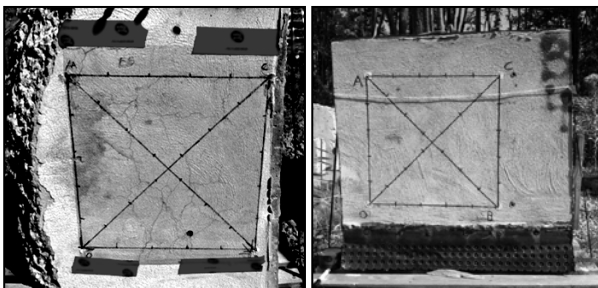
**Fig. 3.** Example of crack mapping

A mapping of the cracking was carried out by tracing each visible crack on a plastic film fixed to the surface of the concrete block (Fig. 3). The layers thus produced were digitized in order to determine the surface density of cracking (total length of crack per evaluated surface). Mapping is performed at the same time as the CI measurements, i.e. by drawing the new cracks with a different color at each measurement to monitor the evolution of the cracking.

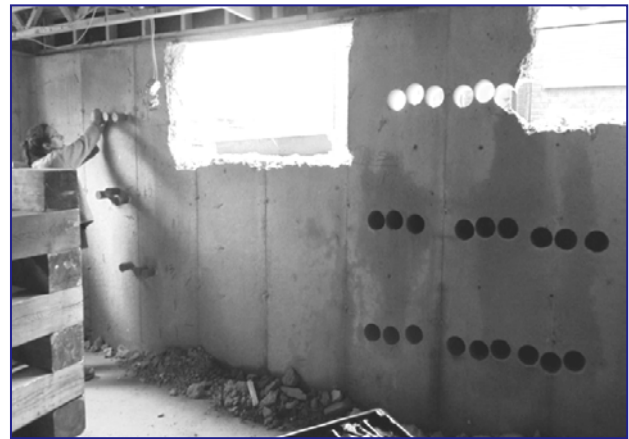
**Fig. 4.** Instrumentation for in-situ temperature and relative humidity measurements

Eight residential foundations showing varying levels of deterioration from low-damaged (1) to severely damaged (3) were selected (Table 2). For each foundation, cores were extracted at three levels, i.e. above ground, at 30 cm below ground level and at the base of the housing foundation. In-situ temperature and relative humidity measurements were taken at these three levels and at different depths (50-75 mm, 100-125 mm, and 150-175 mm) inside the concrete (from the inside) using Vaisala equipment (HUMICAP® SHM40). To do so, dry drilling (16mm in diameter) is first carried out in the foundation wall using a percussion drill at various depths (75, 125 and 175 mm) in the concrete. The hole is then cleaned with a suitable brush and compressed air. A plastic tube is then inserted into the hole while leaving a concrete section of 25 mm long at the bottom of the

hole. The tube is specially machined to insulate this 25 mm section. The probe (Model HMP40S) is then inserted into the hole and a rubber stopper is placed in the tube to once again isolate the 25 mm section at the bottom of the hole. The probe is left in place for a period of one hour so that equilibrium is reached before readings (Fig. 4).

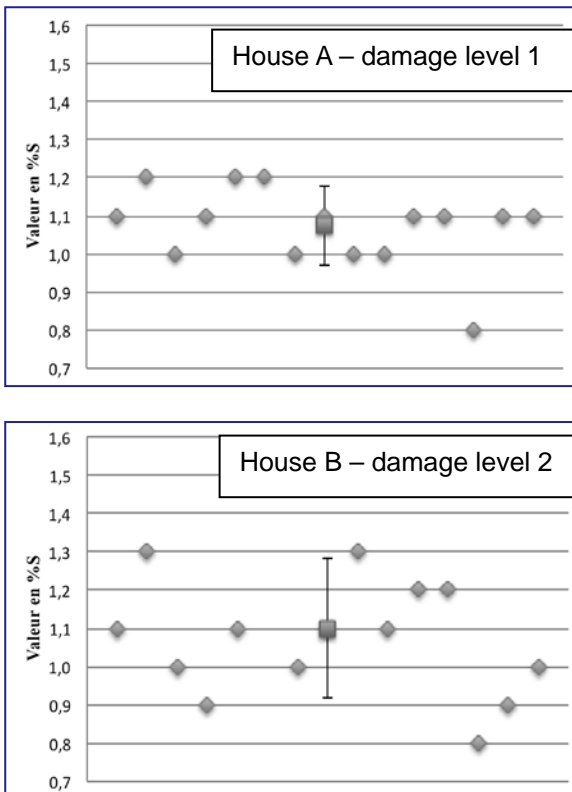
Fig. 10. Variability of the total sulfur content in the aggregate measured from 15 concrete cores extracted from the same foundation

To do this, 15 samples distributed at different locations in the foundations of two houses were analysed and compared. Three samples were drilled into each wall of the foundation and the last three were samples from the floor. For each wall, one sample was taken from the upper part of the wall, another from the central part and one from the base. The goal is to evaluate the possible variations of the sulfur content of the different concrete samples. Results are presented in Fig. 10. This figure shows the distribution of the total sulfur content of the coarse aggregate measured in two foundations with the mean value represented by the square and the bar representing the standard deviation.

House A shows an average of 1.1% with a standard deviation of 0.10 (coefficient of variation of 9.1%), while house B presents more dispersion with a mean of 1.1 and a standard deviation of 0.18 (coefficient of variation of 16.4%).

The data presented in Fig. 10 clearly show the heterogeneity of the distribution of sulfur content in aggregates. House A is showing a maximum variation of 0.4% while house B shows a difference of 0.7% while the mean values measured are only of the order of 1.1%. These values reflect the heterogeneity existing at the level of the aggregate particles. This heterogeneity of the sulfide minerals content is also observable at the quarry level.
