## Comparison data between hybrid and galvanic anode installation in the Arousa Island Bridge

*The Arousa Island Bridge, with its 1980 m is the only road access to the Arousa Island. Built in 1985, this single-cell box girder divided in 40 spans runs entirely on the sea. The deck is between 2 to 12 m above sea level, so after 25 years in a marine environment, the structure showed reinforcement corrosion, especially in piles and deck bottom. Attending to the corrosion damages, caused simply from a chloride attack, the local government decided to intervene with an ambitious repair project. This decision has been taken only after an exhaustive cost analysis to determine the feasibility of repairing the structure against the construction of a new one. In this project, the reparation was divided in three types of intervention: conventional reparation with patches, galvanic anode installation and hybrid anode installation. The objective of this division is the data collection for further repairs. The research will be explained in detail and the comparative results will be explained in depth, therefore examining the corrosion progresion and service life. Currently, after careful analysis

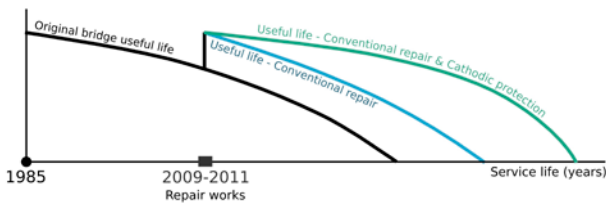
**Fig. 1.** Effect in Useful Life of three intervention decisions: no-intervention, conventional repair and conventional repair & cathodic protection

The main objective of an action of this type is after analysing the results, to lengthen the useful life of the structure, with the objective of postponing the final investment corresponding to the replacement of the infrastructure.

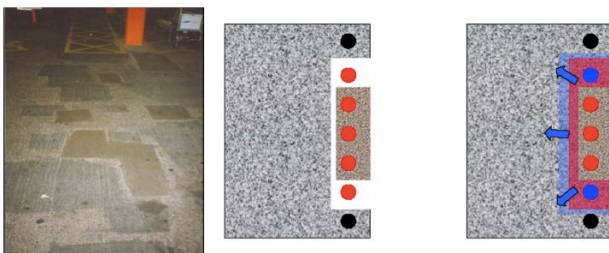
This is the most traditional repair system. It consists of the clean up of the affected areas, uncovering the rebar and applying new mortar to restore the affected area to its original state. This is the fastest and most economical repair option. In case of severe corrosion, this type of repair can produce new corrosion in the perimeter of the repaired area (Fig. 2). Also, there is a "radial expansion" over time. This phenomenon is known as incipient anode.

**Fig. 2.** Examples of patch repair and repair with mortar with corrosion inhibitors

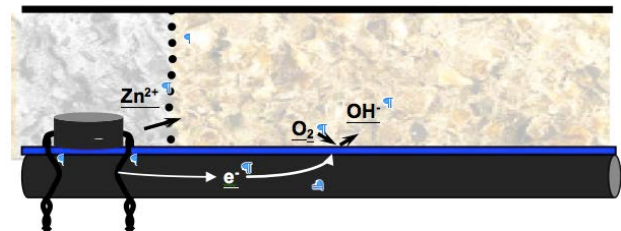
This method uses the knowledge of the scheme corrosion of steel in reinforced concrete, and in particular, the scheme of chloride attack. It applies sacrificial anodes in the perimeter of the repair; with this it prevents the creation of incipient anodes in the outside of the repair patch. Also, it is in compliance with the electrochemical scheme already established in the steel rebars. As stated previously, the corrosion of the sacrifice metal itself is at the same time, protecting the adjacent steel (Fig. 3). This is because the corrosion acidification leads to the re-alkalinization of the contiguous steel, protecting it thanks to the hydroxyl groups that migrate to these areas.

**Fig. 3.** Example of sacrificial anodes protection

This is the principle of cathodic protection, which allows for a controlled corrosion (in this case the anode, not the steel bars), and the re-alkalinization and protection of steel in the vicinity of the anode.

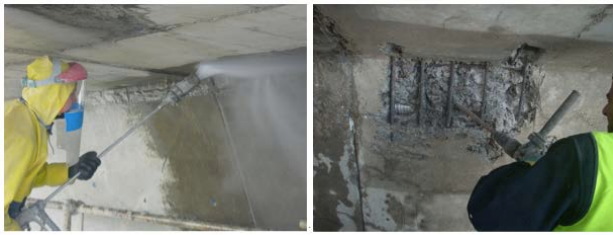
The sanitizing was carried out in the damaged areas performed with two methods, one manually by a chipping hammer and the other by hydro-demolition machine, which proved to be the most effective

method. Both produced acceptable quality and cleanliness of the demolition (Fig. 4).

**Fig. 4.** Techniques of demolition of damaged areas of the deck.

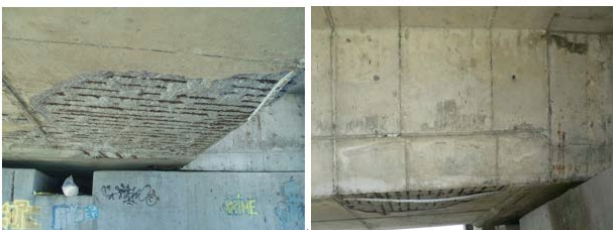
It was detected that many existing corrosion problems had been caused by defects in the concrete placement. In addition, with regards to the bridge it was established to use continuous plastic along the rebars. This type of spacer for reinforcing bars was a novelty at the time and it favoured substantially the entry of aggressive agents more directly and quickly (Fig. 5).

**Fig. 5.** Affected areas of the bottom of the concrete girder.

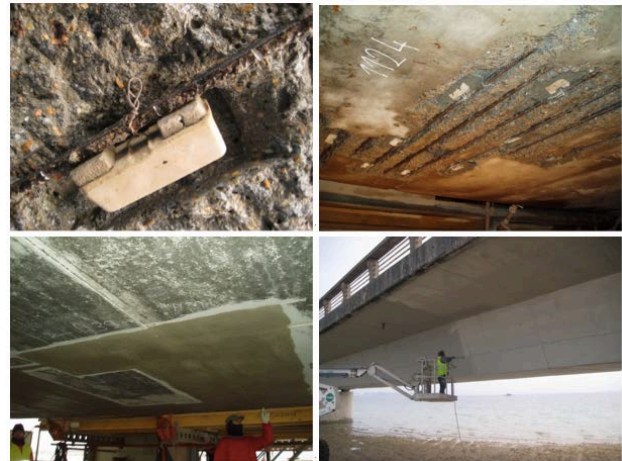
**Fig. 6.** Details of the repairing procedure (sacrifice anodes, application of mortar patches and final painting)

The repair was carried out on the deck which consisted of sanitizing each damaged area, replacement of steel in areas where the loss of section was excessive (Fig. 6). After this, placing discrete zinc anodes in the area of repair, next the application of thixotropic mortars. Finally, the entire surface of the deck (repaired and unrepaired areas) was painted with a special anti-chloride paint.

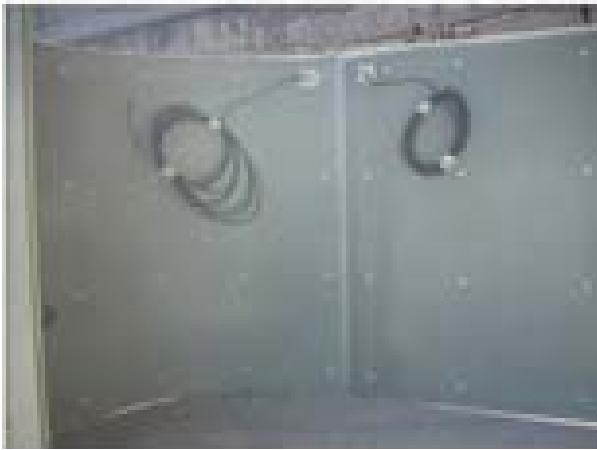
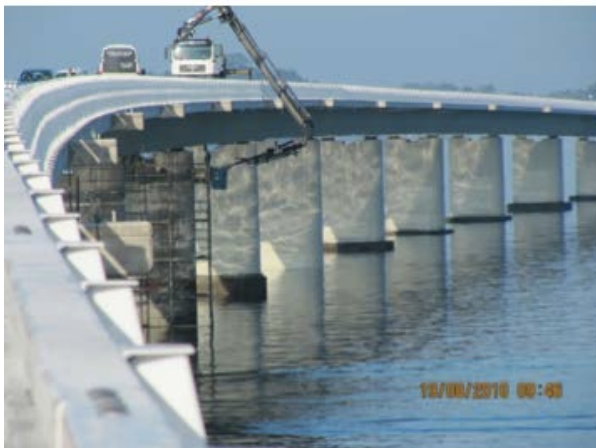
**Fig. 7.** Repair of the piles with the Fosroc jackets

This system consists of placing some jackets of fiberglass mesh + zinc batteries. Filling the gap between the pile and the jacket with an special concrete that allows the current flowing between the mesh of zinc and the reinforcement (Fig. 7). This system was used in a limited group of piles because of the difficulties of the works in the areas hit by the sea. All circuits for the reinforcement and the zinc anodes was conducted to the deck and connected in electric boxes protected inside de girder box. This makes monitoring over time easy.

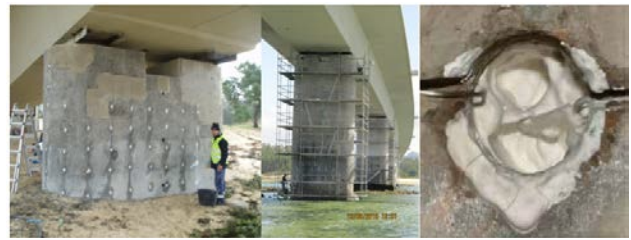
**Fig. 8.** Repair of the piles with conventional technique and CPT cathodic protection

The functioning of this technique stems from the introduction of sacrificial anodes in small holes in the structure and all embedded in a mortar of activation. The arrangement of sacrificial anodes was made based on a grid designed according to the detected damage and location relative to the different zones: tidal, splash, etc. These anodes are connected through titanium wire that closes the circuit against reinforcement steel bars, which in turn are connected in a connection box within the board for later supervision (Fig. 8).

The network of anodes and wiring permits the application of impressed current for a short period of time. This was performed initially after the repair works, however it can also be applied after a period of time since the intervention with a similar effect. The aim was to produce the re-alkalisation of the structure, with the consequent prevention of chloride attack. This delayed treatment would be possible simply by using external batteries and for a very short period of application, between 1 and 2 weeks. Thereafter the system is disconnected from the battery, starting its operation as conventional sacrificial anodes. The new electrochemical equilibrium starts from steel in a substantially improved situation from its initial point due to the

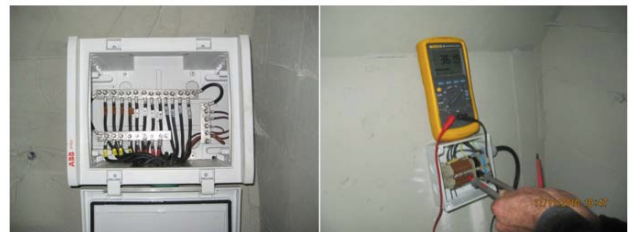
As mentioned above, the repair performed included innovative solutions in many aspects, which include monitoring the cathodic protection. It is possible to measure the connections between the sacrifice anodes and the steel reinforcement, they are accessible in boxes for collecting data that allows the tracking of the installed systems (Fig. 9).

**Fig. 9.** Detail of a connection box and the procedure of measurement of the voltage

The monitor is designed to take data selectively from different areas of the bridge (north side, south side, splash zone, tidal zone). In this way, it is planned to carefully monitor the installed systems. It would permit to compare different electric consumption in the cathodic protection of the different zones depending on the aggressiveness of the areas.

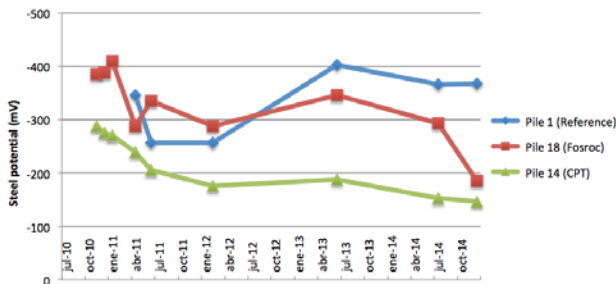
The follow-up visits have produced extensive measurement campaign data. This enables to assess the correct behaviour of the cathodic protection. Whilst ensuring that they fulfil the criteria established by UNE 12696: (2001) and EN 12696 (2012): 2012. Also, it has been made, in first instance, corrosion potential measurements according to ASTM C876-09 (2009). In Fig. 10 are represented results of pile potential in different areas of the bridge repair.

In the displayed graphic is observable the different behaviours on different cathodic protection systems employed in the repair of the bridge. As we can see

in the case of pile 1, a conventional repair was performed, the corrosion potentials were after two years of the repair, below  $-350$  mV. With the predefined criterion of corrosion (less than  $-200$  mV), we would be in a case of highly probable corrosion (Te Liang *et al.*, 2012).

**Fig. 10.** Results of the evolution of the pile potential (V) in the period 2010 to 2014

In the case of the pile 14, in which it was used the system of discrete anodes with CPT hybrid cathodic protection, we see as a major change in the corrosion potentials, led by the first contribution impressed current applied at the initial time (Glass *et al.*, 2001). We see potential are above  $-200$  mV almost from the start, and the trend is almost horizontal with over the years.

The next case is the one of pile 18. In this pile it was used for galvanic protection the system of Fosroc GRP shirts that were covered with zinc anodes. In this case, the corrosion potentials have a different behaviour than the CPT system. As it can be seen, in this case the corrosion potentials increase rapidly after the repair work. With time, the protection system becomes more positive, slowly coming closer to the values given by the CPT system values. The fundamental difference is that this system does not give an initial contribution of impressed current, so that the potential of corrosion of steel are essentially the same as existed prior to the repair. Over time, the potential becomes increasingly positive; turning to over  $-200$  mV positive values, which indicates almost certainly the passivity of steel in reinforced concrete.

Among the techniques used in the project of Repair of Bridge Illa de Arousa, it was used primarily cathodic protection with sacrificial anodes on the deck (using galvanic current), and in the piles it was chosen to perform a test with the different protection systems. In this case, one of the piles was repaired with the conventional repair, to serve as control of the evolution of the corrosion over time. The result after a few years of this repair indicates possibility of corrosion due to the values of electrochemical potential measured.

For the rest of systems analysed, we see the "CPT" hybrid system presented very favorable results from the beginning. The first phase of impressed current represents an advantage over other systems, the values of galvanic potential achieve high values (above  $-200$  mV) faster than the Fosroc system. In this system, although corrosion potentials take longer to get in than  $-200$  mV values, (which is the barrier taken as synonym for passivity of steel in concrete) it does not mean that the system is not working. The trend of the potential indicates that the system is operating, and there are more forms of assessment and other measurement techniques to make these checks.
