Problems of Boğaçayı Watershed and Watershed Management Recommendations in Resolving These Problems

Nilüfer YAZICI^{a*}, Süleyman KARAGÜL^b

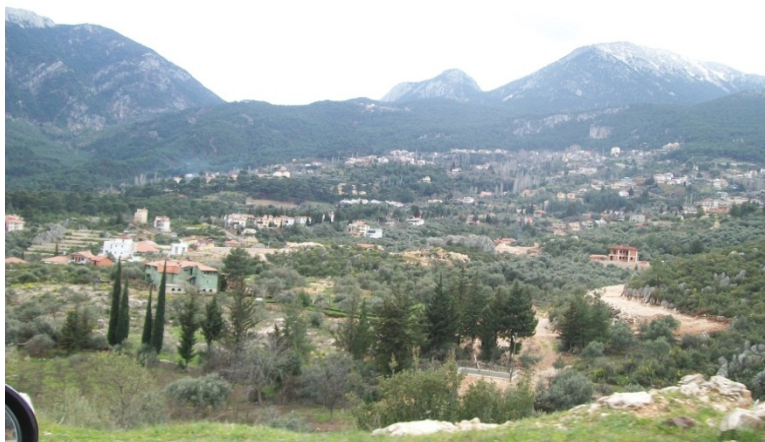
Rapid population growth in Antalya province has primarily led to unplanned urbanization and as a result of this, it caused time-consuming and insolvable problems such as squatting and urban sprawl (Figure 2).

Fig. 2. Within a watershed developing construction

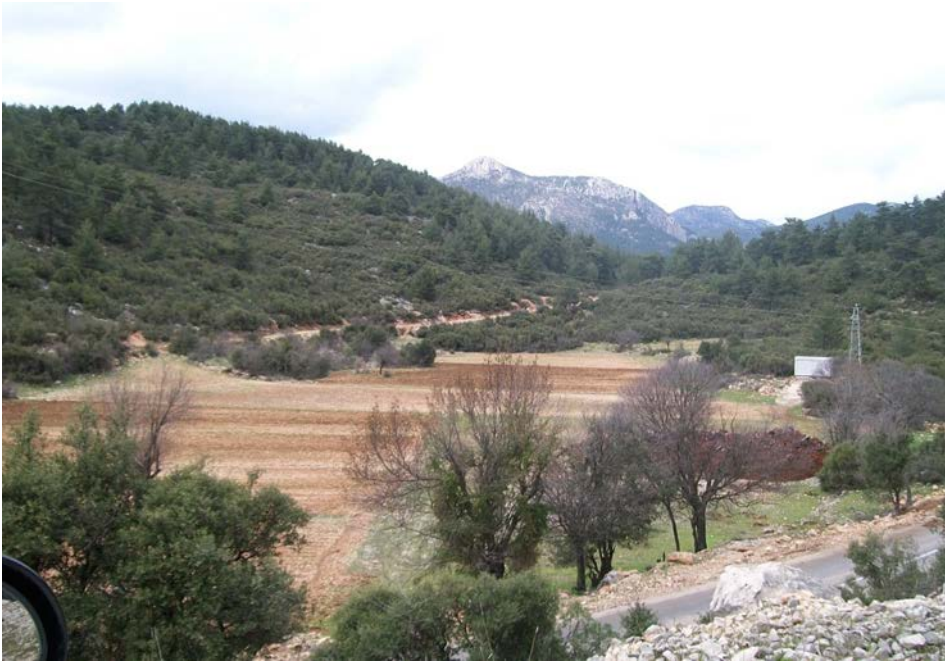
It is noteworthy that forestry areas in upper part of Boğaçayı Watershed are devastated with the reasons such as opening fields, excessive and premature grazing and forest fires. (Figure 3). However, carstic areas with fully devastated forest cover have taken a bare and stony-rocky look. Scrub community has become widespread on the areas where calabrian forests are devastated or over-operated and especially overgrazing is continued.

Fig. 3. Open field in the forest area

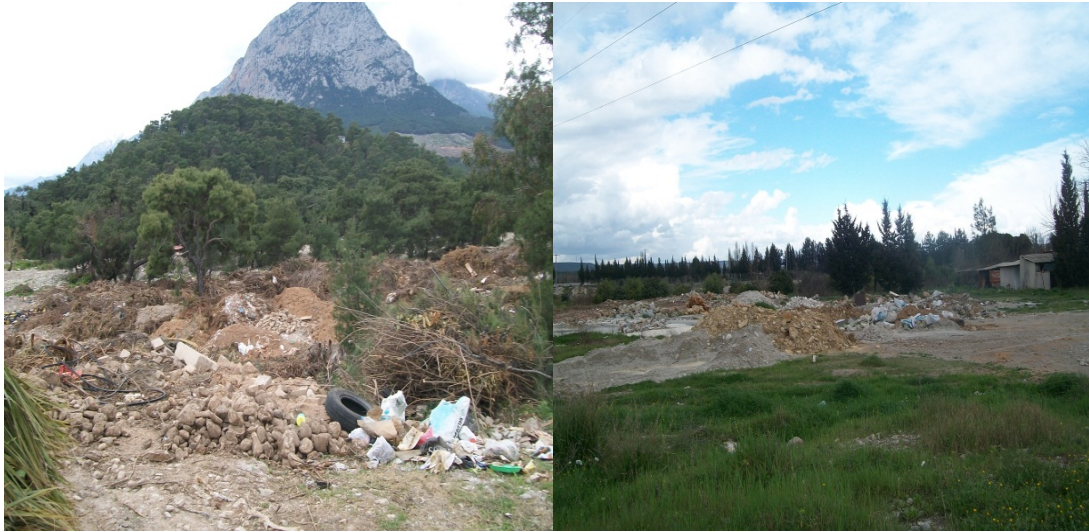
The majority of tourism centers located within the borders of watershed is small residential area having low annual revenue. Solid waste volume generated is increasing in parallel with two-folded populations of these districts and villages in summer season. (Figure 4).

Fig. 4. Within a watershed solid waste

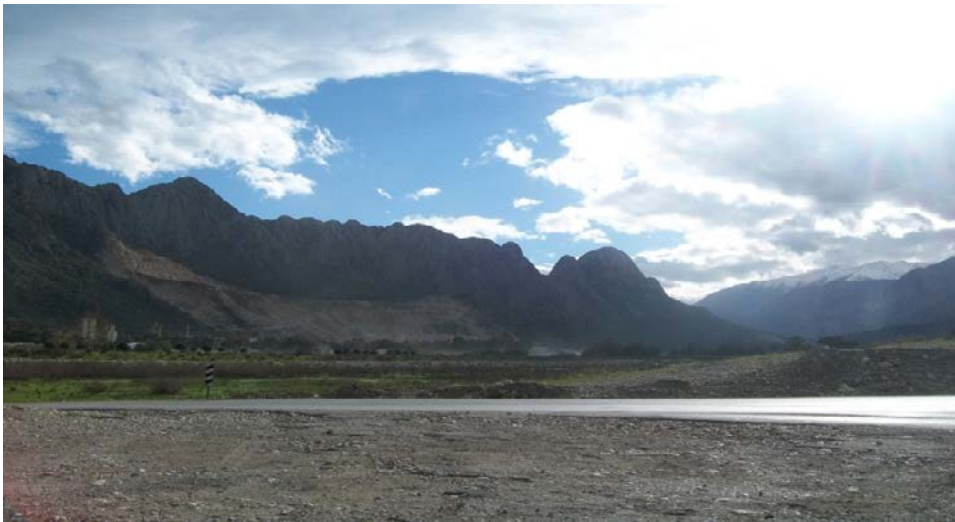
Environment is covered with lime dust as a result of operations in quarries and a unsightly landscape is created with these operations. (Figure 5). Furthermore, dusts emerged from the quarries near to road comes on the road and when these dusts are get wet with light rain or water, road becomes extremely slippery. And this case constitutes a dangerous situation for drivers.

Fig. 5. Caused by quarry dust clouds

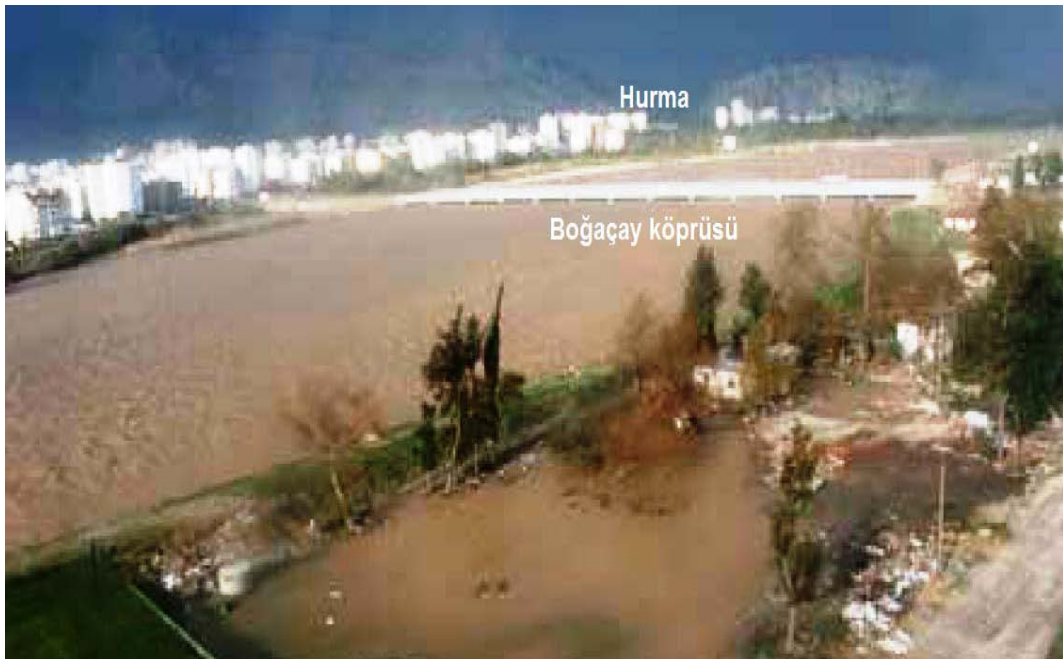
It has been witnessed that unplanned material procurements without permission from beds of sand-gravel quarries and brooks as a result of land observations conducted in Boğaçayı Watershed cause disruptions in river beds. In addition to this, vegetation in the vicinity of bedding is gradually removed. This situation adversely affects ecology of the basin. Therefore, residential areas in Boğaçayı Watershed are exposed to risk of overflowing and flood at all times. Spreading to a vast area of materials such as rock, gravel, debris brought by flood waters and water accumulation in agricultural lands has been experienced for several times. With operations of zoning for construction, damage extents of overflowing and flood have further grown in size (Figure 6).

Fig. 6. Flood resulting image

- Problems occurred as a result of pitting in riverbed resulting from material taken for a long time from Karaman, Doyran, Çandır brooks and consequently ponding occurred herein and degradation of brook bed has put flood water in uncontrollable state. Vegetation should be conserved for minimizing flood risk likely to occur on the site and misuse of the land should be avoided and structuring in the vicinity of Boğaçayı should not be permitted. In addition to this, unauthorized material procurement of sand-gravel-stone quarries should be ceased.
