Journal of Technology and Exploitation in Mechanical Engineering

Review article

CAVITATION WEAR OF PUMP IMPELLERS

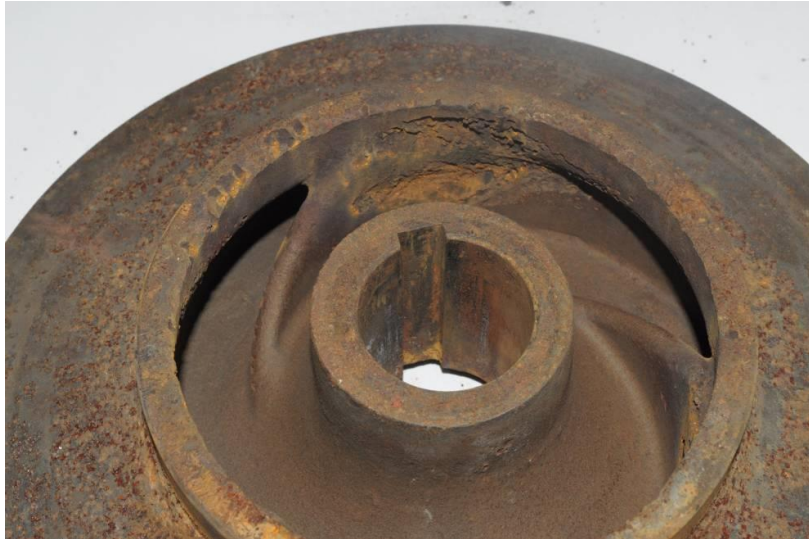
Fig. 2. Centrifugal impeller with a single curvature of the blades.
Cavitation damage: rear wall of the blade near the edge of the inlet, cast iron [3]

The impact of erosion, corrosion and cavitation on pump impellers can be synergetic. In operating conditions one of the above phenomena may dominate. Different stages of damage of centrifugal pumps subjected to cavitation wear are shown in Figs. 2-4. The cavitation-worn areas of the impellers correspond to the cavitation damage shown in Fig. 1. The cavitation-worn areas are characterized by the presence of a rough surface as well as pitting and considerable material losses.

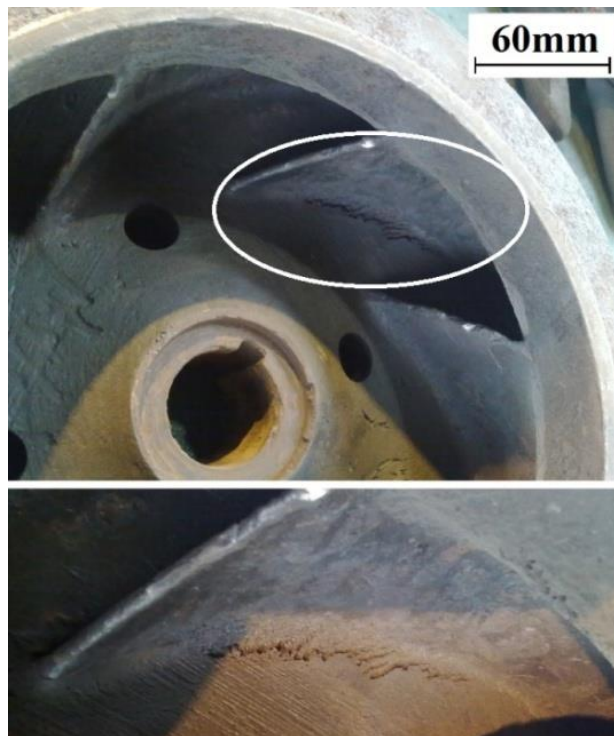
Fig. 3. Cavitation damage of the rotor disk located near the intake edge of the blades.
The magnified area shows a typical, rough surface area of cavitation erosion [16]

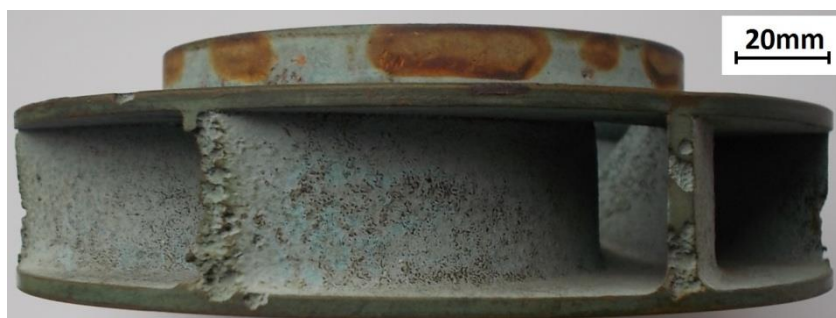
Fig. 4. Centrifugal impeller with a single curvature of the blades.
Cavitation wear of the inlet edges of the impeller blades, silicon bronze [17]
