COMPDYN 2017
6th ECCOMAS Thematic Conference on
Computational Methods in Structural Dynamics and Earthquake Engineering
M. Papadrakakis, M. Fragiadakis (eds.)
Rhodes Island, Greece, 15–17 June 2017

DISCUSSION ON THE RESPONSE OF UNREINFORCED MASONRY TO LOW-AMPLITUDE RECURSIVE LOADS: CASE OF GRONINGEN GAS FIELD

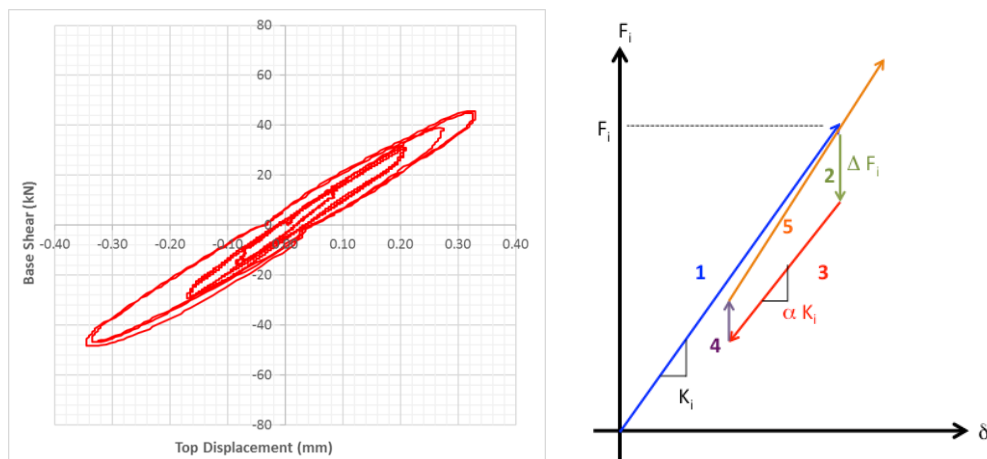
Figure 7: Focus on the experimental load deflection curve for the first 3x3 cycles (left) and an idealized hysteresis backbone (right)

Zoom into the very first 3x3 cycles, as shown in Figure 7 (left), provides insights regarding the extremely low amplitude response of the URM walls in question. The hysteresis loops of the first cycles is quite fat, leading to residual displacement and energy consumption, so damage, in the very beginning of their response. After analyzing several cycles in the experiments, the initial backbone curve suggested for the very low amplitudes can be seen in Figure 7b. It should be noted that the main issue in this behavior, at the very beginning of the response, is the force drop when the cycles reverse. As opposed to bi-linear response, for instance, the constant is the displacement but not the load. This created practical problems in modeling these URM walls since none of the available and suitable models can consider a strength drop under constant displacement, since the hysteresis loops are mostly set for large deformations and the case is the increasing displacement under constant or slightly increasing/decreasing loads. More insights are provided on this issue in the rest of the paper.

In Figure 7 (right), in line with the experimental results, there are two characteristic behaviors that need to be addressed in a suitable hysteresis loop, which are i) at the beginning of every unloading, there is a force drop of ΔF_i , and ii) the unloading stiffness is always smaller than the initial loading stiffness, thus the initial stiffness K_i is multiplied with a coefficient α , that is smaller than or equal to 1.0.
