EUROPEAN ORGANIZATION FOR NUCLEAR RESEARCH
CERN — SL DIVISION

CERN-SL-2002-058 MR

The Dismantling Project for the Large Electron Positron (LEP) Collider

J. Poole

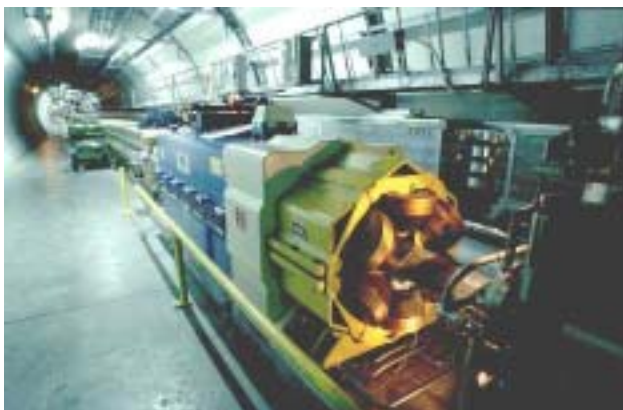
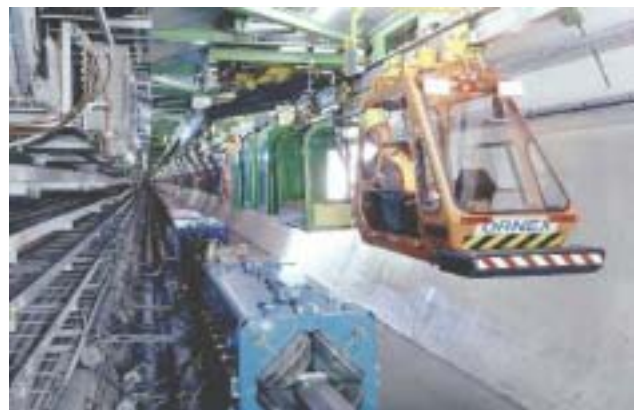
Figure 1 The LEP Tunnel

(a) Regular arc with sextupole/quadrupole assembly in the foreground

(b) Straight section with monorail train

The LEP accelerator was formed of eight arcs with a bending radius of ~ 3500 m with a total circumferential length of around 19 km, separated by eight straight sections which were approximately 1 km long centred on the crossing points. The beams passed within the continuous 27 km long vacuum chamber, guided and focused by powerful electromagnets. The arcs were formed of a regularly repeating structure about 40 m long containing dipole, quadrupole, sextupole and orbit correction magnets. The arc dipoles account for approximately 50% of the weight of equipment of the accelerator. The straight sections contained focusing and correction magnets as well as the accelerating systems, injection systems, electrostatic separators, collimators, beam instrumentation and the beam dump system. Running alongside the accelerator itself between it and the tunnel wall are the services comprising cooling water, electrical cables and bus bars and so on, some of which can be seen in Figures 1, 2 and 3. The four experiments were built around the collision points and spaced equidistantly around the circumference and the beams were separated at the other four crossing points.

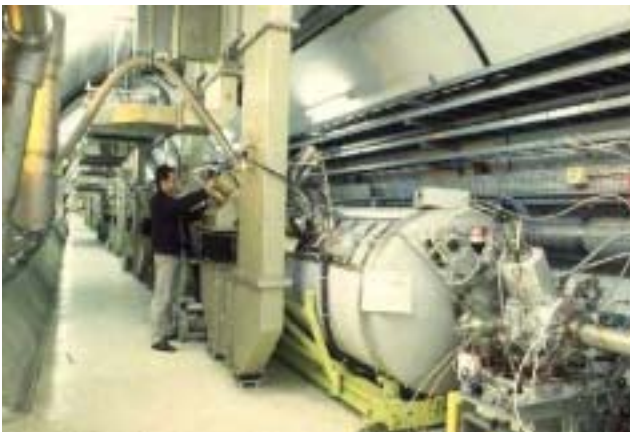
Figure 2 Superconducting RF System Cavity Module

Accelerating energy was supplied through high power radiofrequency (RF) cavities which were installed in the straight sections on either side of the experiments. For LEP2 the copper RF cavities were supplemented by 72 superconducting cavity modules (see Figure 2).

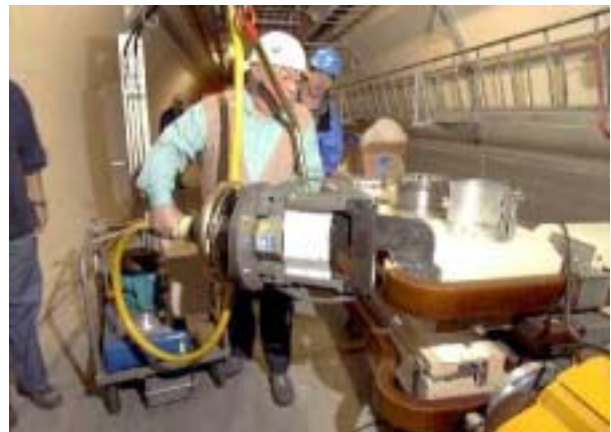
Figure 3 Cutting the dipole magnet excitation bars with a hydraulic nibbler

In order to avoid dust a hydraulic nibbler (Figure 3) was chosen to cut through these elements which measure up to 90 mm square. For similar reasons it was specified that the pipe work from the cooling pipes should be cut using circular pipe cutters and the cables and busbars were cut using hydraulic scissors. Most of the other equipment, including the quadrupoles, sextupoles, vacuum equipment etc. was removed by unbolting it and lifting it out.

The use of hydraulic nibblers for cutting the equipment was certainly a good one however, in the early months many of the cutting blades were broken and the rate of wear was higher than expected. The supplier was able to identify the cause of the problem and by reducing the hydraulic pressure and employing a special surface treatment on the blades the performance was significantly improved. The purchase of a spare nibbler enabled work to continue whilst another was being repaired.

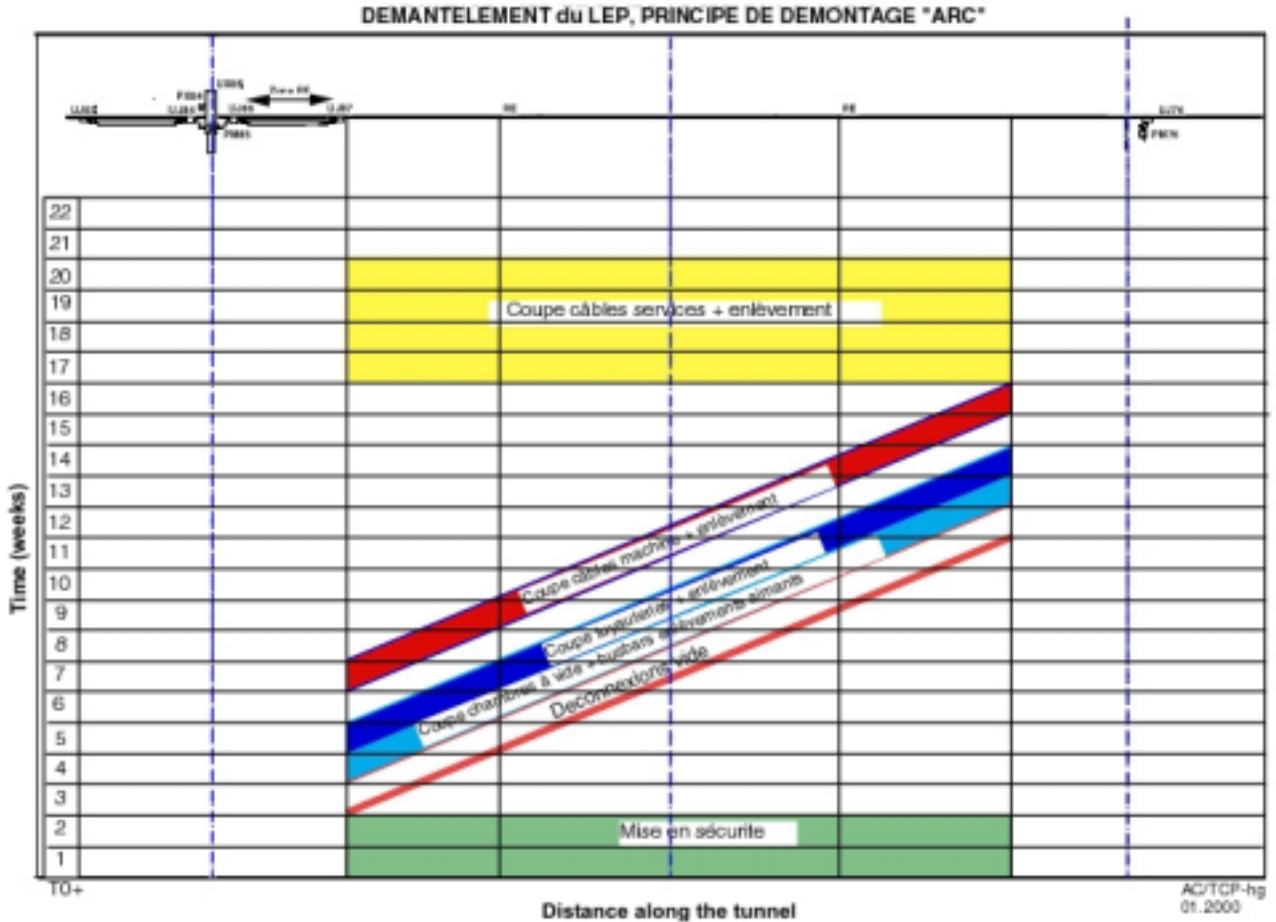
Figure 4 shows schematically the planning for dismantling in a typical section of the accelerator with time along one axis and distance around the tunnel on the other axis. The first two weeks are assigned for making the areas safe and then the first team comes in and opens the vacuum chamber and so on. The sequence of tasks for the dismantling teams was as follows:

Figure 4 Dismantling in a LEP Arc

- Make areas safe from the beam
- Detailed radiological survey to confirm 'zonage'
- Make equipment safe in readiness for dismantling
- Remove radioactive elements
- Disconnect vacuum components
- Cut vacuum chamber and bus bars
- Remove beam line components (magnets, vac. chamber etc.)
- Remove cables
- Remove cooling pipes
- Clean up remaining small items
- Radiological survey and re-classification of zones

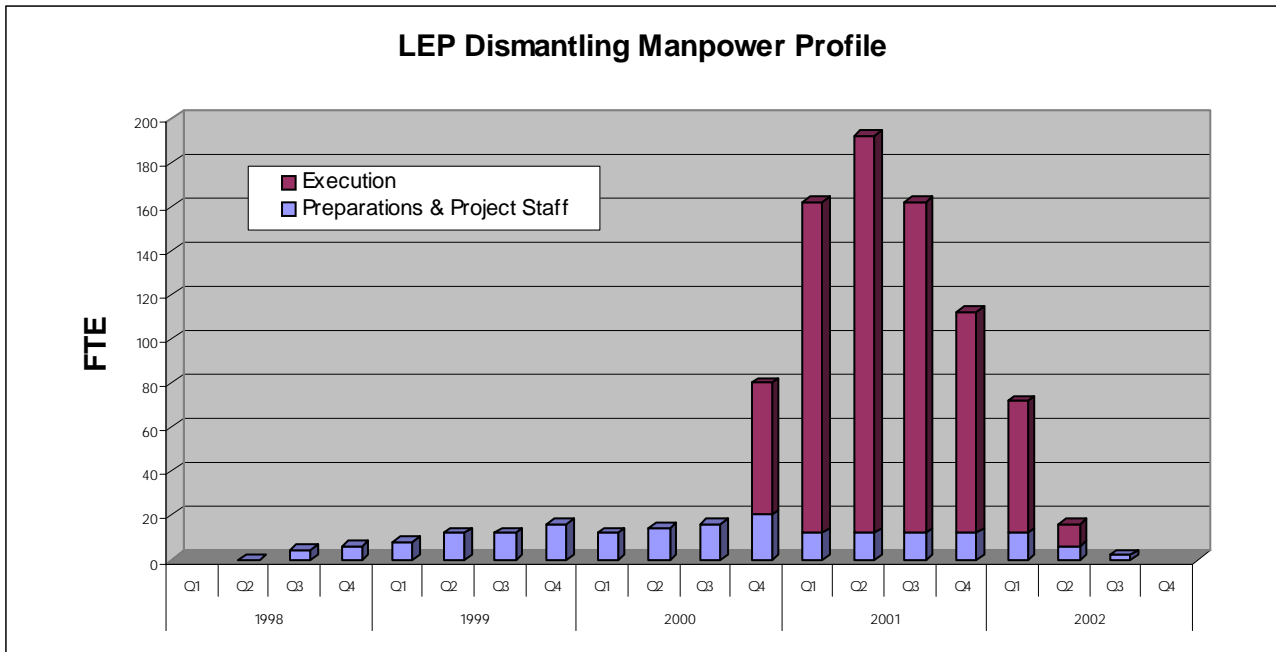
Figure 5 Quarterly distribution of manpower throughout the project

At the end of 1999 there was a step increase caused by the intense activities during November in order to prepare safety documents concerning the experiments. Following this a large number of people were involved in the placing of barcode stickers on equipment in the tunnel during the LEP shutdown and also in the procurement activities.

Teams for the execution were scheduled to arrive in the fourth quarter of 2000 but following exciting physics developments, LEP was still running and the arrival of as many people as possible was delayed until after Christmas when removal of equipment really started. It had been hoped that work would be completed by Christmas 2001 but problems with transport and handling equipment and additional safety procedures led to the continuation in 2002. Most of the teams recruited for the execution finished at the end of February 2002 but some equipment remained to be removed and there were a number of other activities associated with the final cleanup which also continued.
