Reactions of Sandhill Cranes Approaching a Marked Transmission Power Line

Citation: Murphy RK, Dwyer JF, Mojica EK, McPherron MM, Harness RE. 2016. Reactions of sandhill cranes approaching a marked transmission power line. *Journal of Fish and Wildlife Management* 7(2):480-489; e1944-687X. doi: 10.3996/052016-JFWM-037

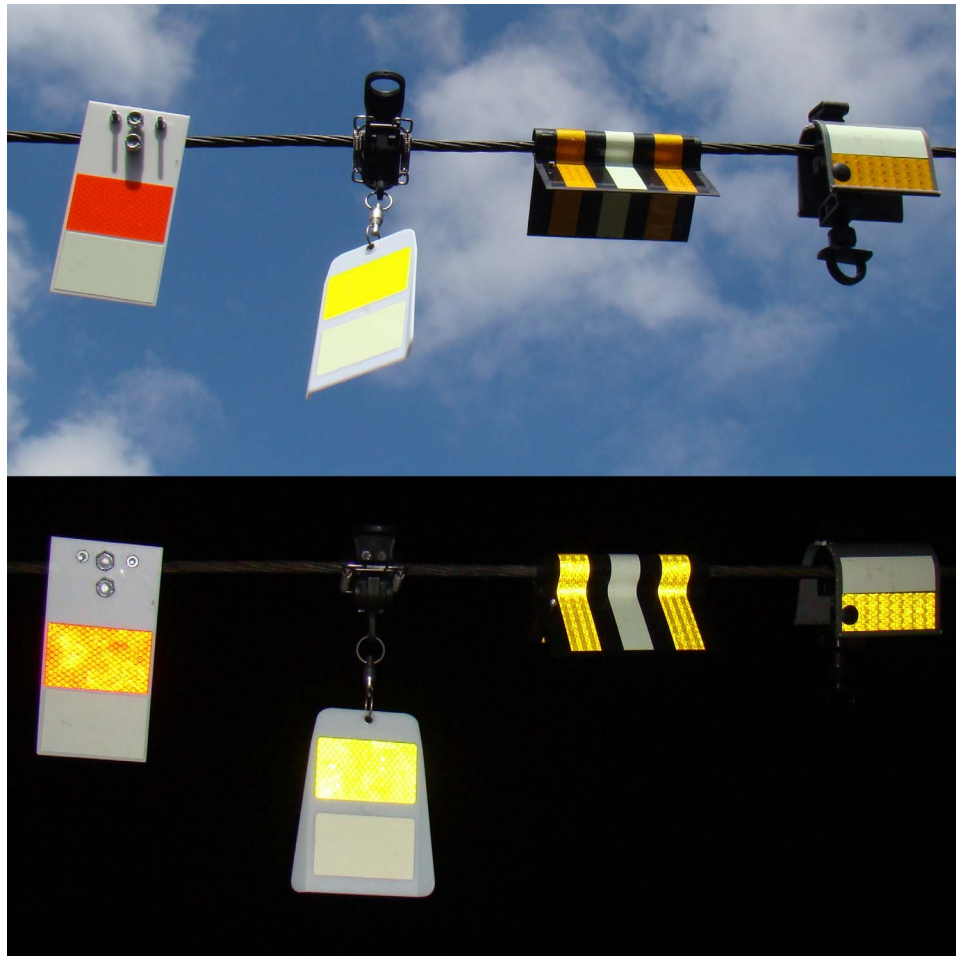
Figure 2. Examples of power line markers with reflective and glow-in-the-dark components designed to increase visual prominence to birds during low-light conditions and thus maximize their effectiveness in reducing avian collisions with power lines in a study of sandhill crane *Antigone canadensis* reaction behavior. Manufacturers are, from left to right, P&R Tech (Beaverton, OR), P&R Tech, Power Line Sentry (Fort Collins, CO), and TE Connectivity (Berwyn, PA). The two P&R Tech markers on the left are the most similar to those we observed in a study of reaction behavior from 4 March to 8 April 2009 at a marked transmission power line bisecting the National Audubon Society’s Lillian Rowe Sanctuary in Gibbon, Nebraska.

attached at 12-m intervals to each of the two overhead shield wires, in an alternating arrangement so that when viewed from perpendicular to the power line, FireFlies occurred at 6-m intervals. These were interspersed with spiral vibration dampers installed several years prior (Wright et al. 2009). We placed a blind on the river bank at each end of the observed span and recorded flocks of sandhill cranes reacting to the power line from 0.5 h before sunset through 2 h after sunset. We used 10 × 50 binoculars to observe sandhill cranes during daylight, and 3× or 5× generation II night-vision spotting scopes to observe sandhill cranes during darkness (Murphy et al. 2016). We used radios to communicate between blinds to avoid creating duplicate records.

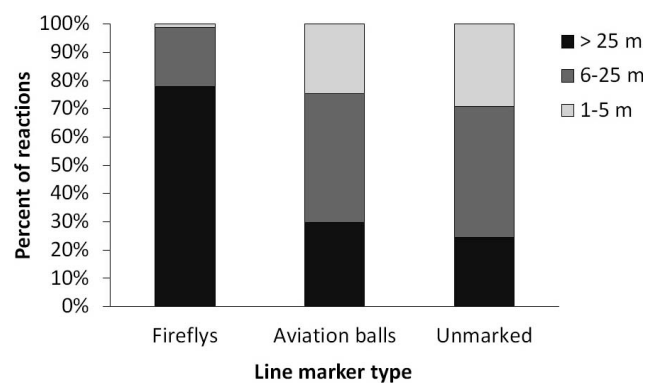
Figure 3. Frequency distribution of reaction distances by sandhill cranes *Antigone canadensis* from 4 March to 8 April 2009 to a marked transmission power line bisecting the National Audubon Society’s Lillian Rowe Sanctuary in Gibbon, Nebraska, compared to other nearby power lines. Flock reactions ($n = 244$) to FireFlys were observed in this study; reactions to power lines marked with aviation balls ($n = 1,199$) and unmarked power lines ($n = 1,608$) and to were observed by Morkill and Anderson (1991).

flocks tended to react >25 m from the power line during daylight and <25 m from the power line during darkness, regardless of flock size. Reactions within 5 m were particularly different; the reactions of only 1.2% of 244 diurnal flights occurred within 5 m, and the reactions of 24.5% of 204 nocturnal flights occurred within 5 m. Proportions of reaction distances also differed in our study compared to the Morkill and Anderson (1991) study of sandhill cranes approaching power lines marked with yellow aviation balls and unmarked power lines ($\chi^2 = 217.7$; $df = 4$; $P < 0.001$; Table 2; Figure 3). Specifically, flocks tended to react from >25 m away when approaching the power line we studied (85.2% of diurnal observations). Flocks tended to react from <25 m away

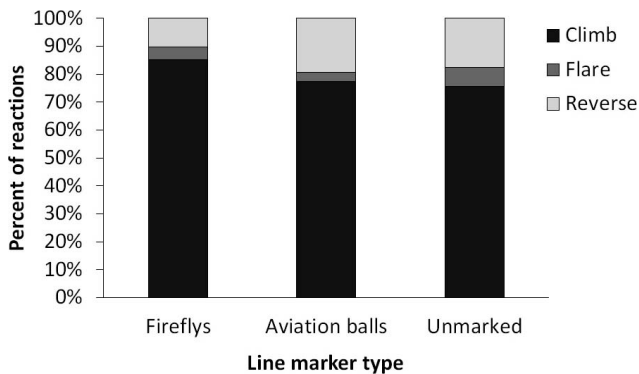
Figure 4. Frequency distribution of behavioral responses by sandhill cranes *Antigone canadensis* from 4 March to 8 April 2009 to a marked transmission power line bisecting the National Audubon Society's Lillian Rowe Sanctuary in Gibbon, Nebraska, compared to other nearby power lines. Flock reactions ($n = 243$) to FireFlies were observed in this study; reactions to power lines marked with aviation balls ($n = 587$) and unmarked power lines ($n = 525$) and to were observed by Morkill and Anderson (1991).

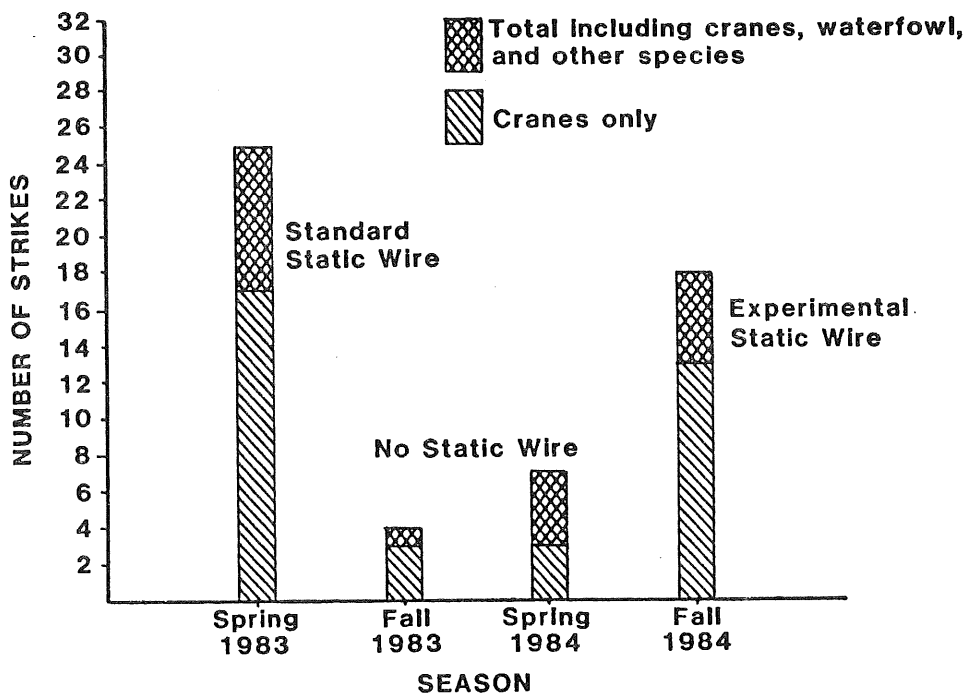
Fig 2. Number of bird strikes found beneath 13 spans of a 115 kv transmission line with experimental static wire modification during spring and fall crane concentration periods in the San Luis Valley, Colorado 1983-84.

In September 1984, cooperators with EEI experimentally replaced two spans (ca. 560 m) of static wire with standard 0.95-cm diameter wire, and two spans with 2.54-cm diameter self-damping wire to determine if the larger wire would be more visible to flying birds and thereby reduce collision frequency. The remaining nine spans were left without static wire. Using remote cameras, EEI contractors filmed crane flights over six experimental spans (T. Nelson, pers. comm.). We continued searches of the entire segment for dead birds.

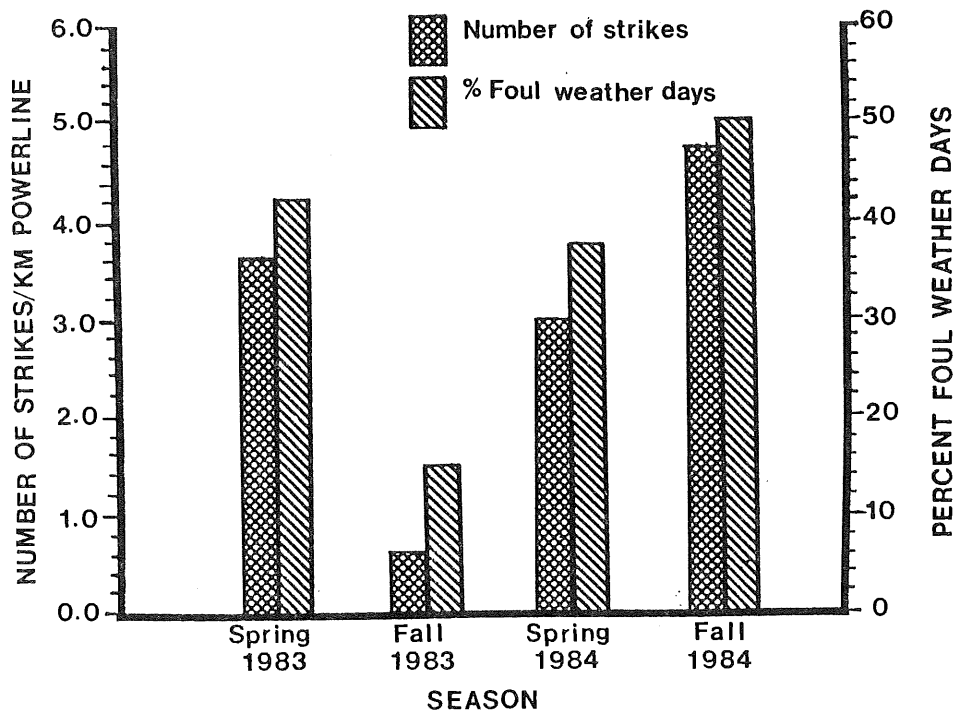
Fig. 3. Number of bird strikes found per kilometer of powerline and percent foul weather days during spring and fall crane concentration periods in the San Luis Valley, Colorado 1983-84.

The relationship between weather and bird strikes was determined using a Chi-square contingency table (Zar 1974). The proportion of fresh bird strikes found on foul weather days was compared to the proportion of foul weather days in the survey period. Chi-square analysis was also used to compare the proportion of juvenile sandhill crane strikes found with the proportion of juveniles in the population.

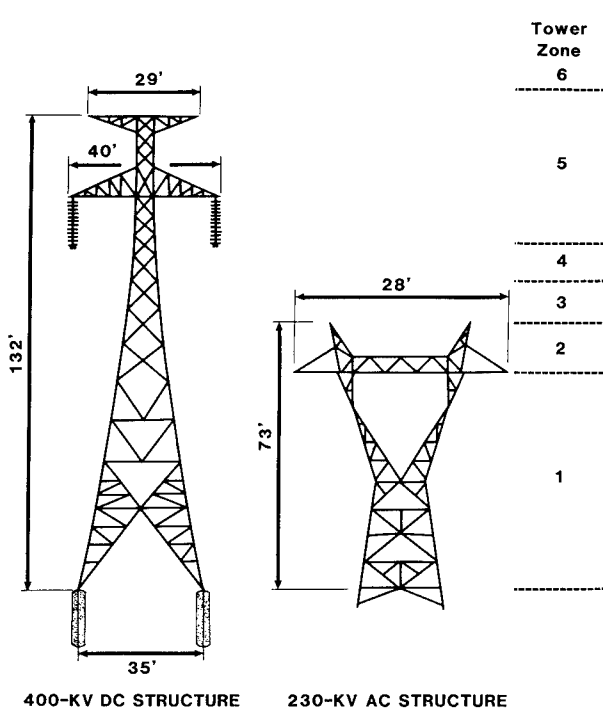
Fig. 1. Dimensions of typical support towers for 400- and 230-kV power transmission lines. Also shown are the tower zones used for recording bird behavior in flight.

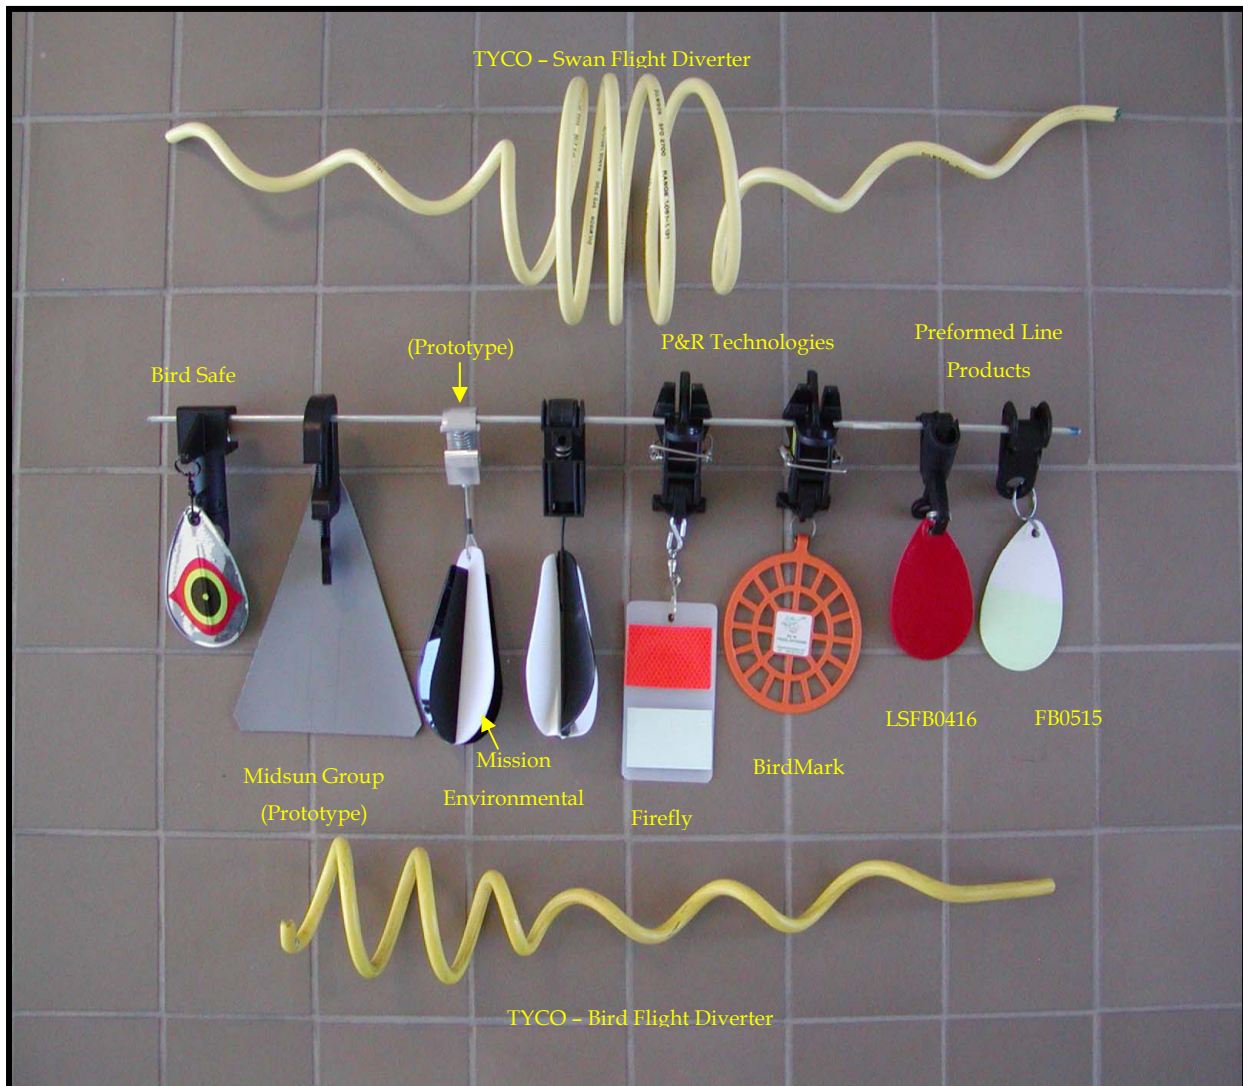
Figure 1. Flight diverters tested as part of the project

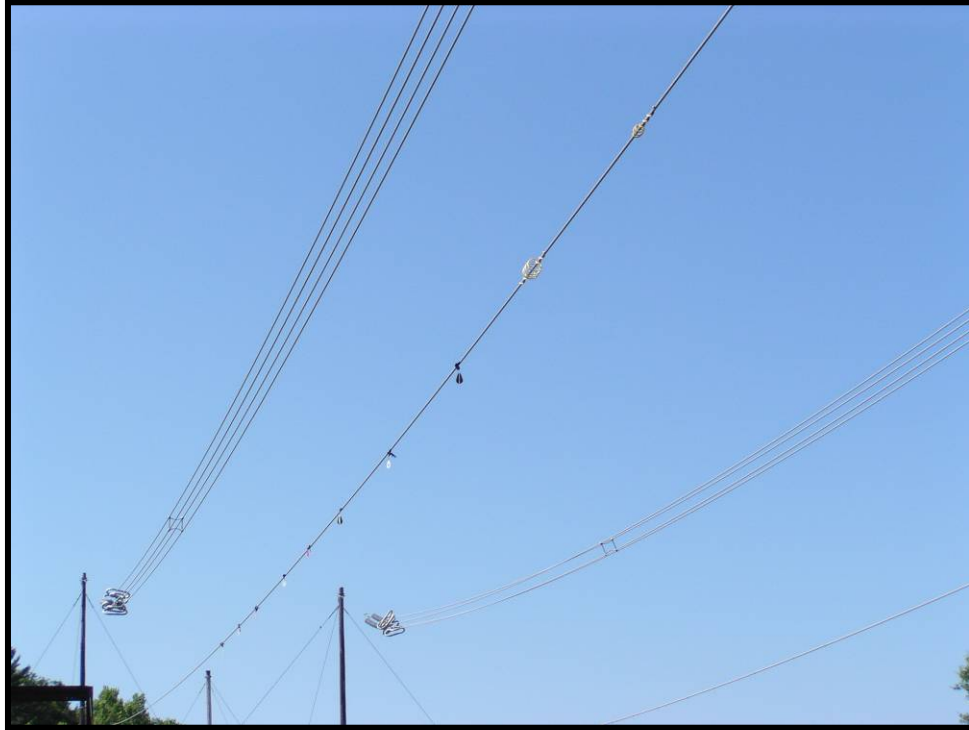
Figure 2. Test setup

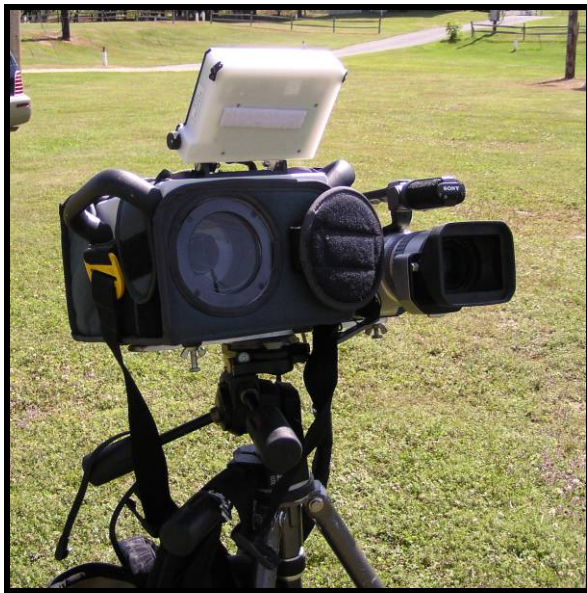
Figure 3. DayCor II camera

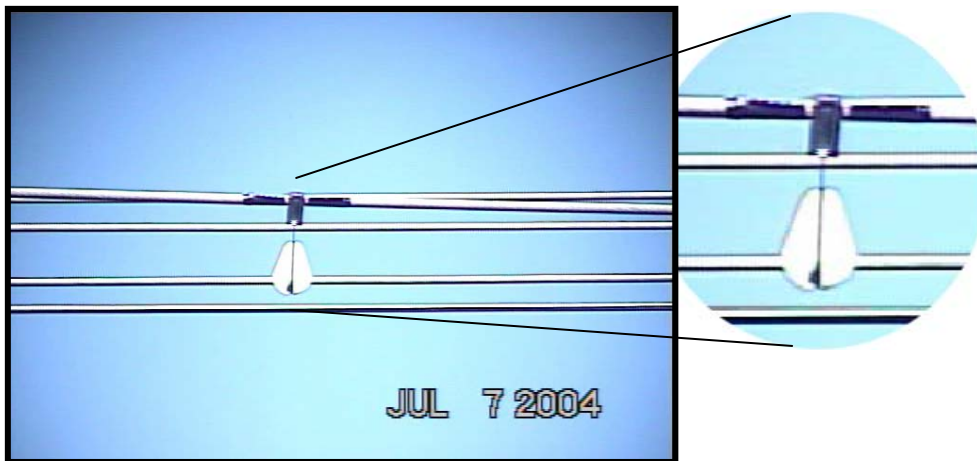
Figure 18. Level 2: Definitely detectable corona (*at bottom of cable clamp*)

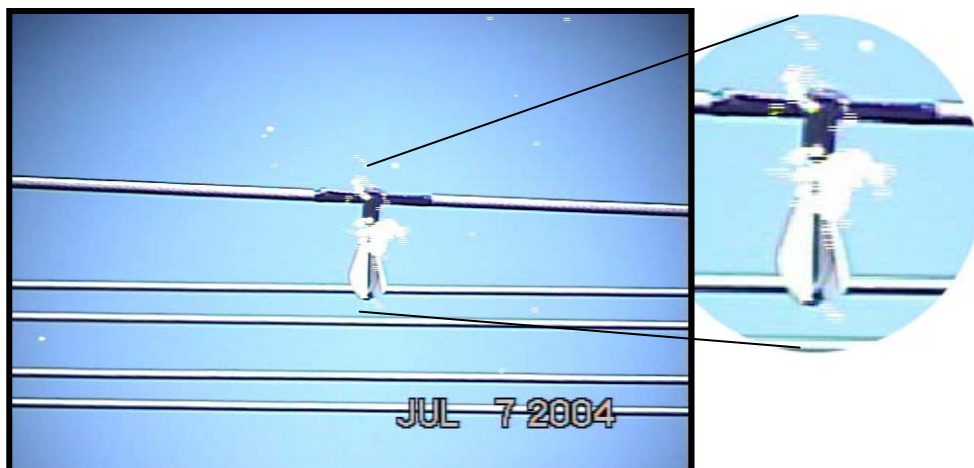
Figure 20. Level 4: High level of corona

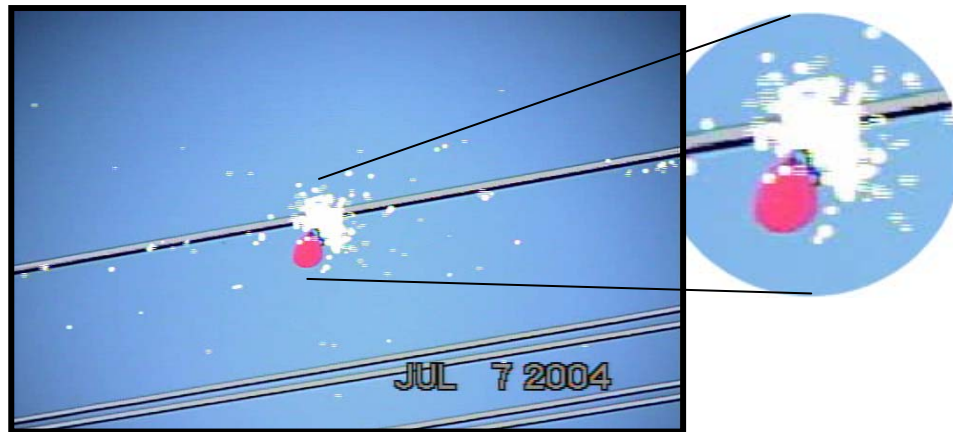
Figure 21. Level 5: Very high level of corona

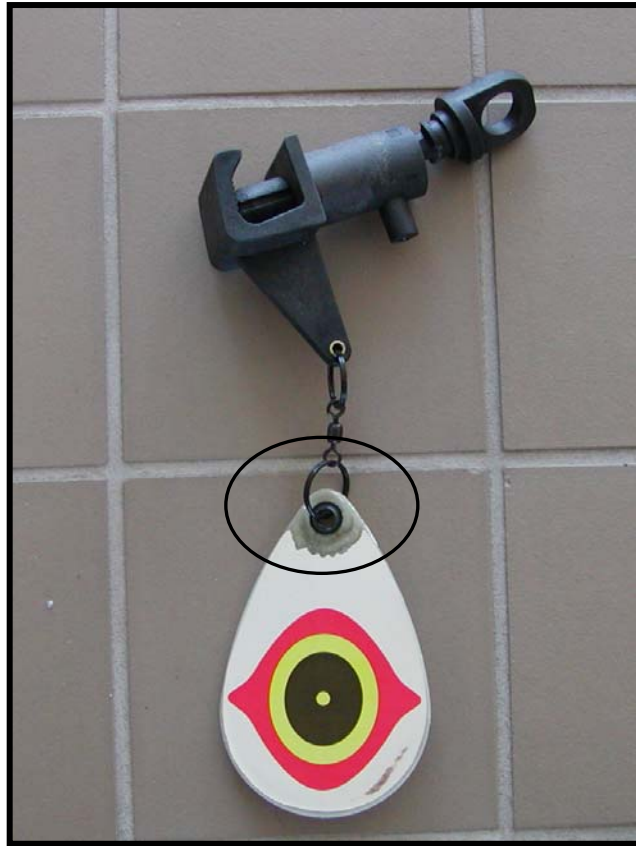
Figure 22. Corona-induced damage on diverter #5

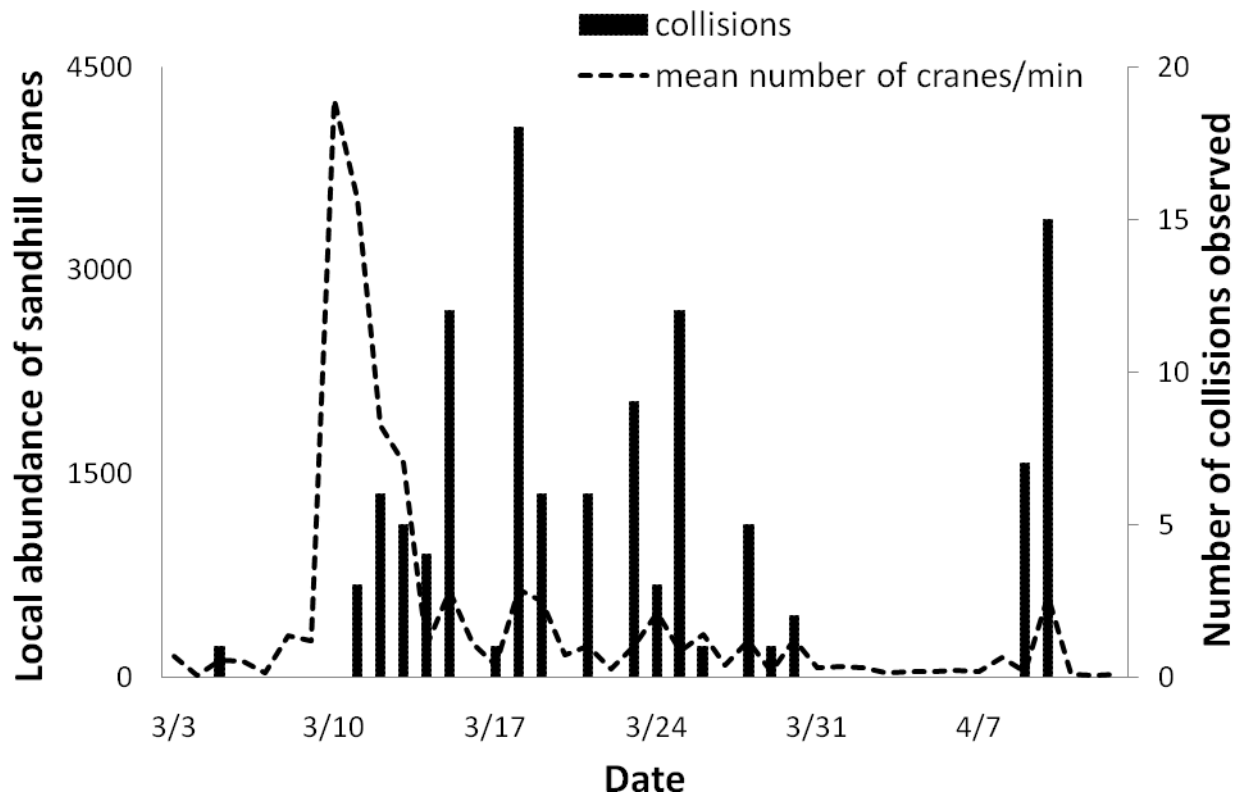
Figure 1. Relationship between the observed number of collisions by sandhill cranes with the eastern powerline over the Platte River at Rowe Sanctuary in Buffalo County, Nebraska, and local abundance of cranes defined as the mean number observed flying past the powerline per minute during evenings (i.e., about 0.5 hours before sunset until 2 hours after sunset), 3 March to 13 April 2009. Data were based on 30-second counts every 5 minutes.

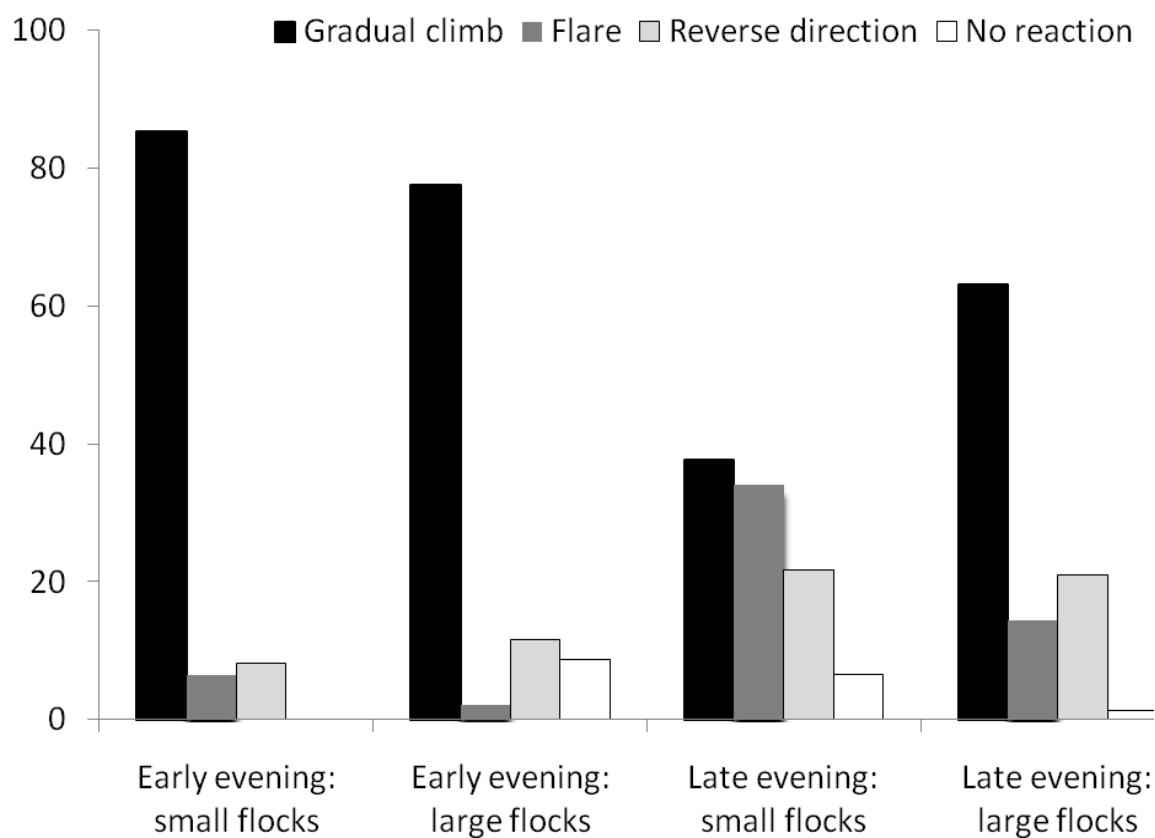
Figure 2. Behavioral reactions of flighted sandhill cranes to a 69-kV powerline over a night roosting area for the cranes on the Platte River at Audubon’s Lillian Rowe Sanctuary in south central Nebraska, as determined by direct observation, 3 March to 13 April 2009. Small flocks included one to three individuals and large flocks included more than three individuals. The first flock in each 5-minute interval was included in the sample. Numbers of reaction observations are in parentheses. Data were collected from about 0.5 hours before sunset until 2 hours after sunset; early evening was up to 45 minutes after sunset and late evening was more than 45 minutes after sunset. Flare was defined as a sudden increase in altitude as cranes flapped quickly to rise above the powerline.

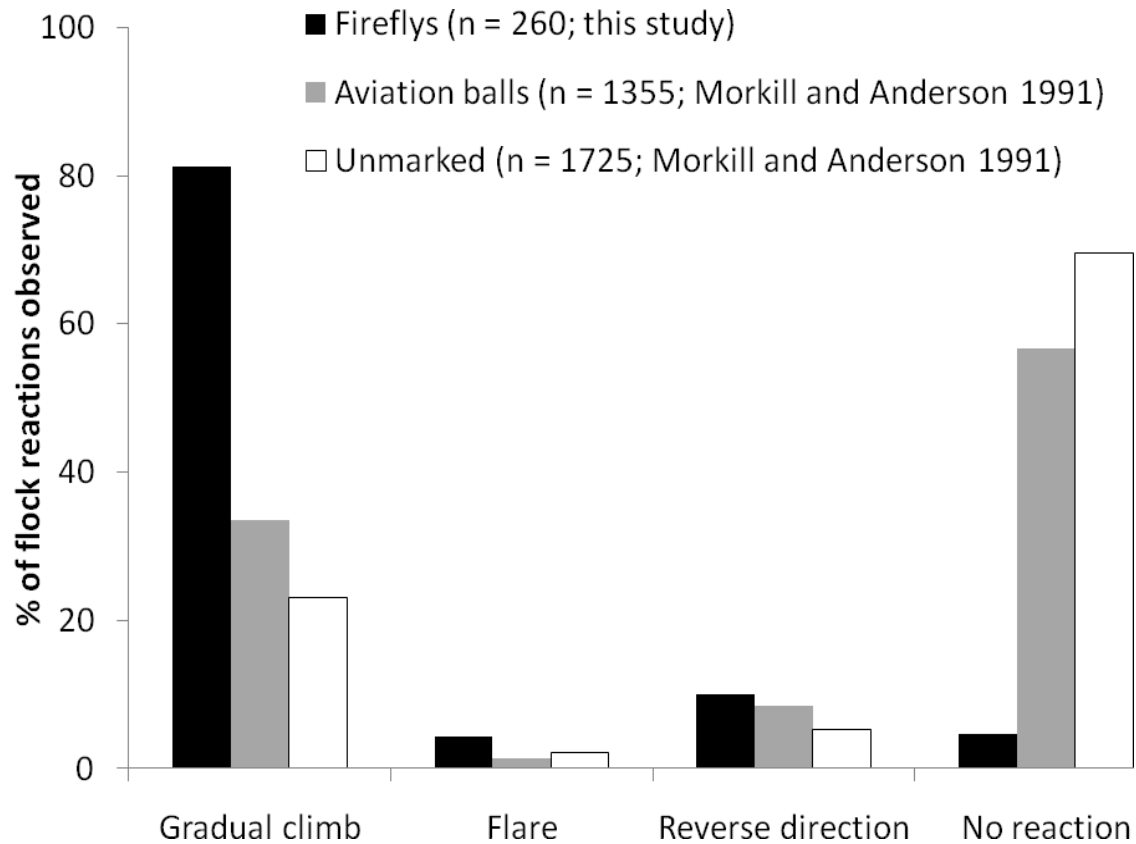
Figure 3. Behavioral responses of flighted sandhill cranes to a 69-kV powerline marked with Firefly avian flight diverters over the Platte River in south-central Nebraska during spring 2009, and of reactions of sandhill cranes to unmarked powerline spans and powerline spans marked with 30-cm diameter aviation marker balls over croplands in south-central Nebraska during spring 1988-1990, based on data in Morkill and Anderson (1991). Sample sizes (i.e., number of flock reactions observed) are in parentheses.

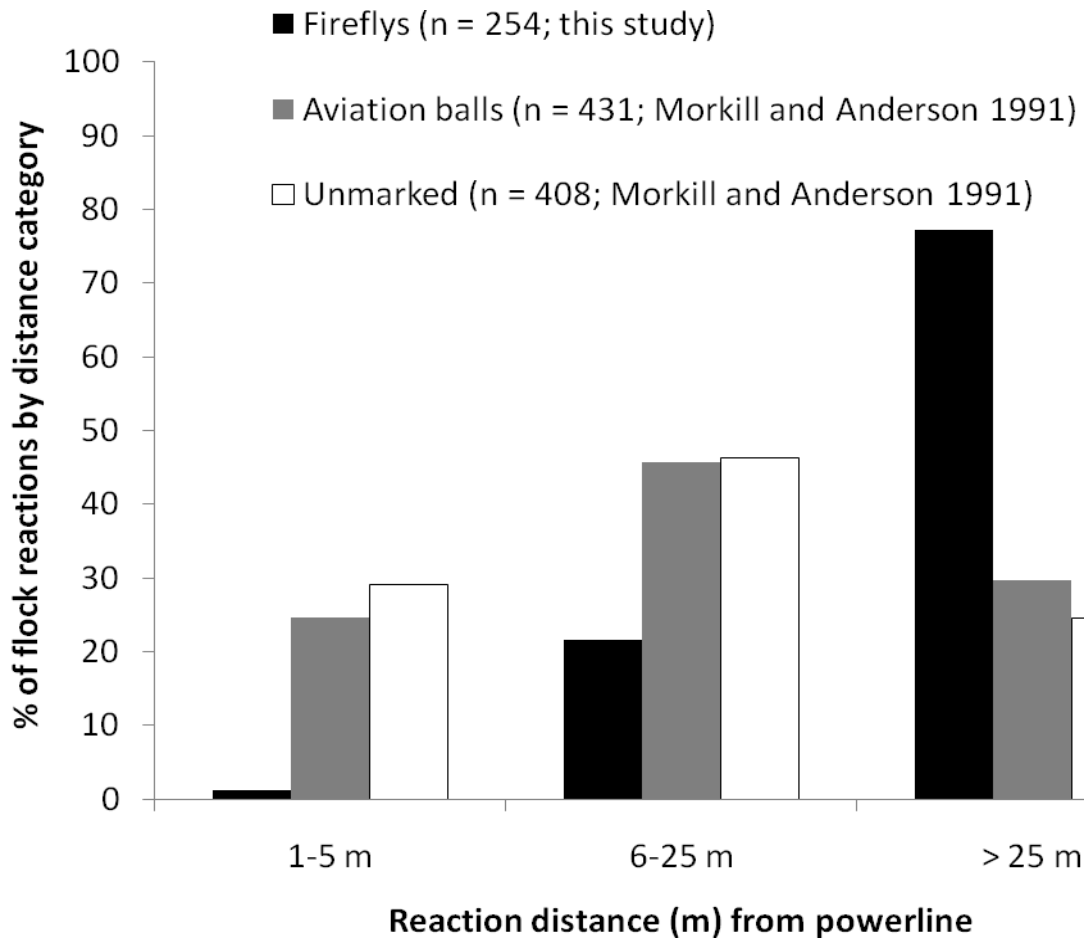
Figure 4. Frequency distribution of distances of initial reactions of flighted sandhill cranes to a 69-kV powerline marked with Firefly avian flight diverters over the Platte River in south-central Nebraska during spring 2009, and of reactions of sandhill cranes to powerline spans marked with 30-cm diameter aviation marker balls and to unmarked spans over croplands in south-central Nebraska during spring 1988-1990, based on data in Morkill and Anderson (1991). Sample sizes (i.e., number of flock reactions observed) are in parentheses.

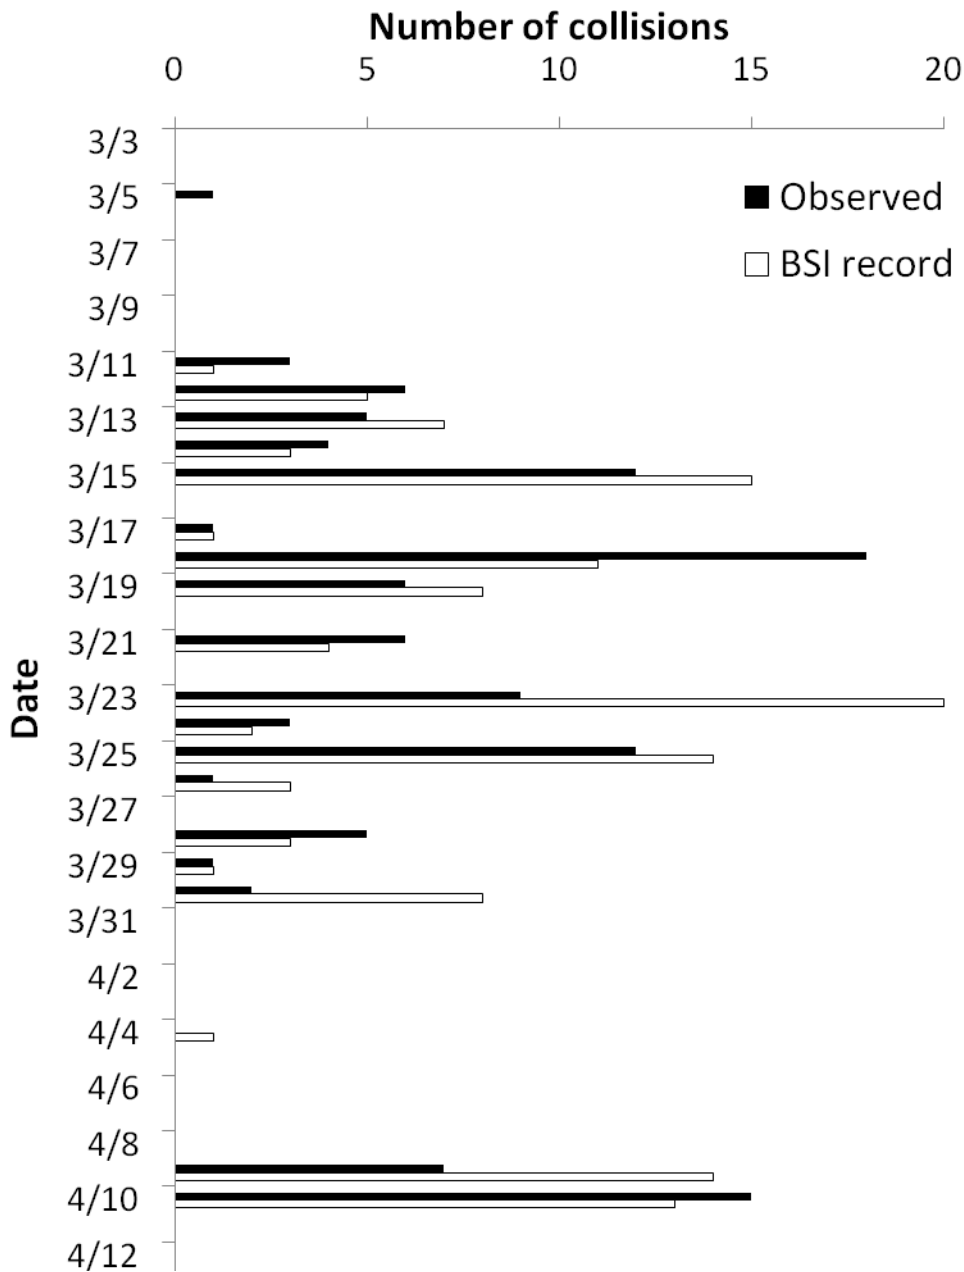
Figure 5. Number of collisions by birds with the eastern powerline over the Platte River at National Audubon Society's Lillian Rowe Sanctuary in south central Nebraska, as recorded by direct observation and by electronic bird strike indicators (BSIs; EDM International, Fort Collins, Colorado) during evenings, 3 March to 13 April 2009. All collisions directly observed were of sandhill cranes, while those recorded by BSIs were of relatively large birds of unknown species. No BSI data were collected on 3 March.

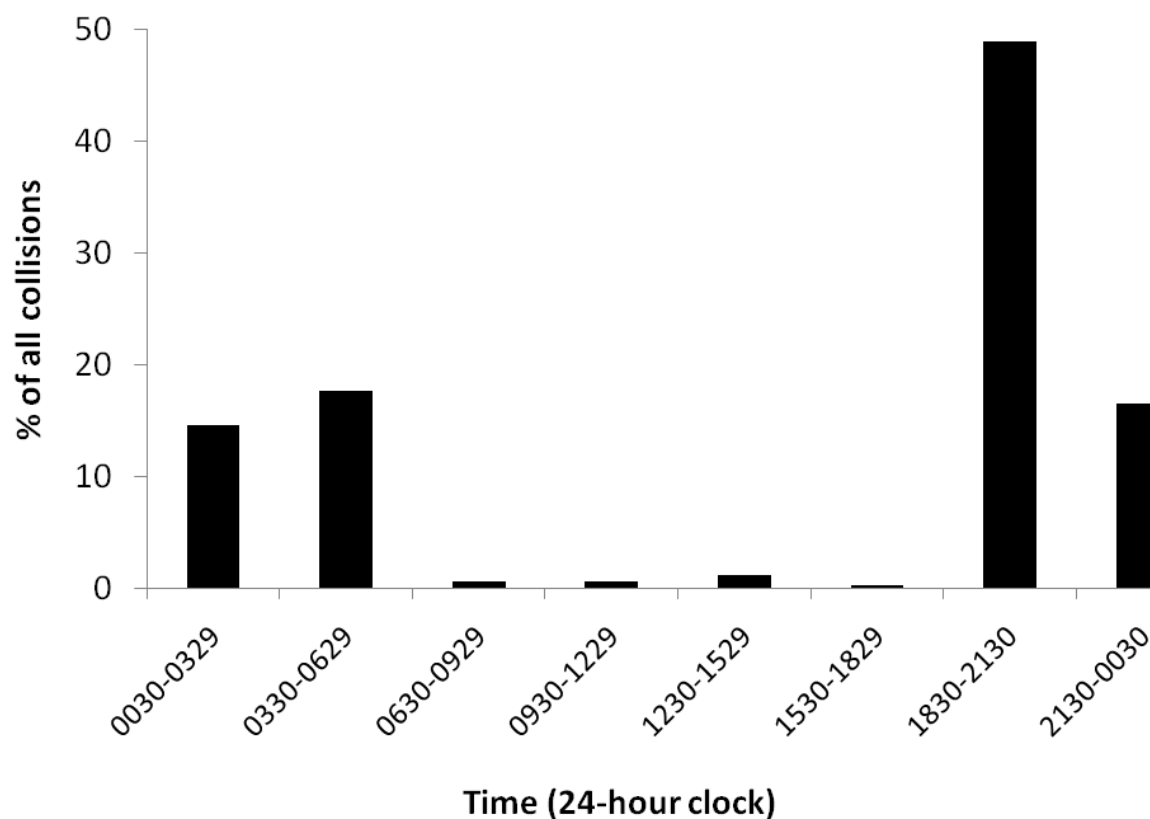
Figure 6. Diel timing of collisions by birds with the eastern powerline at National Audubon Society's Lillian Rowe Sanctuary in south central Nebraska, as detected by electronic bird strike indicators (EDM International, Fort Collins, Colorado) during 11 February to 15 April 2009. Data are presented as percentage of total collisions recorded (n = 358).

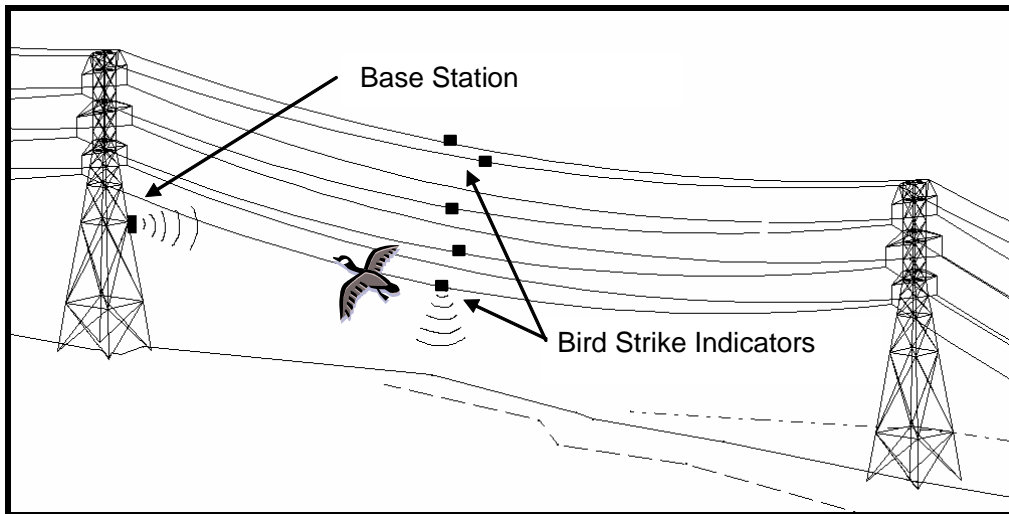
Figure 1. Schematic showing attachment locations for bird strike indicators and their associated base station on a power line

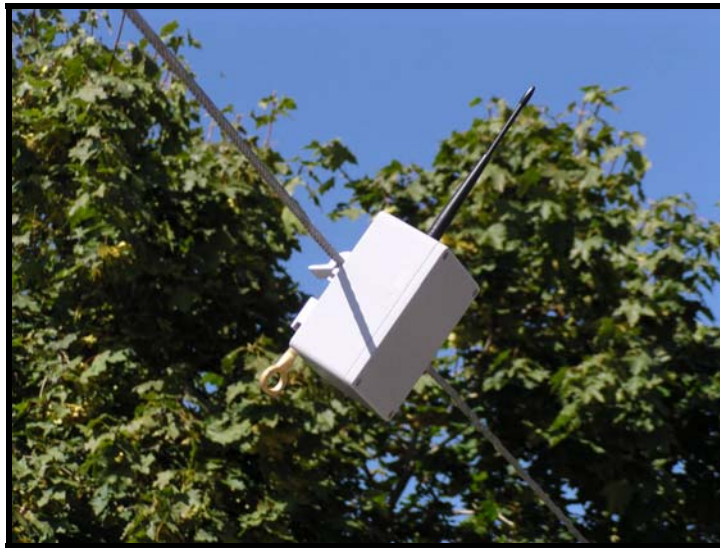
Figure 2. BSI sensor installed on a wire

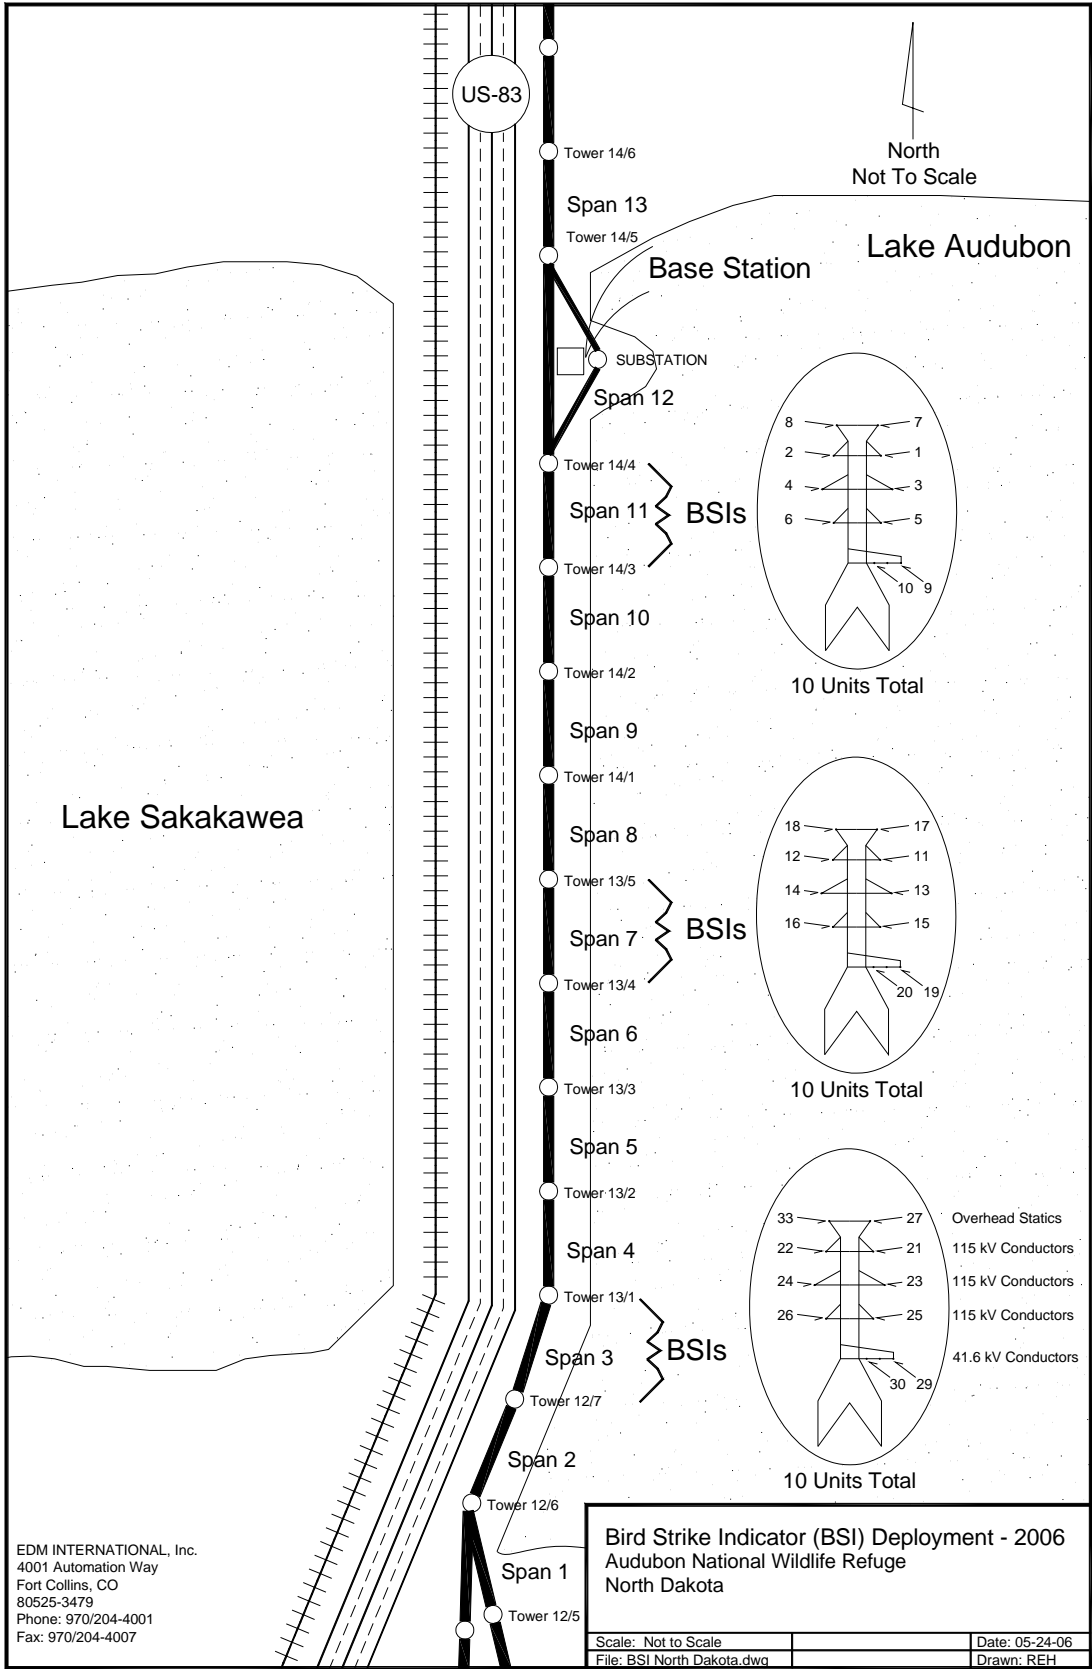
Figure 6. BSI sensor installation detail for the North Dakota field trials

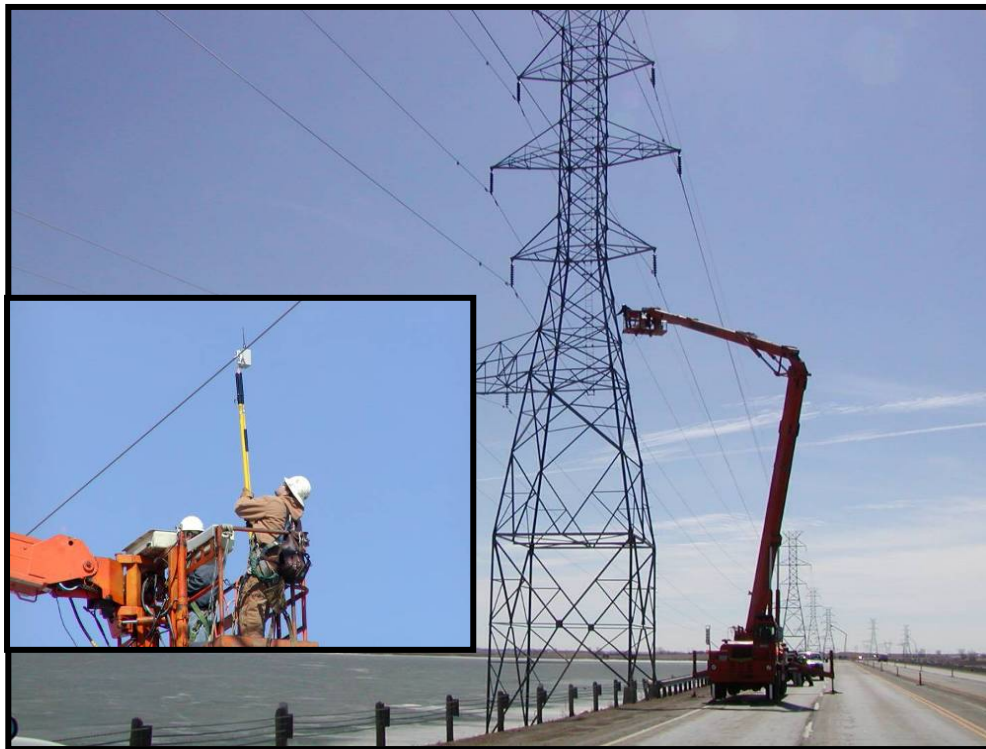
Figure 7. Installation of BSI sensors using a bucket truck and hot stick

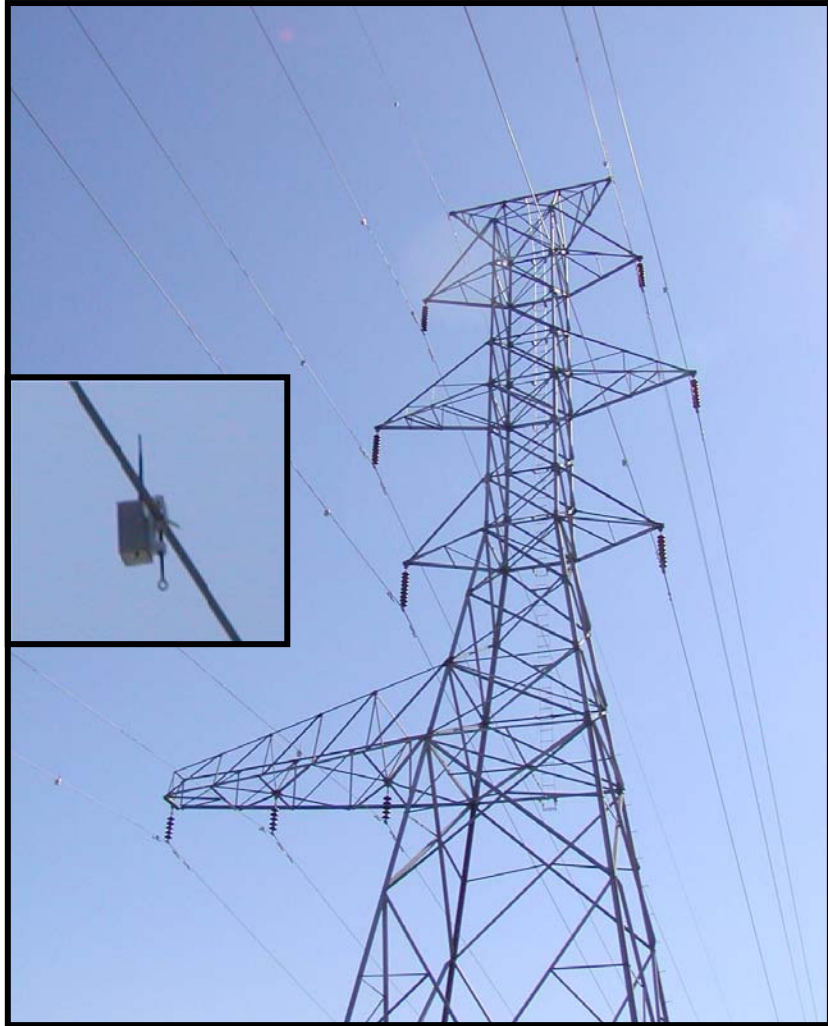
Figure 8. Sensors installed on a typical span at the North Dakota test site

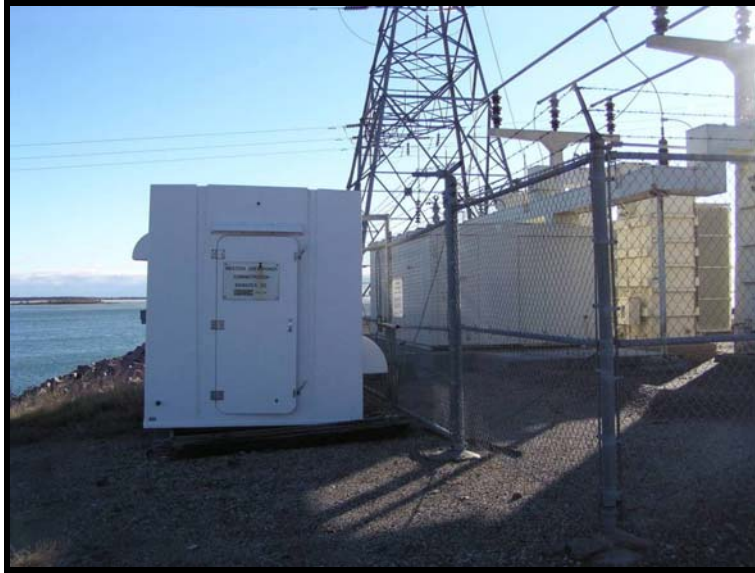
Figure 6. Communication shack housing the BSI base station

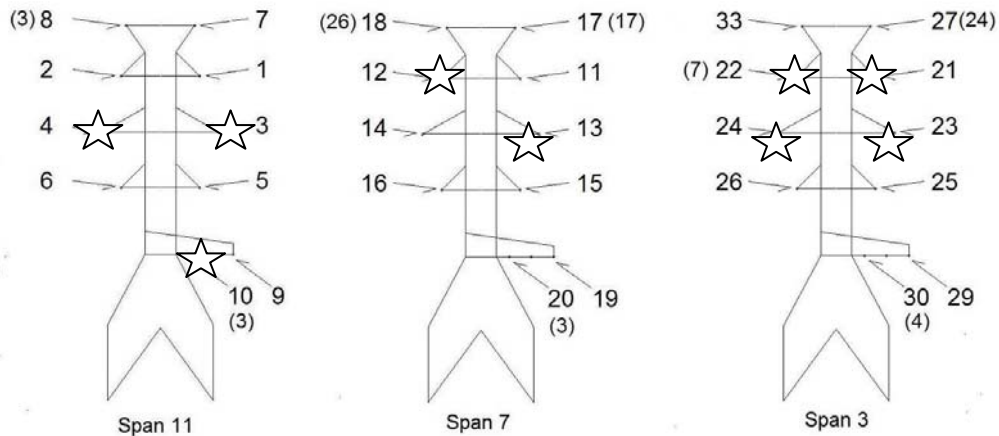
Figure 9. Representation of BSI sensors recorded strikes (number in parenthesis is the number of bird collisions recorded by that sensor). Stars represent units that failed at some point during the field trials.

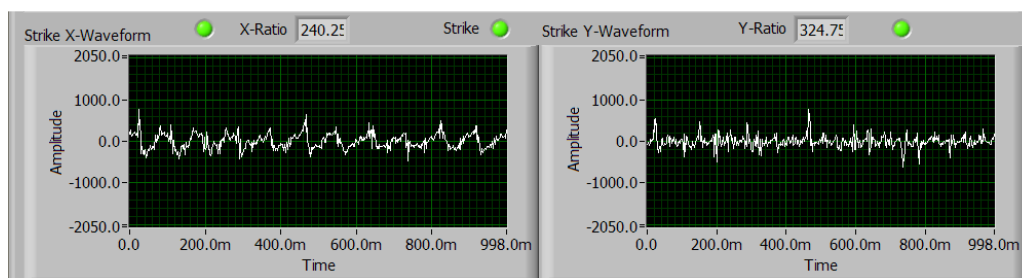
Figure 14. A typical train-induced vibration recording

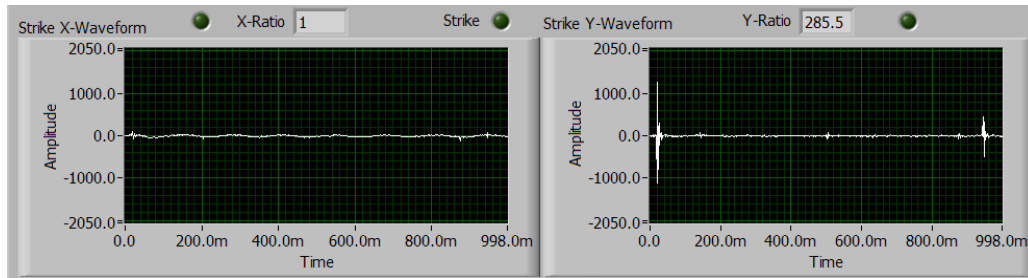
Figure 15. Vibration signature likely produced by hail

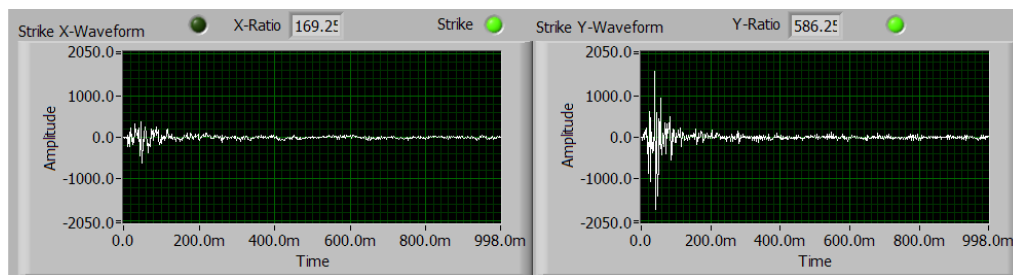
Figure 16. Vibration signature produced by extreme wind gusts exceeding 30 to 40 mph

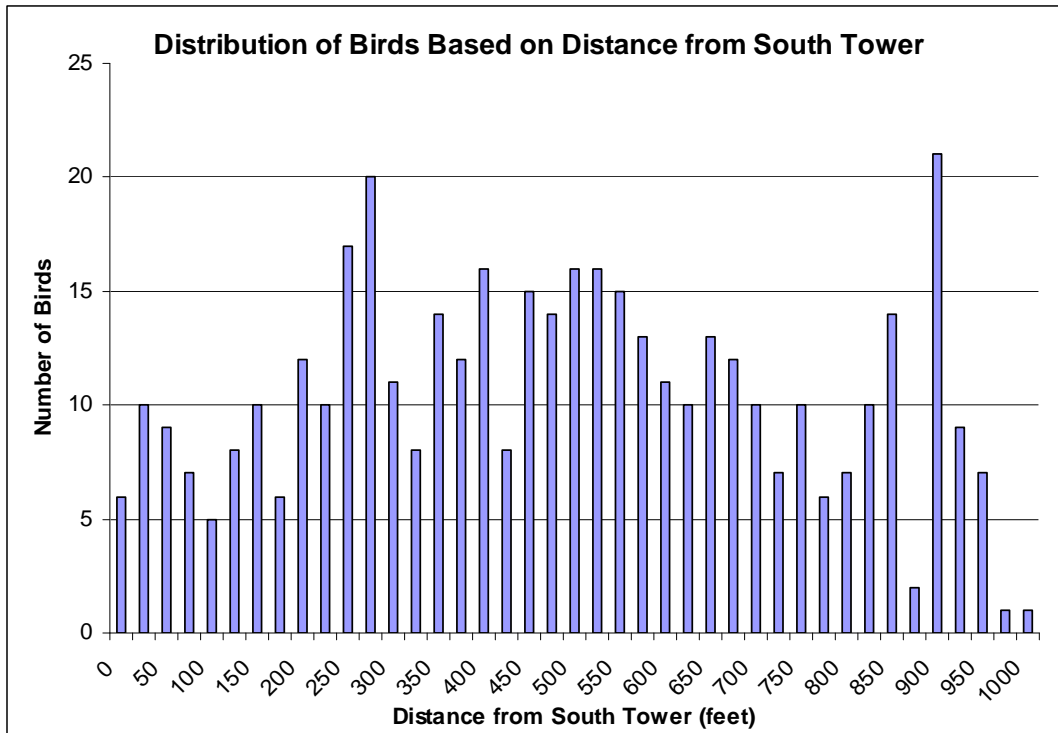
Figure 17. Distribution pattern of dead birds based on distance from tower locations
