Reactions of Sandhill Cranes Approaching a Marked Transmission Power Line

Citation: Murphy RK, Dwyer JF, Mojica EK, McPherron MM, Harness RE. 2016. Reactions of sandhill cranes approaching a marked transmission power line. *Journal of Fish and Wildlife Management* 7(2):480-489; e1944-687X. doi: 10.3996/052016-JFWM-037

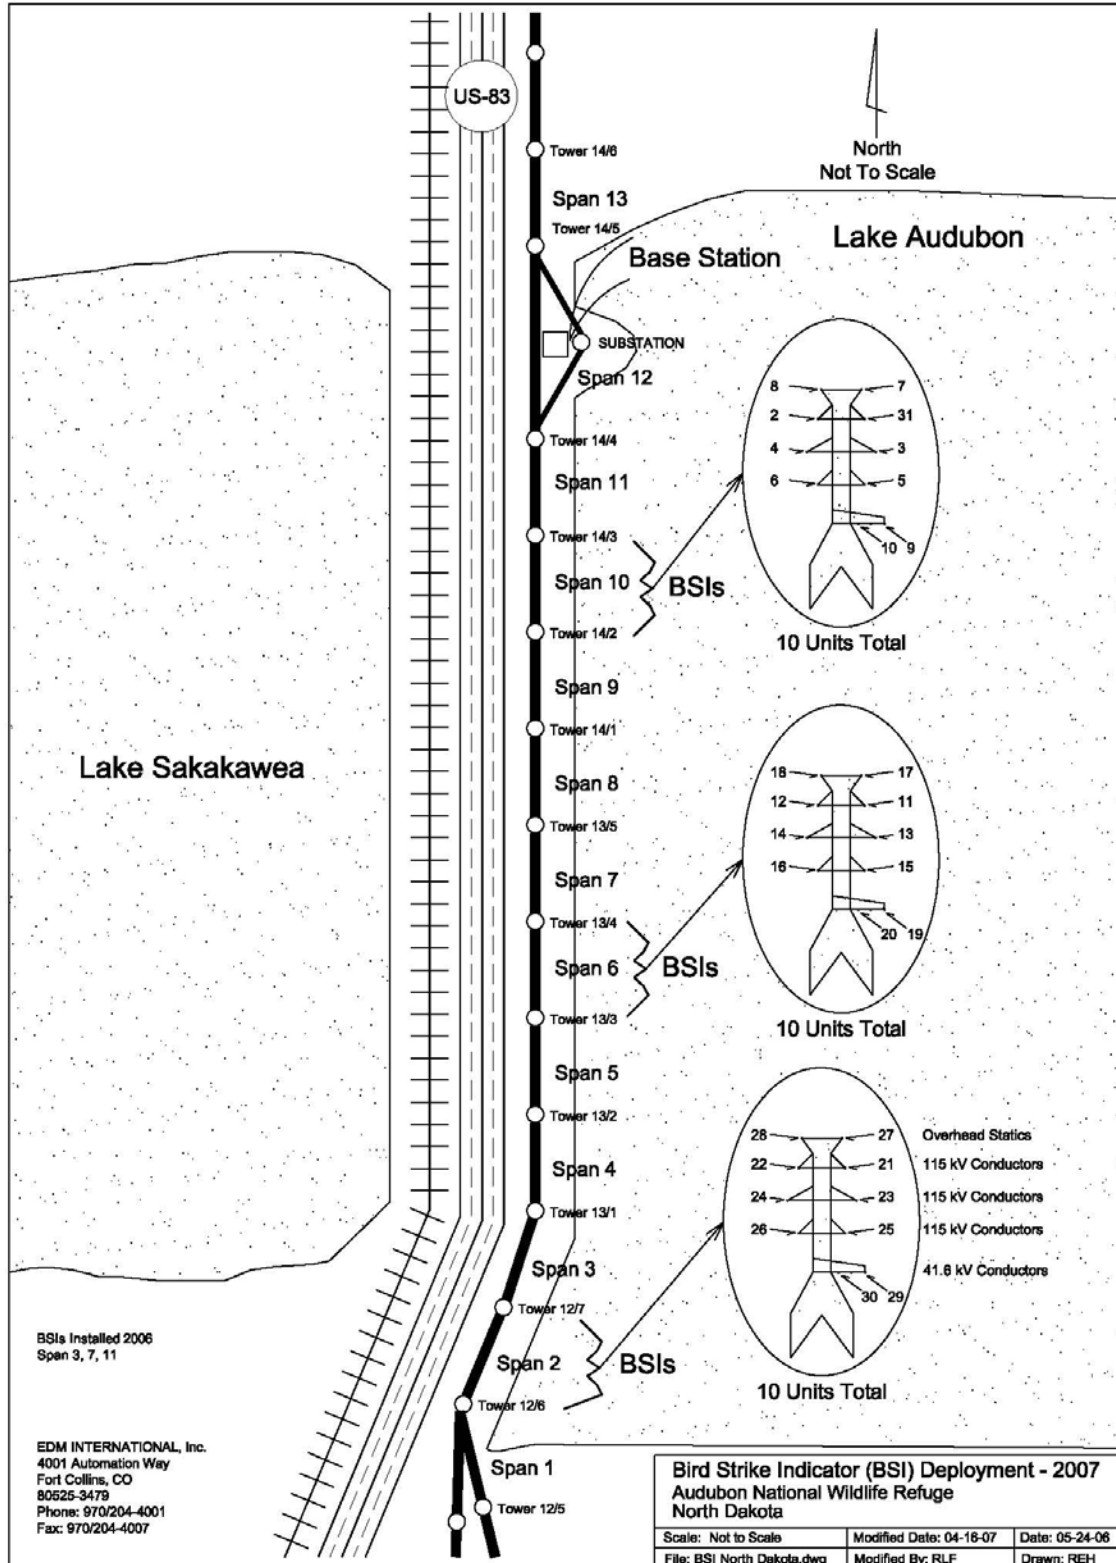
Figure 20. BSI sensor installation details for the 2007 field tests

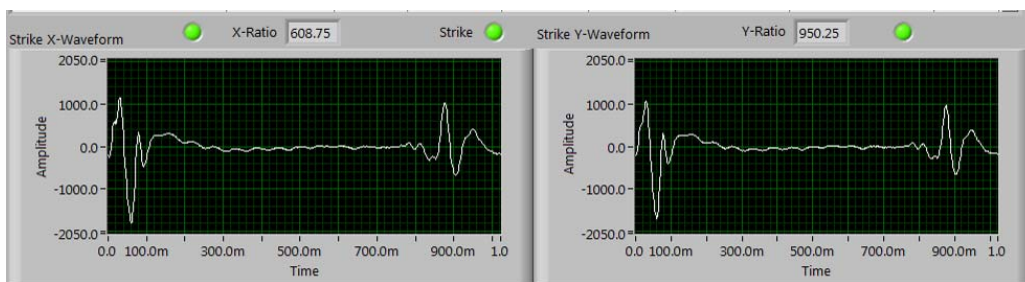
Figure 22. Vibration recording from a likely two-bird collision within a second

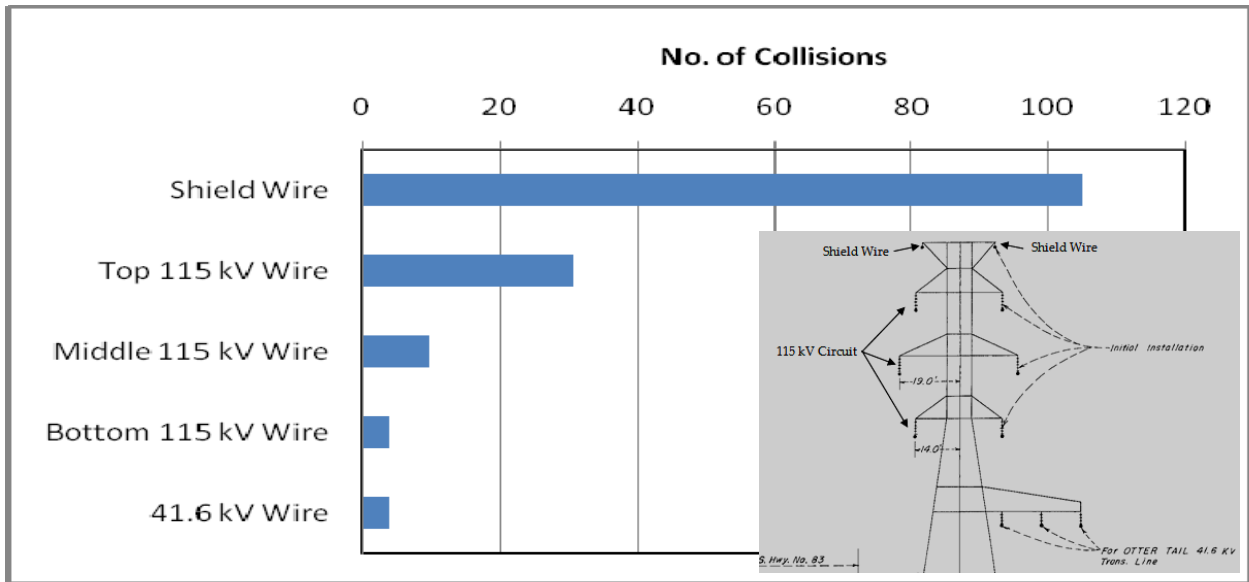
Figure 23. Summary of bird collision recordings in 2007 by wire location

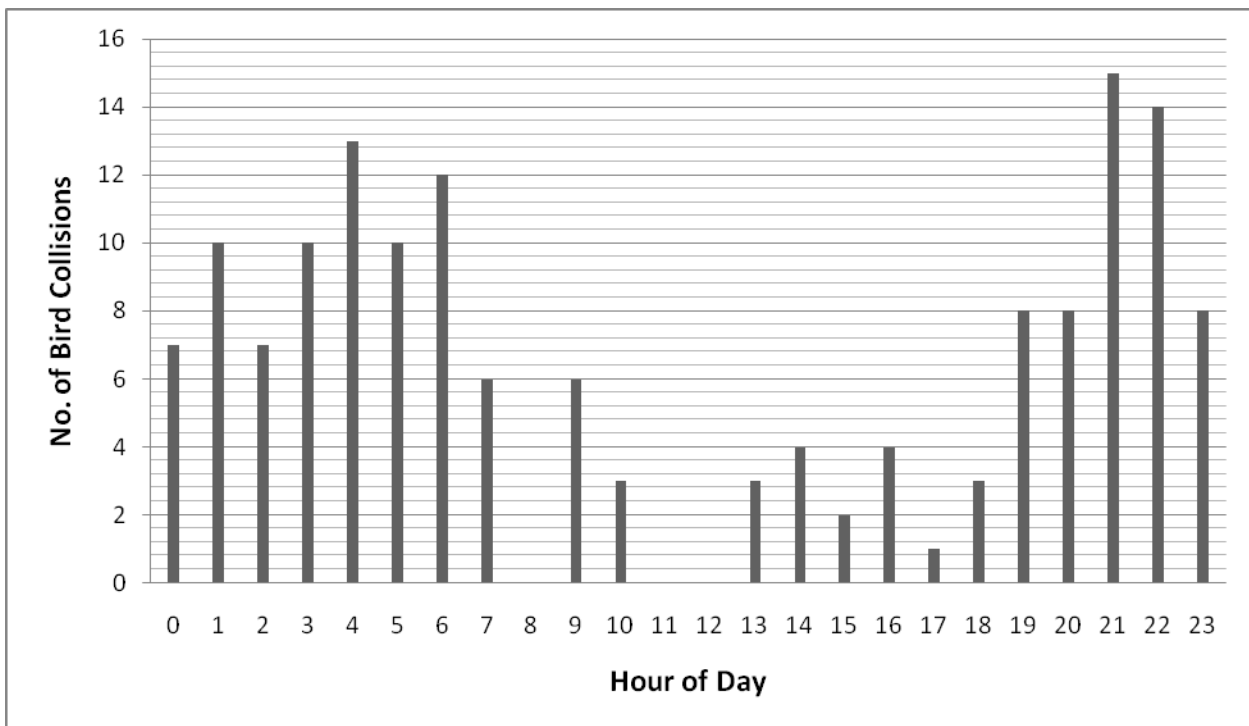
Figure 24. Bird collisions recorded in 2007, by hour of day

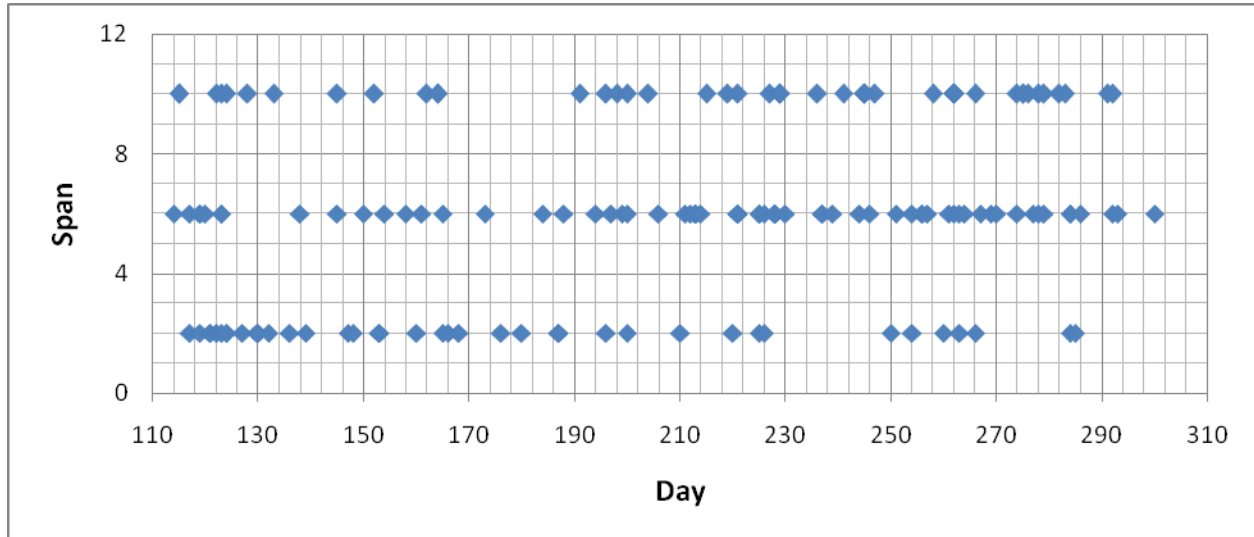
Figure 25. Bird collision recording distribution by day on the three spans
